All Saints Vestry

Kingston Upon Thames

**Historic Building Investigation
and Recording**

December 2006

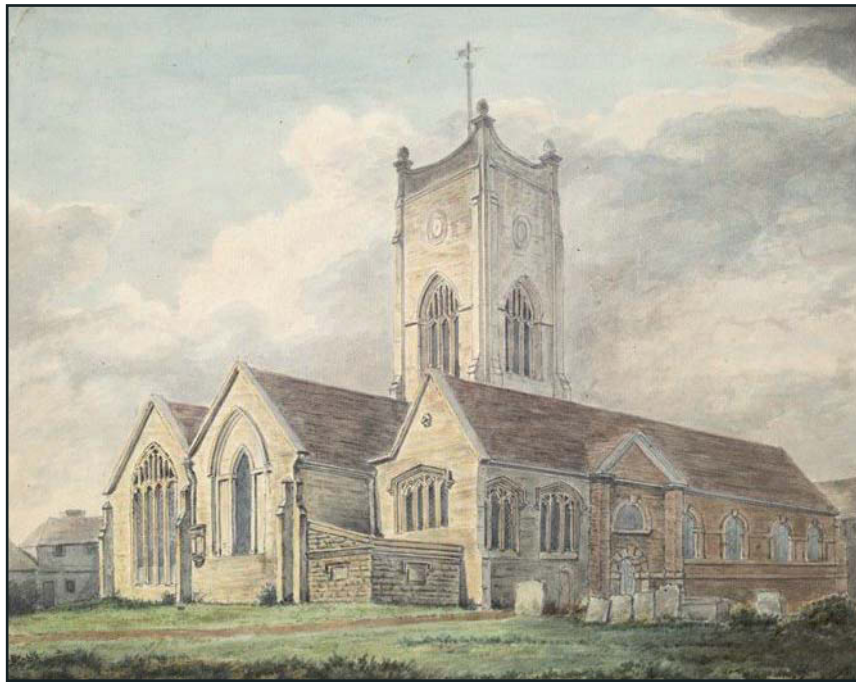
- 1.1.18 During the 19th century a doorway was inserted into the eastern elevation of the vestry. There is no evidence in the building fabric of an earlier doorway prior to this date and early sketches of the church confirm this (Figures 2 and 3).

Figure 2: All Saints Vestry, Kingston: 1787 sketch
'View of Kingston church in the county of Surrey'

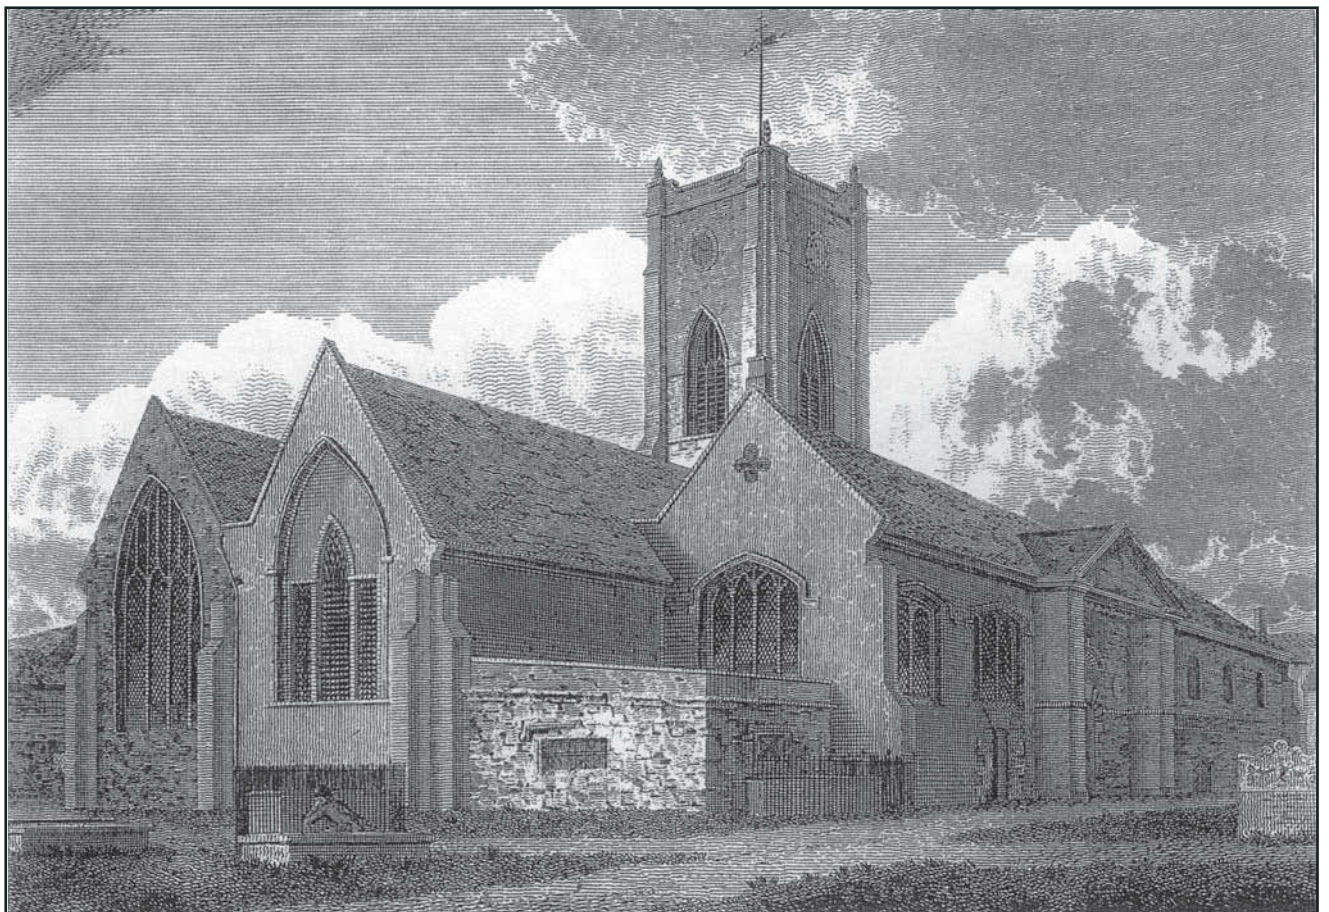
- 1.1.36 Sketches of the church dated 1787 do not show a chest tomb in this position but a drawing dated 1798 does. This indicates that the chest tomb was erected at the end of the 18th century. It is also likely that the tomb has been reset at some point.

Figure 3: All Saints Vestry, Kingston: 1798 sketch 'All Saints Kingston' by JP Malcolm

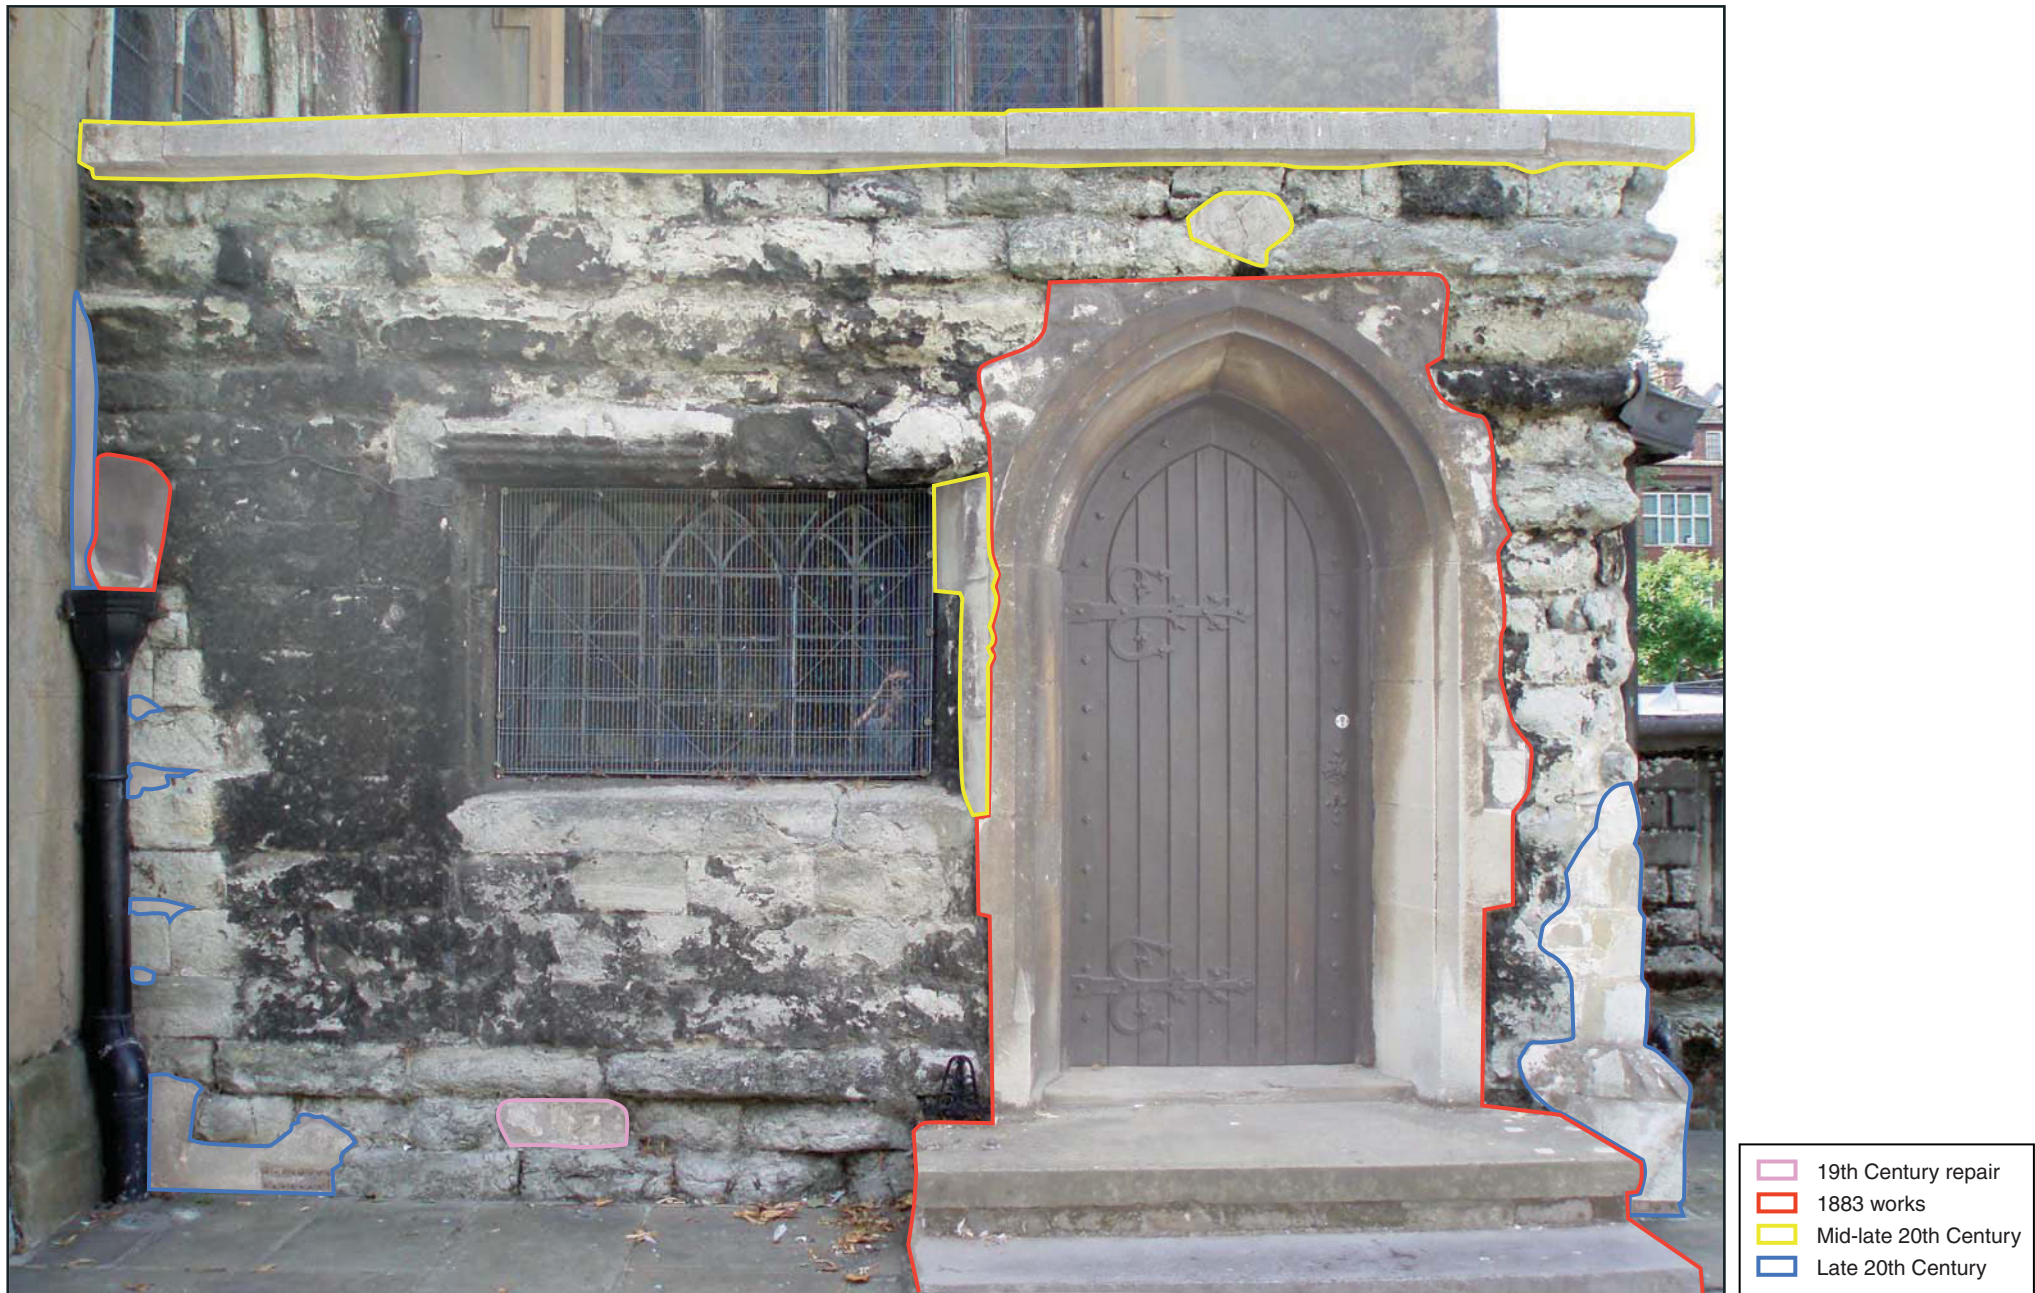
Figure 4: All Saints Vestry, Kingston: Phased east elevation

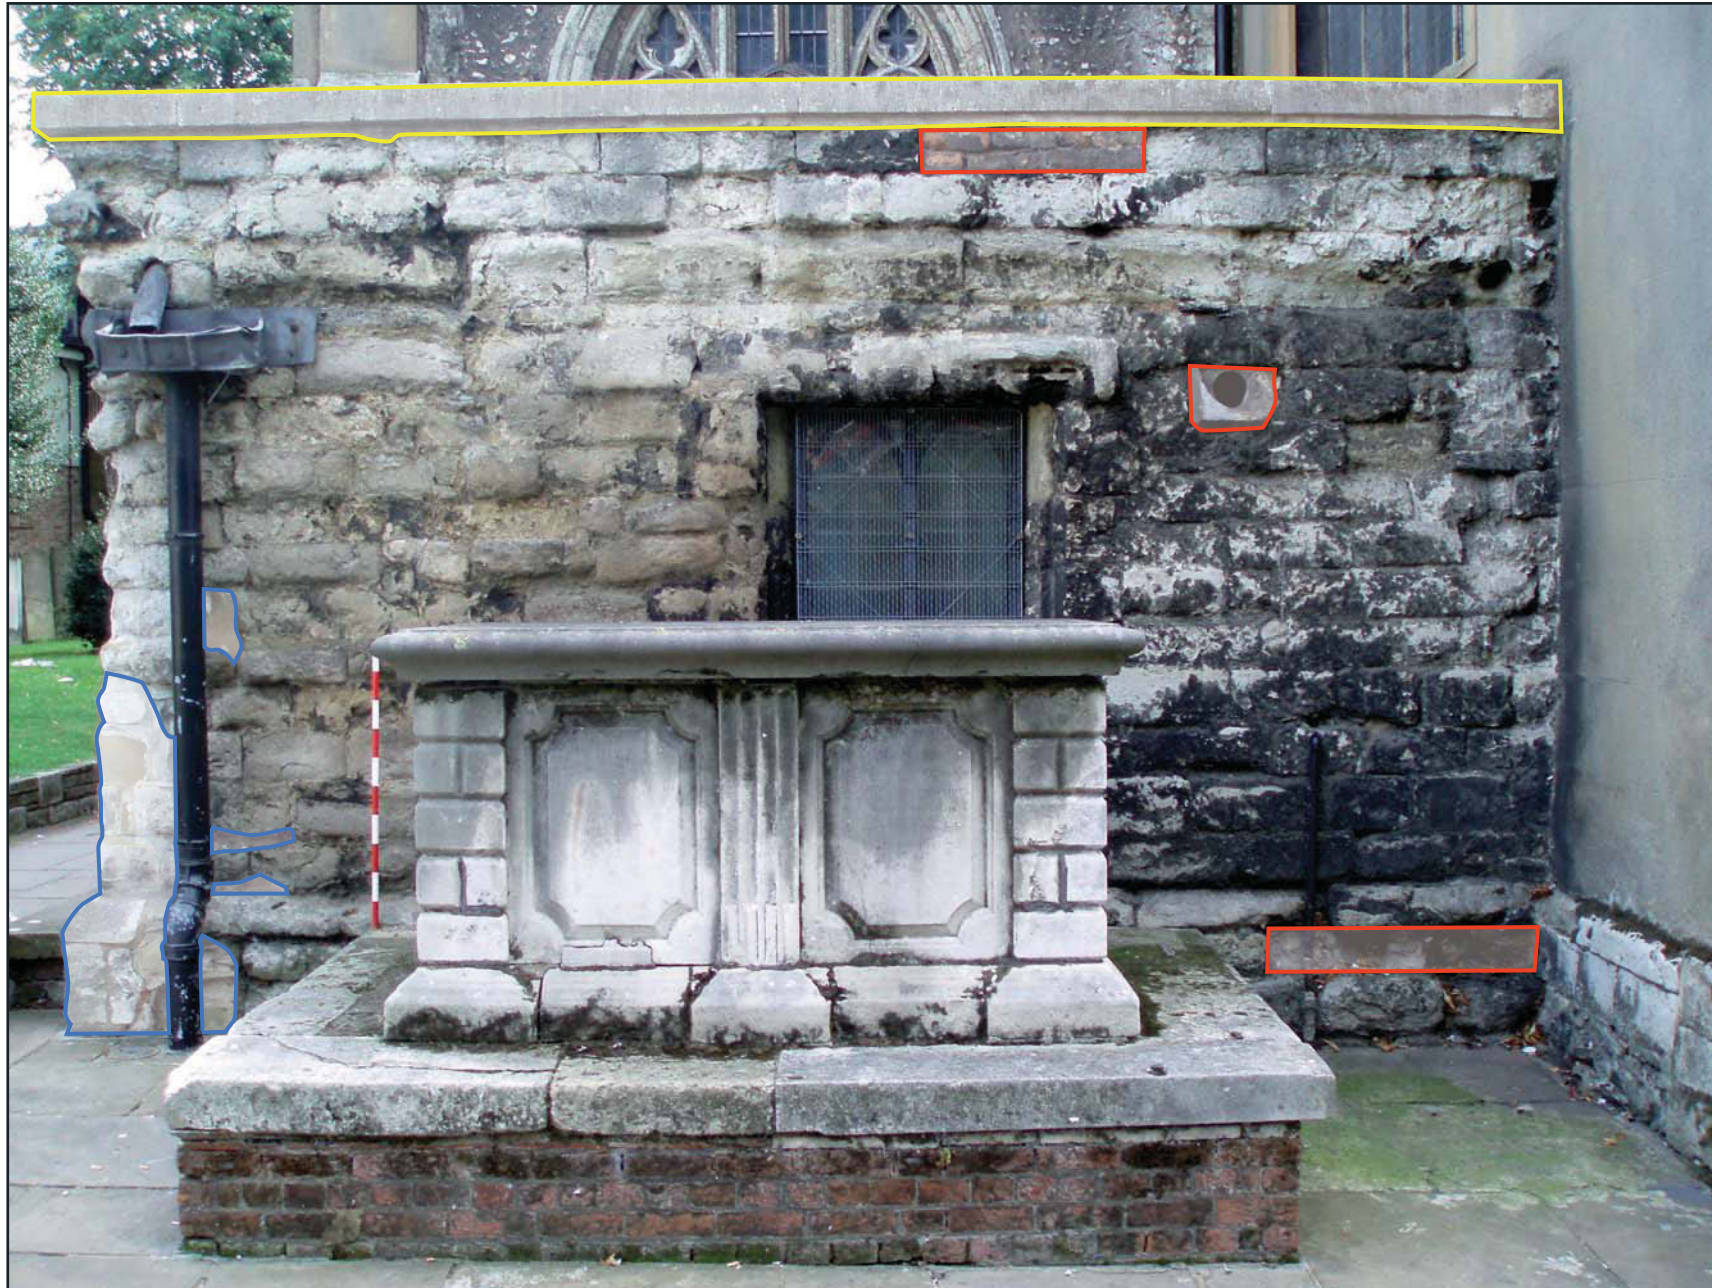
Figure 5: All Saints Vestry, Kingston:Phased north elevation

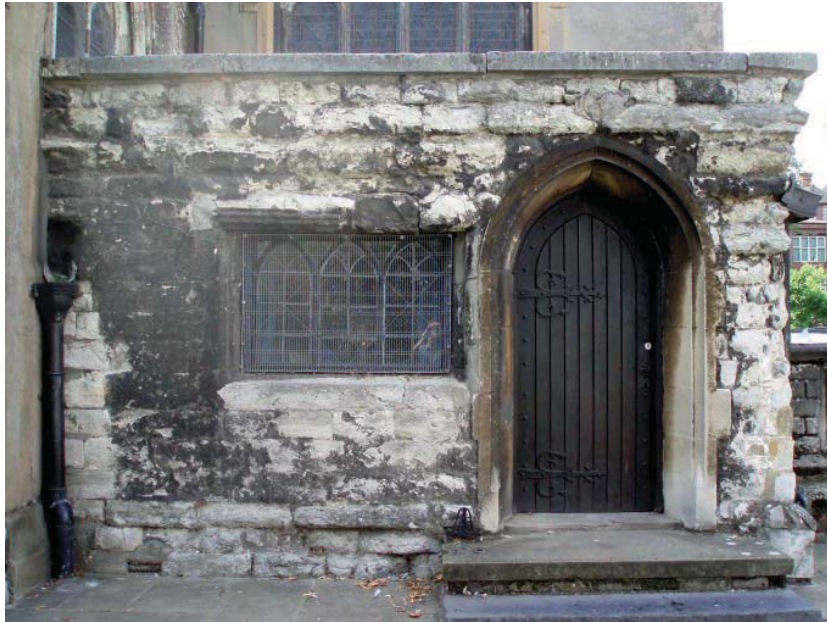
1.1.16 The stonework is mostly primary but large parts are badly eroded and in need of repair. Most stones are very blackened by calcification and pollution but some stones appear clean as fracturing has occurred and the exterior layer has fallen off. This is probably as a result of brushing the stonework for assessment. Some stones are heavily fragmented.

Plate 1: All Saints Vestry, Kingston: East Elevation

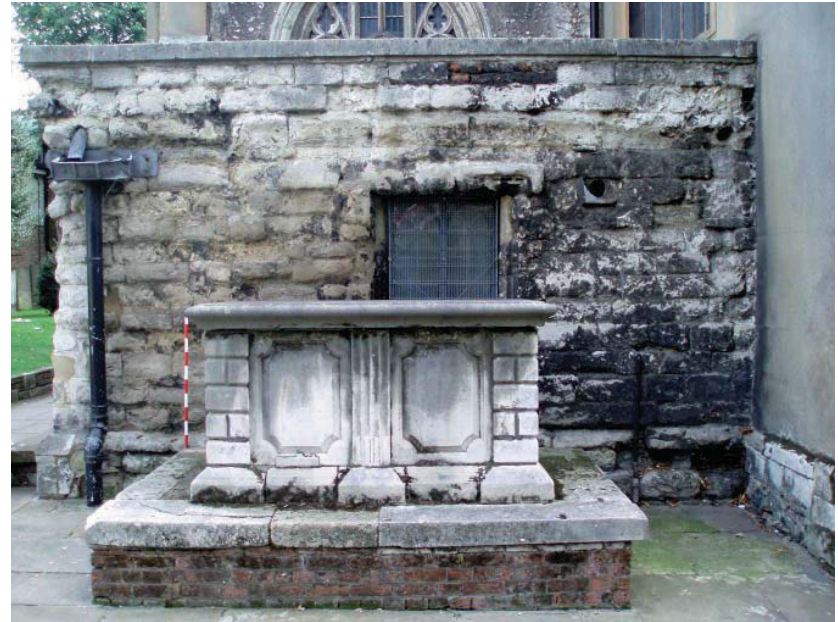
1.1.26 As with the east elevation, the stonework mostly appears primary with some areas of repair and replacement. The string course continues from the east elevation but is very weathered.

Plate 2: All Saints Vestry, Kingston: North Elevation

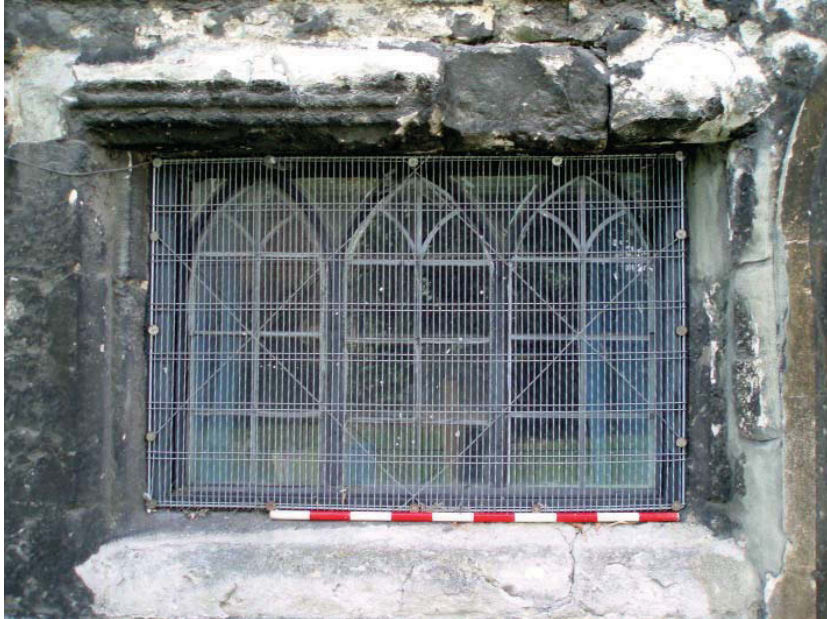
- 1.1.21 Immediately to the south of the door is a primary square headed window (135 x 190 cms) with moulded head, sill and jambs, suggestive of an early 16th century date. The moulded hood around the top of the window is extremely weathered, however the moulding is visible on the southern side. The end of the moulding on the northern side has been cut by the later insertion of the doorway. The moulding arches out approximately 10 cms from the base of the stone. One stone has the face fractured off and therefore has no decorative moulding.

- 1.1.22 The jambs of the window are moulded in a reveal design and there are claw tool marks visible on the south jamb. There is one replacement stone on the north side of the window, this stone also has recent mortaring and is part of repairs to the south eastern jamb of the doorway. The sill is formed from two pieces of stone, which are moulded, and there is a thin layer of slate below the bed joint of the sill masonry at the base of the window. There is a cast iron frame with three arch detail. Some of the lead is recent replacement. The window frame probably dates to the 19th century. The frame and glass are covered by a modern metal protective grille. There is a metal fitment remnant beside the window which is possibly part of a shutter fitting.

Plate 3: All Saints Vestry, Kingston: East elevation - detail of window

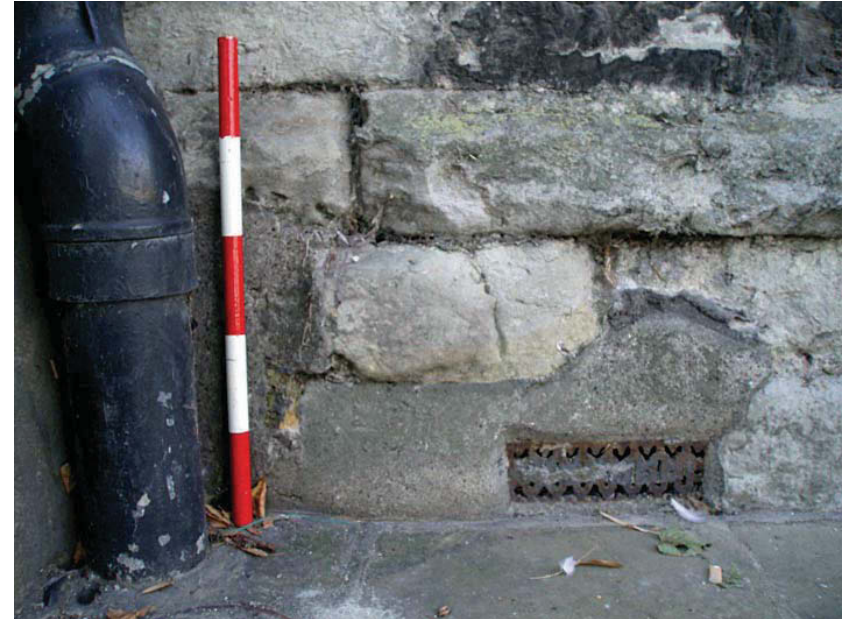
cementitious mortar repair work behind the drainpipe. At the base of the pipe the mortaring extends outwards to a nearby vent. The hole is not lead lined and the stonework within is extremely calcified suggesting it has been there a long time. However, it is probable that this drain was inserted at the time of the 19th century works to the vestry to allow rainwater egress from the newly realigned roof.

Plate 4: All Saints Vestry, Kingston:
East elevation - repair at base of pipe

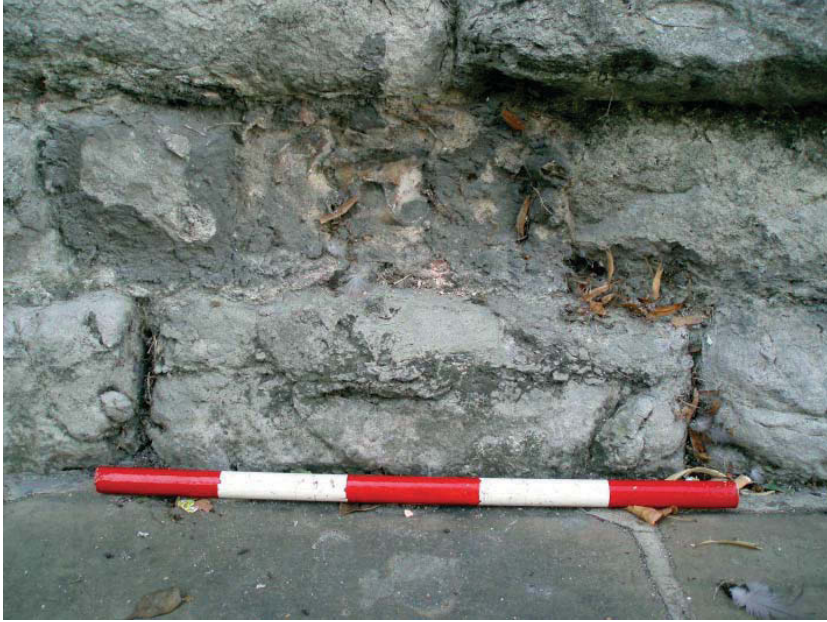
- 1.1.23 At the base of the elevation a single stone has been removed. There is rubble infill but this is recessed into the wall. It is possible that either the rubble infill has eroded or a stone face was applied but has since been lost. This may be the location for a vent which was later closed up.

Plate 5: All Saints Vestry, Kingston:
East elevation - rubble infill at base of elevation

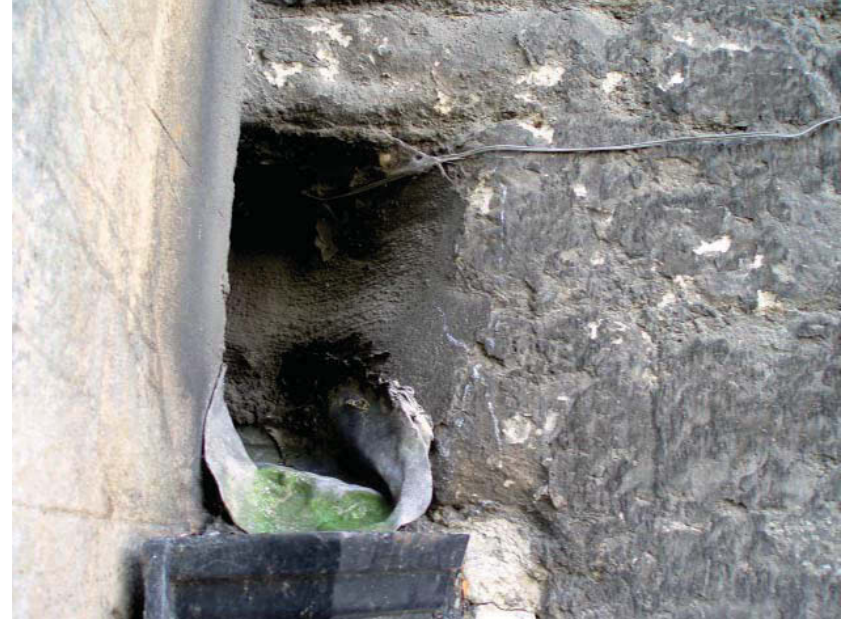
- 1.1.24 There is an unlined drain hole on the southern corner, which begins five courses from the top course. A pipe runs down to the base of the building. There is recent

Plate 6: All Saints Vestry, Kingston:
East elevation - drain hole to south east

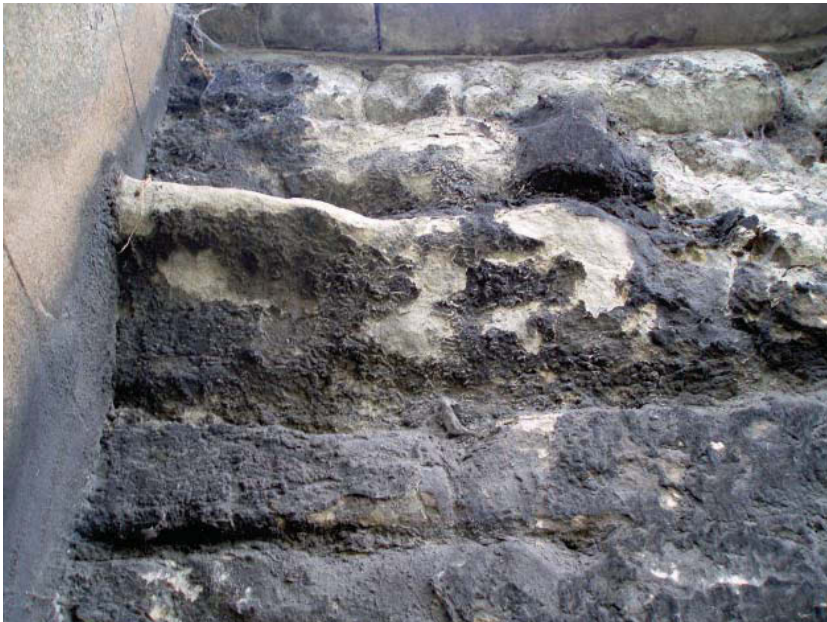
1.1.17 There is a line of prominent string coursing forming the third course down from the top of the wall. The string course is extremely weathered and on this elevation is

most prominent on the extreme south eastern side.

Plate 7: All Saints Vestry, Kingston:
East Elevation - string course

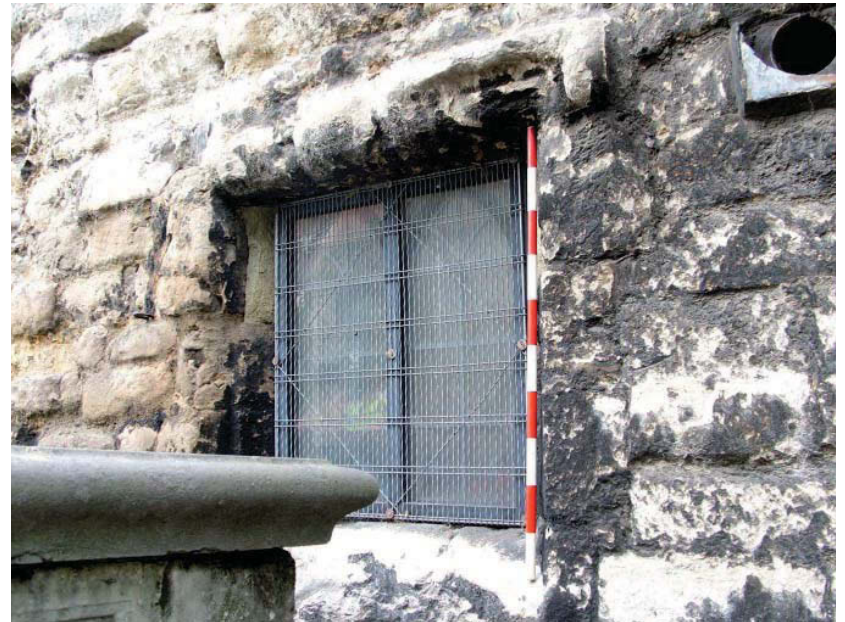
1.1.27 The main feature of the elevation is a window just to the west of centre. At 81 x 89cms the window is narrower than the east elevation window, the hood mould is heavily eroded and the moulding is only visible on the western side. The window has a two arch leaded decoration with clear glass and a protective metal grille. There are two metal fitment remnants either side of the window. The window appears to be primary and is suggestive of an early 16th century date.

Plate 8: All Saints Vestry, Kingston:
North Elevation - window detail

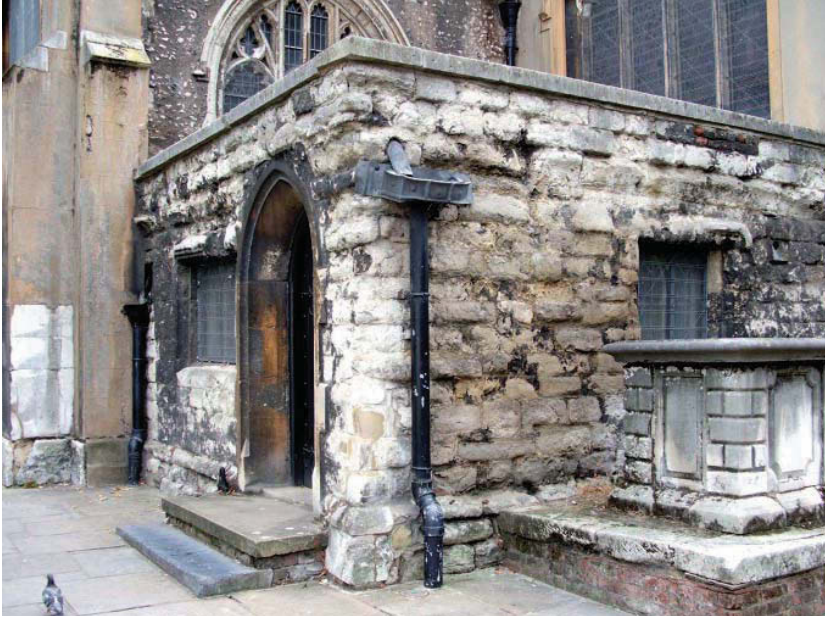
1.1.28 The stonework to the north east of this elevation has a distinctive dark cream colour and the stones are extremely crumbly as a result of damp possibly relating to the drainpipe. The roof of the vestry also leaked on a regular basis (pers. comm. with church volunteer) and this will have affected the stonework.

1.1.29 There are replacement quoins with painted mortaring on the corner of the building as discussed previously in §3.2.10 and there are patches of recent mortaring behind the drainpipe.

Plate 9: All Saints Vestry, Kingston: North Elevation - repairs to corner and discolouration of stonework caused by damp

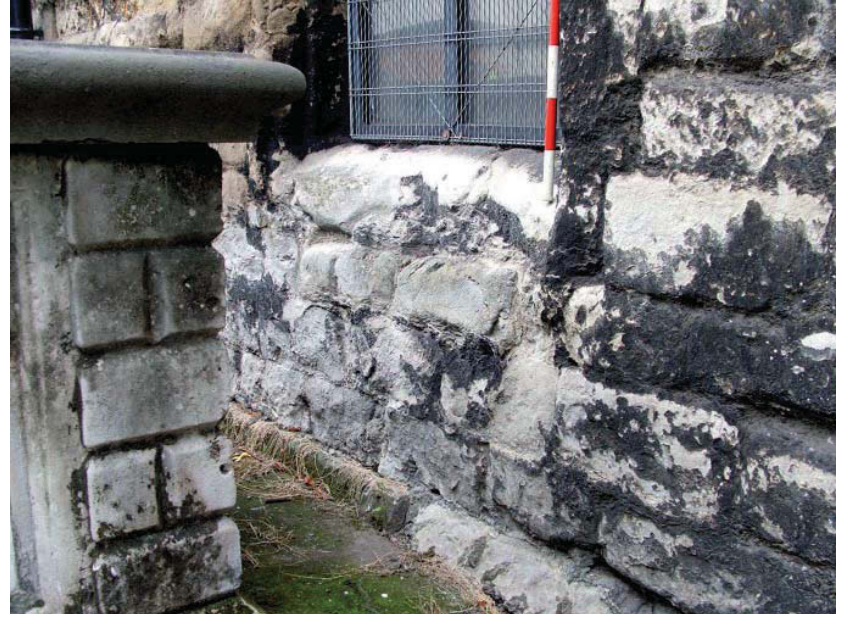
- 1.1.35 Beside this elevation is a chest tomb which has a red brick pedestal abutting against the lower masonry. This tomb has many inscribed plaques most of which are indecipherable. One visible detail is the family name 'Bradney' and a date of 1817 upon one plaque. There are the tops of three possibly upright stone slabs between the lower vestry wall and the pedestal base, probably covering an entrance to a vault underneath.

Plate 10: All Saints Vestry, Kingston: North Elevation - stonework behind the Bradney tomb

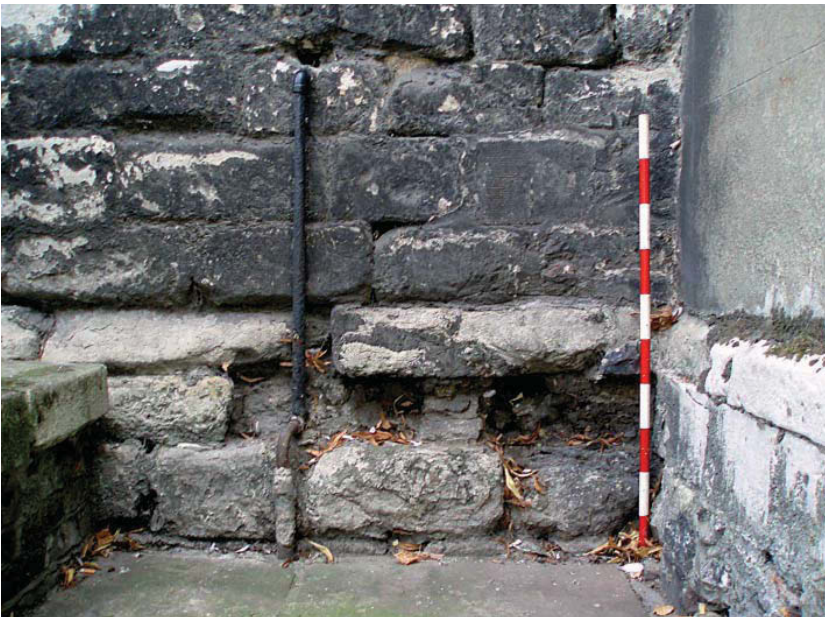
1.1.30 There is a section of red brick replacement on the top course of the right hand side of the building. There are small pieces of red brick/flint infill visible below the window and on top of the course above the drain hole. There is a stone on the 5th course from the bottom on the north western side that appears to be an old replacement. This stone has claw tool marks running horizontally across it.

Plate 11: All Saints Vestry, Kingston: North Elevation - replacement stone with tool marks and weathered plinth

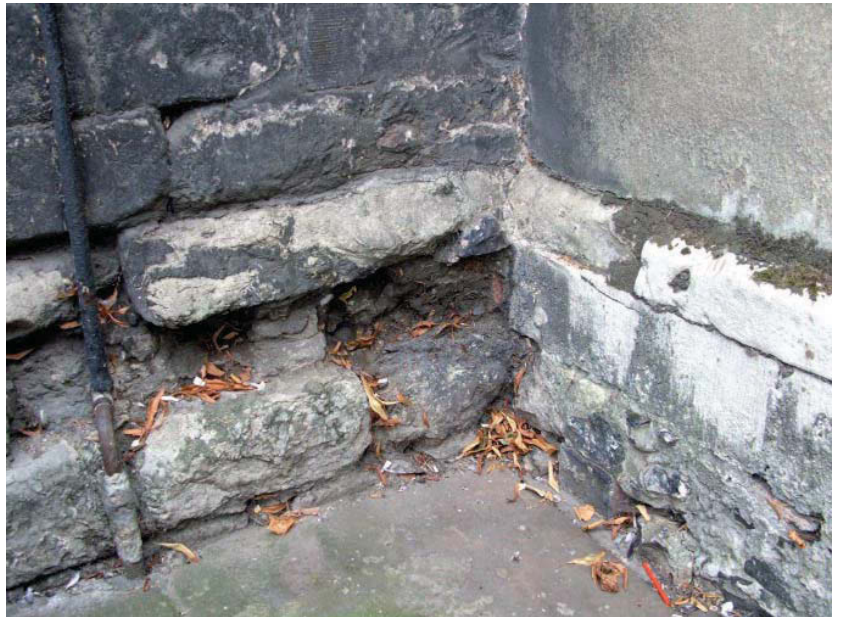
- 1.1.34 From an examination of the join between the vestry and the chapel it can be seen that the vestry is a later addition. The chapel wall is rendered so the join cannot be examined but the stonework at plinth level in both buildings is visible. The corner of the vestry has a specially mitred stone which extends around to form part of the chapel wall. This shows that care was taken to bind the two plinths together but the construction of each is distinct.

Plate 12: All Saints Vestry, Kingston: North Elevation - detail of join with Holy Trinity Chapel

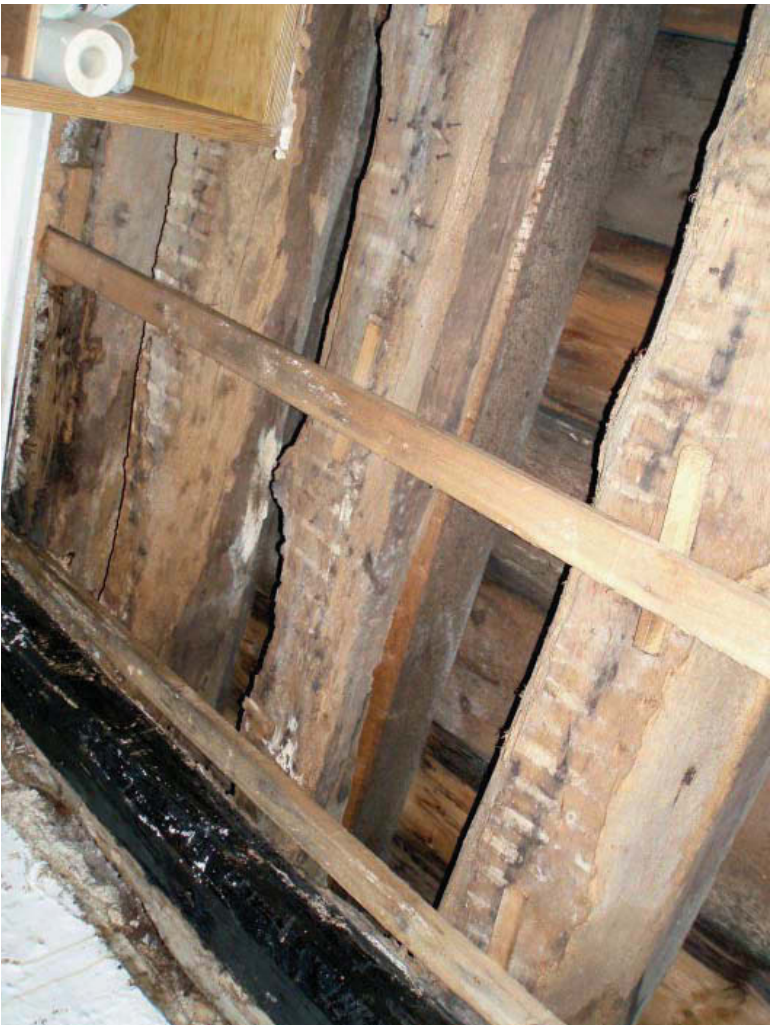
- 1.1.40 When the single-pitch roof was replaced the walls of the vestry were also levelled at the top. The string course remains in its original position upon both elevations.
- 1.1.41 Inside the vestry part of the ceiling has been removed and it was possible to see the oak beams supporting the roof structure. The visible beams measure 10" x 10" and are approximately 16ft long and have imprints of the lath and plaster ceiling that would have once been attached. Some beams have eroded to around 5" deep in parts and, in one case, modern timber had been added to provide extra support.
- 1.1.42 It is possible that some of these beams are primary to the vestry construction and have been reset at the time of the changes to the roofline.

Plate 13: All Saints Vestry, Kingston: Roof timbers inside the vestry

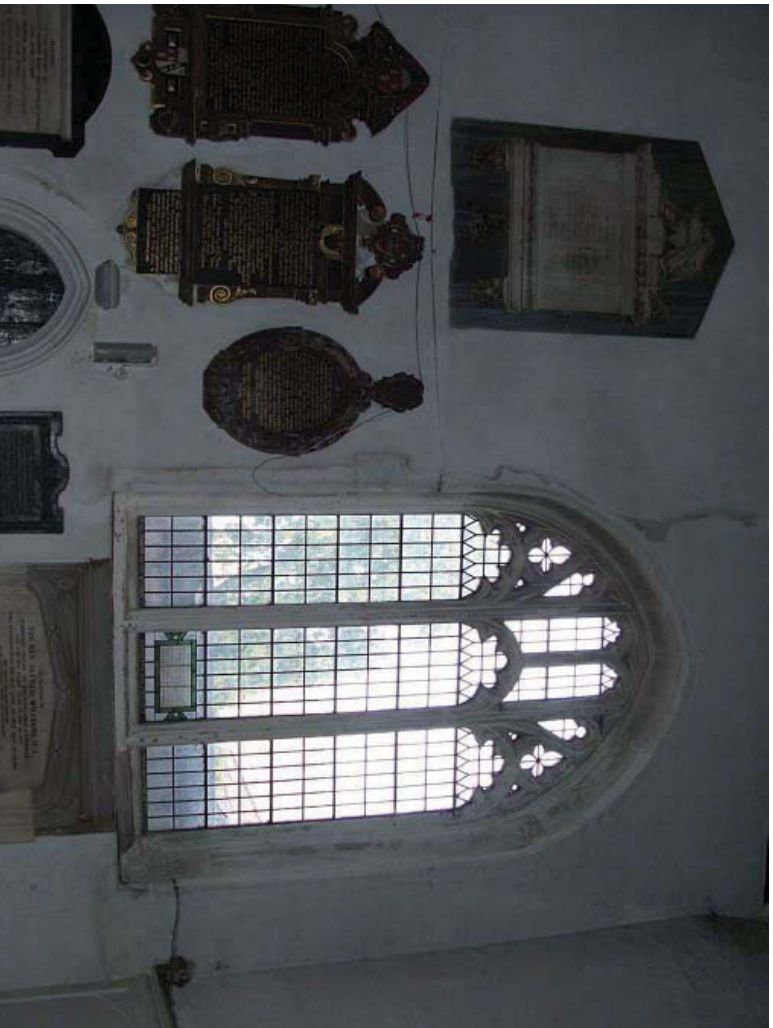
- 1.1.38 During the 19th century works, a medieval perpendicular window was revealed in the north eastern elevation of the chancel. This window had been covered and the wall rendered, probably during the 18th century 'dressing' of the church. The ghost of this window was included in sketches of the church in the 18th century by CT Cracklow (published in 1823) and H Hunt (published in 1851). According to the inscription in the current glass of the window there was a Victorian memorial stained glass window placed there in 1862 indicating that the window was reopened as part of the 1862-6 restoration works.

Plate 14: All Saints Vestry, Kingston: The earlier perpendicular window from inside the church
