Parterre Gardens Witley Court Great Witley Worcestershire

Archaeological Investigation Report Volume I

Oxford Archaeology

May 2004

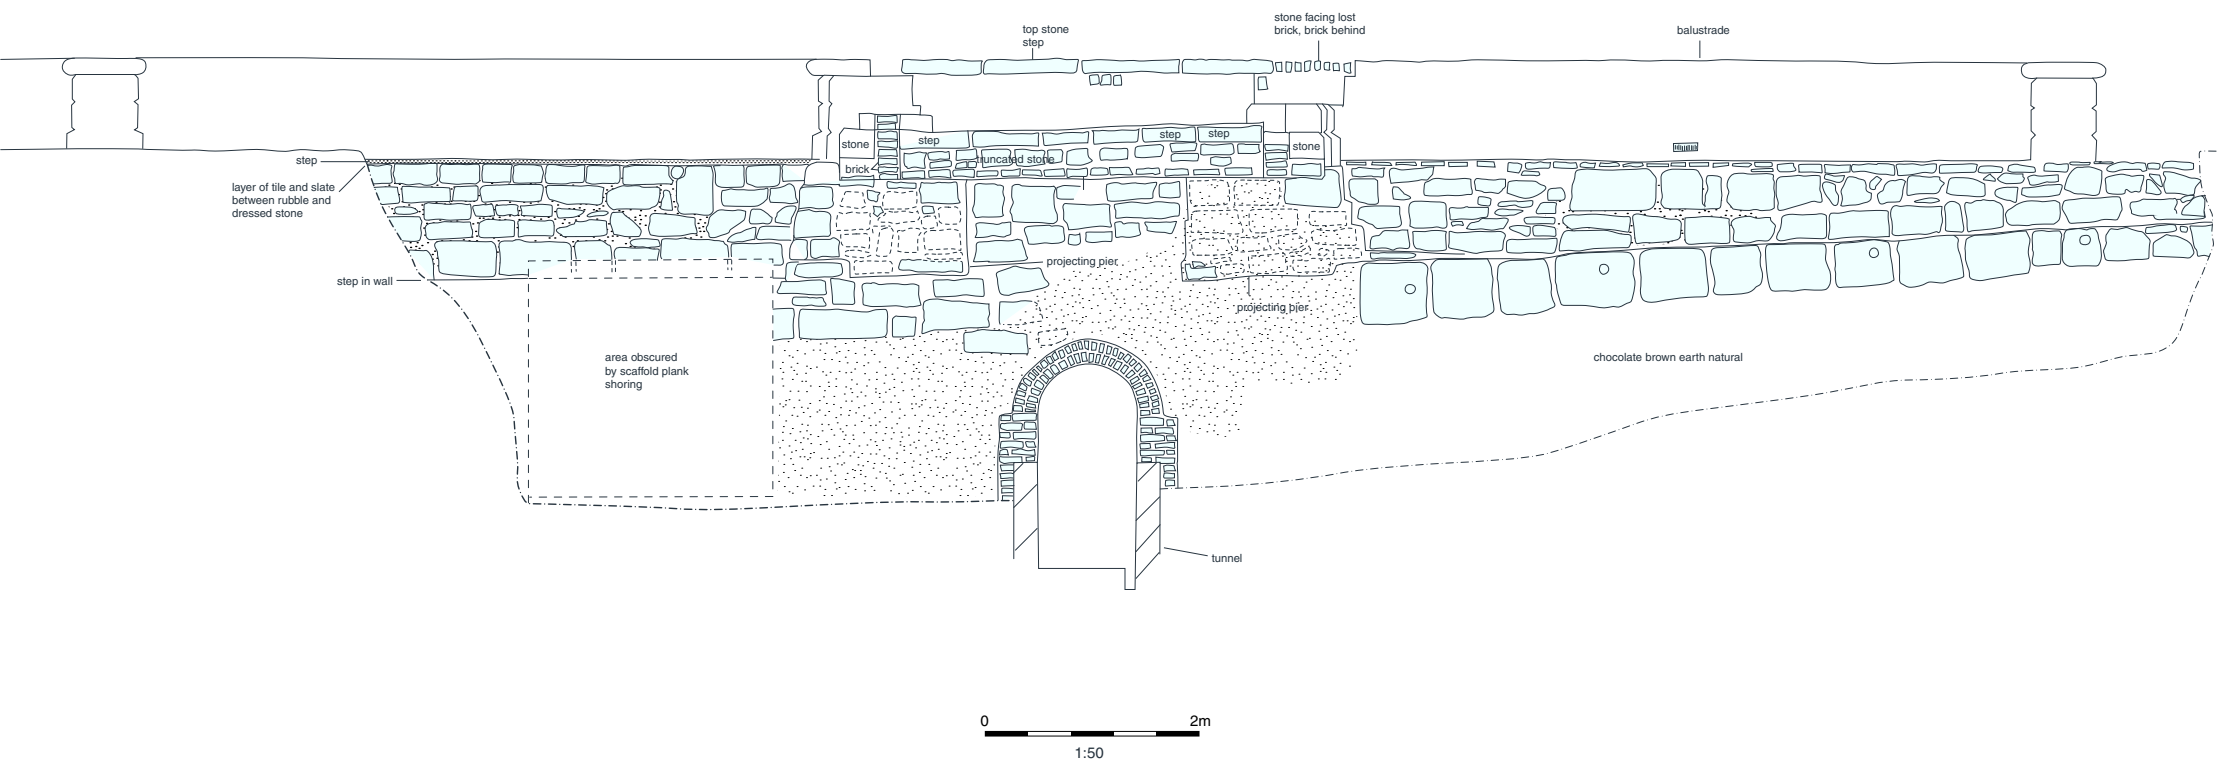
Figure 6 : Elevation of Balustrade, Steps S7 and Tunnel entrance in area of new Pumphouse excavations (Trench 20)

- 7.2.3 The section of exposed balustrade within the excavation area (Trench 20) has been recorded in a detailed elevation showing the three elements of the build; sub-foundation, foundation-proper and balustrade (Fig. 6). The foundation-proper is constructed in sandstone, the sub-foundation of very rough large blocks with some bonding and areas of silt in-filling. The tunnel entrance and antechamber appear likely to have been contemporary with the construction of the balustrade foundations as the deposit sequence indicates that this area was required to be in-filled in order to raise the ground level for the construction of the buttresses which underpin the brick arch foundation recorded beneath steps S7. Furthermore, the slight angle of the brick arch would not support S7 without the secondary in-filling bringing the level up to the base of the balustrade footing and filling the cavity beneath the arch.

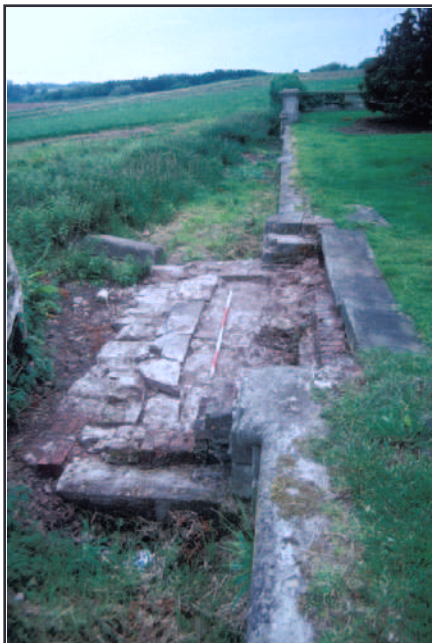
Plate 12 - Existing survival of step foundations S7. Looking south.

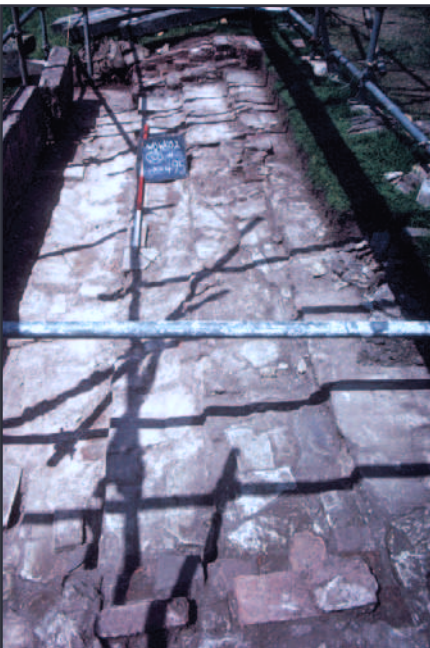
Plate 17 - Trench 7, surviving foundations of steps S2. Looking west.

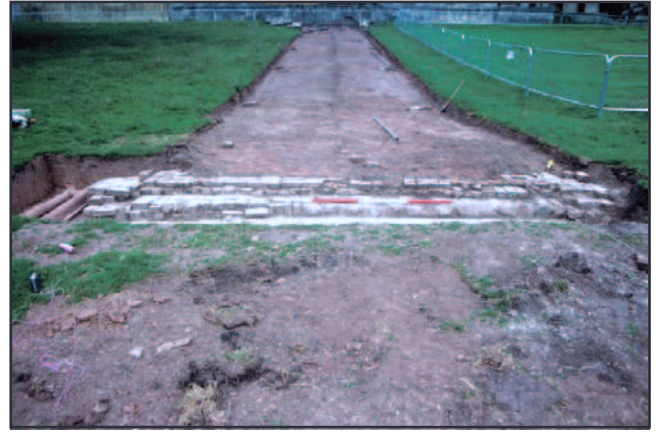
Plate 20 - Trench 3, surviving step foundations S3. Looking north.

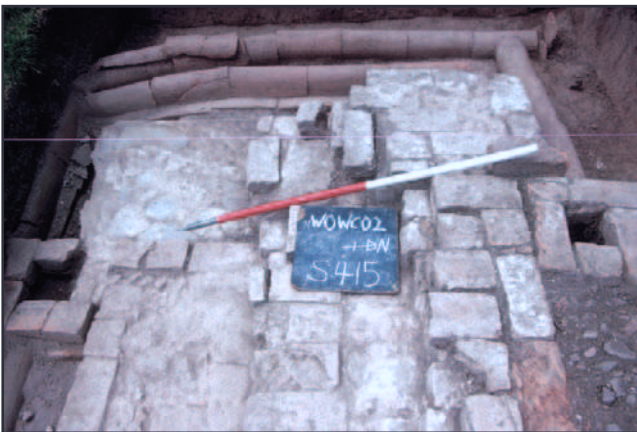
Plate 21 - Trench 3, detail of step foundations and stringer of S3. Looking west.

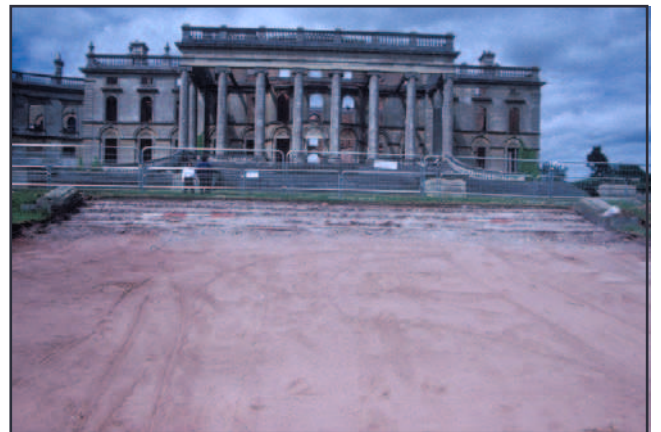
Plate 22 - Trench 5, surviving step foundations of S4 with former path width re-exposed. Looking north.

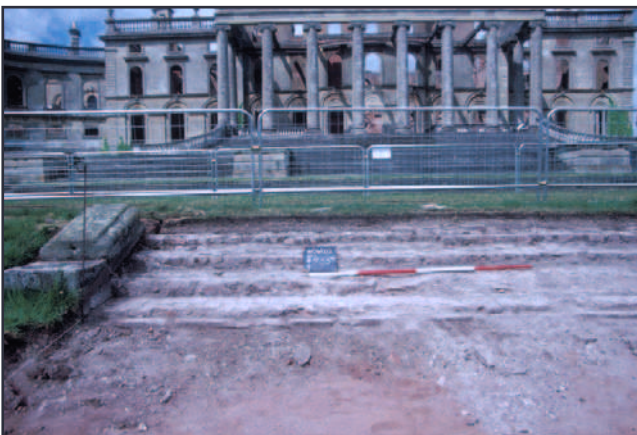
Plate 23 - Trench 5, surviving step foundations S4. Looking north.

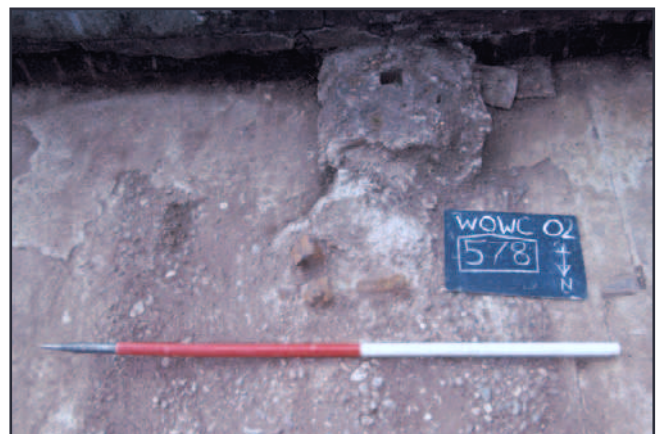
located to the north of the West pavilion had been heavily damaged (Plate 42), whilst Steps S31, situated to the north of the East pavilion, appear not to have been subject to such similar disturbance (see Fig. 6; Plates 37-38 and 40).

Plate 37 - Trench 22, excavation of step foundations S31. Looking south.

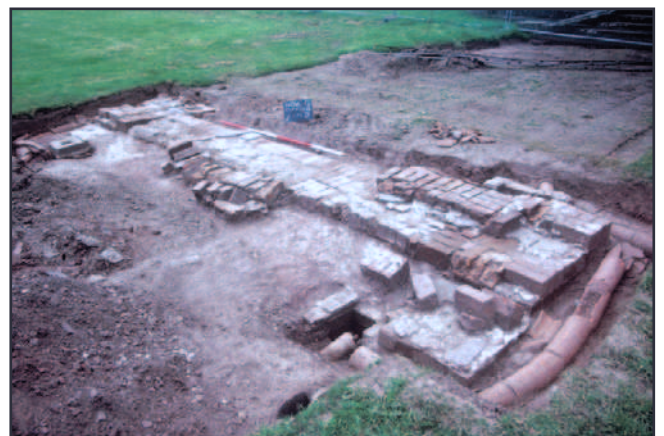
Plate 42 - Trench 21, excavation of step foundations S30. Looking south east.

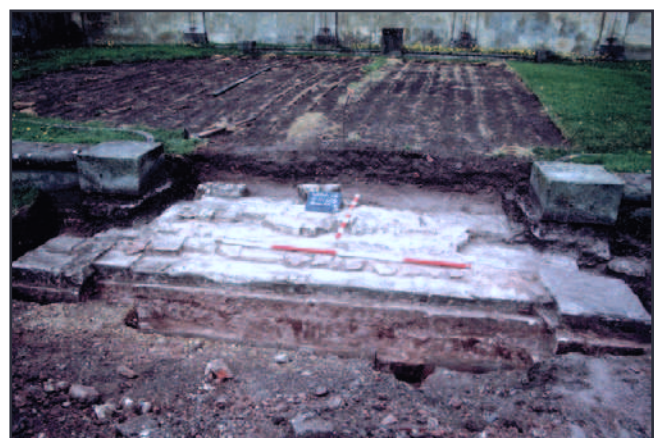
- 7.5.4 Steps S1, which form the access from the South parterre gardens to the Winter garden, were constructed entirely of limestone and were founded on an earlier sandstone structure (Plate 48). This earlier structure may represent the remains of a step base, or, structure related to the house prior to the construction of the Nesfield garden.

Plate 48 - Trench 15, excavation of step foundations S1 after brick ramp removed. Looking north.

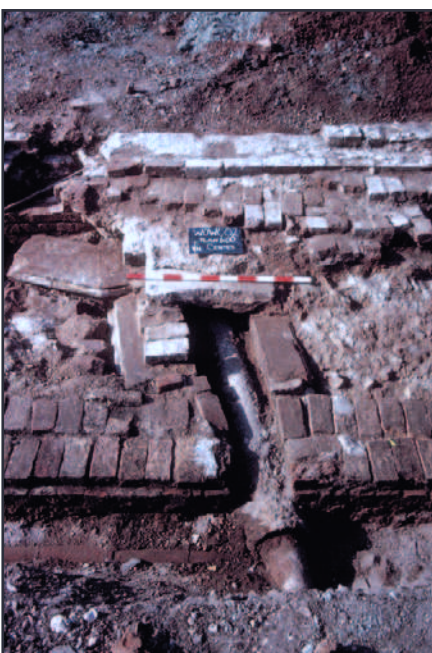
Plate 53 - Trench 100, detail of service that cut step foundations S16. Looking south.

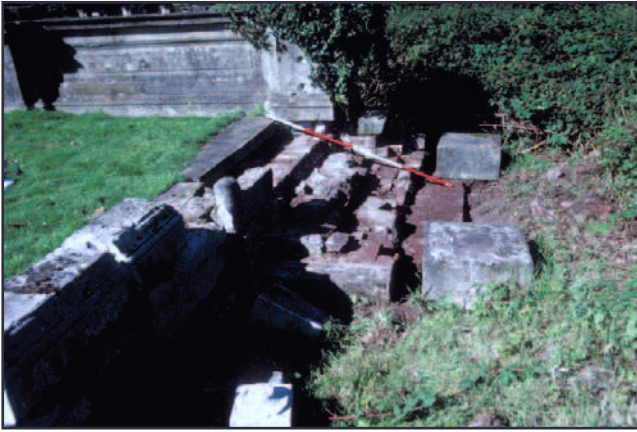
Plate 55 - Trench 102, shows current surviving state of step foundations S11 in East Parterre gardens. Looking north.

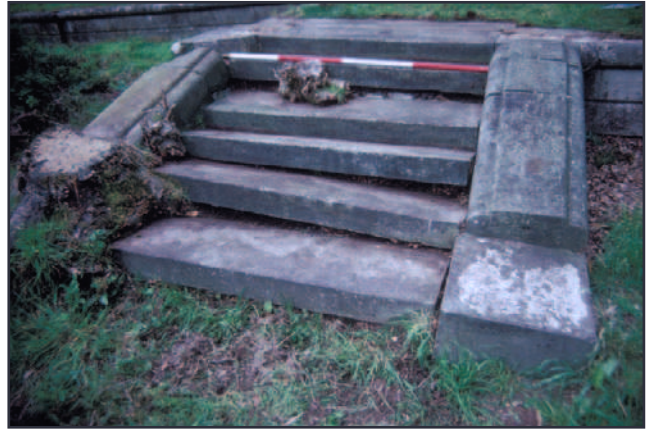
Plate 56 - Trench 103, shows current surviving state of steps S9. Looking west.

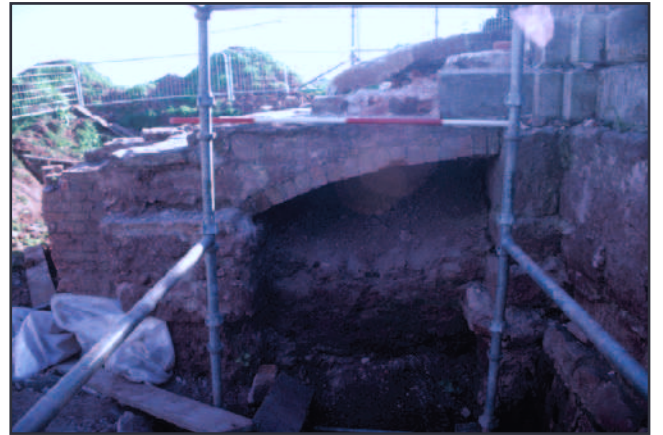
Plate 64 - Trench 20, arched foundation of steps S7 above fountain tunnel. Looking south.
