Church Farm
Lewknor
Oxfordshire

Historic Buildings Recording
and Investigation

October 2009

**Client: Regeneration Holdings
Limited**

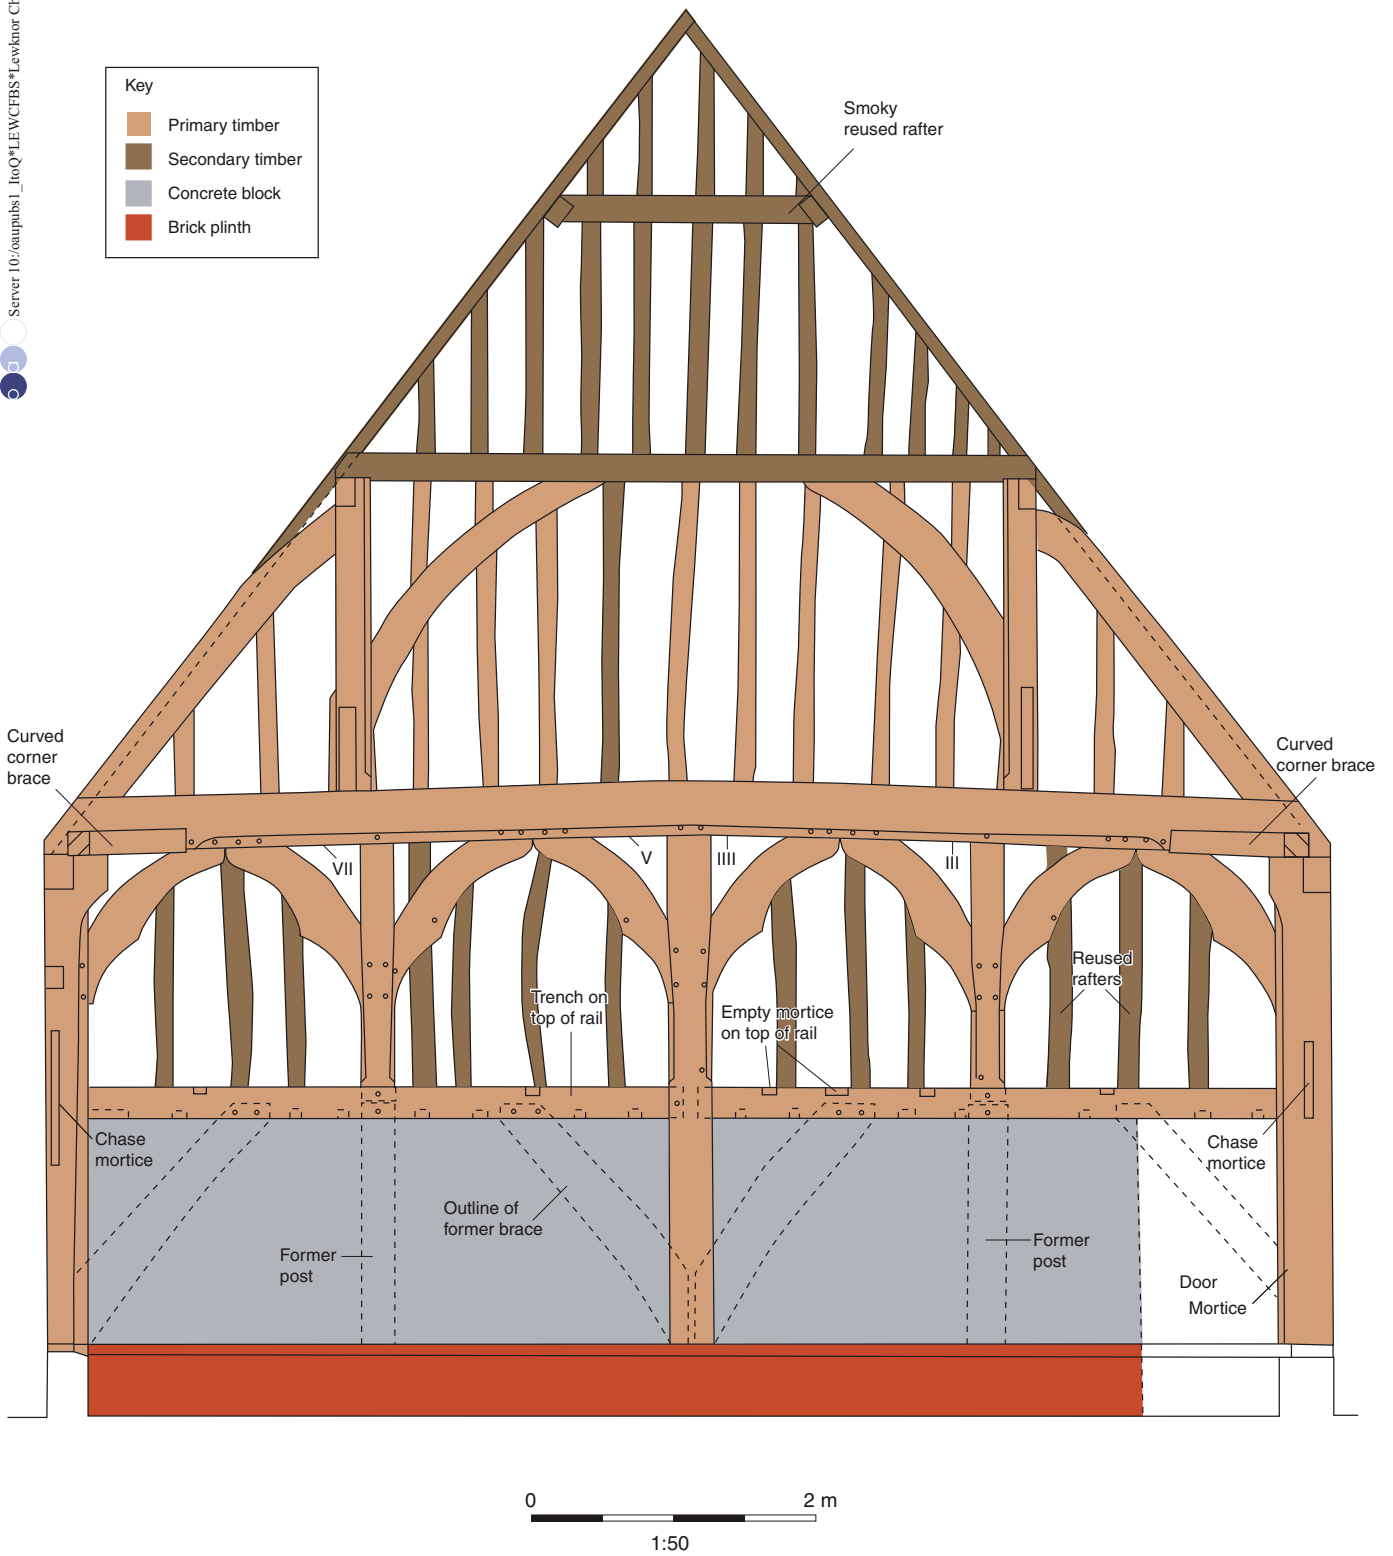
Figure 3: East end wall, internal elevation

- 3.6.2 The east wall (Frame 1) of the barn would have formed the upper (dais) end of the open hall and it is an attractively decorated frame with cusping and mouldings which were clearly intended to impress visitors to the hall (Fig 3, Pl. 12). The wall divides into two main elements: i) the truss and half hipped gable; ii) the wall beneath the truss.
- 3.6.3 The truss comprises tie-beam, principal rafters, lower collar (or upper tie), upper collar, raised aisle posts and curved struts between raised aisle posts and lower collar. Unlike in

- 3.6.4 The tie-beam is chamfered and it is supported by five posts which divide the main wall into four bays. Three of the posts (central and corner posts) are full height from the plinth while the other two posts are smaller in section and only rise from the mid rail. Within each bay there are two scratched Roman numeral carpenter's marks on the tie-beam's soffit which are different to the unusual primary marks found elsewhere in the barn (see below) but are assumed to be primary.

- 3.6.5 Below the tie-beam there are pairs of cusped braces in each of the four bays between post and tie. Behind the braces there are three secondary studs (several smoke blackened reused rafters) in each bay between tie and mid-rail. The studs which hold the weatherboarding are fixed with hand-made nails of probable 18th or 19th century date. In the upper face of the mid-rail there is a trench, apparently along the entire length of the rail, within which the primary studs from the wall would have sat. These would have supported wattle and daub panels. There are also several other small mortices in the upper face, which appear to be secondary and which are inside (ie to the west of) the trench. At either end of the truss there is a curved horizontal corner brace tenoned into the face of the tie-beam which extends around to the north and south walls. These corner braces are found at each of the four corners of the former hall and they are tenoned into upper wall plates in the long main walls.

- 3.6.6 In the soffit of the mid-rail there are also a series of mortices although at this lowest level the wall has been almost entirely replaced by concrete block which appears to have been constructed since the RCHM recording in 1972. The studs are known to have been intact in 1911 as they are shown in a valuable photograph included in the 2002 report by Dr James Moir of Finial Associates. The three main posts (central and at each corner) survive down to the plinth but the two smaller posts, bracing and studs have all been lost. There are regular mortices for studs as well as two larger ones from the missing posts, and within each bay is a mortice with two pegs which would have housed the upper tenon of a curved brace. It is possible that these braces were cusped similarly to the surviving ones beneath the tie-beam but the photograph from 1911 mentioned above suggests that they were not. The photograph shows plain straight braces but they do not appear to correspond with the existing mortices and smaller posts beneath the mid-rail are not shown suggesting that by 1911 the original arrangement in this area had been substantially altered. Therefore it is still possible that the primary lower braces were cusped but these had been lost before 1911. From the surviving mortices it is apparent that there would just have been a single brace in each bay as opposed to the pair of braces in each bay above the mid-rail. The corresponding lower mortices from the bases of the braces are also apparent with three pegs each in the sides of the the three surviving posts. At the southern end of the wall is a small doorway in the concrete blockwork which leads through into the modern barn (being demolished in the current works). This doorway is clearly modern and would have been blocked by one of the former braces. The plinth is

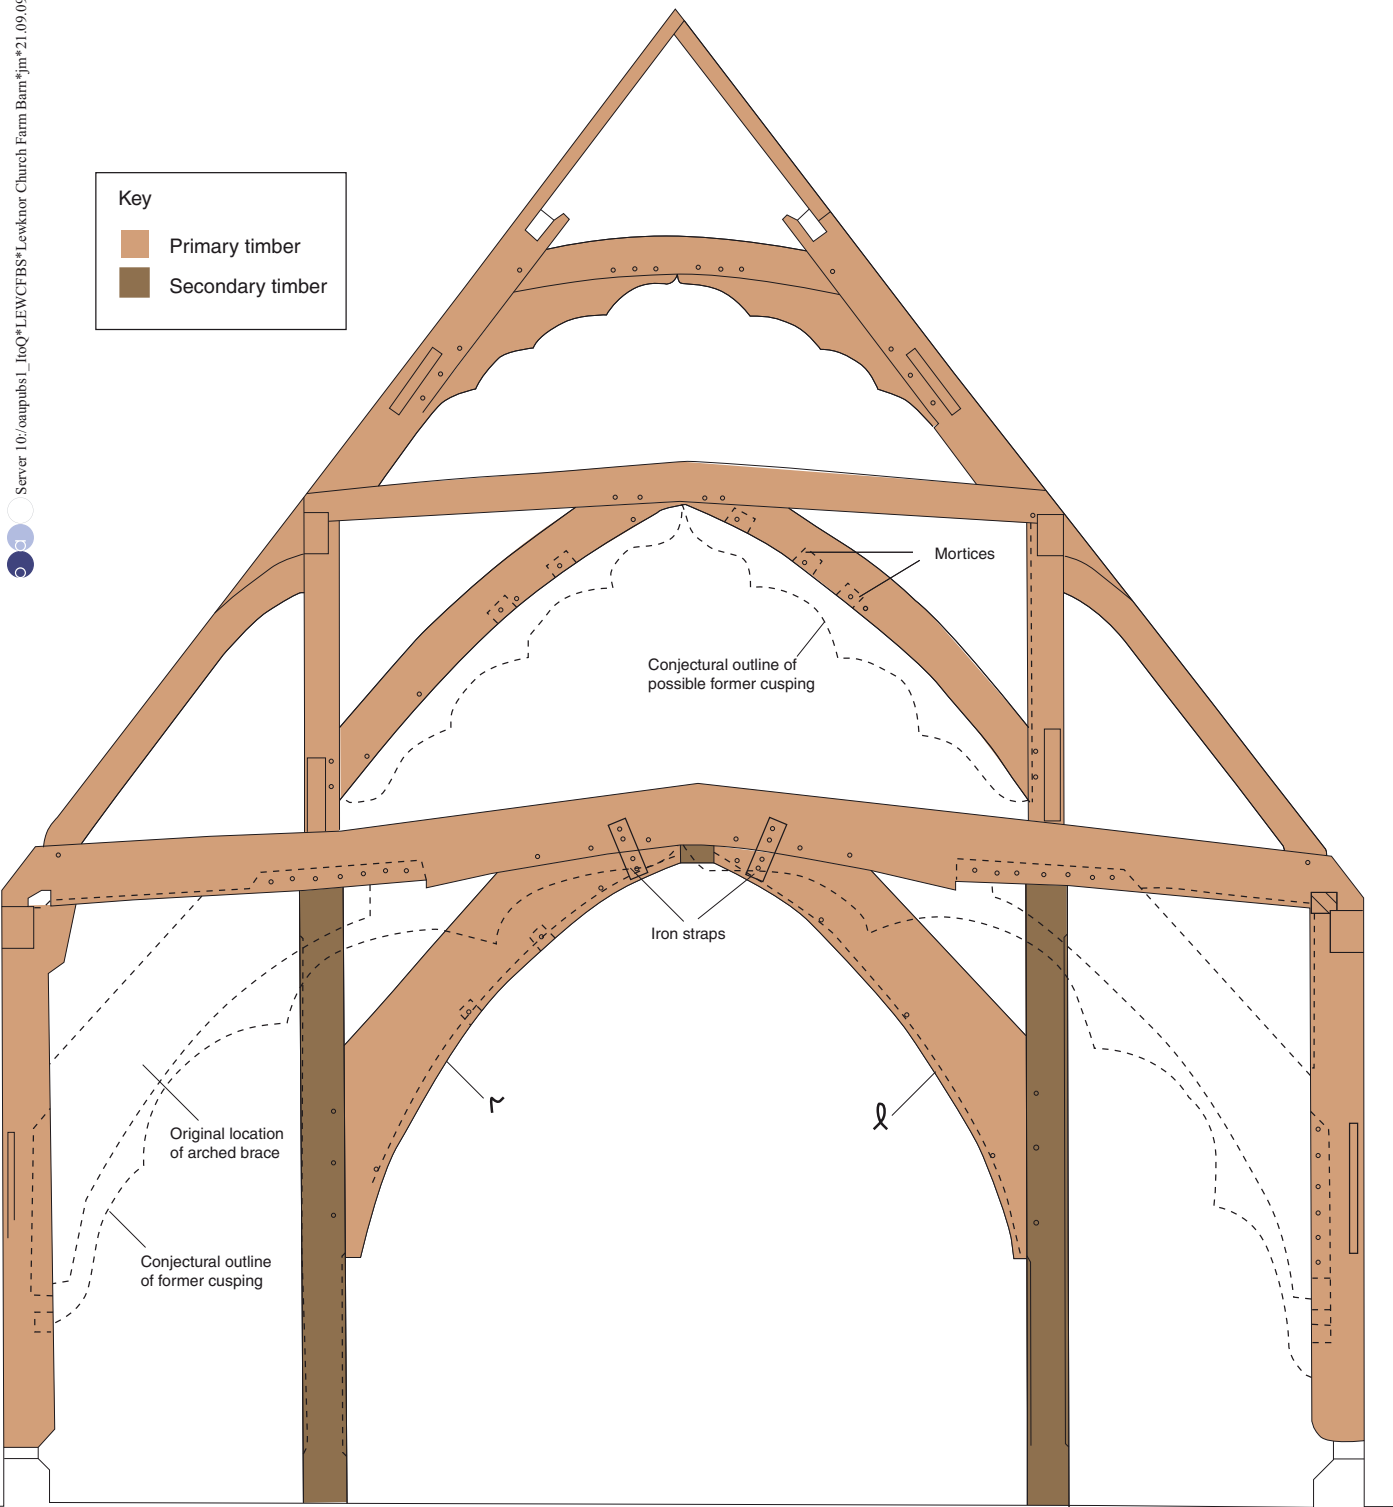
Figure 4: East central truss from west

- 3.6.8 The cross frame on the east side of the central bay (Frame 2) would have formed the central display truss of the original two-bay open hall. It is now superficially similar to the spere truss on the west side of this bay but this is due to a 20th-century alteration and its primary form would have been significantly different. The original frame would have been formed a remarkably wide, clear span below tie-beam level for a building of this date (c.8.8 m) but it has been altered by the repositioning of the arched braces towards the centre in order to provide greater support for the tie-beam. In the original building these braces would have been supported by the outer posts but they are now supported by inserted 20th-century 'aisle posts'. Large empty mortices with sloped shoulders are clearly visible in both main posts (with 6 peg holes) and in the soffits of the slightly cambered tie-beam (7 peg holes). The lower edge of the tie-beam is cut back slightly towards the outer edges and there is a clear step down at the points where the arched braces would have sat. There is now a small block (c.25 cm wide) between the heads of the two braces whereas they would originally have been c.3.75 m apart.

- 3.6.9 It is known that this alteration was undertaken in the 20th century because the braces are shown in their primary position in the photograph referred to above from 1911 (Pl. 1). The photograph shows the southern arched brace supported at its head by a large temporary prop (apparently a circular section post). The arched braces are each formed from a single very large piece of timber (c.70 cm wide at the widest point) but the southern member has had a new section added towards the upper edge on the east face. The two braces are moulded with a central trench to their undersides and they each incorporate three small mortices which probably held cusping to the underside of the braces and tie-beam. There are two similar small empty mortices to the underside of the tie-beam immediate inside (ie towards the centre) of the point where the arched braces would have been located. These presumably helped to hold the upper parts of the cusping. There are further mortices in the faces of the main posts, immediately below where the braces would have adjoined, which presumably housed the bases of the cusping.

- 3.6.10 A number of sections of iron strapping have been added to strengthen the cross-frame including plates between arched braces and tie beam and a long iron strap bolted to the northern post. The west side of this post head has been cut back and re-profiled to the allow the insertion of the ironwork; the east side is jowled. A modern horizontal bearer has been added between the 20th-century 'aisle post' and the main primary post.

- 3.6.11 The truss within Frame 2 (above the tie) is of raised aisle type and it appears to survive largely intact from its original arrangement. It comprises upper collar, lower collar, principal rafters (diminished above the upper collar), raised aisle posts, lower principals with arched heads supporting the aisle posts, arched braces beneath the lower collar and cusping beneath the upper collar. There are a series of mortices in the soffits of the two braces which presumably would have supported further ogival cusping within the truss.

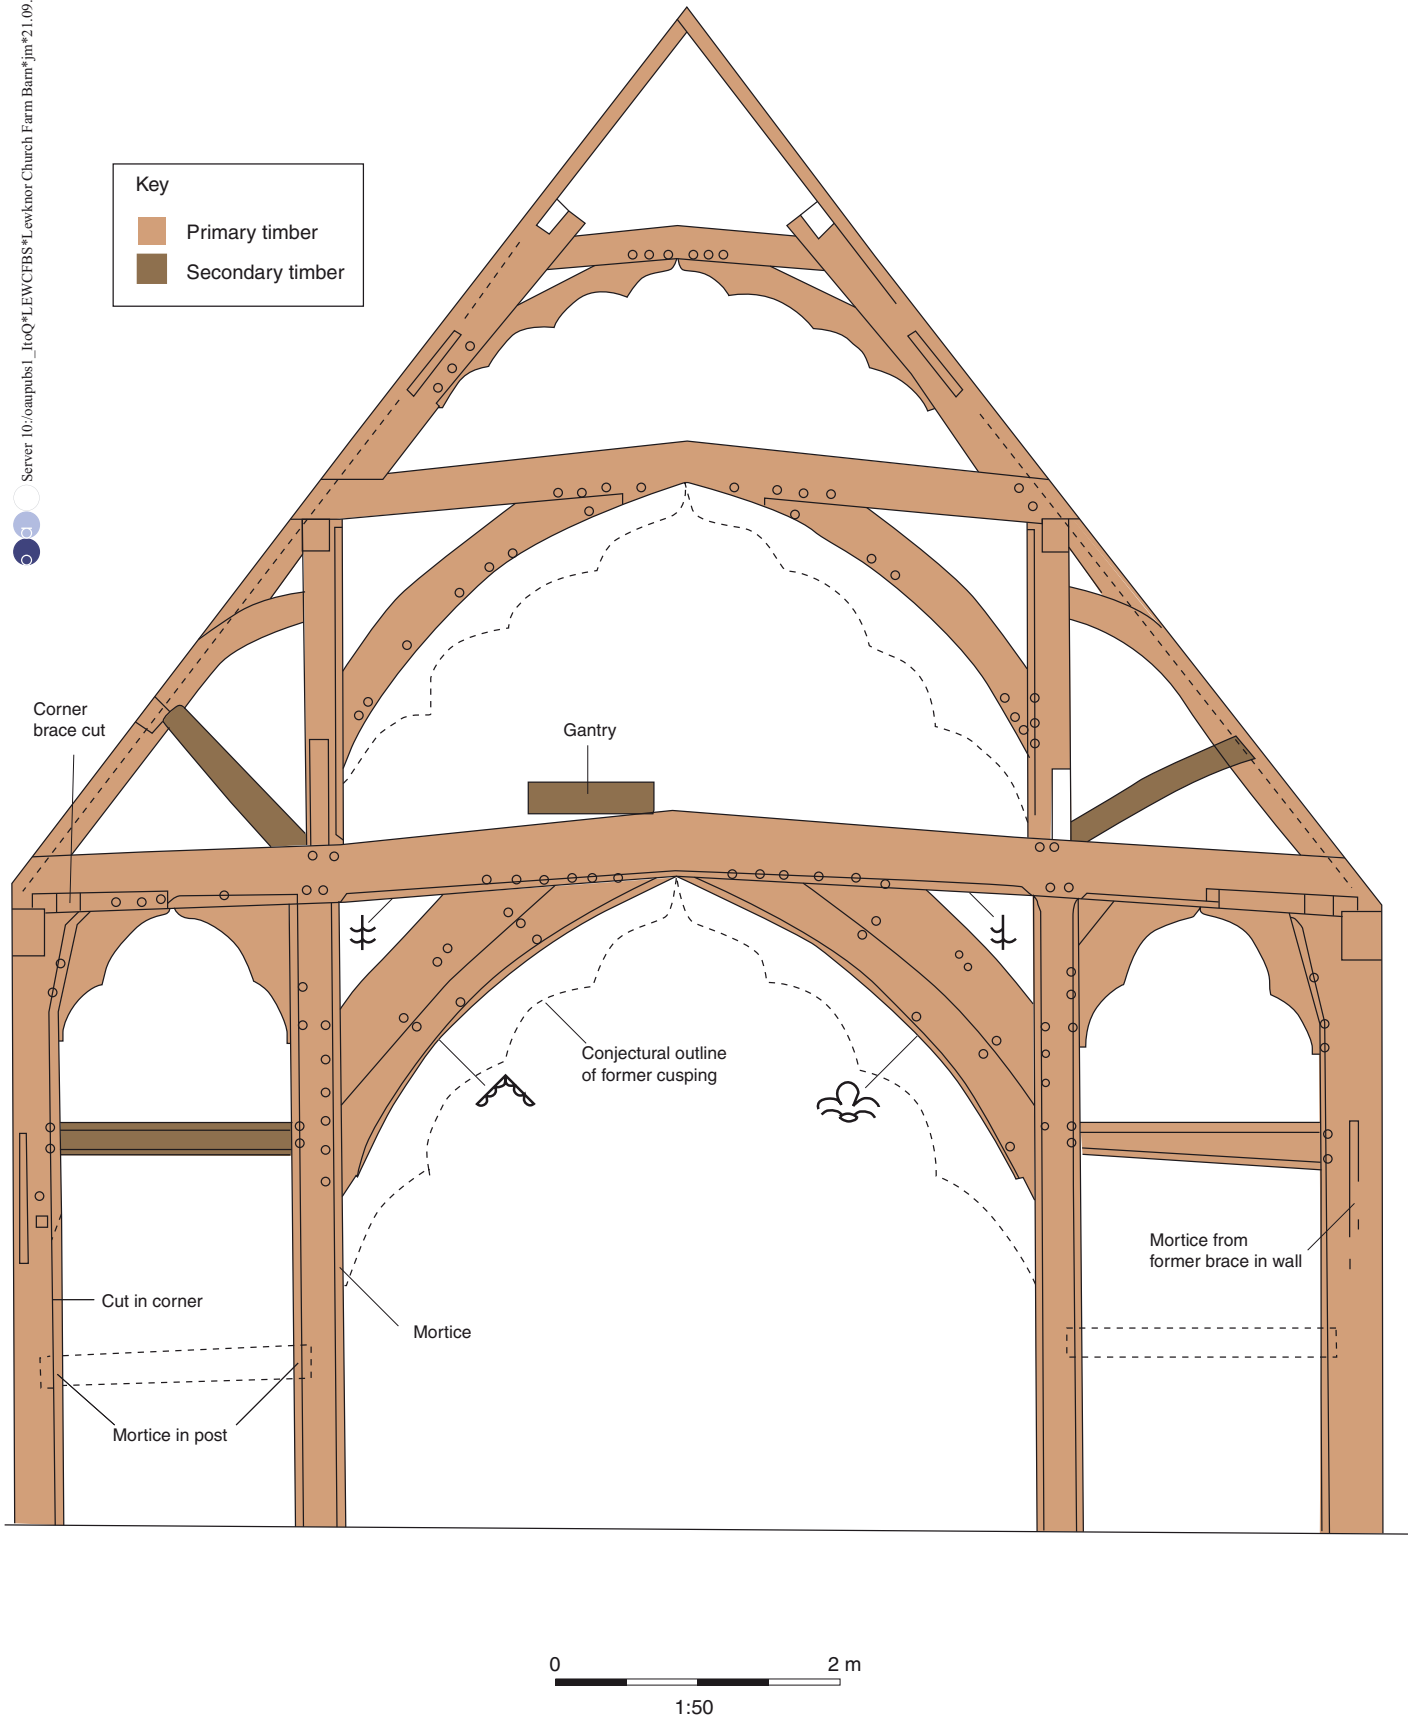
Figure 5: West central truss from east

- 3.8.5 On the corresponding soffit of the southern arched brace in the spere truss is an unusual *V shaped mark with half circles (two to one side and three to the other)* and again this was scribe-cut with a race knife (Fig 5). It is likely that the race knife had a central point that enabled the user to make circular shapes of approximately 40mm diameter. This central point is not found on post 18th century race knives. It is again unlikely that this is an assembly mark and is probably a graffiti or decoration.

- 3.8.6 Also on the spere truss a number of similar marks were identified with *half circles and lines* and these do form part of a pattern of assembly marks (Fig 5, Pl 20). Each mark includes a straight central line and half circles branching to either side from this line. On one set of marks there are two half circles to either side while another set has a single half circle to one side and two to the other. Corresponding marks are found to either side of the truss on the tie beam soffit and side of the post. This mark is very similar to arrow style markings seen elsewhere (eg. moulded roof truss in the Chapel Royal Hampton Court Palace c. 1536). It would appear that the lower two half circles denote whether the frame goes on the left or right with only one half circle on one side of the barn and two on the other. This appears to be made with the same size (40mm) circular race knife as the two marks above suggesting they are all of a similar date.

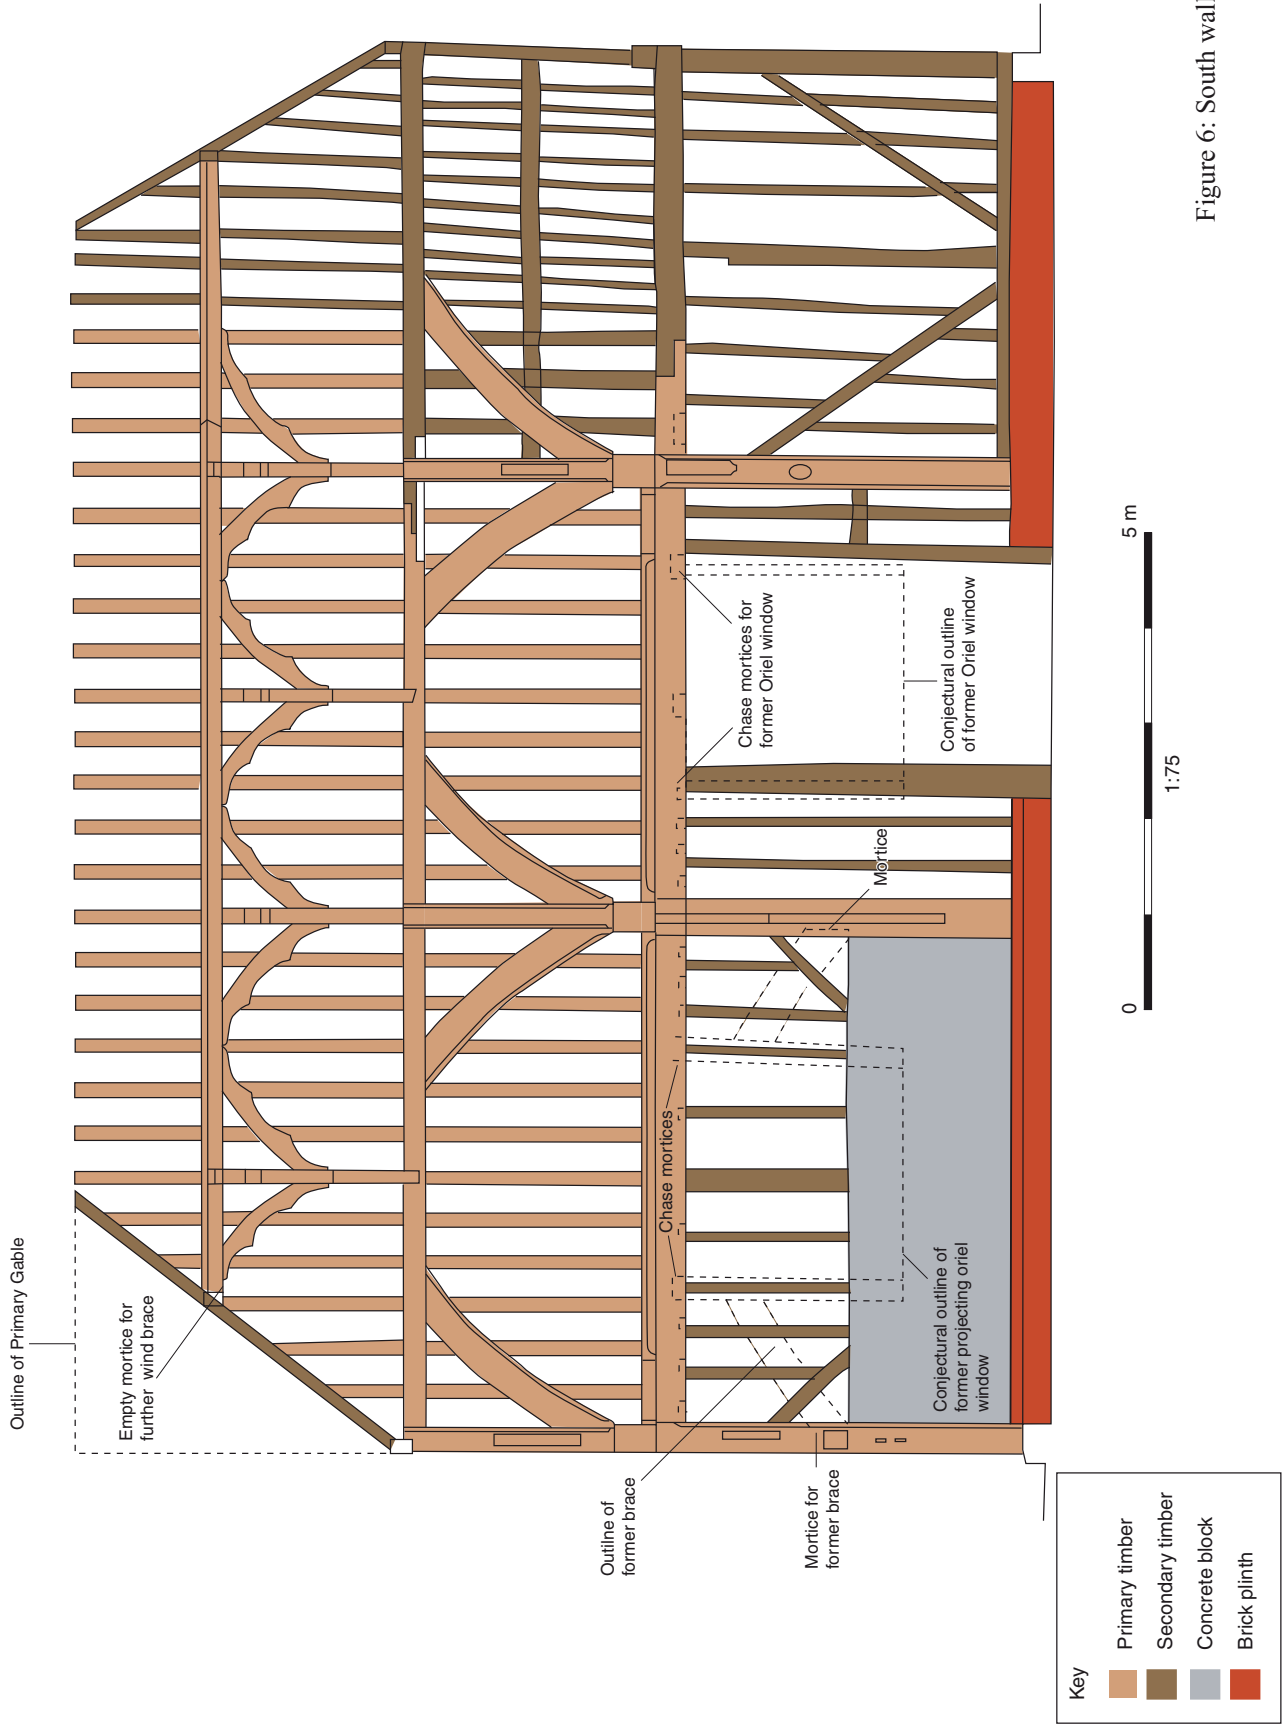
Figure 6: South wall internal elevation

- 3.5.2 The phasing of the south wall divides into the largely primary eastern two bays and the western bay which has been entirely reconstructed, possibly in the 18th century (Fig 6).

- 3.5.4 The main framing in the south wall is entirely secondary but there are a series of empty mortices in the underside of the principal wall plate which provides an indication of the former wall arrangement and this includes some of the most significant features revealed in the current project. Several of the mortices relate to the former wall framing but there are also four horizontal mortices now observed for the first time on the outside of the wallplates, immediately beneath the eaves, two in each of the main bays within the former open hall (central and eastern bays). Located adjacent to vertical mortices for wall posts, the horizontal mortices are chased (i.e. have an angled side) and would have housed horizontal members which projected out from the external walls of the building at an angle rather than at 90 degrees to the wall (Pl. 21).

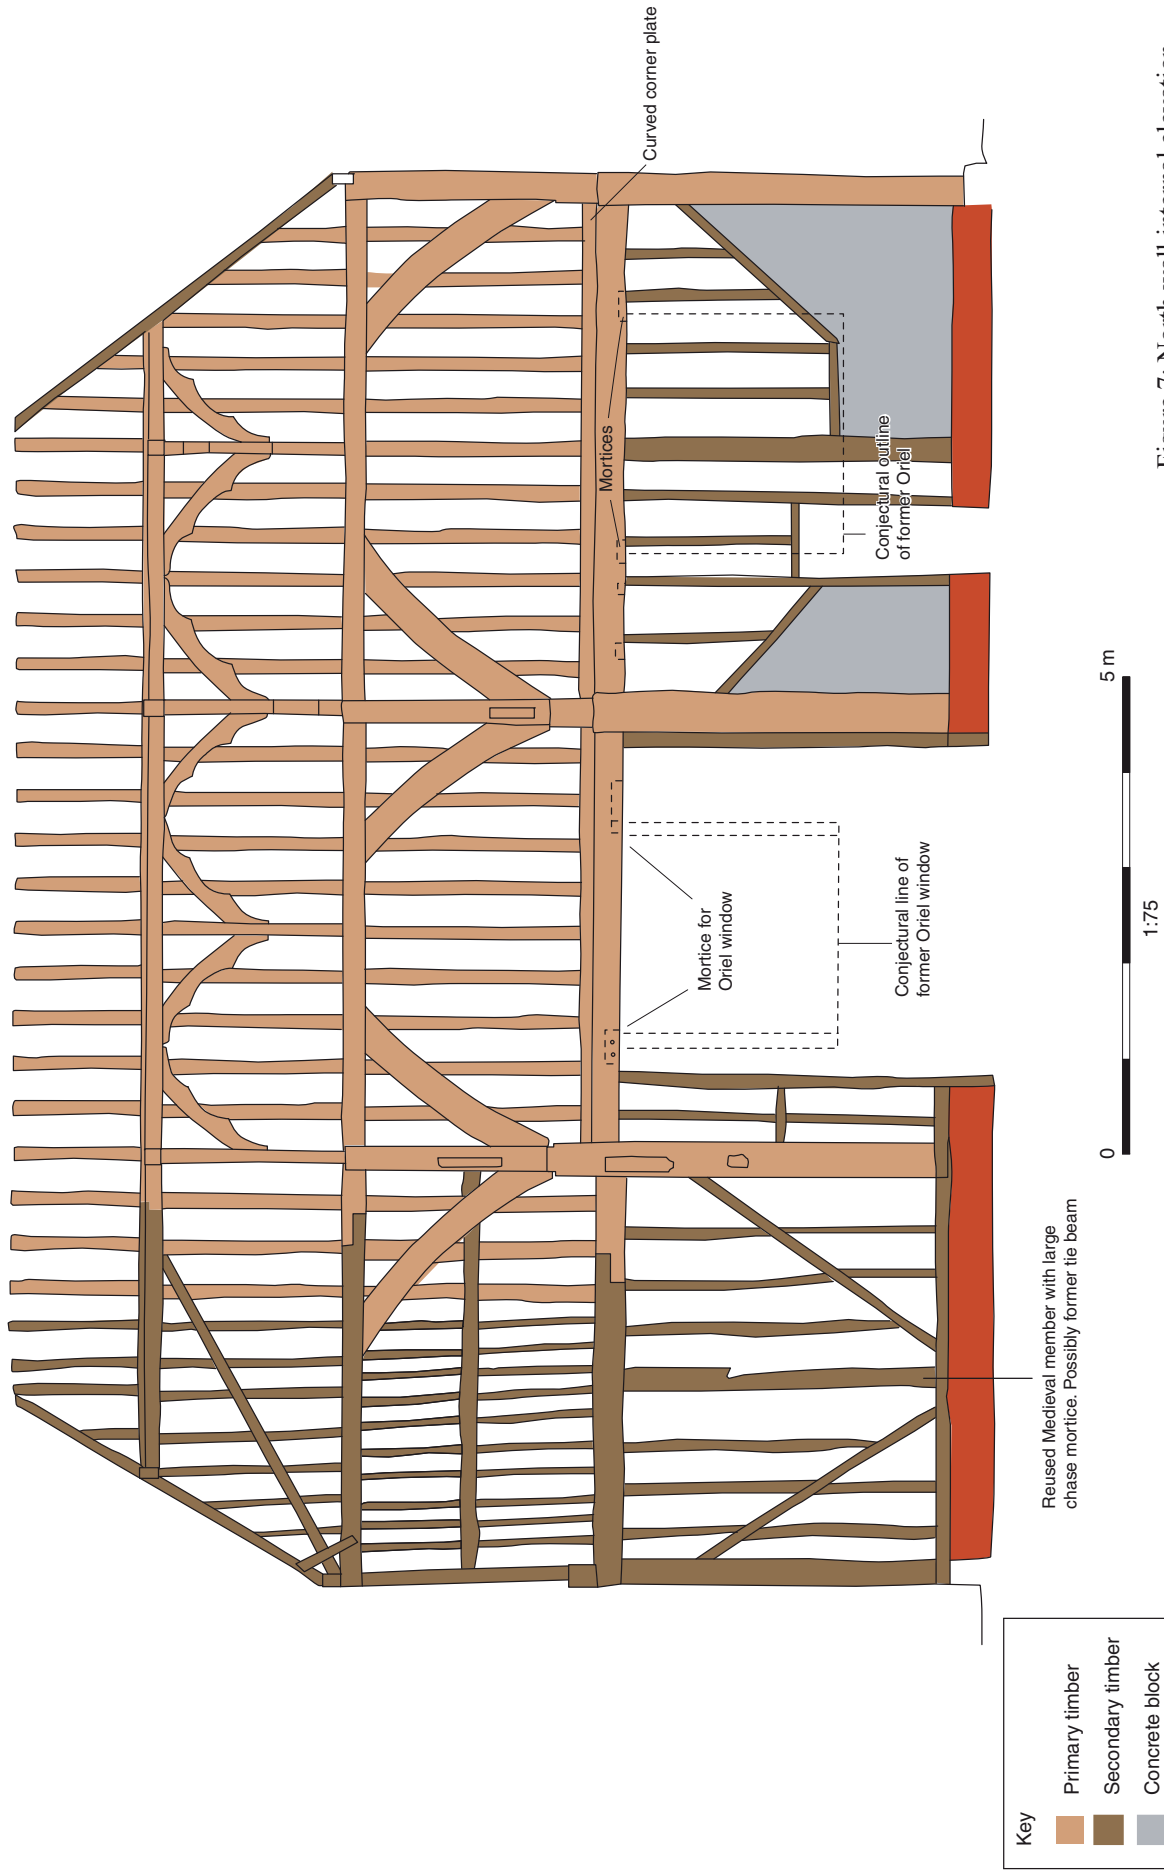
Figure 7: North wall internal elevation

- 3.5.8 *North wall (recorded by OA)***
- 3.5.9 The north wall framing (Fig 7) is also broadly similar to the south wall. The eastern bay of the north wall incorporates concrete blockwork (post 1972) to the lower section and secondary elm stud framing above. One of the members in this frame (the sloped eastern bearer or plate) may be a reused medieval member.

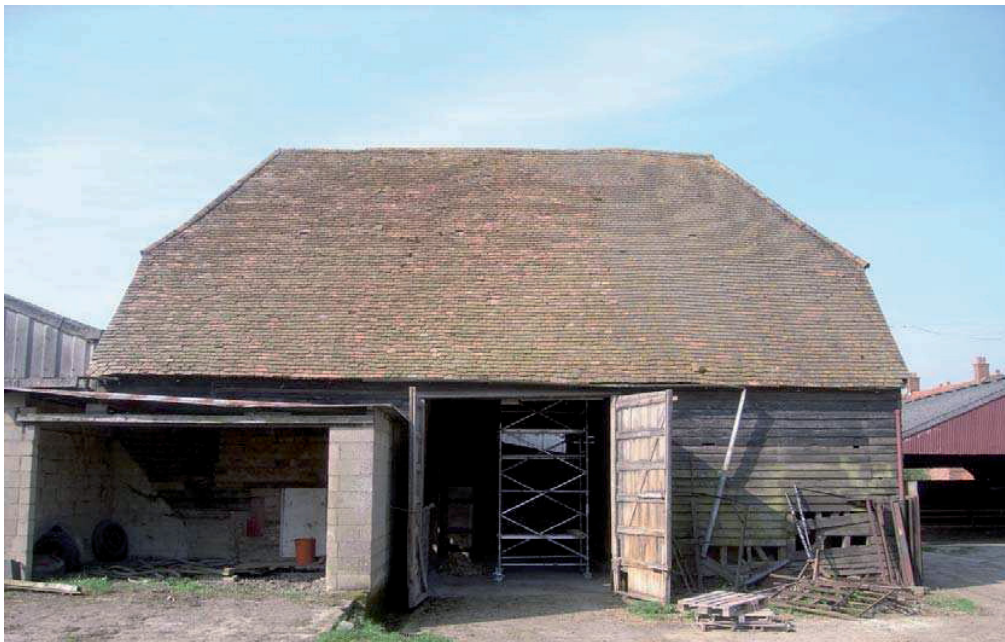
- 3.3.2 The barn has a half-hipped roof, clad in clay tiles, and the walls, which are largely clad in weatherboarding of several phases, are now in poor condition (Pl.2-4). The exception to this are the lower sections of the east wall and the eastern end of the north and south walls, which were reconstructed in the later 20th-century in concrete blockwork. The main walls are set on a brick plinth and there are tall double threshing doors in both the north and south walls. The external cladding has been stripped and replaced, some of this prior to the site inspection, so the external timber faces were not inspected.

Plate 2: Exterior of barn from north

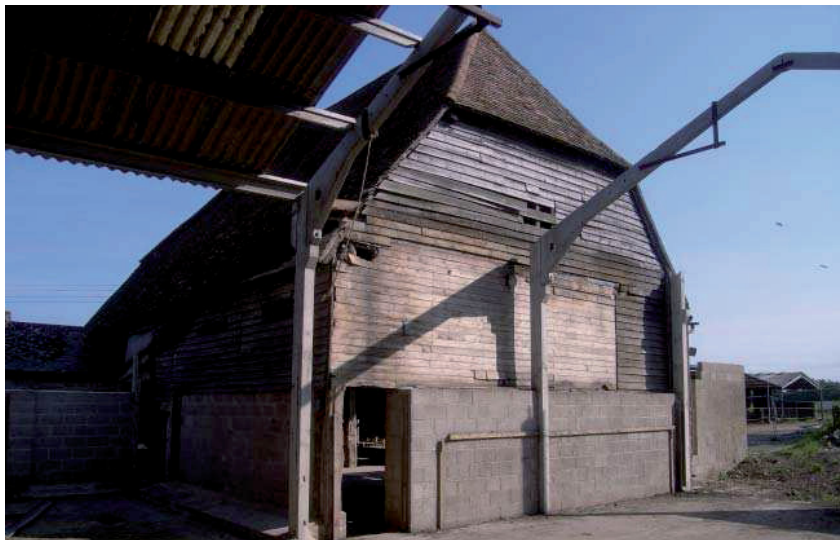
Plate 3: Exterior of barn from SE during demolition of adjacent modern structure

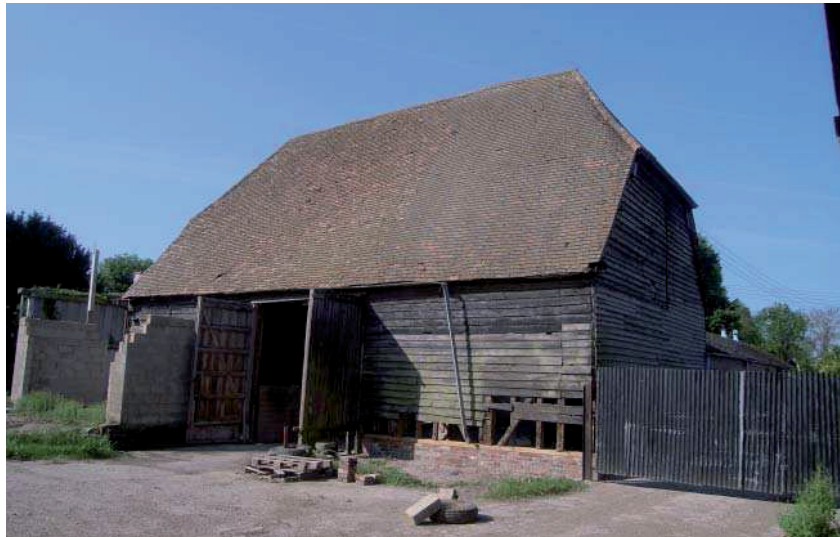
Plate 4: Exterior of barn from NW

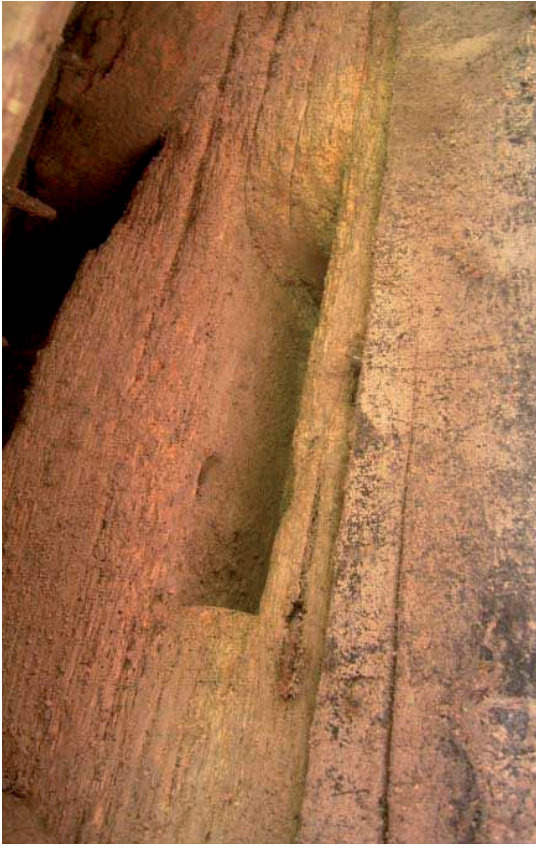
Plate 21: Chase mortise in face of wall plate, under eaves, from former projecting oriel

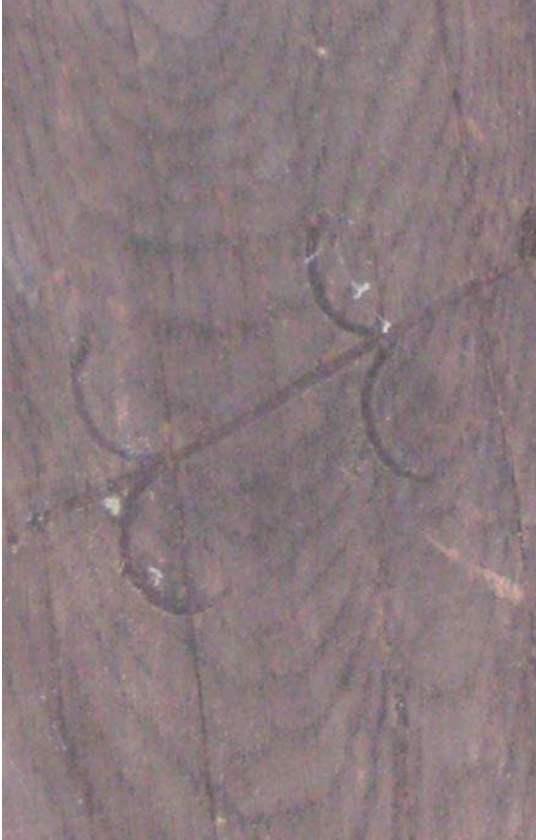
Plate 20: Carpenters mark on Frame 3 (W central)

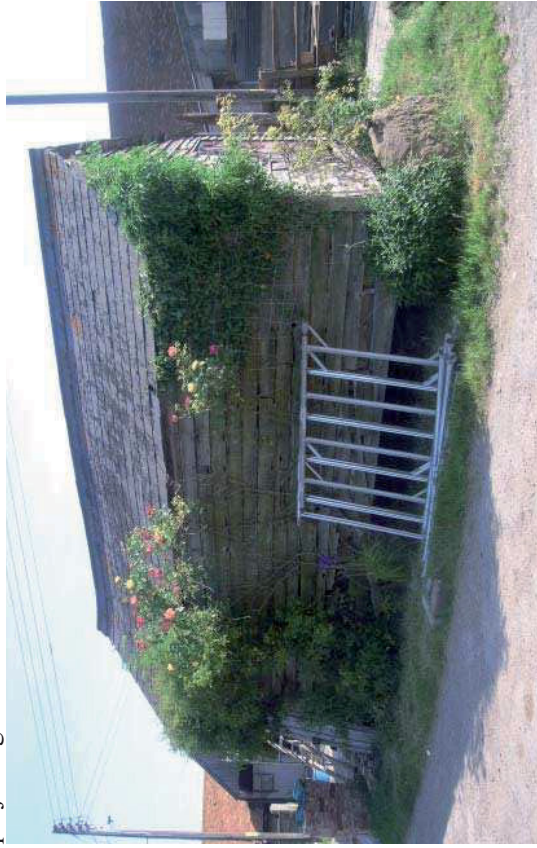
- 4.3.1 The granary (Pl. 23-24) is a rectangular plan, single-storey building (7 x 4.5m) with a slate-covered gabled roof and walls clad in weatherboarding. The condition of the building is now very poor and it is being substantially rebuilt in the current project reusing materials from the existing building.

Plate 23: Granary from south

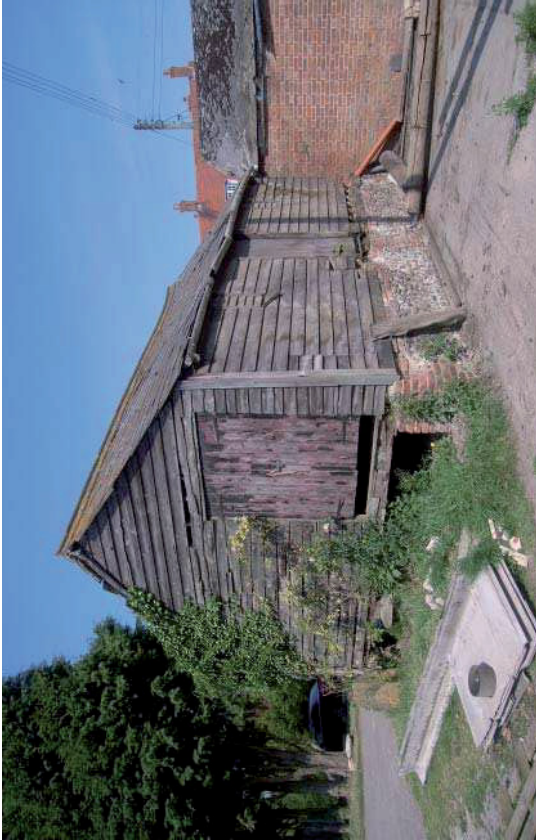
Plate 24: Granary from east
