Eaton Weir Anchor Island Buscot Oxfordshire

**Historic Buildings Recording
and Investigation**

August 2010

Client: The National Trust

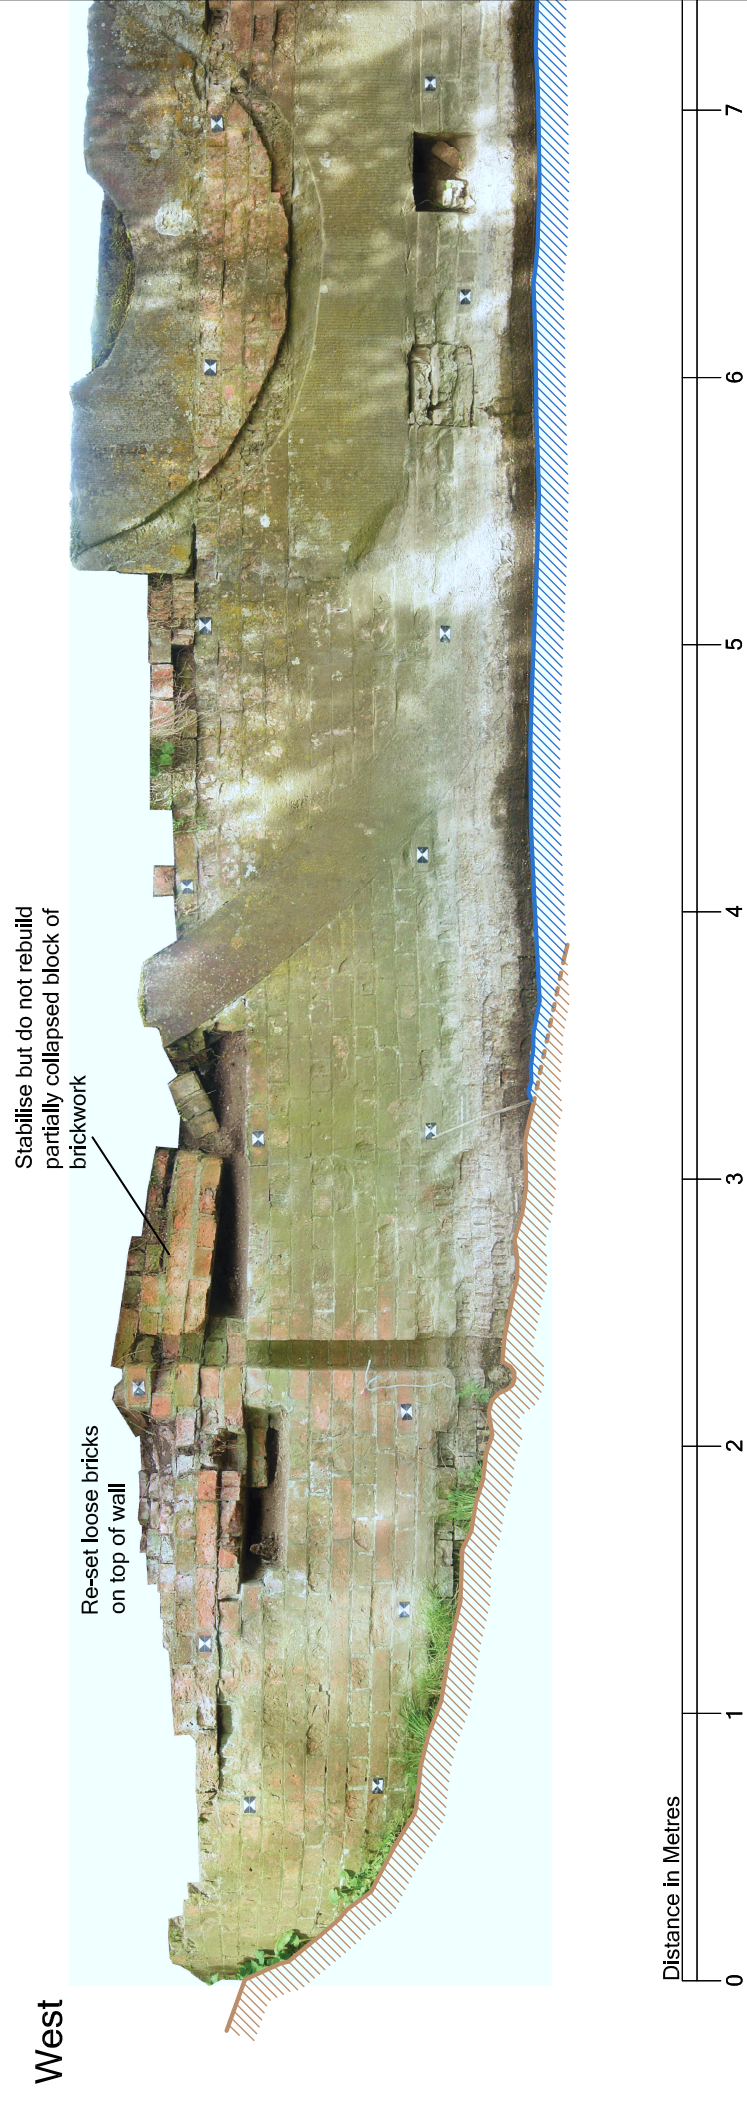
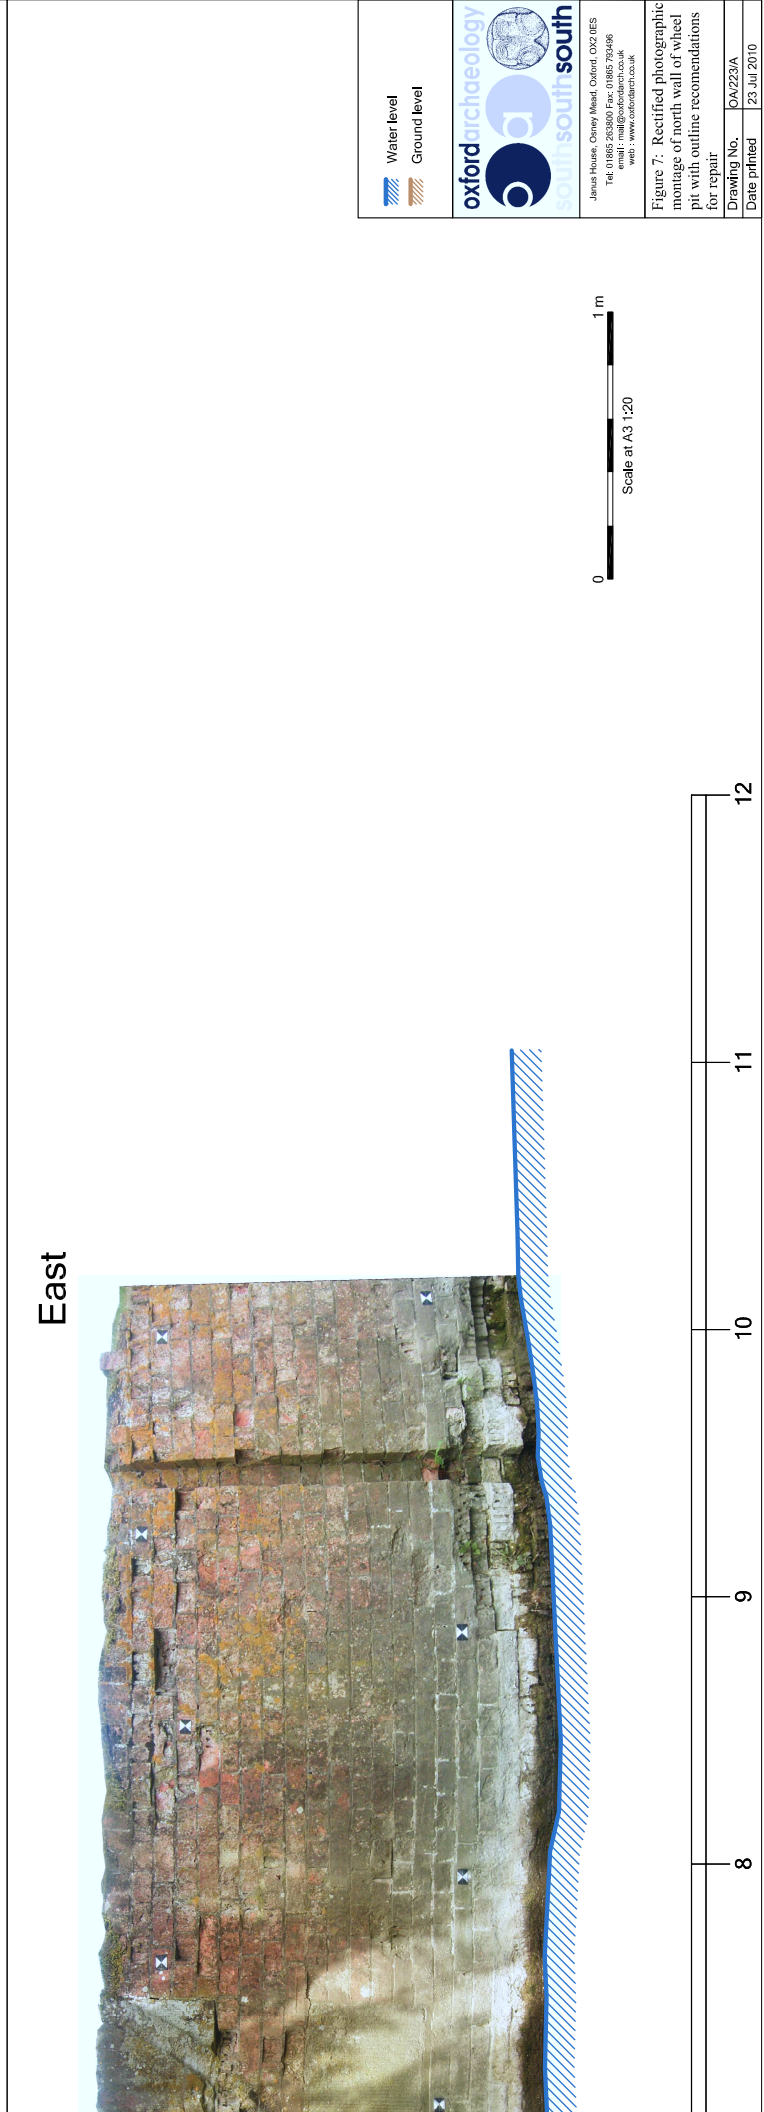
Figure 7: Rectified photographic montage of north wall of wheel pit with outline recommendations for repair

- 3.2.13 Similarly to the south face of the pit this wall retains many features which provide evidence of the wheel including to large stone bearing blocks which would have supported the axle of the wheel. The stone blocks are each approximately 2.2 m long by 45 cm tall by 1.02 m and they are set with one along the upper edge of the wall and the other c.35 cm below. An iron axle housing or shoe would have been set on top of the upper stone and although this does not survive there is a segmentally curved rebate (c.7 cm deep) at the surface which indicates where the main iron bearing for the axle would have sat. There is also a further concentric groove (c.12 cm thick) within the stone and brick face which is 75 cm below the upper surface (at its deepest point) and which would have prevented one part of the wheel from scraping against the wall. There is no clear surviving oil staining on the beneath the former axle location.

- 3.2.14 Immediately beneath the lower stone block there are two access sockets (30 cm x 23 cm) into the body of the wall and which would have been used to secure the lower ends of two large holding-down bolts to 'sandwich' the two stone bearing blocks together. These sockets would almost certainly both have been roughly infilled and although the infill remains in-situ in the western void it has been removed from the eastern void. The lower end of the wrought iron bolt is clearly visible in the hole with a square cast iron nut (c.20 cm x 20 cm) directly beneath the underside of the stone.

- 3.2.15 To the west of the stone bearing blocks and bolt access sockets is a curved cast-iron guard plate which is flush with the face of the wall and which would have protected the wall from abrasions from the wheel paddles. This forms another partial concentric circle with the other groove and rebate referred to above but there is no comparable plate on the eastern half of this wall.

- 3.2.16 Immediately to the west of this cast-iron plate is a clear but partially collapsed horizontal socket (c.1.2 m wide x 18 cm tall) which would have housed an adjoining structure. As referred to above this corresponds with an area of collapse on the south wall and it is likely that a beam or frame spanned the pit at this point to support the end of an iron channel which fed the water into the paddles of the waterwheel. The location of this socket immediately behind the iron guard plate is strongly suggestive of this interpretation although there may also have been a small footbridge in this general area.

- 3.3.5 The general condition of the north wall is better than the south wall and there are fewer areas where the wall facing has been lost. The main structural issues on the south wall are towards the west end where part of the upper courses of the wall have been lost and the partial collapse of a socket has dislodged the brickwork above.

- 3.3.8 Each of the two wheel-pit walls would benefit from remedial stabilisation and repair works. The most important work should be to stabilise areas where the brickwork is gradually eroding through firmly re-setting loose bricks.

- 3.3.9 In-situ but loose bricks should be reset with an appropriate bedding mortar both to prevent loss of individual bricks and to halt the deterioration of the wider wall. In some areas it is apparent that structural collapses have taken place leaving sections of brickwork dislodged from their original location. It would be possible to reconstruct collapsed areas of brickwork to the probable original height but that would involve a considerable element of speculative rebuild and from the heritage viewpoint this would not be recommended. This may however be necessary due to other considerations such as health and safety.

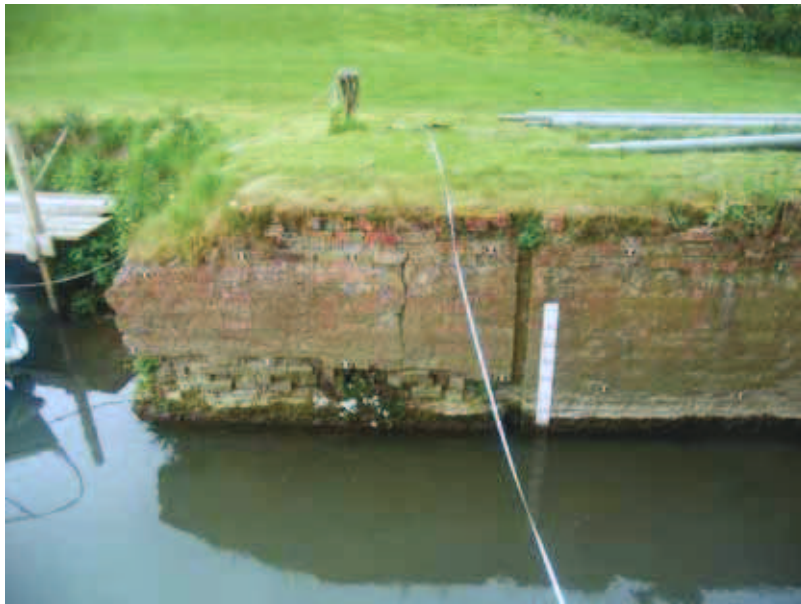
Plate 3: East end of south wall

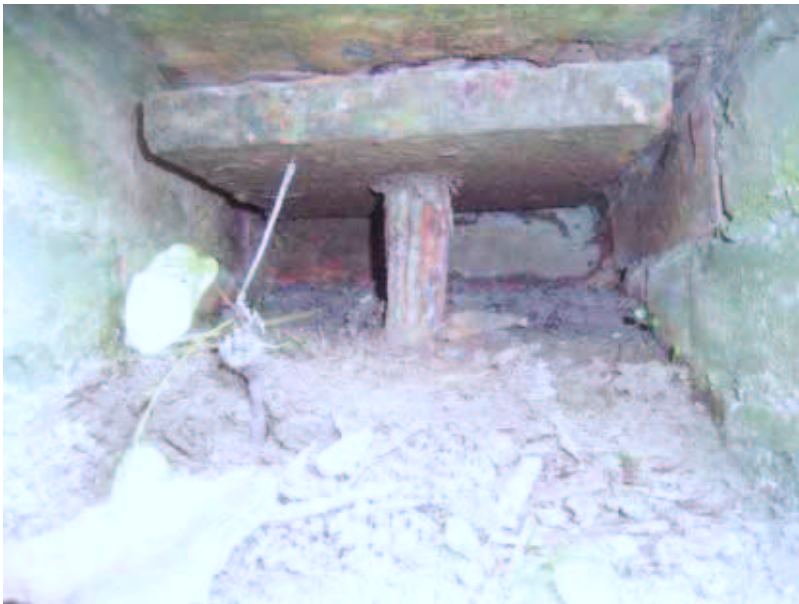
Plate 7: Bolt within access void beneath lower stone in north face of wall

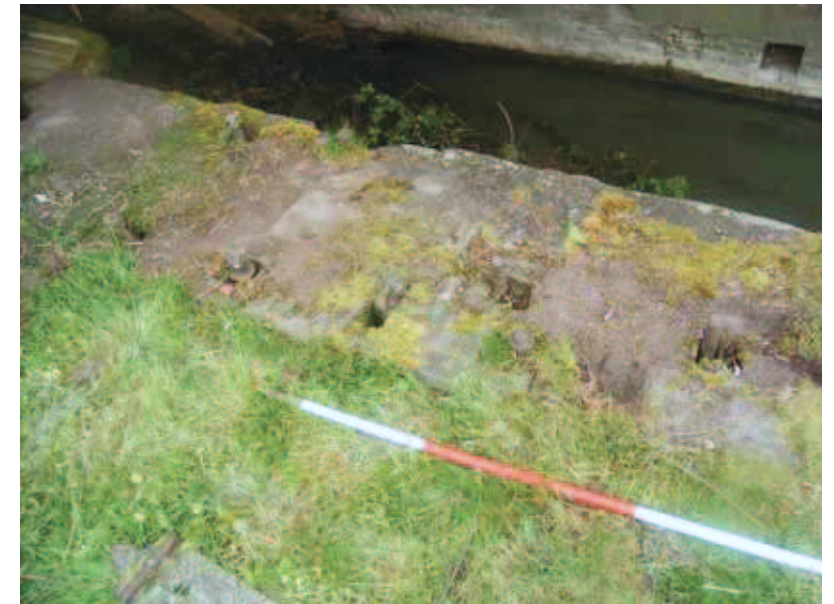
Plate 8: Holding-down bolts in upper face of stone bearing in south wall
