# Privy Kitchen Court Hampton Court Palace

Archaeological Excavation and Client Watching Brief Report

**July 2008**

**Document Type:** Excavation and Watching Brief, Client Report

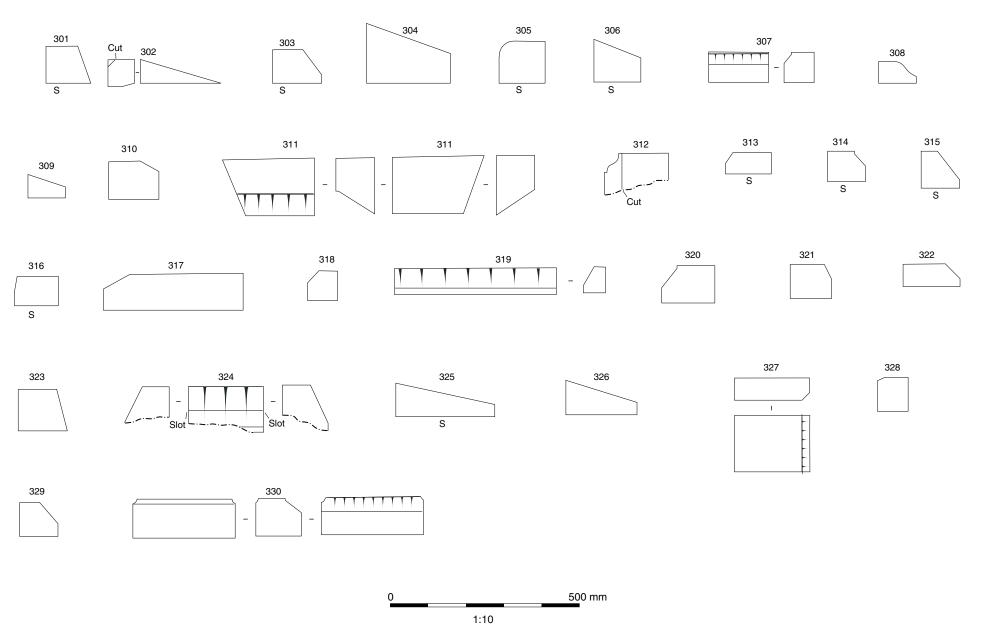
Figure 4: Profiles of selected paviours

1.1.43 Some pieces of removed stone (nos. 312 and 324) are possibly reused sections of older stonework which show signs of weathering, whilst the majority of paviours represent off-cuts and/or surplus material from a programme of refenestration undertaken in the 1850s (Colvin 1973, 331). The taking of the moulding profiles of these pieces will enable further studies to be made.

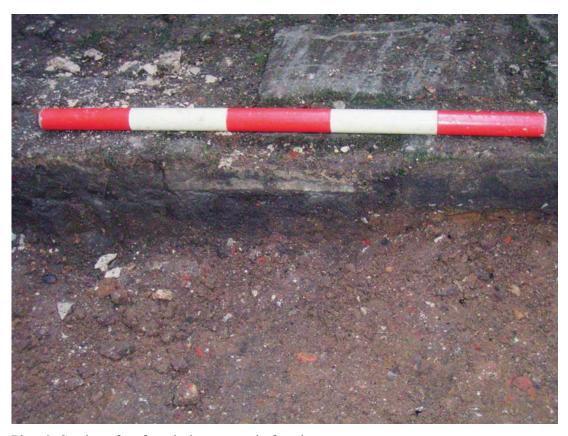
Plate 2: Section of surface during removal of paviours

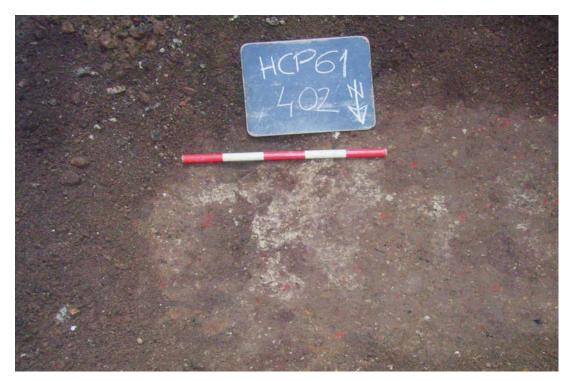
- 1.1.28 Underneath this context, an irregular portion of an earlier layer was found in the north end of the courtyard (402). It consisted on a very thin deposit approximately 0.02m thick which appeared to have been more extensive but had not been fully preserved. The very low consistency meant that it mixed easily with the context below (403) making it difficult to determine a precise boundary. The layer was composed of a sandy mortar of light colour mixed with very small fragments of ceramic building material.

Plate 3: Context 402 - bedding mortar

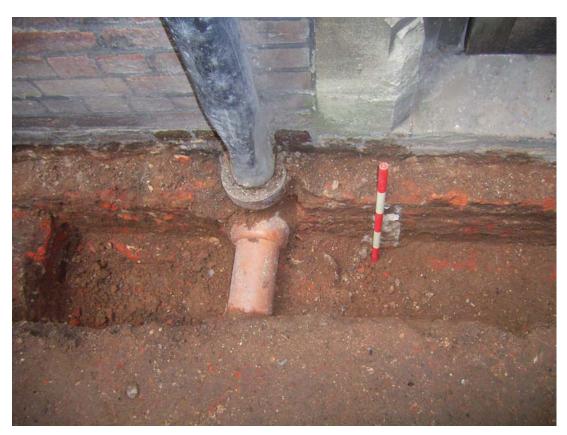
Plate 4: East - brick footing and ceramic pipe

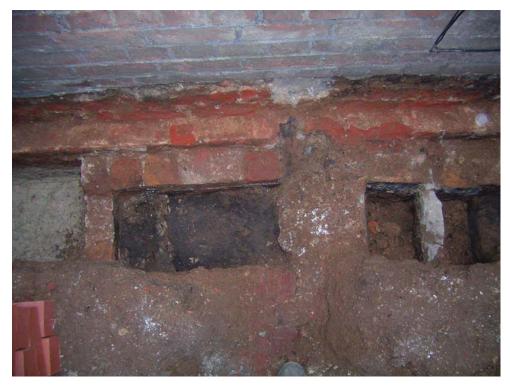
- 1.1.31 Surface (411) was smooth and extremely hard, at least 1.5m long and 0.25m wide. This structure does not have a physical relationship with the structure (404), located a bit further to the south. Structure (404) has been built with bricks and covered with plaster, which has peeled off in parts. The western wall was made of slate. To the north it had a thin stone exactly between (411) and (404) itself. The gap was approximately 0.7 x 0.4m and its southern wall was 0.08m and the northern, which is 0.34m, thus the total length is approximately 1.12m. This void had a slate cover which in turn was covered with fill (403).

- 1.1.40 The structures (411) and (404) do not have any physical relationship although they seem to have a related functionally. The outer line of (411) is clearly aligned with the outer line of the cavity of (404) and they look like they were part of some system of sinks or deposits for water. However, the few remains unveiled by the works do not give enough information to make a more reliable interpretation.

Plate 5: West - contexts 404, 403 and 411

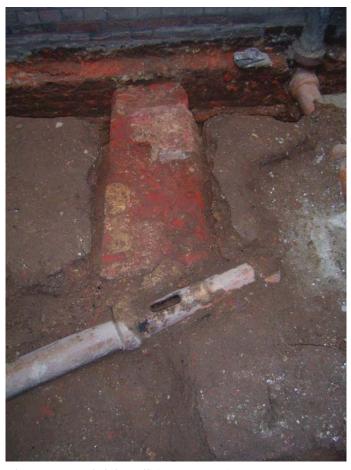
- 1.1.34 Abutting the east wall there was another wall (410) made of red bricks (0.19 x 0.05 x 0.1m) with thin joints filled by a hard yellowish white mortar. The full extent of this feature was not revealed during the course of the works. It appeared to be a solid wall about 1.2m long, 0.3m tall and 0.4m wide. It looked like it had been cut and may have been longer towards the west.

- 1.1.42 The walling (410) would appear to be part of the Late 17<sup>th</sup> early 18<sup>th</sup> century walling

Plate 6: East - brick wall (context 410)

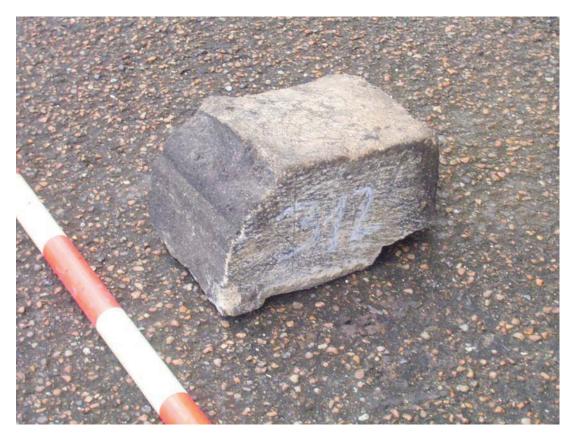
Plate 17: Paviour 312

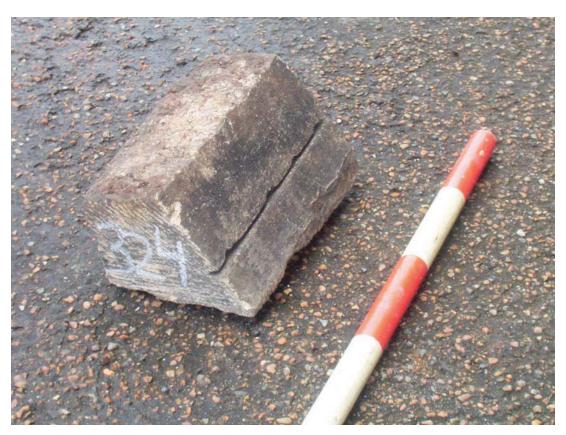
Plate 18: Paviour 324
