Wigglesworth Hall Laithe Jack Lane, Wigglesworth, North Yorkshire: Historic Building Record

April 2011

STEPHEN HAIGH

Wigglesworth Hall Laithe is a large aisled barn of the 16th or early 17th century, standing next to the former manorial centre of Wigglesworth Hall (NGR: SD 812574); it may have been built as the tithe barn for Long Preston parish and is listed, grade II. The original structure was thirteen bays long, with wide aisles to both long sides, but was altered in the 19th century, and almost all of the timber frame was destroyed by fire in 1958, so that little survives other than the masonry walls. Historic building recording, principally photographic, was carried out in April 2011 for Mr S Doney, to fulfil a condition of planning consent for its conversion to residential use.

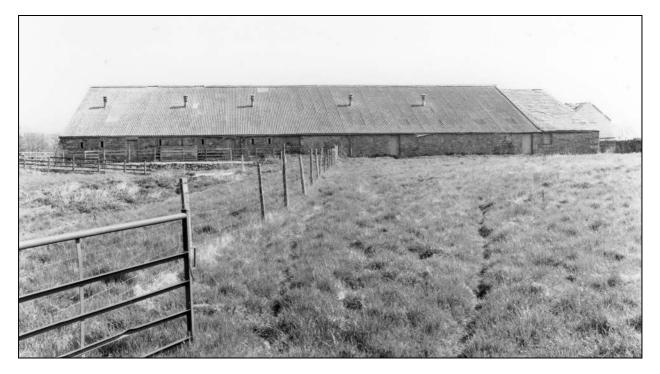
- 7.1 The building occupies a level site just to the south of the Wigglesworth Beck, and its long axis runs from SSE to NNW, so that one long side faces south-west towards the prevailing wind (perhaps chosen for the advantage when threshing), although its front is considered to be that side facing north-east (hereafter east). From a distance the barn could be mistaken for a modern farm shed, with its great length and span, and low asbestos-clad roof (1), but on closer inspection its stone walls show its true age. These are of coursed rubble, chiefly gritstone, with roughly squared quoins, and dressings of various types, although the original openings generally have plain, deep chamfers. At the south end, the barn has been extended by the addition of a bay running the full width of the building, an alteration which had clearly taken place by 1894 (see figures 3 and 4), and this is the only part of the building to have retained its stone slate roof after the 1958 fire (2).

Photo 1: The barn from the west, showing extension with stone slate roof

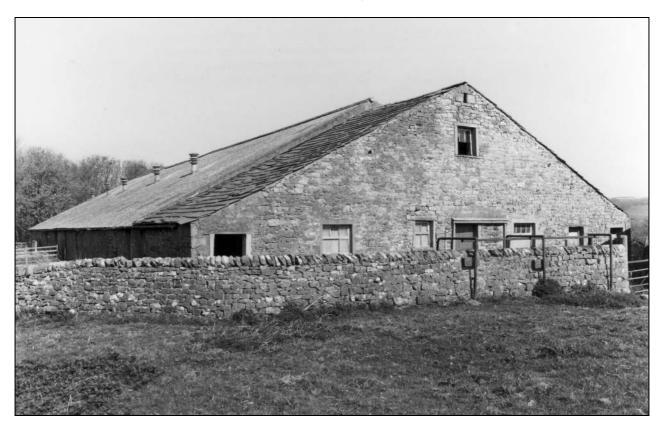
Photo 2: The barn from the south-west, showing extension with stone slate roof

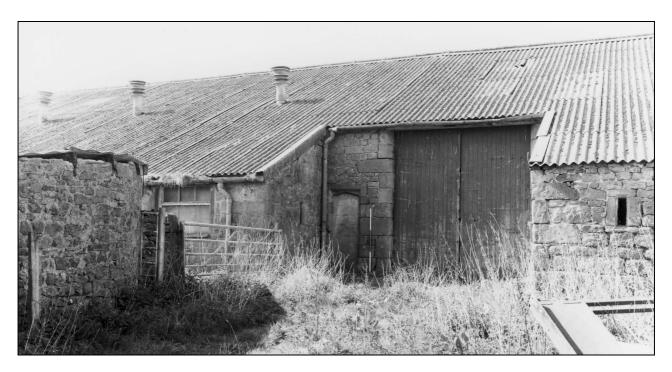
- 7.2 The principal entrance into the barn is in the middle of its east side, and is set back between the pair of flanking aisles which serve as shippons (3,4). A double doorway is set between chamfered, quoined jambs, but the timber lintel over this, and the doors, are post-1958. (Grooves worn into one of the quoins, noted by O'Flaherty, may be the result of tool sharpening (5).) To the left of this doorway is a pedestrian entrance, now blocked, but notable as the most distinguished of the building's openings, in that it has a Tudor arch with sunk spandrels (6).

Photo 3: East cart entry to aisled barn, flanked by shippons

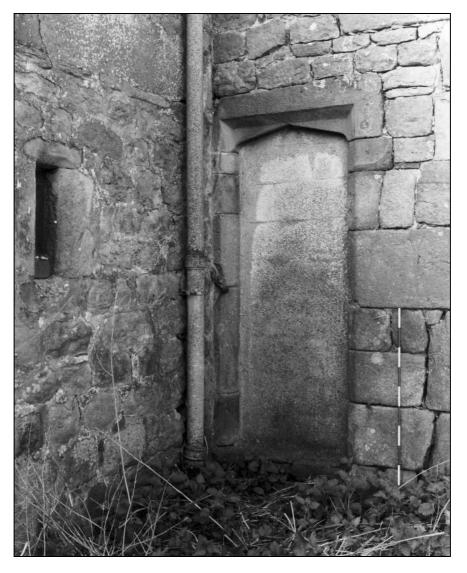
Photo 6: Blocked pedestrian doorway next to east cart entry

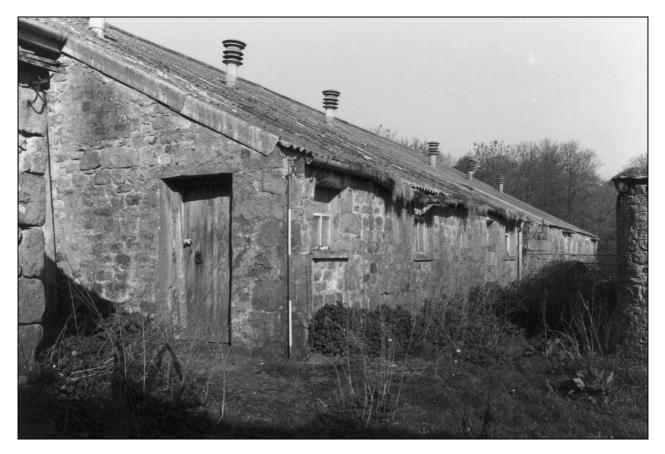
- 7.3 The two shippons occupying the aisles to either side of this entry appear to have been symmetrical when first built, but changes have been made to the south one. The original arrangement of each, well preserved in the outer walls of the north one, include two pedestrian entrances, with splayed, chamfered breathers arranged between them, as well as breathers in the north and south ends (7-9). (A quoin at the south-east corner of the north-east aisle bears the initials "I L" (10), probably for J L, although the identity of the carver is not known.) The south-east shippon has been shortened by the insertion of a new cart entrance at the very south end of the original building (probably when a cross-wall was built in the barn to create two halves, most likely in the 19th century) (11), but besides this has also had its pattern of openings radically altered, with a number of windows having been put in, and one of its doorways partly blocked (12,13).

Photo 12: South-east shippon, from the south-east: truncated, and with inserted openings

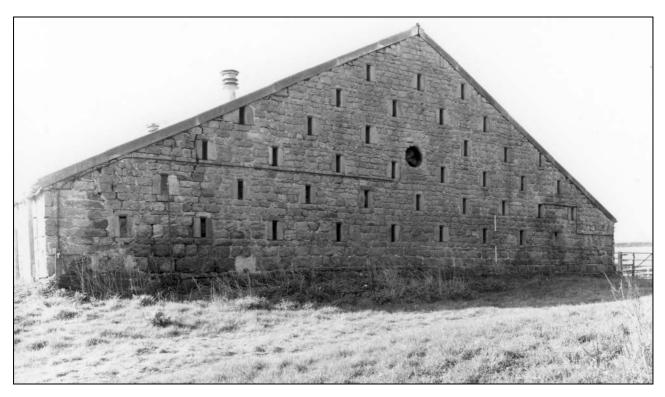
- 7.5 The aisled barn's gables also seem to have been symmetrical: the north one is well preserved, and has seven rows of breathers, regularly spaced, with large footings below (**17**,**18**). Sanderson's illustration (above) shows there to have been ten rows of breathers before the 1958 fire, which suggests that the roof line has been reduced by around 3m, but this might be attributable to inaccuracy on the artist's part. The south gable now faces into the adjoining addition and has had doorways inserted, but its general arrangement is readily seen to mirror that of the barn's other end (**19**).

Photo 17: The north gable

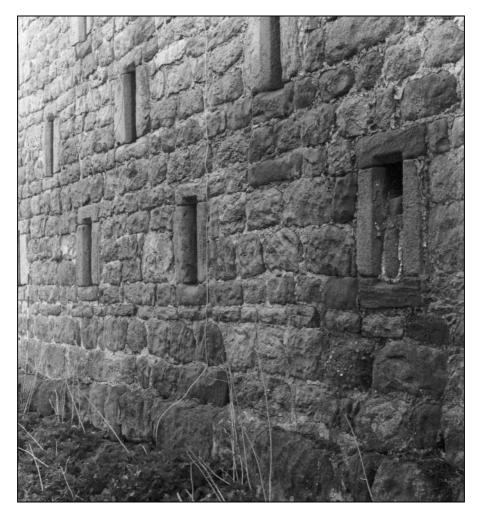
Photo 18: North gable: detail of breathers and footings

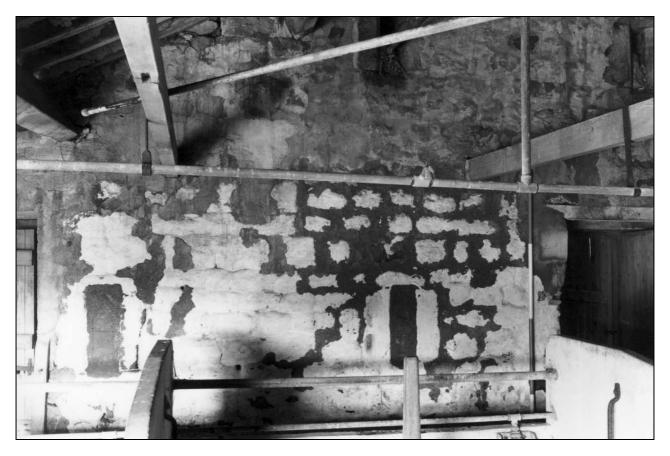
Photo 19: Blocked vents in south gable of aisled barn, now facing into south extension

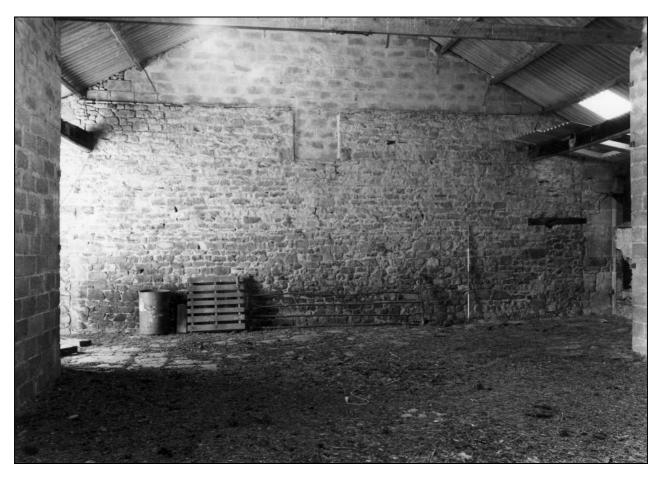
Photo 25: Inserted cross wall in aisled barn, from the north

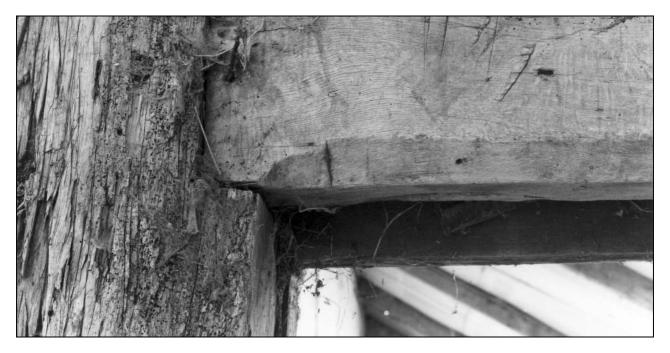
the east side (**32**), as an indicator of the quality of the carpentry. However, the very top parts of the posts appear to have been removed (**32**), and it seems that the horizontal timbers which link the posts to the inserted cross wall are not the true arcade plates, as these would have been positioned at the top of the posts, where they would bear the weight of the roof, so it is thought that these were reset at their present, lower height when that wall was put in. However the arcade braces which support these horizontal members are chamfered and pegged in place, so this is not certain, and it may be that some adaptation of the original timbers has been carried out (**33-35**). Also visible in the outer faces of the arcade posts are the mortices for aisle rafters.

Photo 32: Detail of chamfer and stop on east aisle tie (south side)

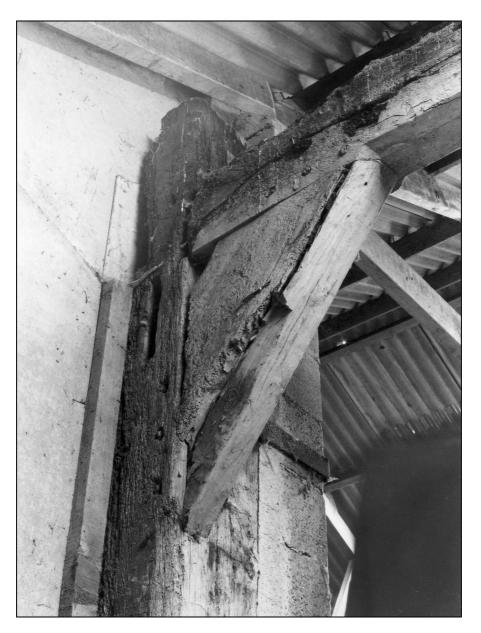
Photo 34: Top part of outer face of west arcade post (arcade plate lowered?)

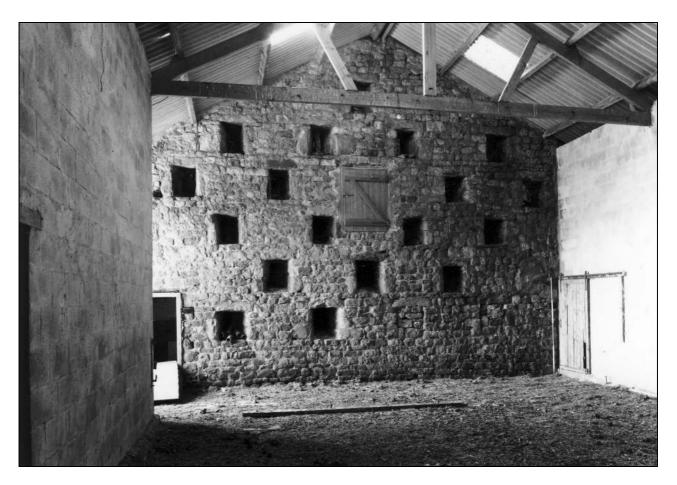
7.8 Although nothing of any other timber framing survives beyond these elements, the positions of the earlier trusses can be determined from the five pairs of padstones remaining to the north, standing slightly proud of the concrete floor in the north-east and north-west shippons which occupy the aisles (36-38). The role of the arcade posts in supporting the roof is now served by two breeze block walls which divide this half of the building into these three areas (39), but originally there may have been only timber partitions, or none at all, to separate the main central area from the aisles. This central area, which has a cobbled floor, would have been a storage area for crops, and the numerous breathers in the north gable would have been necessary to ensure it remained well ventilated (40), as well as allowing some light into the building (which now benefits from roof lights). To either side, the aisles must have been shippons, as they are today (41,42). A mirror image of this arrangement exists in the south end of the barn beyond the inserted cross wall, although the 19th century cart entry at the south-east corner interrupts this simplicity (43-45), and here, the padstones

Photo 43: Interior face of south gable of aisled barn

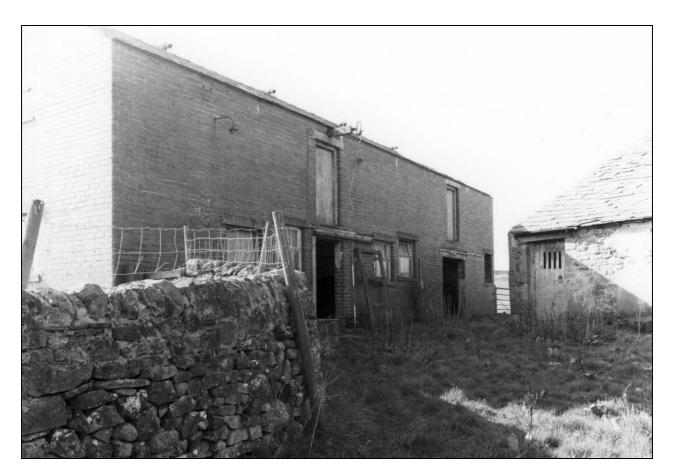
- 7.11 A small detached building to the south-west of the aisled barn is probably late 19th century and has an adjoining pen; it has an entrance in its north side and what may be a fowl hole in the south side, so may have been used for poultry (52,53).
- 7.12 The two buildings to the east of the barn, set into the slope, are former middensteads (for storing manure), but have been altered and roofed over, and are not of particular interest (**54**).
- 7.13 To the south is a brick building of two storeys, erected after 1909 according to the Ordnance Survey. On the whole it is not of interest, although one of the ground floor rooms contains the original timber fixtures of a stable, with a well made stall divider, heel post, hay rack and row of pegs (**55**,**56**).

Photo 55: Brick built stable, from the north-east

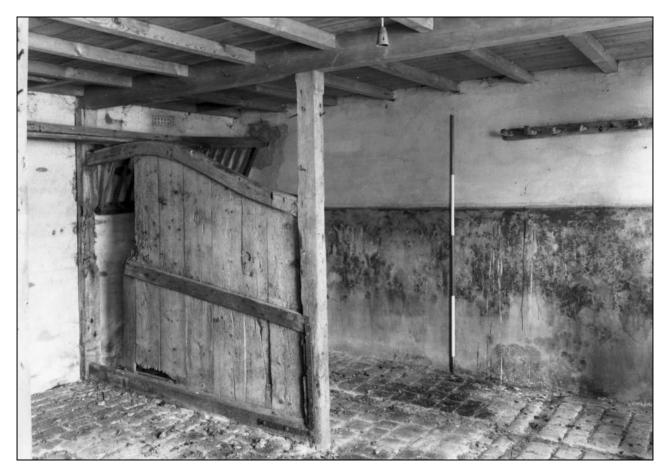
Photo 56: Stable in brick building to south of aisled barn
