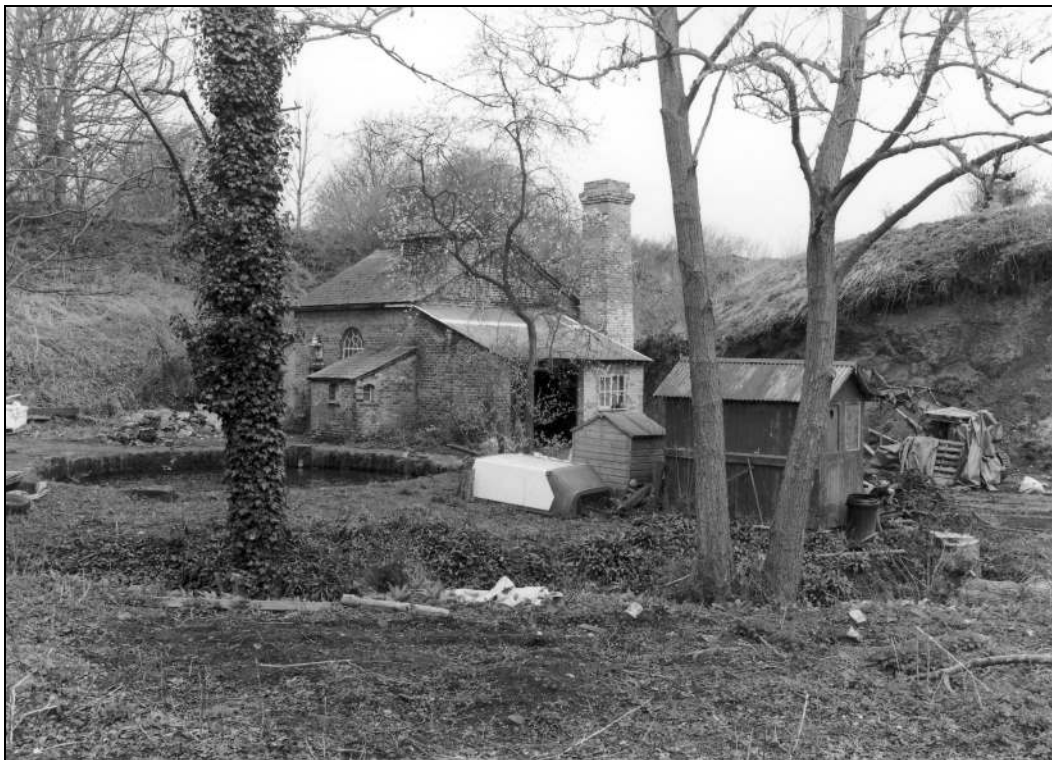
Photo 2: The retort house and gasholder pit, from the east (film 2, frame 2)

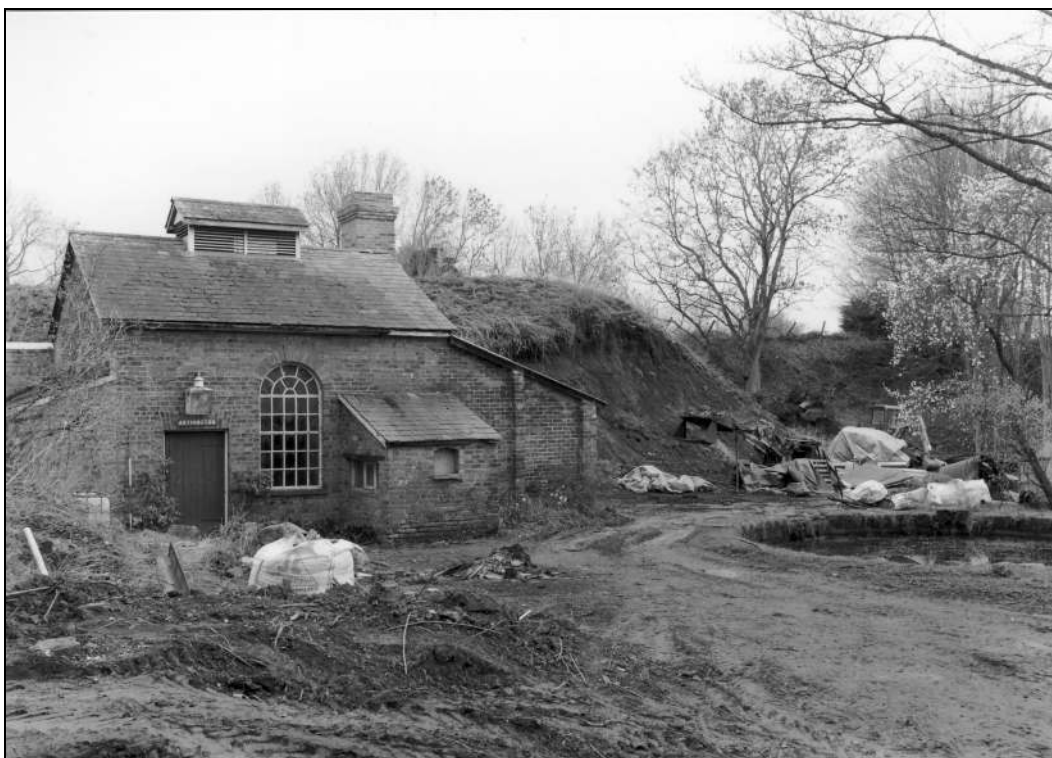
Photo 3: The retort house and gasholder pit, from the south (film 1, frame 1)

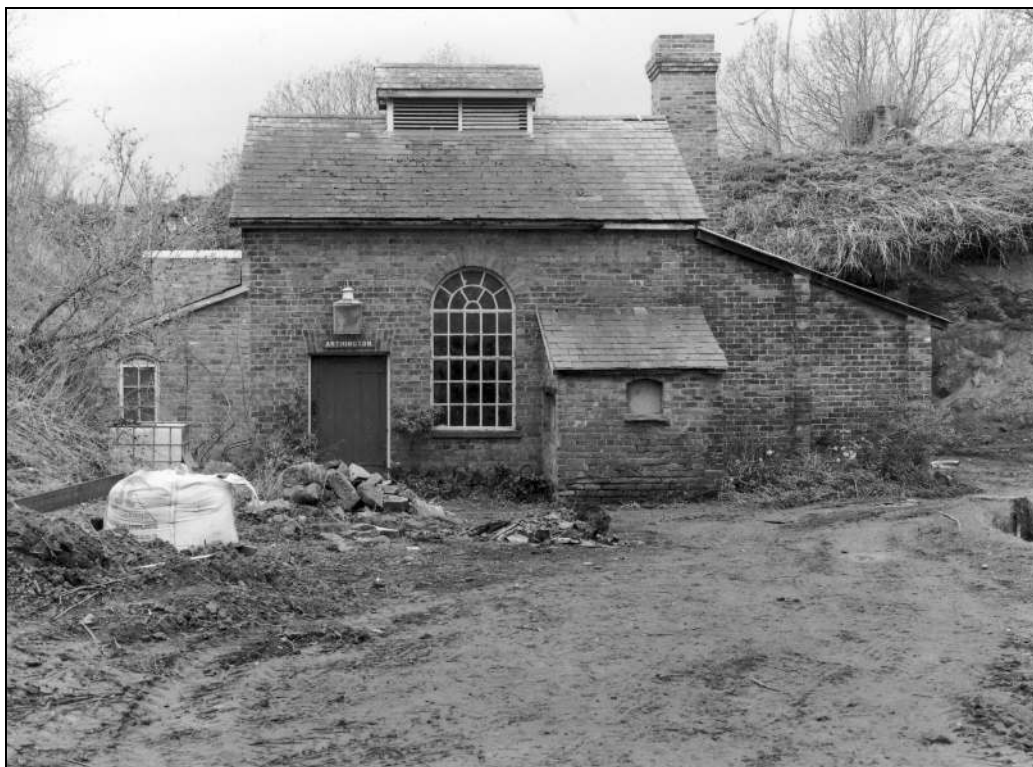
Photo 5: The retort house, from the south-east (film 3, frame 11)

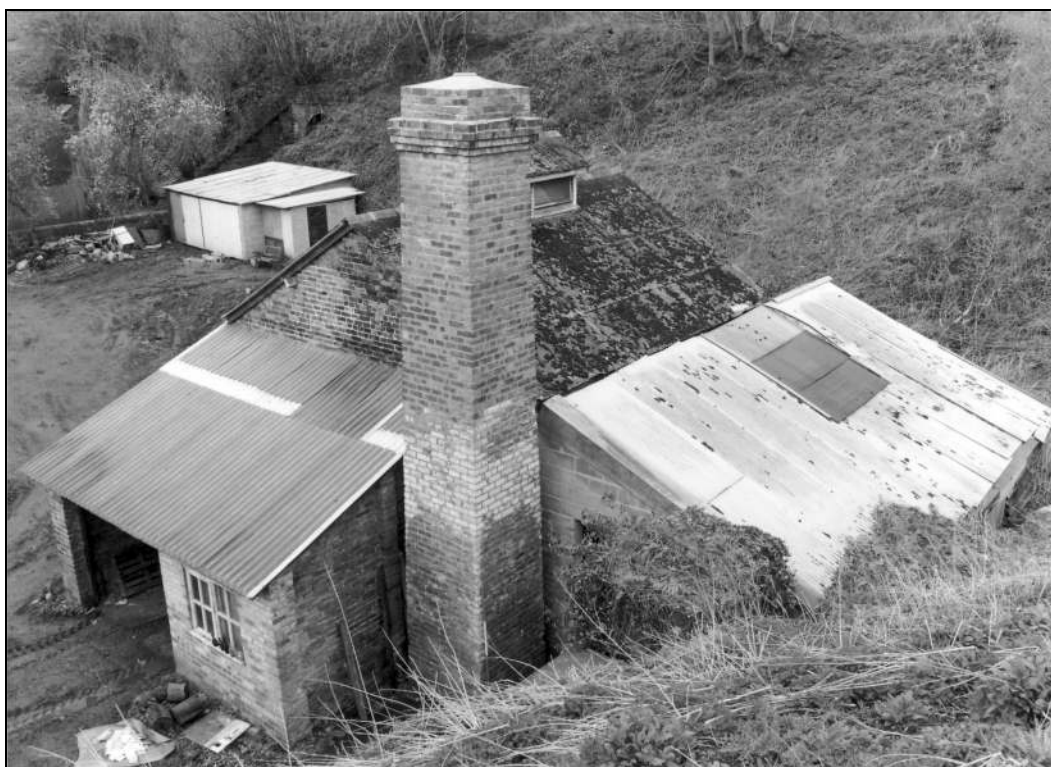
Photo 6: The retort house with repaired chimney, from the north (film 1, frame 7)

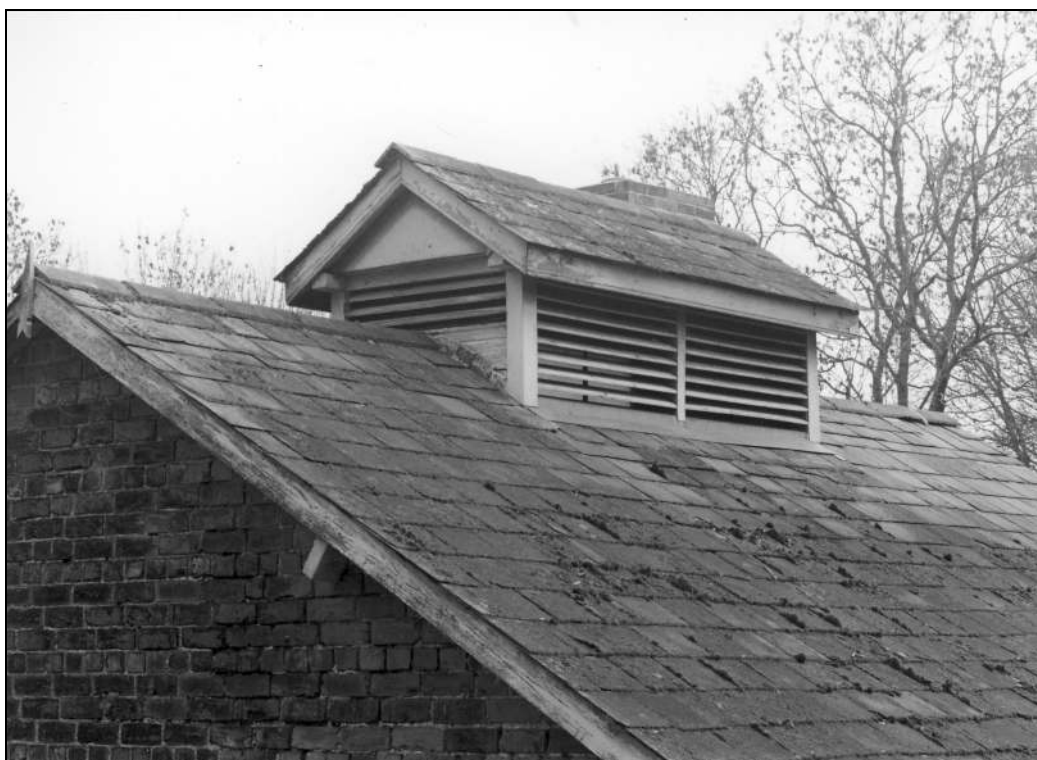
Photo 7: Detail of ridge ventilator to retort house, from the south (film 1, frame 13)

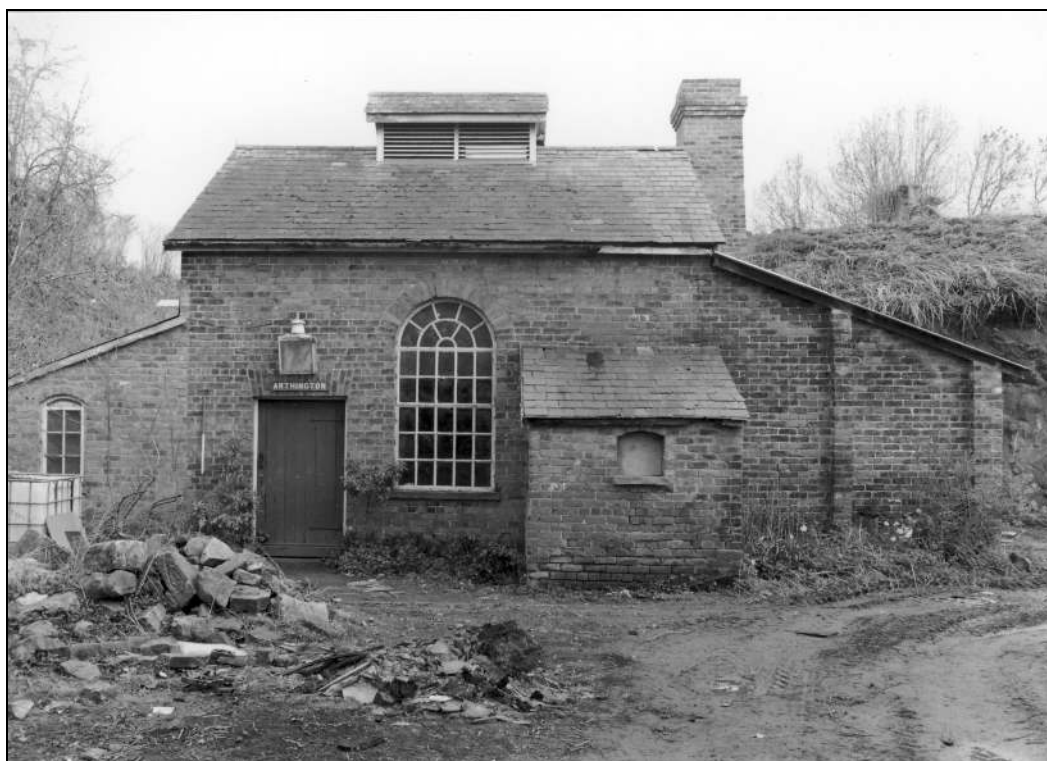
Photo 8: The retort house, from the south-east (film 1, frame 2)

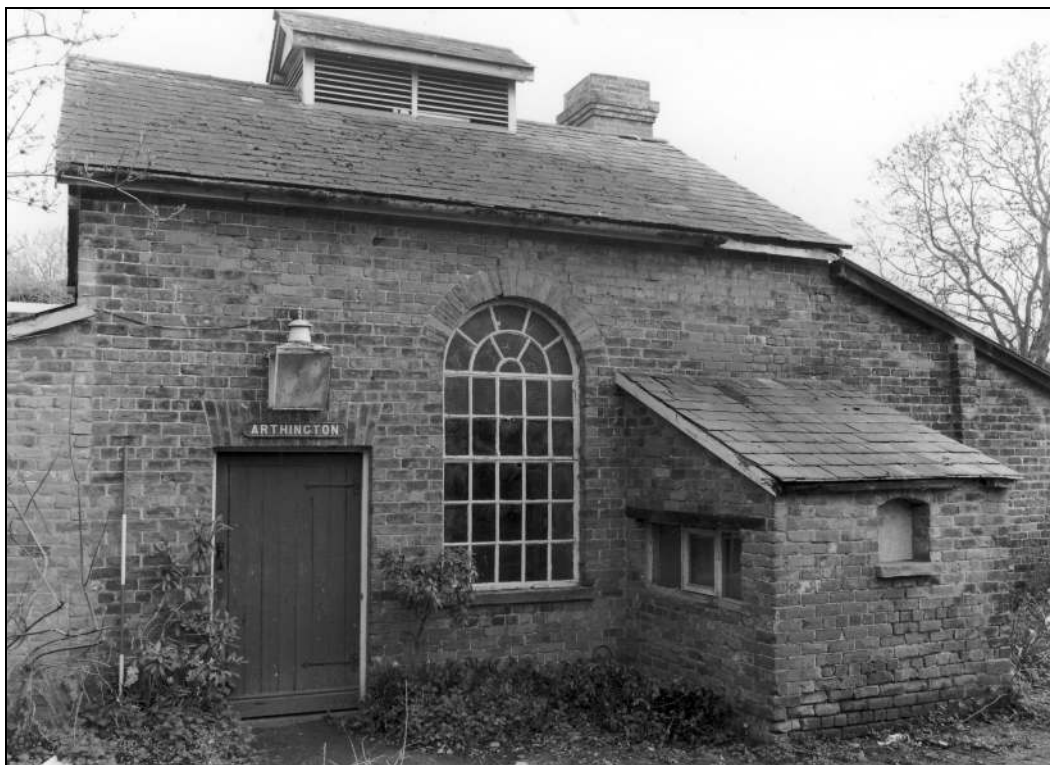
Photo 9: The retort house, from the south (film 1, frame 4)

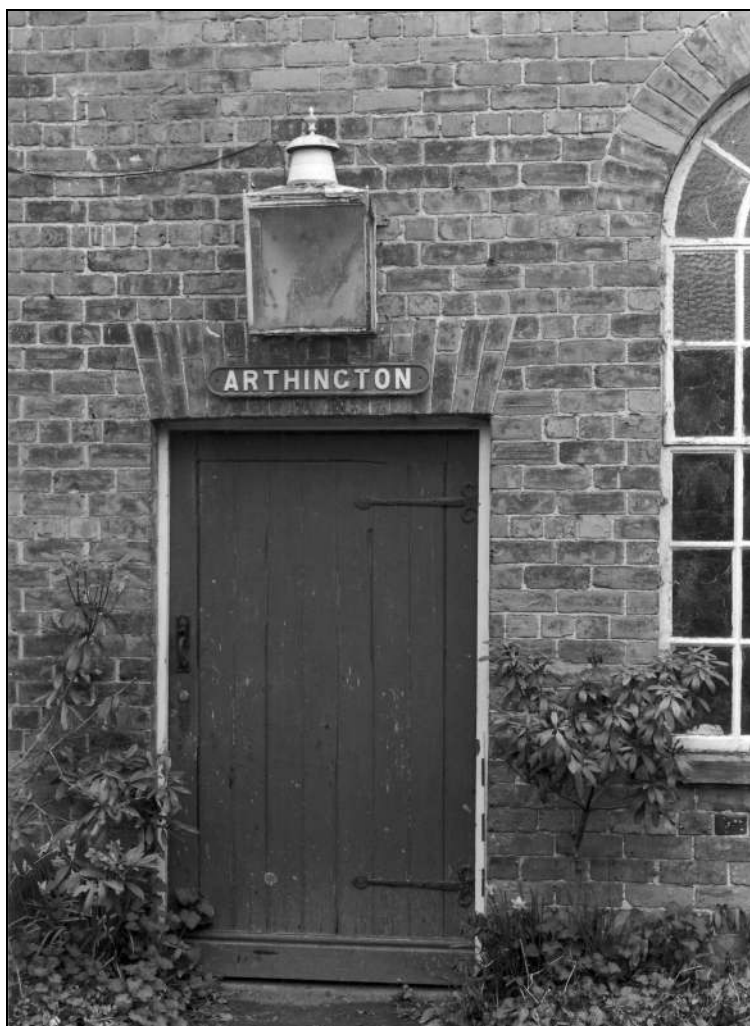
Photo 10: The retort house: detail of original doorway (film 1, frame 18)

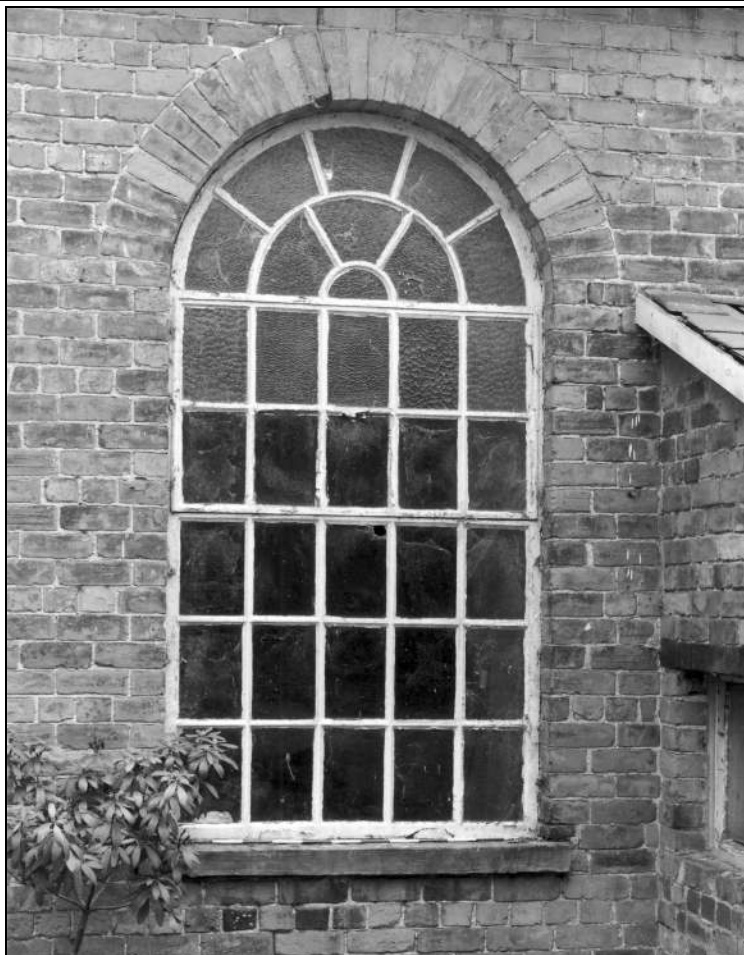
Photo 11: The retort house: detail of original window (film 2, frame 1)

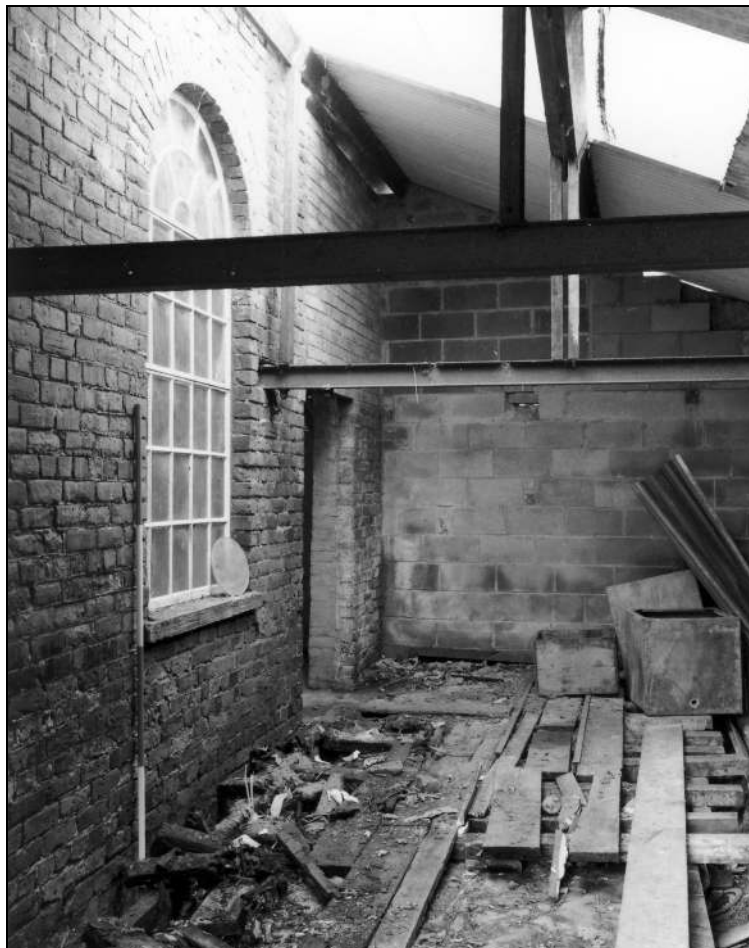
Photo 12: The retort house: north-west elevation (film 2, frame 18)

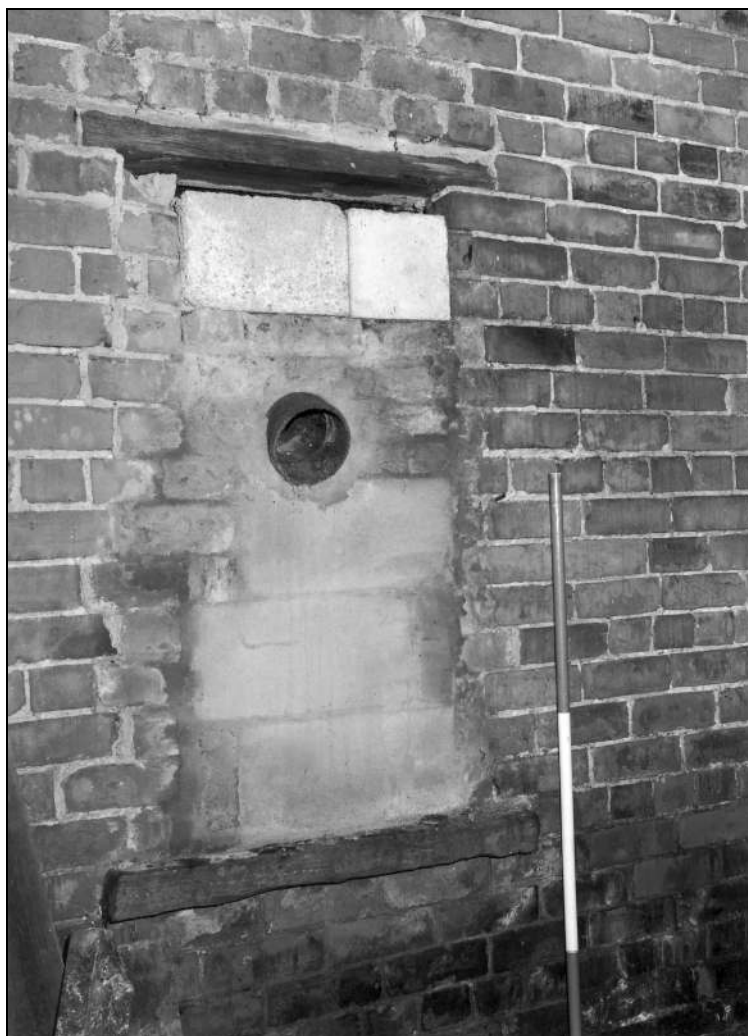
Photo 13: The retort house: altered window in north-west elevation (film 3, frame 2)

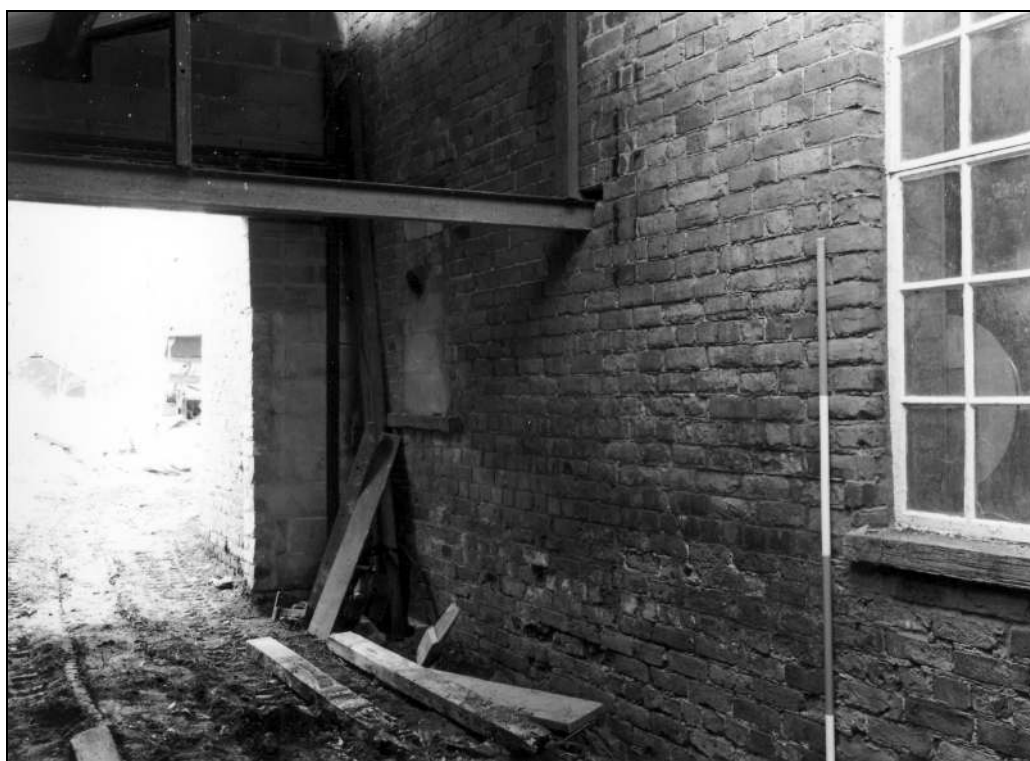
Photo 14: The retort house: north-west elevation (film 3, frame 1)

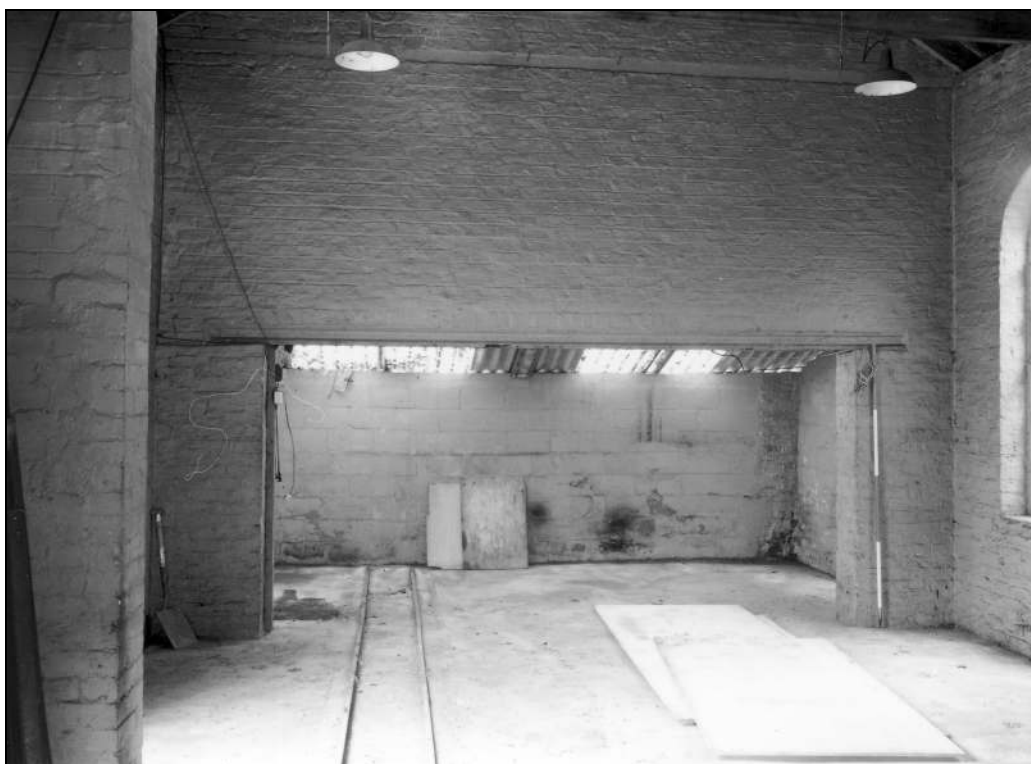
Photo 15: The retort house: interior, from the north-east (film 3, frame 9)

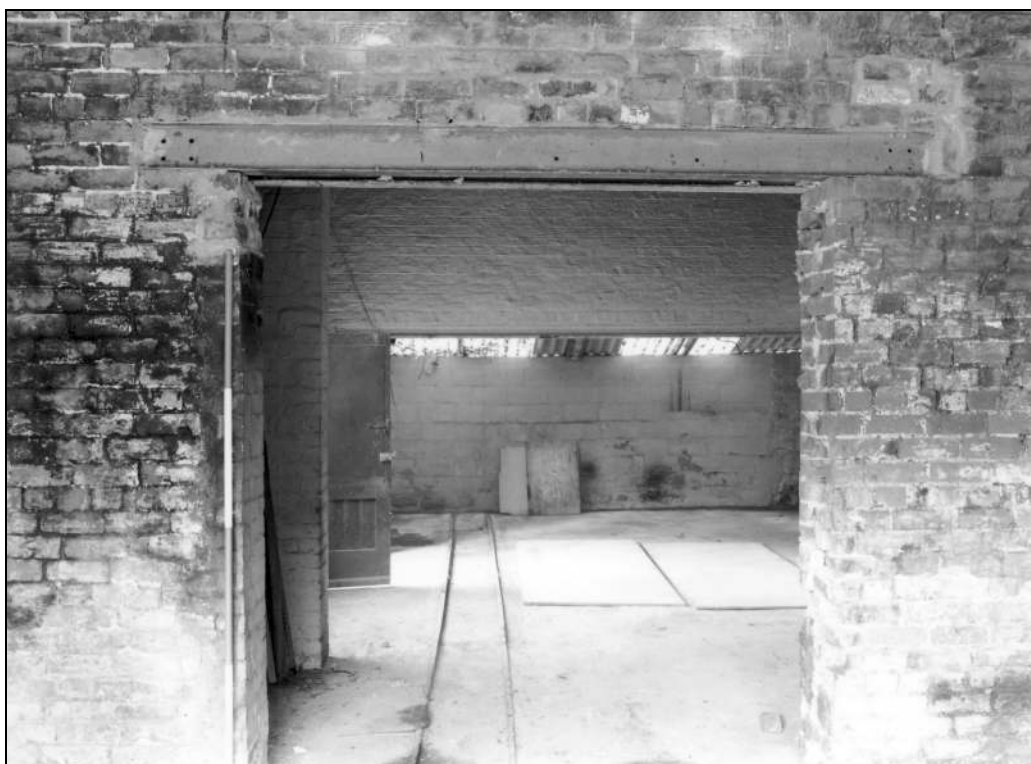
Photo 16: The retort house: modern opening in north-east gable (film 3, frame 10)

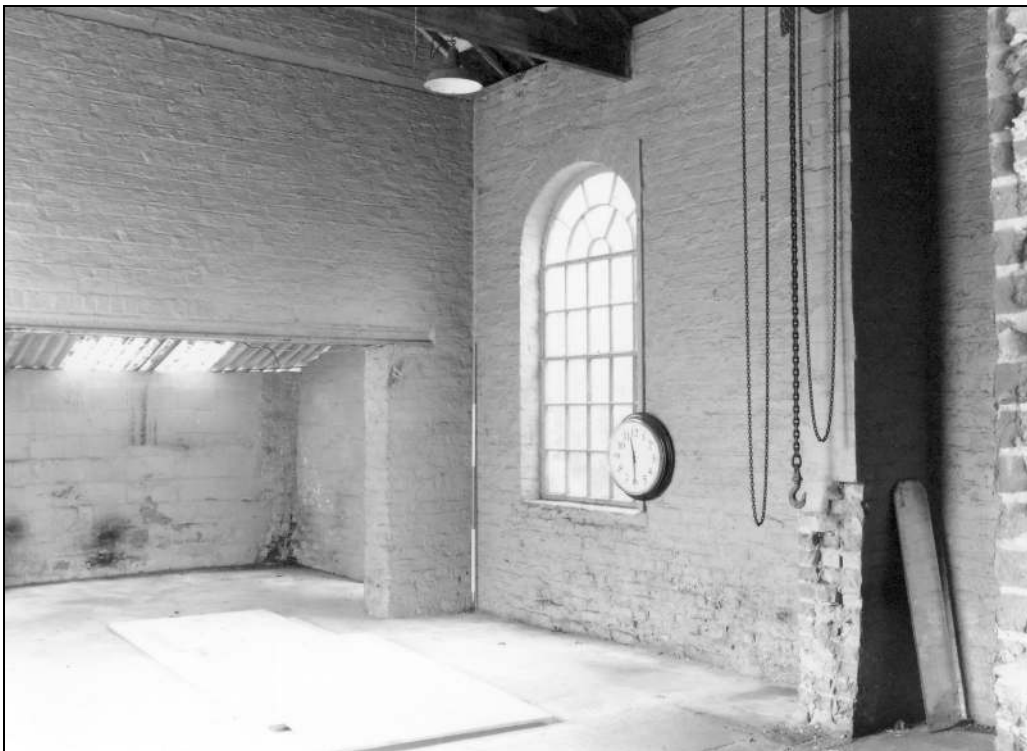
Photo 18: The retort house: interior, from the east (film 2, frame 8)

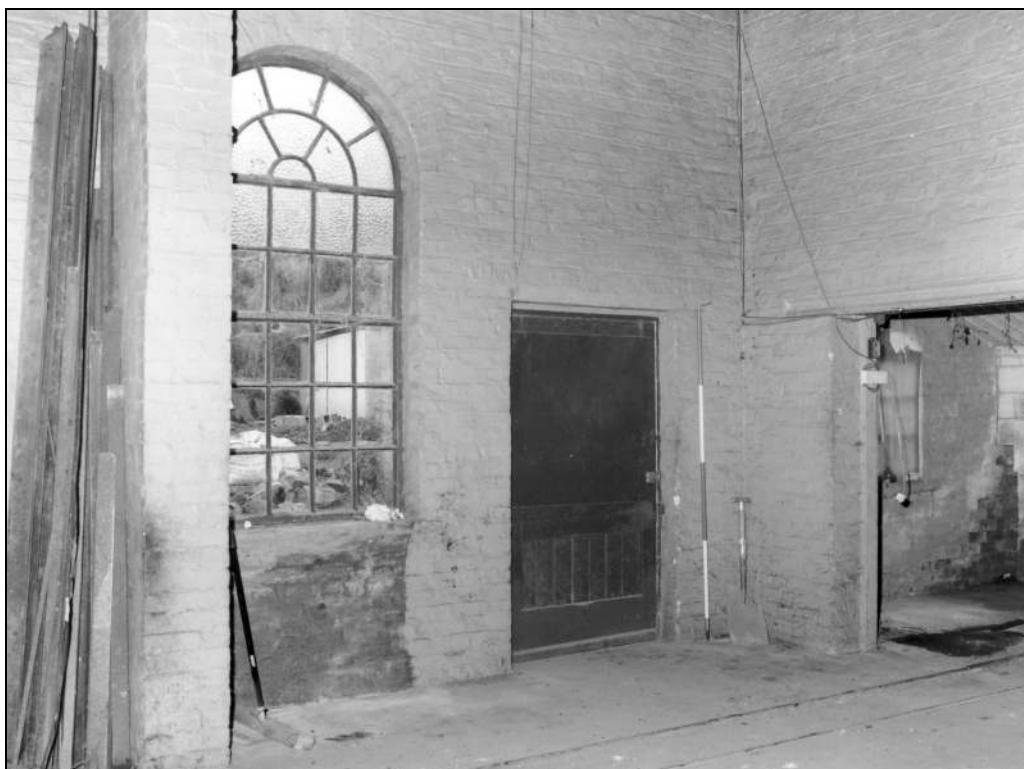
Photo 19: The retort house: interior, from the north (film 2, frame 7)

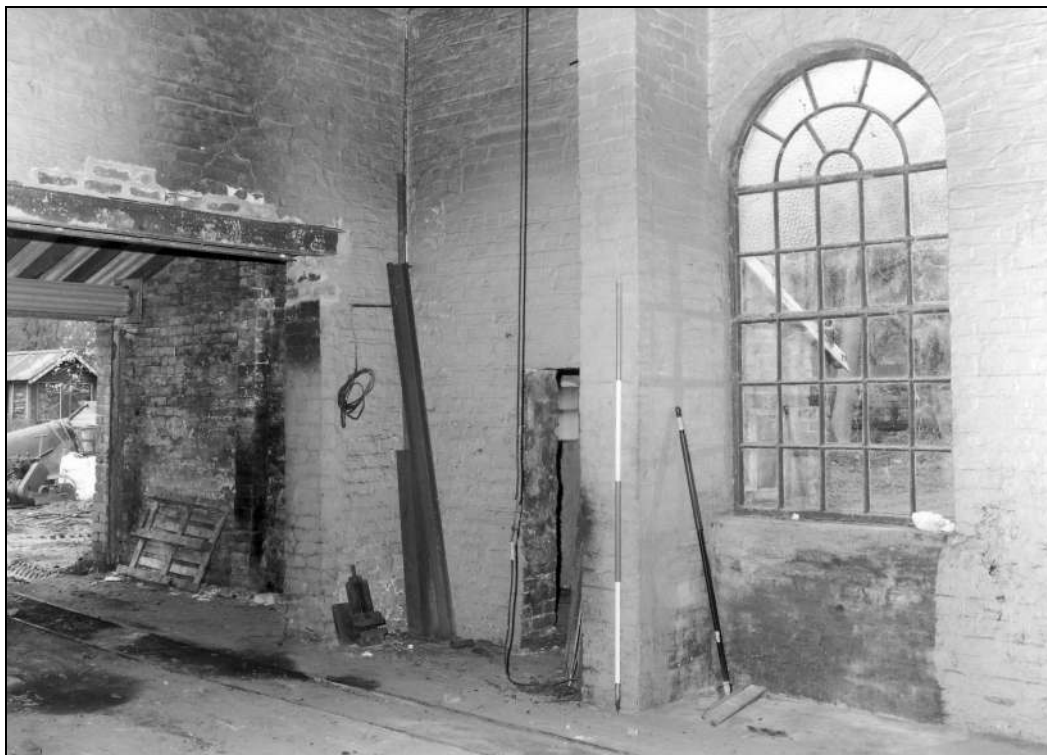
Photo 20: The retort house: interior, from the west (film 2, frame 5)

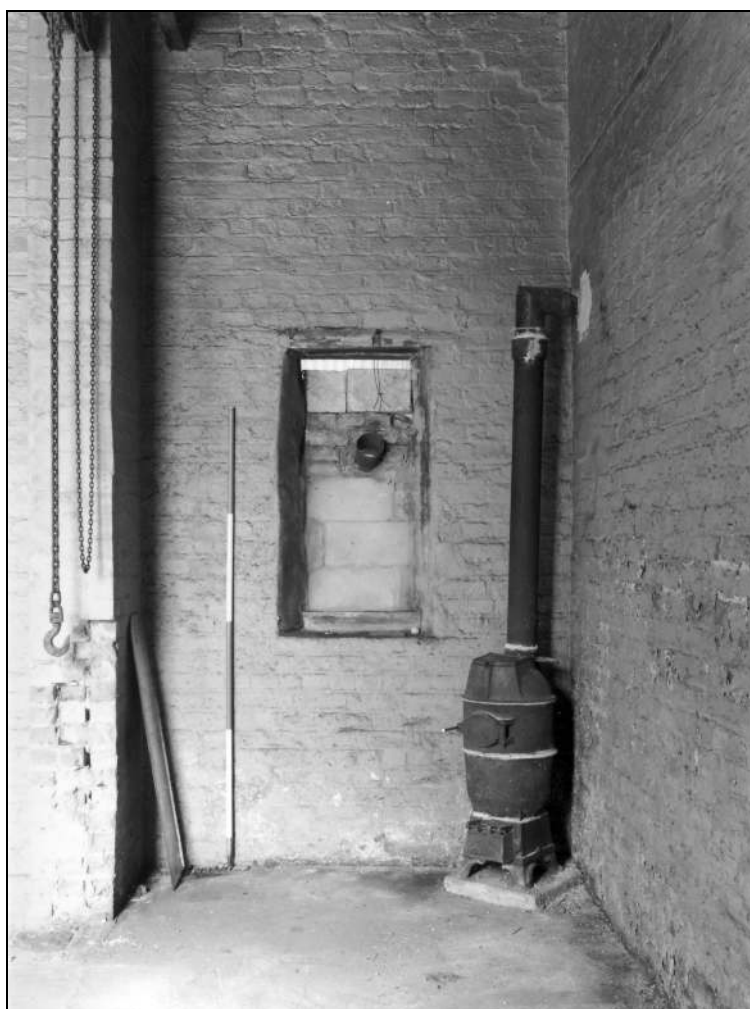
Photo 21: The retort house: former location of retorts, from the south-east (film 2, frame 10)

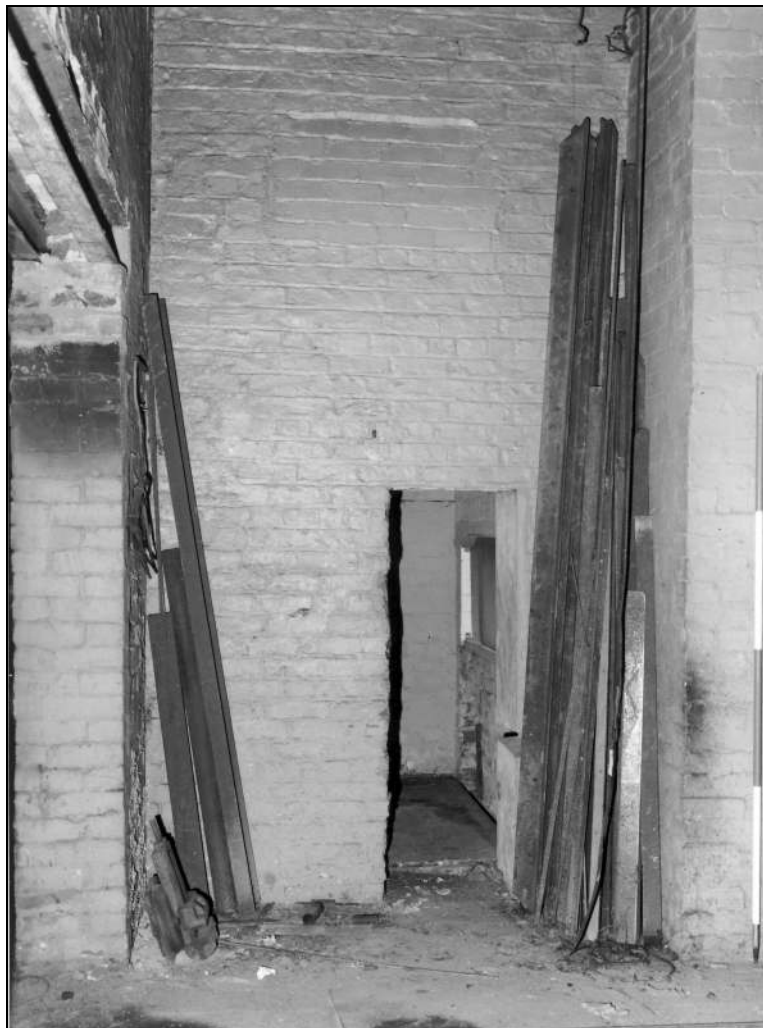
Photo 22: The retort house: inserted opening into south-east lean-to (film 2, frame 6)

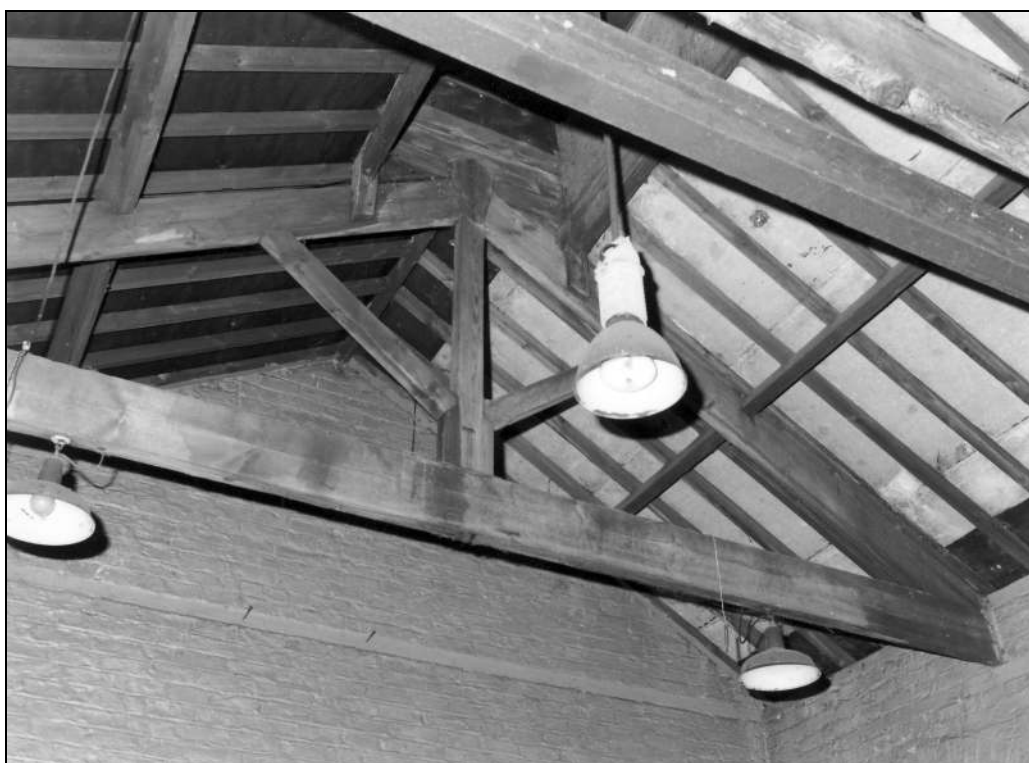
Photo 23: The retort house: roof truss, from the east (film 2, frame 11)

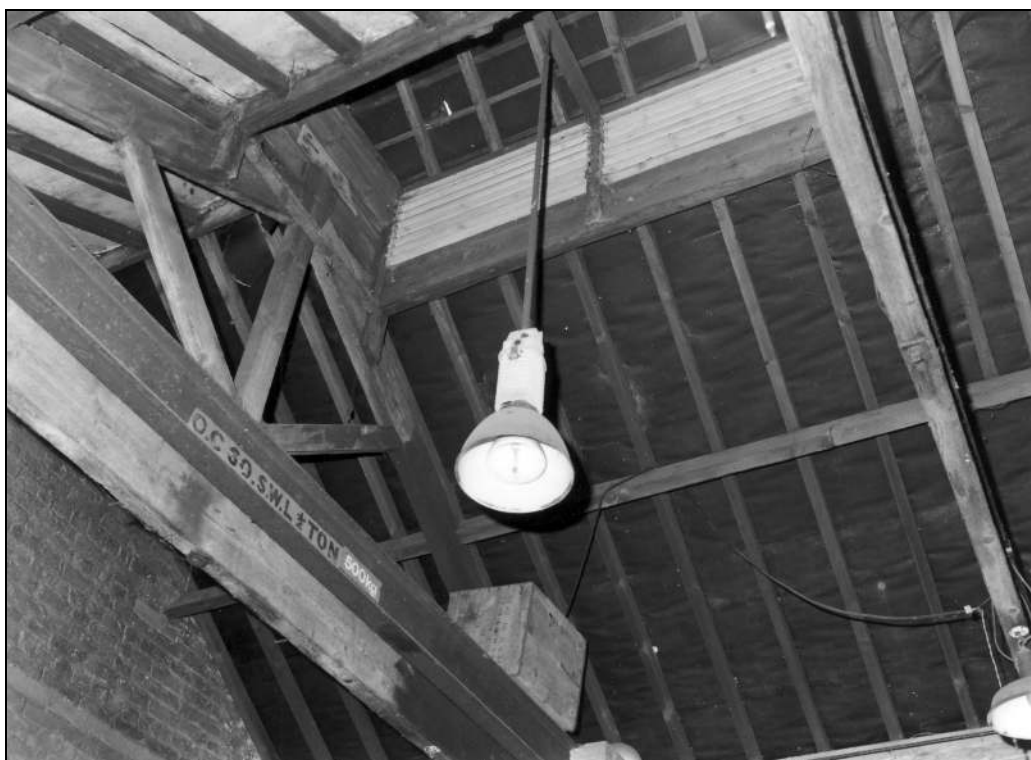
Photo 24: The retort house: roof truss and ridge vent, from the west (film 2, frame 12)

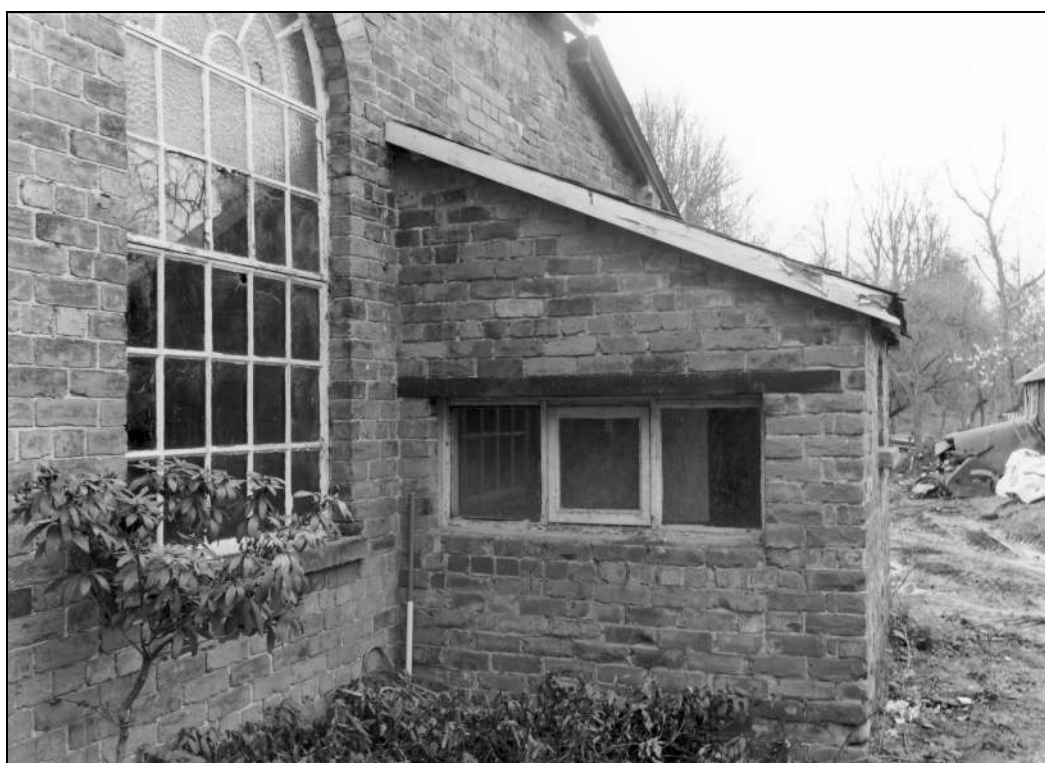
Photo 25: The retort house: south-east lean-to (film 1, frame 14)

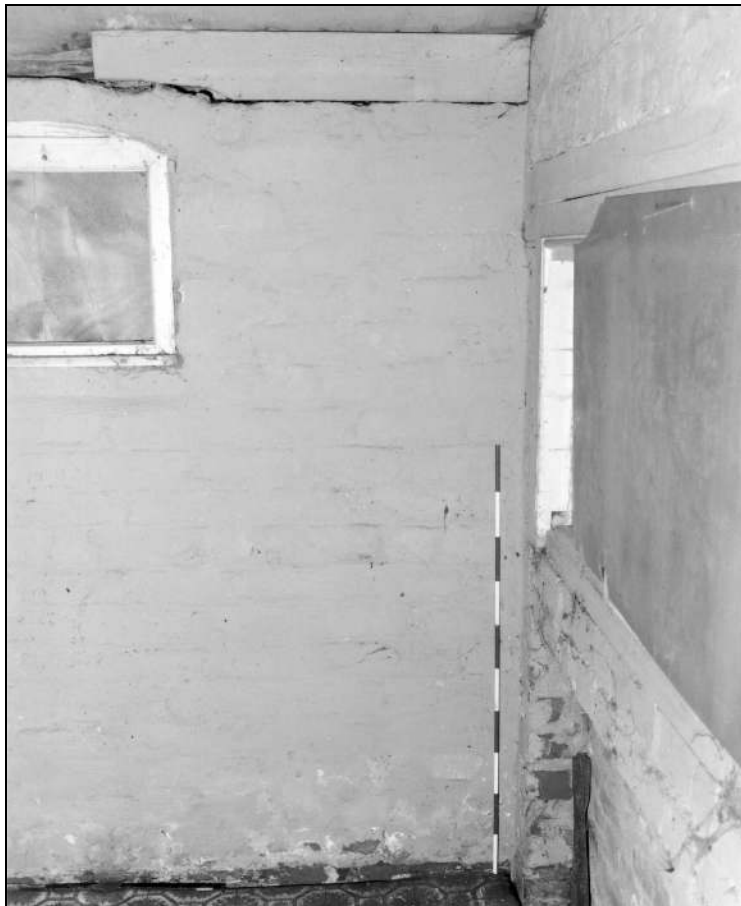
Photo 26: The retort house: interior of south-east lean-to (film 3, frame 7)

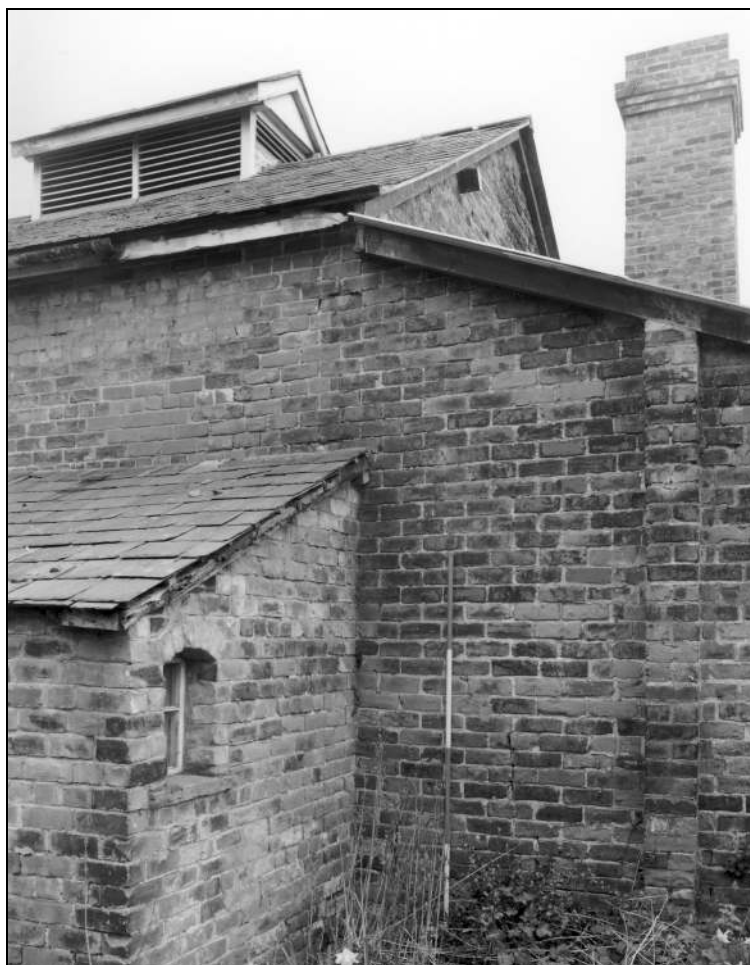
Photo 27: The retort house: detail of brickwork in south-east elevation (film 1, frame 16)

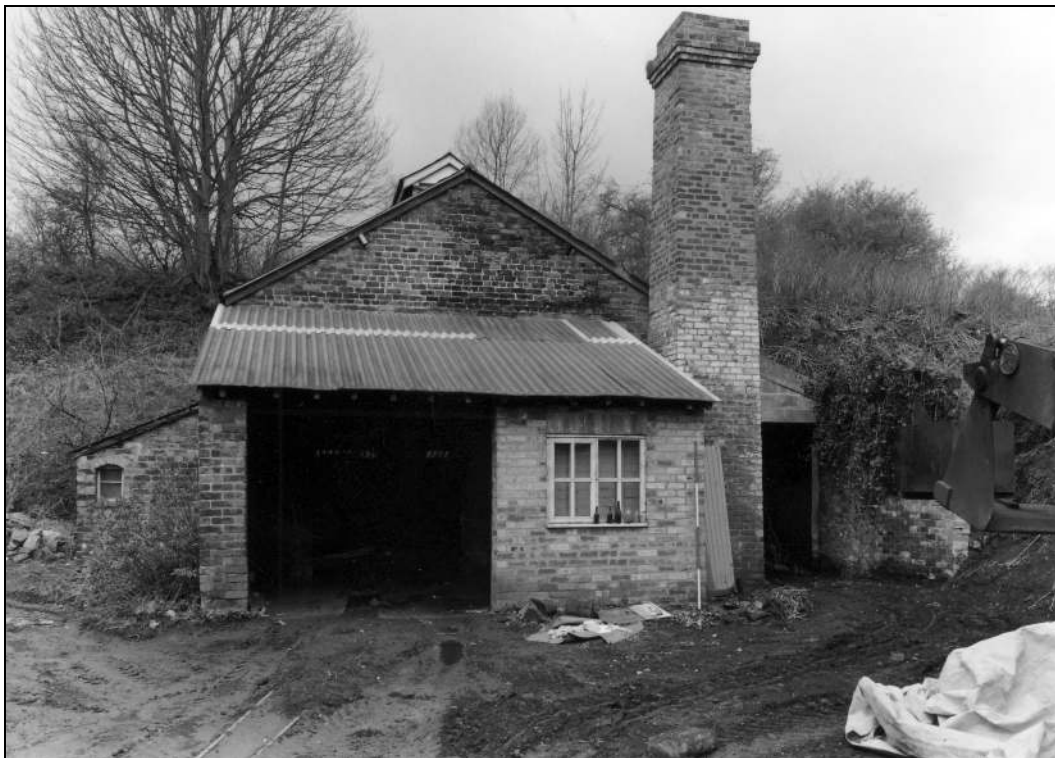
Photo 28: The retort house, from the north-east, showing gable lean-to (film 1, frame 6)

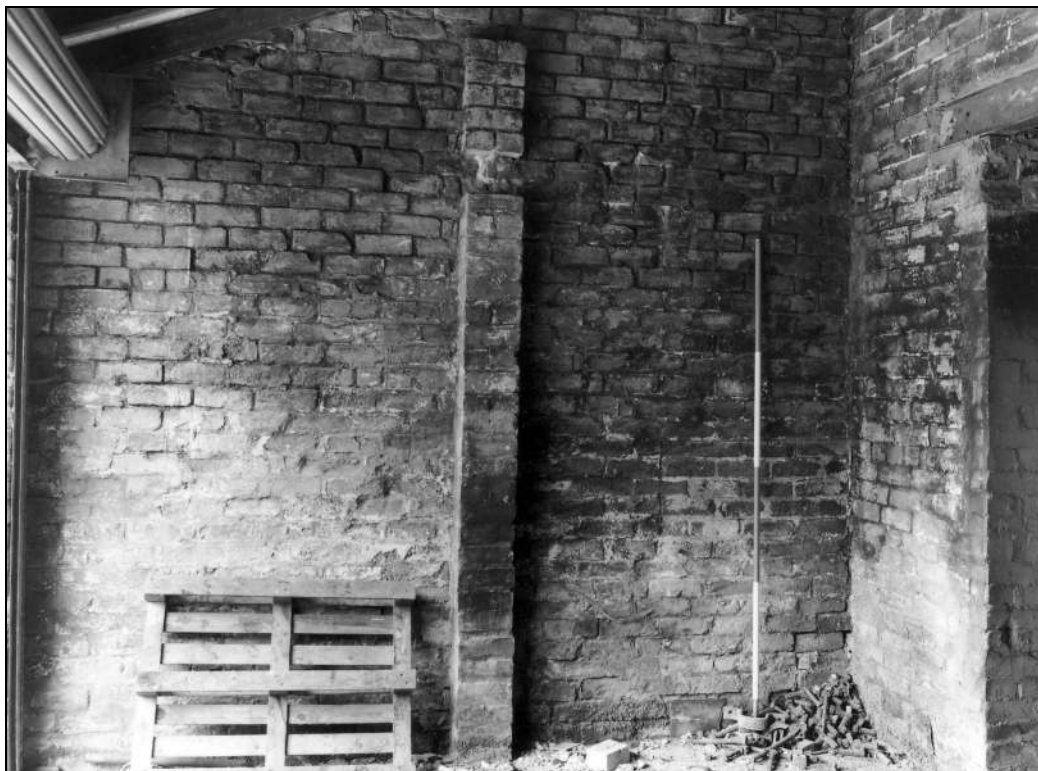
Photo 29: The retort house: interior of north-east lean-to, from the north-west (film 3, frame 5)

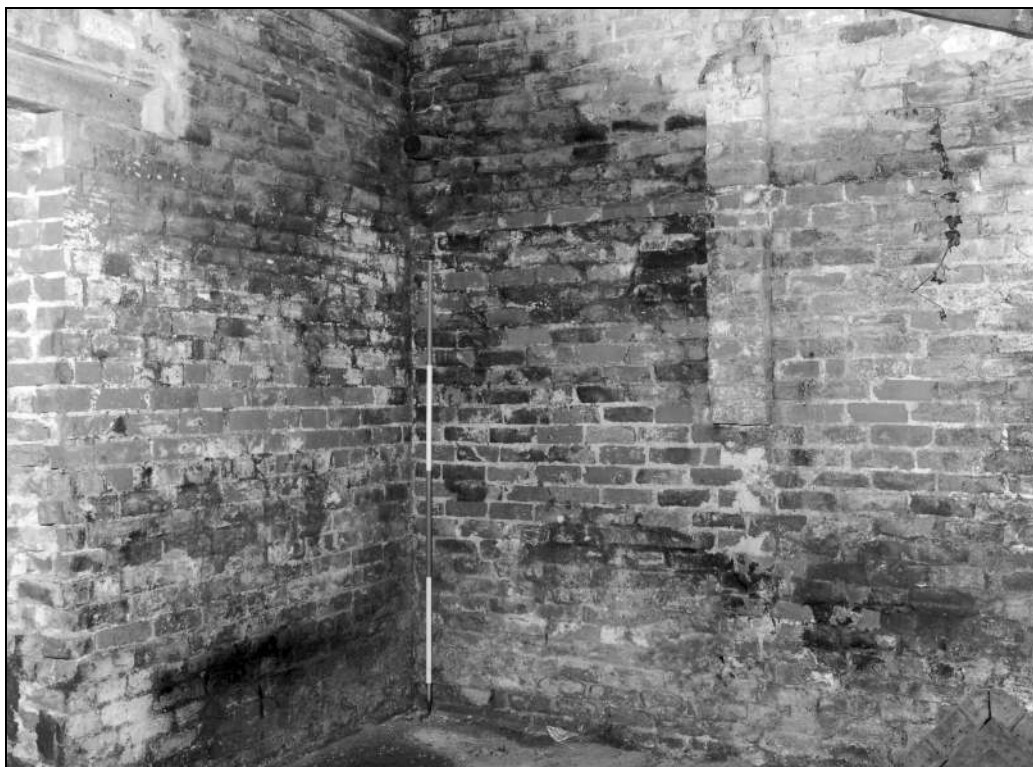
Photo 30: The retort house: interior of north-east lean-to, from the south (film 3, frame 4)

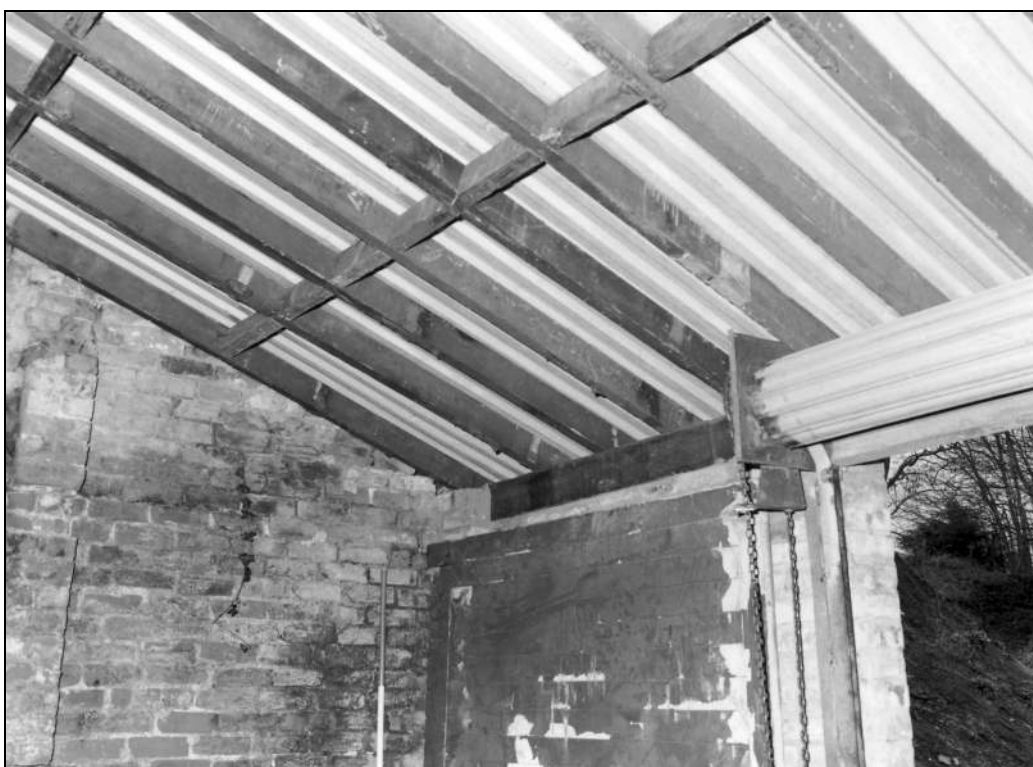
Photo 31: The retort house: interior of north-east lean-to, showing modern roof (film 3, frame 6)

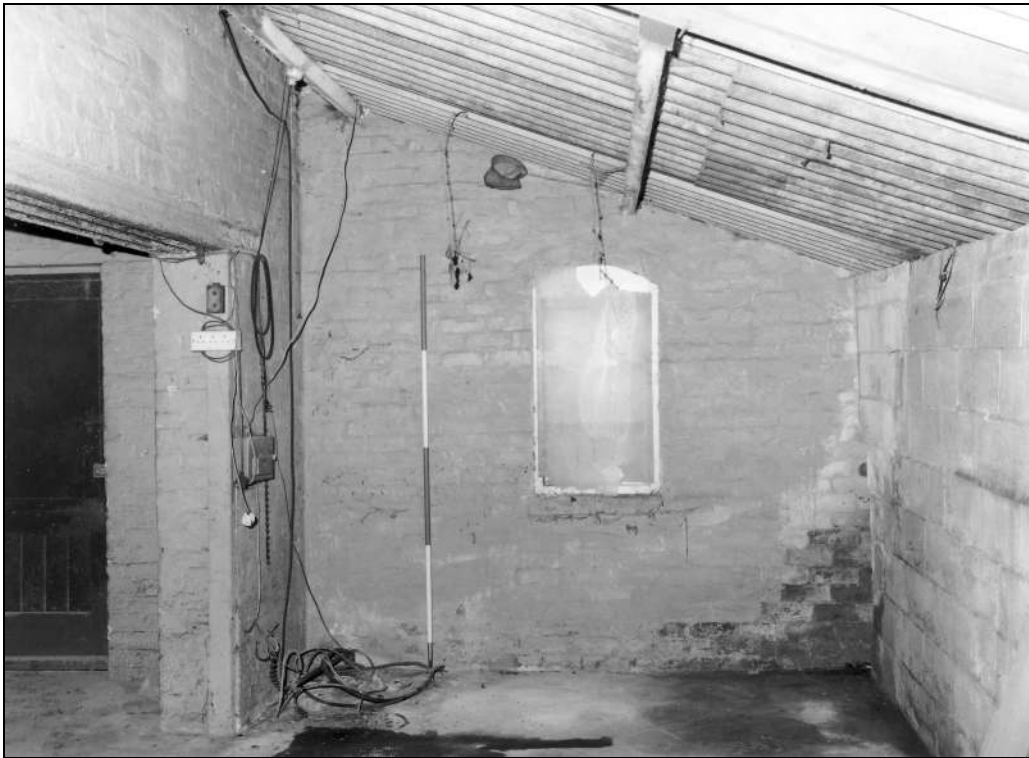
Photo 32: The retort house: interior of modern south-west lean-to, from the north-west (film 2, frame 14)
