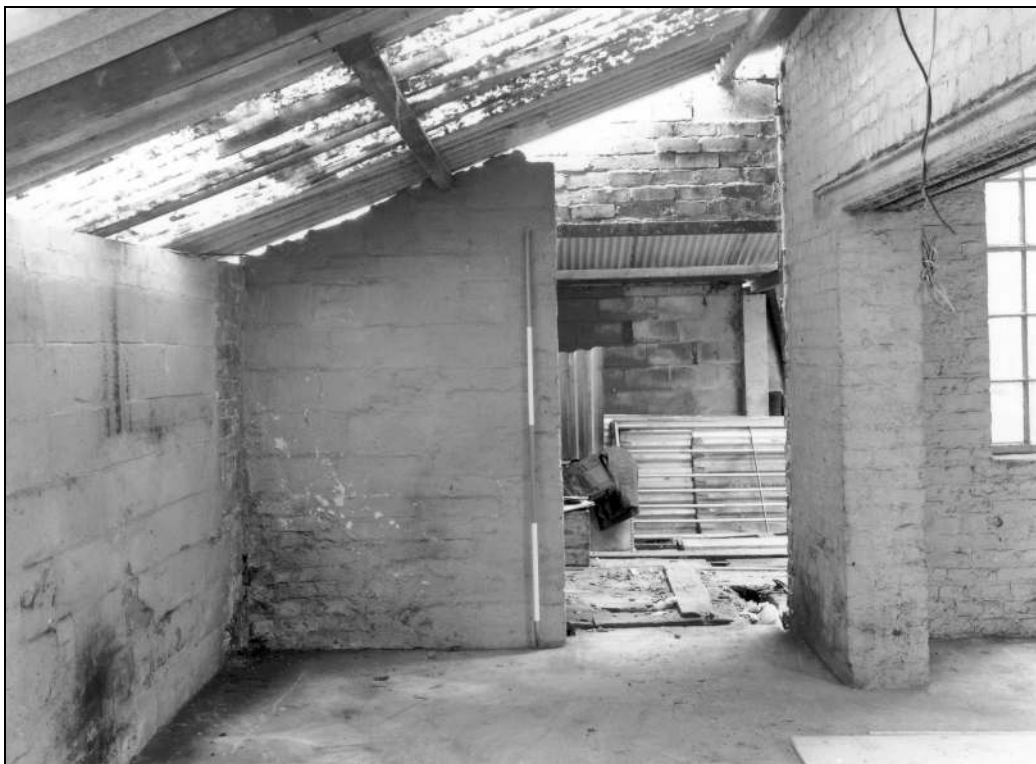
Photo 33: The retort house: interior of modern south-west lean-to, from the south-east (film 2, frame 16)

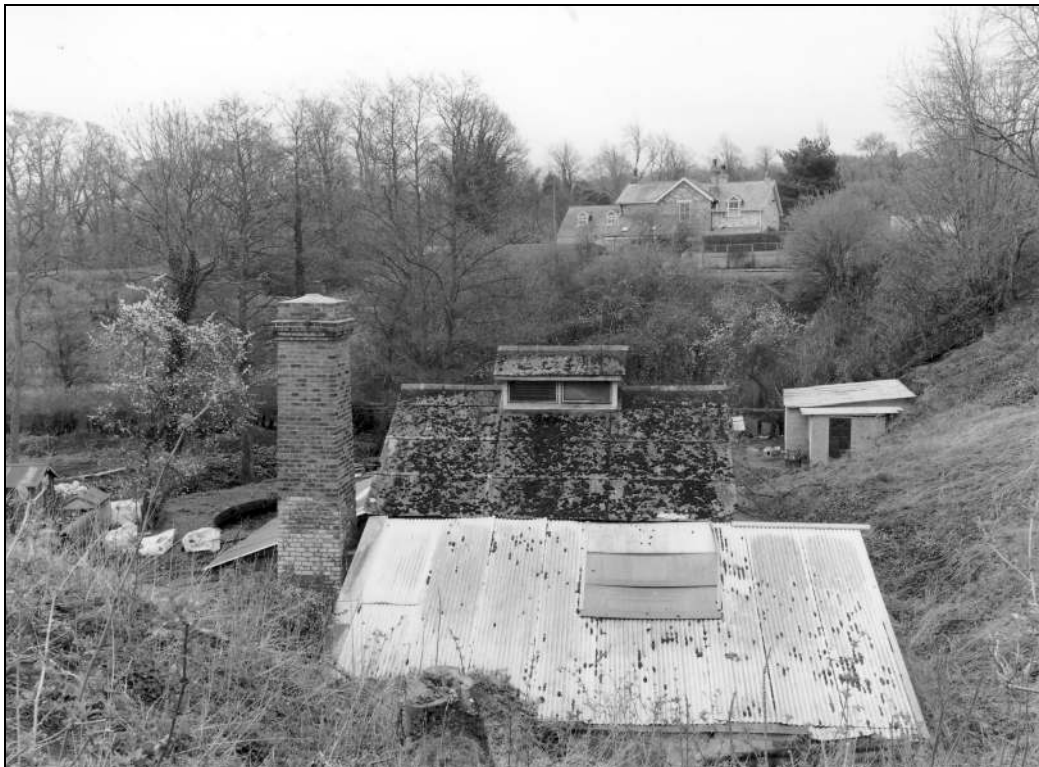
Photo 34: The retort house, from the north-west, showing rebuilt top of chimney (film 1, frame 8)

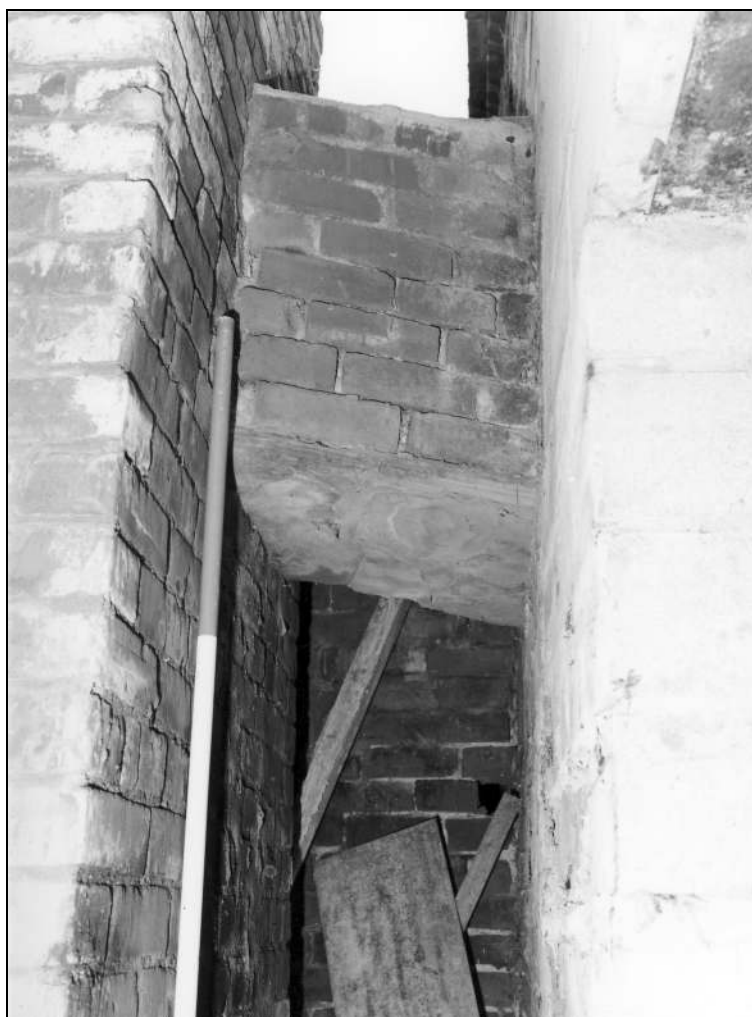
Photo 35: Detail of flue from retort house to chimney (film 2, frame 17)

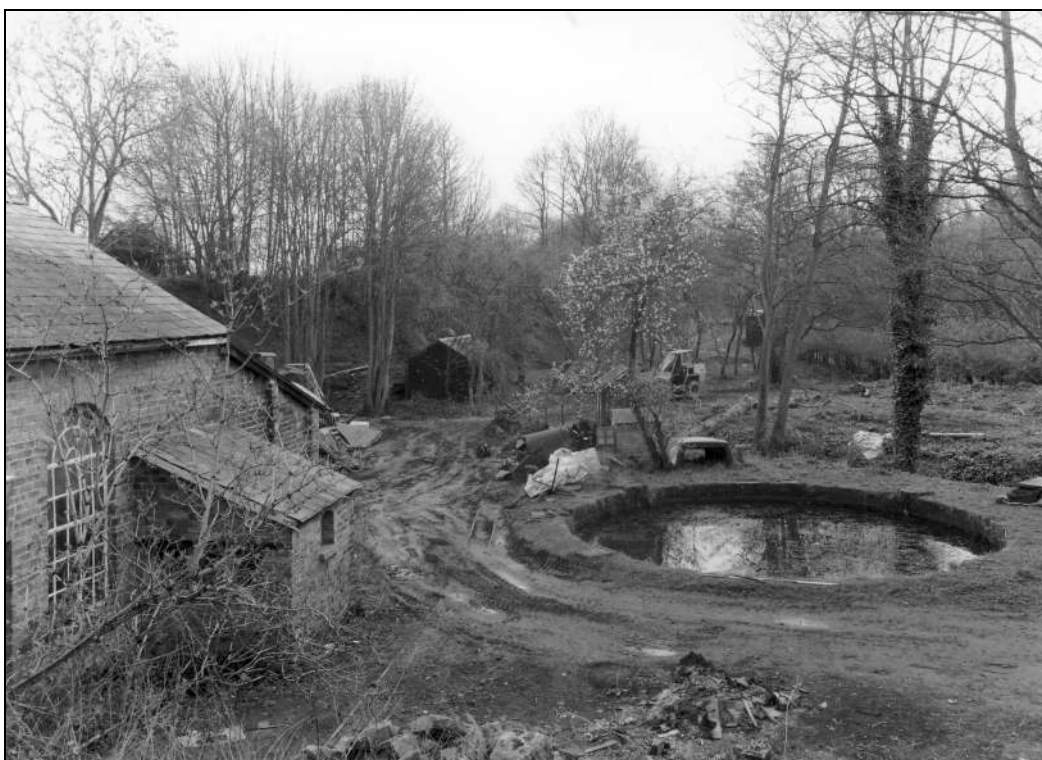
Photo 36: Gasholder pit, from the south-west (film 1, frame 11)

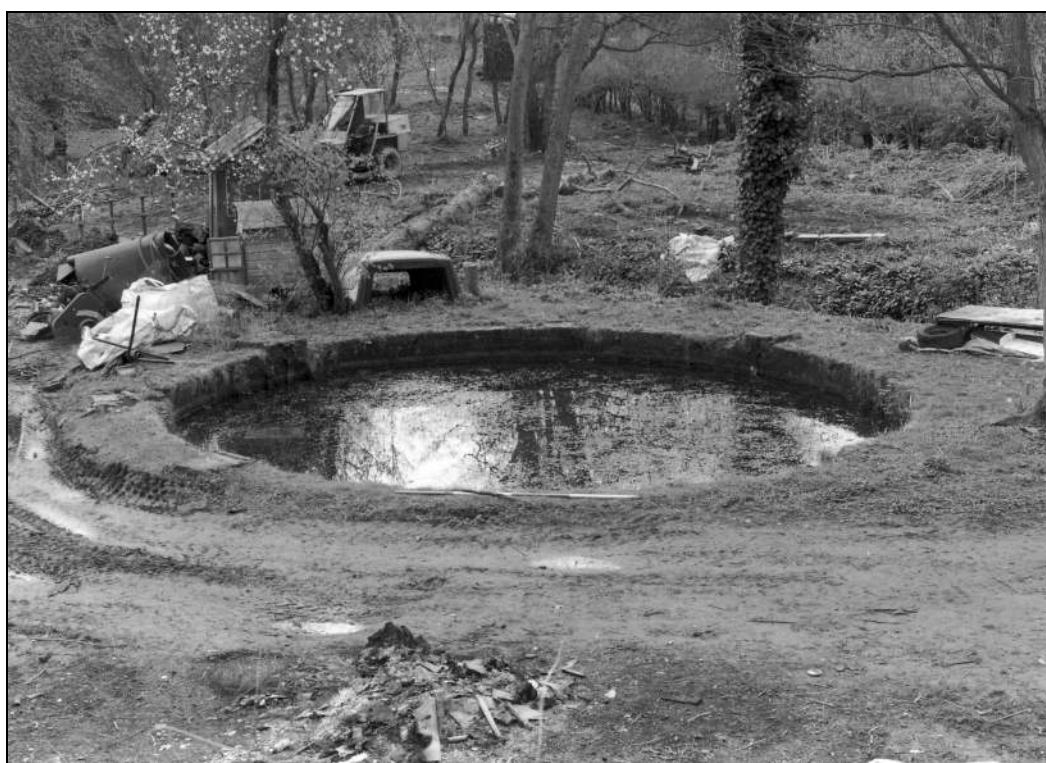
Photo 37: Gasholder pit, from the south-west (film 1, frame 12)

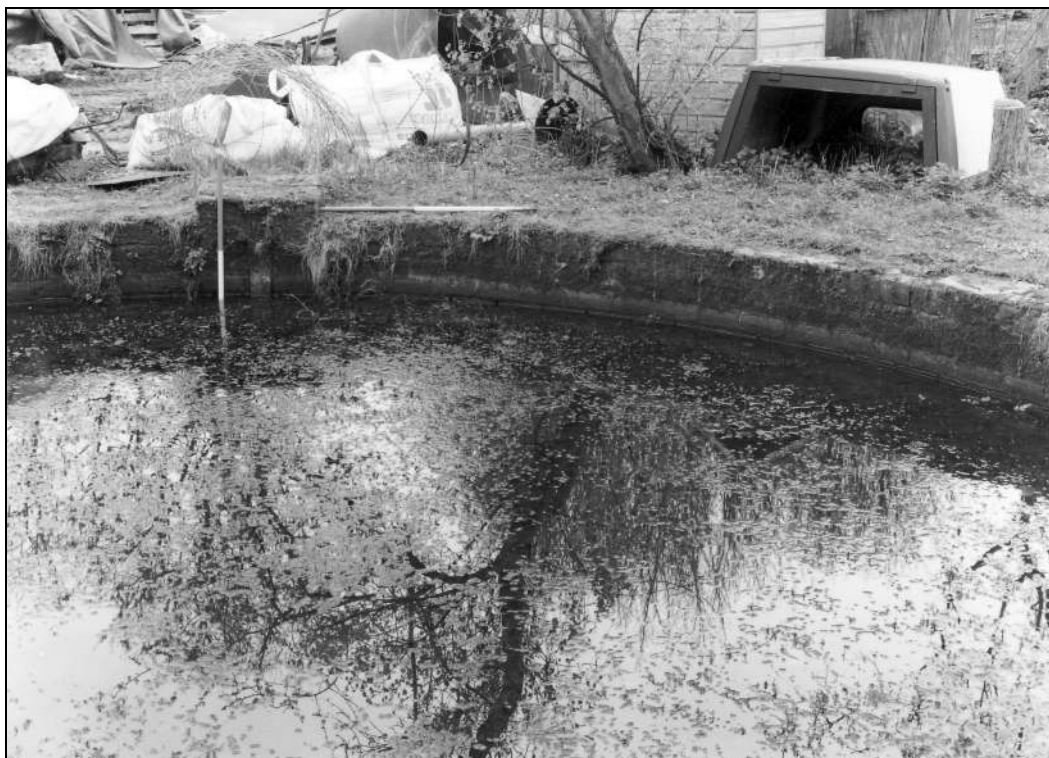
Photo 38: Gasholder pit: detail of brick lining with stone block, from the south (film 1, frame 17)
