Barn at Lower Rookes Farm  
Rookes Lane, Norwood Green, West Yorkshire:  
Historic Building Record

July 2014  
NGR: SE 14081 26343  
Historic township: Hipperholme with Brighouse

### Historic Building Record

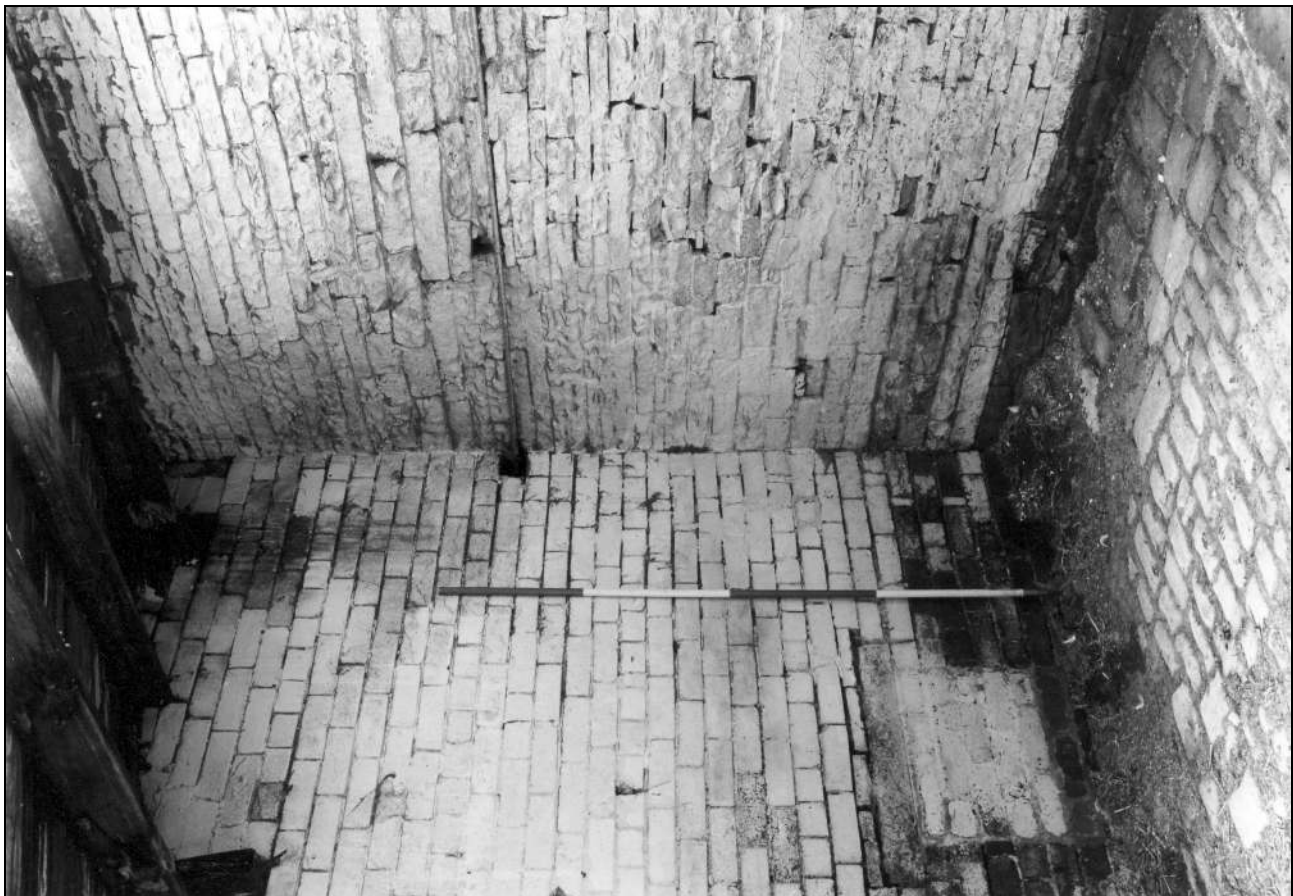
Photo 24: East wall of barn within later lean-to, showing rebuilt masonry, from the north-east (film 2, frame 11)

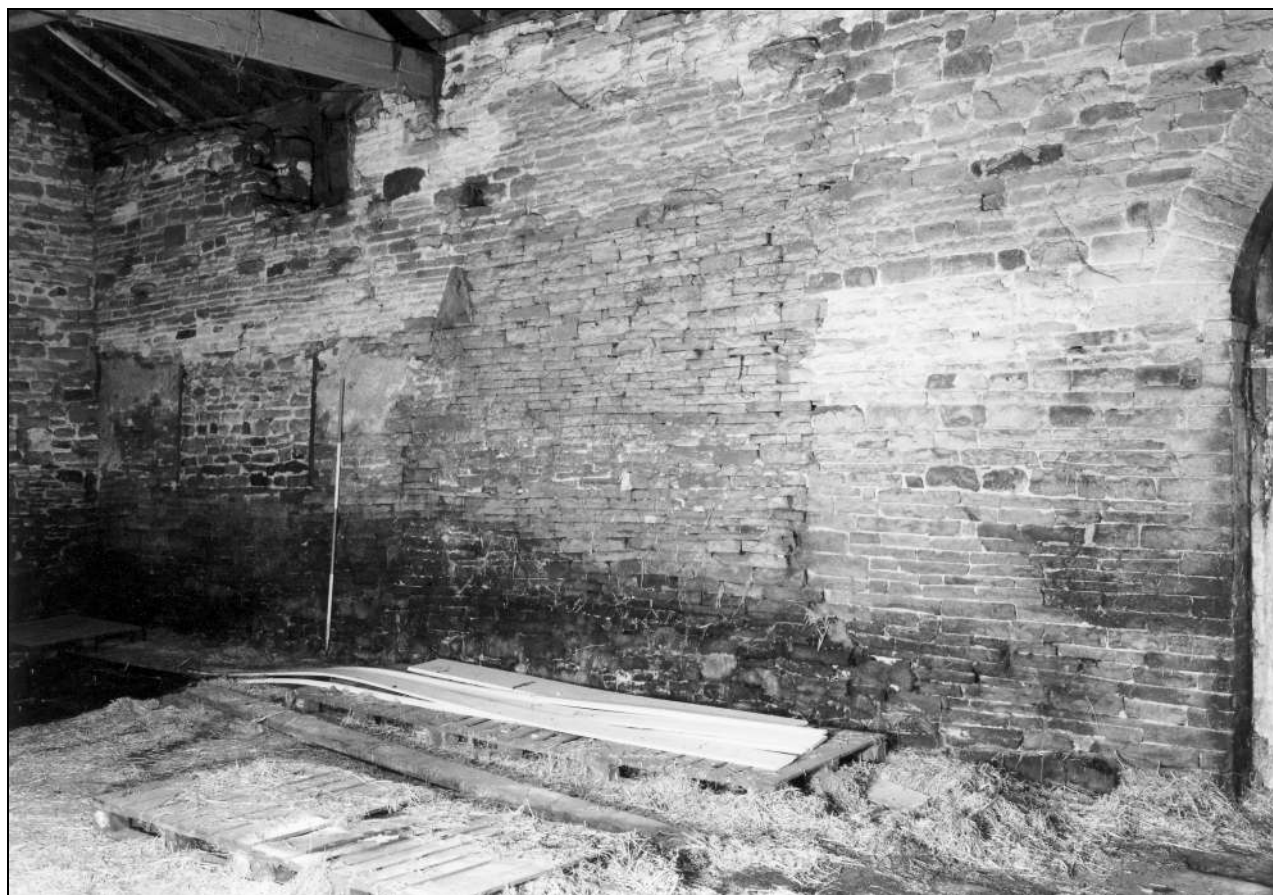
Photo 51: North end of east wall, inside barn, showing areas of disturbed and rebuilt stonework (film 4, frame 18)

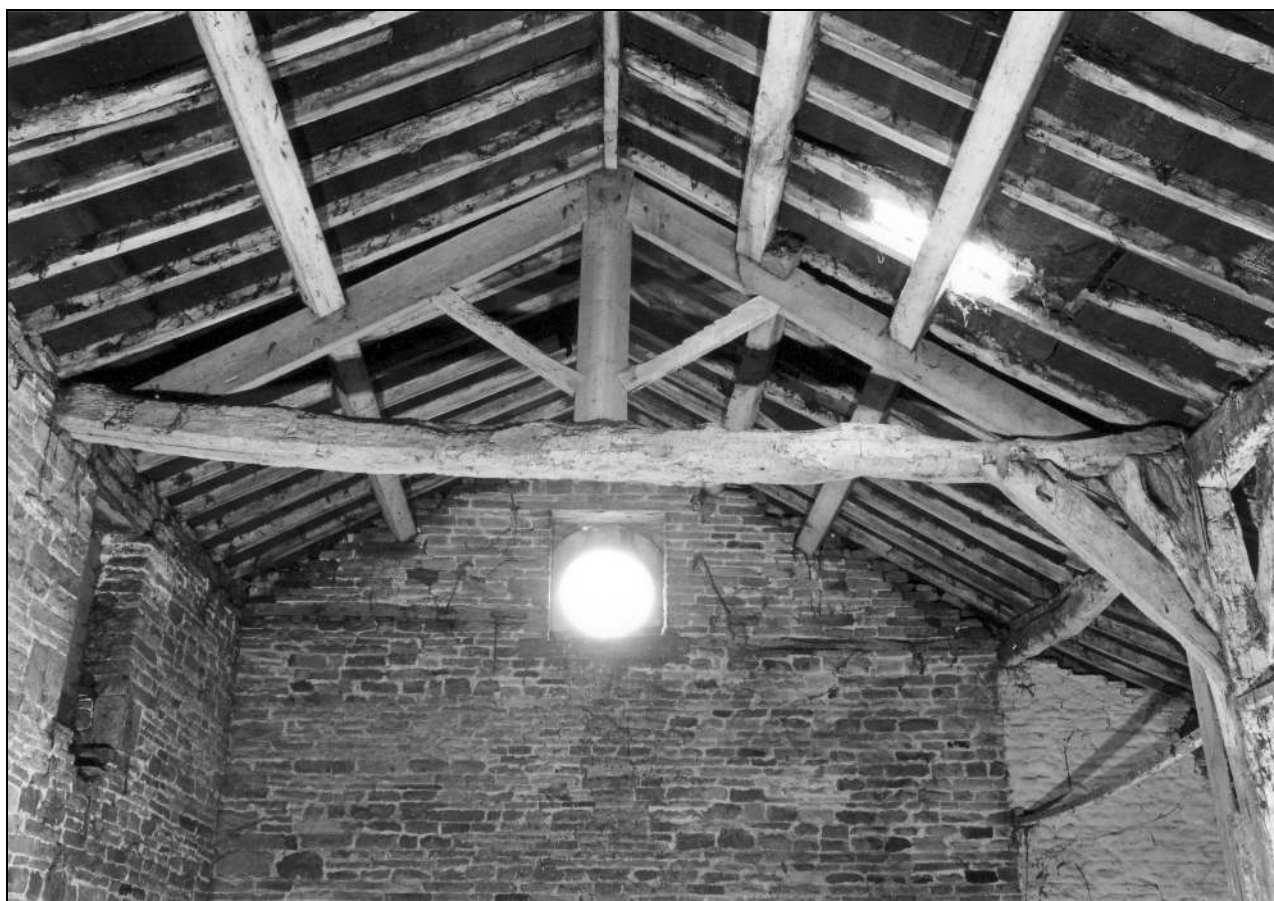
- 7.7 Many parts of truss 1 have been replaced in machine sawn softwood (55), but the tie beam, arcade post and aisle tie are all oak and therefore probably original to the barn. The arcade post is badly decayed (56) but still rests on its pad-stone, now sandwiched between the concrete walls to either side (57), and splays out at its top to support the lap dovetail assembly; the arch brace has been replaced in softwood, but the arcade braces are original and bear notches to indicate they are numbers "I" and "II" in the series (58-60). West of here, the aisle tie and vertical aisle strut are probably original, but the aisle rafter and angled strut are softwood (61).

Photo 55: Truss 1, from the north (film 4, frame 1)

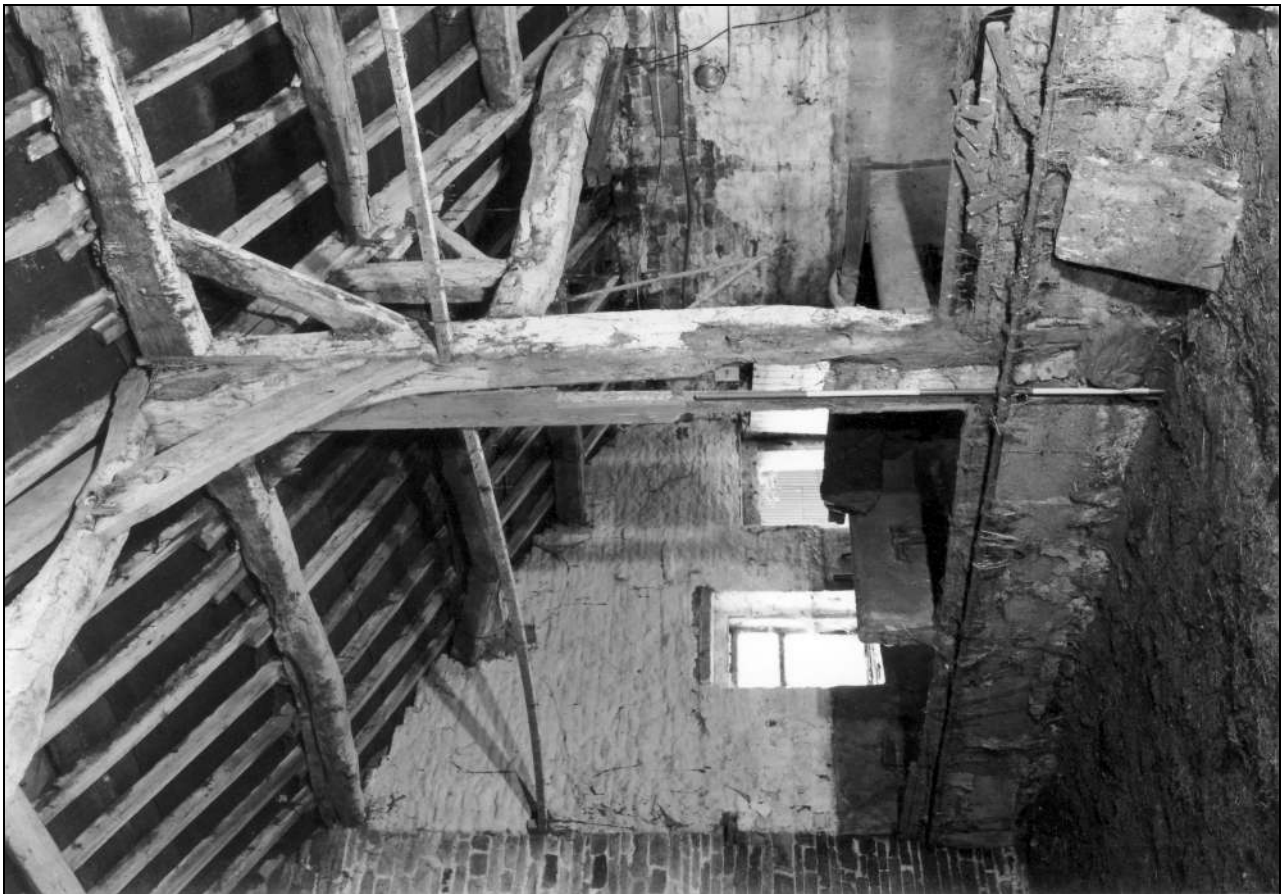
Photo 56: Truss 1: arcade post, from the north-east (film 3, frame 18)

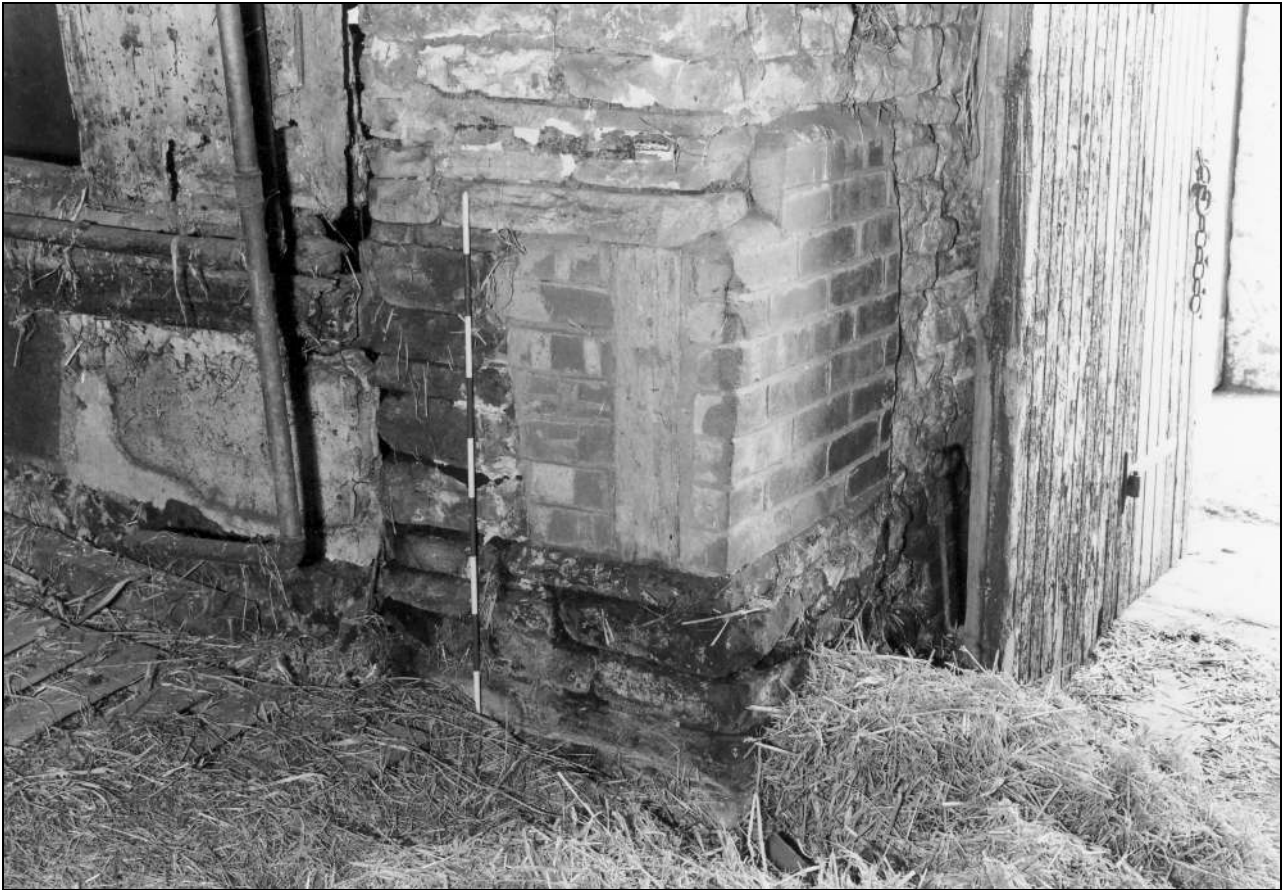
Photo 75: Brickwork repair and softwood timber in south side of west entry (film 4, frame 10)

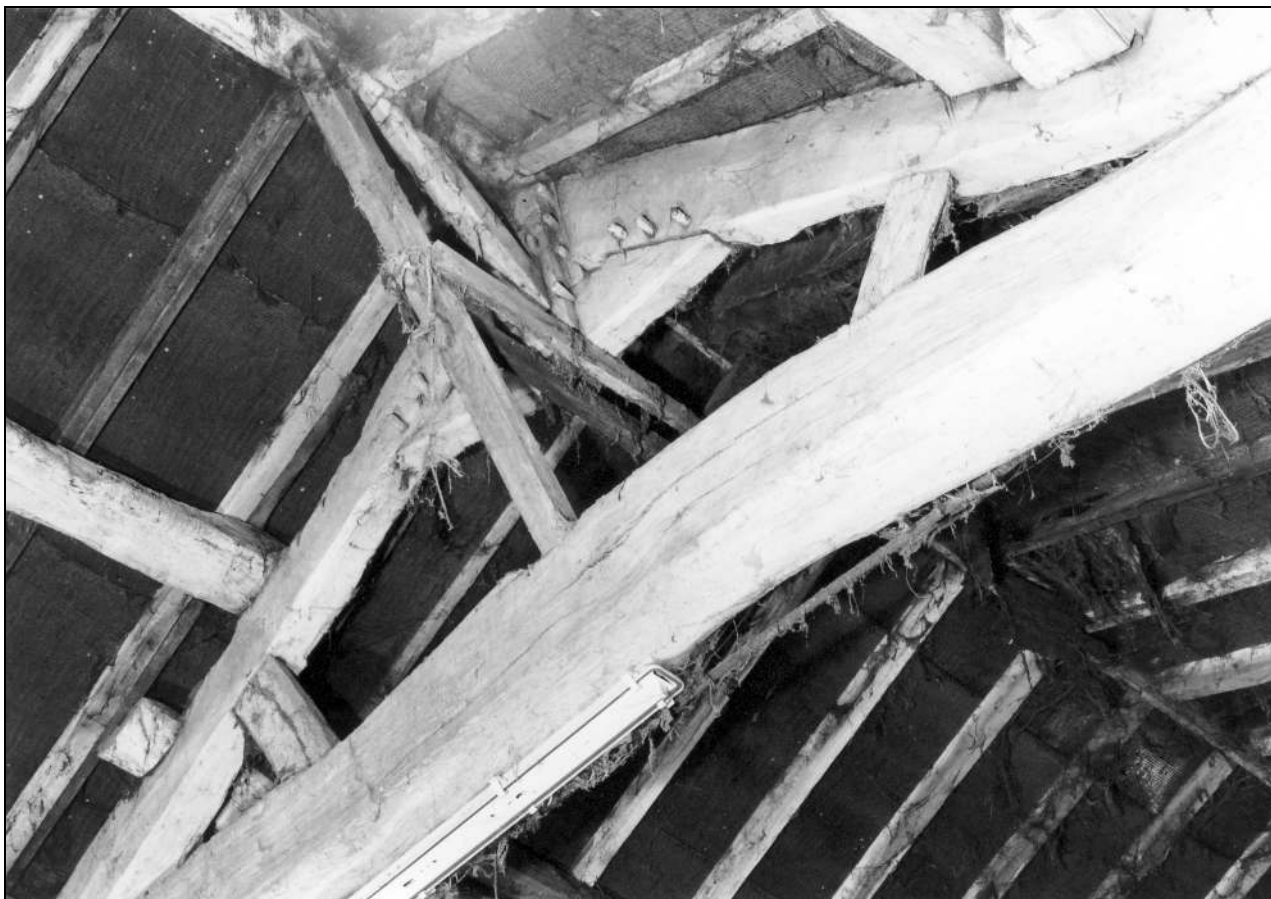
- 7.11 The apexes of trusses 3 and 4 are unusual, and it is unfortunate that their partial failure means the later reinforcing timbers obscure some of their details (80,81). They comprise a short king post, T-shaped in section, with three pegs to either side holding the tenoned ends of the principal rafters, and a short collar immediately below, with three pegs to the tenon at each end. The front part of the king post (which stands proud of the principal rafters only by about 25mm)

Photo 80: Truss 4, from the south-east (film 5, frame 7)

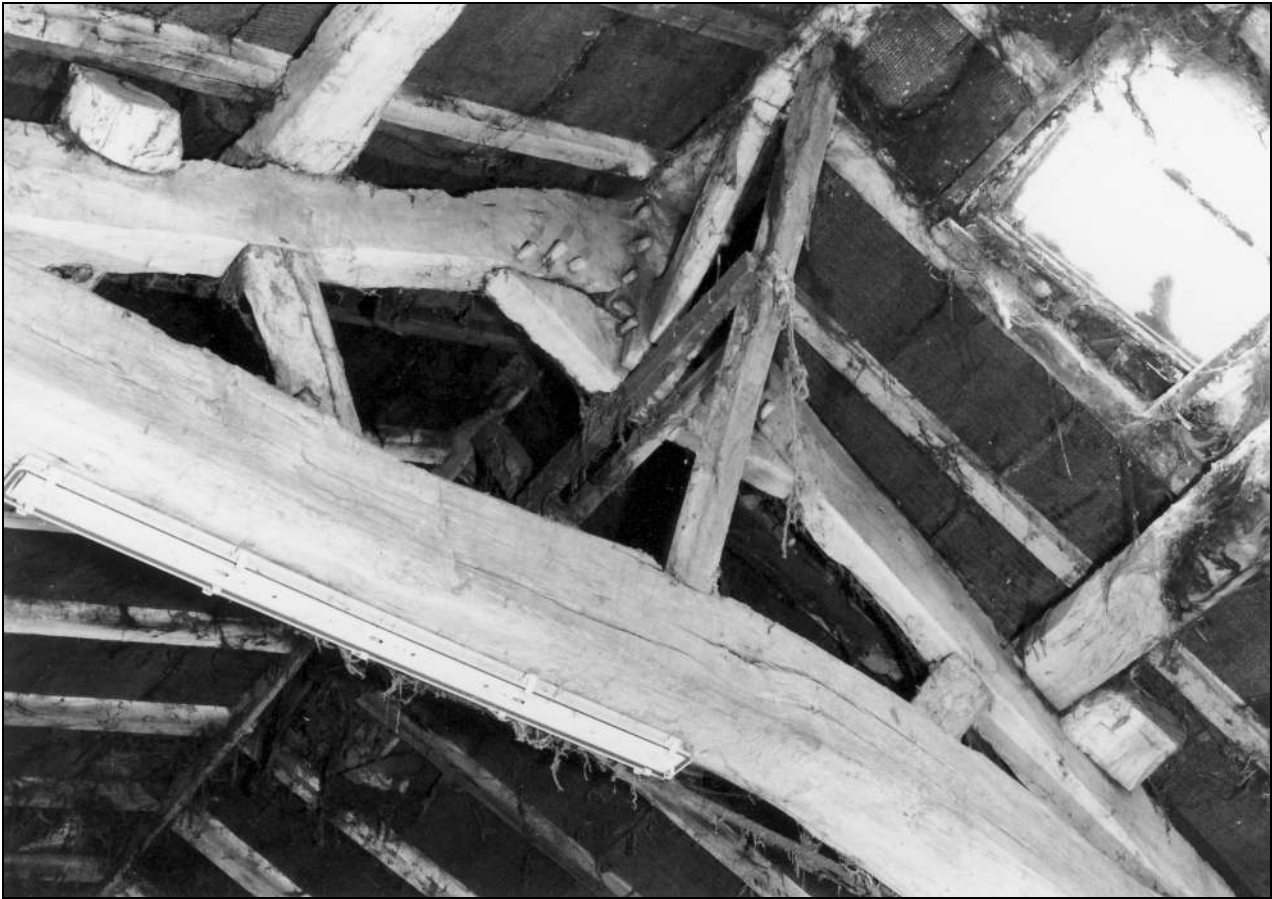
Photo 81: Truss 4, from the south-west (film 5, frame 9)

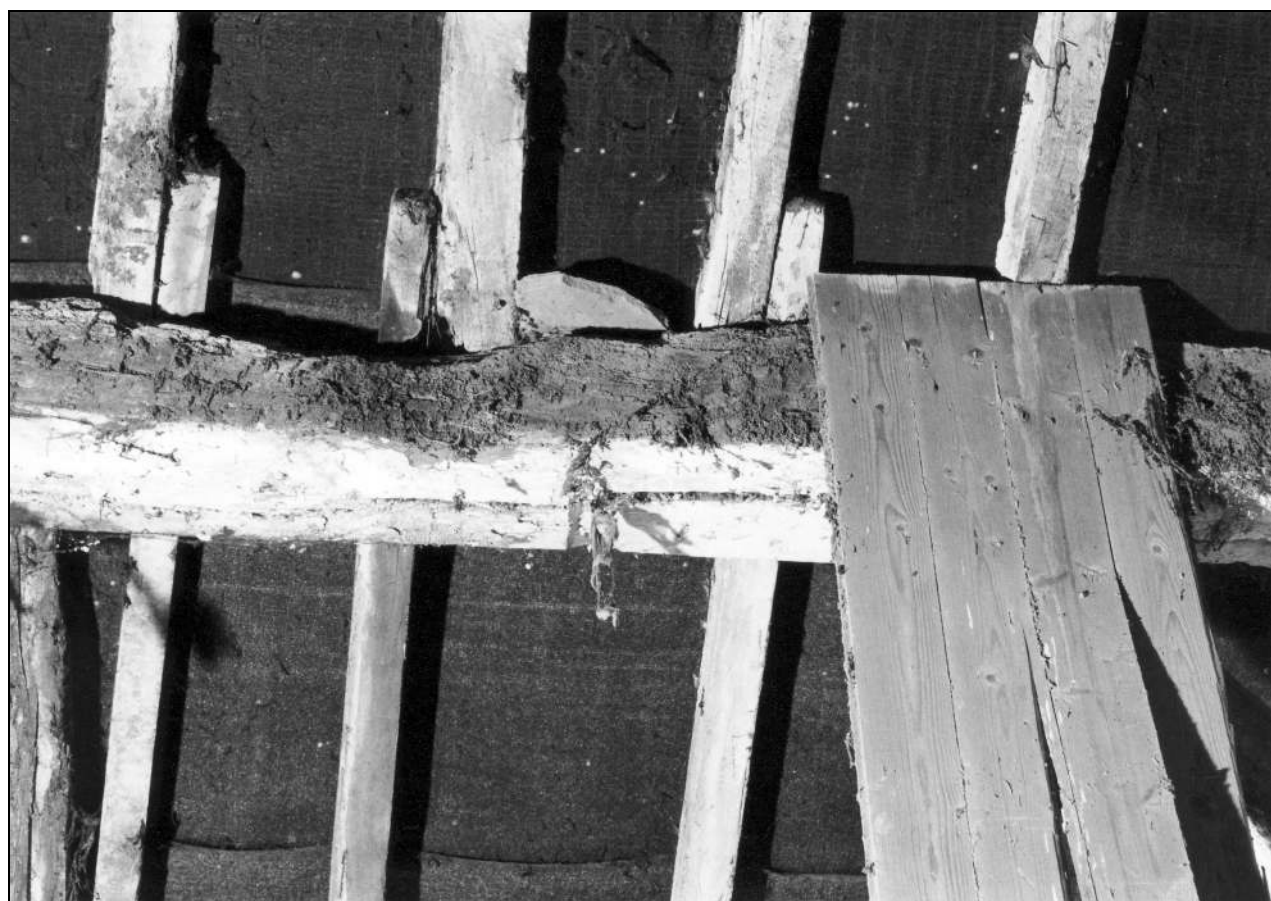
- 7.13 The arcade plate running along the west side of the barn appears intact to the south of the entry, where there is a scarf joint between trusses 1 and 2 (**88**). A second scarf joint is positioned over the south wall of the entry, and a third close to truss 5 (**89**). North of here the arcade plate has been turned through 180°, so the original seatings for the rafters are now within the soffit, an alteration probably carried out when the truss was replaced (**90**).

Photo 88: Scarf joint in arcade plate, between trusses 1 and 2, from the east (film 6, frame 4)

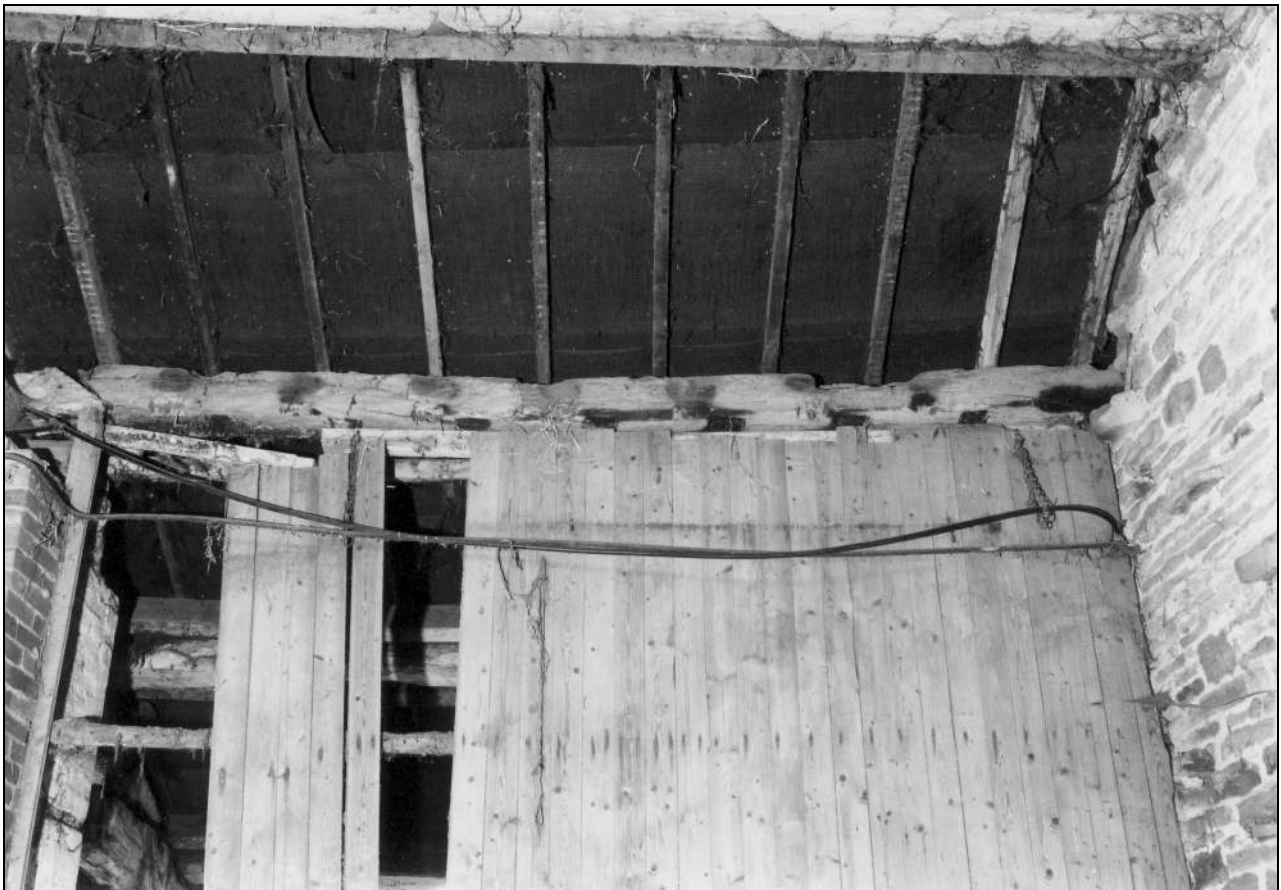
Photo 90: Arcade plate north of truss 5, from the east (timber inverted) (film 5, frame 18)
