10 Lower Hathershelf
Hathershelf Lane, Luddenden Foot, West Yorkshire:
Historic Building Record

August 2012 (Revised March 2013)
NGR: SE 02618 25235
Historic township: Sowerby

STEPHEN HAIGH
B u i l d i n g s A r c h a e o l o g i s t

Historic Building Record

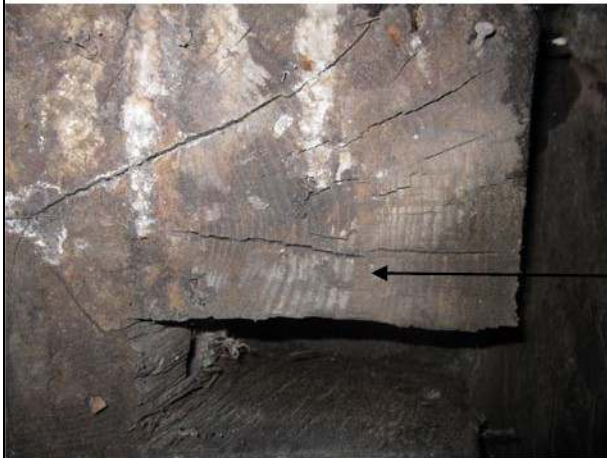
Fast growing oak timber with narrow band of growth (highlighted) probably indicating pollarding cycle.

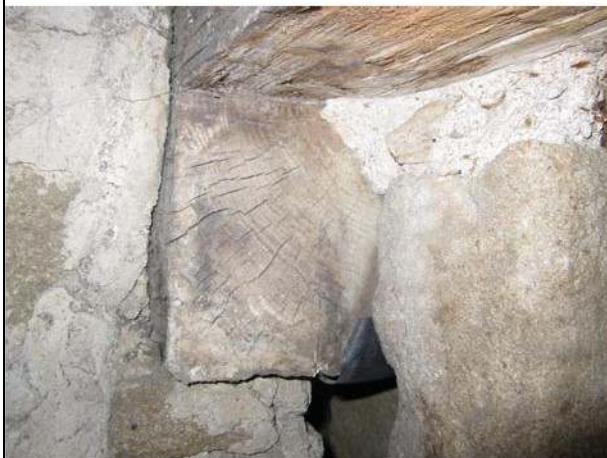
Timber with similar banding

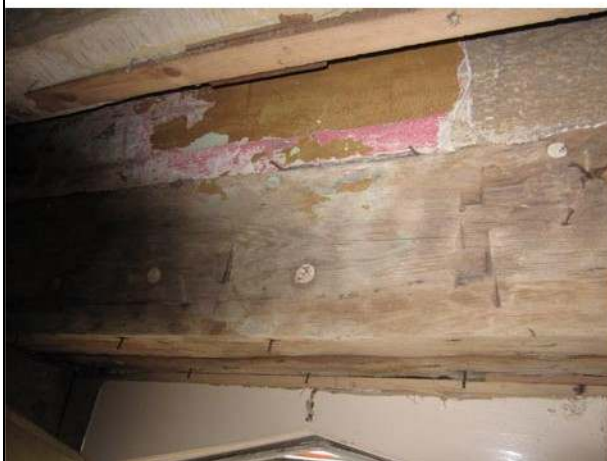
Fast growing timber, with notch & chop toolmarks from the original squaring of the trunk

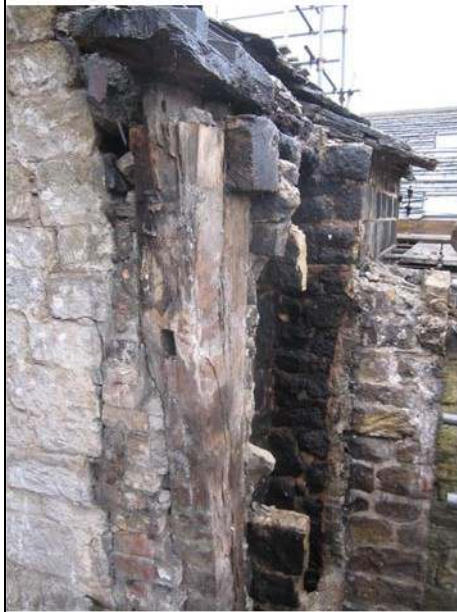
Timbers exposed on the outside of the building

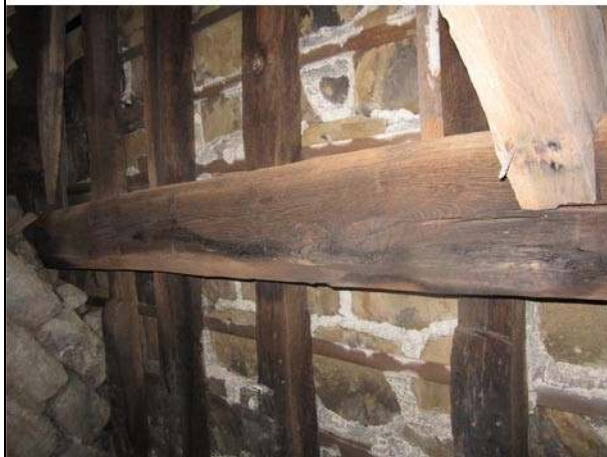
These wall timbers also have notch & chop markings
