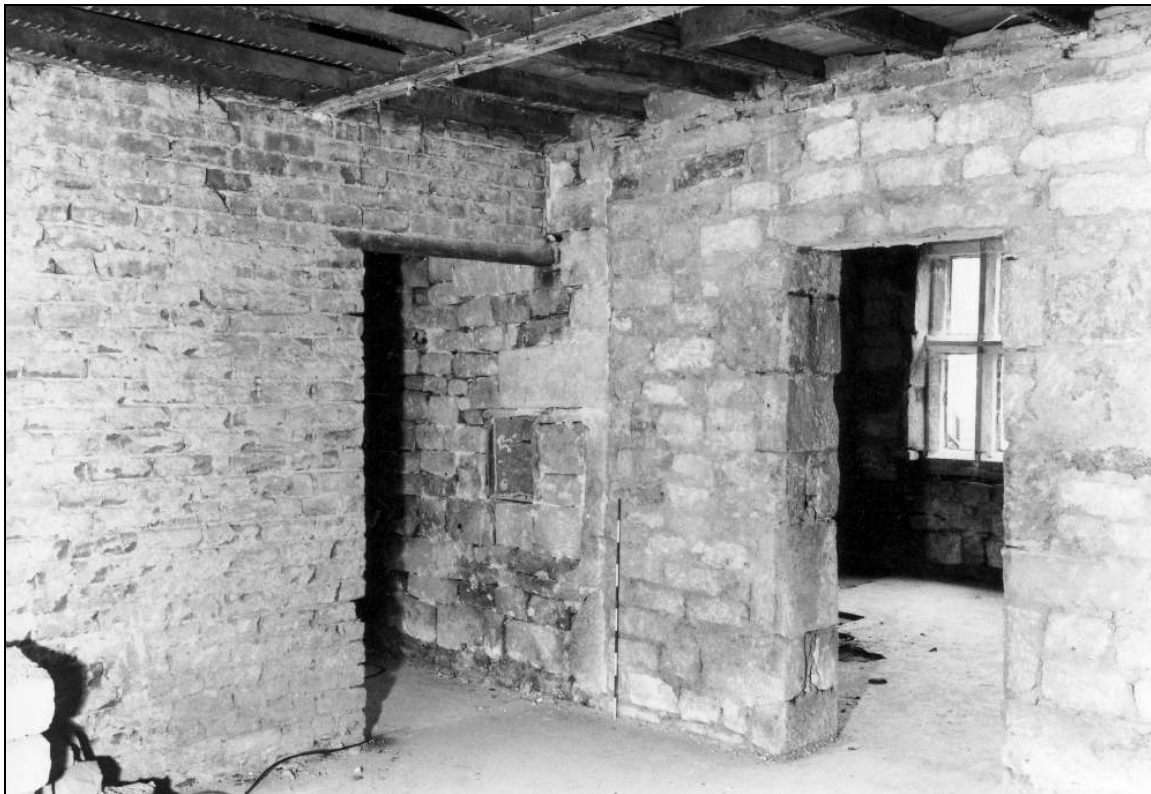
Photo 46: Kitchen, from the north-west, with walls of 1886 to left and right, the latter butting earlier heck (film 3, frame 18)

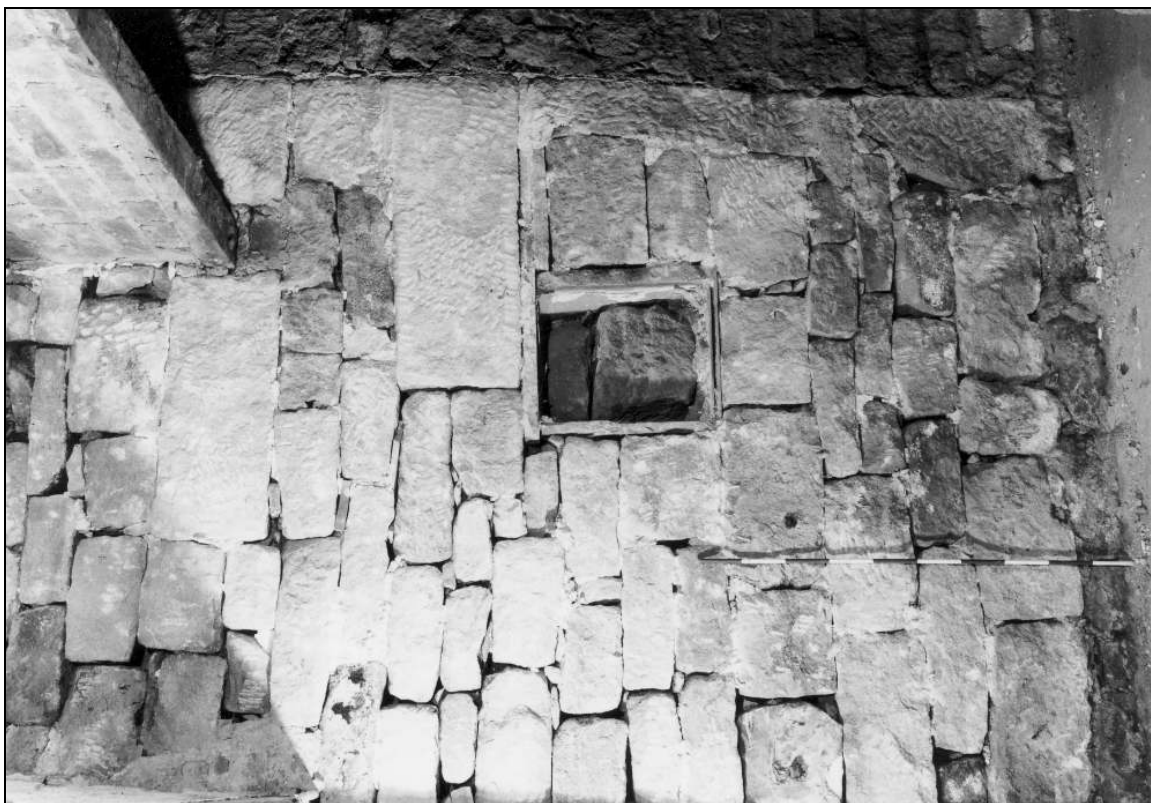
Photo 47: Stone heck, to north of housebody fireplace, from the north (film 4, frame 4)

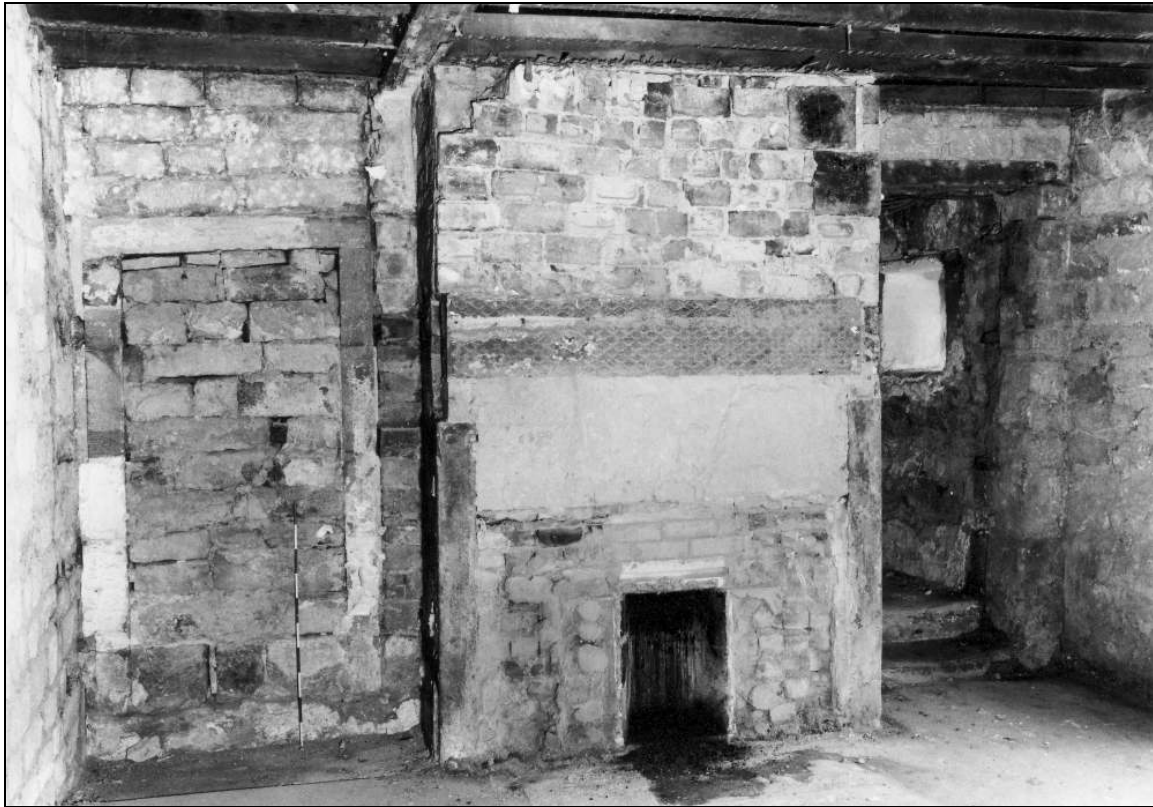
Photo 48: Kitchen fireplace, with blocked doorway to west wing, from the east (film 3, frame 17)

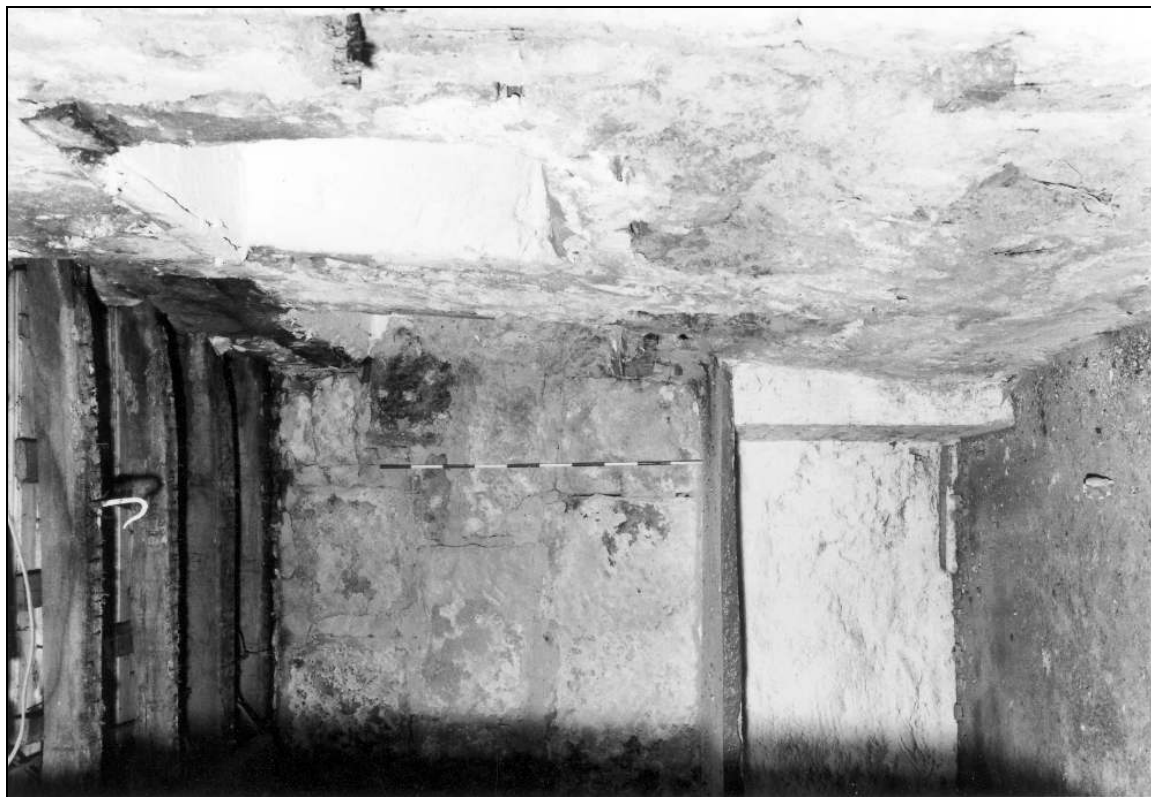
Photo 49: Small larder in north-east corner of west wing,  
from the east (film 4, frame 3)

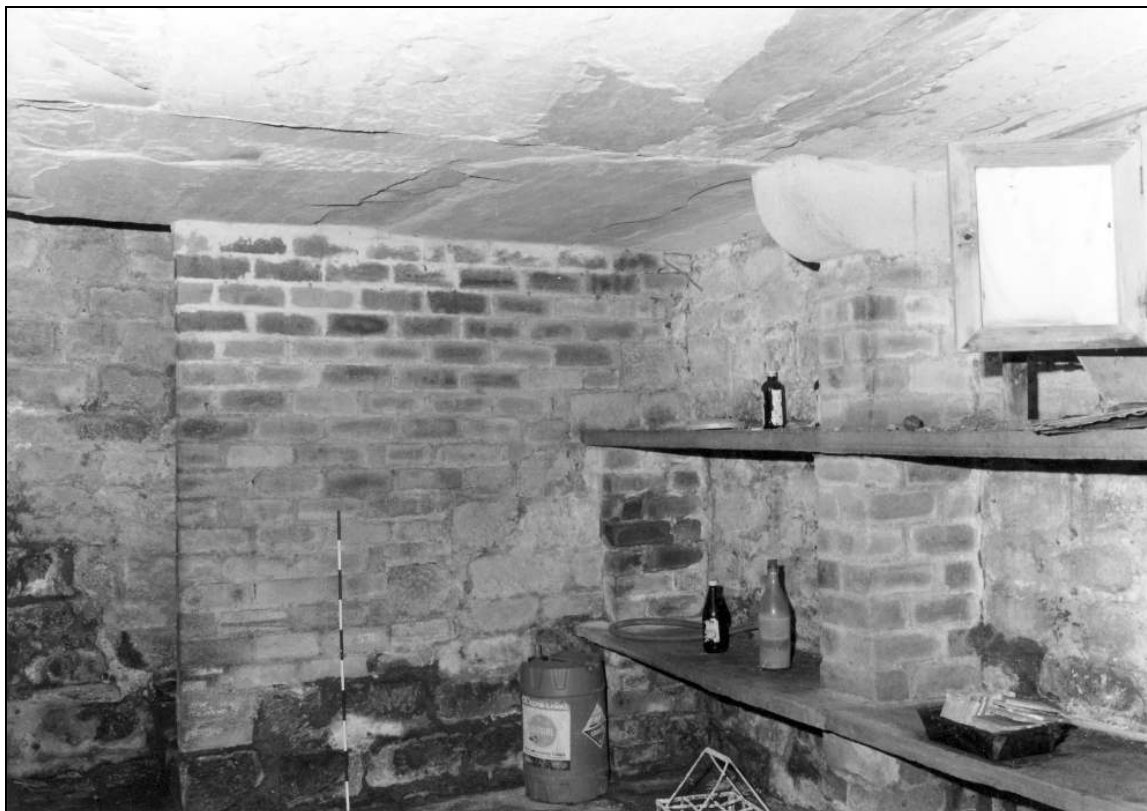
Photo 50: Cellar (created 1886), from the north-west (film 2, frame 13)

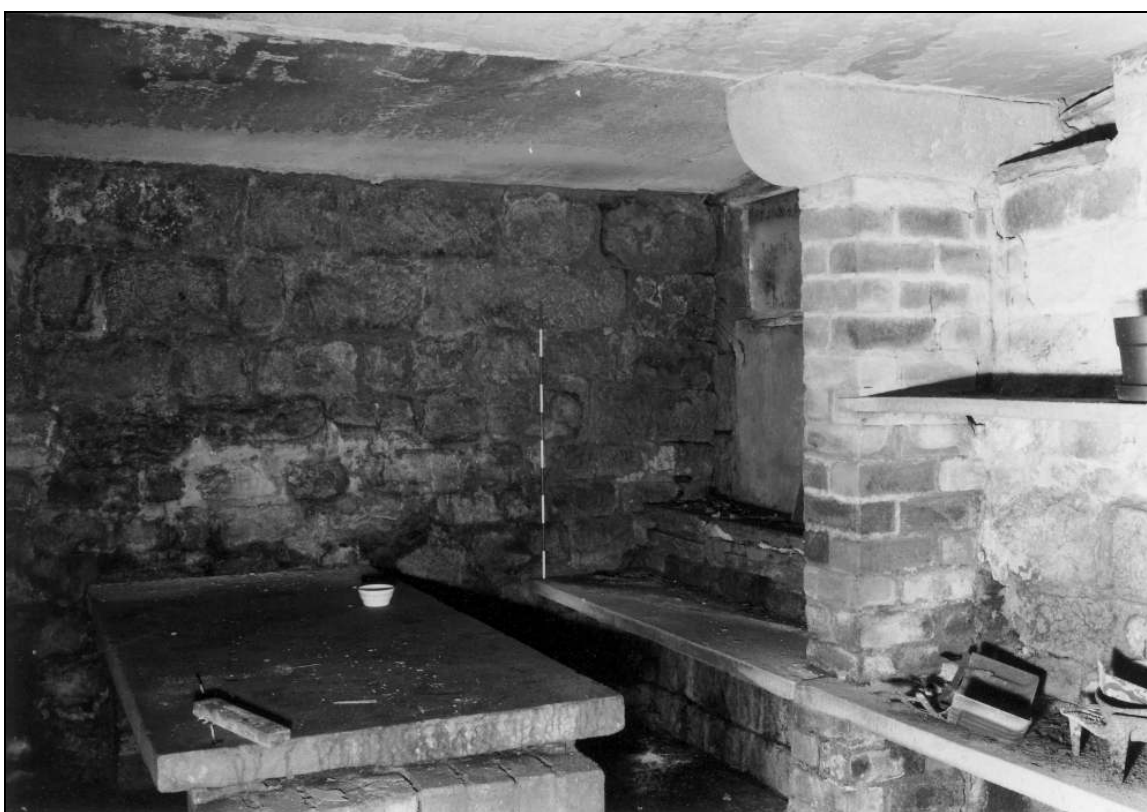
Photo 51: Cellar (created 1886), from the south-east (film 2, frame 12)

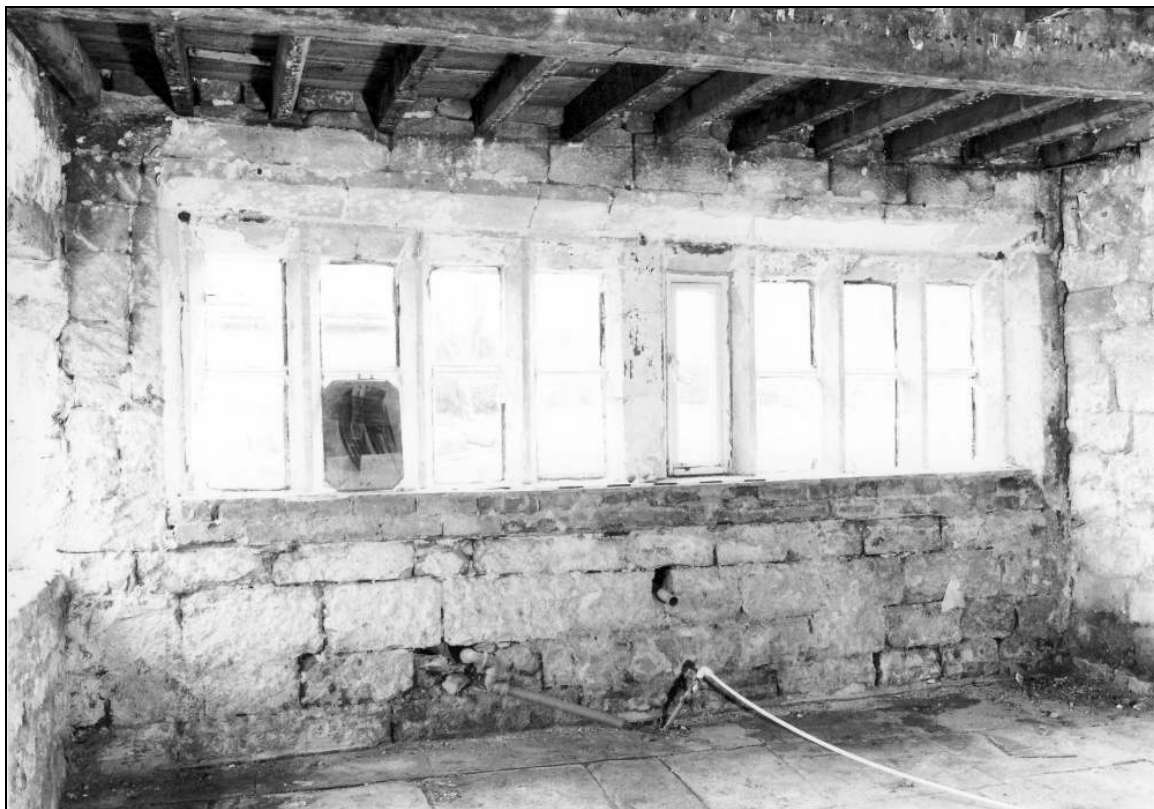
Photo 52: Parlour window, east wing, from the north-east (film 4, frame 9)

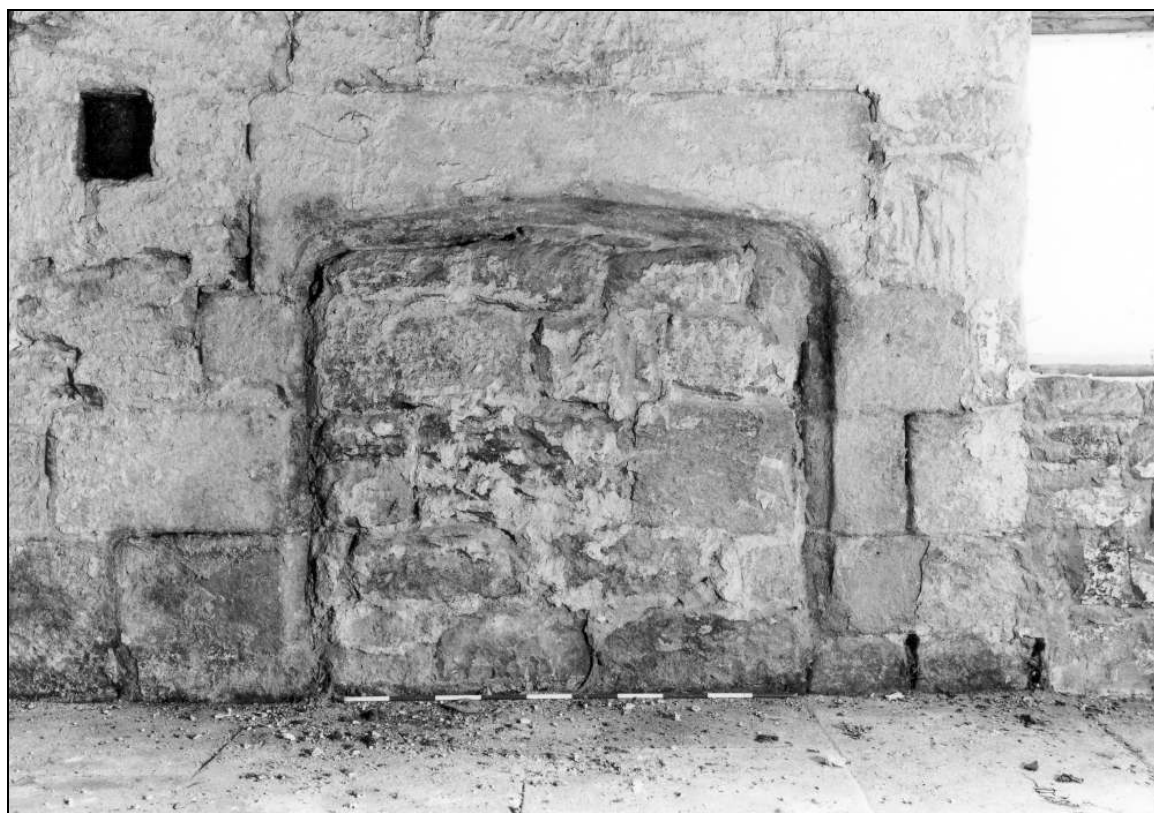
Photo 53: Seventeenth century fireplace in parlour, from the west (film 4, frame 12)

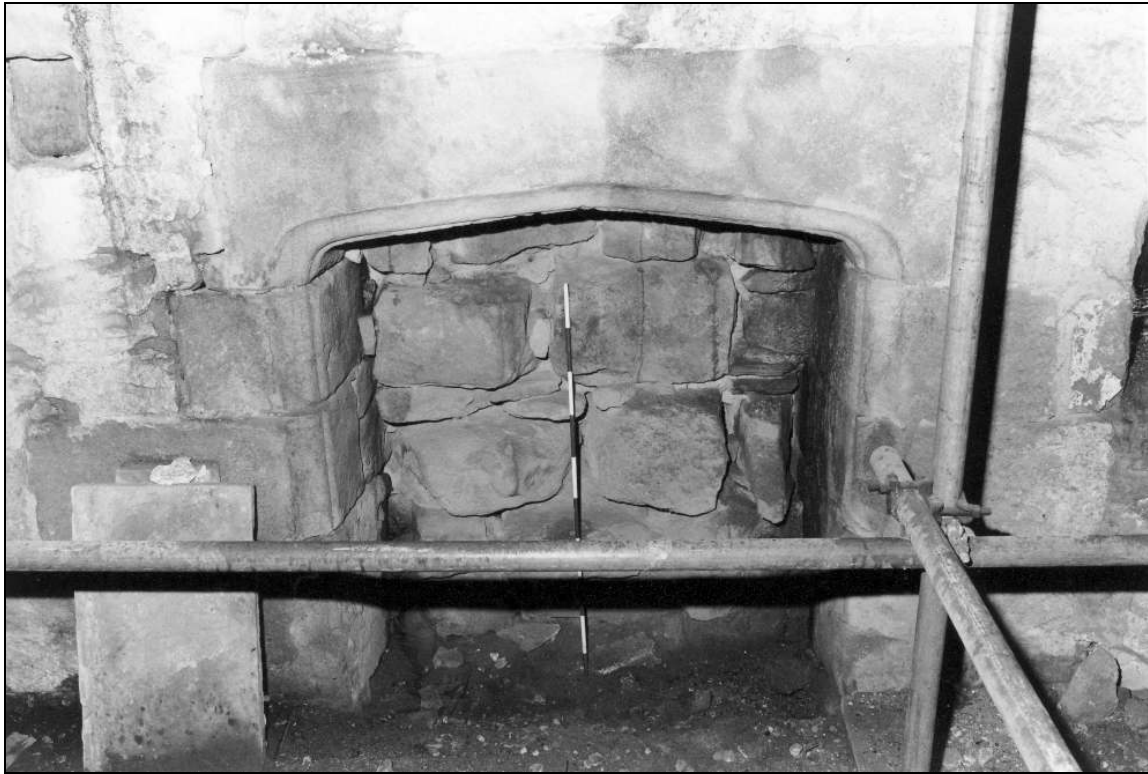
Photo 54: Seventeenth century fireplace in parlour, as revealed during repairs (film 7, frame 4)

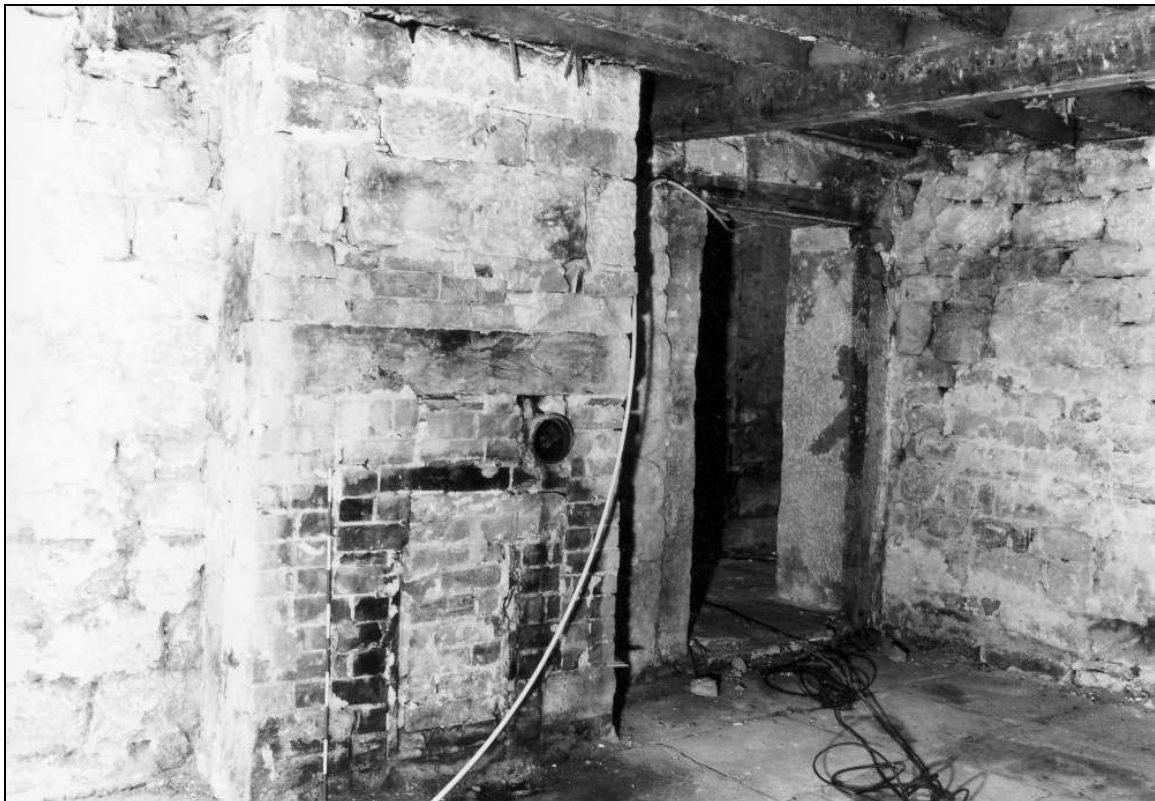
Photo 55: Eighteenth/nineteenth century fireplace in parlour of east wing, from the south-east (film 4, frame 10)

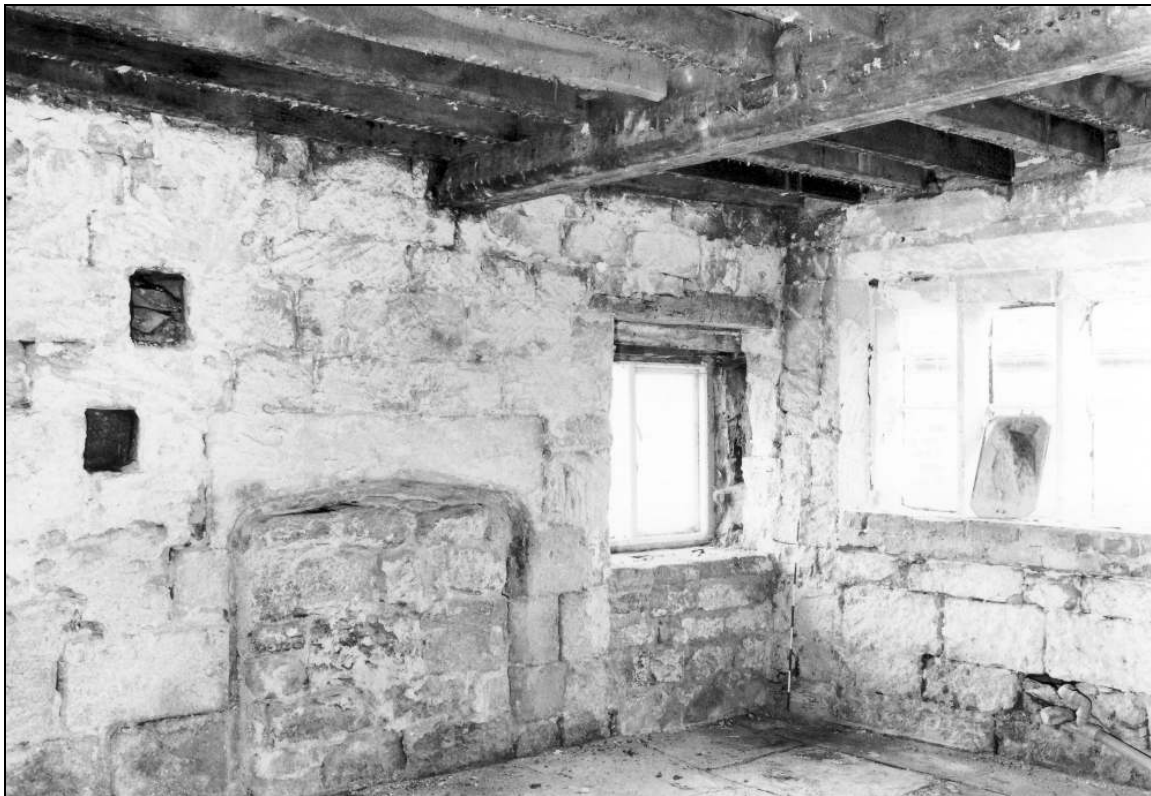
Photo 56: Parlour, in front of east wing, from the north-west (film 4, frame 7)

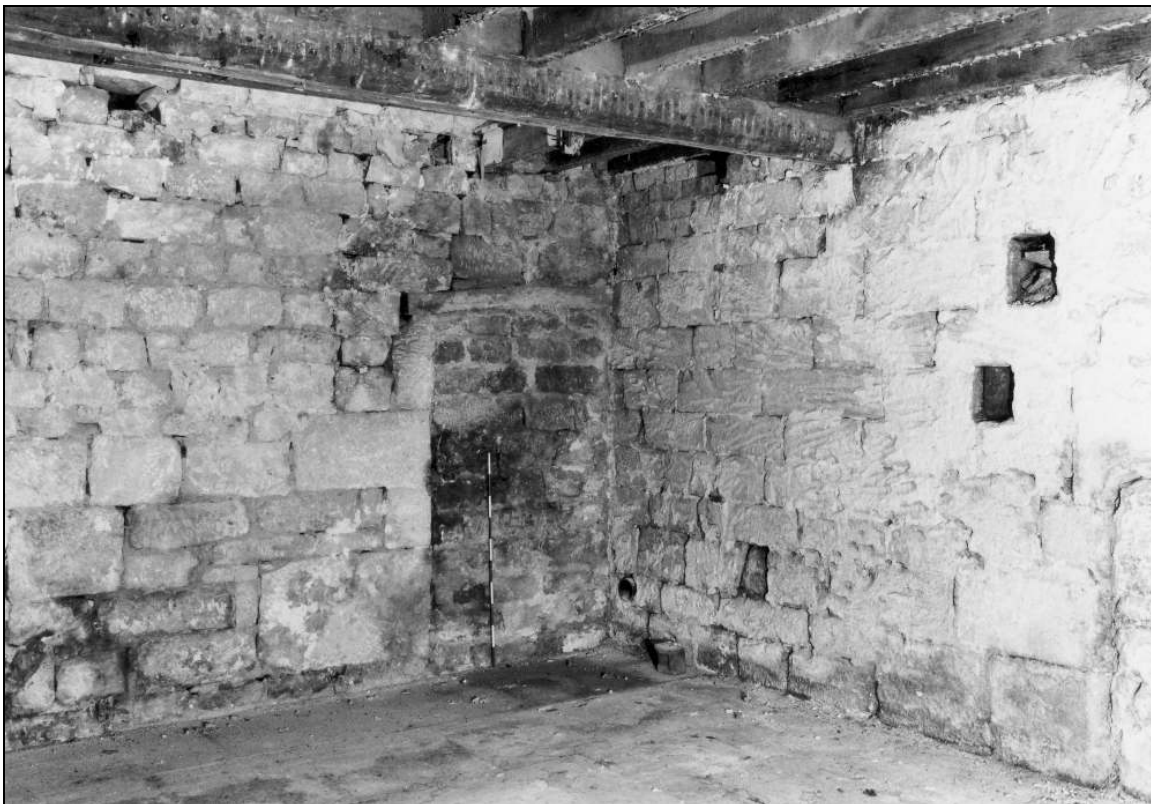
Photo 57: Parlour, in front of east wing, from the south-west (film 4, frame 11)

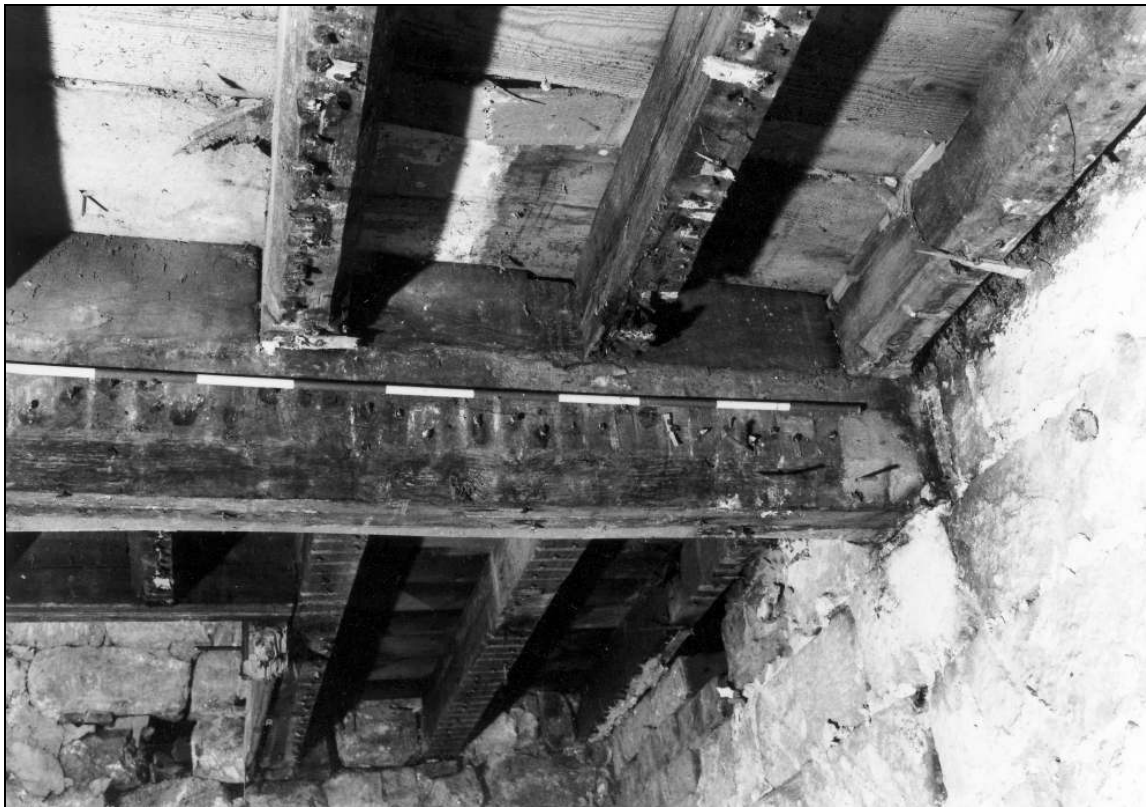
Photo 58: Parlour, in front of east wing: floor frame over, from the south (film 4, frame 13)

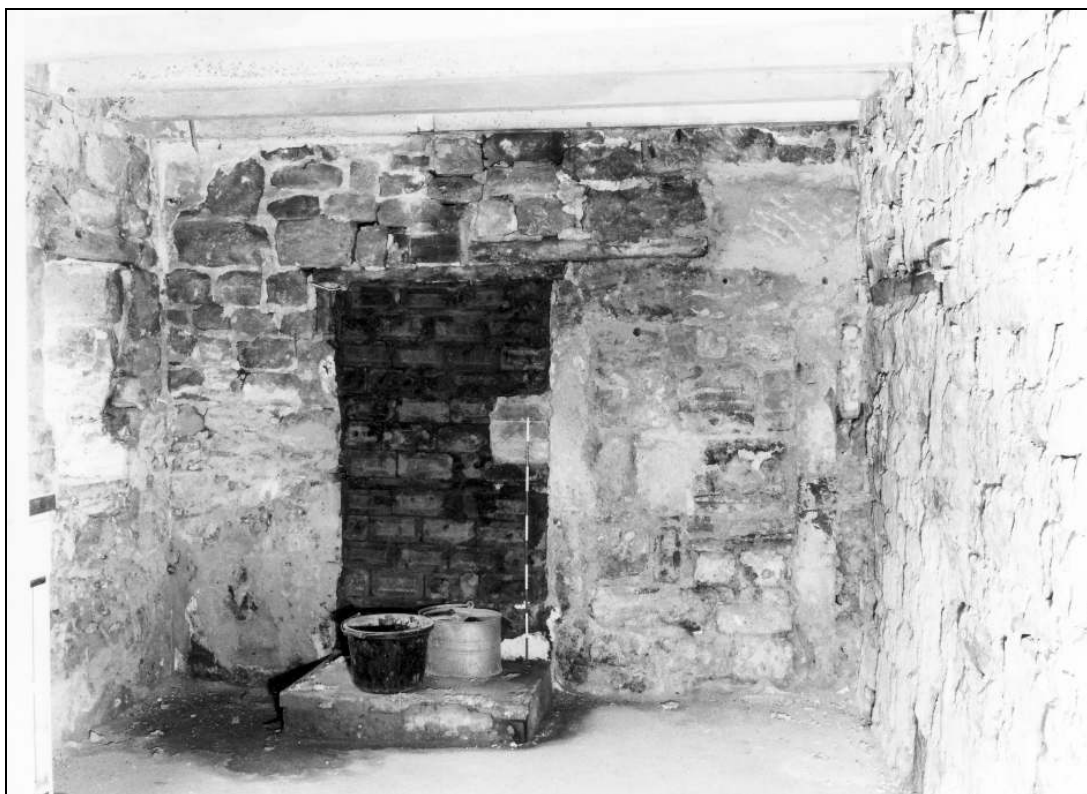
Photo 59: Back kitchen, in east wing, from the west (film 4, frame 16)

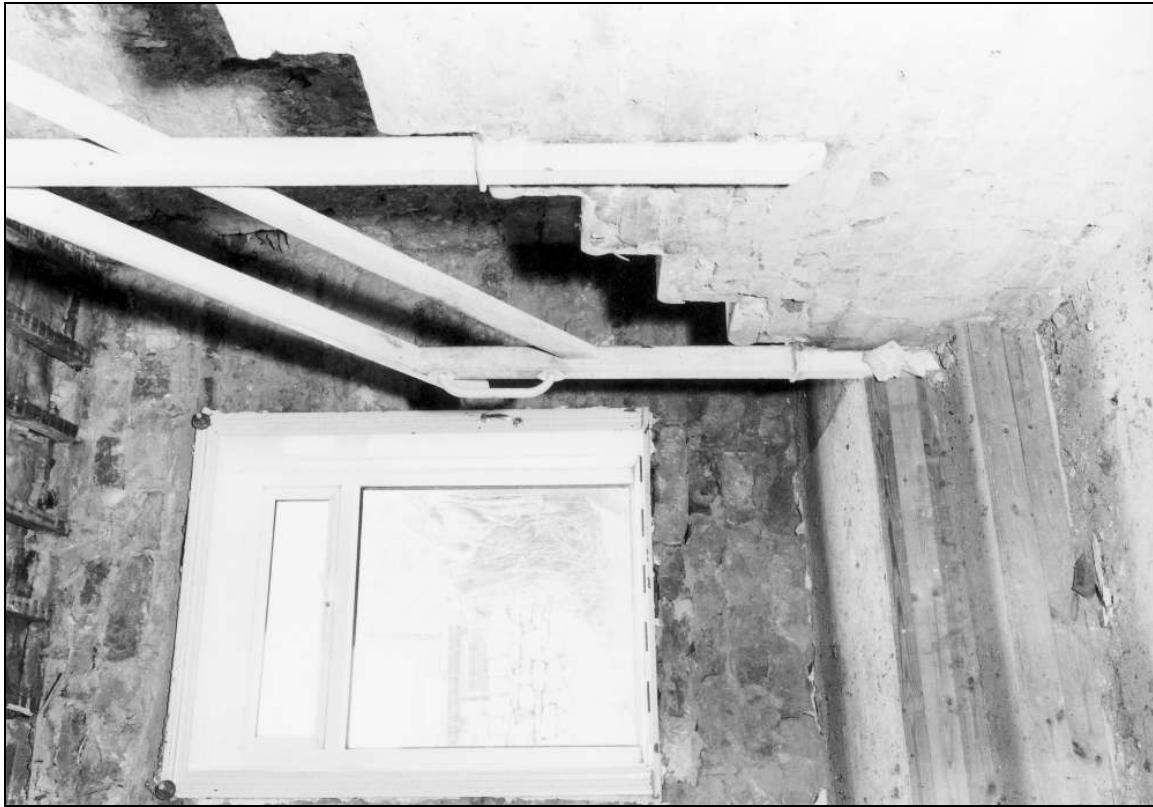
Photo 61: Stairwell, from the south-west (film 4, frame 6)

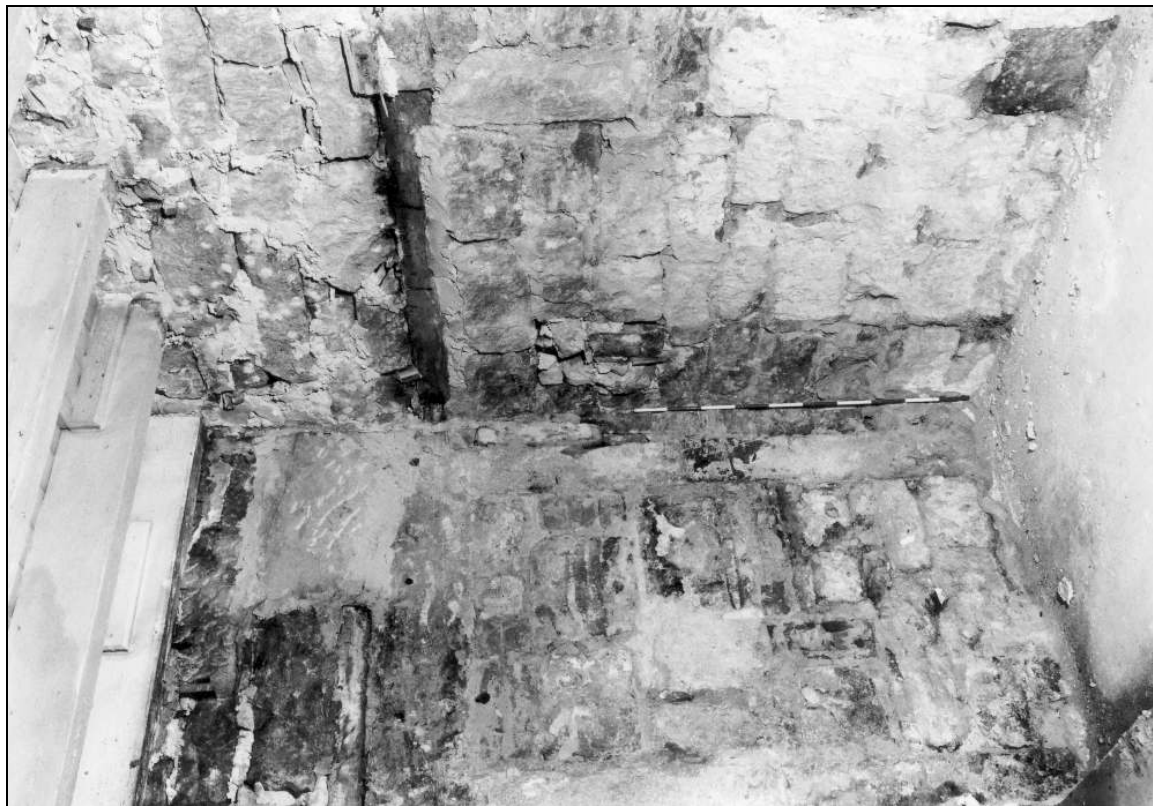
Photo 60: Blocked doorways in south-east corner of back kitchen (film 4, frame 17)

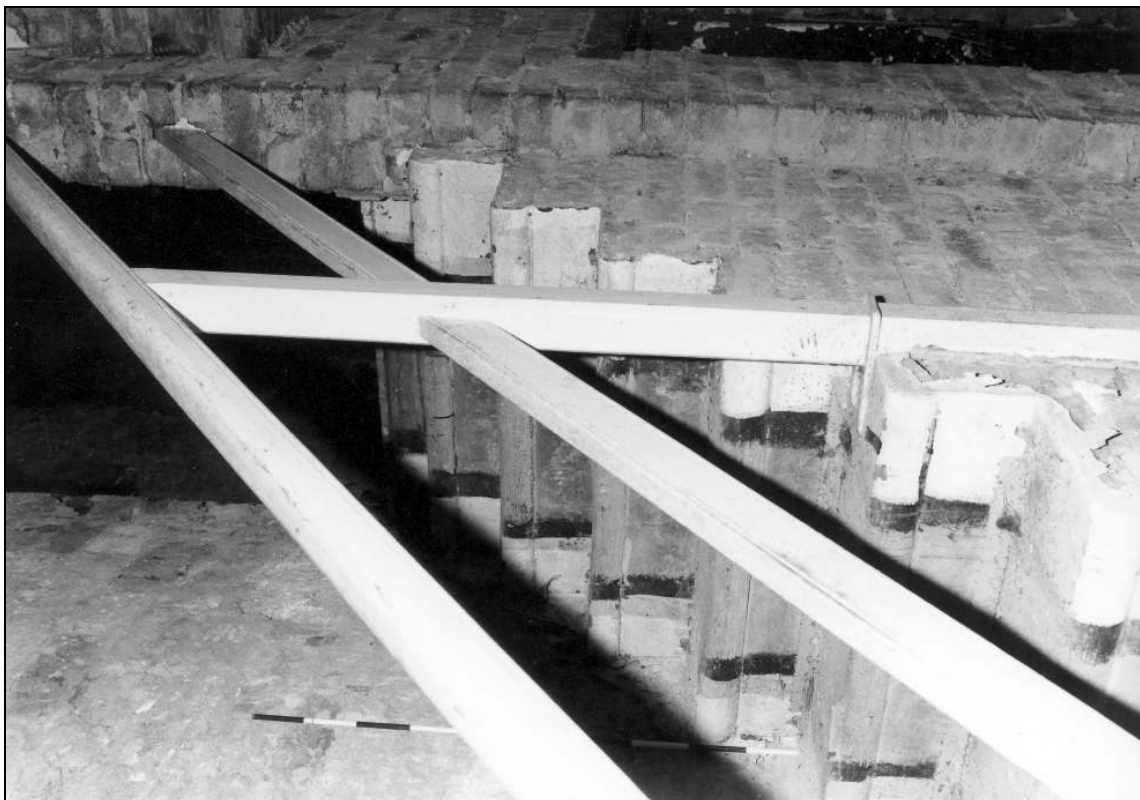
Photo 62: Stairs to first floor, from the north-west (film 4, frame 5)

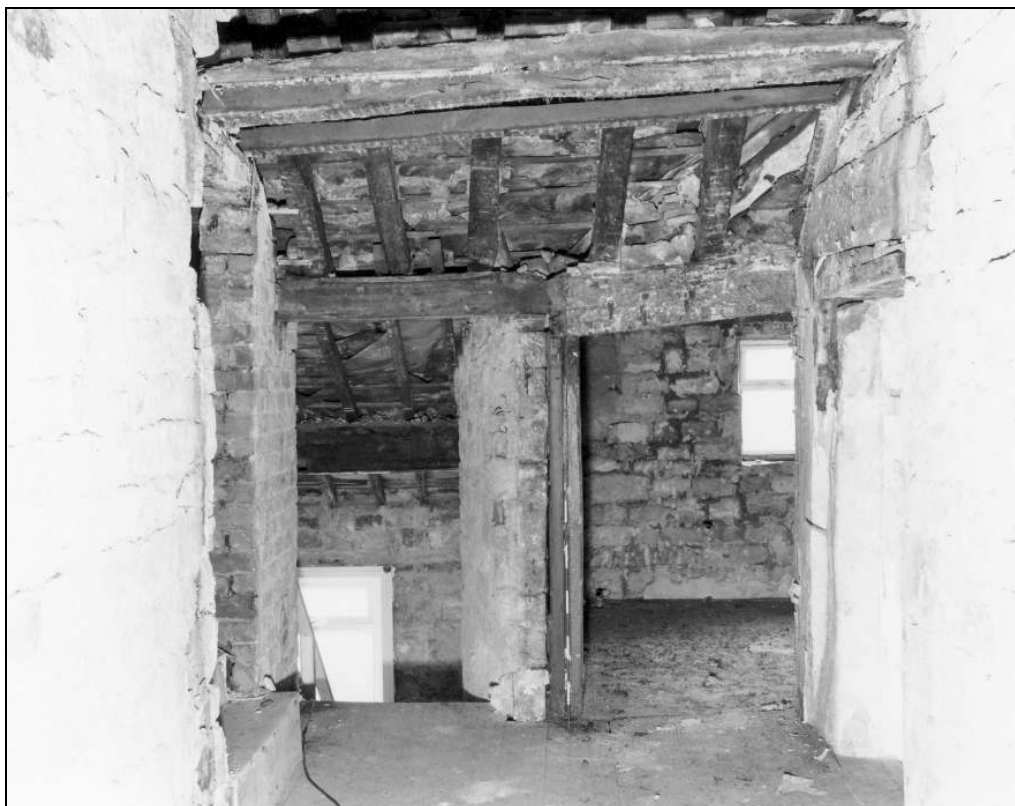
Photo 63: First floor room over hearth passage, from the south (film 5, frame 2)

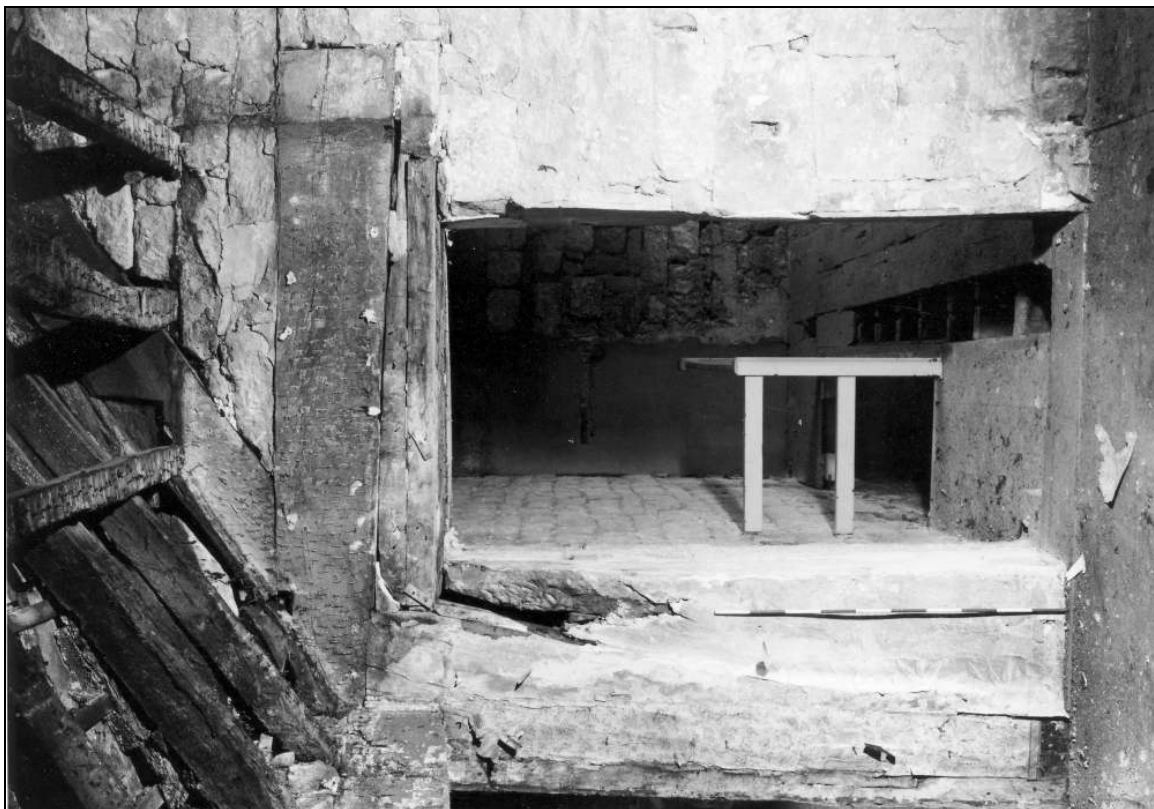
Photo 65: Top of north wall post and remains of truss, to east of hearth passage, from the west (film 5, frame 4)

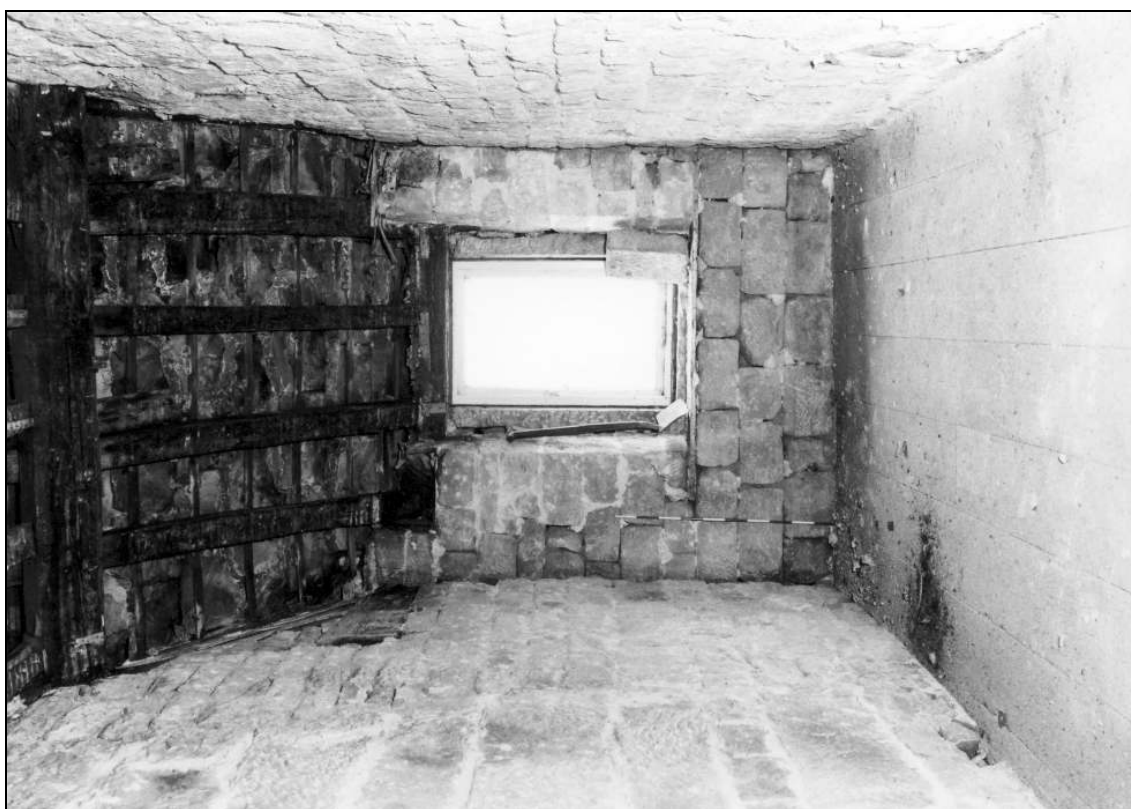
Photo 64: First floor room over hearth passage, from the north (film 4, frame 18)

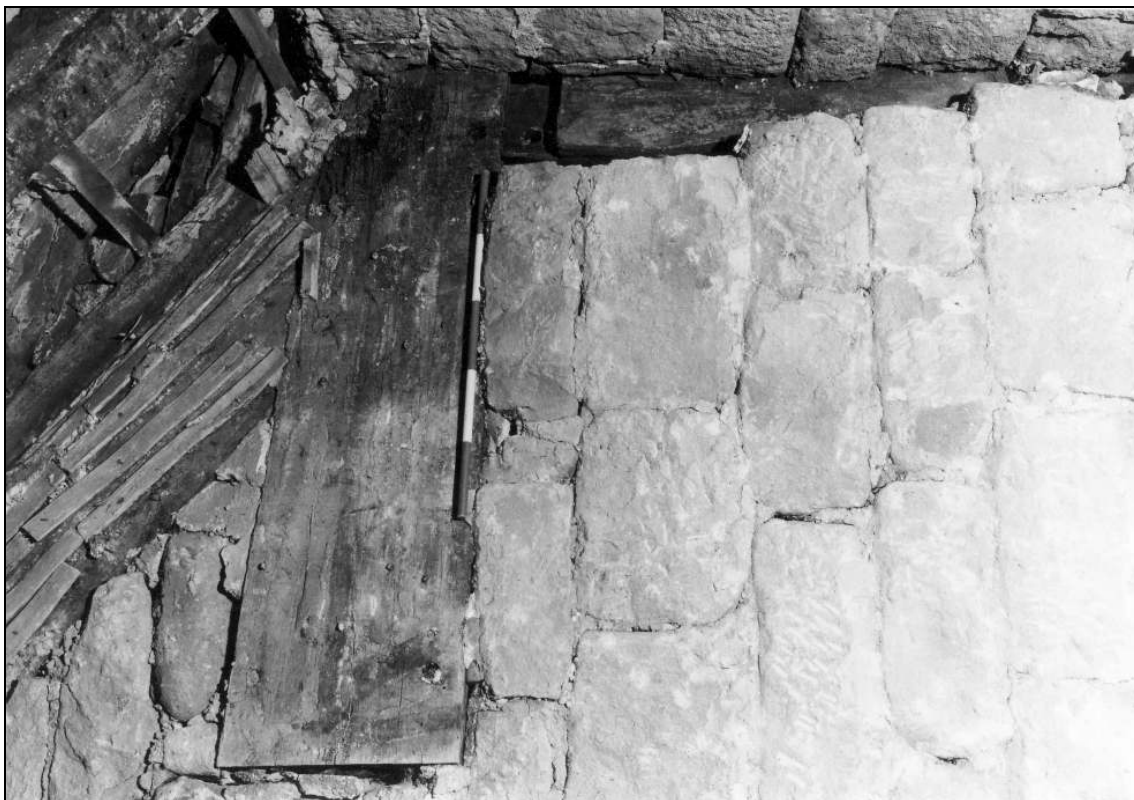
Photo 66: Top of south wall post and remains of truss, to east of hearth passage, from the west (film 5, frame 1)

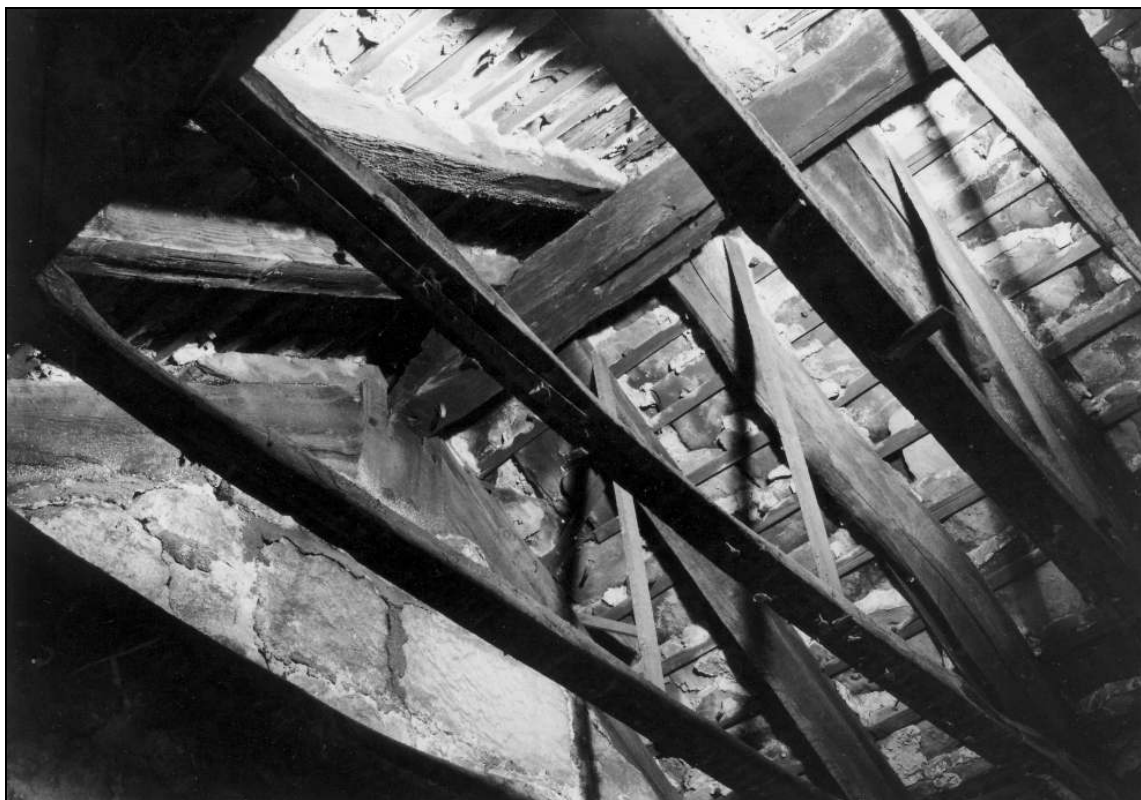
Photo 67: Remains of truss and ridge over hearth passage, from the north-west (film 5, frame 5)

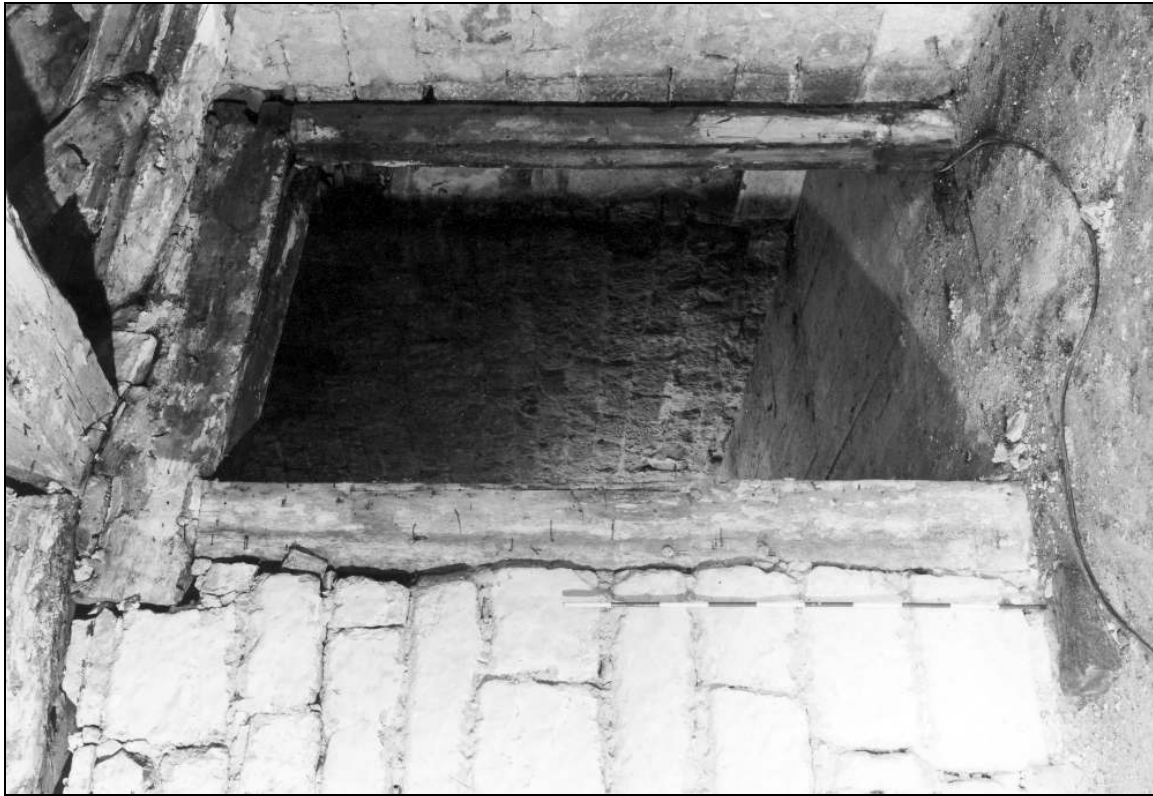
Photo 68: Rear chamber, east wing: doorway, from the north, showing wall or arcade post at left (film 5, frame 14)

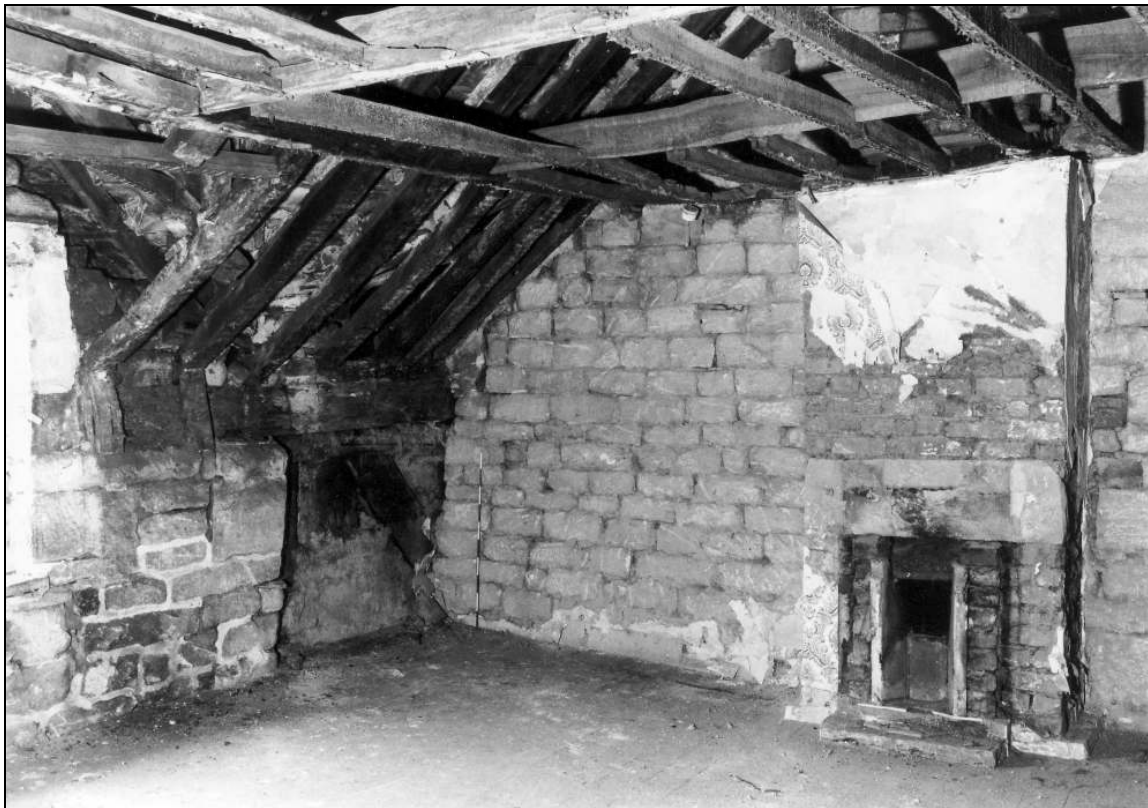
Photo 69: Chamber over housebody, from the north-east, showing exposed studs in corner, and 1886 fireplace (film 6, frame 5)
