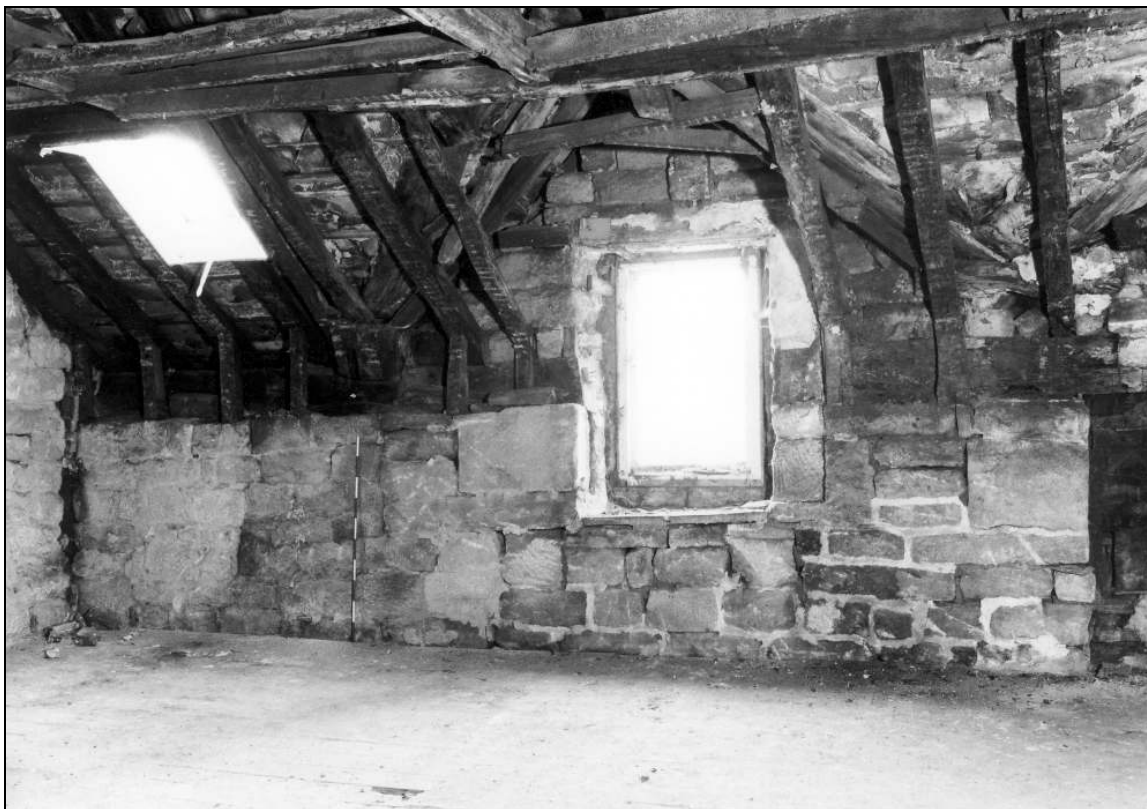
Photo 70: Chamber over housebody, from the north (film 6, frame 3)

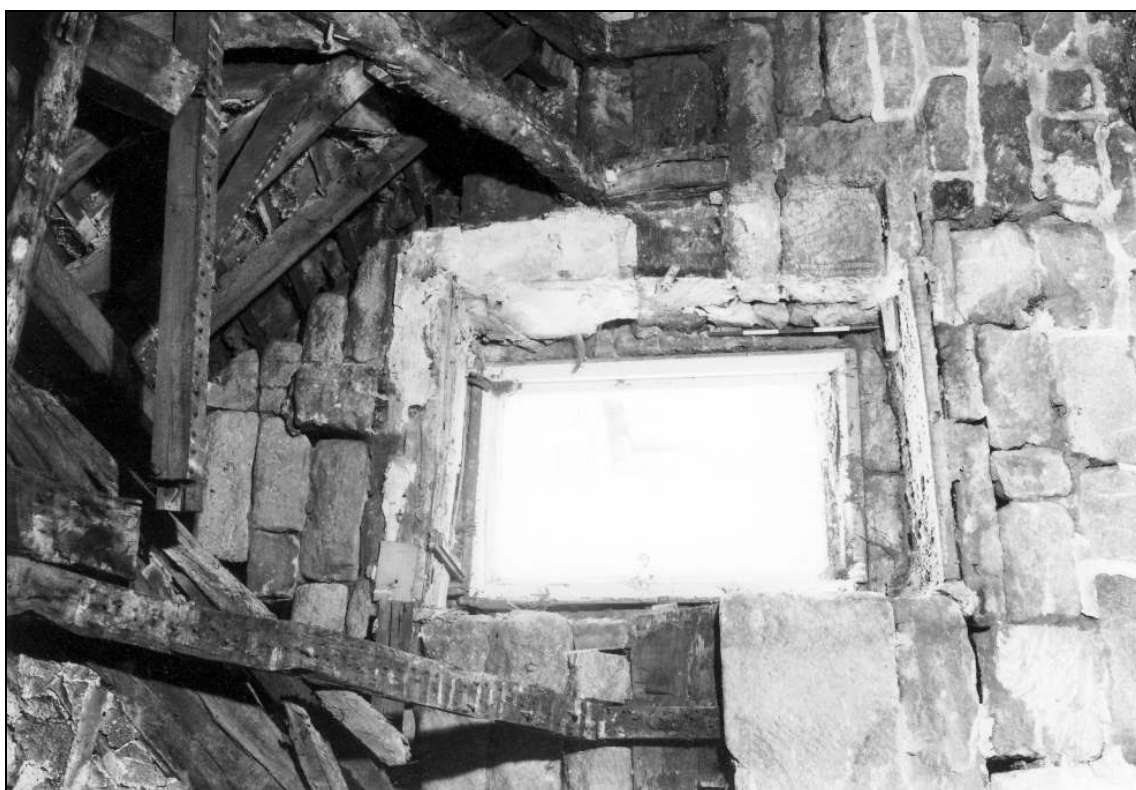
Photo 71: Window in gablet to chamber over housebody,  
with wall plate to either side (film 6, frame 11)

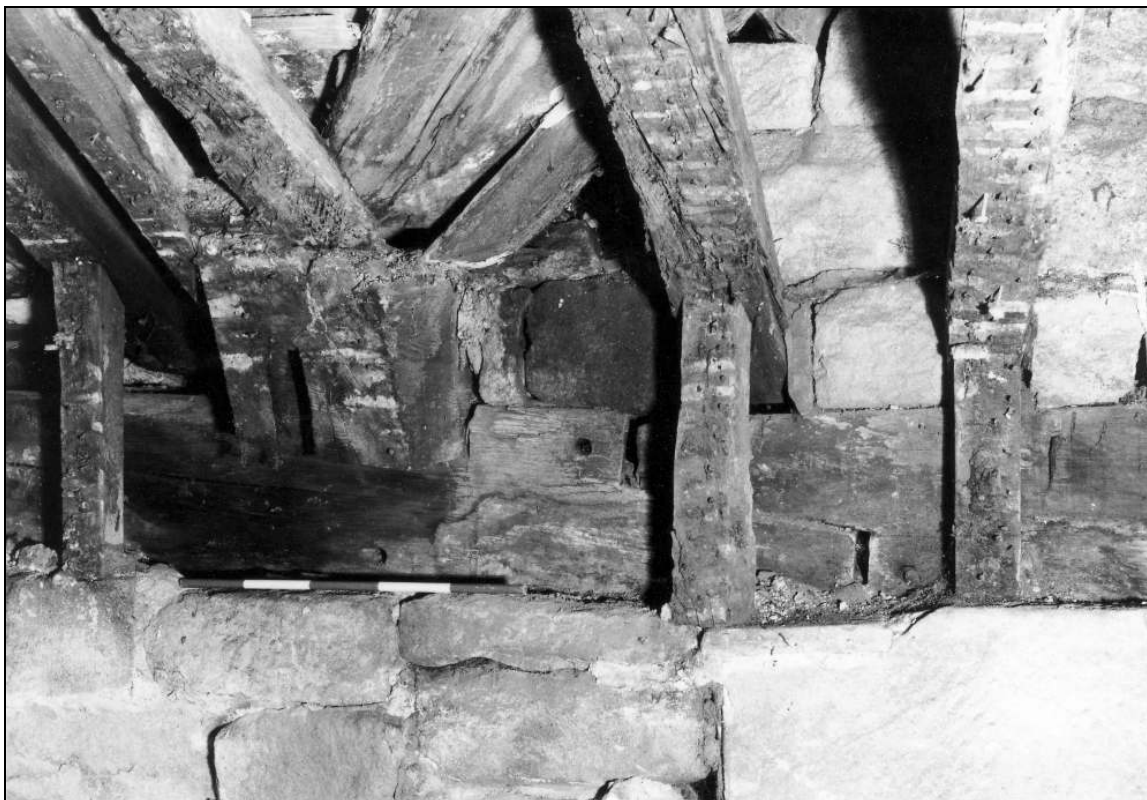
Photo 72: Chamber over housebody: stub of sawn-off tie beam, and scarf joint in wall plate, south wall (film 6, frame 4)

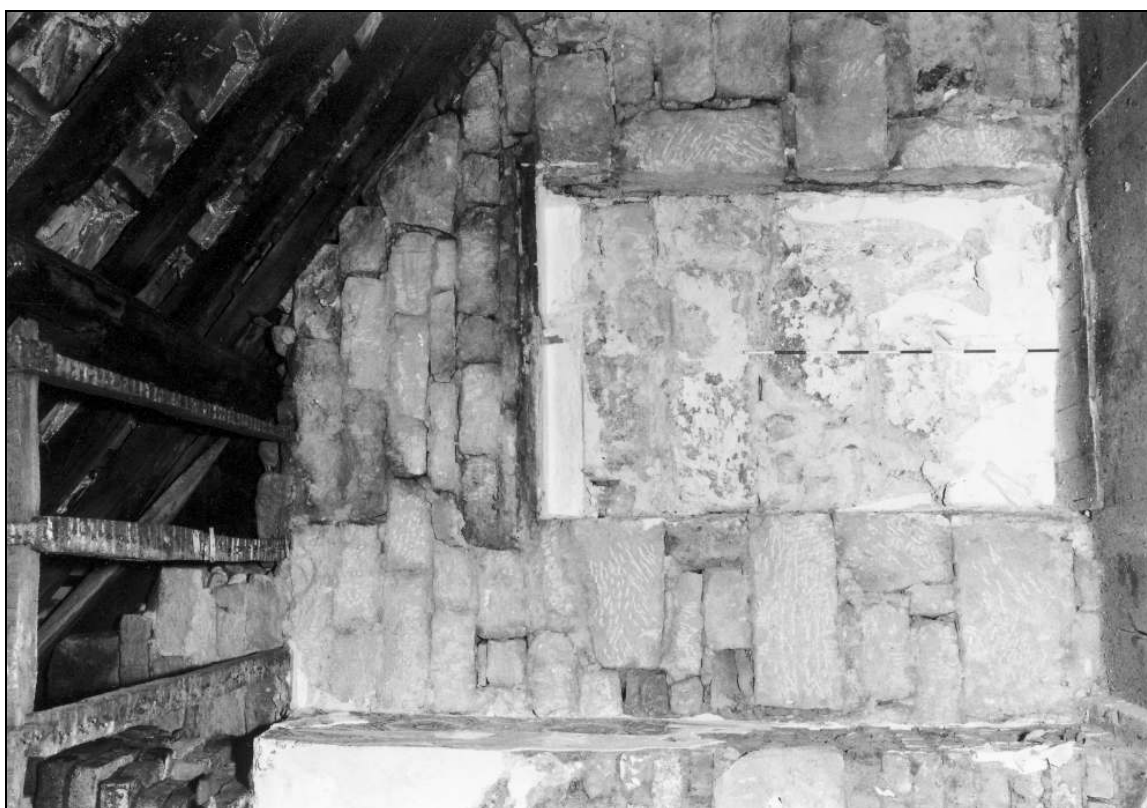
Photo 73: Chamber over housebody: blocked doorway to west wing (film 6, frame 9)

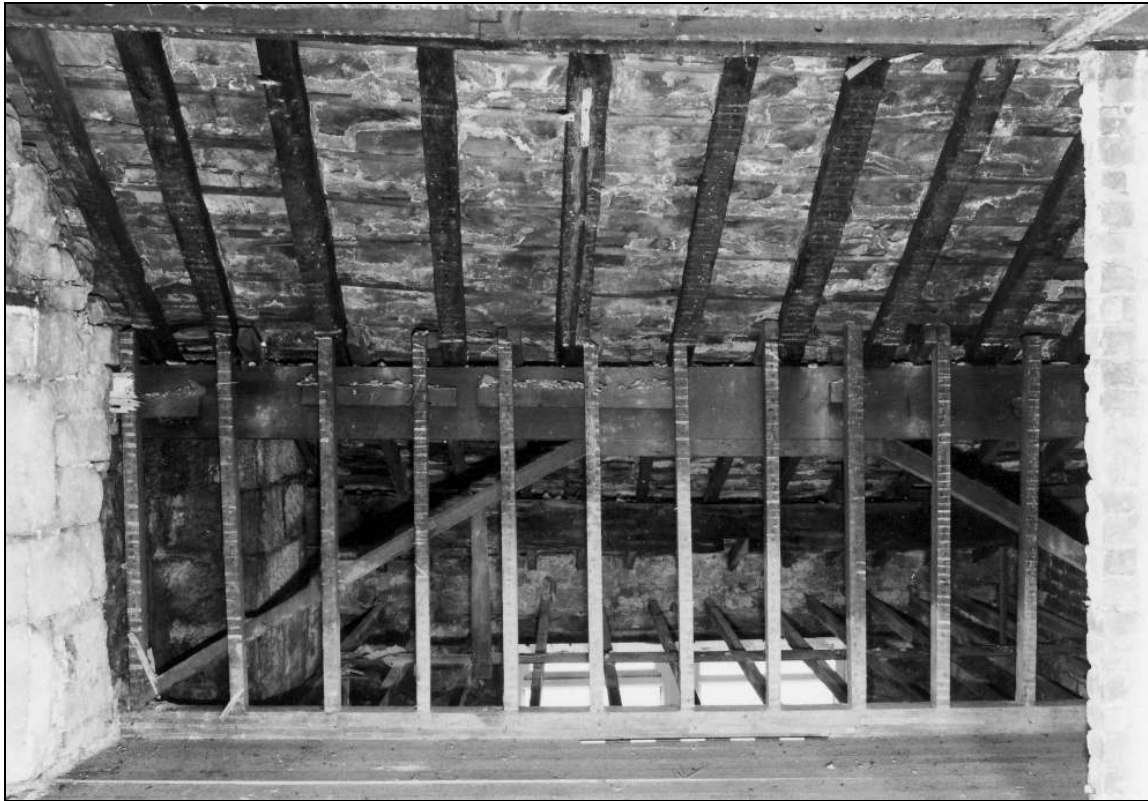
Photo 74: Chamber over housebody, from the south (film 6, frame 10)

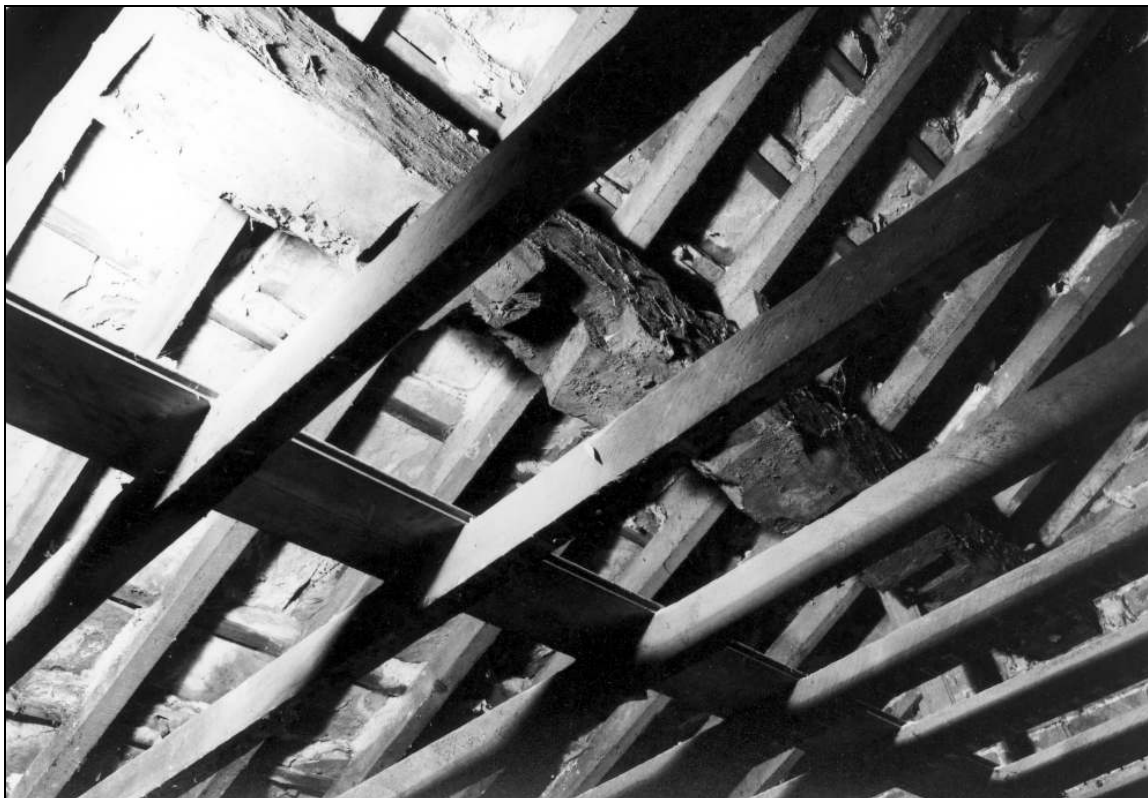
Photo 75: Wall or arcade plate re-used as purlin, over kitchen, from the south-west (film 4, frame 1)

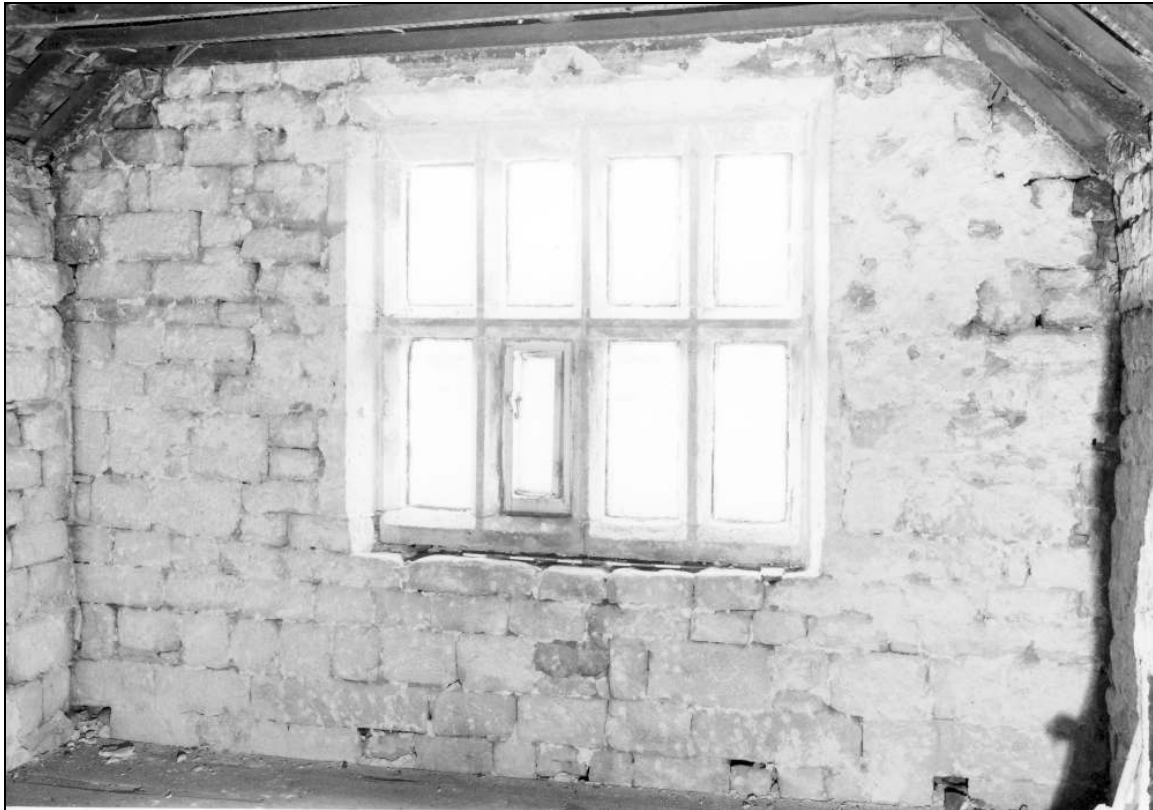
Photo 76: Chamber over parlour, east wing, from the north (film 5, frame 7)

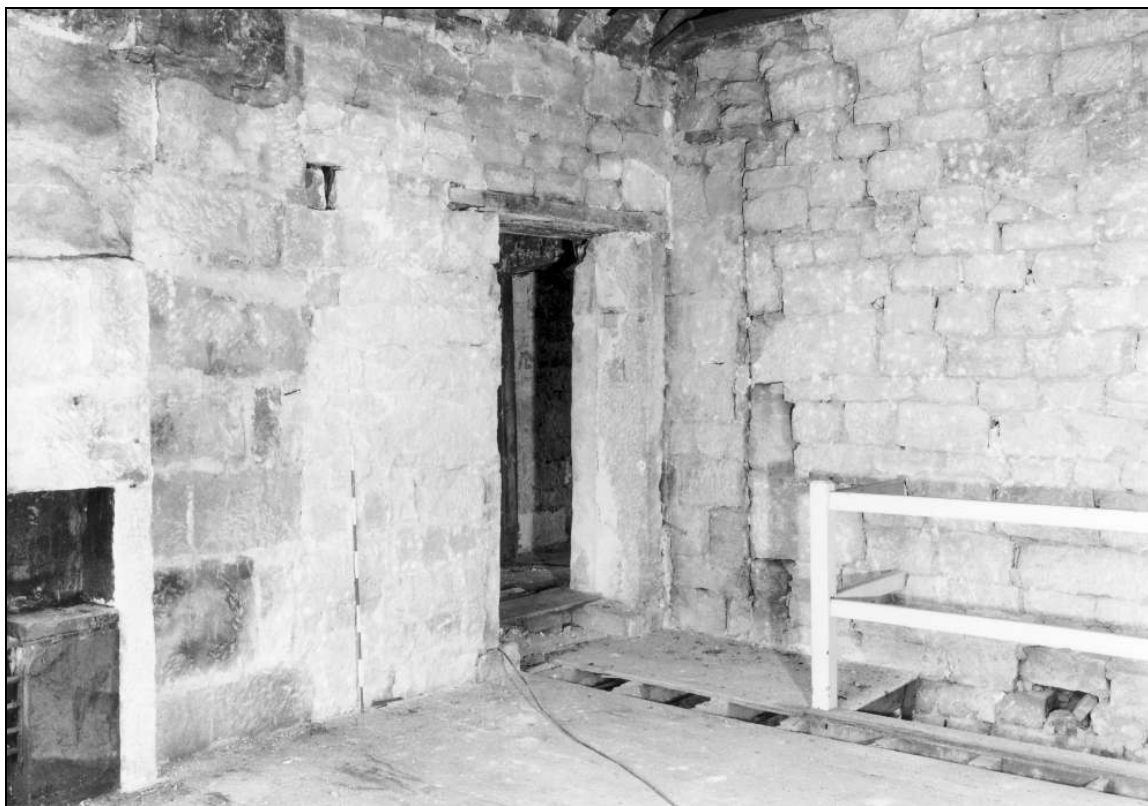
Photo 77: Chamber over parlour, east wing, from the south-east (film 5, frame 8)

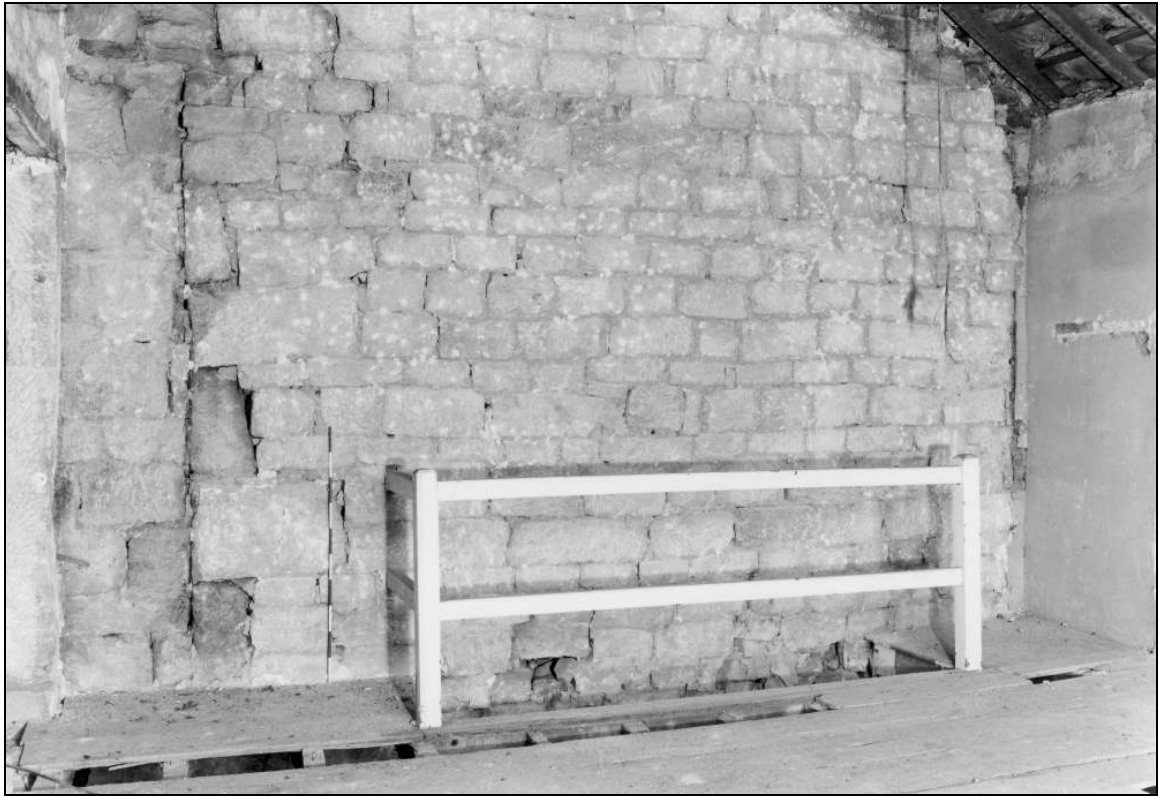
Photo 78: Chamber over parlour, east wing, from the south-west (film 5, frame 11)

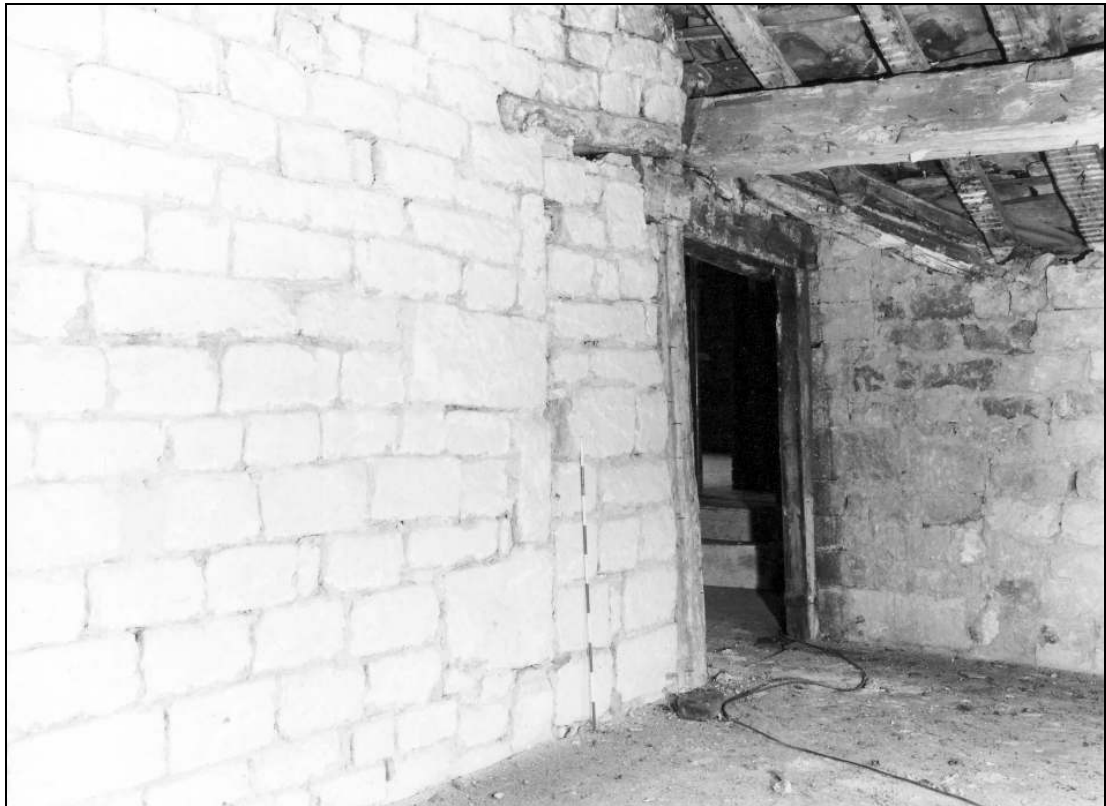
Photo 79: Rear chamber, east wing, from the north-east (film 5, frame 13)

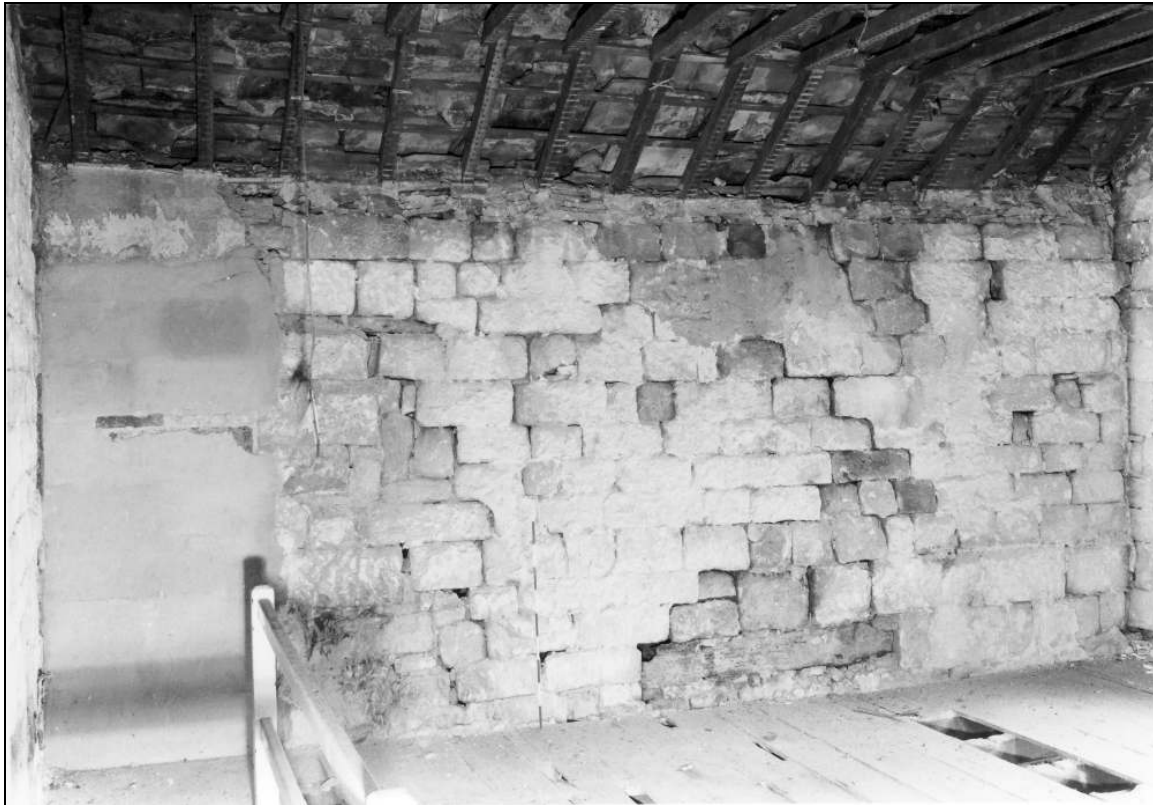
Photo 80: Chamber over parlour, east wing, from the north-west (film 5, frame 6)

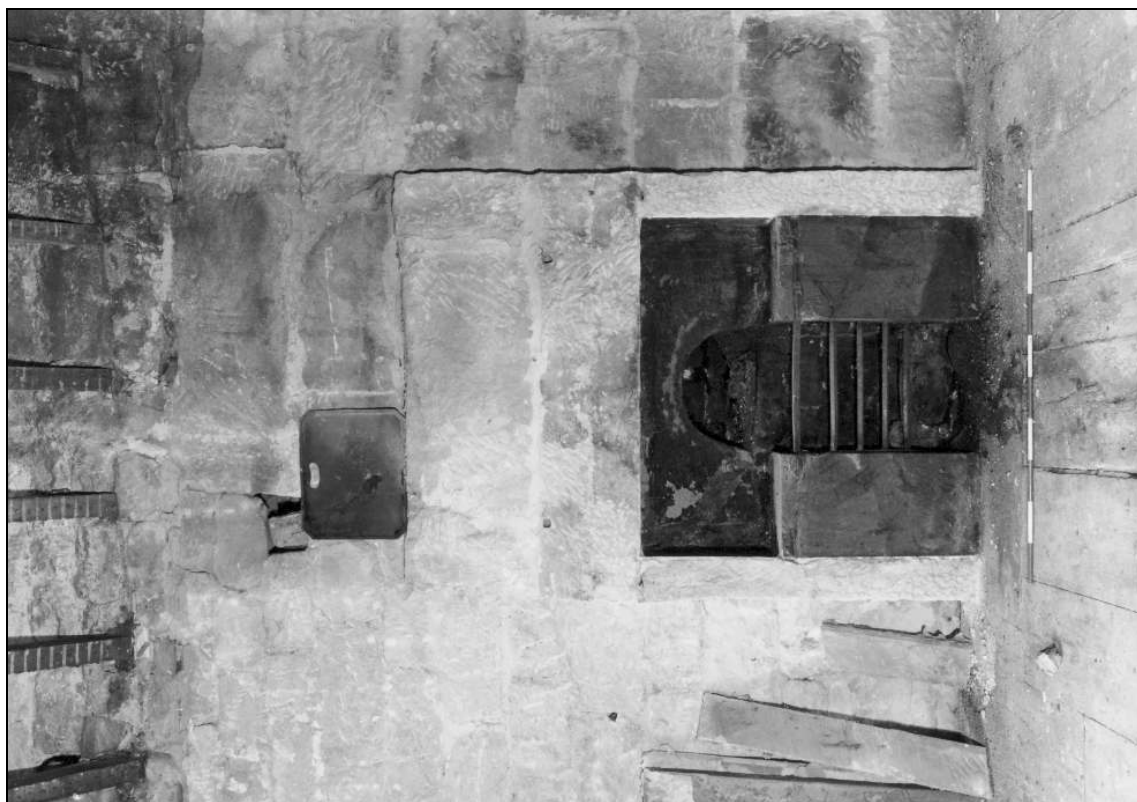
Photo 81: Chamber over parlour, east wing:  
eighteenth/nineteenth century fireplace, from the east (film  
5, frame 10)

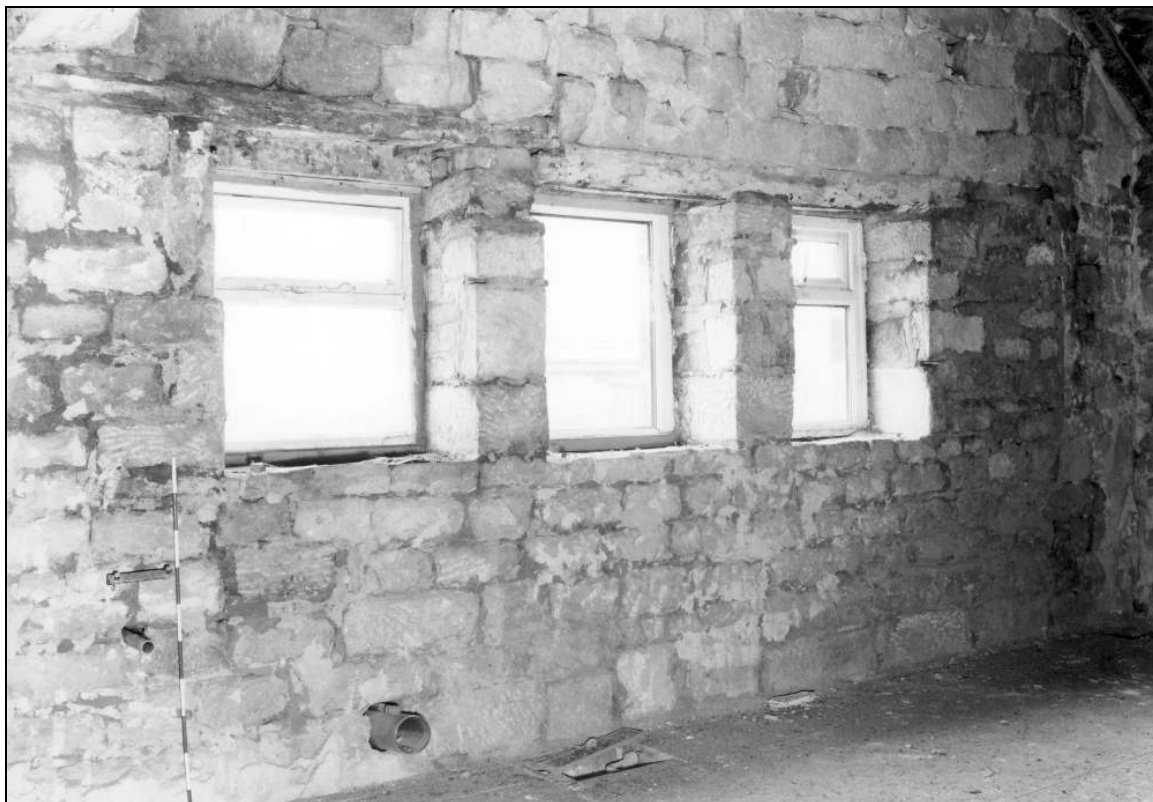
Photo 82: Rear chamber, east wing, from the south-west (film 5, frame 17)

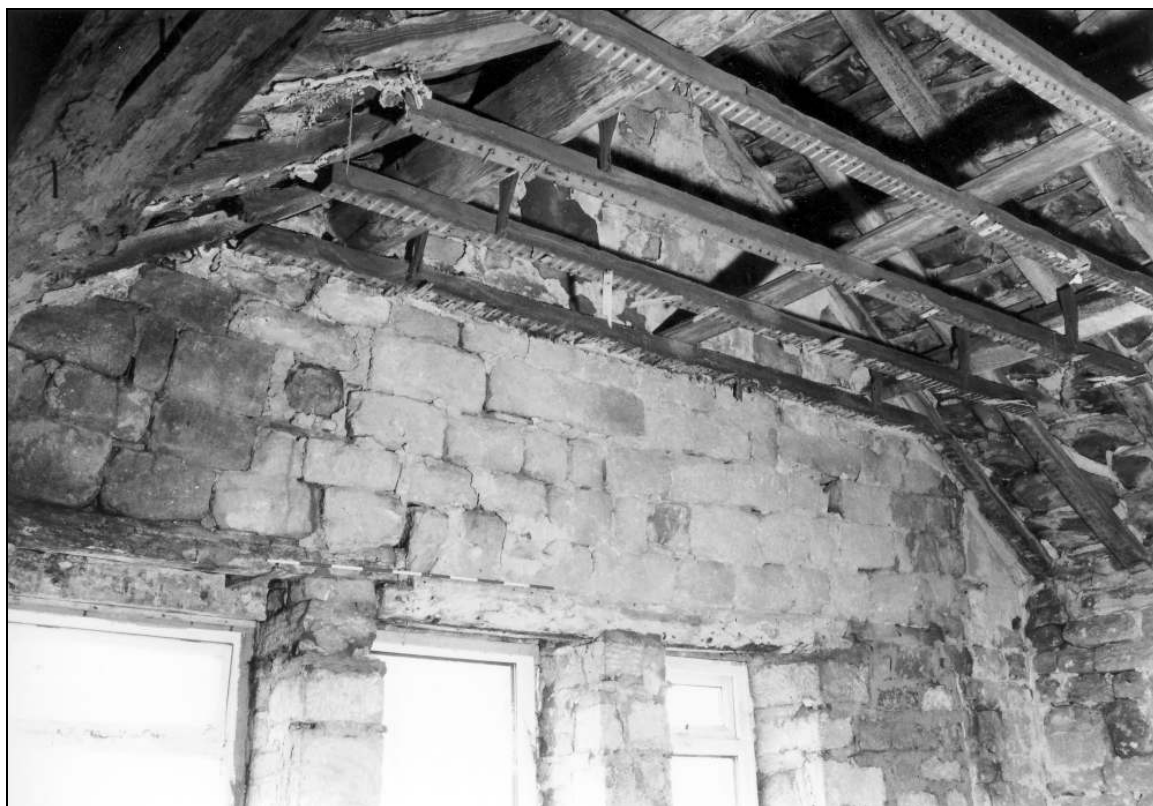
Photo 83: Rear chamber, east wing, from the south-west (film 5, frame 18)

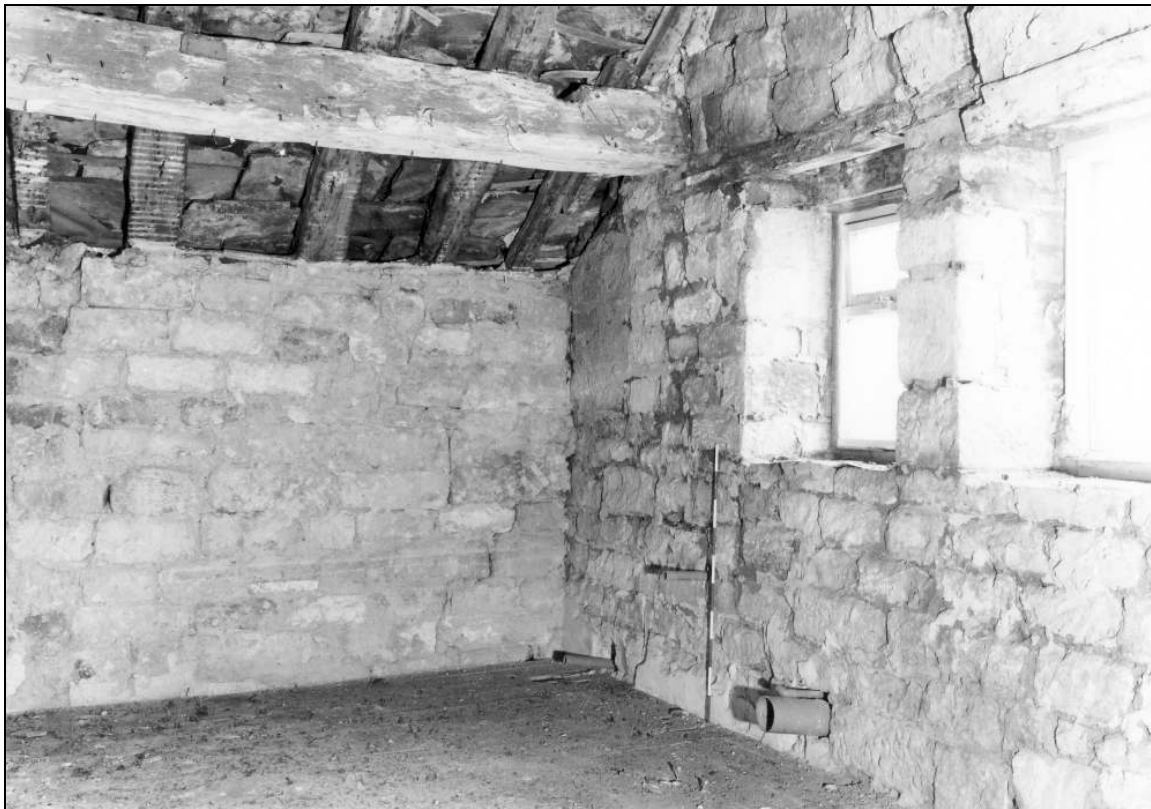
Photo 84: Rear chamber, east wing, from the south-east (film 5, frame 16)

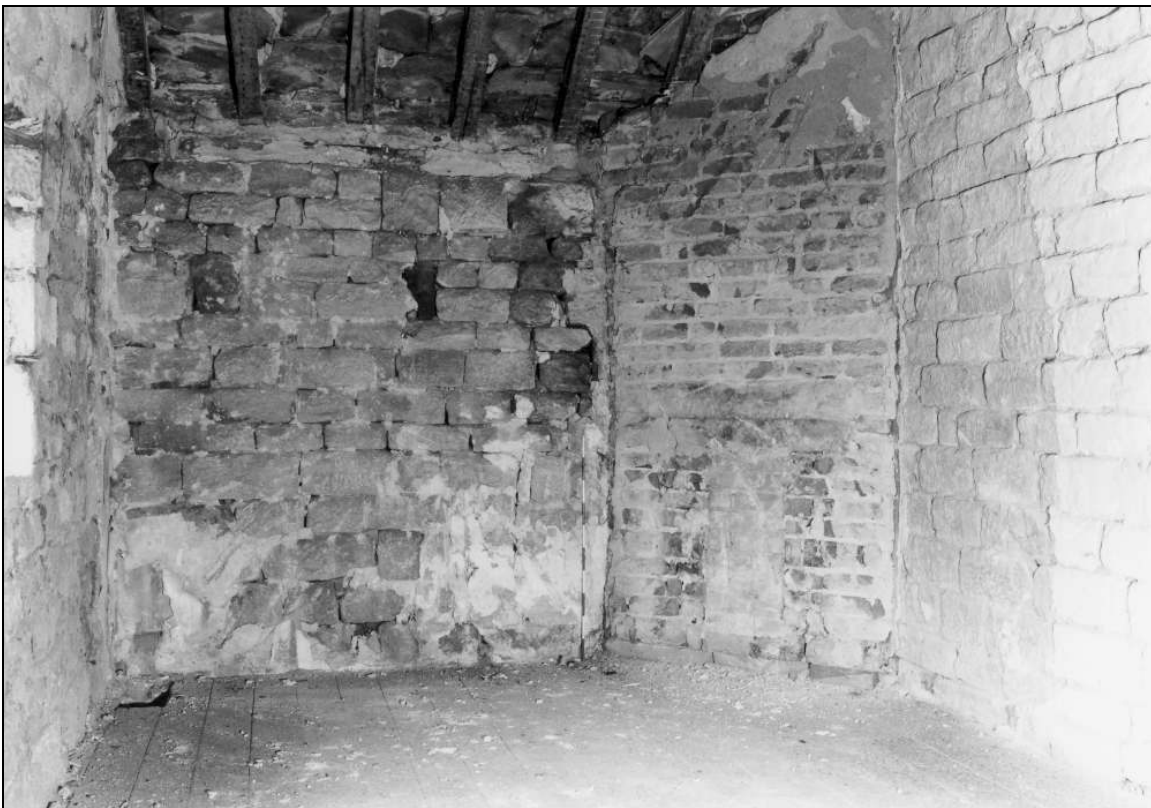
Photo 85: Rear chamber, east wing, from the west (film 5, frame 12)

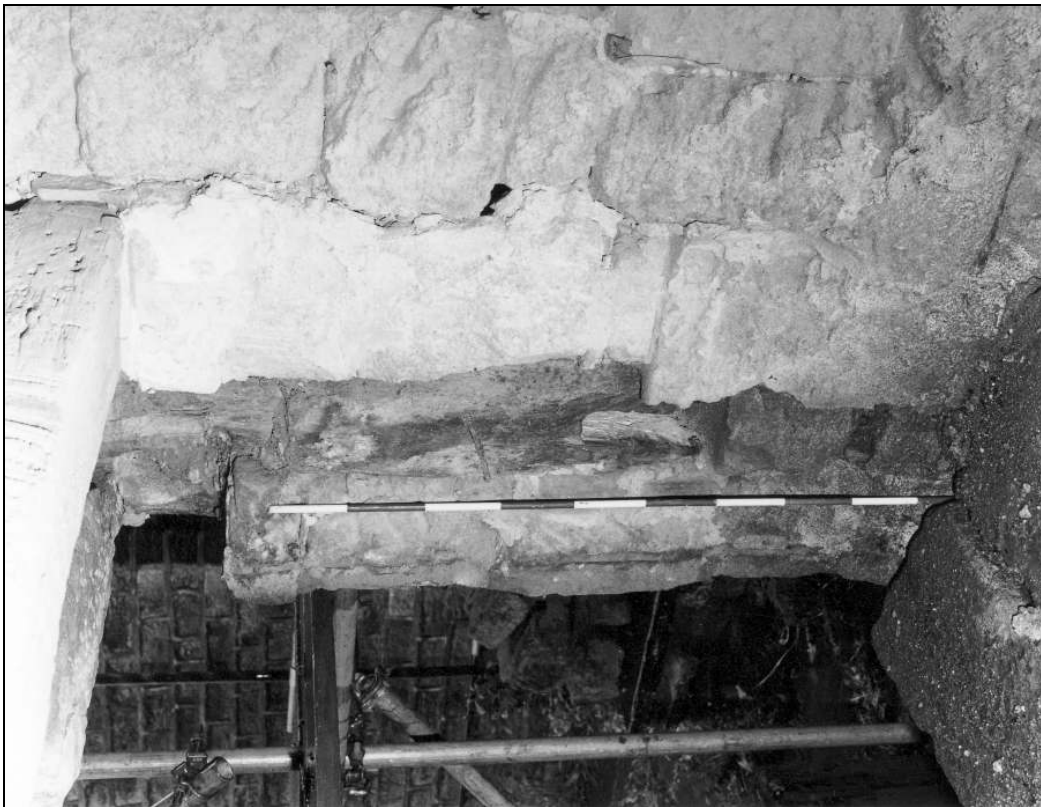
Photo 87: Remains of post at south-east corner of house (ground floor), revealed during repairs (film 7, frame 1)

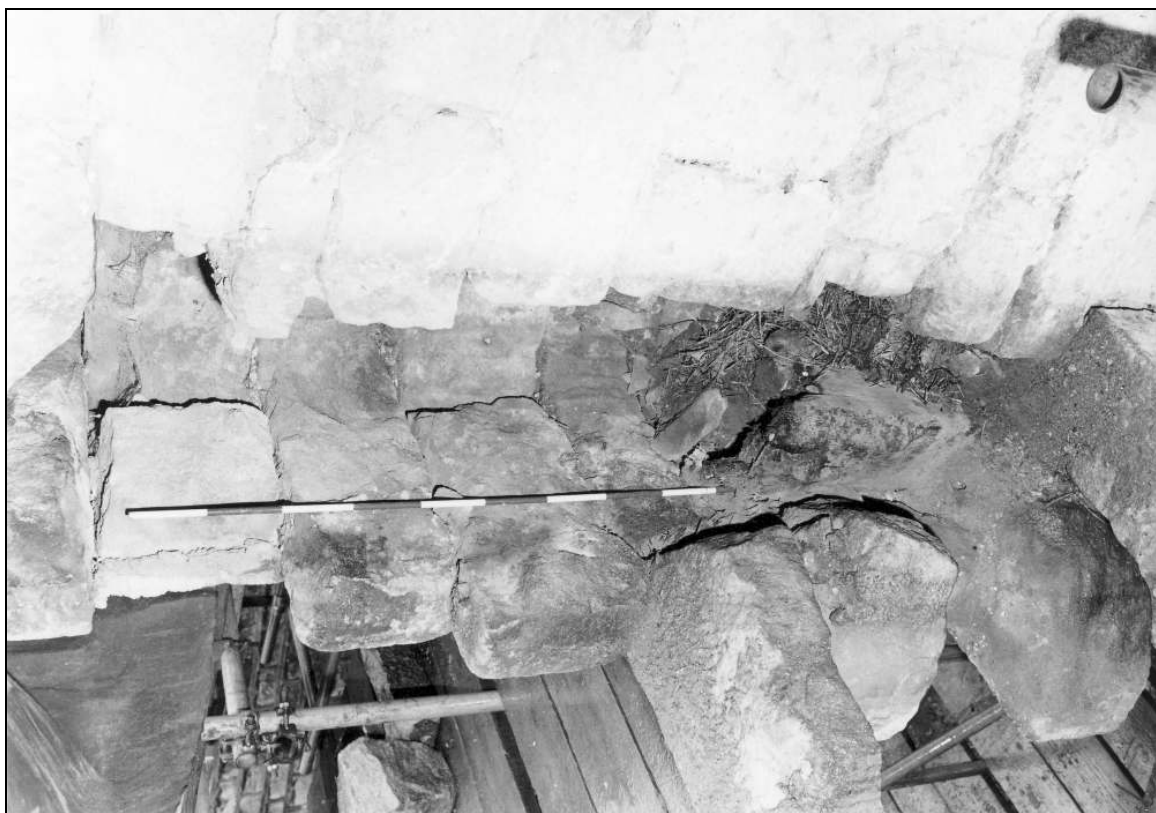
Photo 86: Remains of post at south-east corner of house (first floor), revealed during repairs (film 7, frame 2)

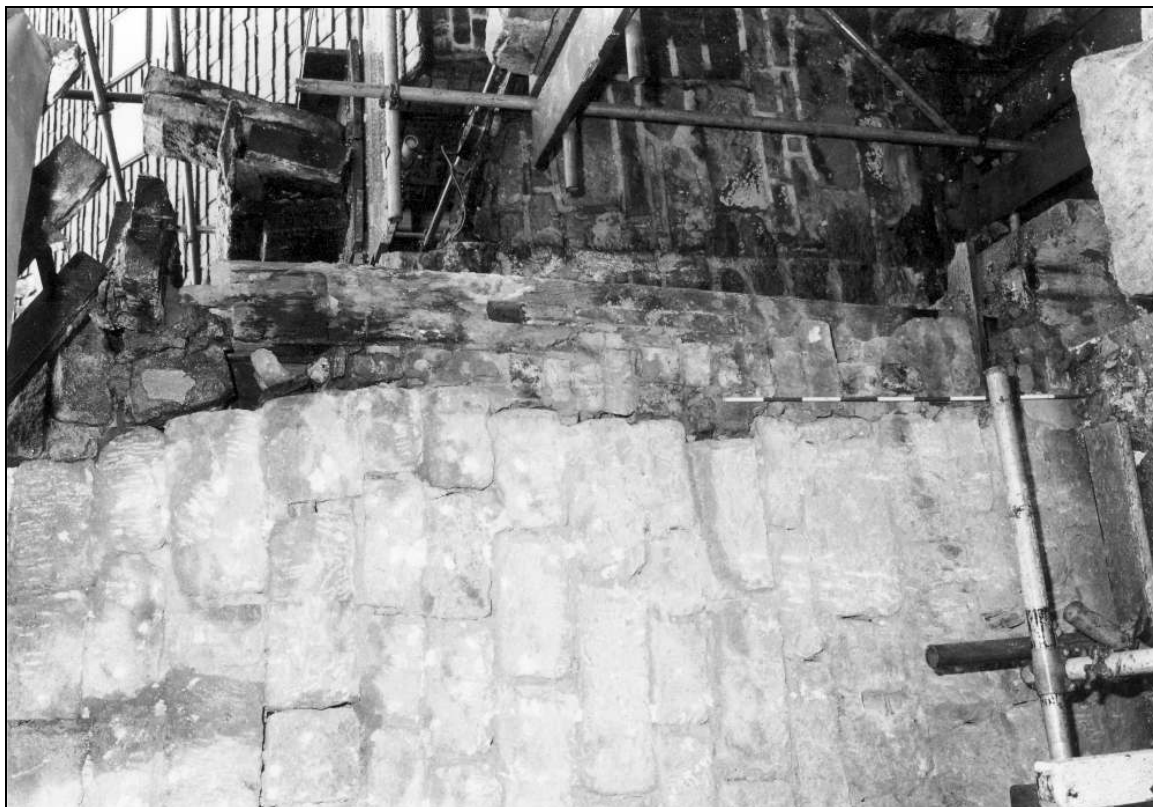
Photo 89: Remains of post at north-east corner of house (first floor), revealed during repairs (film 7, frame 5)

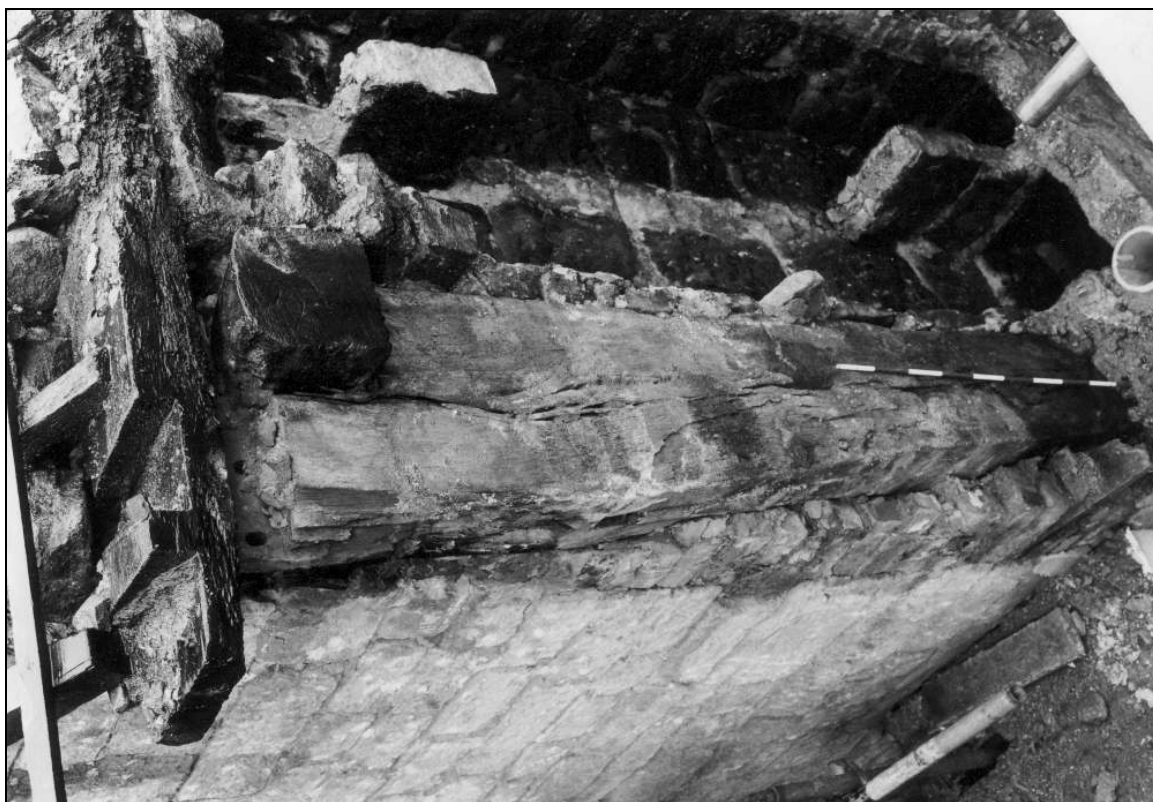
Photo 88: Remains of post at north-east corner of house (first floor), revealed during repairs (film 7, frame 7)

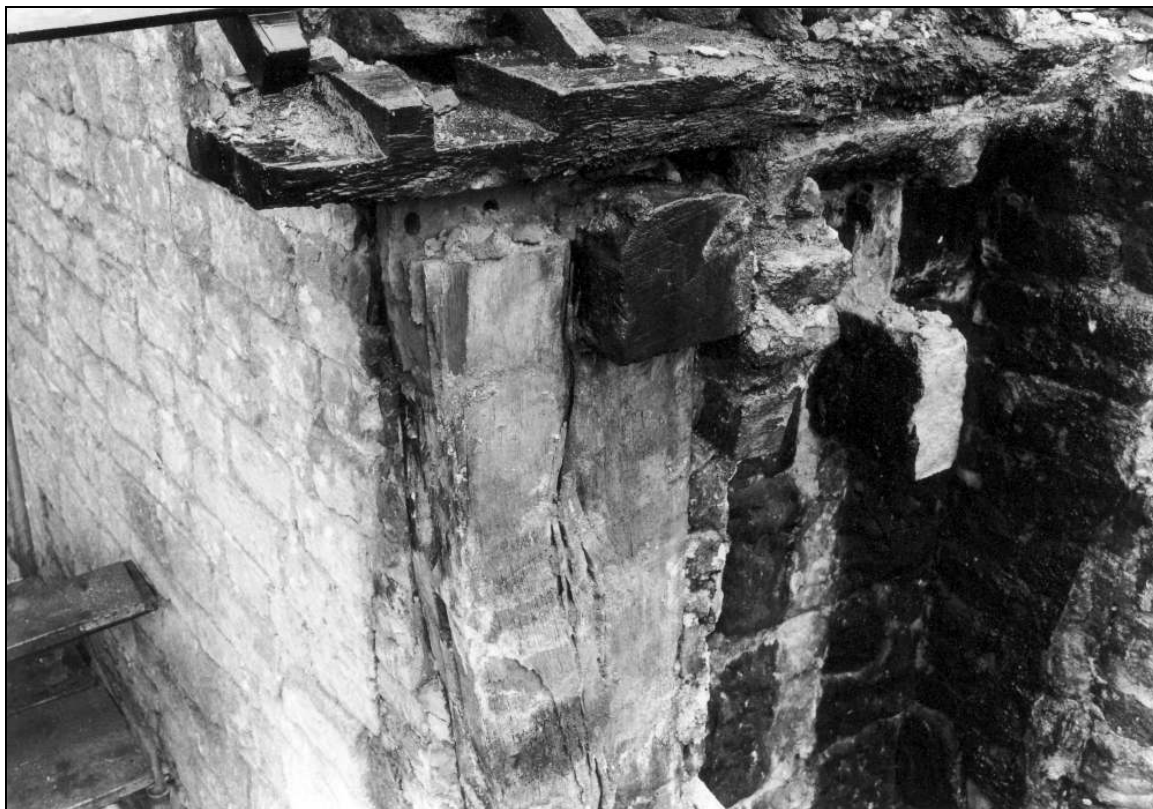
Photo 90: Remains of post at north-east corner of house (first floor), revealed during repairs (film 7, frame 6)

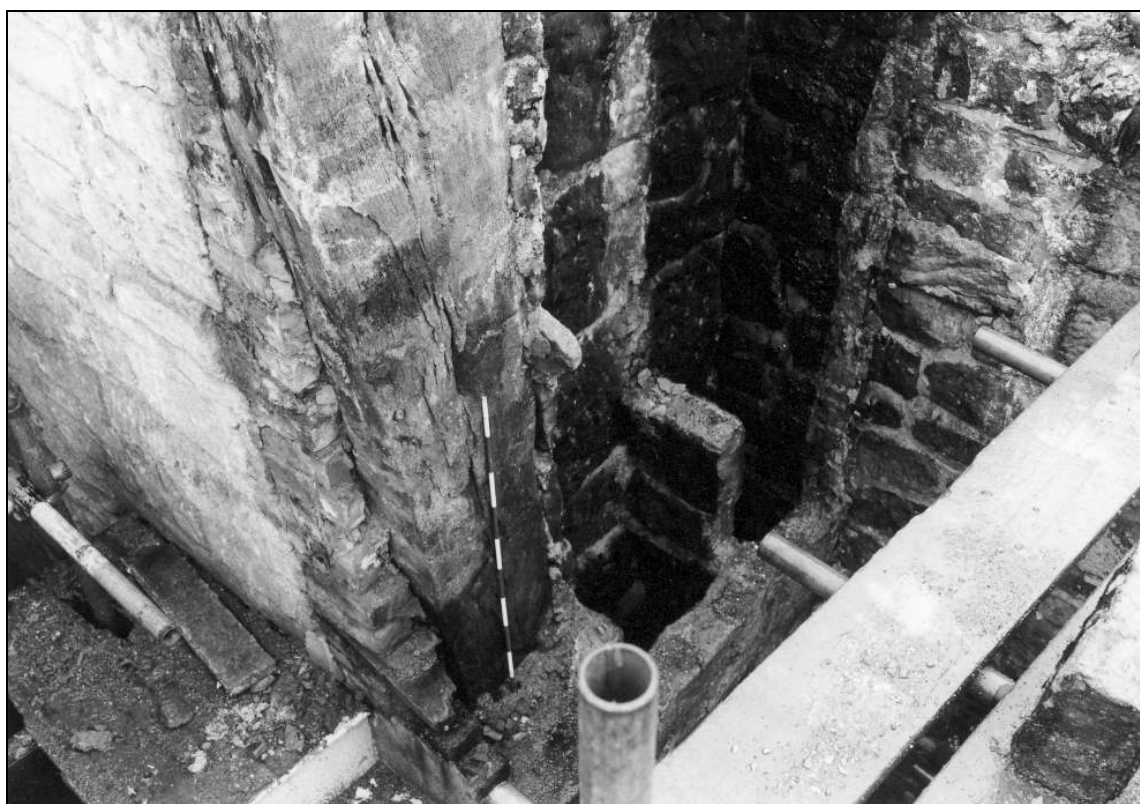
Photo 91: Remains of post at north-east corner of house, with adjacent flues (film 7, frame 9)

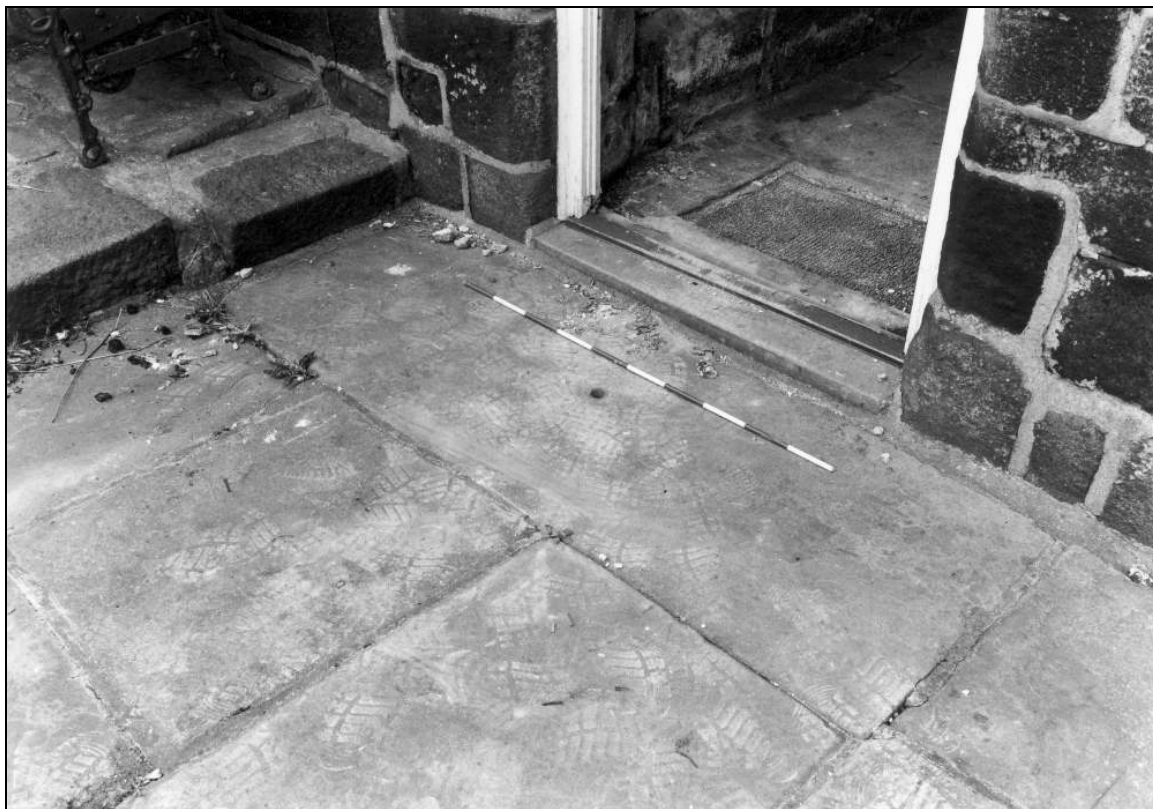
Photo 92: Threshold at front entrance (possible grave marker) (film 6, frame 12)
