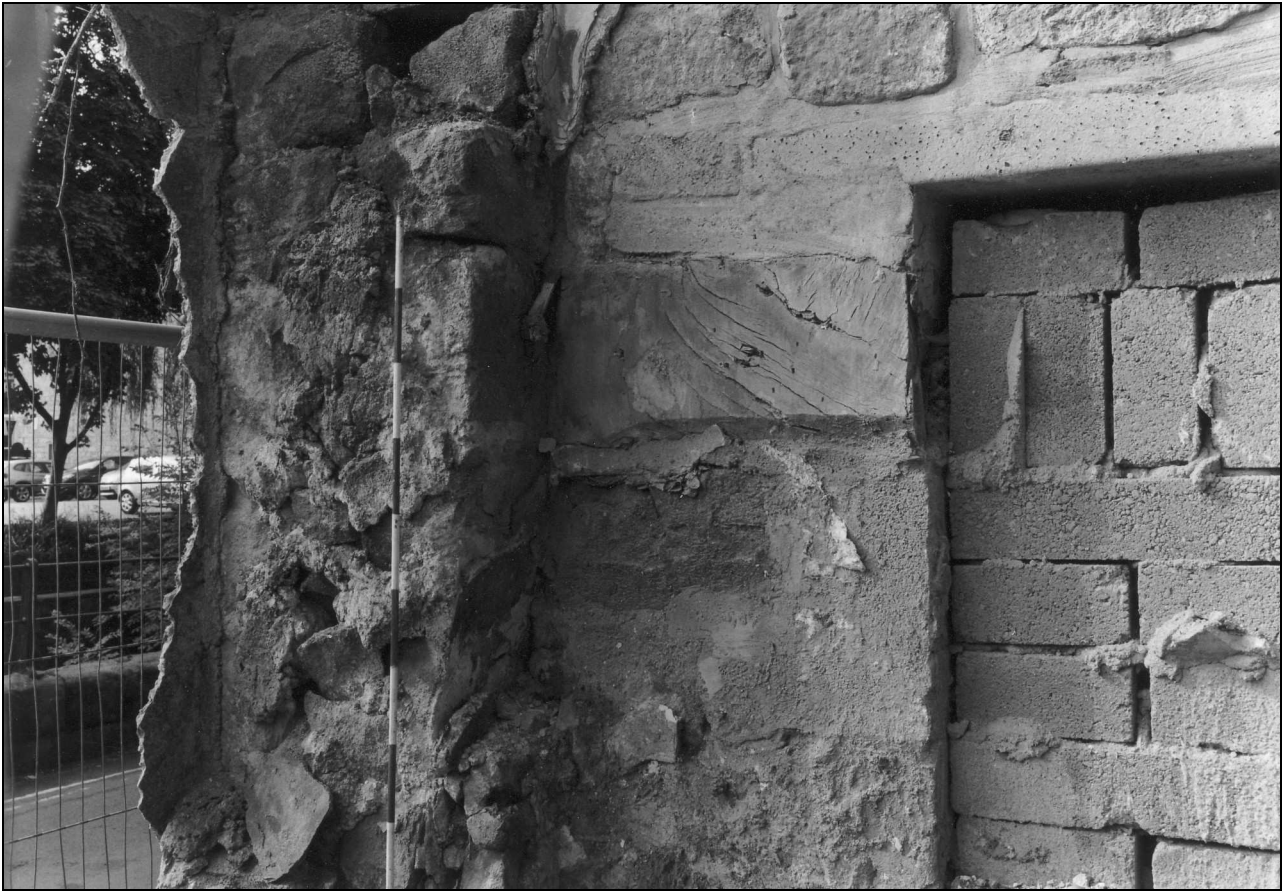
Photo 31: Cottage 1: south-west gable on ground floor, showing remains of oak timber, cut by modern doorway (film 6, film 5)

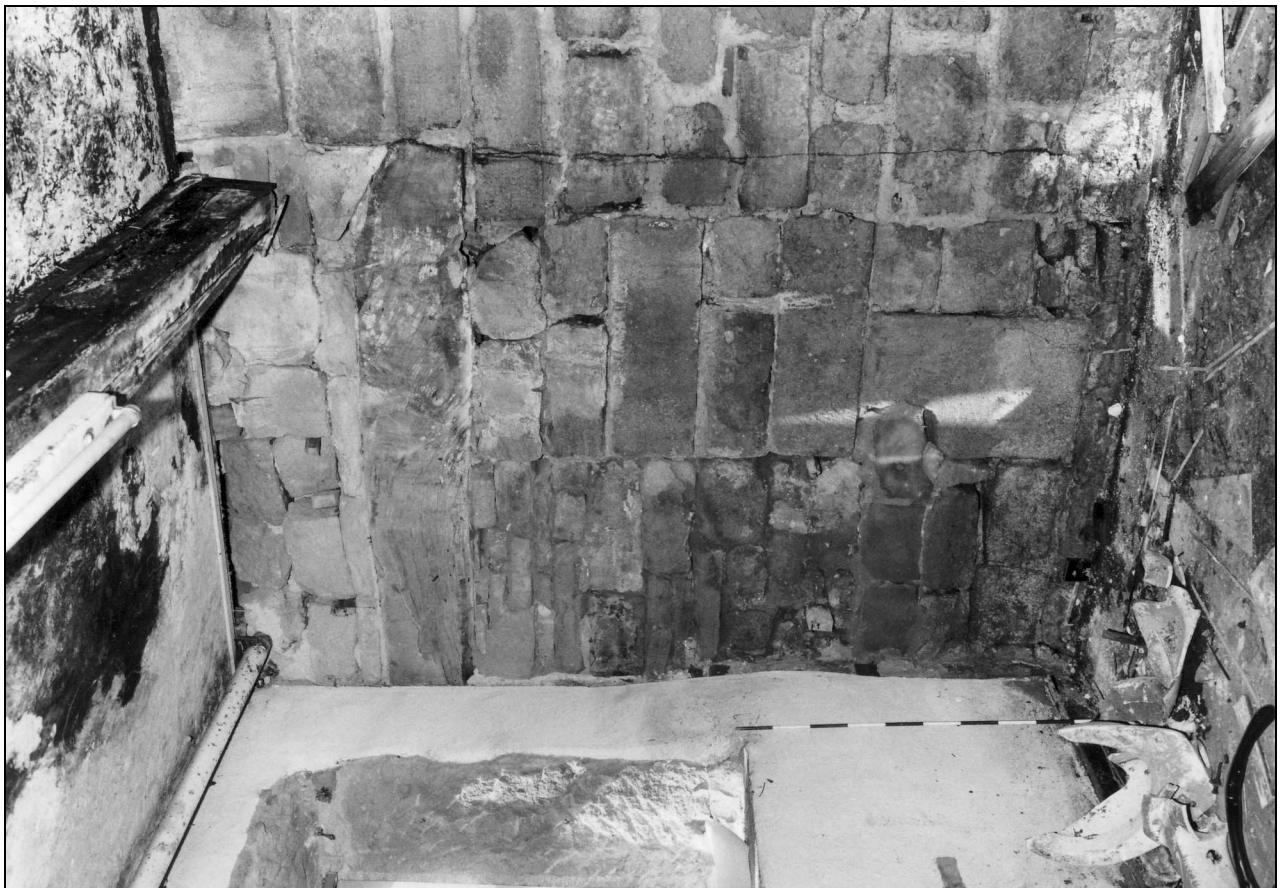
Photo 32: Cottage 2: south-west cross-wall on ground floor, showing oak timber, with former recess (?) below (film 4, film 4)

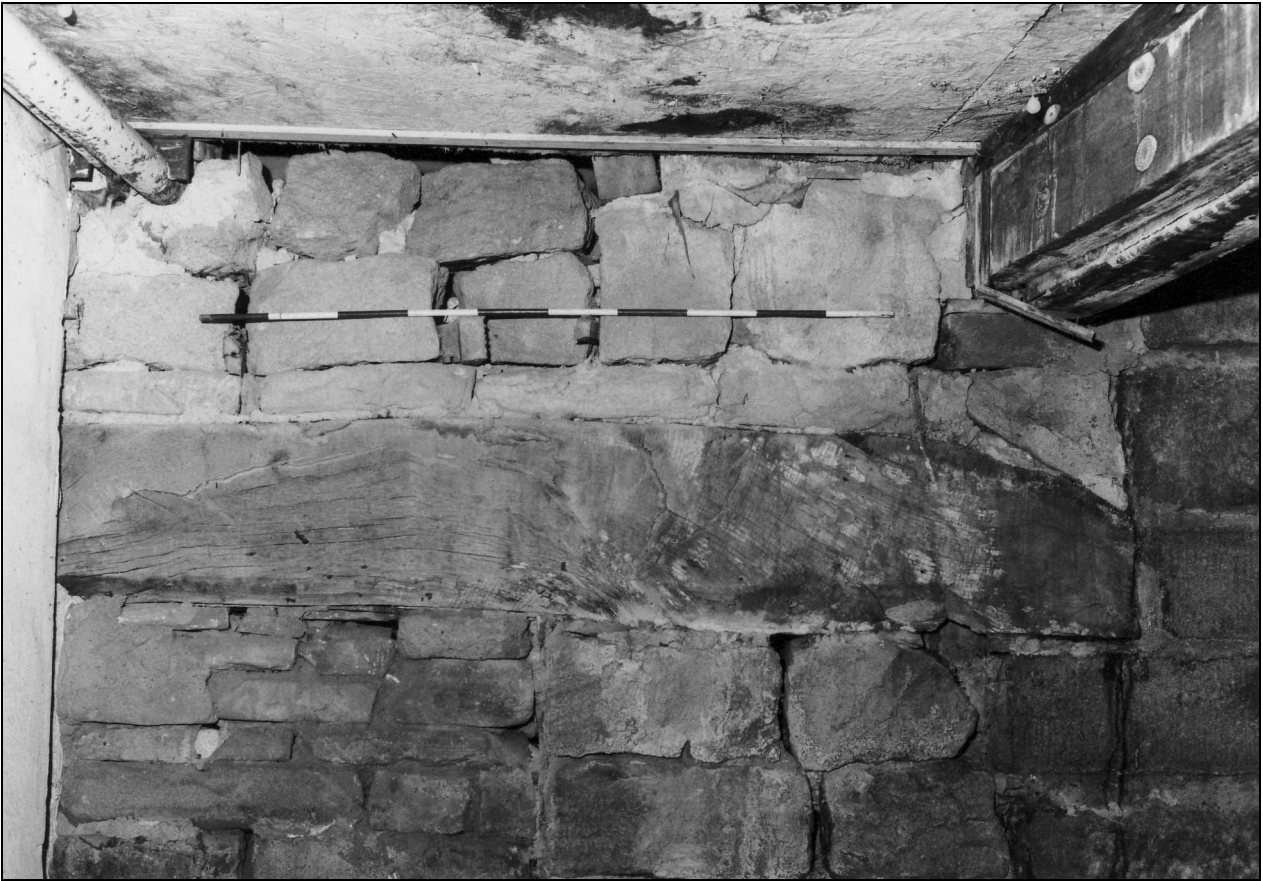
Photo 33: Cottage 2: south-west cross-wall on ground floor, showing oak timber (film 4, film 5)

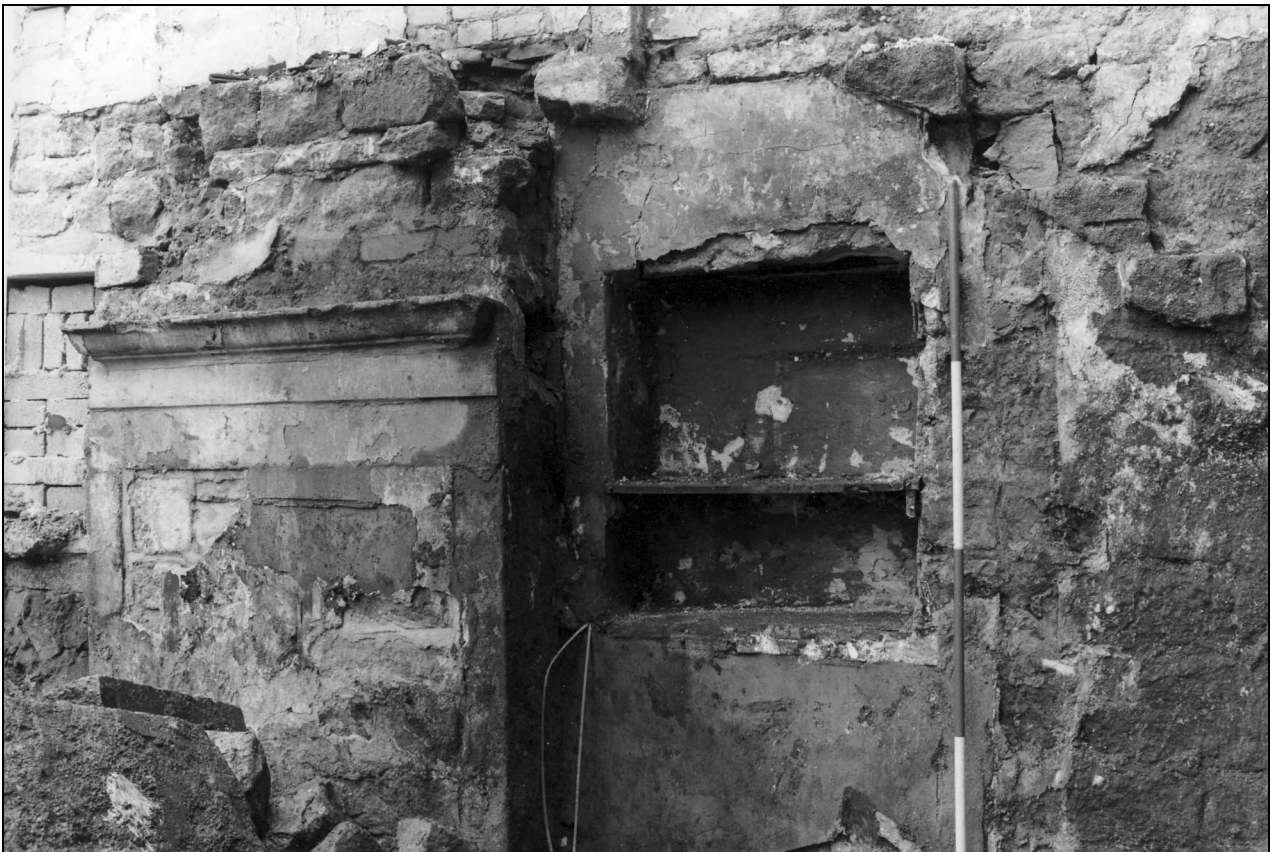
Photo 34 : Cottage 1: cupboard in south-west gable, beneath former stairs (film 5, film 11)

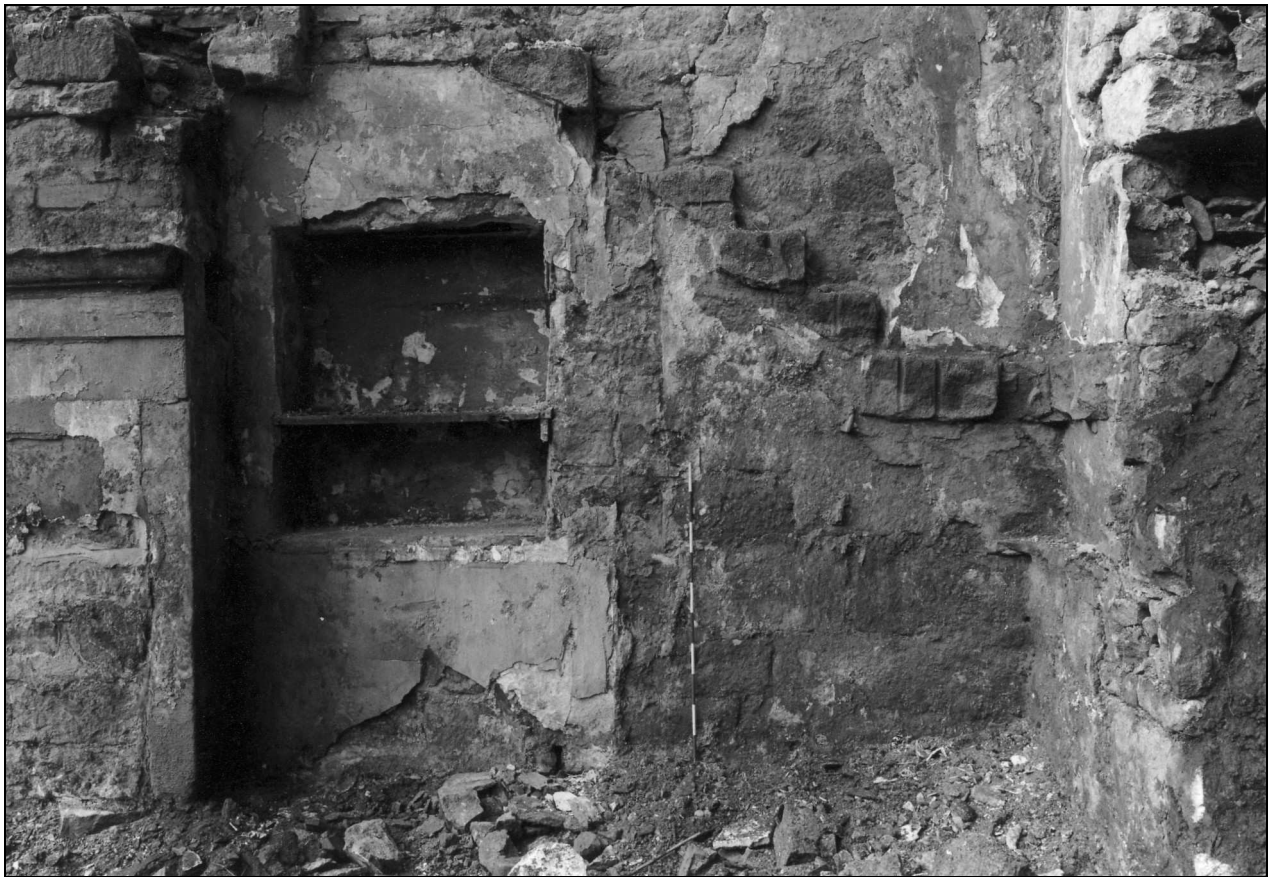
Photo 35: Cottage 1: remains of stairs in south-west gable (film 6, film 6)

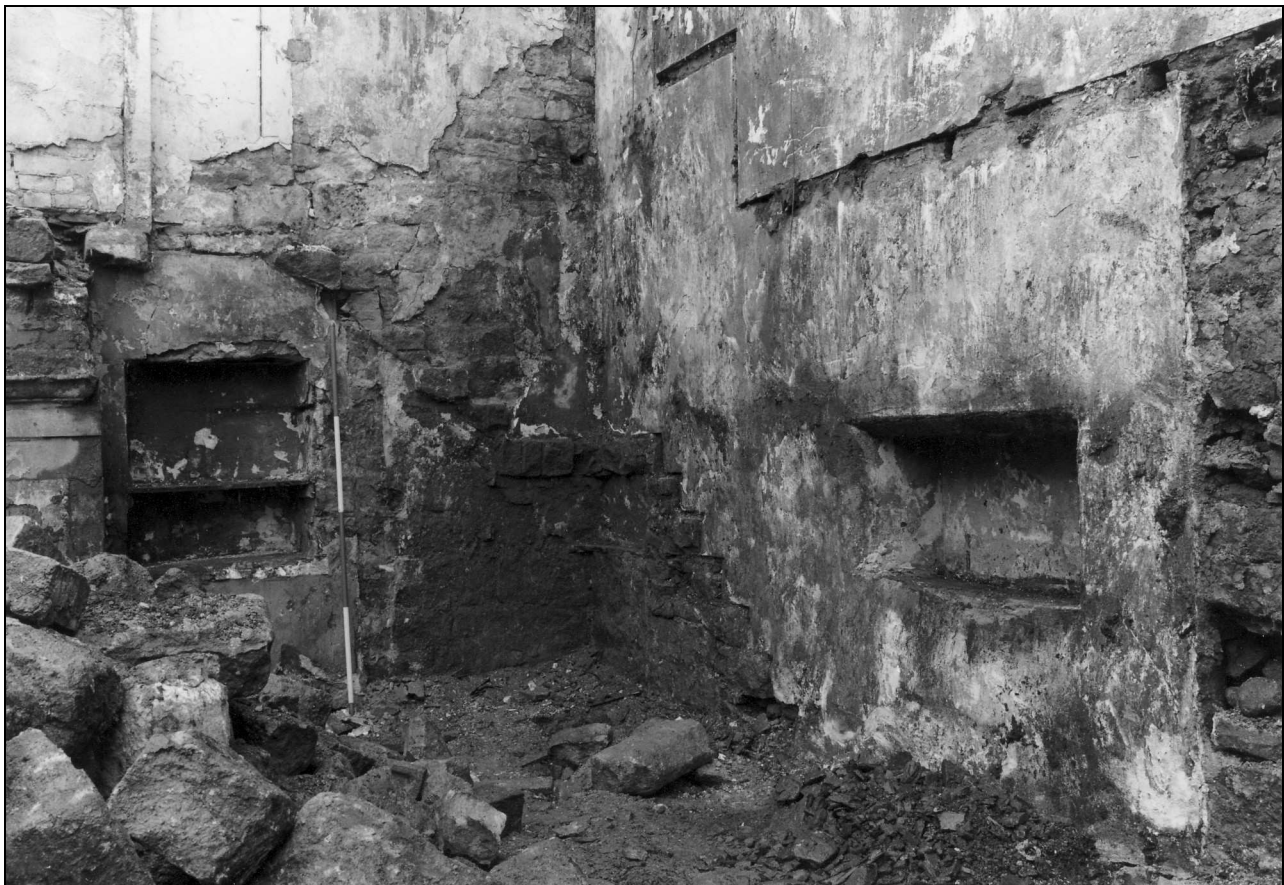
Photo 36: Cottage 1: rear part of former living room (formerly partitioned off), with recess in rear wall (film 5, film 10)

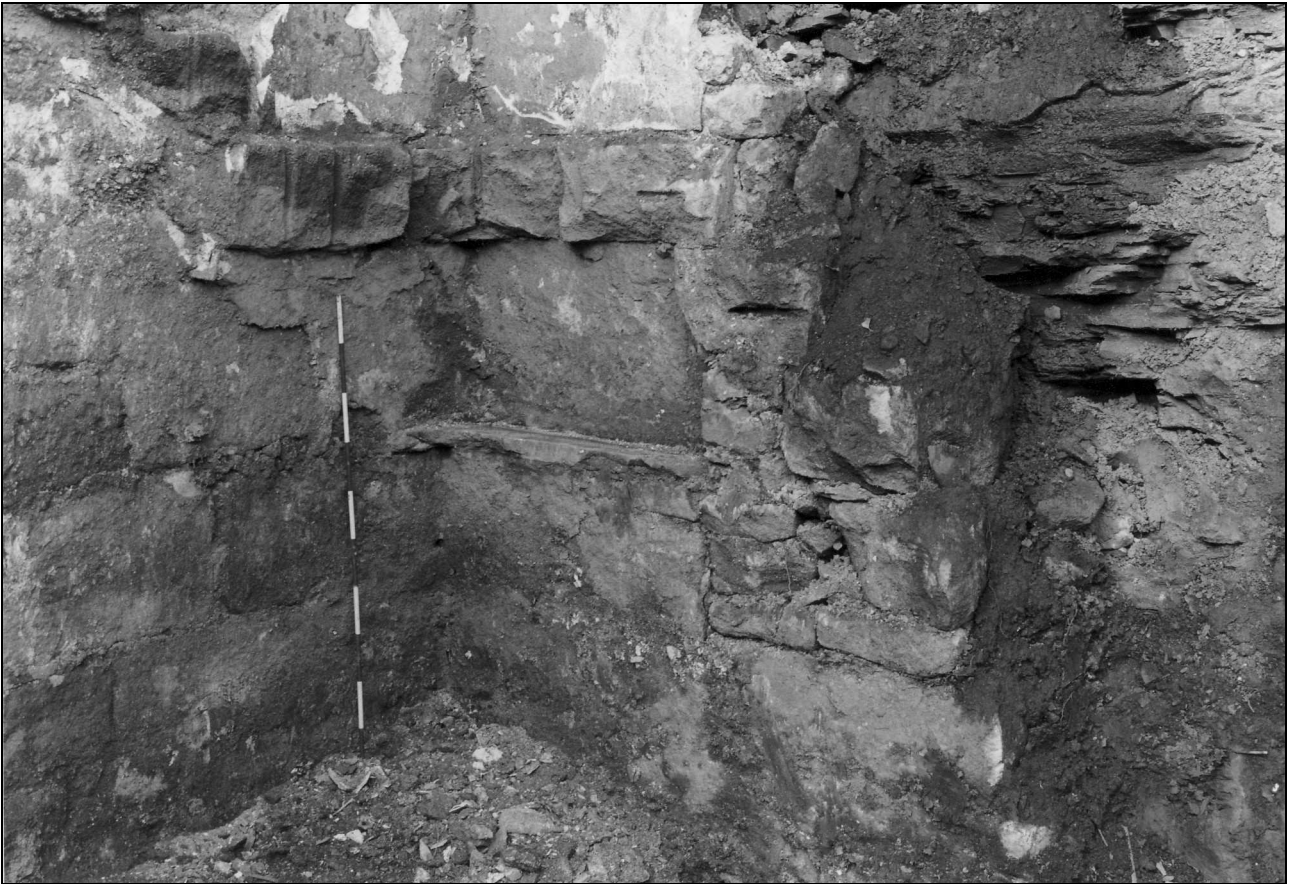
Photo 37: Cottage 1: recess or former shelf base beneath stairs (film 6, film 11)

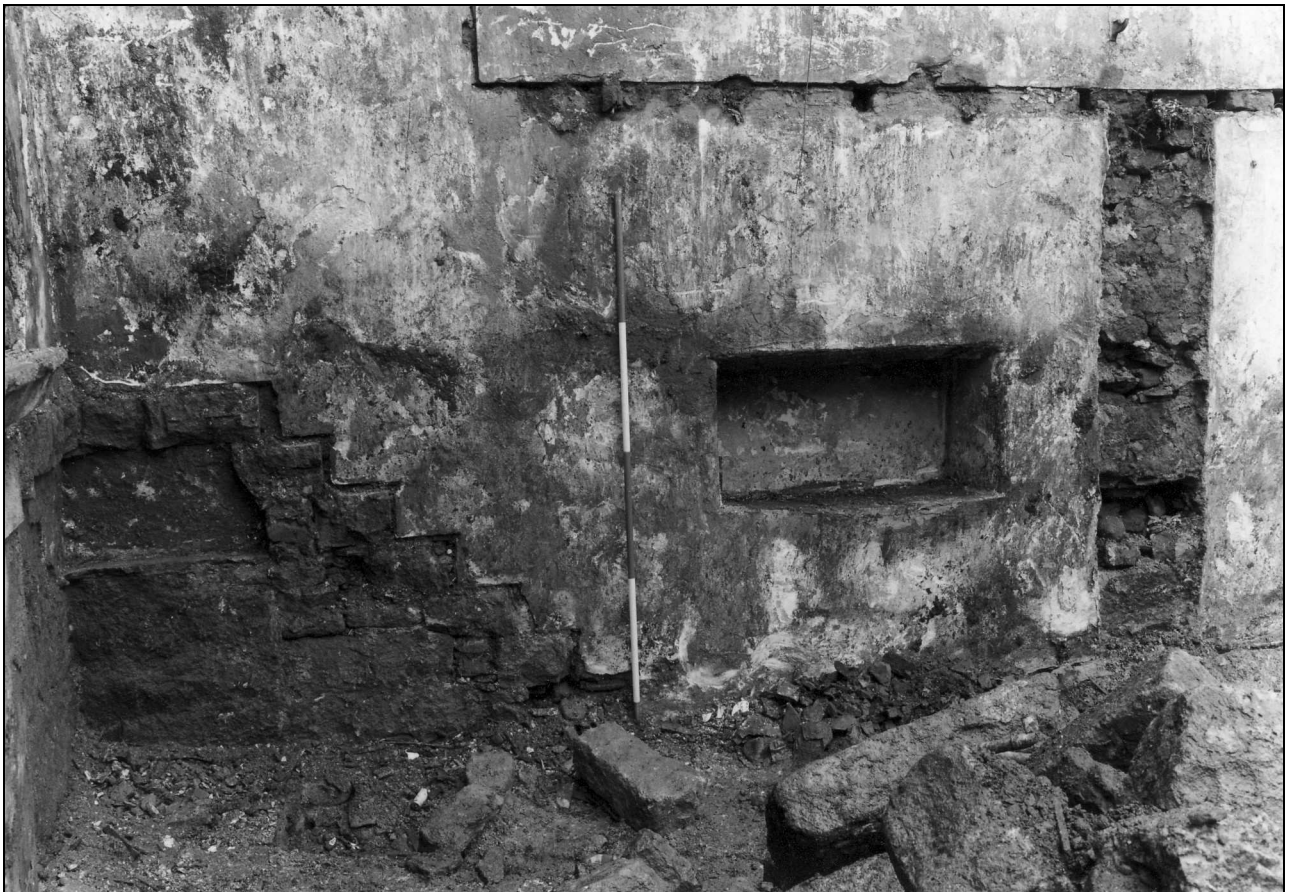
Photo 38: Cottage 1: rear part of former living room (formerly partitioned off), with recess in rear wall (film 5, film 13)

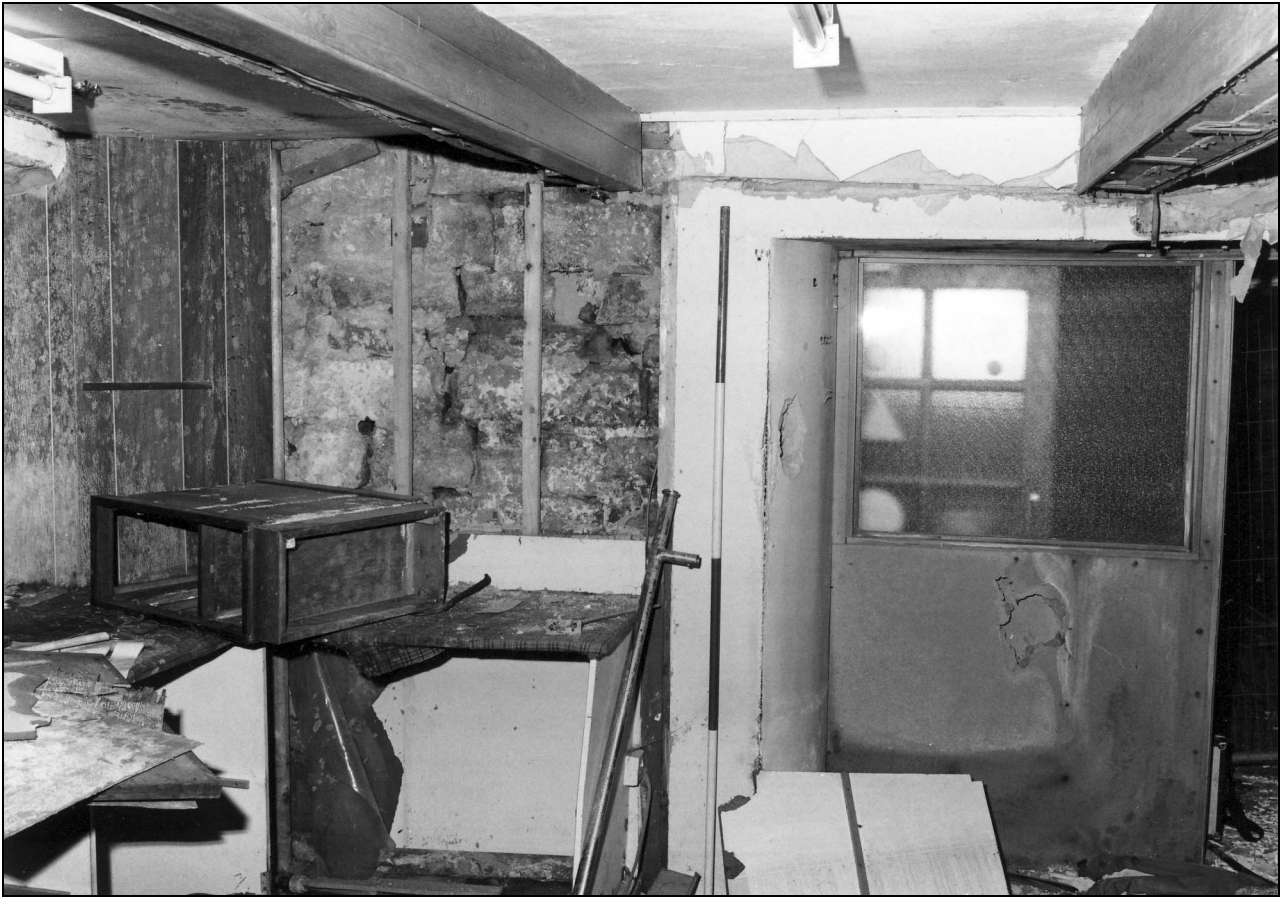
Photo 39: Cottage 4: inserted doorway in cross-wall to cottage 3 (film 1, film 7)

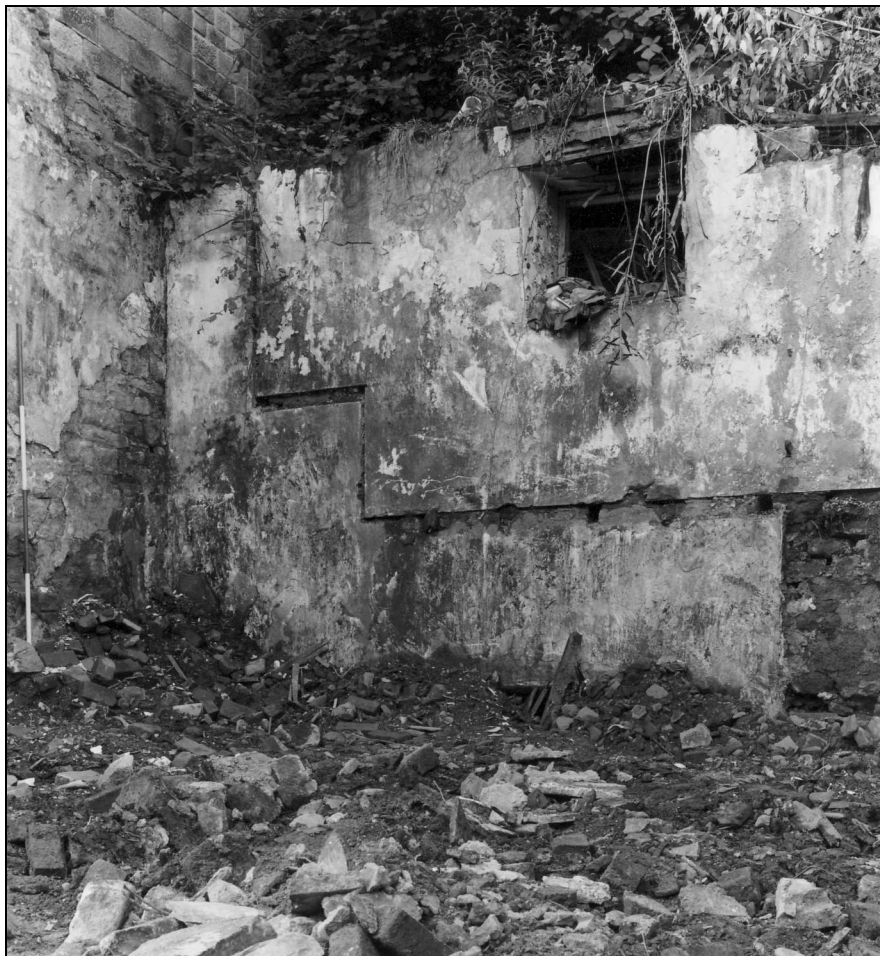
Photo 40: Cottage 1: interior, during demolition (film 5, film 7)

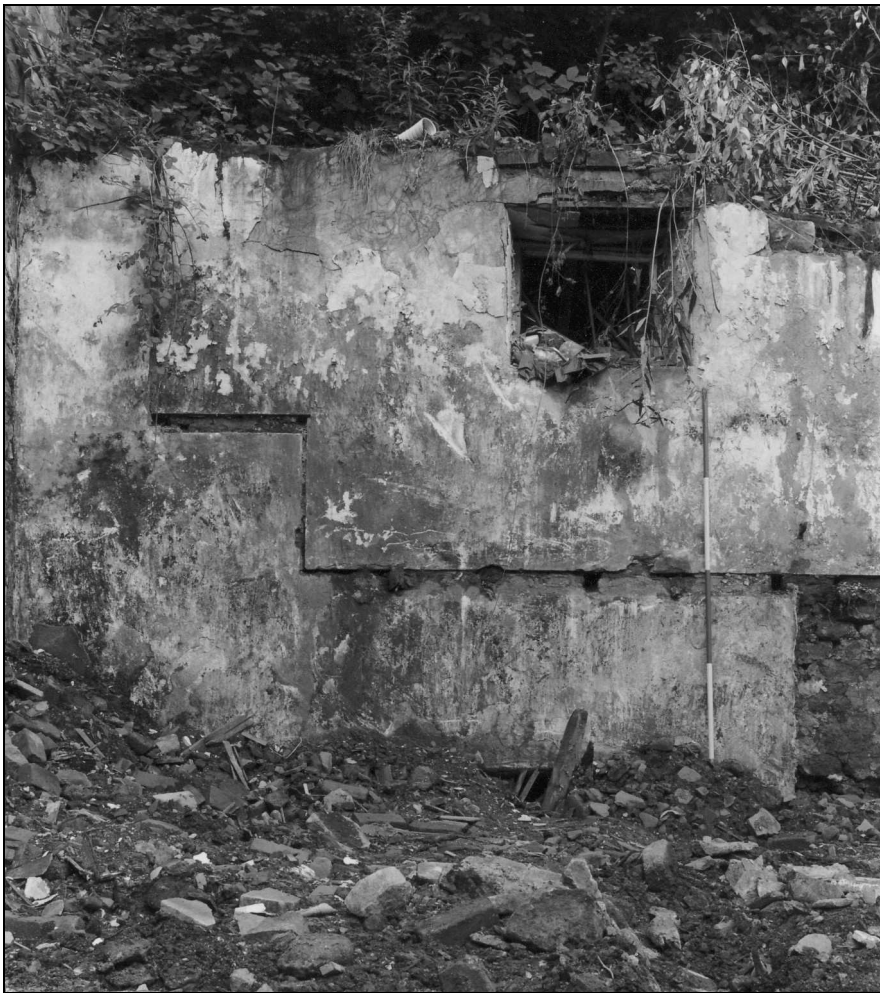
Photo 41: Cottage 1: rear wall, during demolition, showing line of first floor and position of stairs (film 5, film 8)

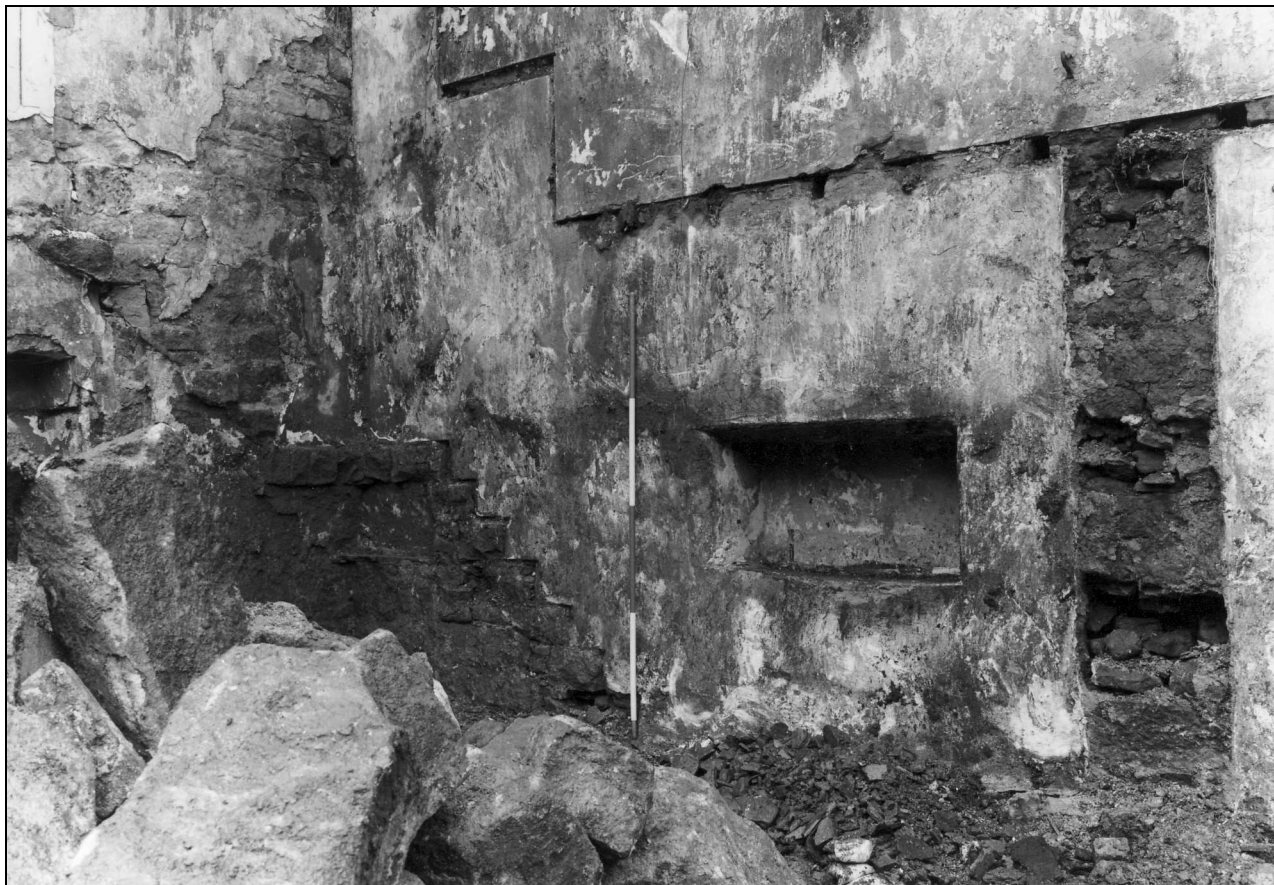
Photo 42: Cottage 1: ground floor interior during demolition, showing line of first floor and position of stairs (film 5, film 12)

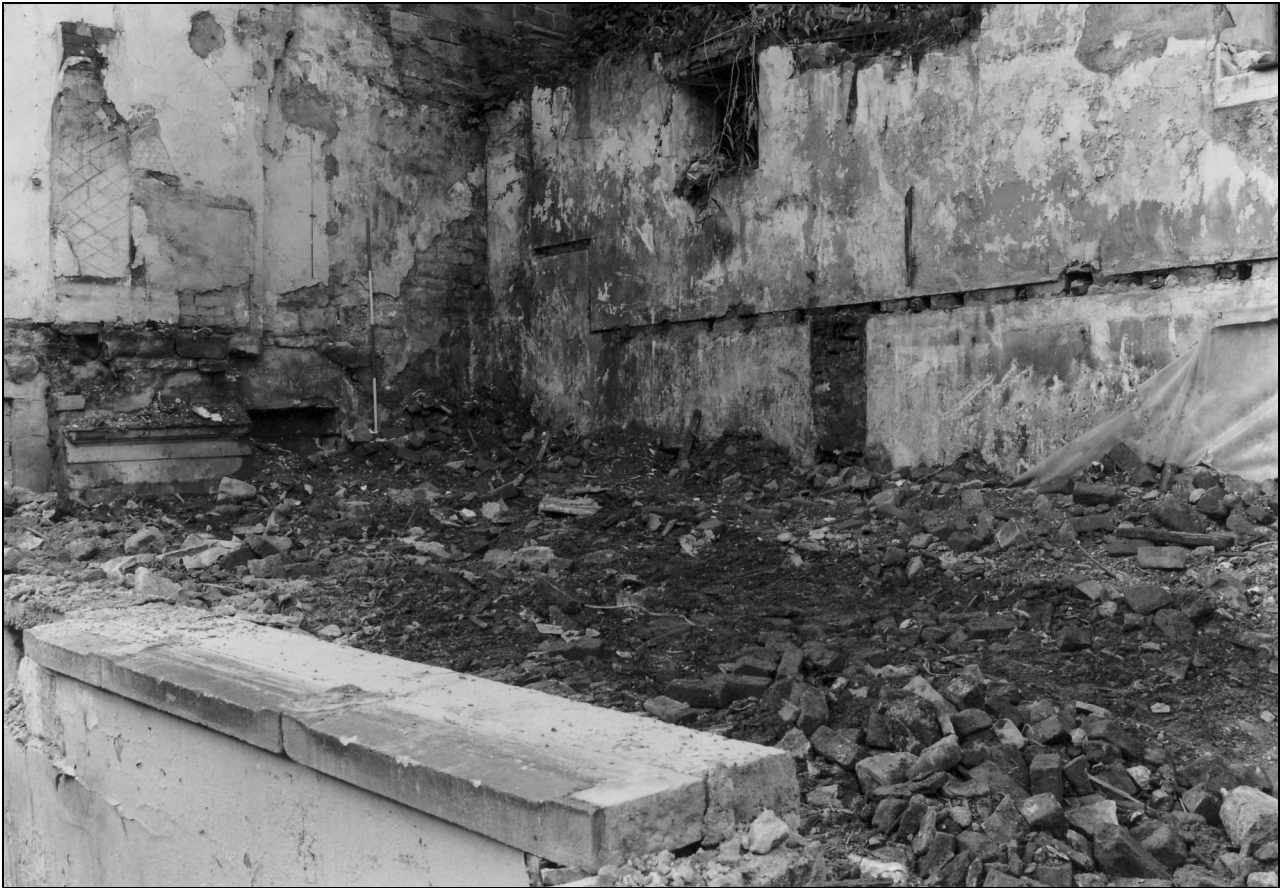
Photo 43: Cottages 1 and 2 during demolition (note modern window sill in foreground) (film 5, film 6)

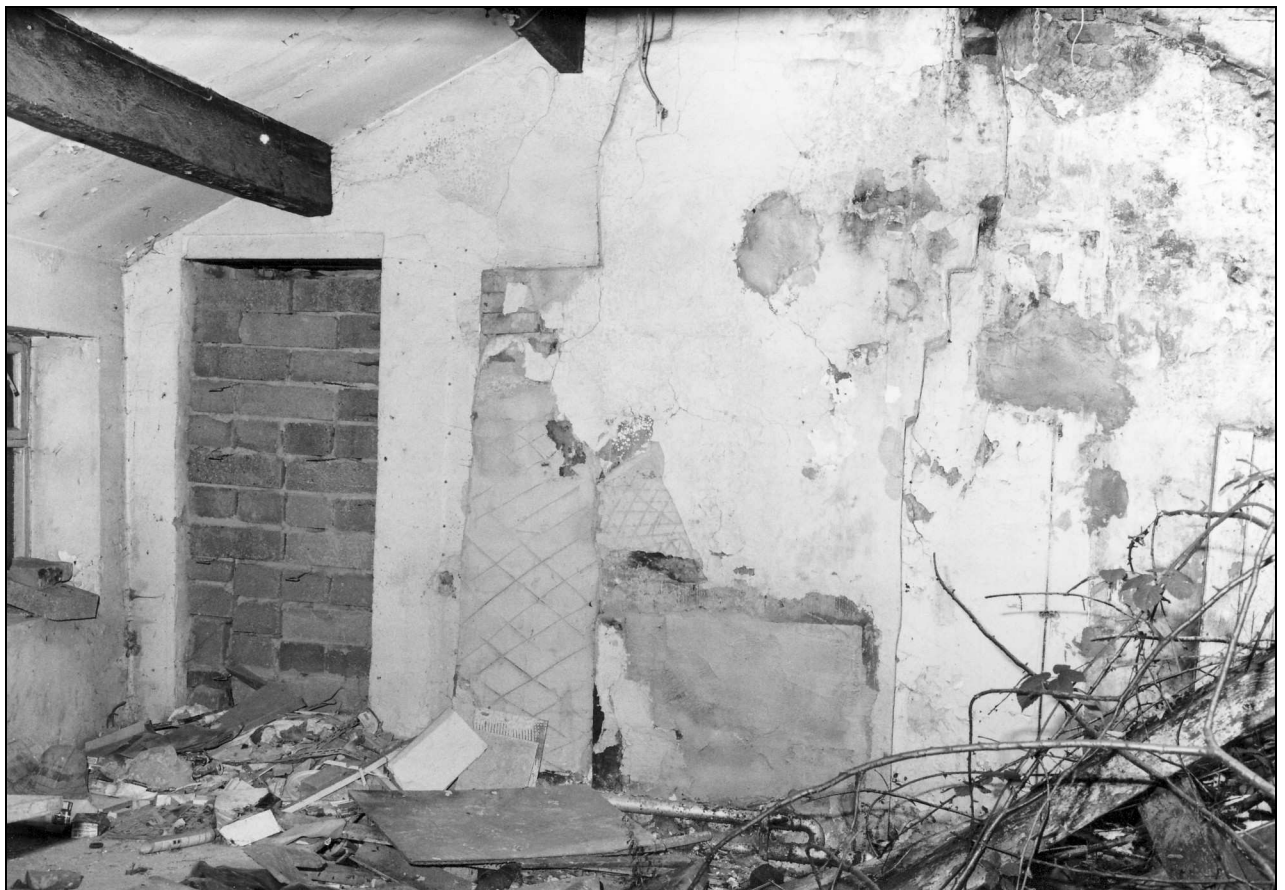
Photo 44: Cottage 1: south-west gable at first floor, with blocked fireplace (film 1, film 11)

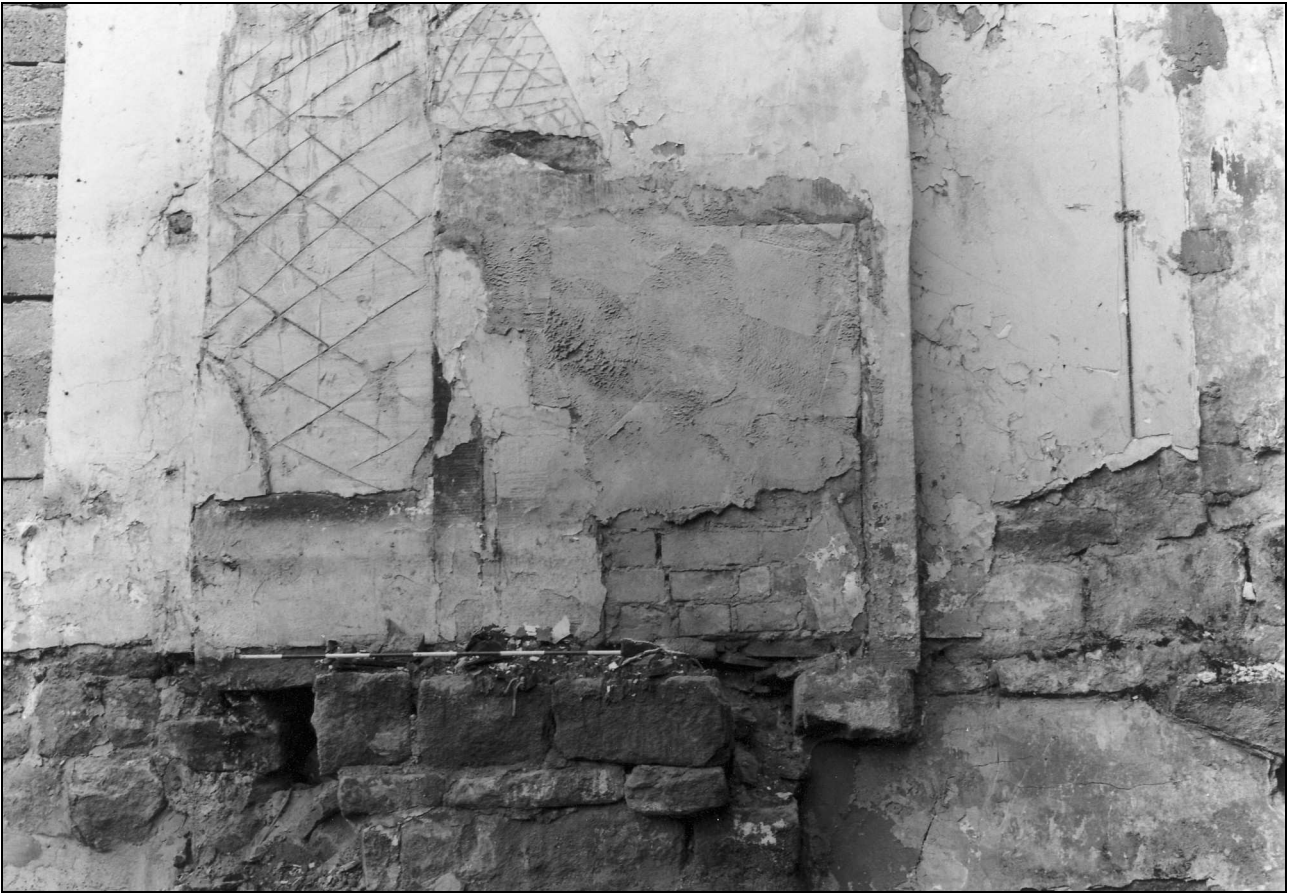
Photo 45: Cottage 1: detail of first floor fireplace (film 6, film 10)

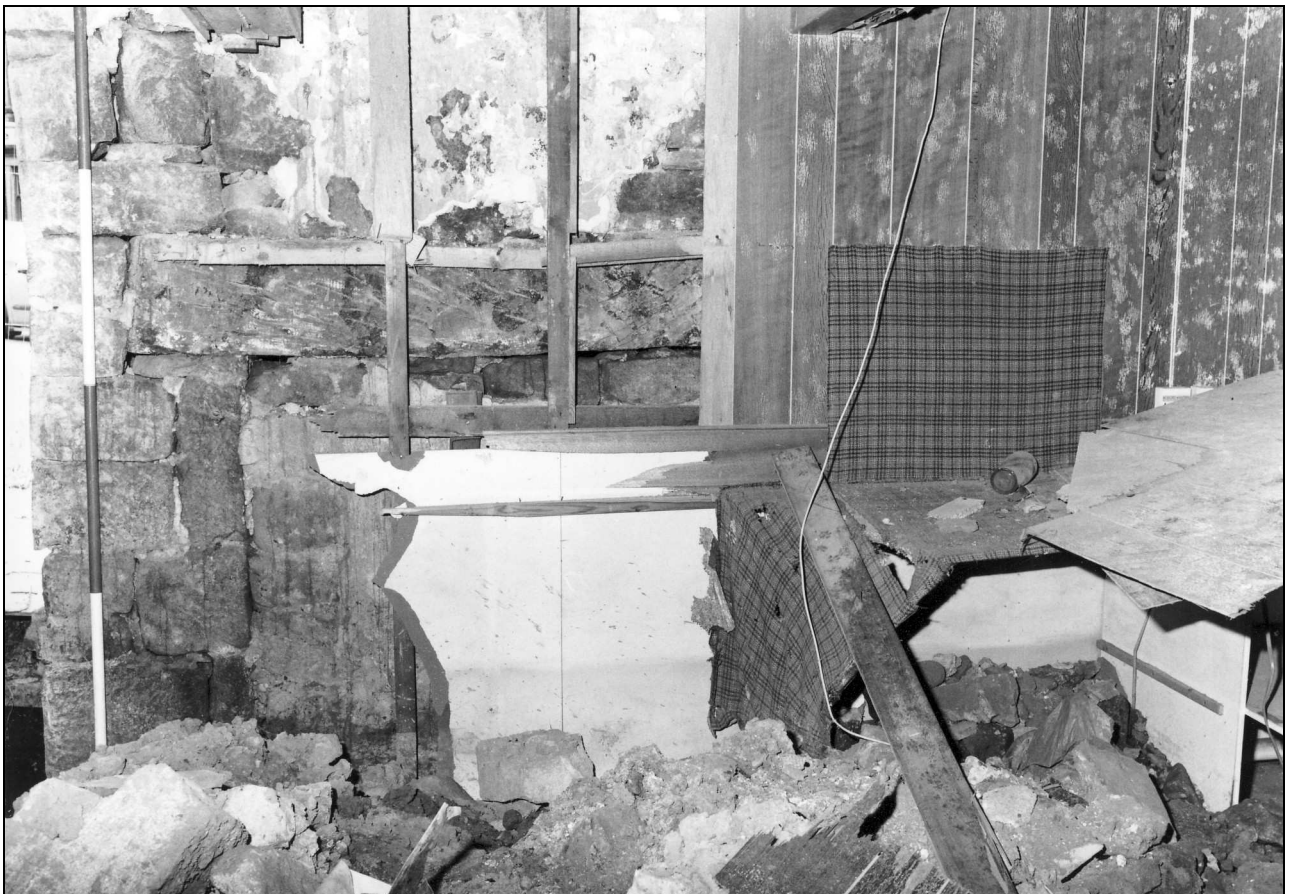
Photo 46: Cottage 4: inserted fireplace in north-east gable, ground floor (film 1, film 10)

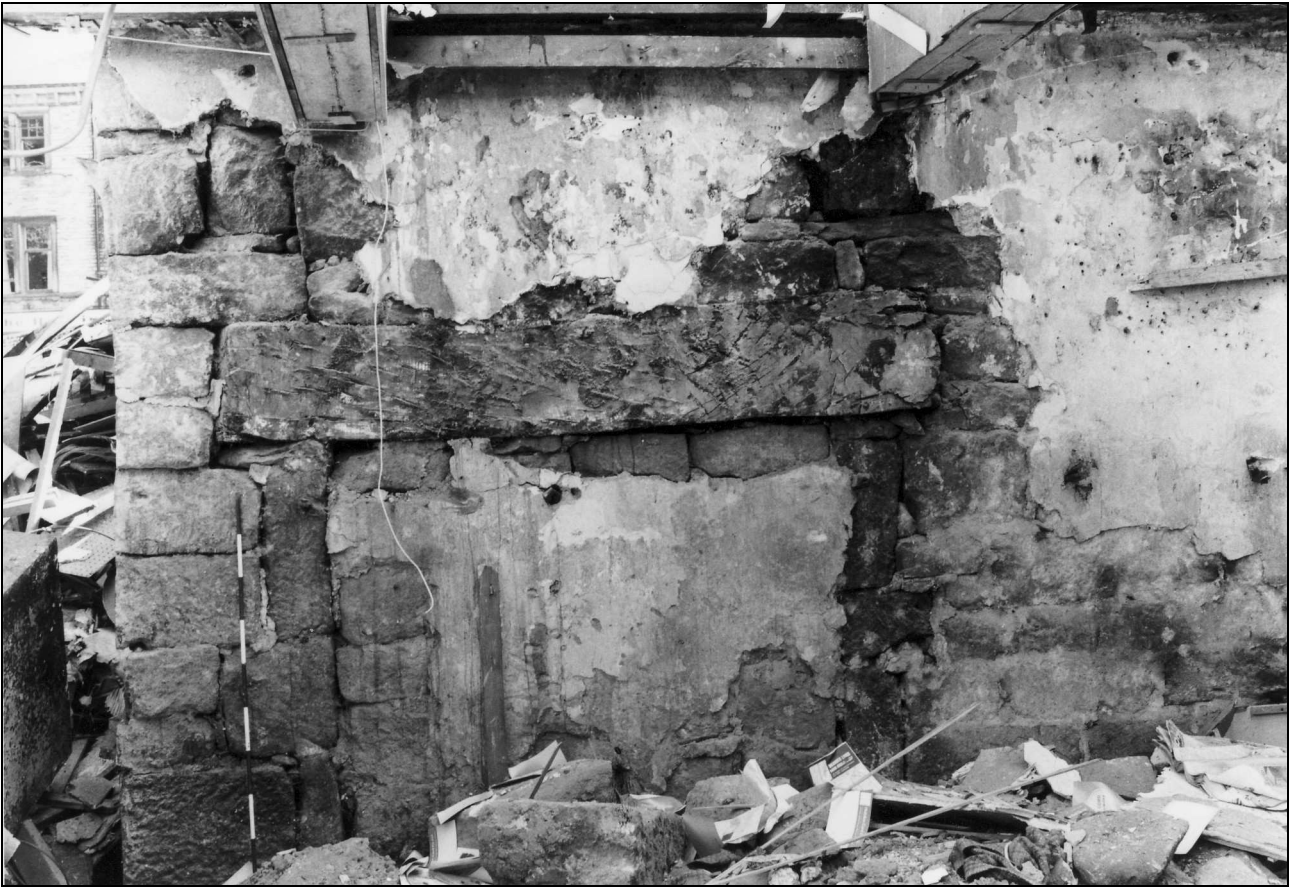
Photo 47: Cottage 4: inserted fireplace in north-east gable, ground floor (film 4, film 1)

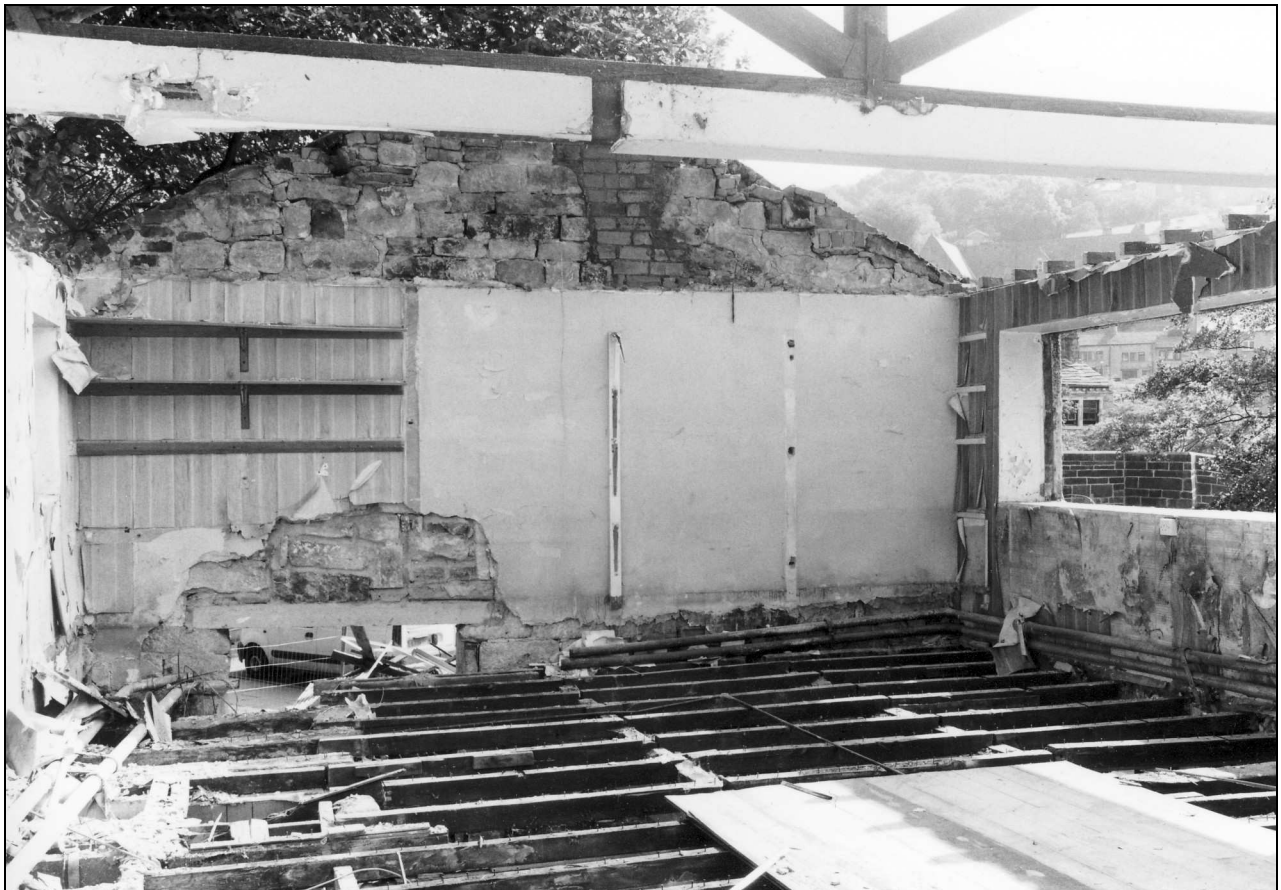
Photo 48: Cottage 4 during demolition, showing brick flue in gable and modern roof truss (film 4, film 2)

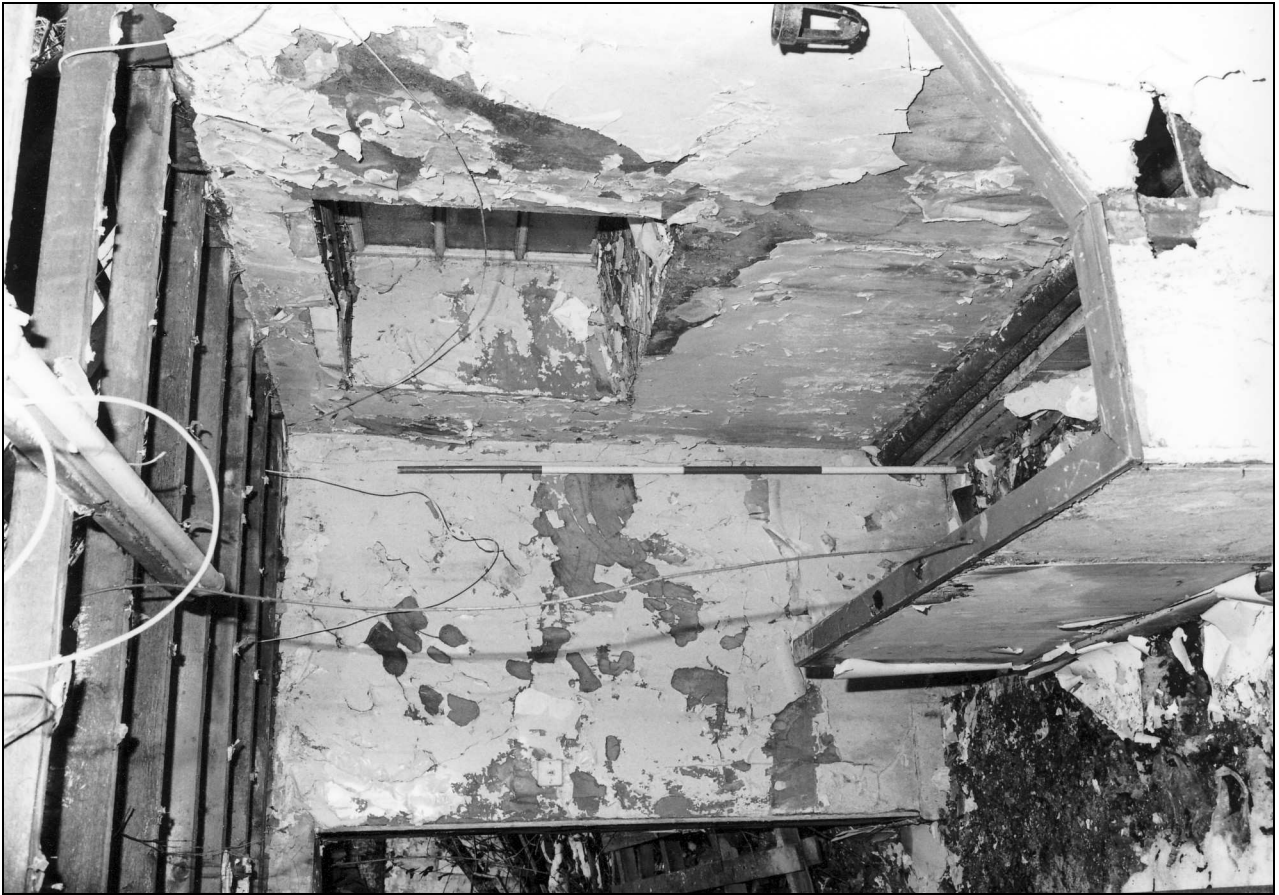
Photo 50: Cottage 3: modern stairs and inserted rear window on first floor (film 1, film 15)

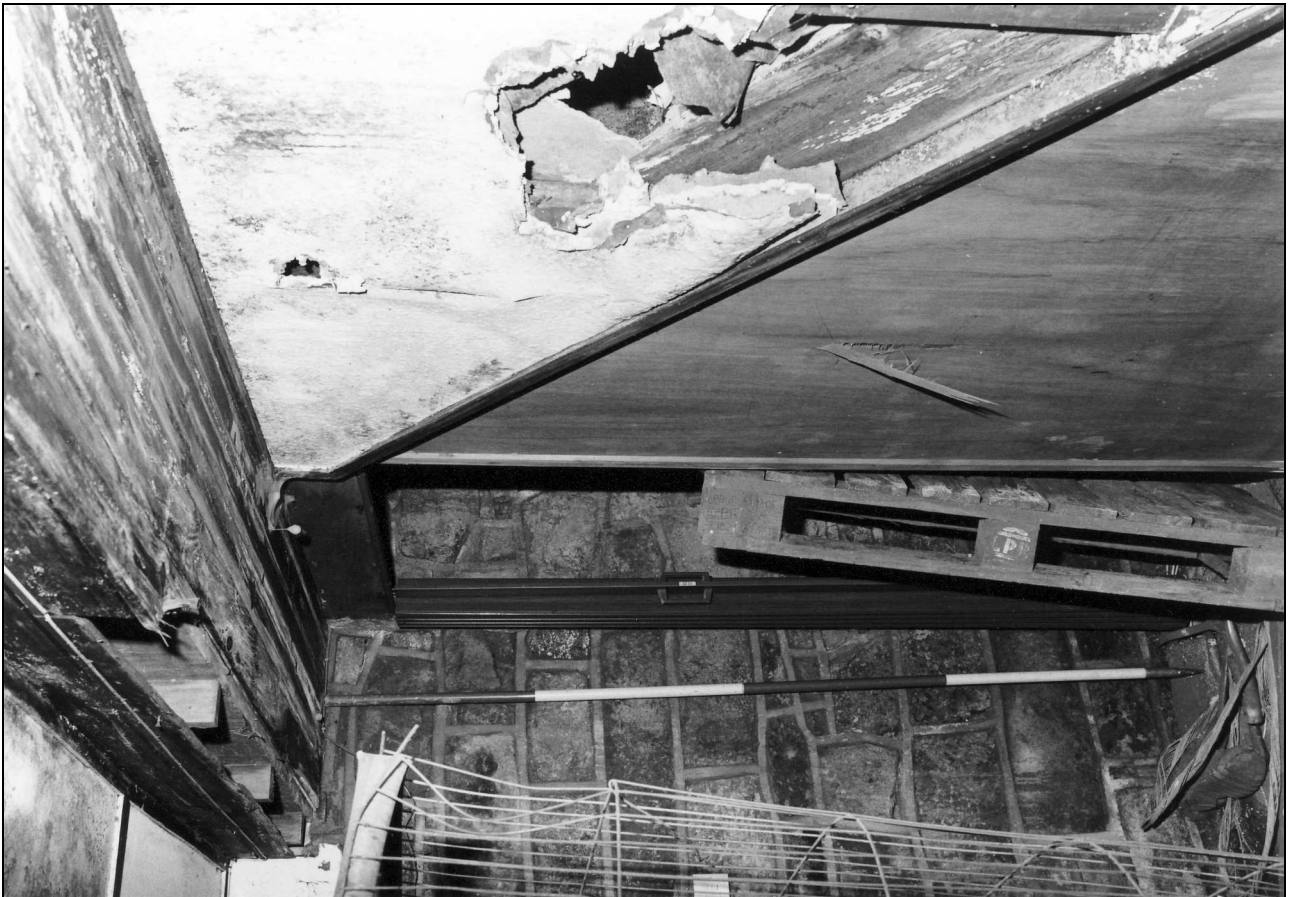
Photo 49: Cottage 3: modern stairs against rear wall (film 1, film 6)
