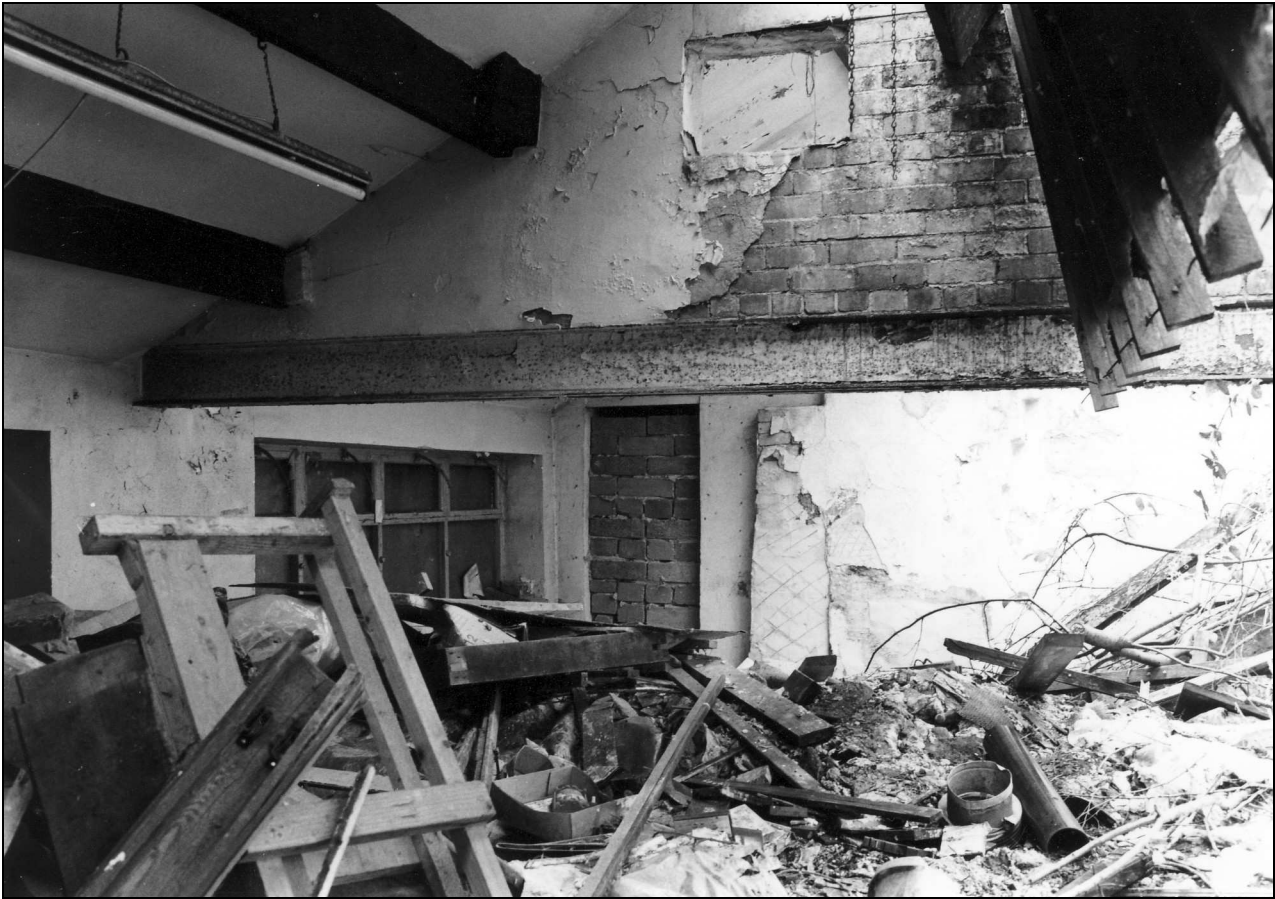
Photo 51: Cottages 2 & 3: first floor, with modern steel beam and roof structure, from the north-east (film 1, film 12)

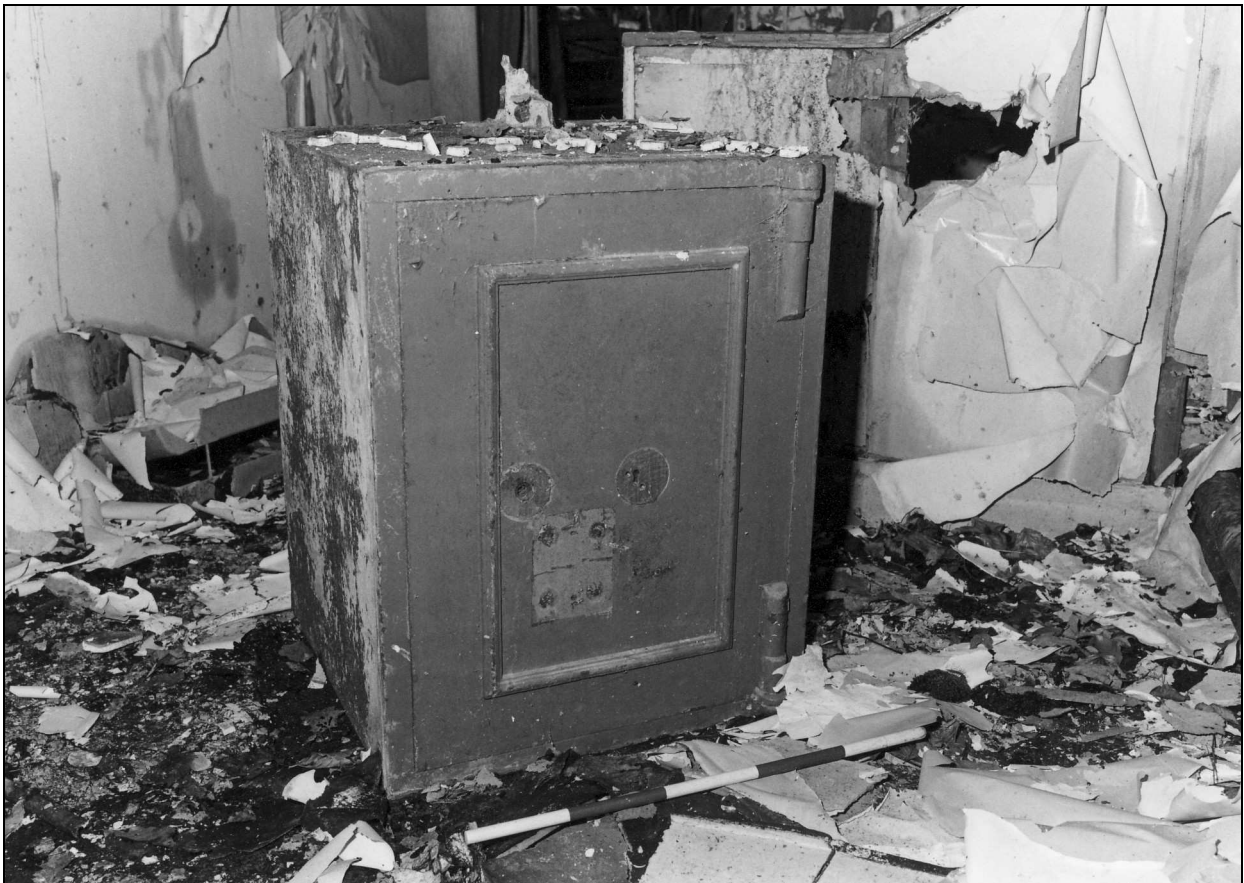
Photo 52: Cottage 3: small, portable safe on first floor (film 3, film 15)

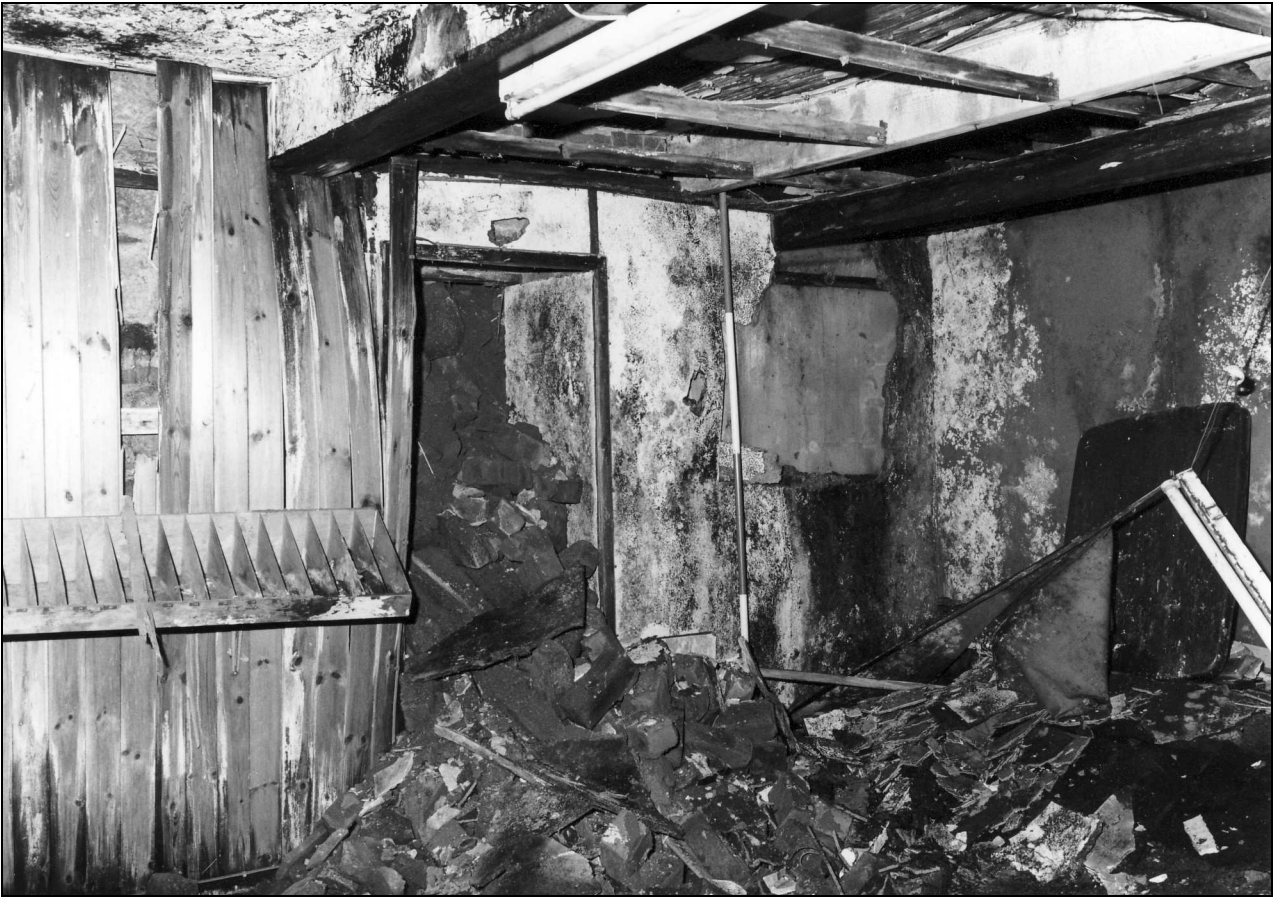
Photo 53: Cottage 2: ground floor, from the north-east, showing inserted doorway to cottage 1 (film 1, film 4)

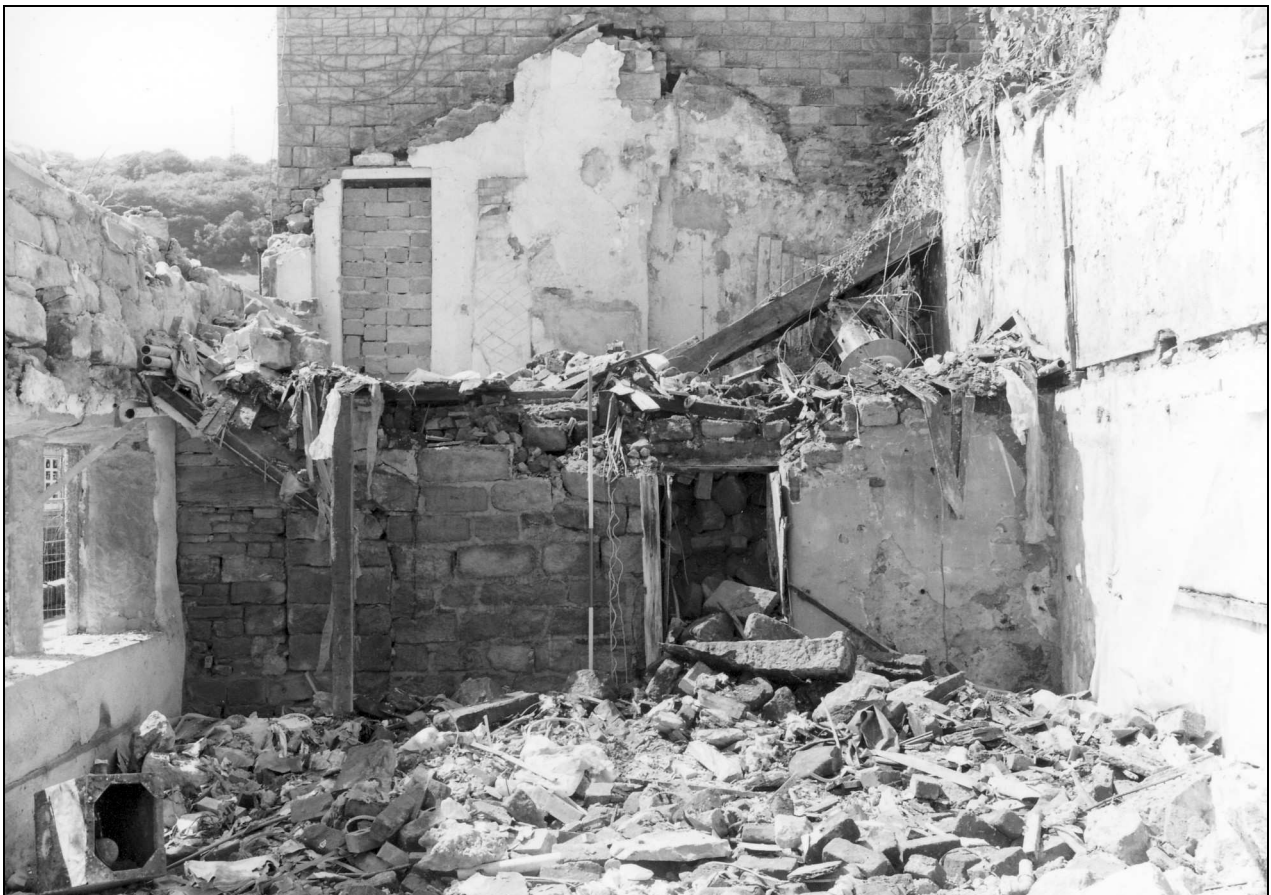
Photo 54: Cottage 2, during demolition (film 5, film 2)

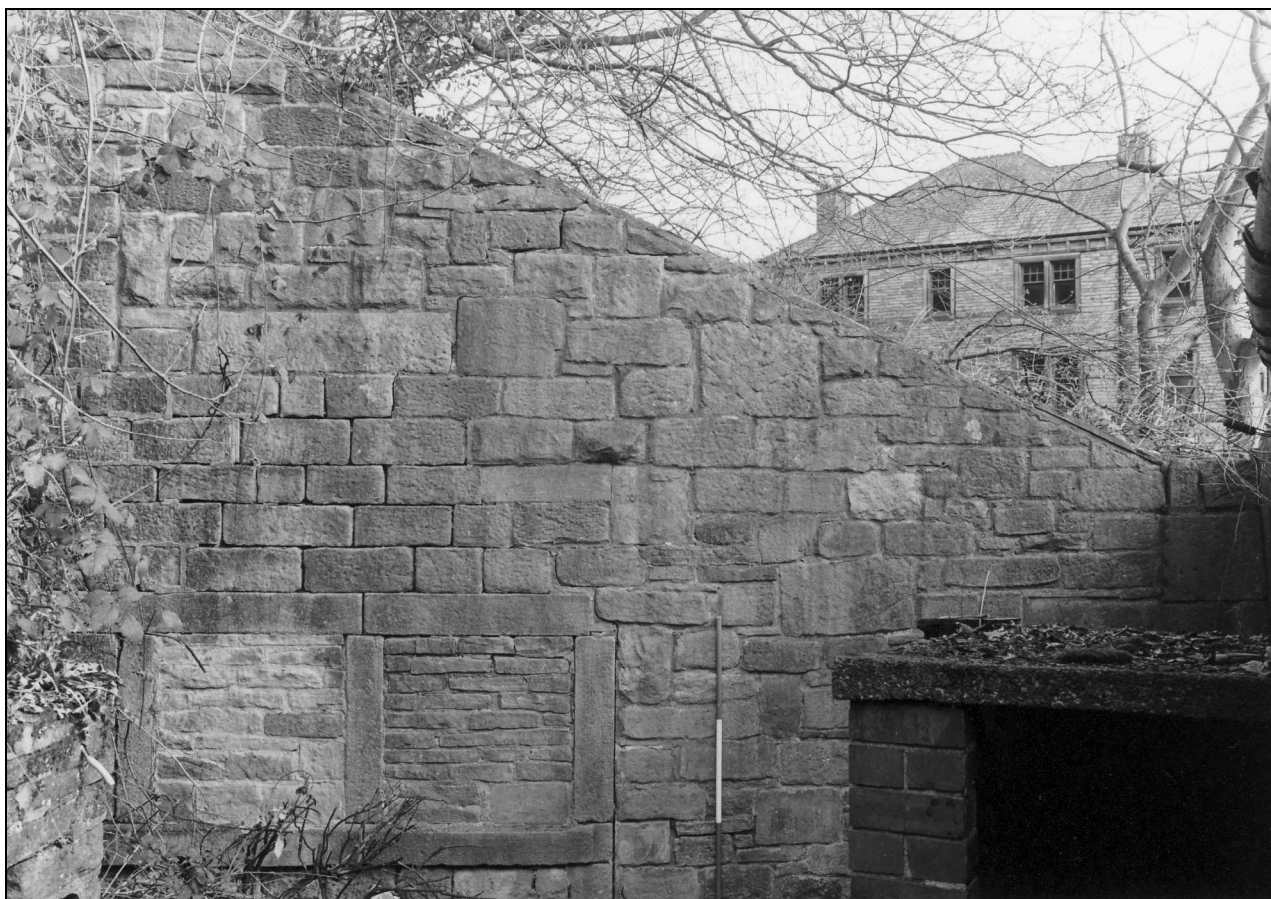
Photo 55: Retaining wall on north side of rear yard, with blocked windows of former building (film 3, film 2)

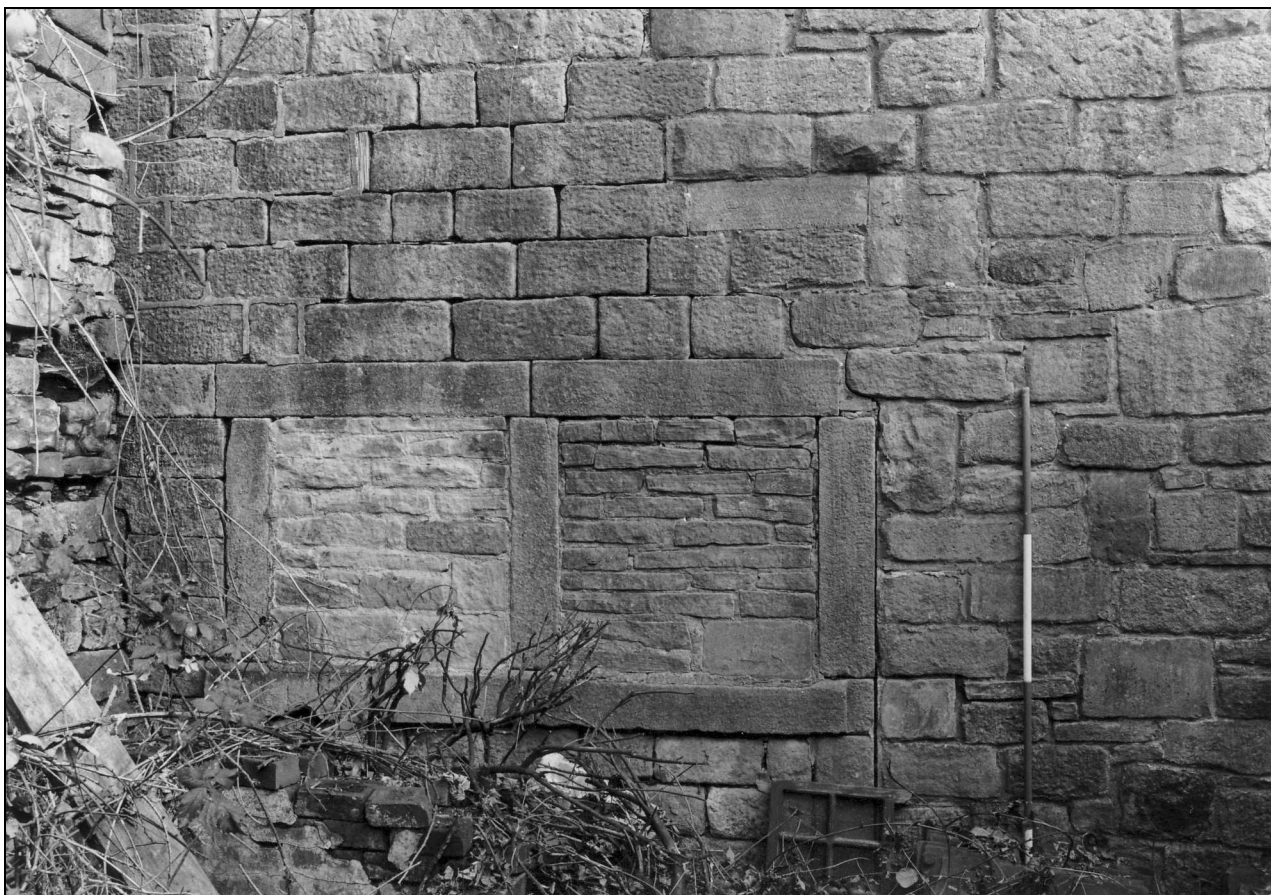
Photo 56: Retaining wall on north side of rear yard, with blocked windows of former building (film 3, film 1)

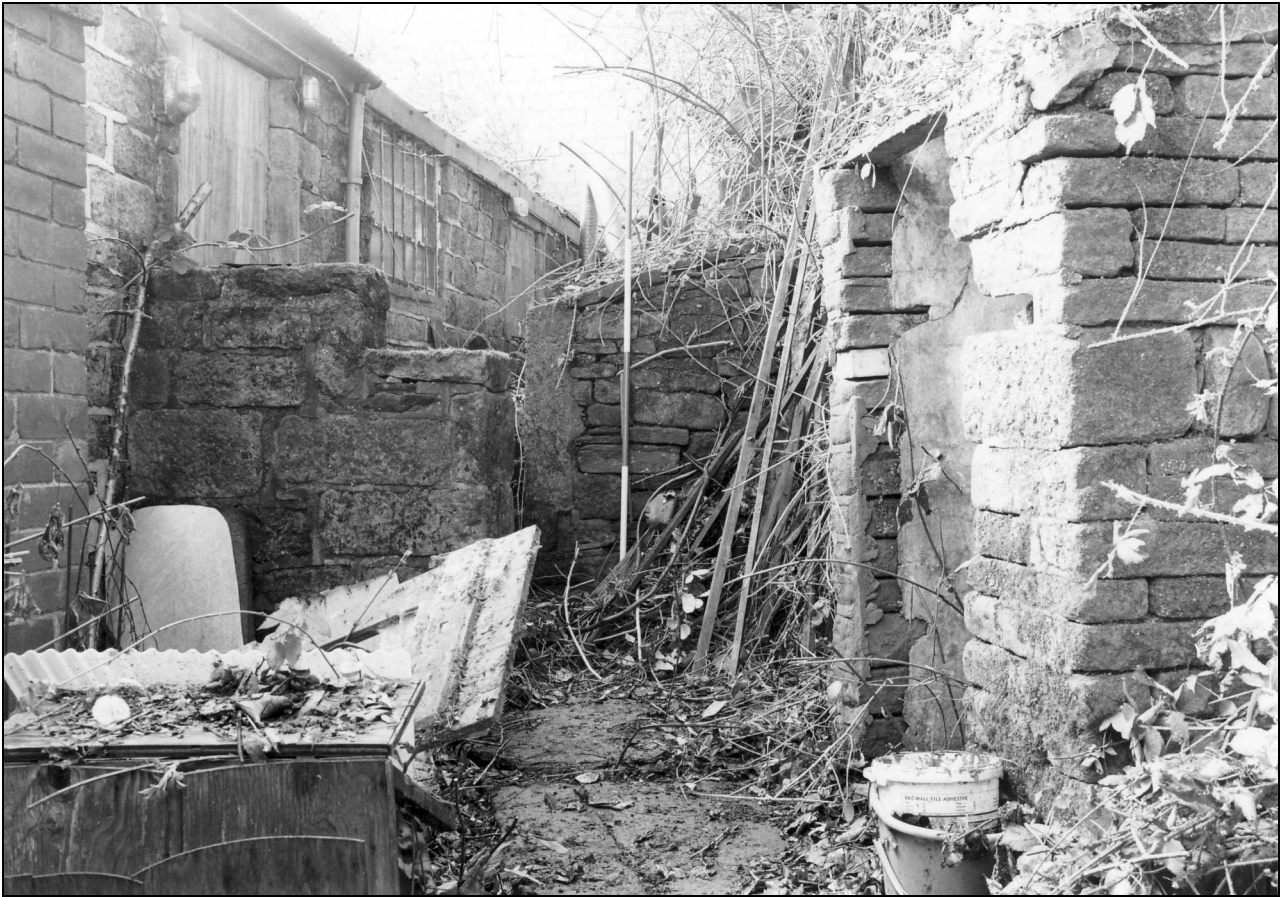
Photo 57: Rear yard, with privy at right, from the north (film 3, film 5)

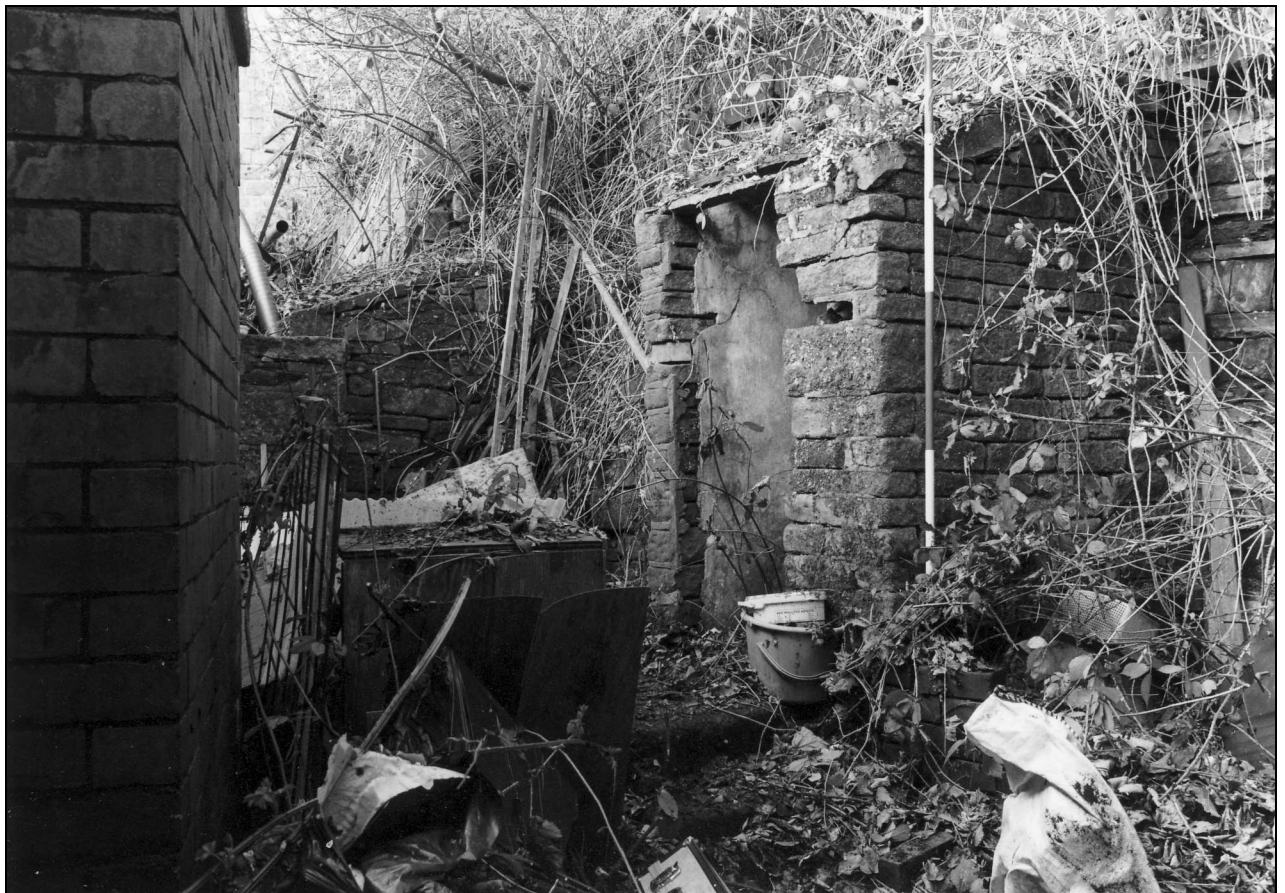
Photo 58: Rear yard, with privy at right, from the north (film 3, film 13)

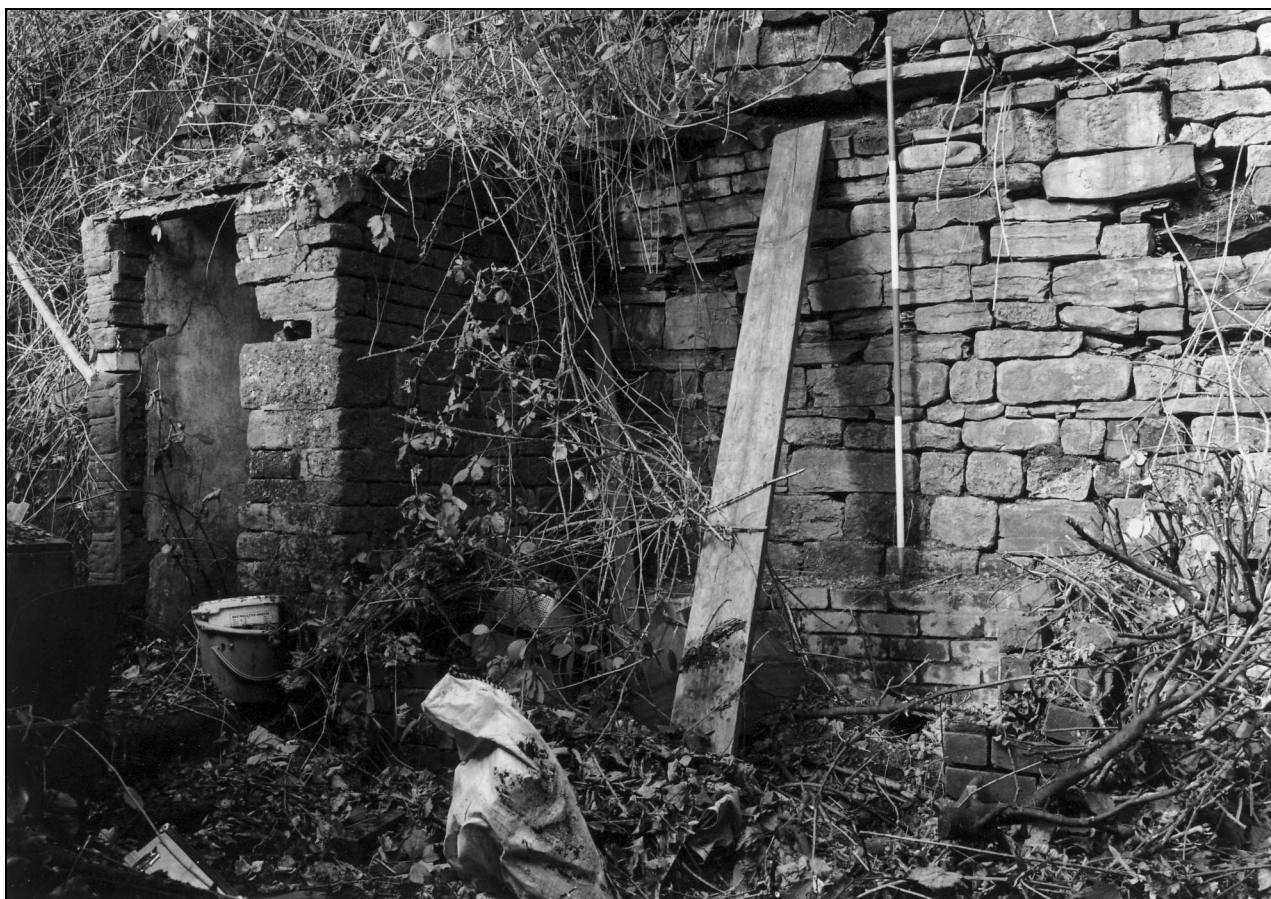
Photo 59: Rear yard with retaining wall and privy at left, from the north-east (film 3, film 12)

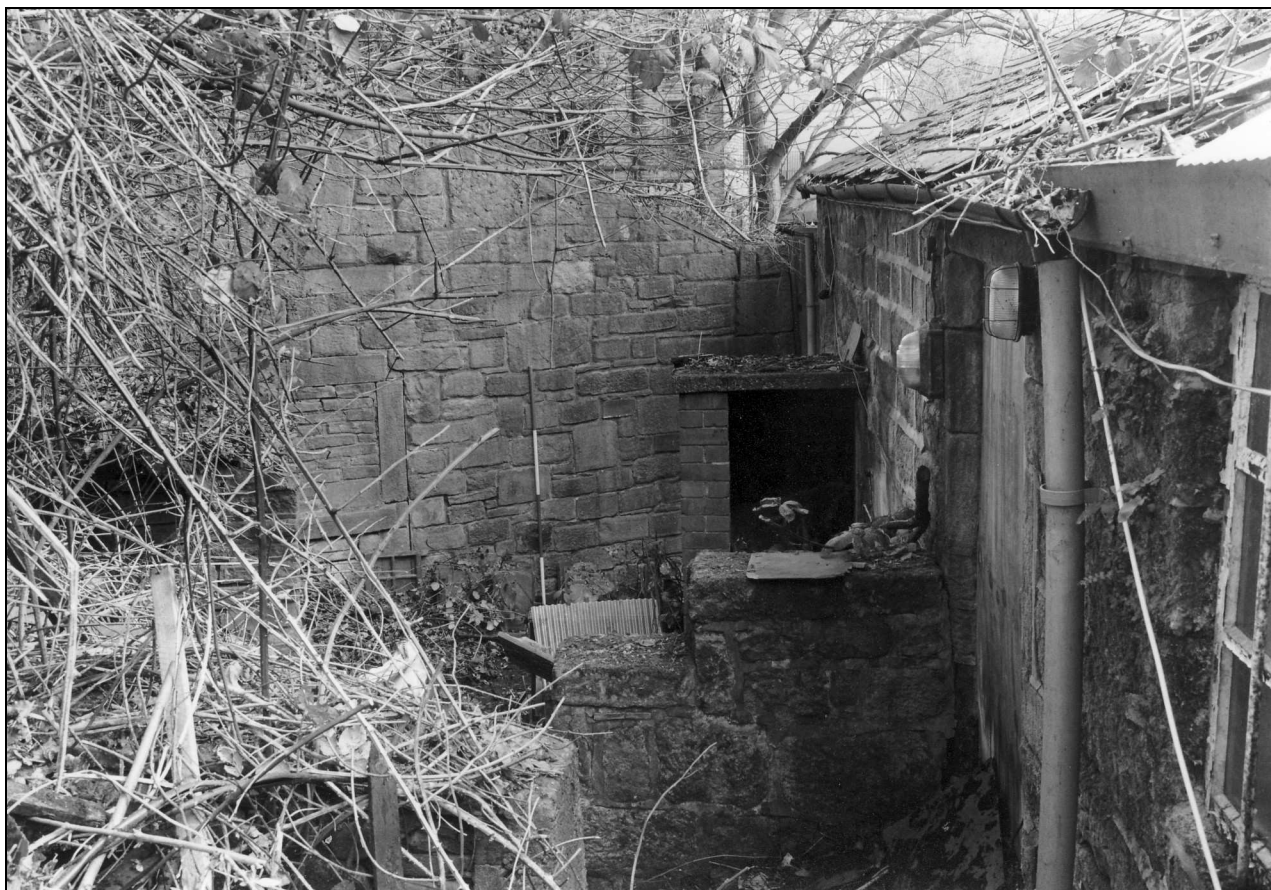
Photo 60: Rear yard, from the south-west (film 3, film 11)
