Shackerley House Farm
Mellor, Lancashire:
Drawn record of roof timbers

March 2018

STEPHEN HAIGH

OASIS project ID: stephenh1-312557

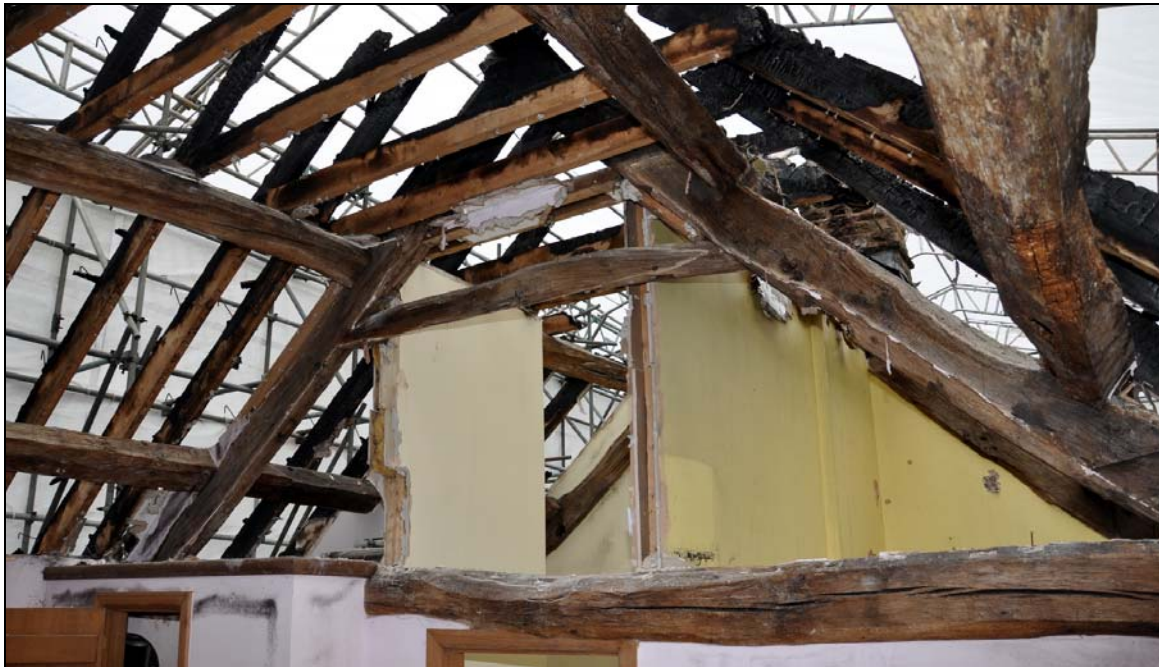
- 7.5 The second truss is structurally identical, but the individual conformation and timbers display different characteristics. The tie beam lacks the redundant halvings and row of mid level peg holes seen in the east truss, but does have a row of joist sockets on its upper surface. The numeral “II” is used at either end to mark the joints with the principal rafters. Both raking struts have been removed, but the collar remains intact. Redundant peg holes are evident on the face of the principal rafters, and at the apex, there is less fire damage than in the east truss. Here, the two are halved together, with the joint being held in place by two pegs, and the diamond-set ridge sits between them.

Photo 1: West face (upper face) of west truss

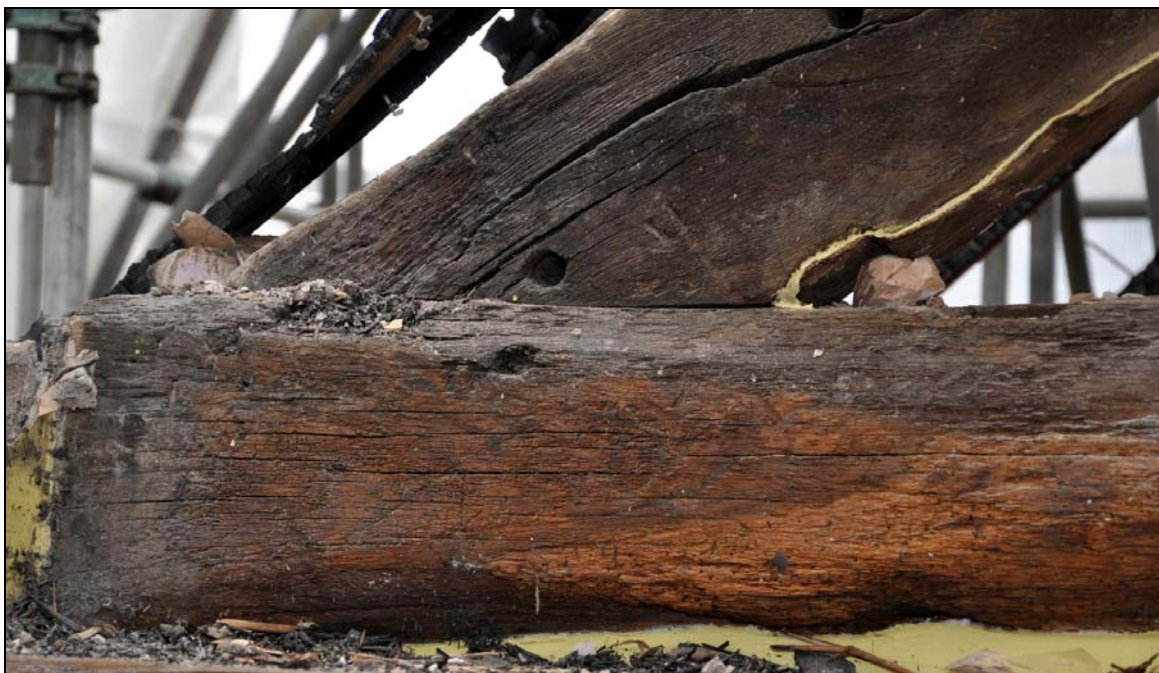
Photo 2: Detail of pegs and numbering on west truss

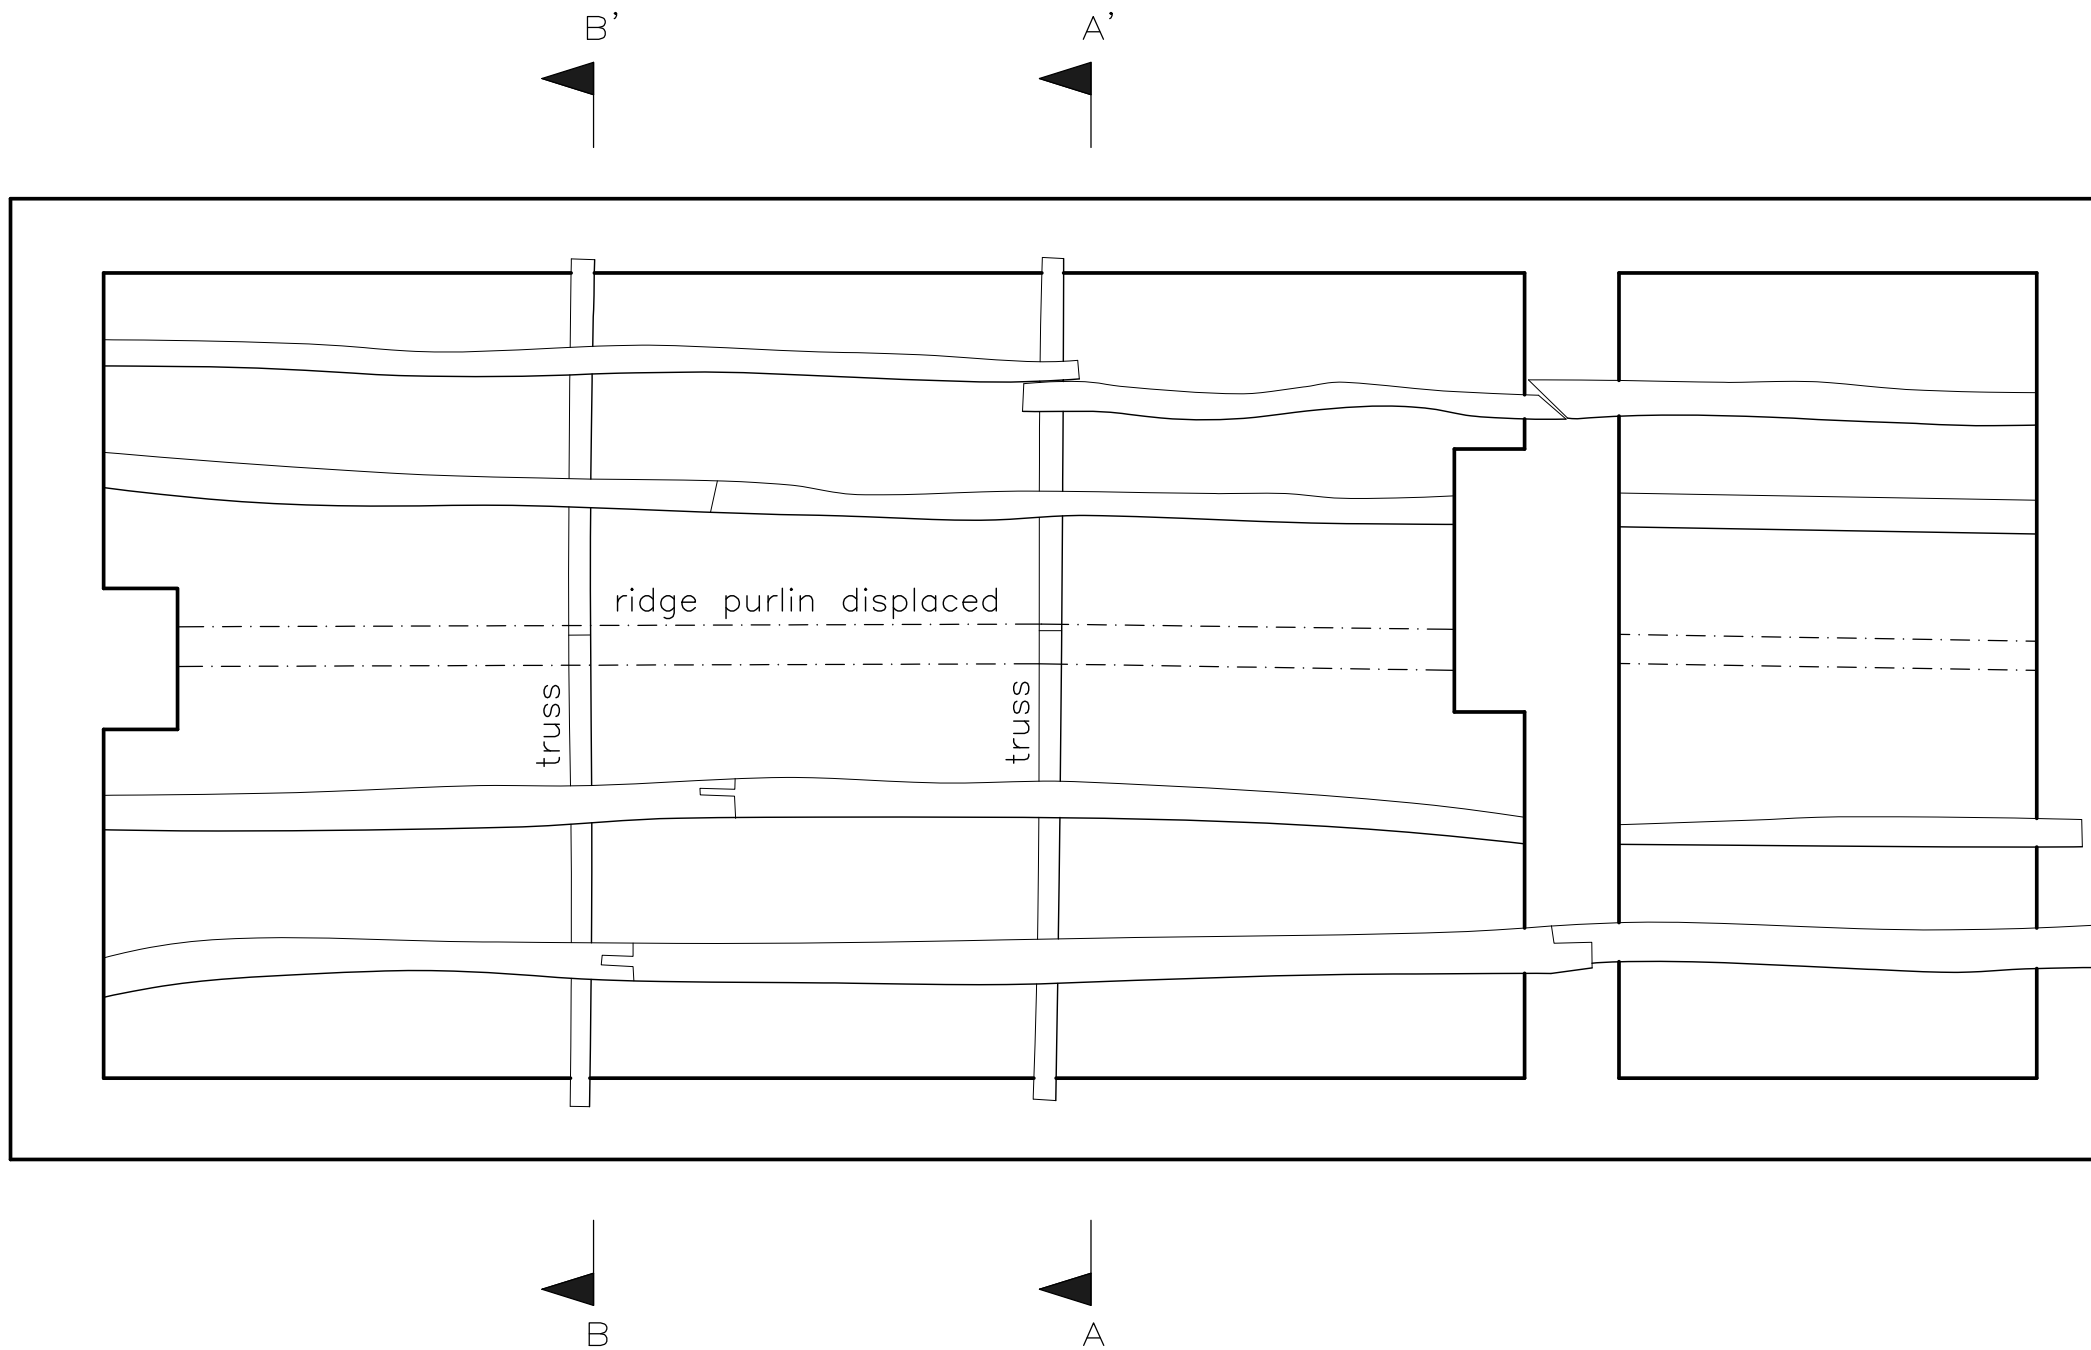
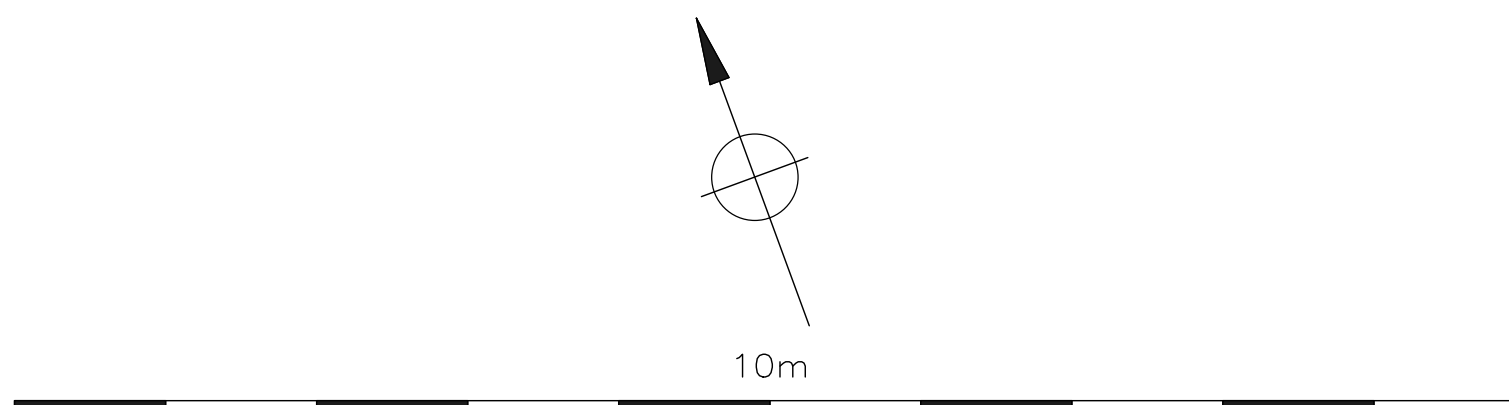
FIGURE 4:
 PLAN OF PRINCIPAL ROOF TIMBERS

- 7.6 Within bays 1, 2 and 3 of the house (counting from west to east), each of the four side purlins are made up of two lengths of timber. The two on the south pitch have bridled joints, while in the north pitch, the lower purlins are staggered over the east truss, and the upper purlins appear to be scarf-jointed together. In all cases, the timbers which make up these four components are of different lengths. In bay 4, the purlins simply span between the masonry cross-walls to either side. Some of the purlins display further evidence for previous uses, in the presence of redundant joints and peg holes.

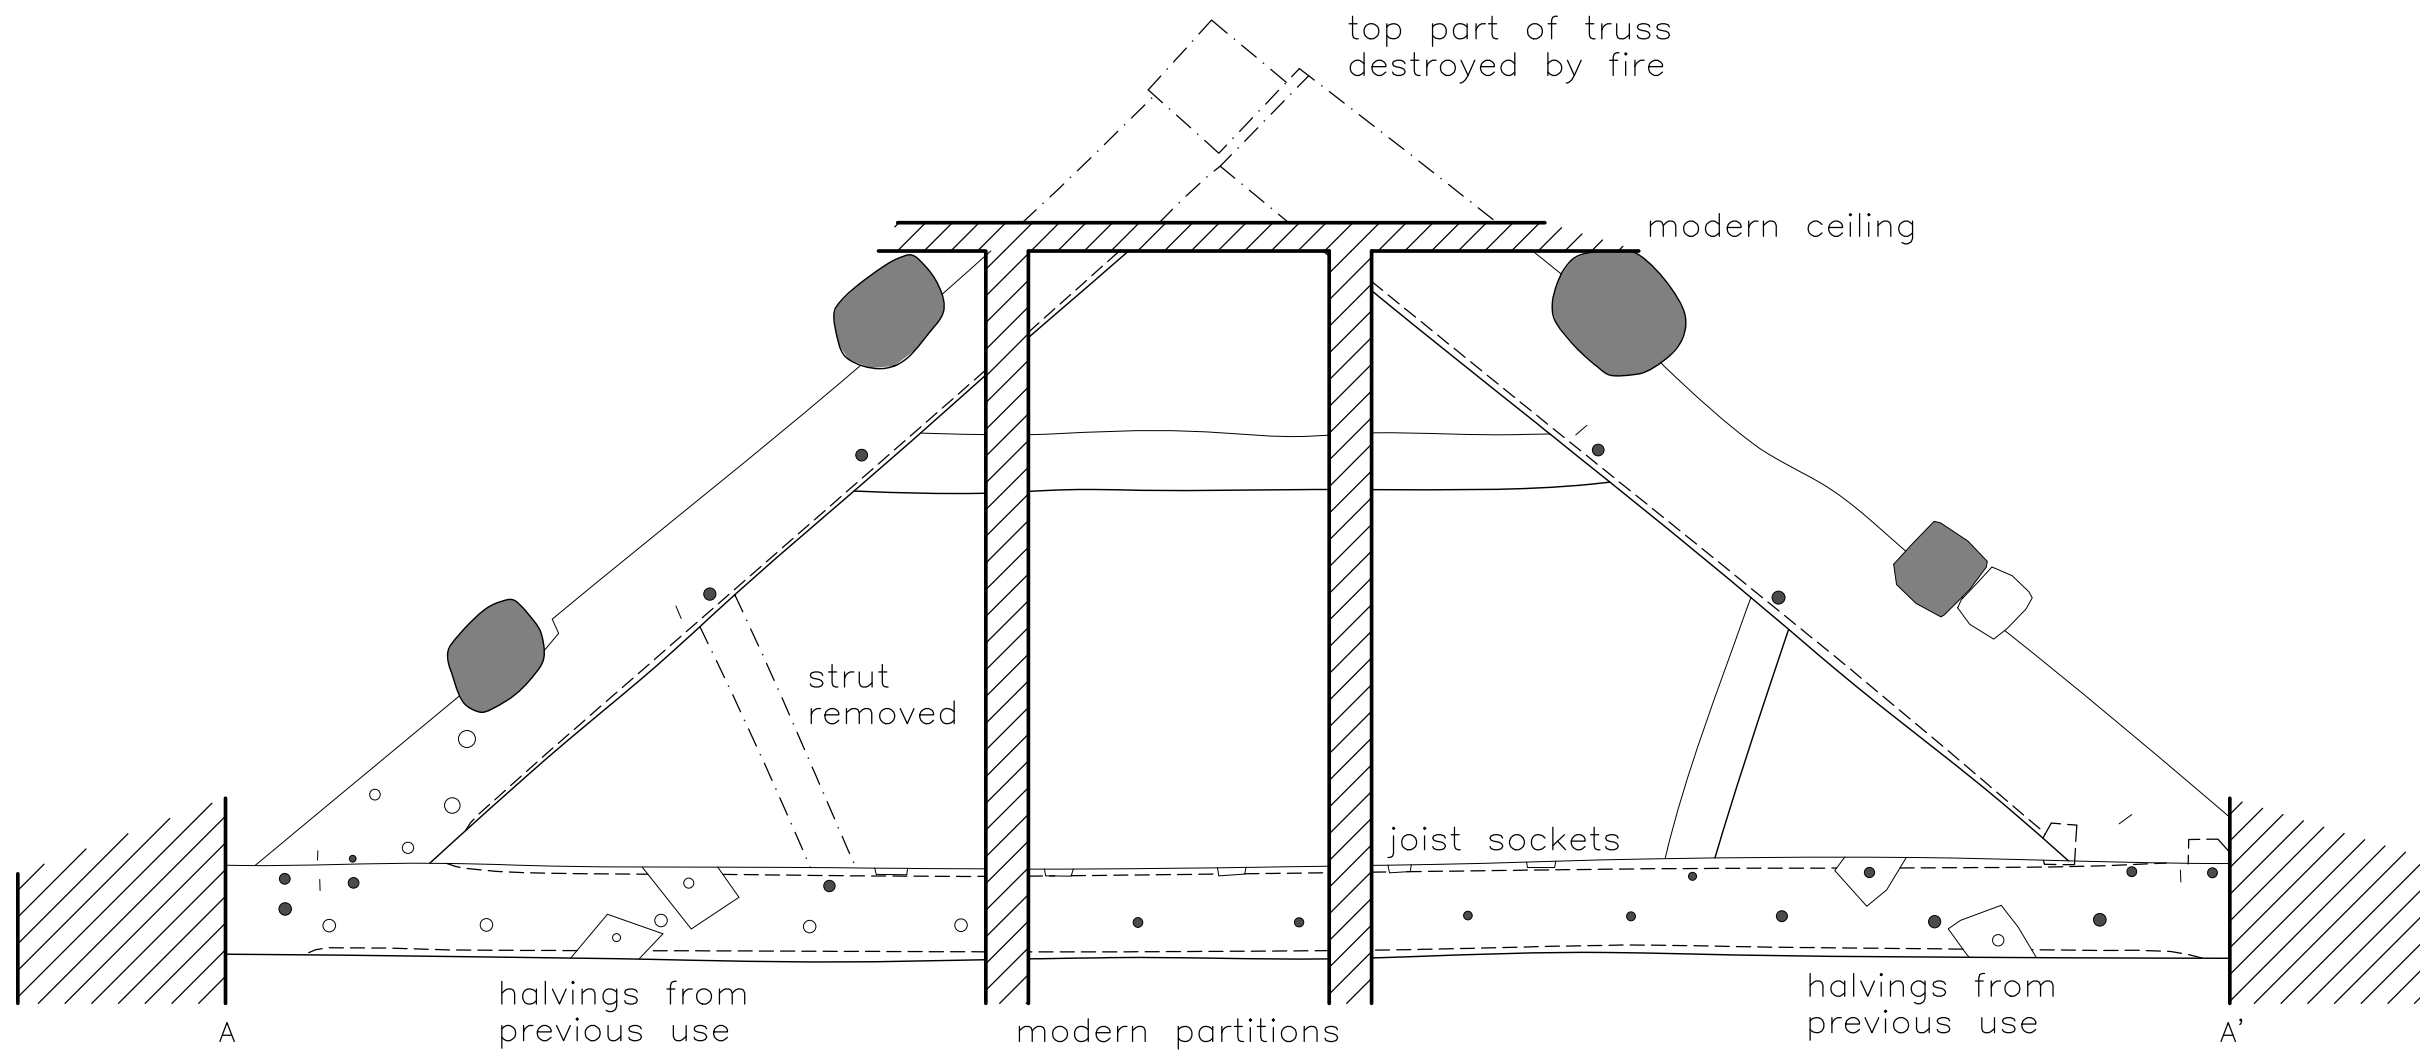
FIGURE 5:
 EAST ROOF TRUSS
 EAST ELEVATION (UPPER FACE)

- 7.2 The east truss faces east, towards the house's main fireplace, and has a tie beam which appears to have been re-used from a timber-framed building, as it has redundant, paired halvings on its upper face. Of these halvings, the two lower ones would then have held the upper ends of arch braces from wall posts at either end, while the upper ones would have held the lower ends of raking struts, in different positions from those employed in the present arrangement. The tie beam also has a row of peg or stave holes (some still filled), approximately 400mm apart, which are also likely to date from the timber's original use, perhaps as part of an earlier ceiling or canopy associated with the tie beam. On the top face of the tie beam is a row of shallow, rectangular joist sockets, likely to have supported the ceiling structure in the 17th century house or later.

- 7.3 The two principal rafters are tenoned into the ends of the tie beam, with two pegs securing each tenon, and at each joint there is a pair of Roman "I"s impressed into the surface with a chisel. There are a number of peg holes and pegs within them, which do not relate to the present structure, again raising the likelihood that they have been re-used from an earlier building. Both were formerly supported by raking struts, although only the north strut survives. Its tenons at either end are held in place by single pegs, and the survival of these pegs and

associated mortices in the south half of the truss indicates the former position of a second matching strut there. A collar ties the upper parts of the principal rafters, but above these the ends have been destroyed by fire.

- 7.4 The backs of the principal rafters have trenches cut for two side purlins each. These purlins vary in scantling, but all are of “whole tree” section, and the lower north purlin is staggered over the truss.
