Barn at Castlehaw
Sedbergh
Cumbria:
Historic Buildings Record (Level 3 Survey)

June 2020

STEPHEN HAIGH

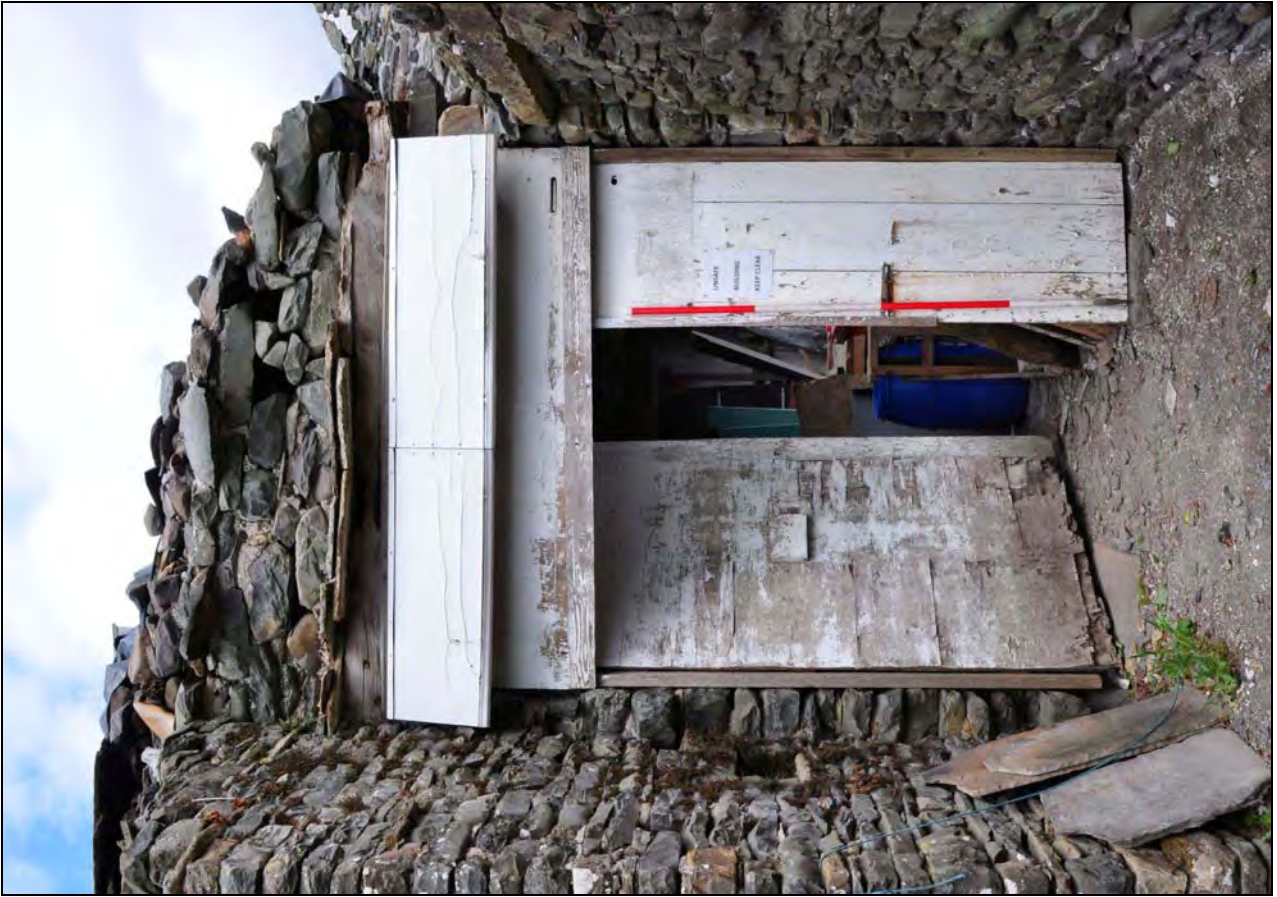
- 8.3 The main entrance to the barn, which opens onto a threshing bay, is located within the angle with the south wing, and comprises a tall doorway, for either sleds or narrow carts, beneath an oak lintel which bears marks of previous use (**5**). The doorway is protected by a short projecting wall, which once carried a porch roof, and which contains a small recess in its south side. It contains modern doors.

Photo 5: West doorway to threshing bay, and remains of porch

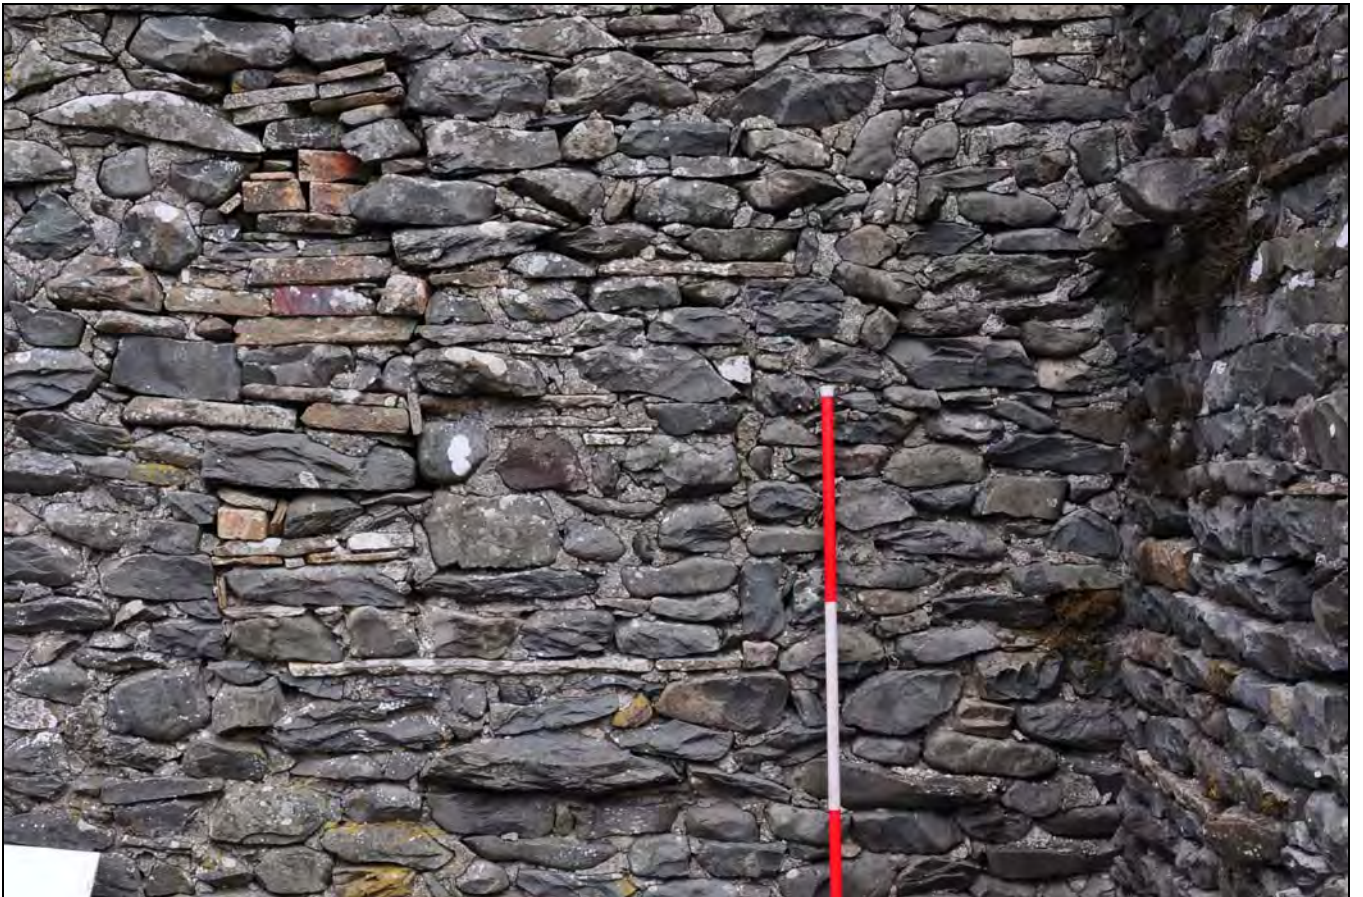
- 8.4 To the left of the former porch, a blocked, poorly defined, former window can be discerned (**6**). The opening appears to have been altered in size, historically.

Photo 6: Blocked window to north of porch

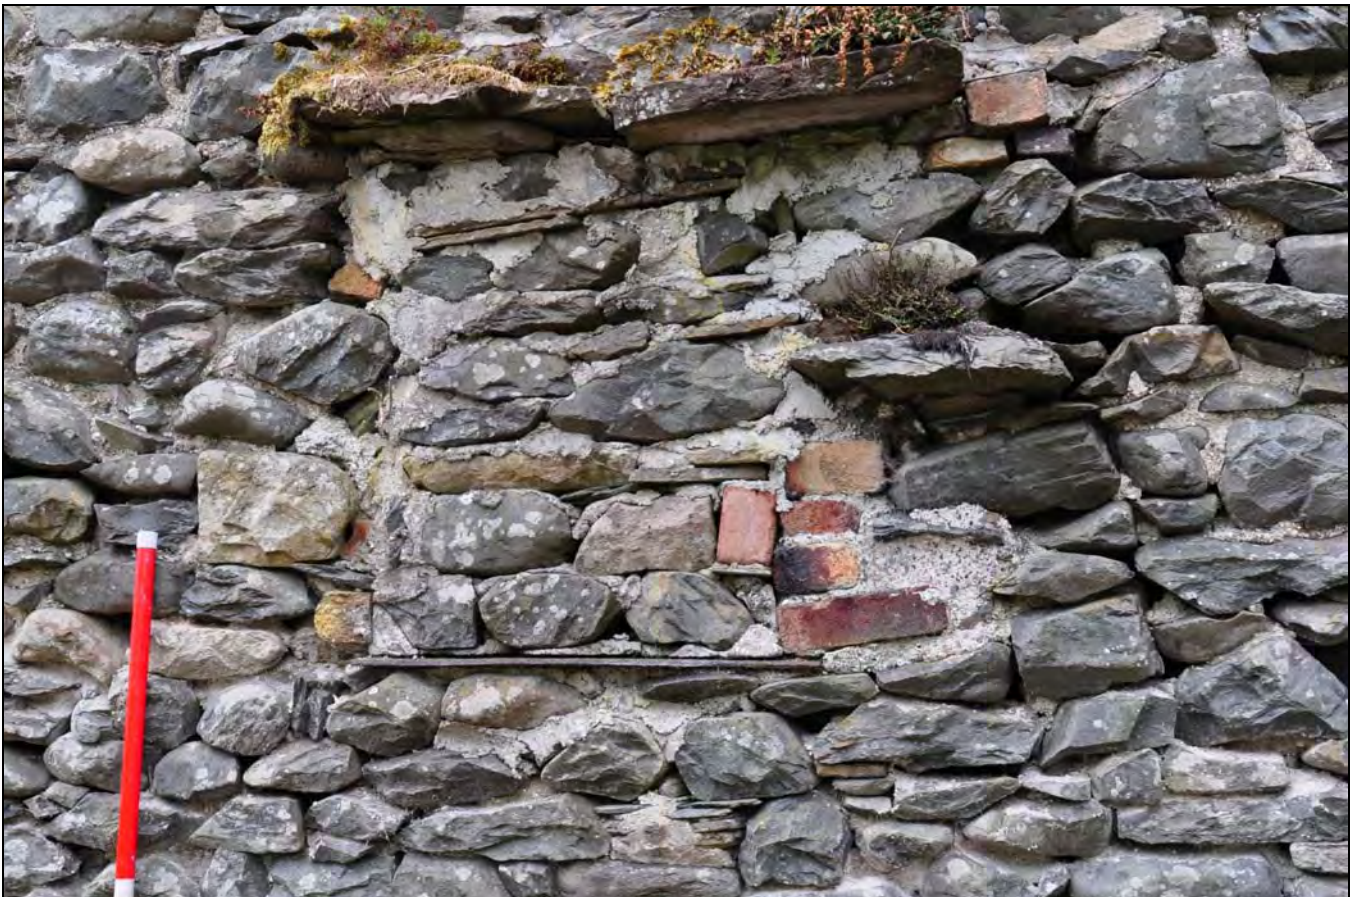
Photo 14: Detail of blocked window, east side of main range

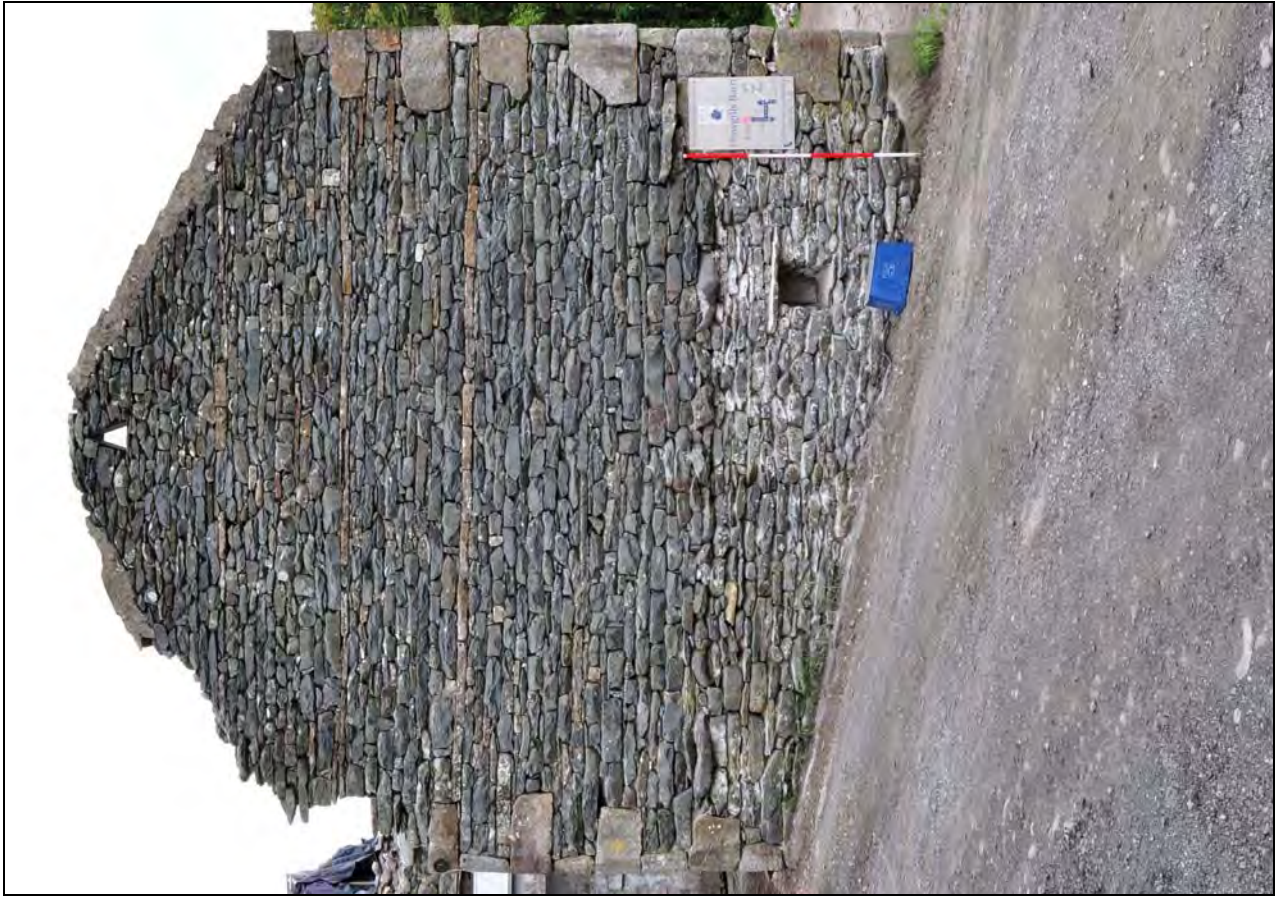
- 8.10 The stonework of the south wing's west gable is distinct from all other walls in the barn range, and it appears to have been largely rebuilt in the 19th or 20th century (23). It incorporates three courses of sandstone flags as throughstones, although the lowest row of throughs is of slate rubble, as elsewhere. Above those, the walling stone has a neater face and shows more evidence of dressing. It also incorporates a muck hole close to ground level, and a simple triangular owl-hole near the ridge. In contrast, the east gable has not been rebuilt, and its older, more random stone is similar to that in the rest of the building (24,25).

Photo 23: West gable of south wing (largely rebuilt)

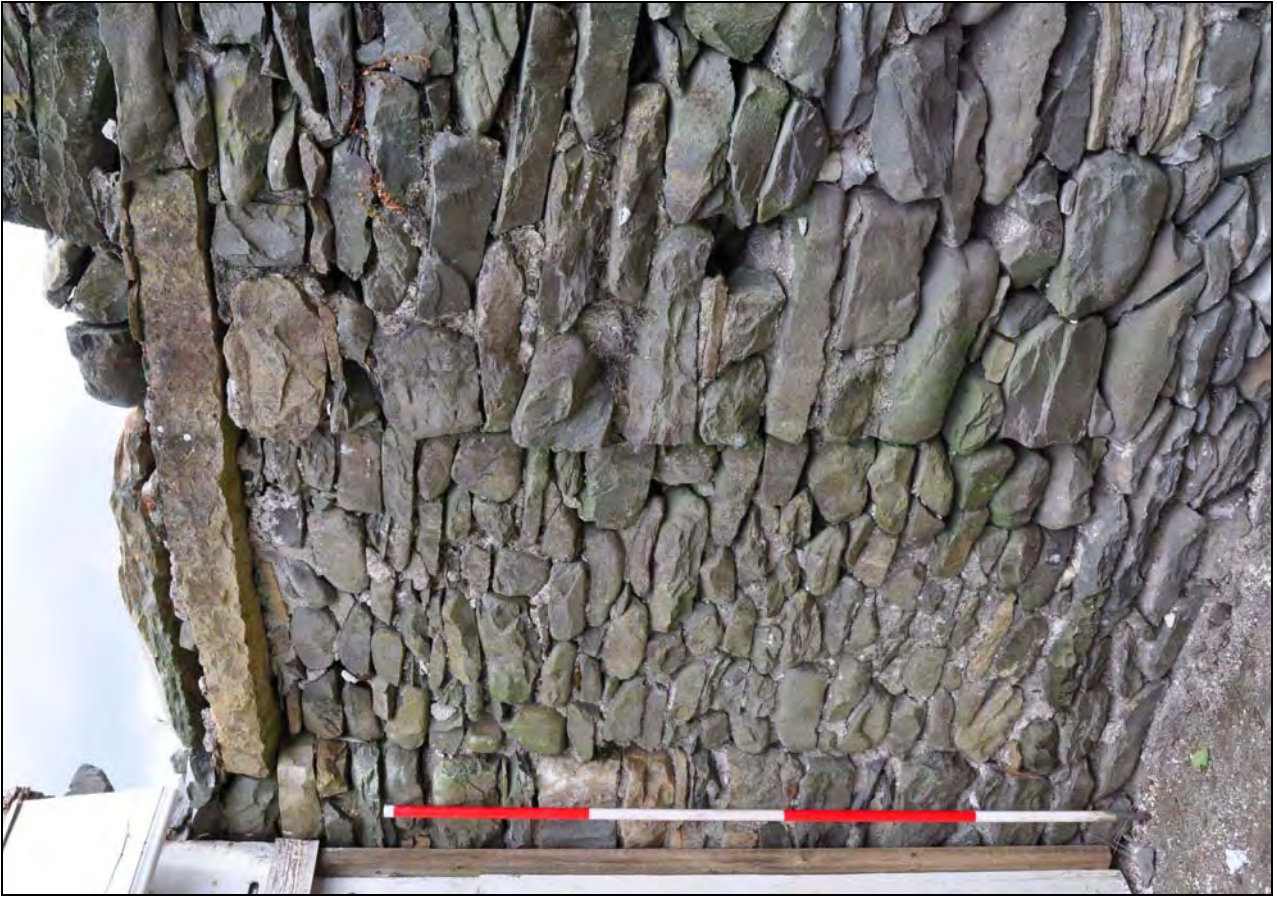
- 8.11 The south wing's short north-facing return has a blocked doorway which was formerly situated under the porch roof (**26,27**). The 2015 drawings show a high level opening above this, either a window or forking hole, within walling which has now collapsed.
- 8.12 Roof coverings only survive to the northern part of the barn, to the north of the threshing bay; that over the remainder, including the whole of the south wing, has been removed. The surviving slates are of local stone slate to the lower parts of both west and east pitches, with green Westmorland slate above, and this dichotomy is most probably attributable to 19th or 20th century replacement of stone slate in those upper parts. The ridge is sandstone.

Photo 27: Blocked doorway in north side of south wing, formerly within porch

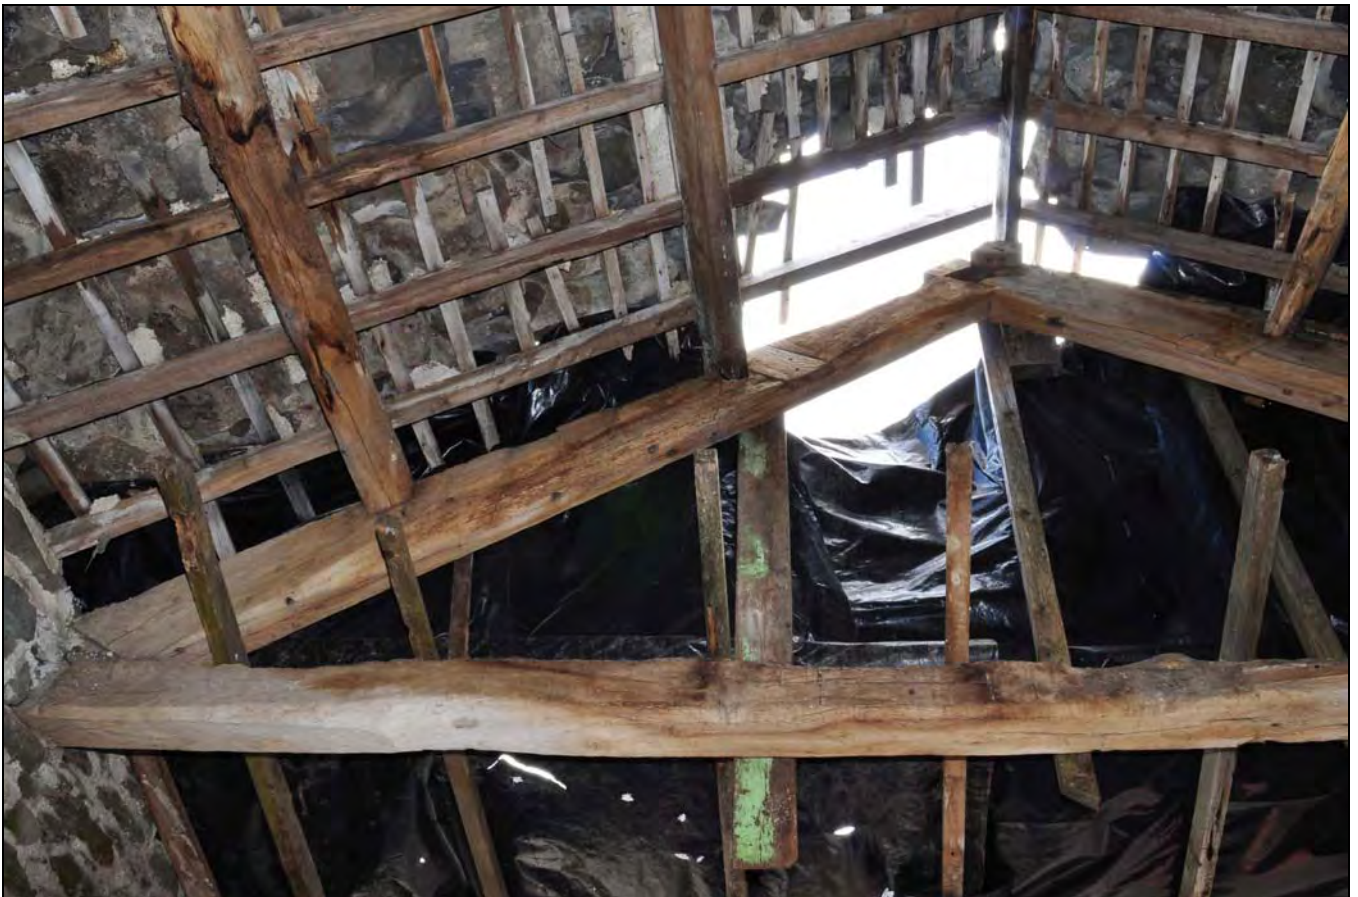
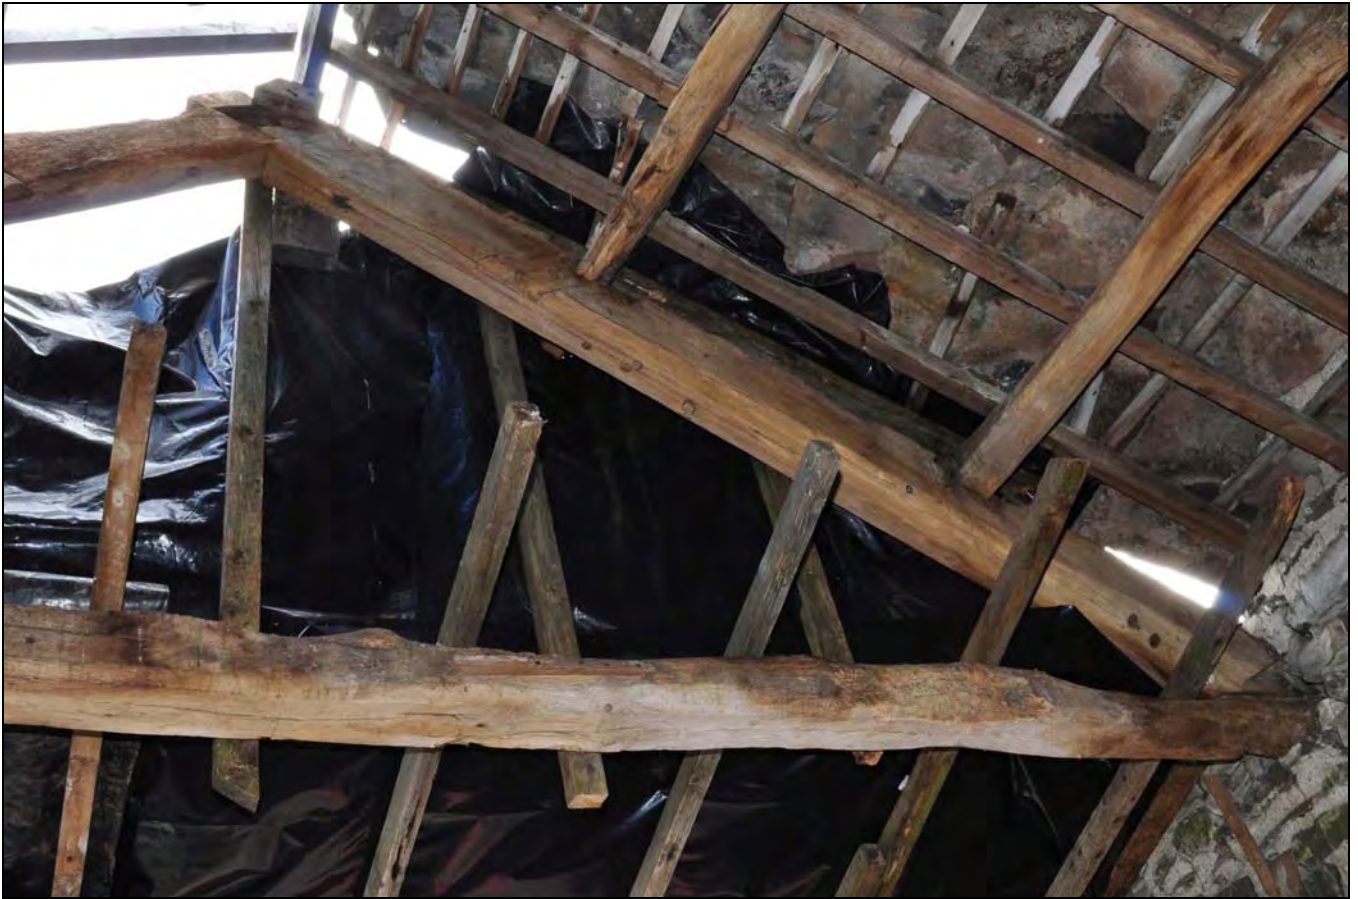
- 8.14 Both of these two bays are open to the roof, and an original roof truss survives between them (**32-34**) (the plastic roof shown in the photographs is a recent temporary arrangement). This is the only remaining truss in the building, following the collapse of the two which once served the south wing.

Photo 32: Roof truss over threshing bay, from the north

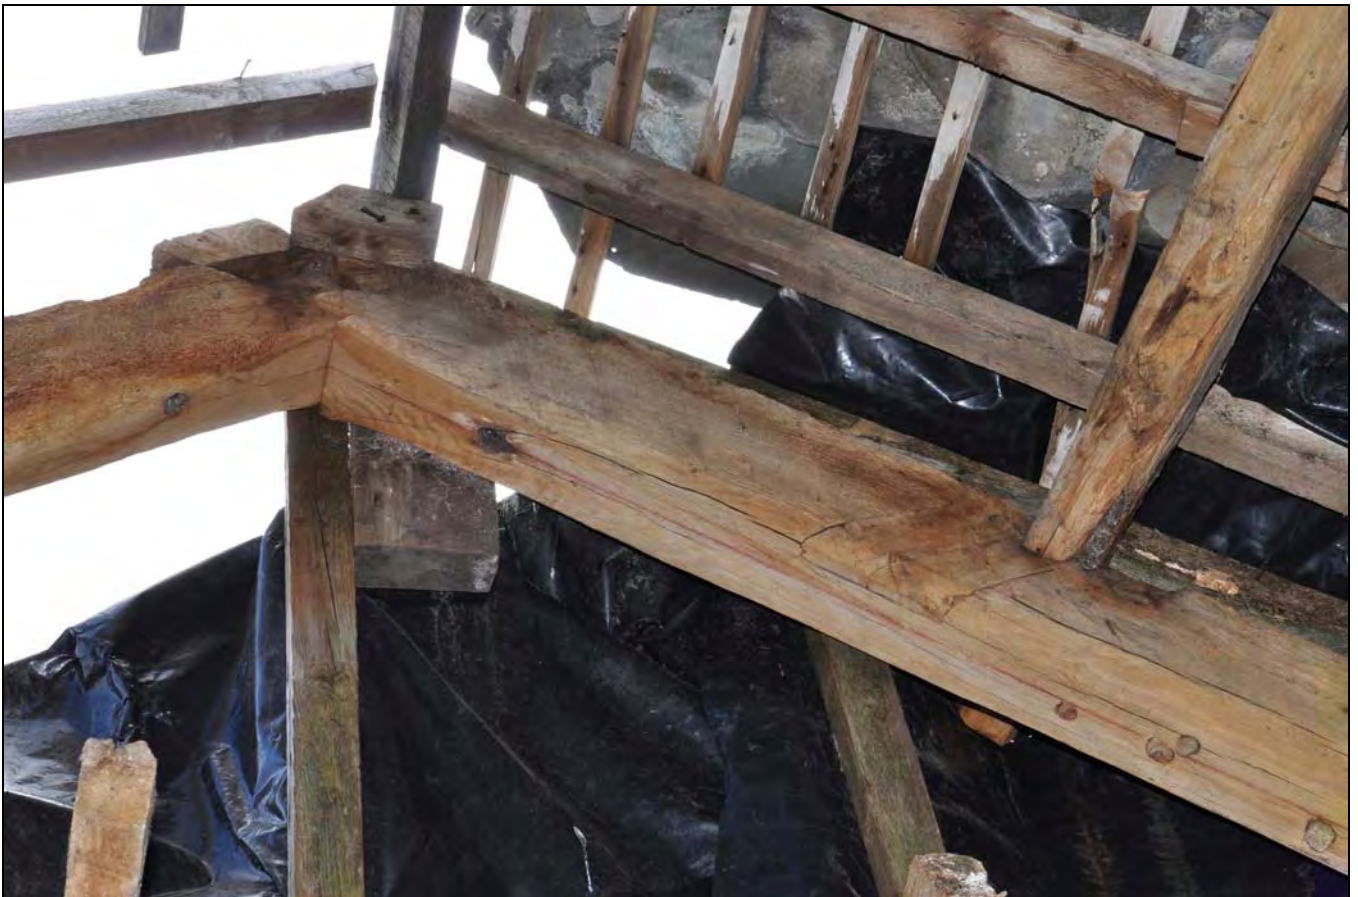
- 8.15 The surviving truss is of oak, and consists of tie-beam with principal rafters, without struts. Both of the principal rafters have pegs, peg-holes, and two halvings, in positions which suggest they are former cruck blades. The carpenter's red chalk, used in setting out the present truss, remains on some surfaces. The two pairs of side purlins are also oak, and their other ends are set within the cross-wall to the north. All features of the roof structure are typical for the early eighteenth century in the district.

Photo 34: Detail of infilled halvings, pegs and chalk to roof truss over threshing bay, from the north

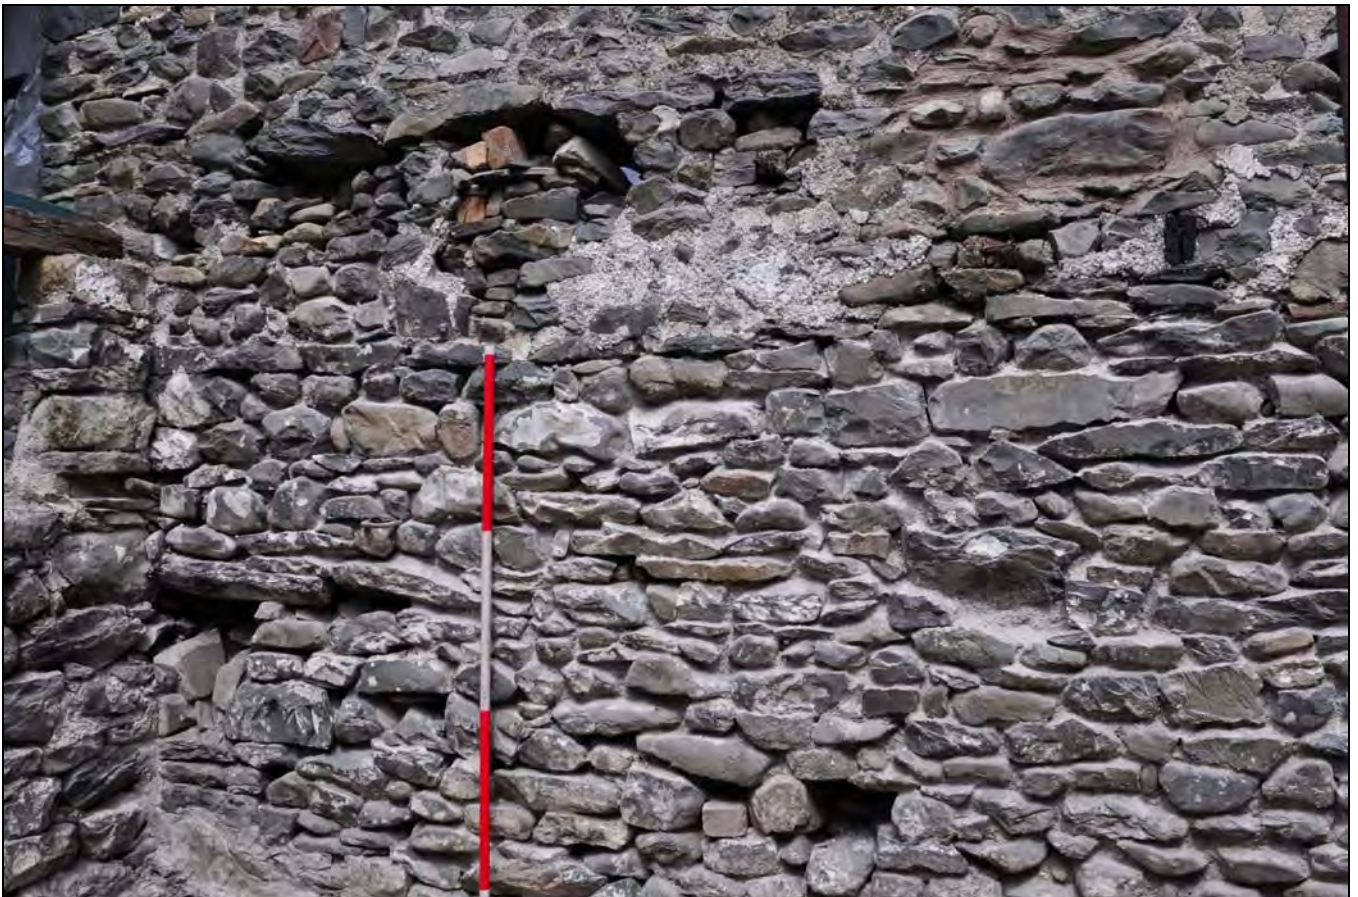
- 44).** At that time, the hayloft was most probably carried on beams supported only by the outer walls, and on the posts of the animal stalls. The lower ground floor was later altered, at an unknown date but probably before the mid twentieth century, and the present cross-wall was built, partly blocking off one of the pedestrian doorways to the south (the south end of the cross-wall has since collapsed – see 2015 drawings) (**45-47**). It also appears that the hayloft to the east of the cross-wall was raised at this time, as there are two rows of sockets in the east gable (**48**).

Photo 48: North-east corner of south wing, from the south-west; note two rows of loft timbers

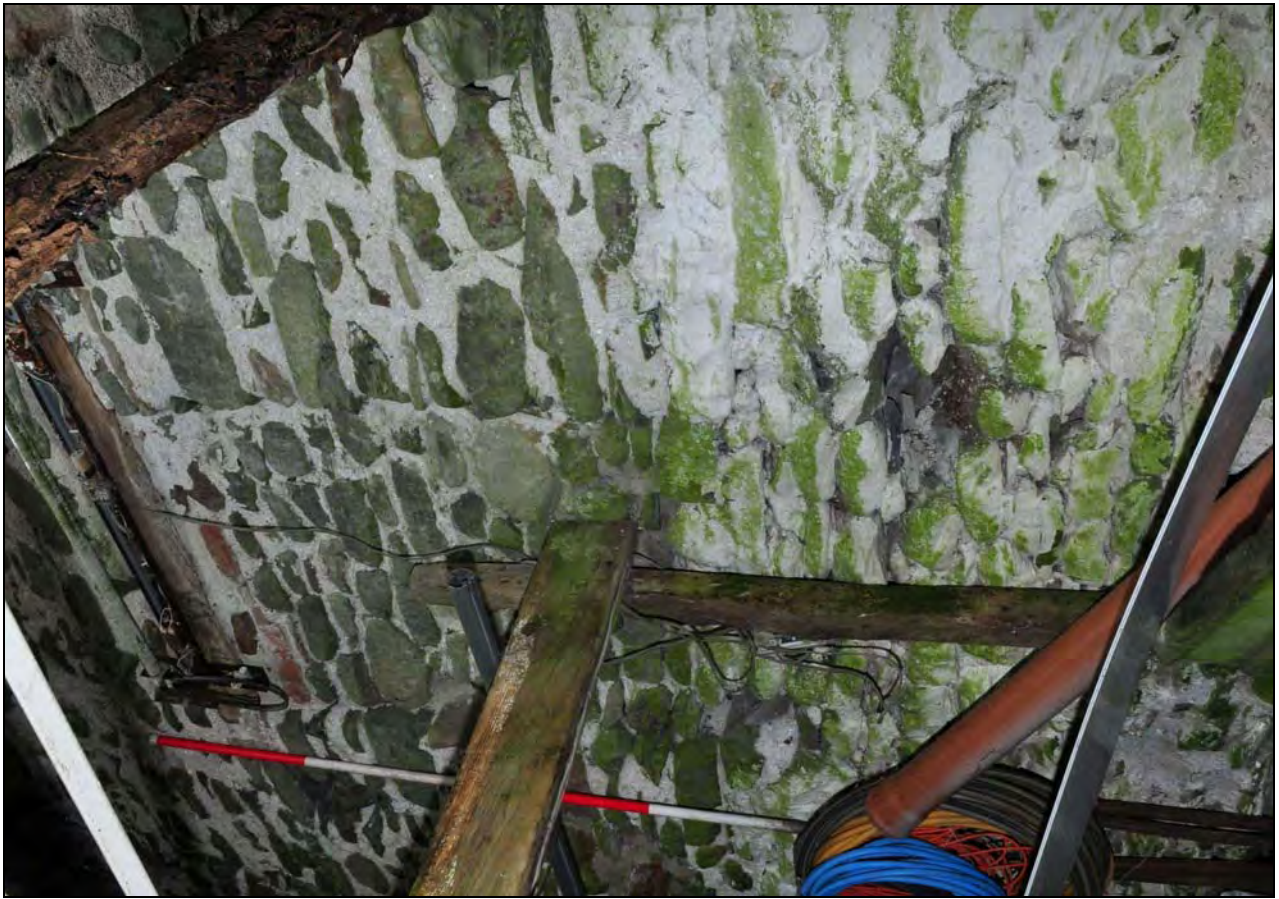
Photo 51: Blocked doorway at upper level, north side of former stable

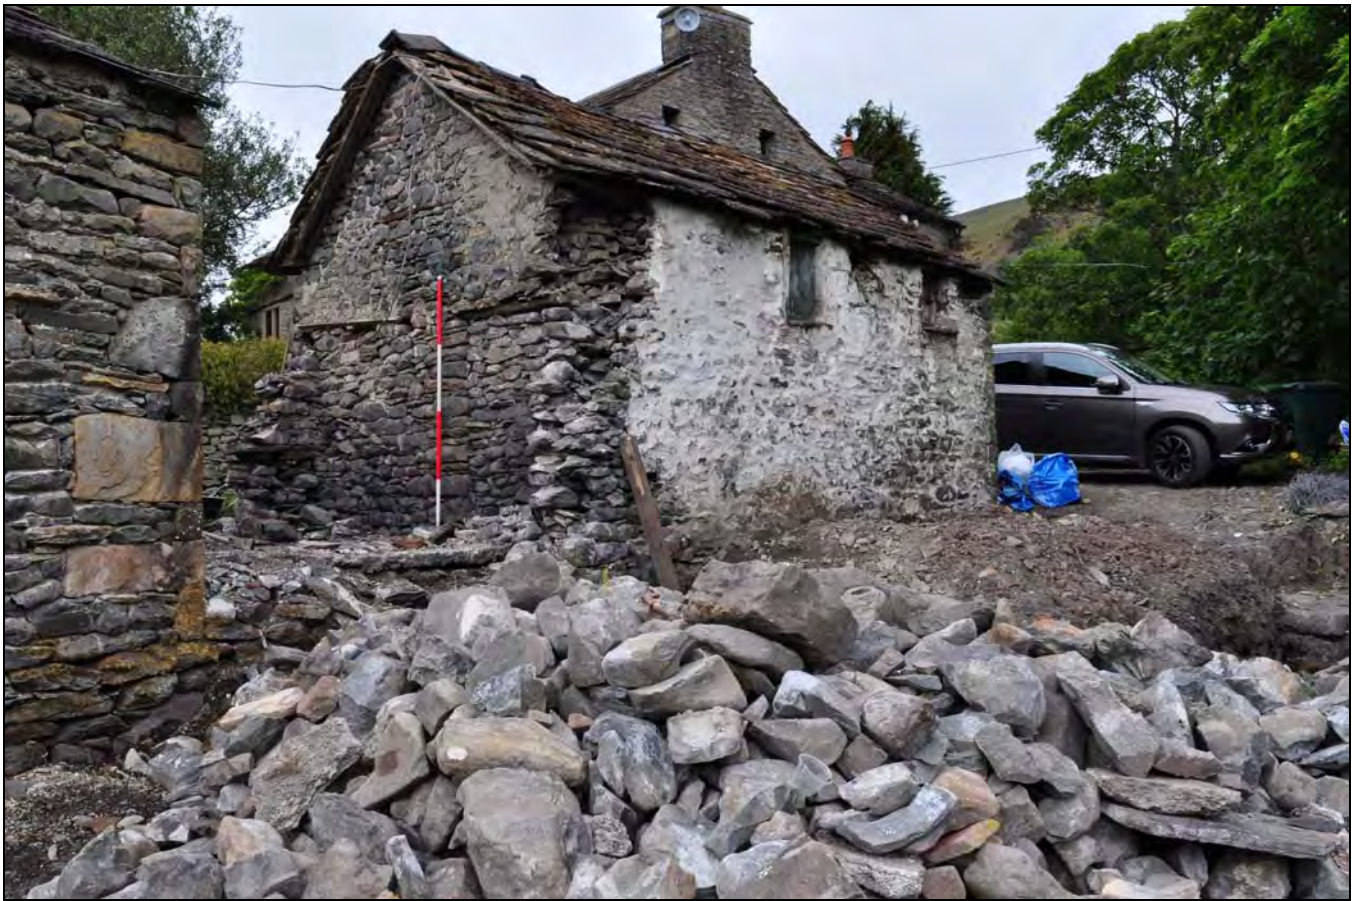
Photo 61: Garage, from the south-east, with site of collapsed lean-to in foreground

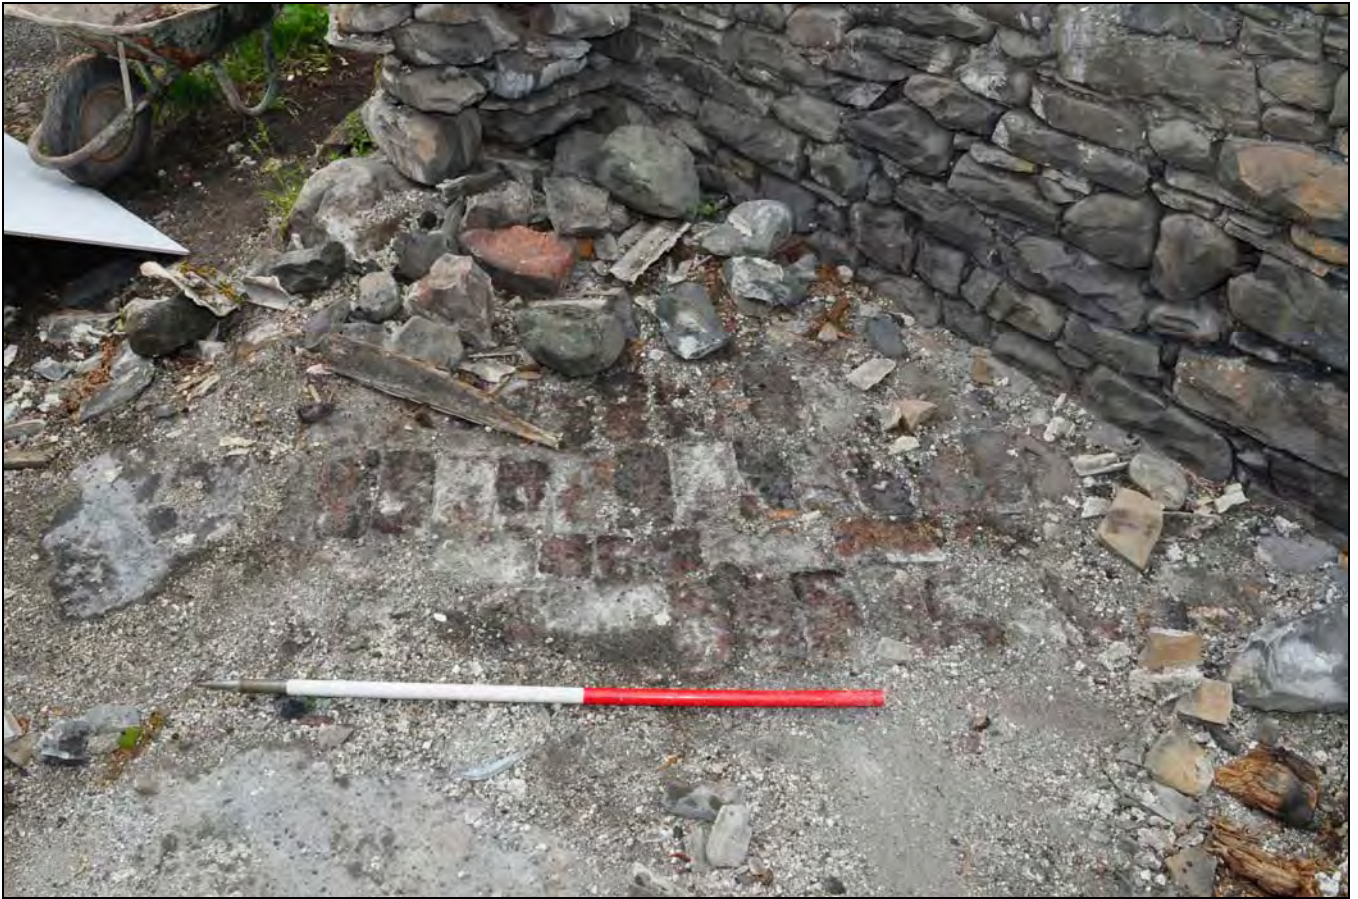
- 8.22 Few details of the interior of the link building survive, but brick flooring exists within its north-west corner, perhaps associated with a corner stove or set-pot, such as would have been used in a wash-house (**65**).

Photo 65: Brick floor within link building, between garage and main range
