Barn at Green Hill Borwick, Lancashire: Historic Building Survey (Level 2 Record)

July 2021

STEPHEN HAIGH

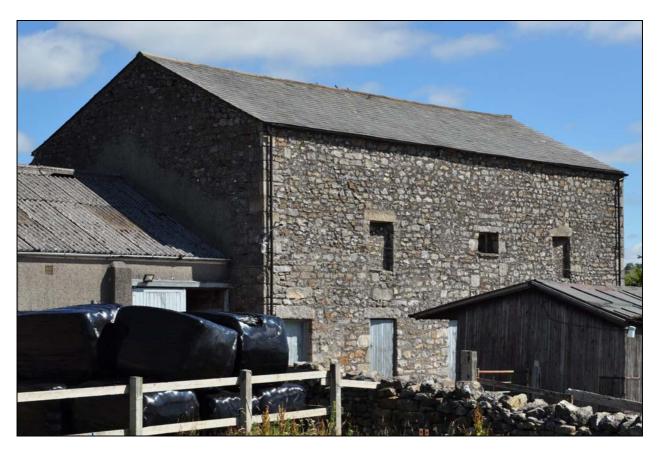
- 7.1 The barn is built from random rubble, predominantly limestone (the native bedrock), with some sandstone, and dressings are similarly of both stone types. Most of the roof is Cumbrian slate, with sandstone ridge, and has been relaid within the last thirty years (1), but two outshuts on the north side have asbestoscement roofs.
- 7.2 The south front faces onto a concrete yard, and contains the entrances to the lower ground floor, as well as some blind forking holes and a former winnowing door to the hayloft (2,3). The latter are notable for the use of unconverted timbers to support the rubble fill, between the outer and inner lintels (4), and it is not certain whether these holes were ever open, or were intended to be merely

Photo 1: General view of the barn, from the south-west

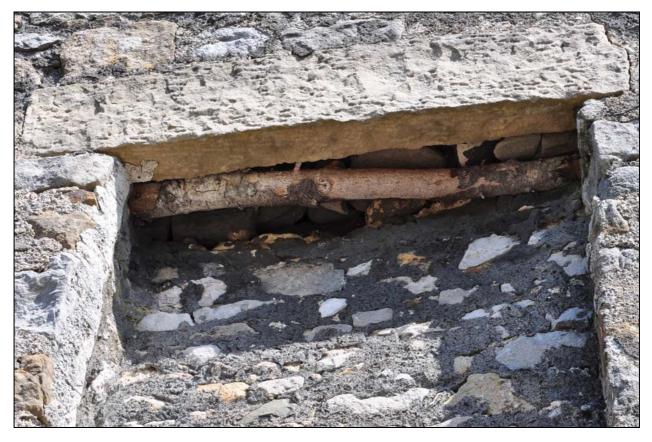
Photo 4: Detail of lintel to blind opening, upper part of south elevation, with timber to rubble core

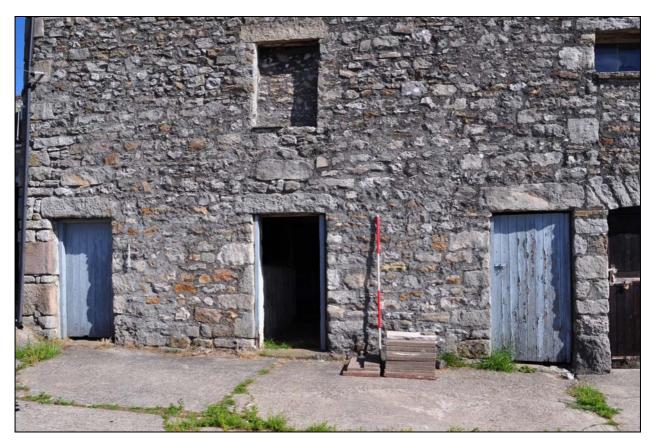
decorative. Of the lower doorways, the three in the west half serve a shippon with central feeding passage (5), while to the right is an arched doorway to a narrow cart bay, and a stable doorway (6).

Photo 5: South elevation: three doorways to shippon

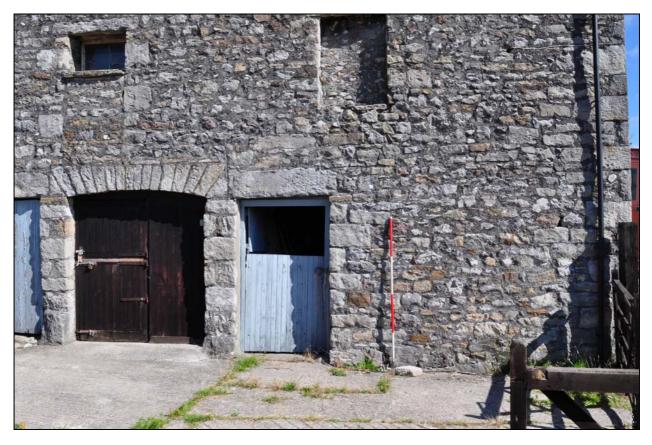
Photo 6: South elevation: doorways to cart bay and stable

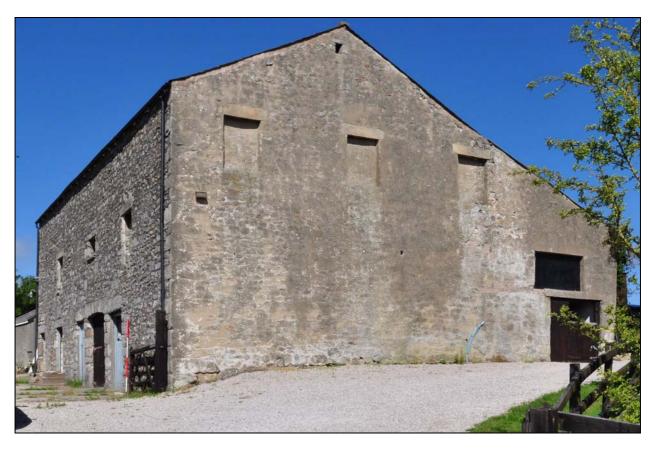
- 7.3 The east gable has cement render, and the barn has been extended at the northeast corner (7), before 1844-5, according to the Ordnance Survey. The original part has three blind forking holes to the hayloft, and a plain owl hole, while the extension has two large openings under concrete lintels (8).

Photo 7: General view of the barn, from the south-east

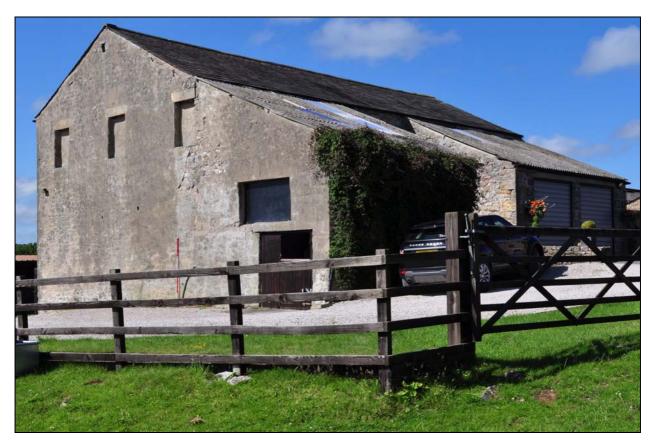
Photo 8: General view of the barn, from the north-east

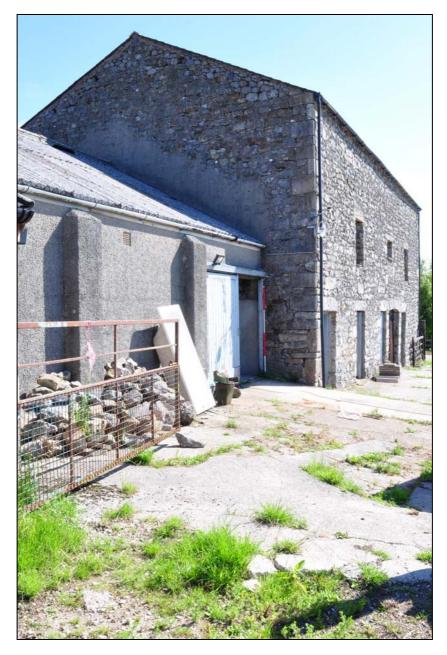
- 7.4 A single storey shippon has been built up to the west gable in the mid twentieth century, above which are cement render and signs of rebuilding (9,10). A ground floor doorway in this gable is a twentieth century insertion (11). The extension of the barn's north-west corner appears to have been late nineteenth century, although it was subsequently altered to form a double garage (12).

Photo 9: General view of the barn, from the south-west

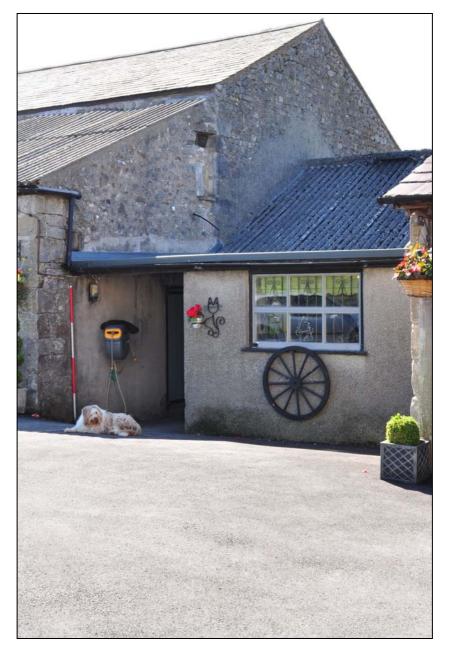
Photo 10: General view of the barn, from the north-west

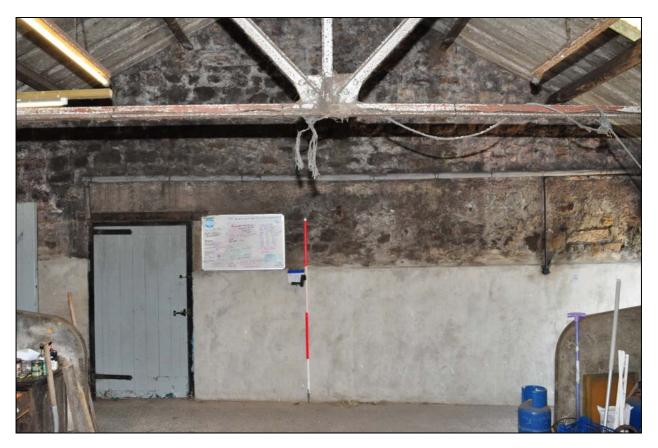
Photo 11: Inserted doorway in west gable, inside modern shippon

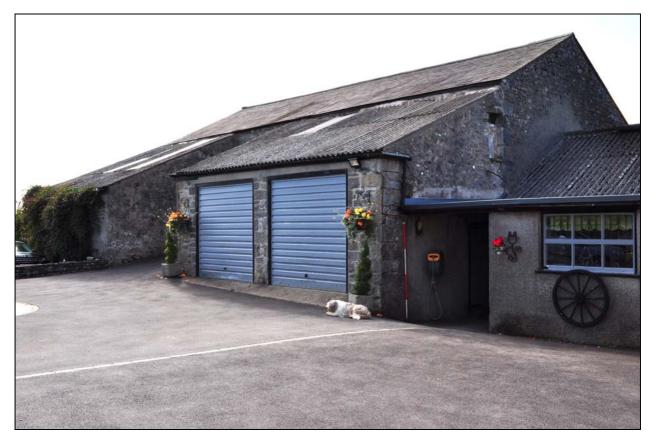
Photo 12: General view of the barn, from the north-west

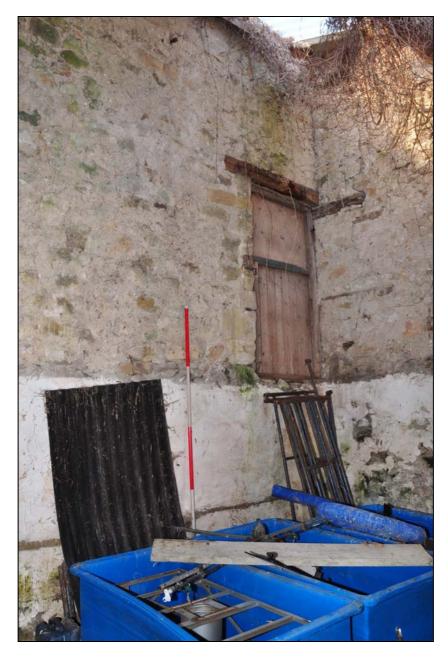
- 7.5 The two additions on the north side of the barn largely mask its original elevation, but they leave the cart entrance to the hayloft open (13,14). It is reached up a ramp, and has stone arch and harr-hung doors. To the east, within the later outshut, a doorway has been inserted to communicate between the two haylofts (15).

Photo 15: Interior of north-east outshut: inserted hayloft doorway

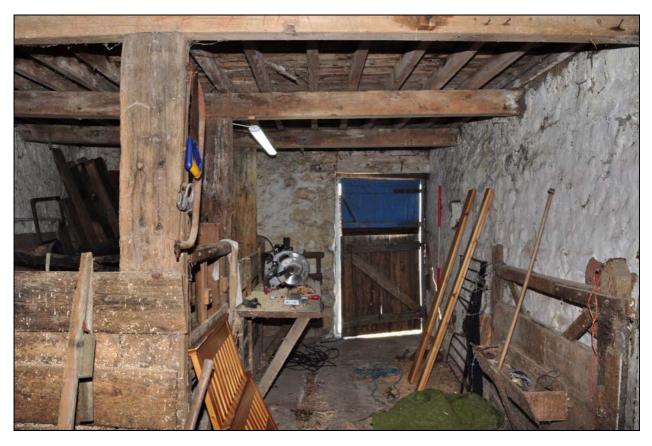
- 7.7 The narrow room to the east of the shippon (**28**,**29**) is interpreted as a cart bay, but an alternative function may have been a root store.
- 7.8 The former stable beyond has been modified to house cattle (**30**,**31**). The beams overhead suggest stalls arranged east-west, but no related fixtures or fittings appear to have survived.

Photo 30: Former stable, looking south

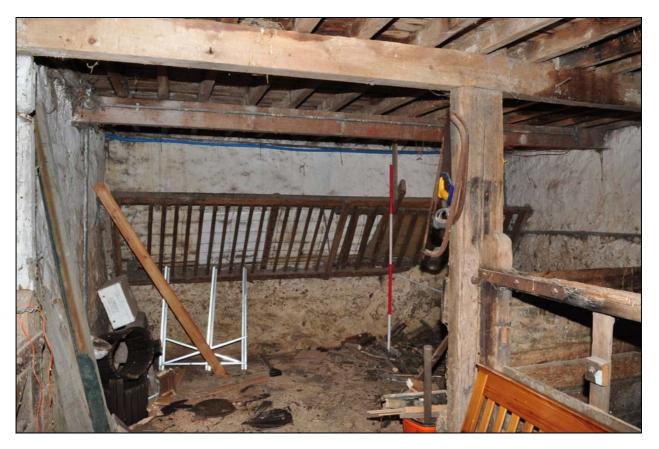
Photo 31: Former stable, looking north

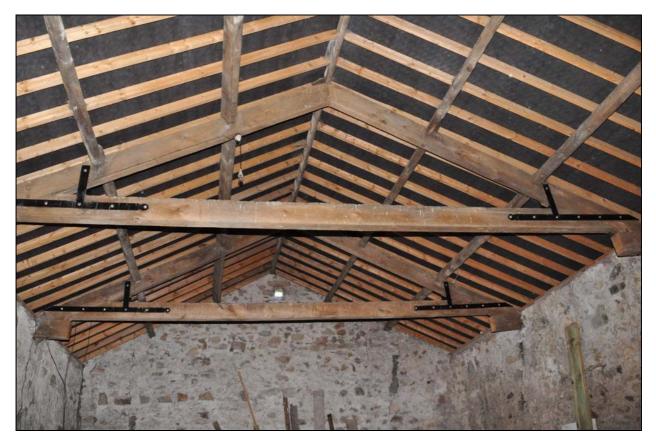
- 7.9 The main hayloft forms a single space open to the roof, with no evidence for any divisions (32-37). The trusses over have all been altered in the modern re-roofing, which took place following collapse (38).

Photo 38: Roof over hayloft, looking east

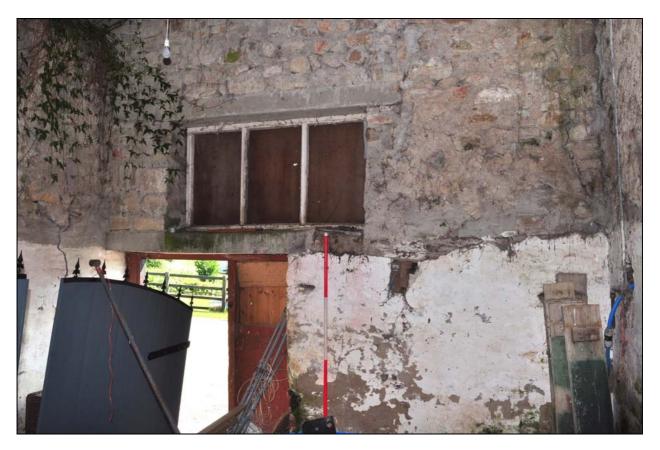
7.10 The two northern outshuts appear also to have provided livestock housing, with haylofts over, but internal divisions have been removed and no features of interest remain (**39-41**).

Photo 39: North-east outshut, looking north-east

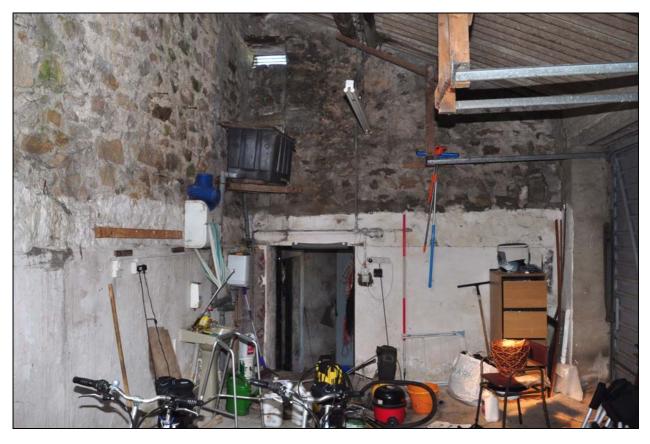
Photo 40: North-west outshut, looking west
