King Henry's Parlour Bracewell, Lancashire: Supplementary Report on Archaeological Building Recording

June 2008

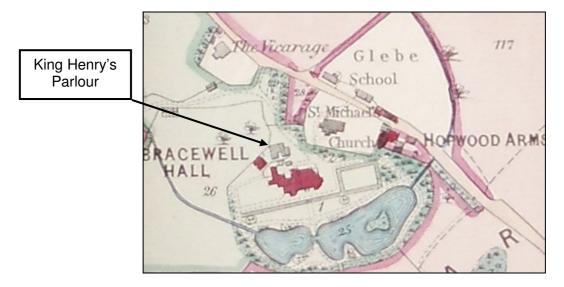
- 3.1 A sale document held by the John Goodchild Collection in Wakefield (a private archive), describes the Bracewell Hall Estate when offered for sale in 1874², and includes a plan of the estate, reproduced as Figure 2. The document does not mention King Henry's Parlour by name, but describes what is thought to be the building, as the stables: "The stabling is only of a temporary character, converted out of a stone-built barn, divided into coach house, three-stall stable, harness loft, pony stable &c...". If in fact this does describe King Henry's Parlour, it suggests that the building was not of particular interest at the time, and that it was then recognised as a former barn.

Figure 2: Extract from the plan of the Bracewell Hall, from the same document of 1874.

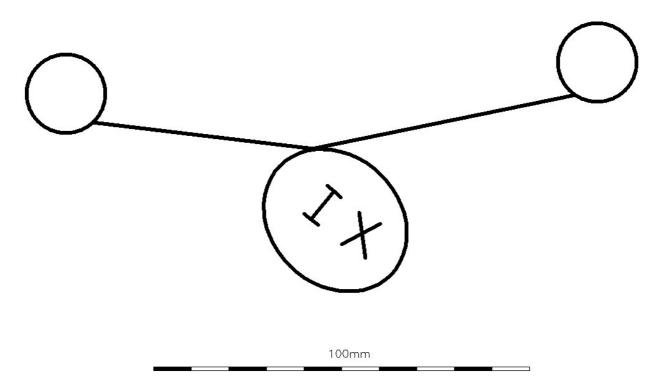
- 4.5 At first floor level, openings are essentially confined to the south-west end of the building. The two opposed, now blocked doorways which clearly used to serve the hay loft, are in the characteristic position for forking holes, to allow hay to be taken into the building directly from a cart; that on the south-east side (D6) has been made up with very weathered stone on the outside, incorporating an arch, almost certainly re-used in this position, but whether or not the dressed stone was used for picturesque effect, or simply for convenience, is uncertain. In contrast, the former doorway to the front elevation (D1) is plain, but incorporates an inscribed mark on the face within the building, probably a post-medieval graffito as it incorporates what may be Roman numerals, but alternatively a medieval mason's mark. It is illustrated as Figure 3.

Figure 3: Tracing of mason's mark or graffito, on internal jamb of doorway D1
