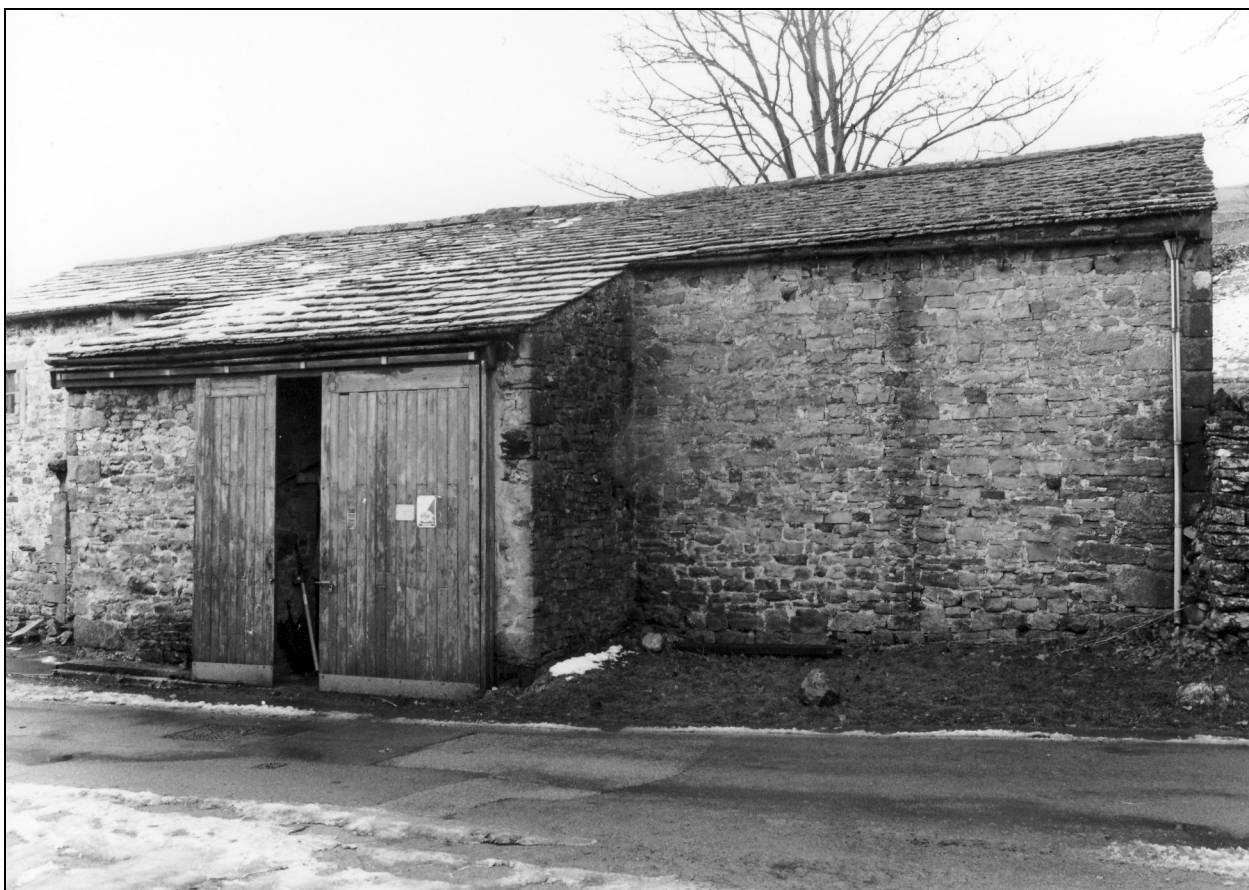
Photo 1: The barn, from the south-east (with roof covering exposed)

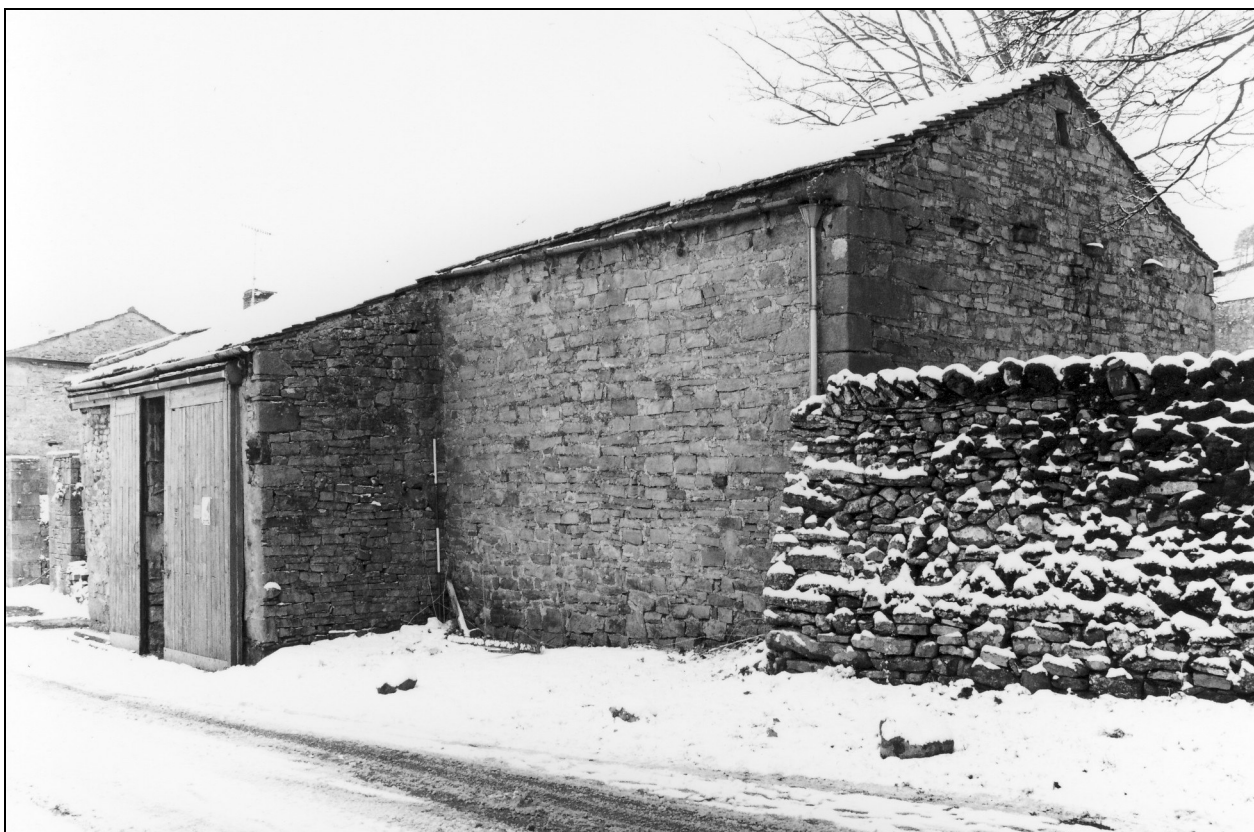
Photo 2: The barn, from the south-east

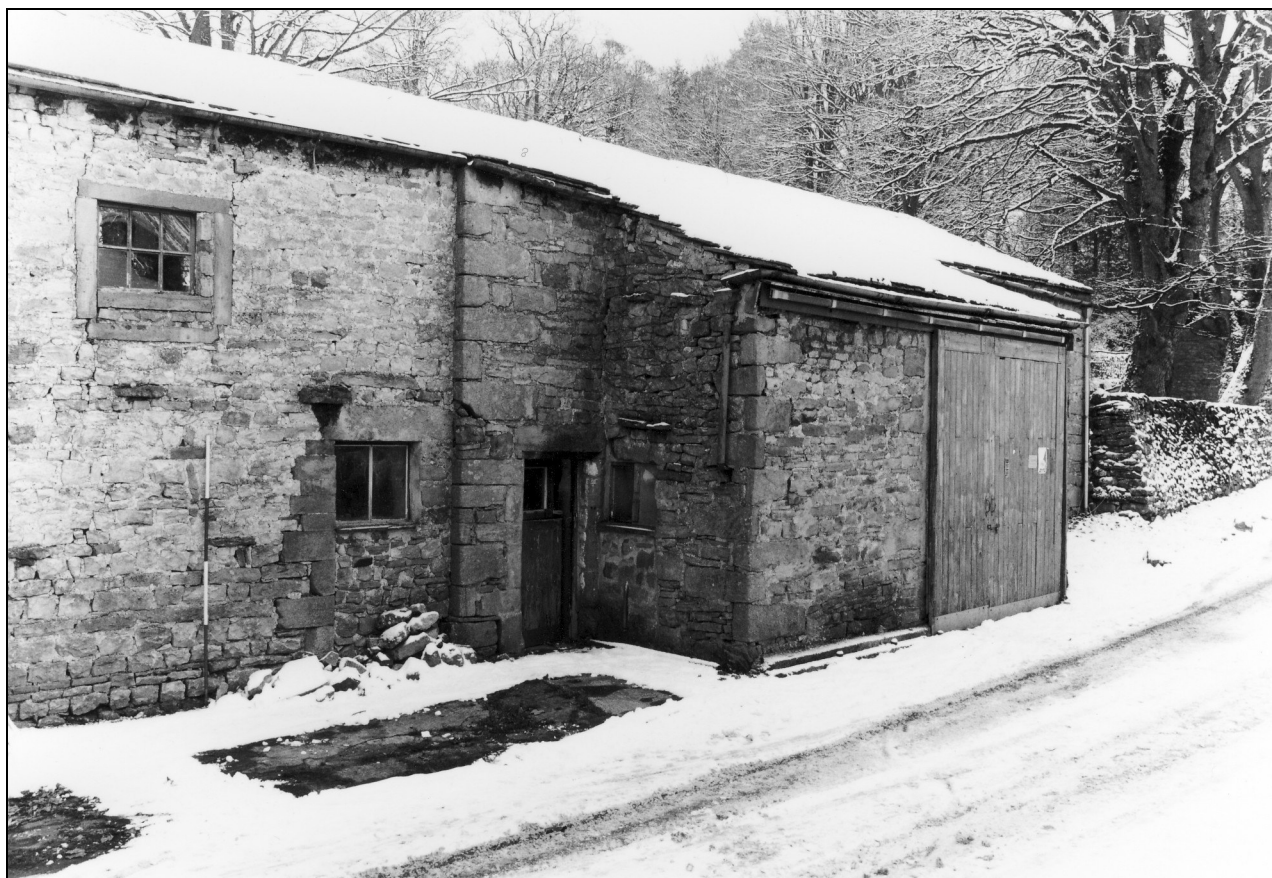
Photo 3: The earlier part of the barn, from the south-west

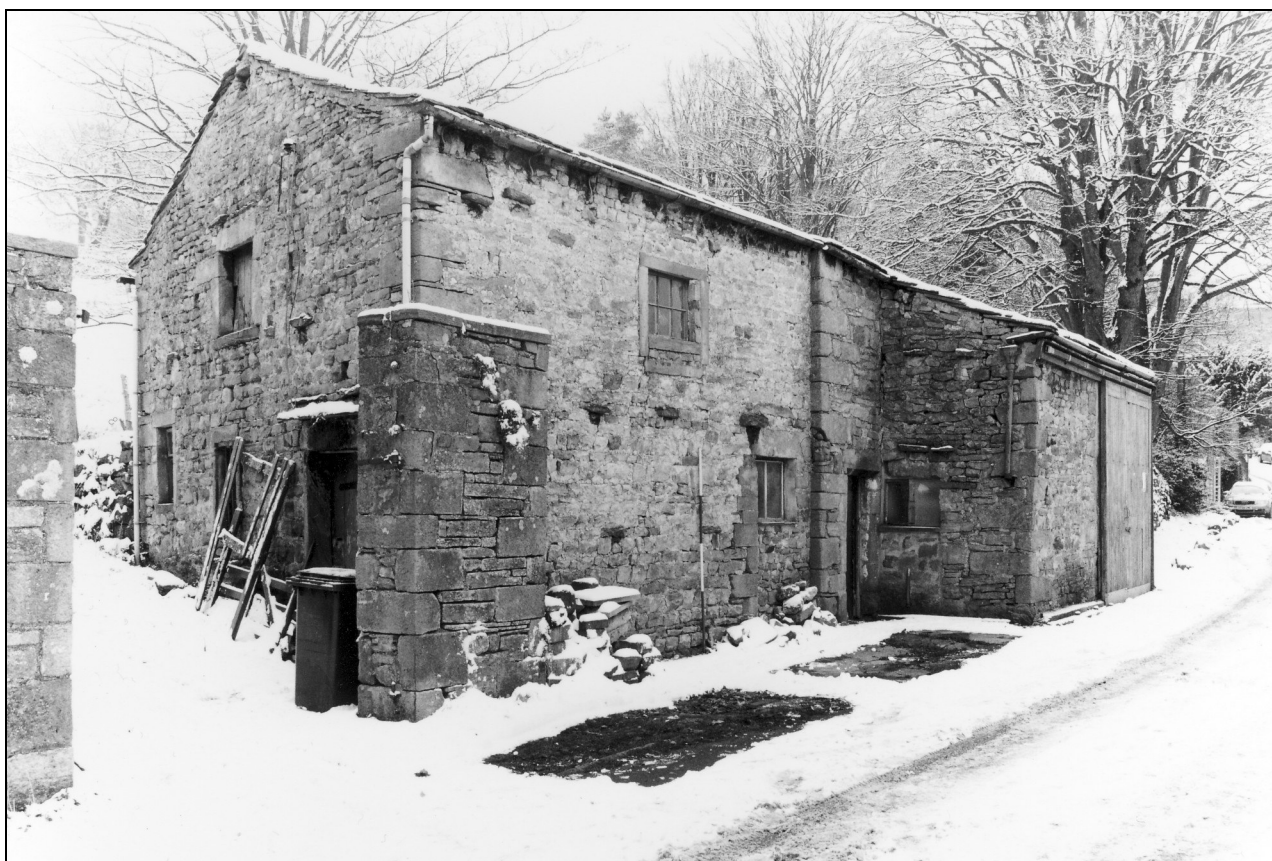
Photo 4: The barn, from the south-west

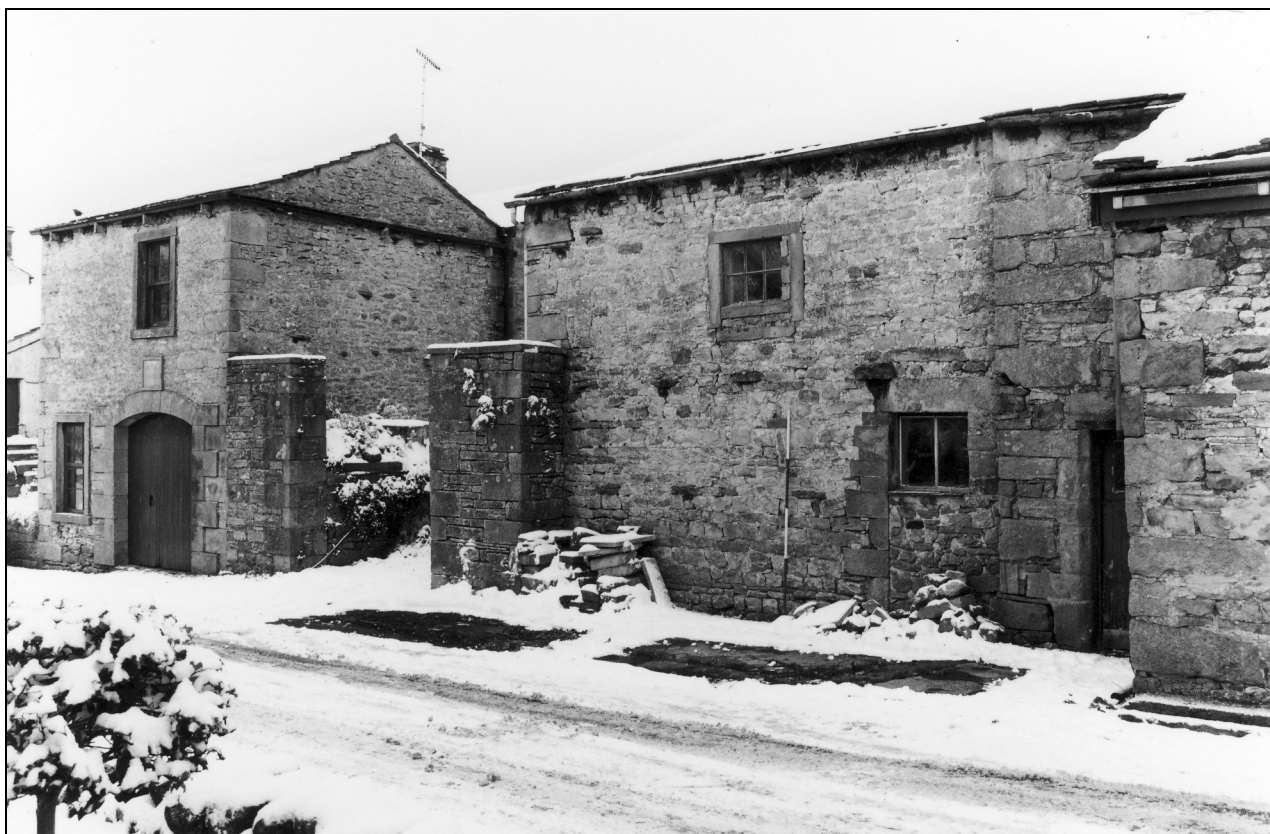
Photo 5: The stable and gateway, from the south-east

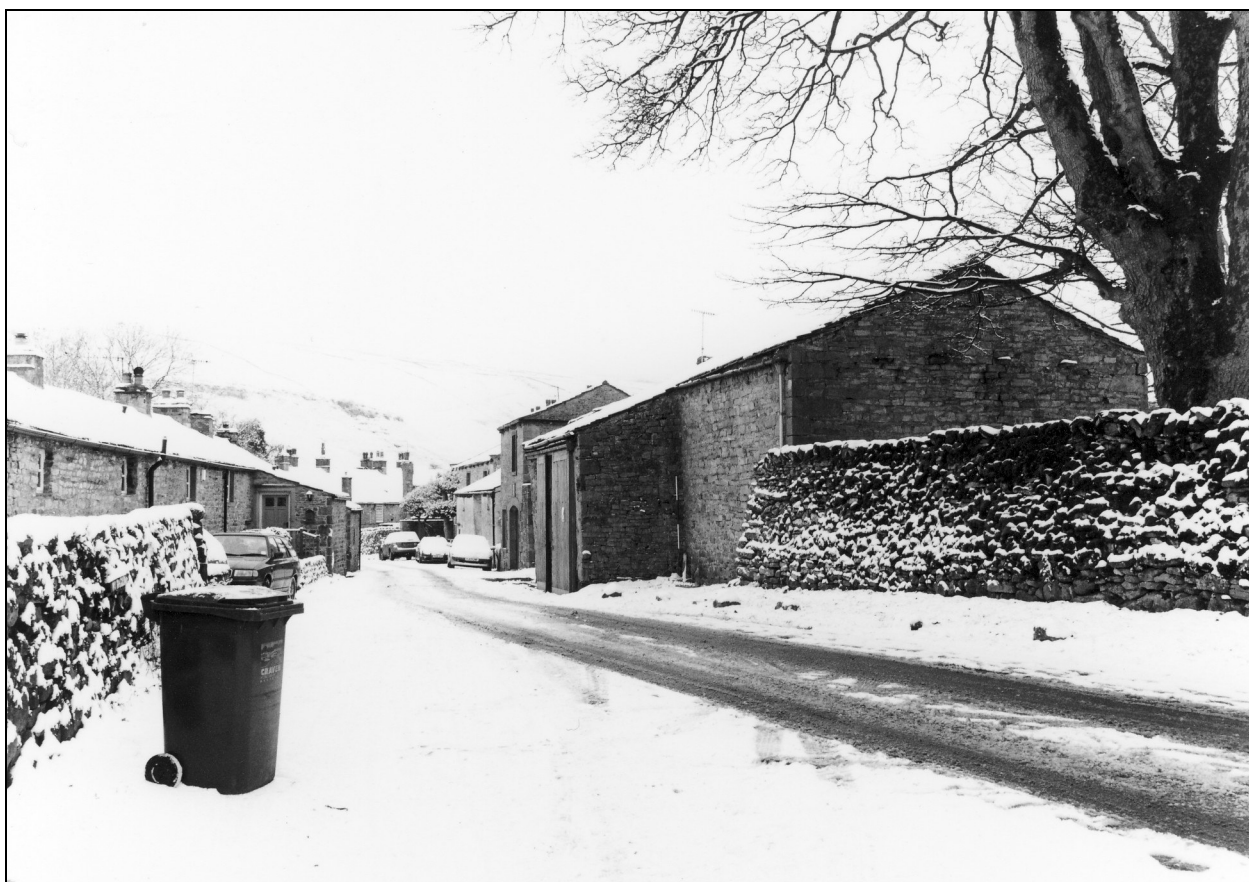
Photo 6: General view of the site, from the east

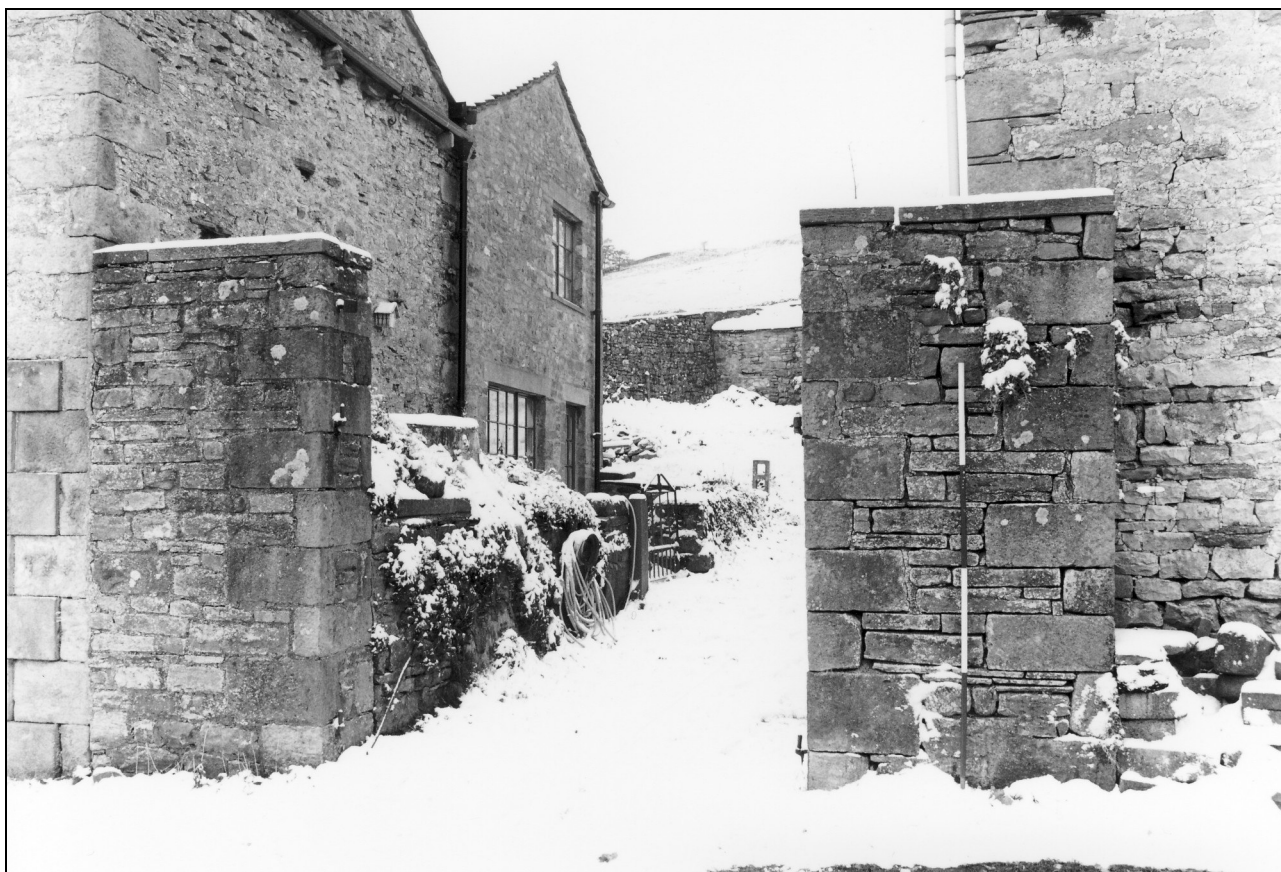
Photo 7: Gateway at west side, from the south

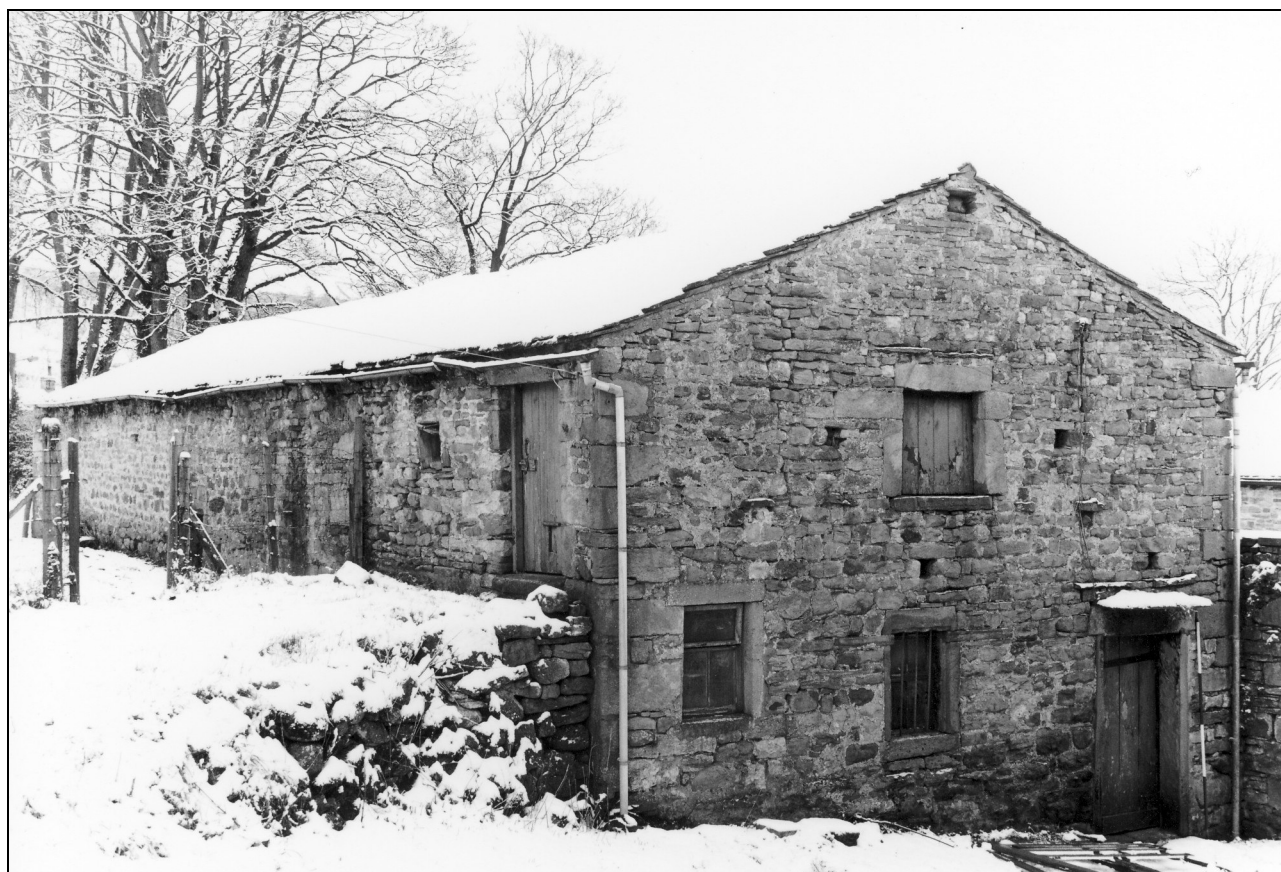
Photo 9: The barn, from the north-west

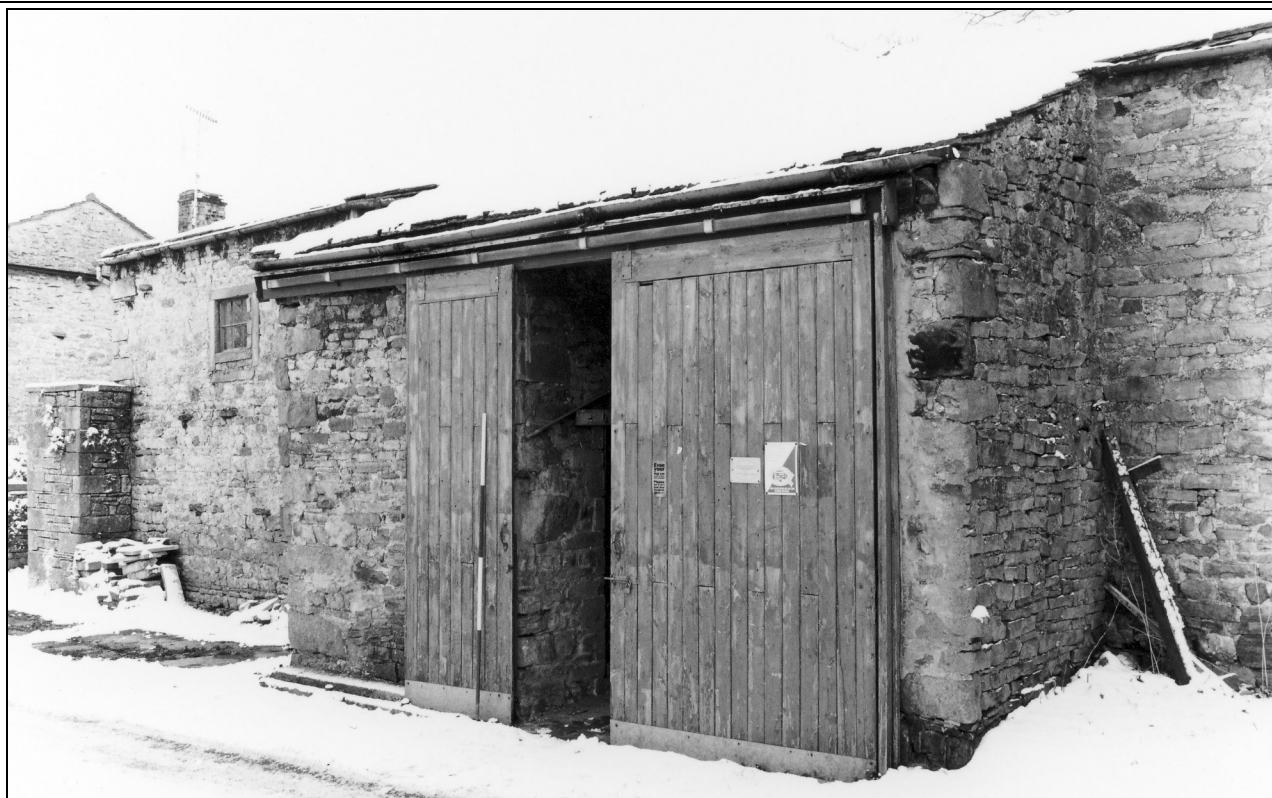
Photo 11: Barn porch, from the south-east

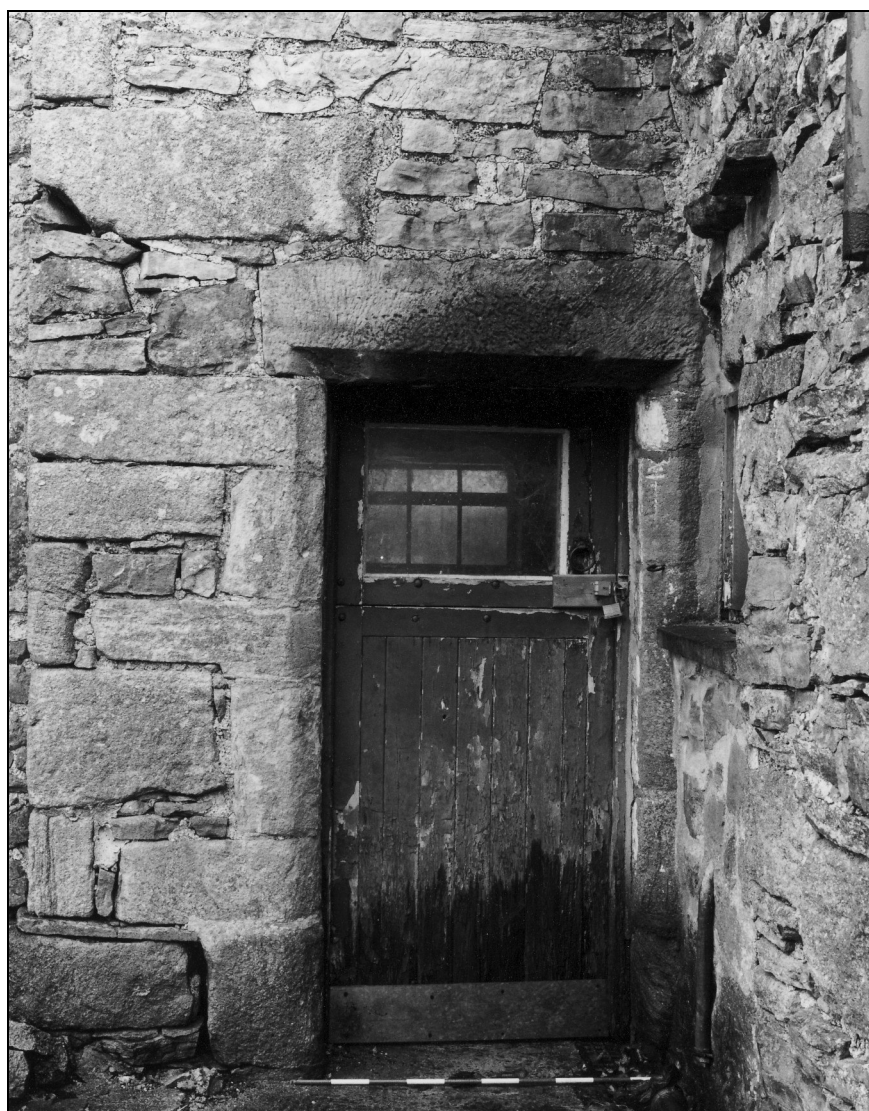
Photo 13: Detail of chamfered doorway to shippon in barn

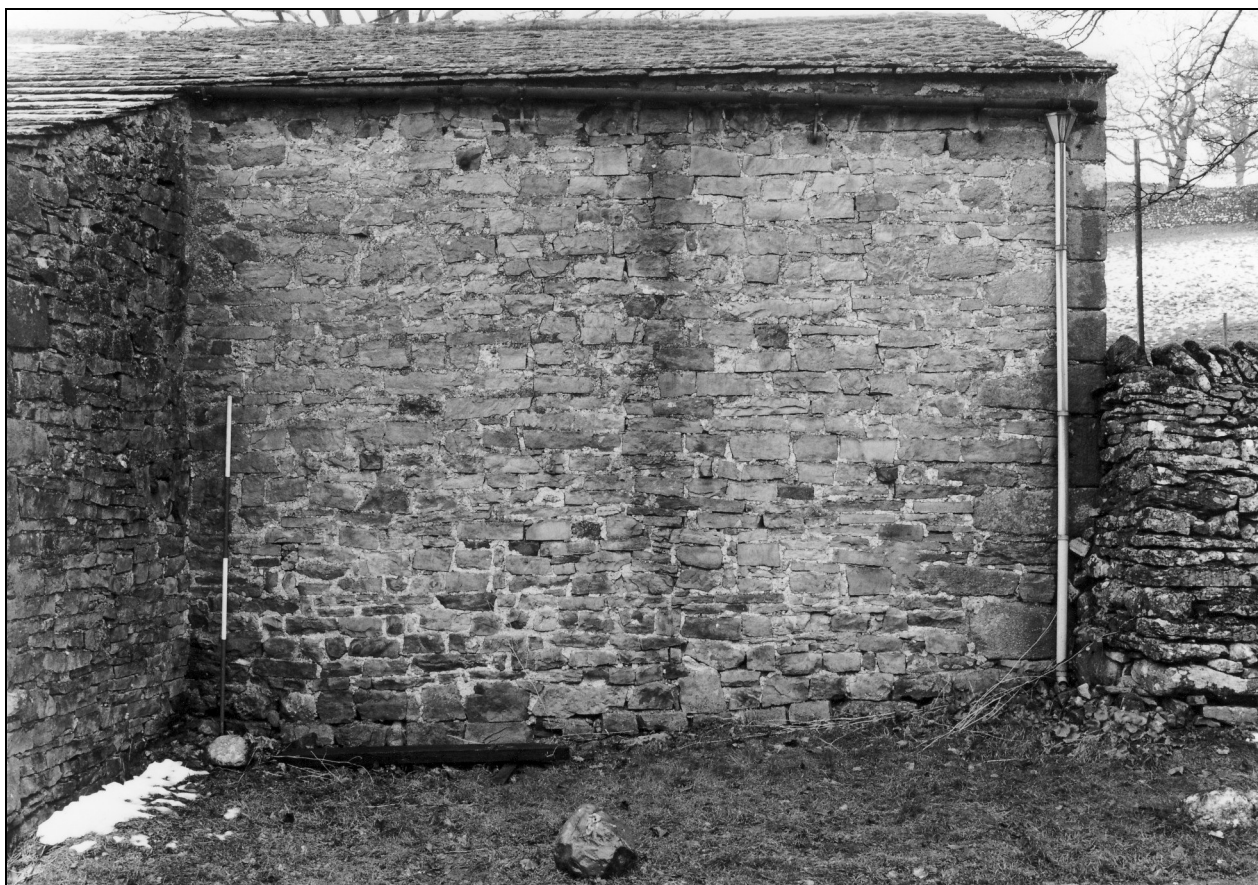
Photo 14: South side of barn to east of porch, showing row of blocked breathers

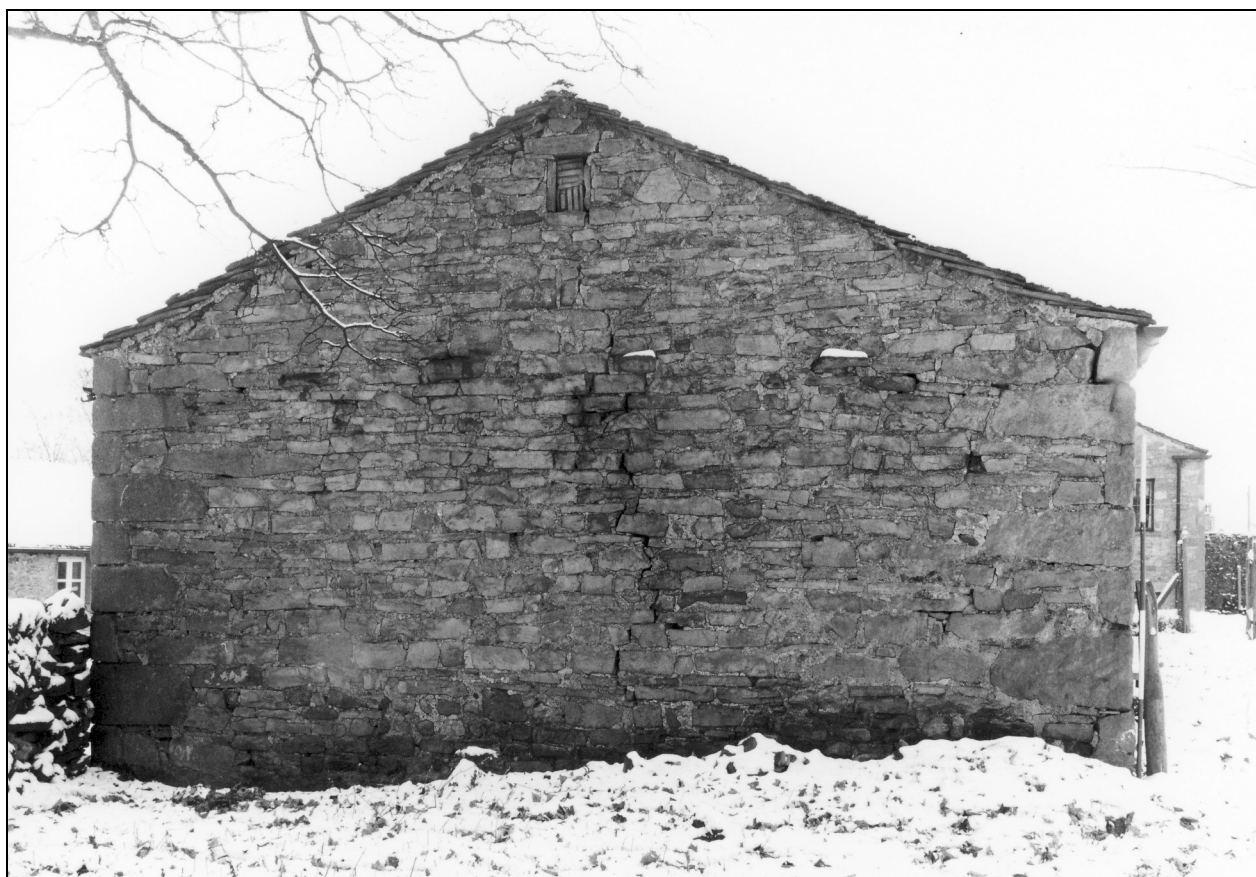
Photo 16: The east gable

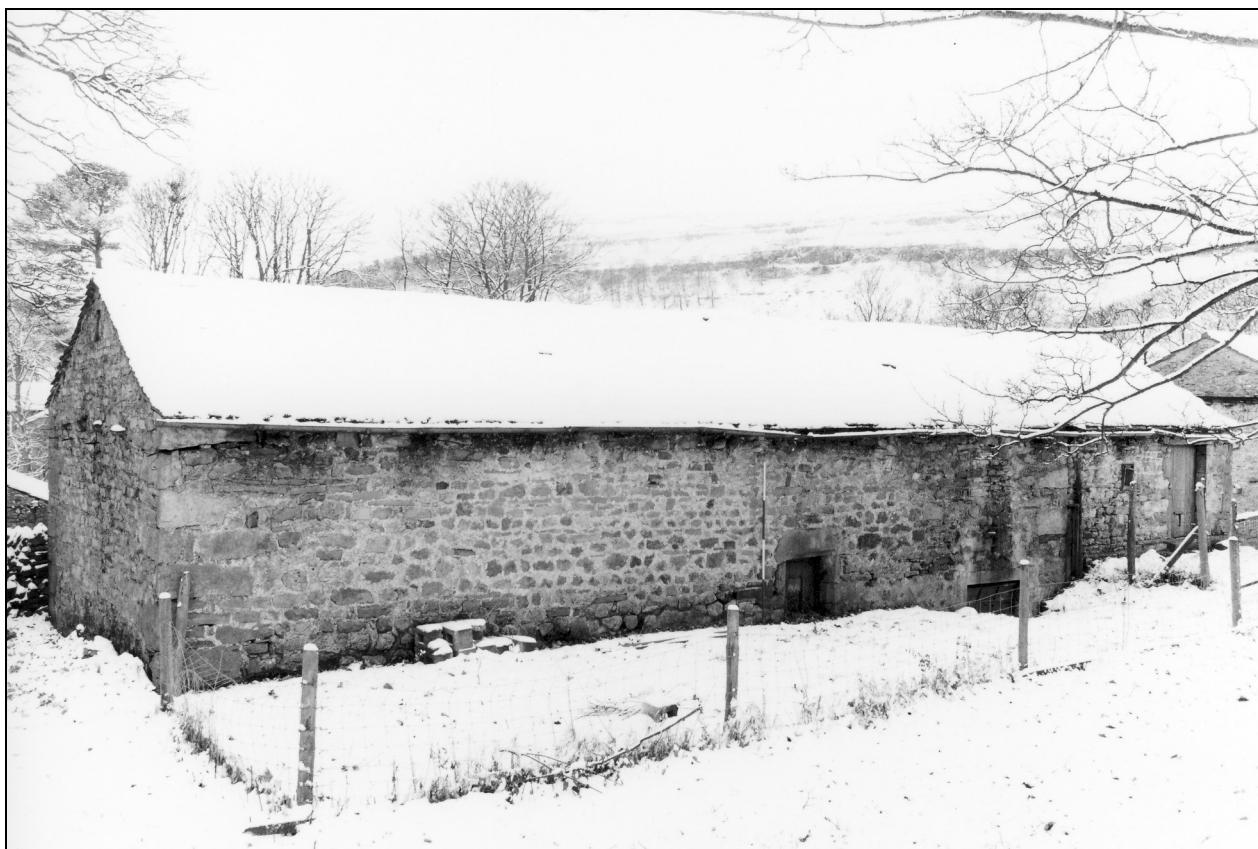
Photo 17: The barn, from the north-east

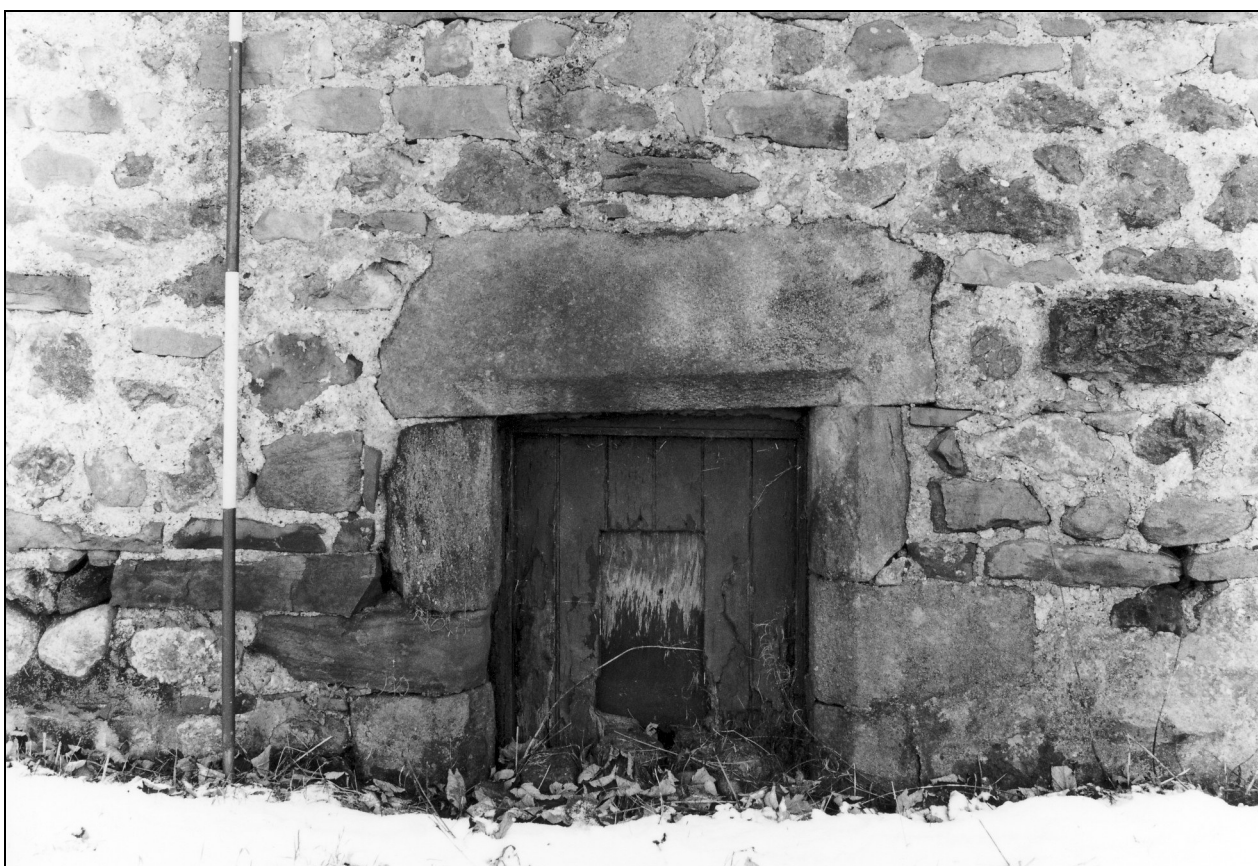
Photo 18: Detail of former doorway in north elevation

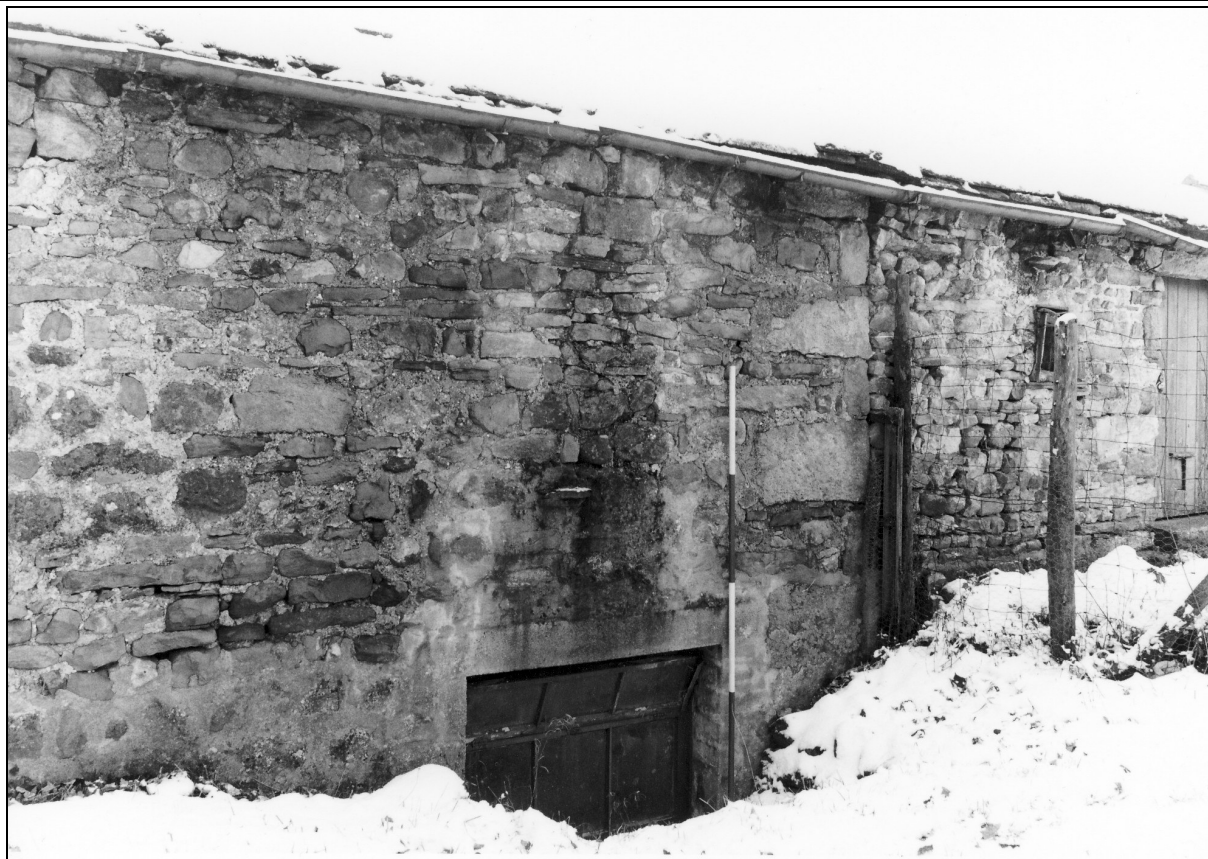
Photo 19: Window in north elevation of barn

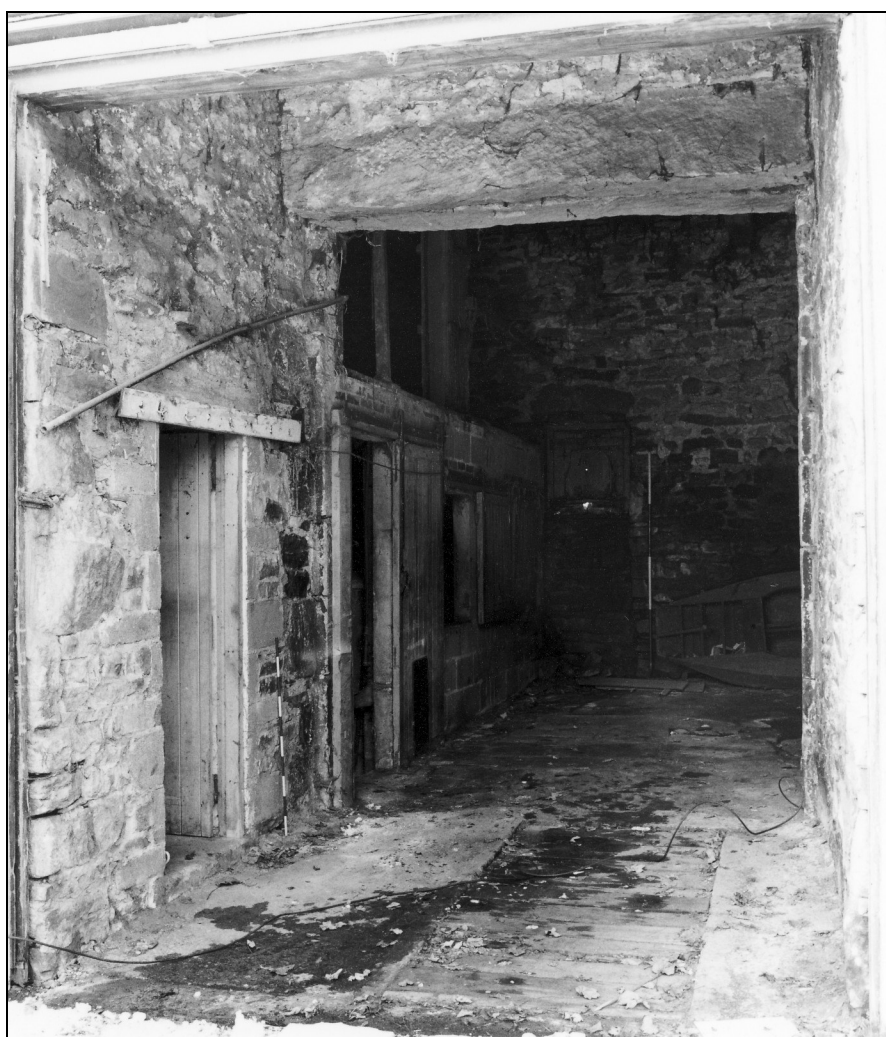
Photo 20: View into barn porch and threshing floor, from the south-east

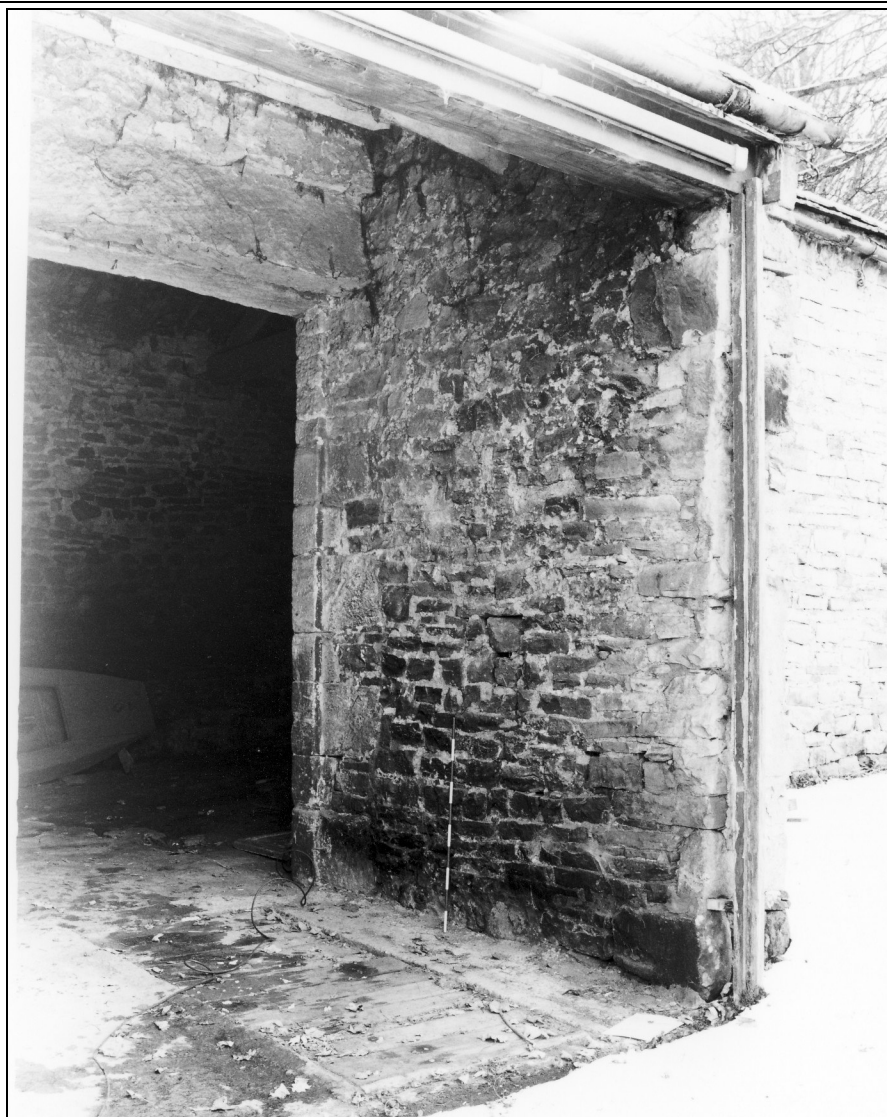
Photo 21: View into barn porch, from the south-west

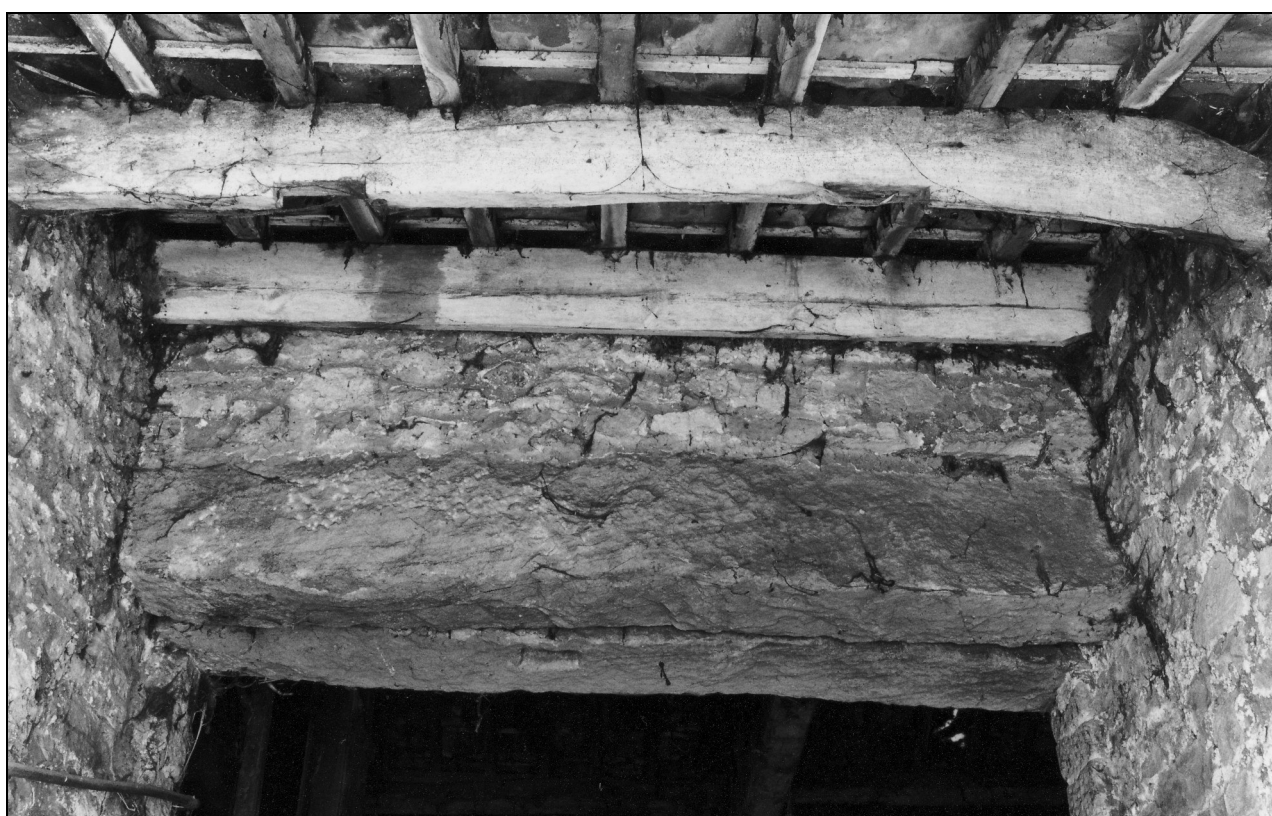
Photo 22: Stone lintels of barn entrance and purlins of porch roof

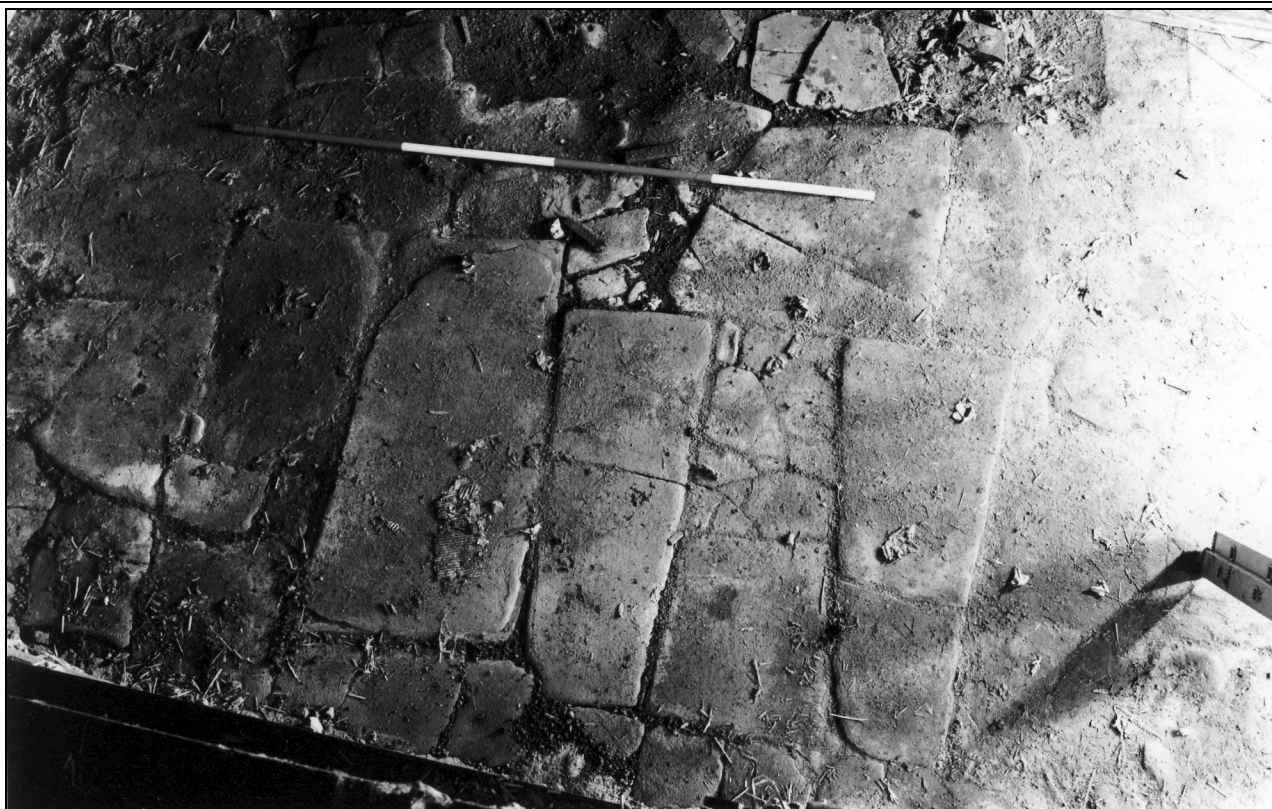
Photo 25: Vertical view of threshing floor, from the west

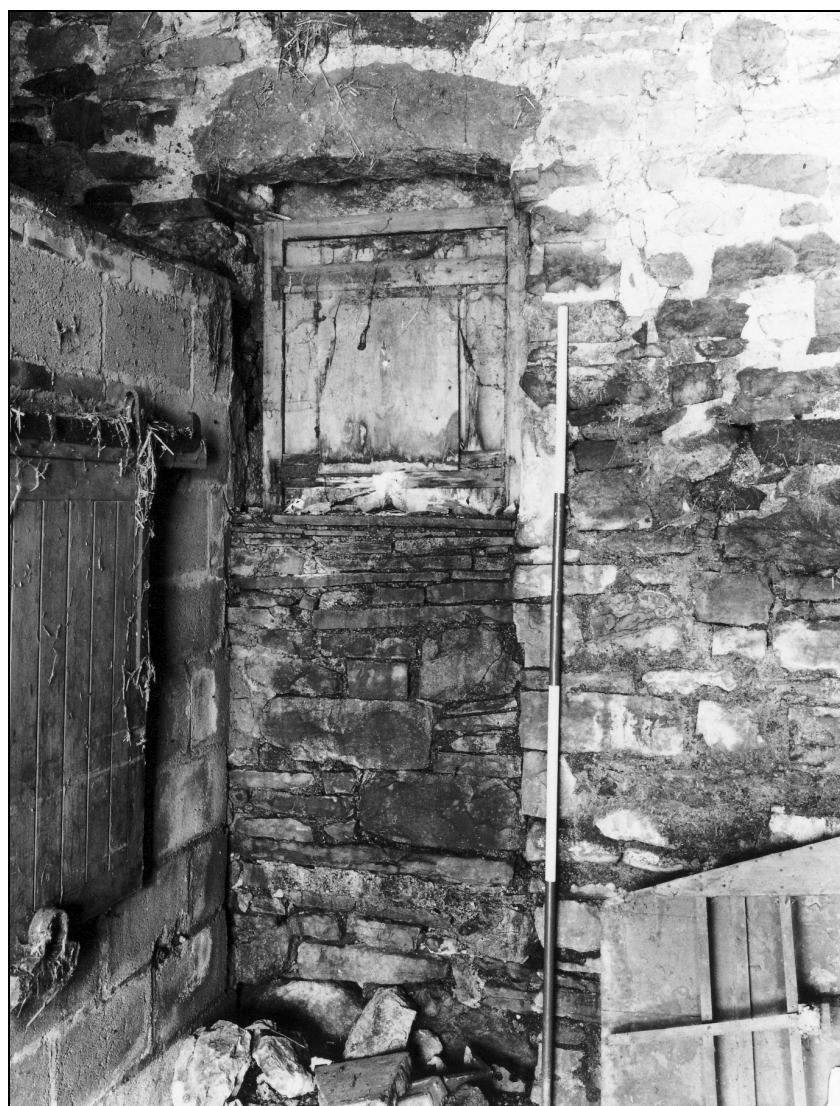
Photo 26: Former doorway in north side of threshing bay
