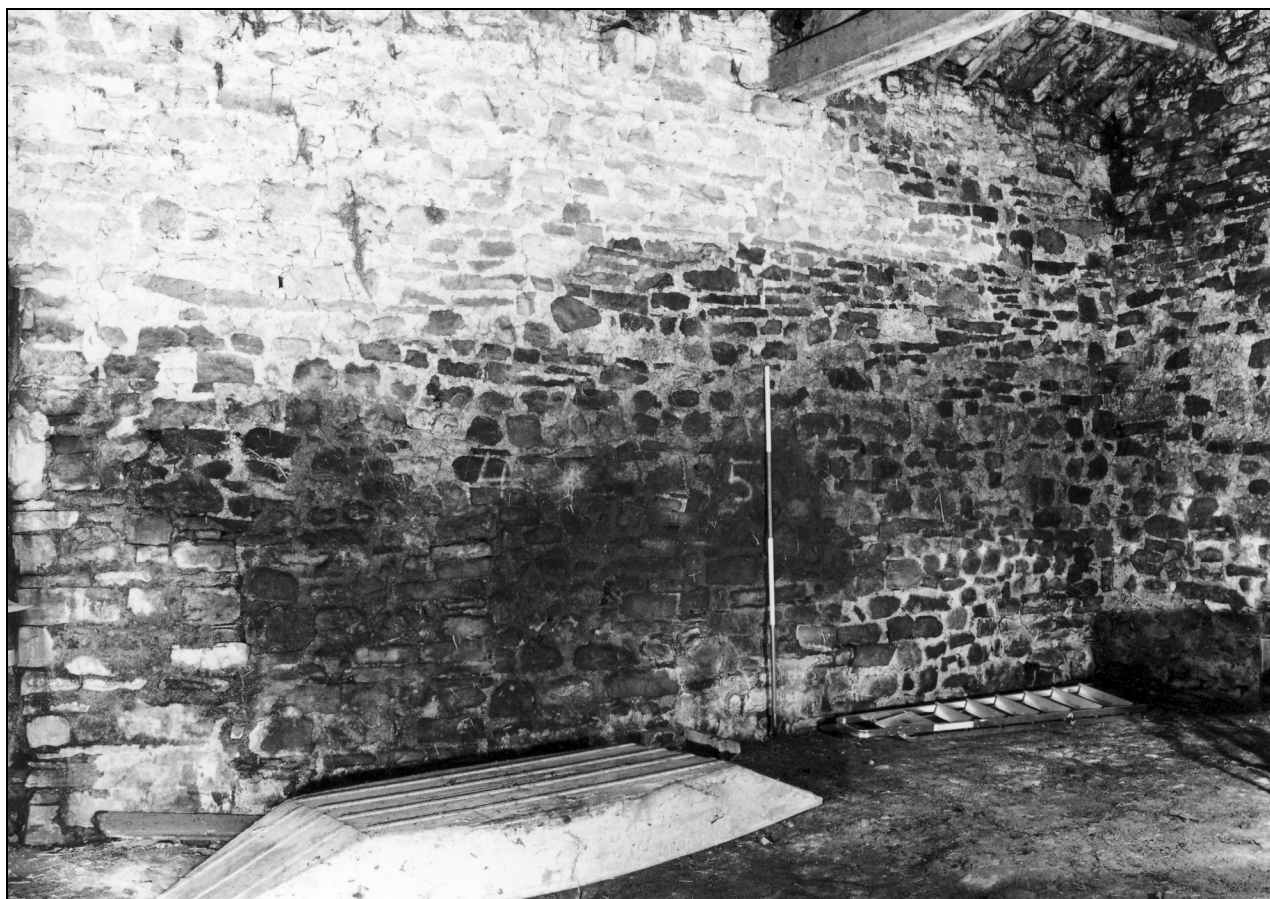
Photo 27: Mewstead, from the south-west (note possible blocked doorway at left)

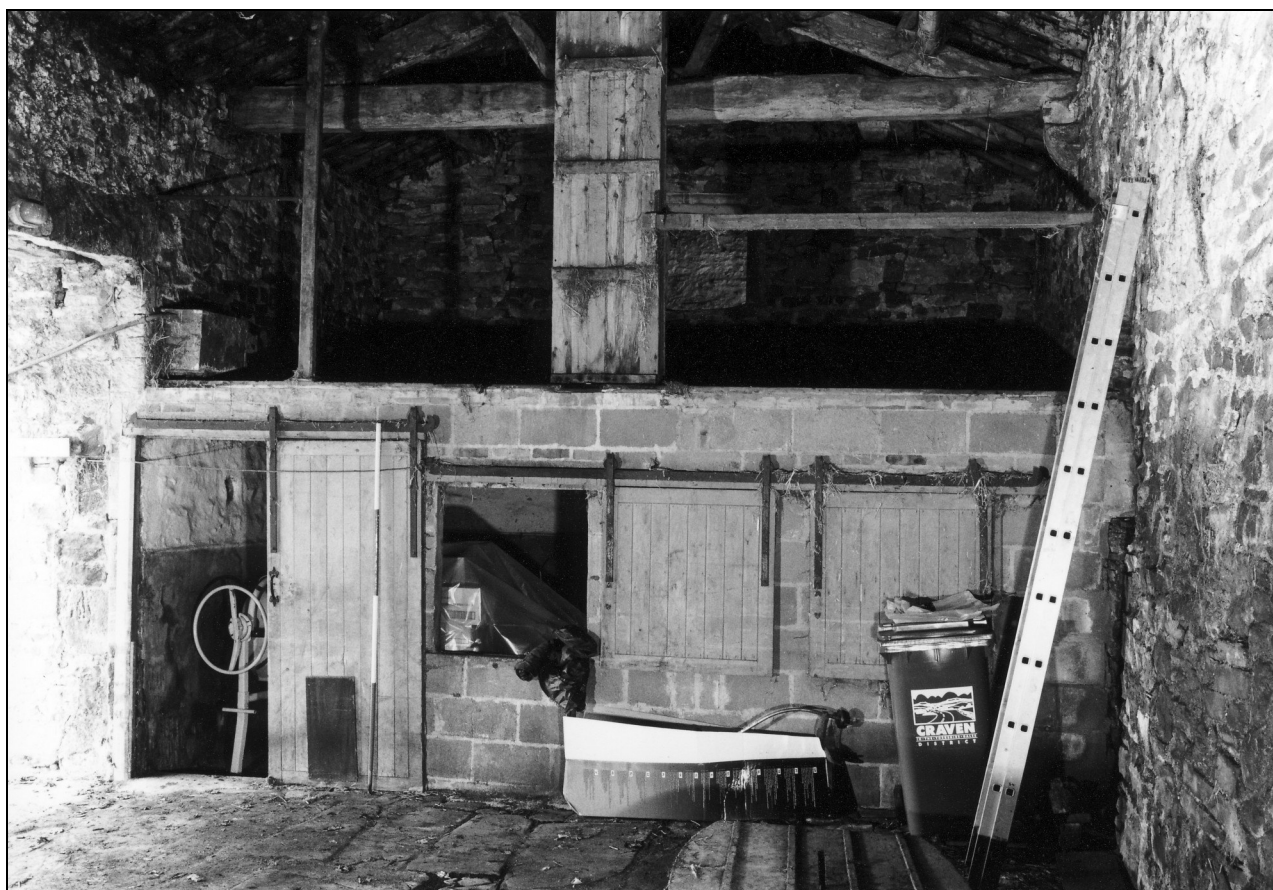
Photo 30: Shippon in west end of barn, from the east

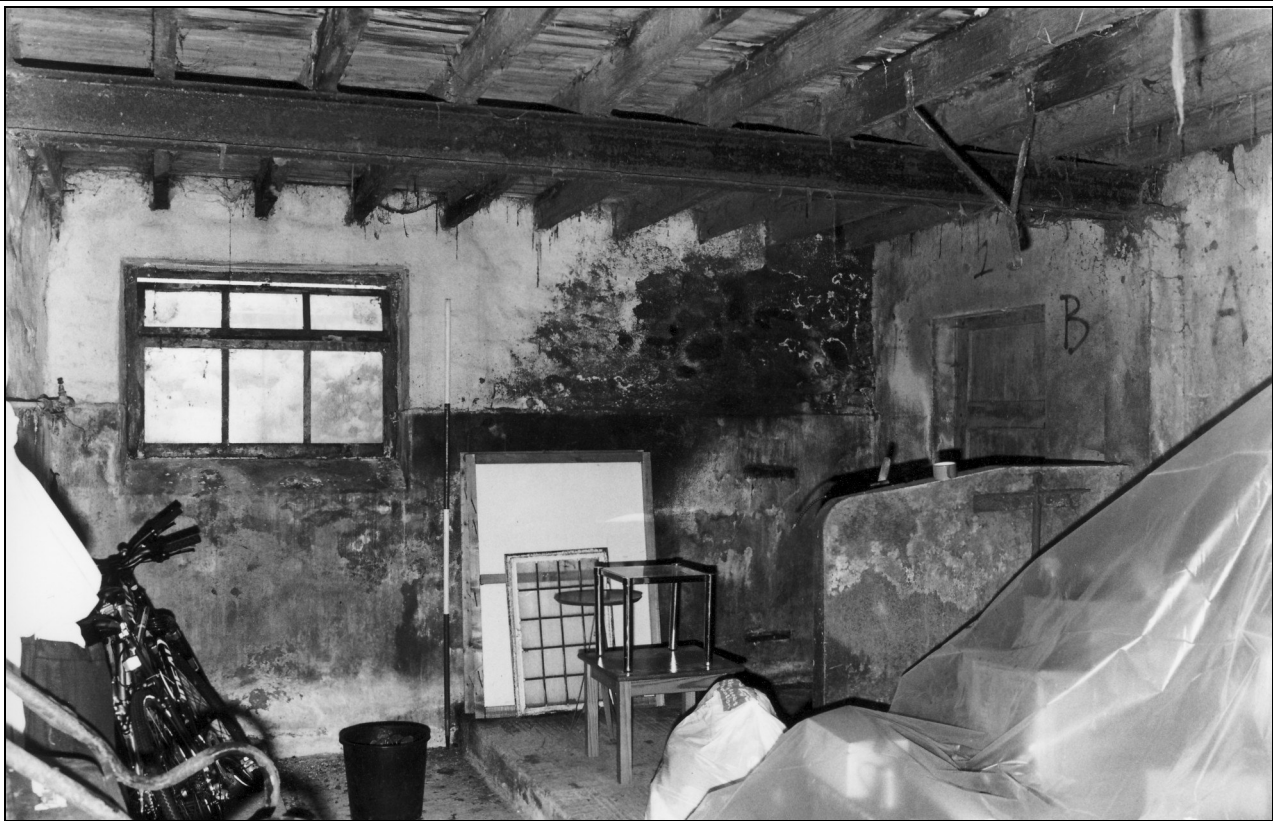
Photo 32: Interior of shippon, from the south (refitted in 20th century)

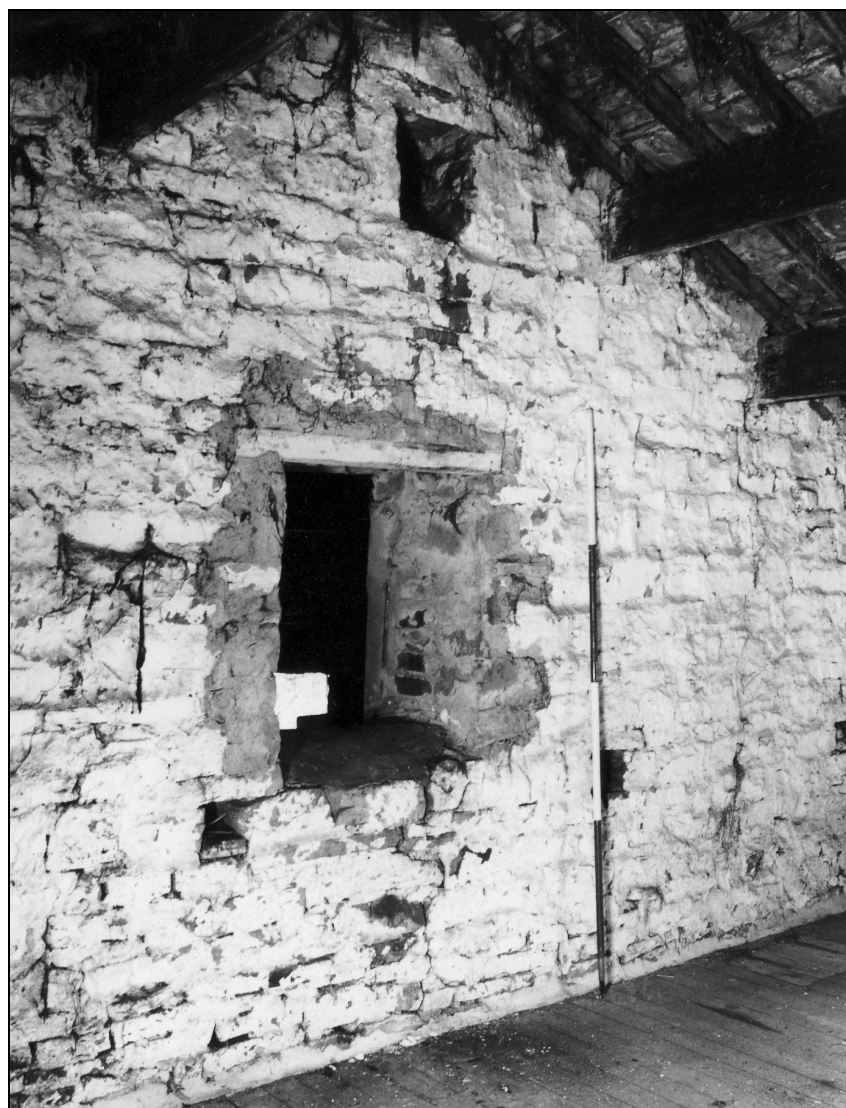
Photo 33: Inserted first floor opening, and earlier owl hole, between lofts in stable and barn, from the west

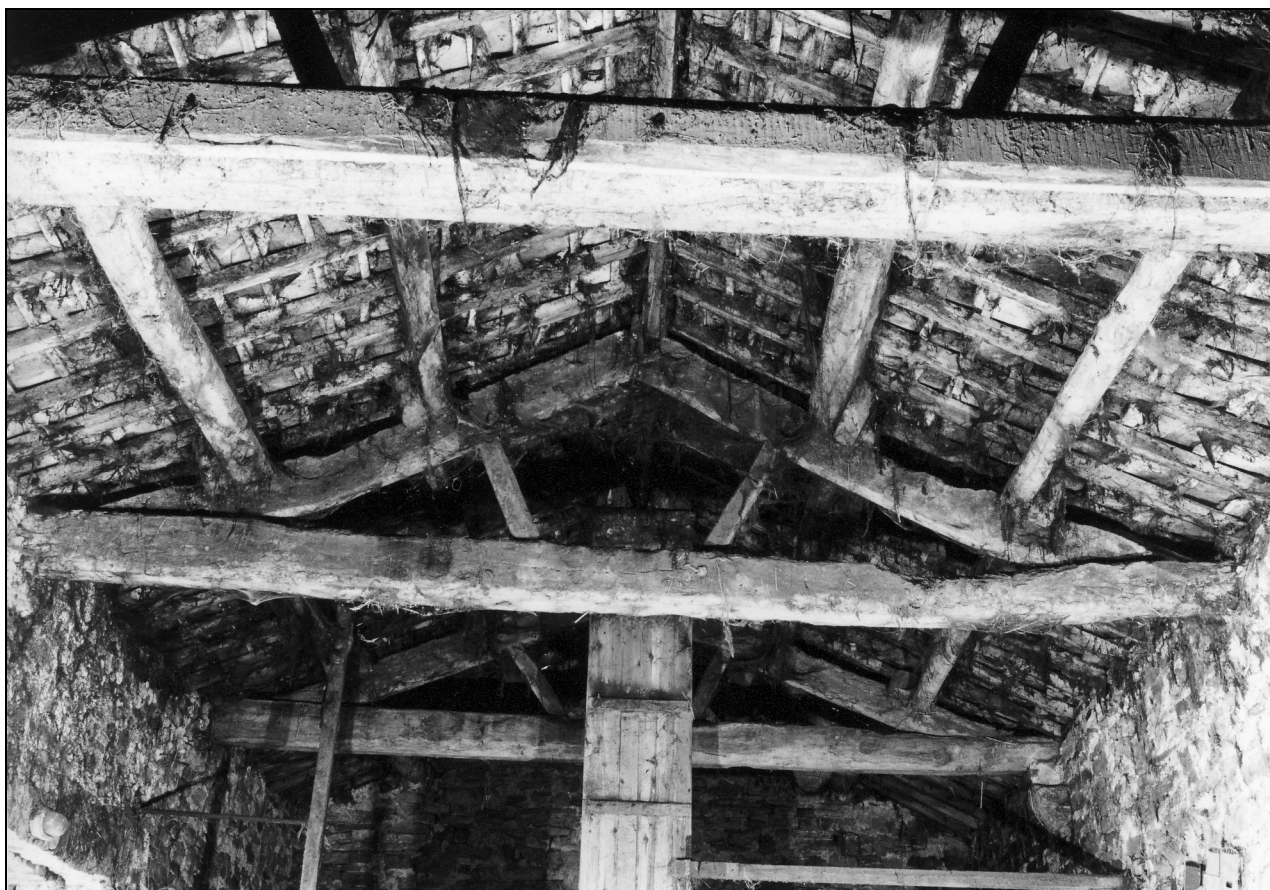
Photo 35: Central roof truss, from the east

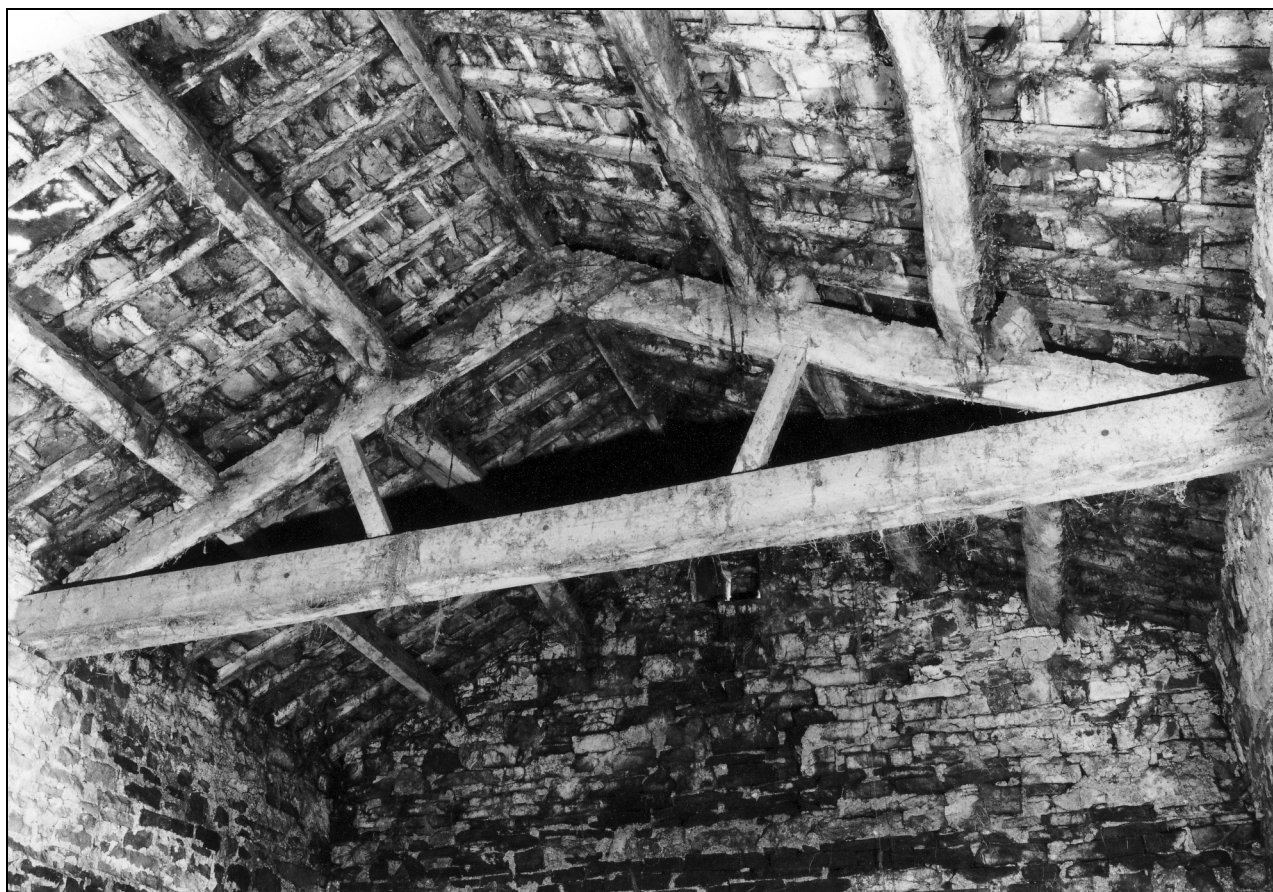
Photo 37: East roof truss, from the west

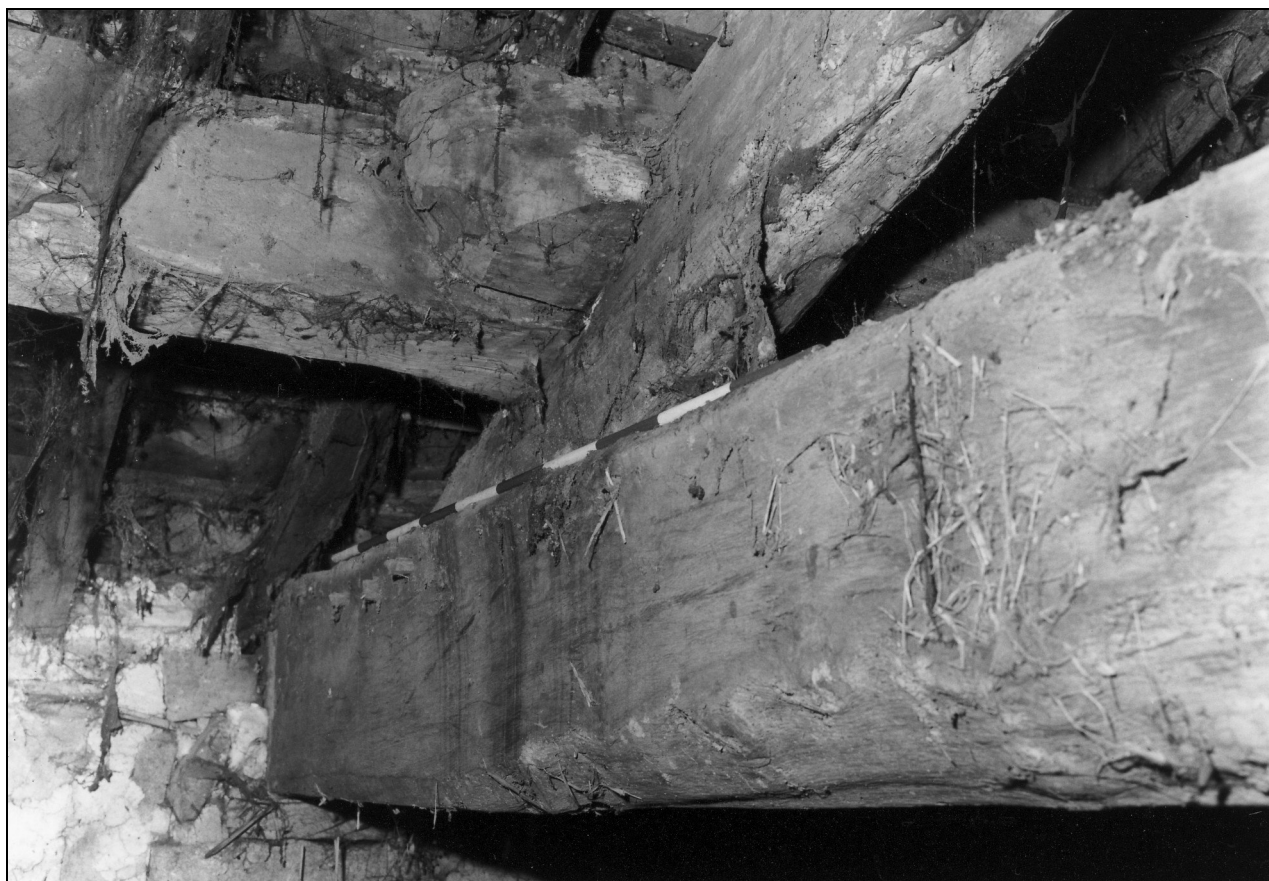
Photo 39: South end of west roof truss, from the north-east

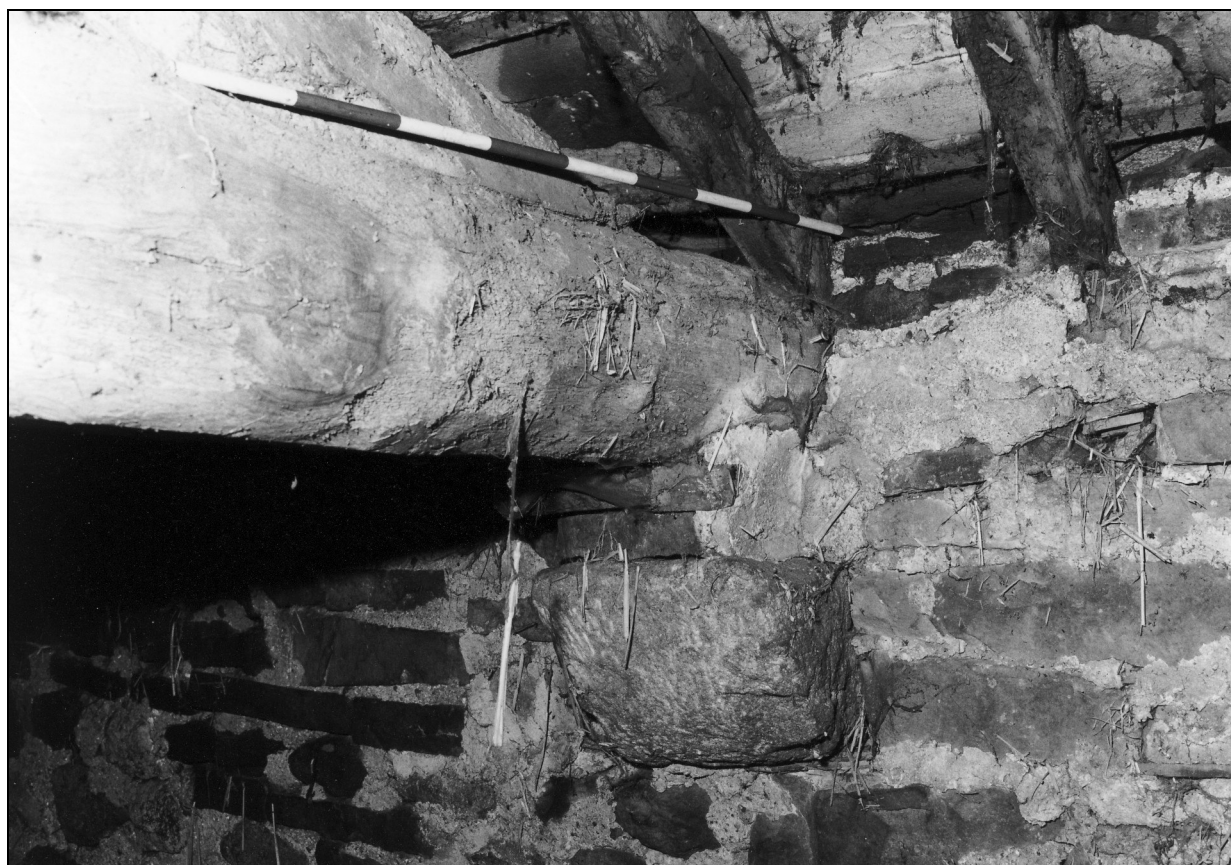
Photo 41: North end of west roof truss, with corbel, from the south-east

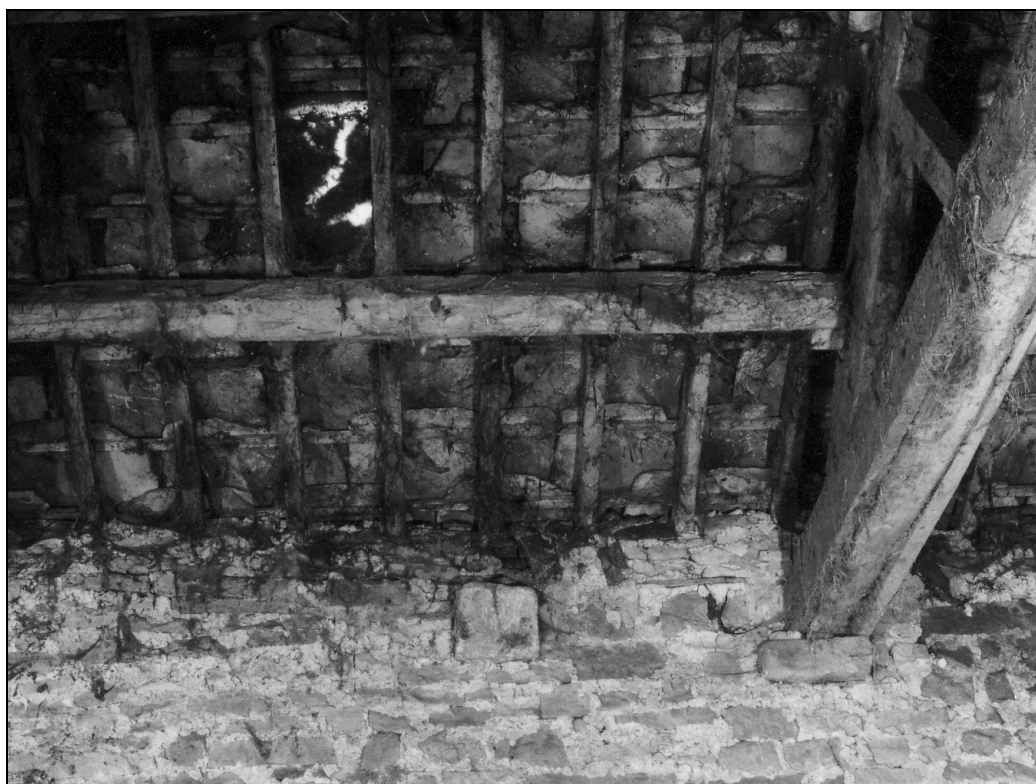
Photo 42: Redundant corbel in north side of mewstead

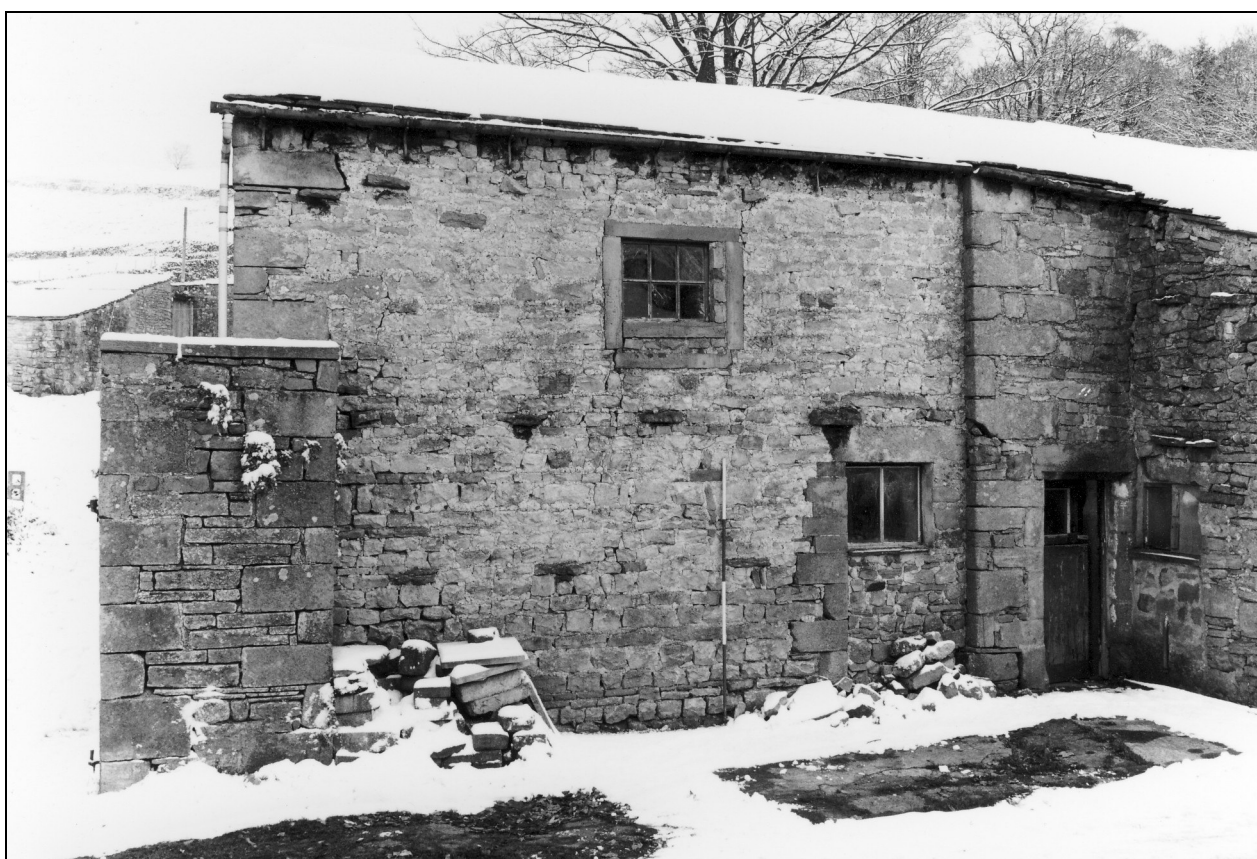
Photo 43: South side of stable

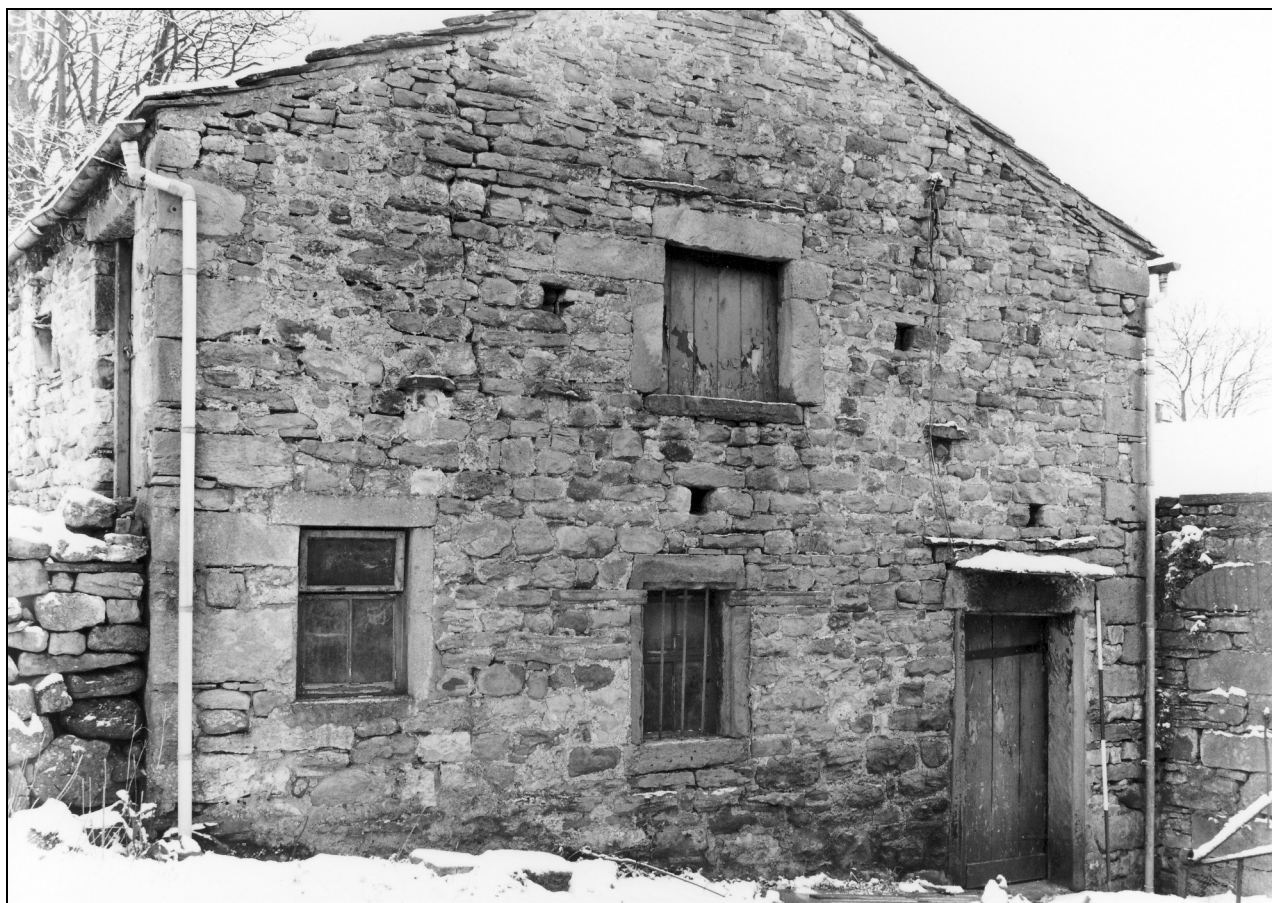
Photo 44: The west gable

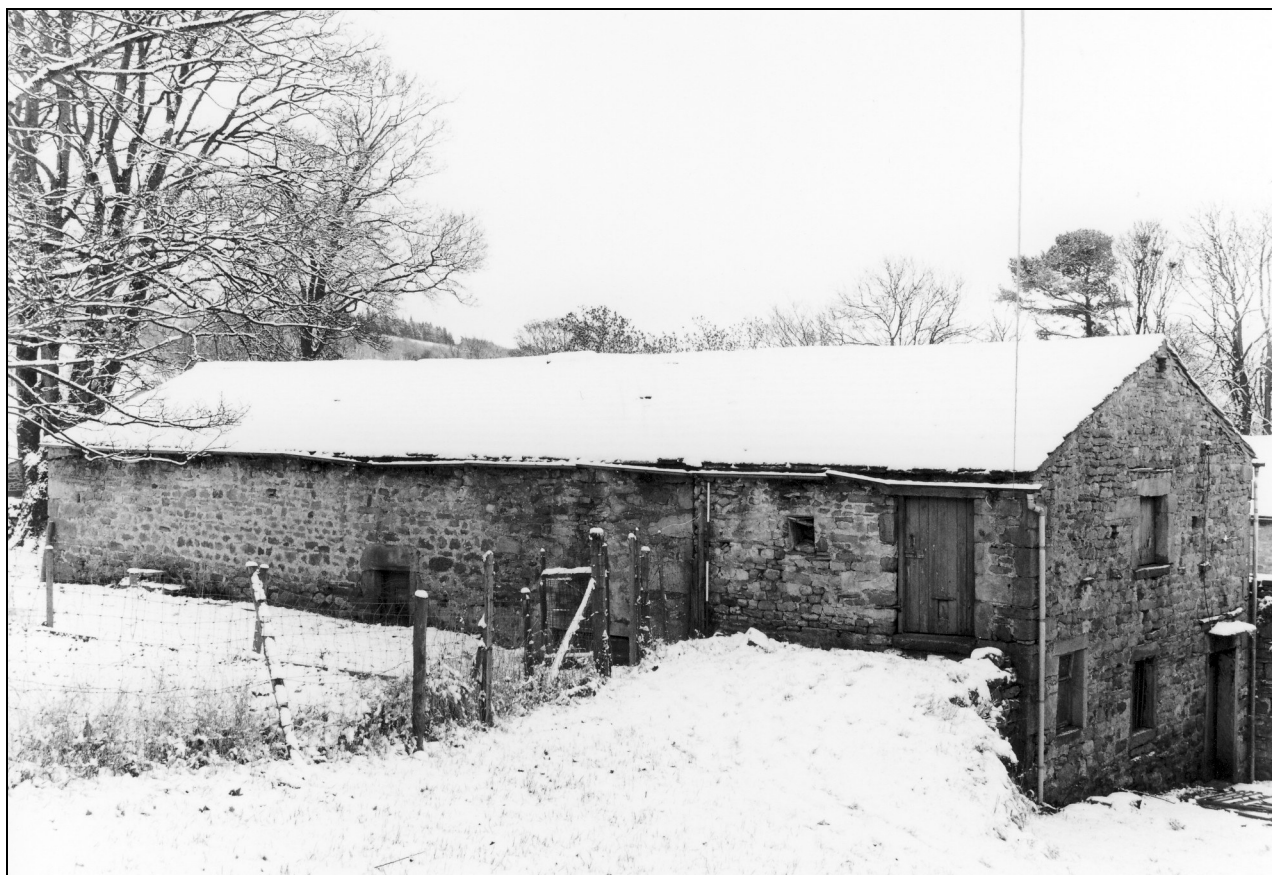
Photo 45: The barn, from the north-west

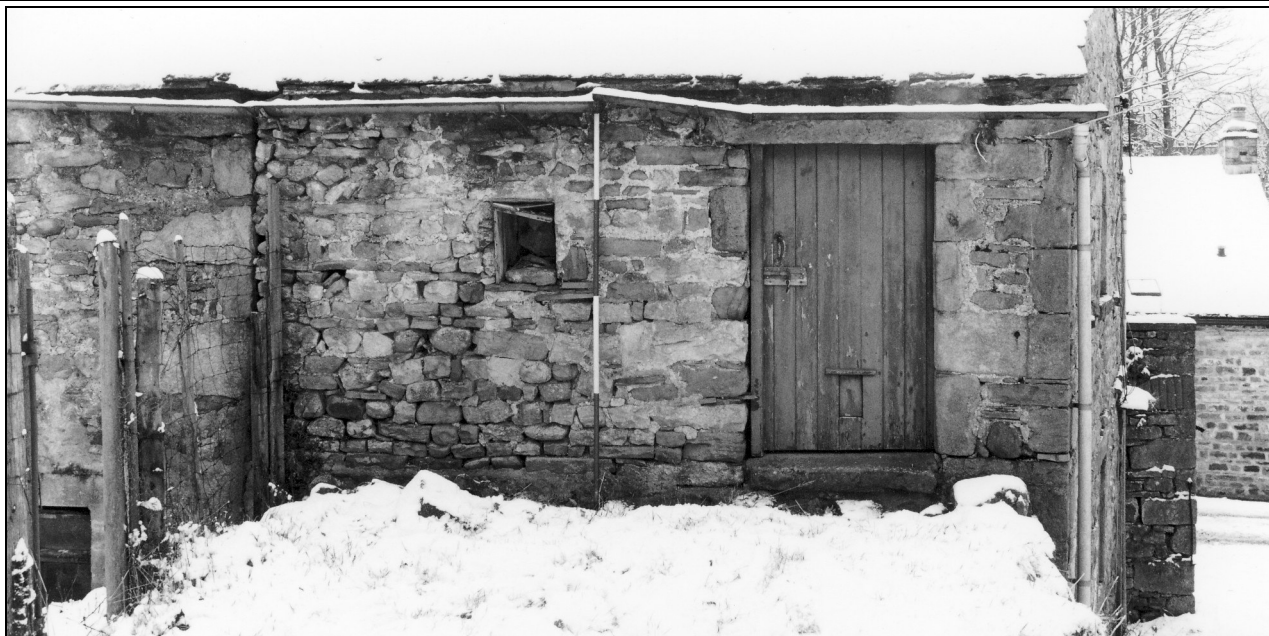
Photo 46: Rear elevation of stable feed loft

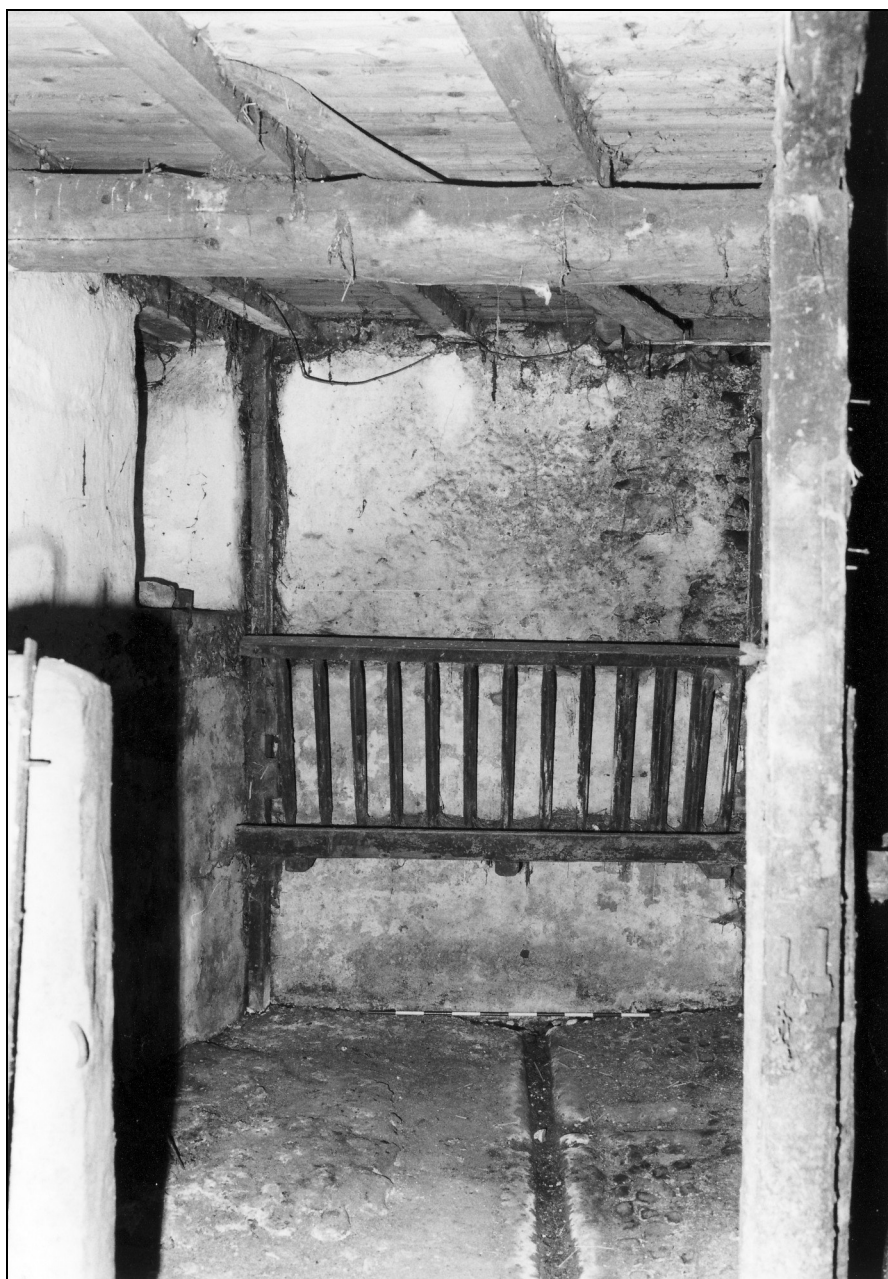
Photo 47: North-west stall in stable, from the south

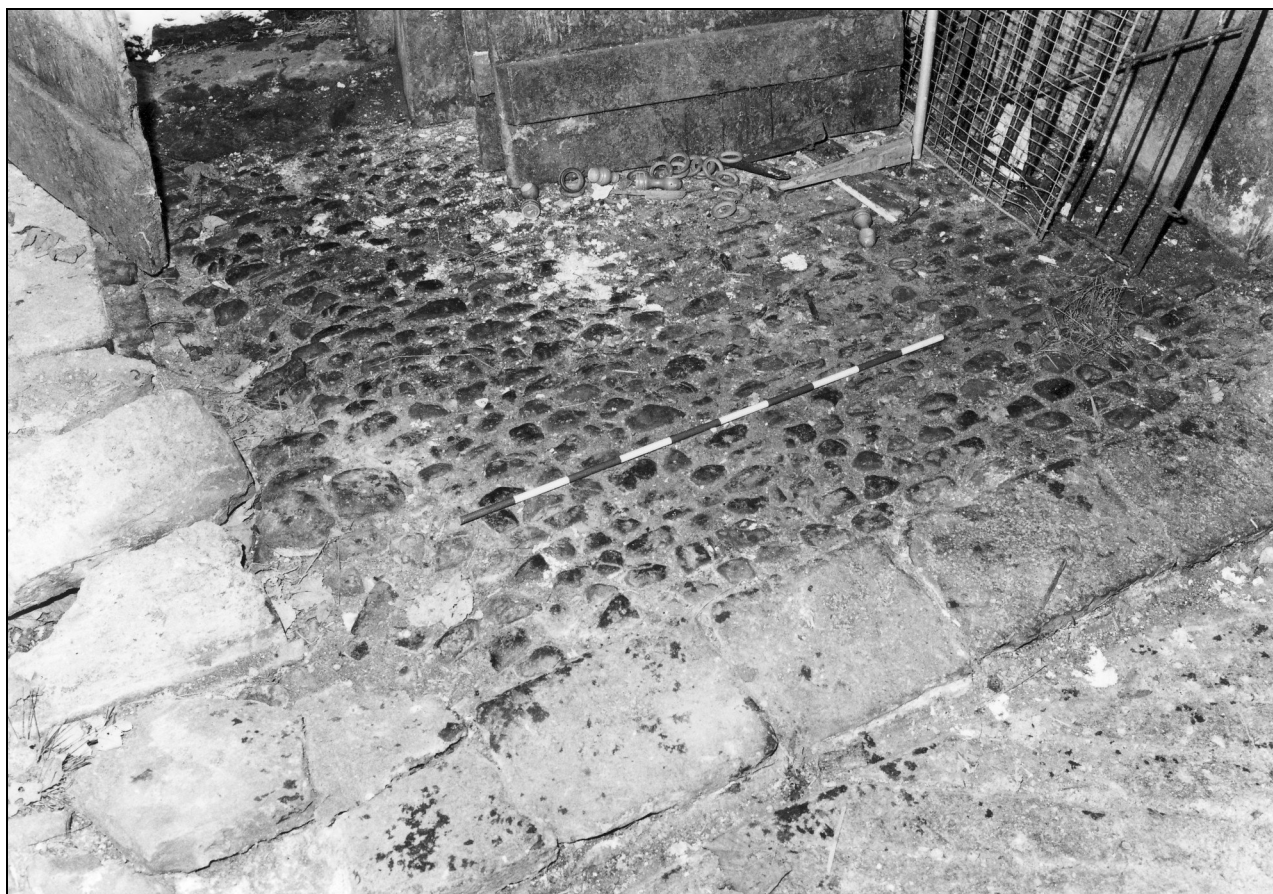
Photo 51: Cobbled floor and stone kerb in stable, from the east

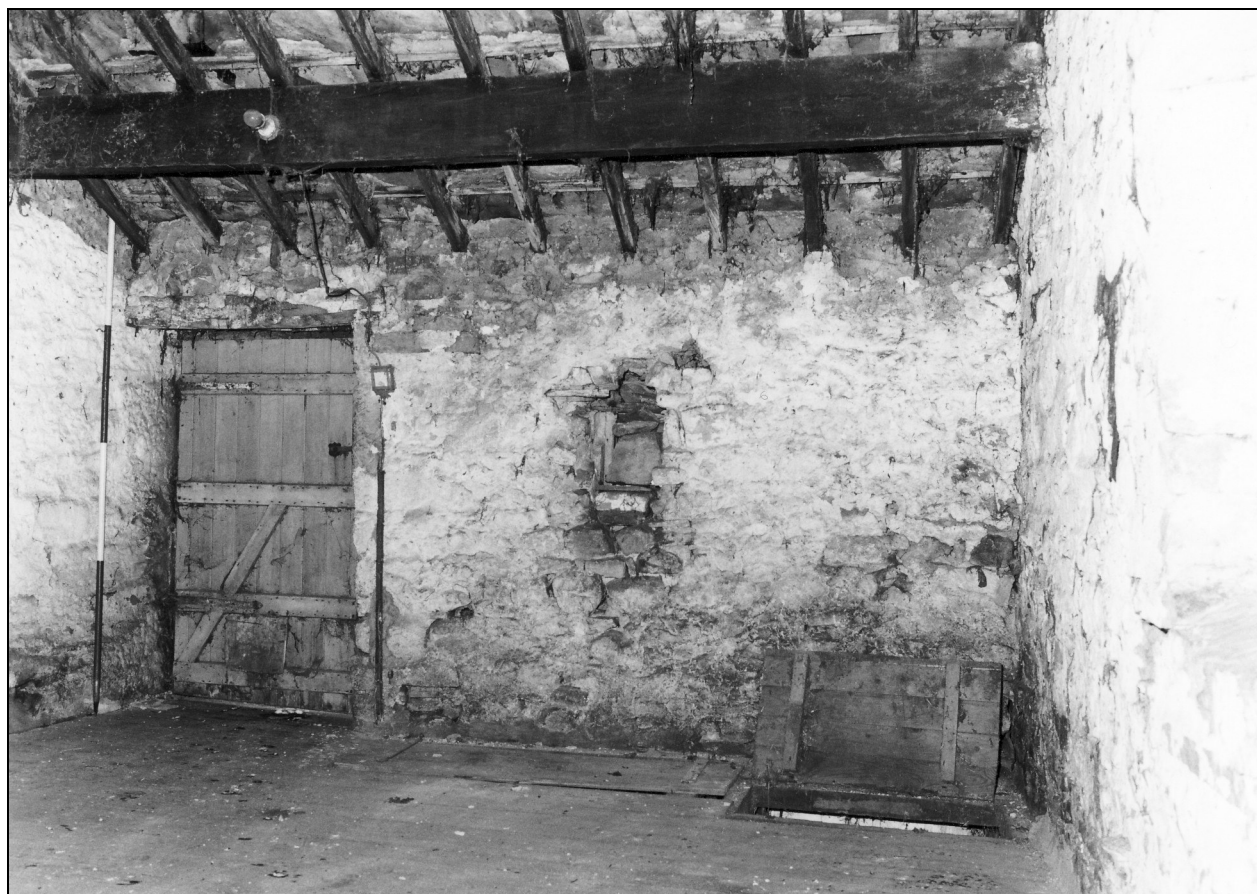
Photo 53: Hay loft over stable, from the south-east

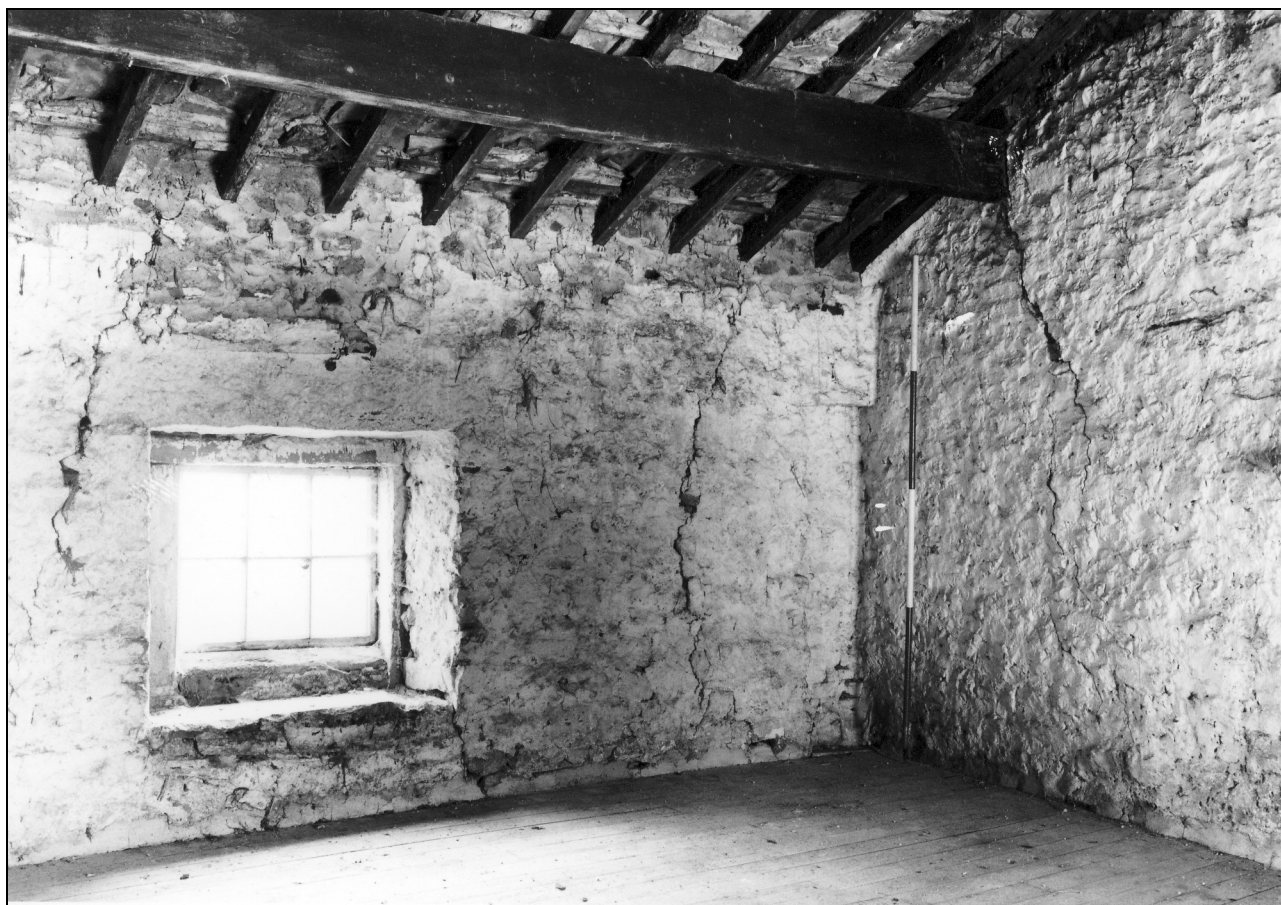
Photo 54: Hay loft over stable, from the north-east

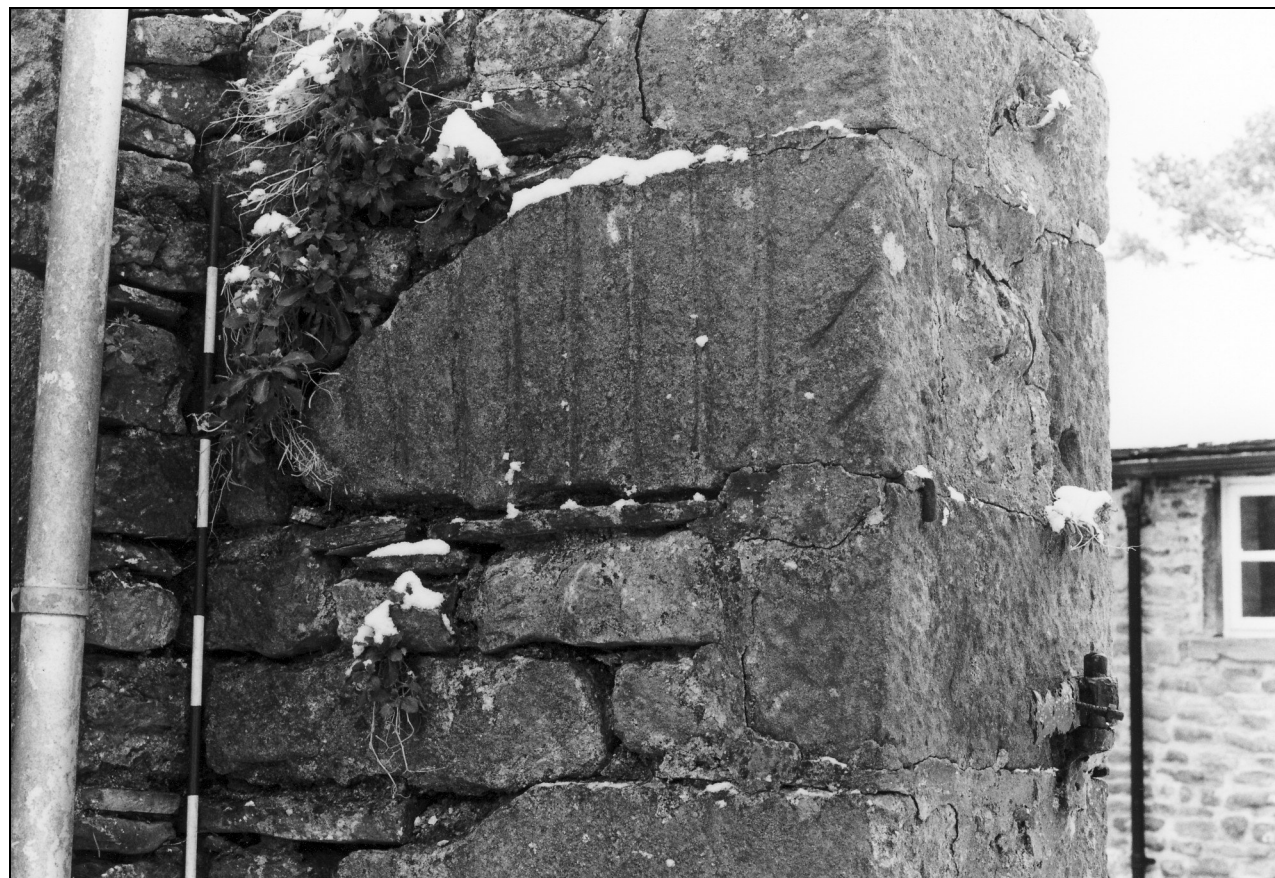
Photo 56: Detail of millstone fragment in east gate pier
