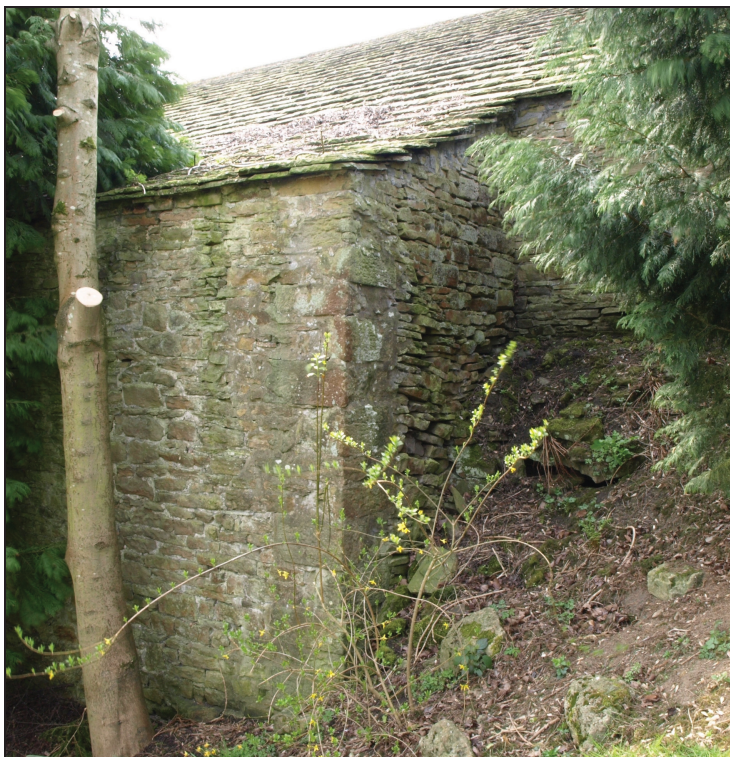
Photo 23: North corner of wheel-house, with bank of pond dam at foot

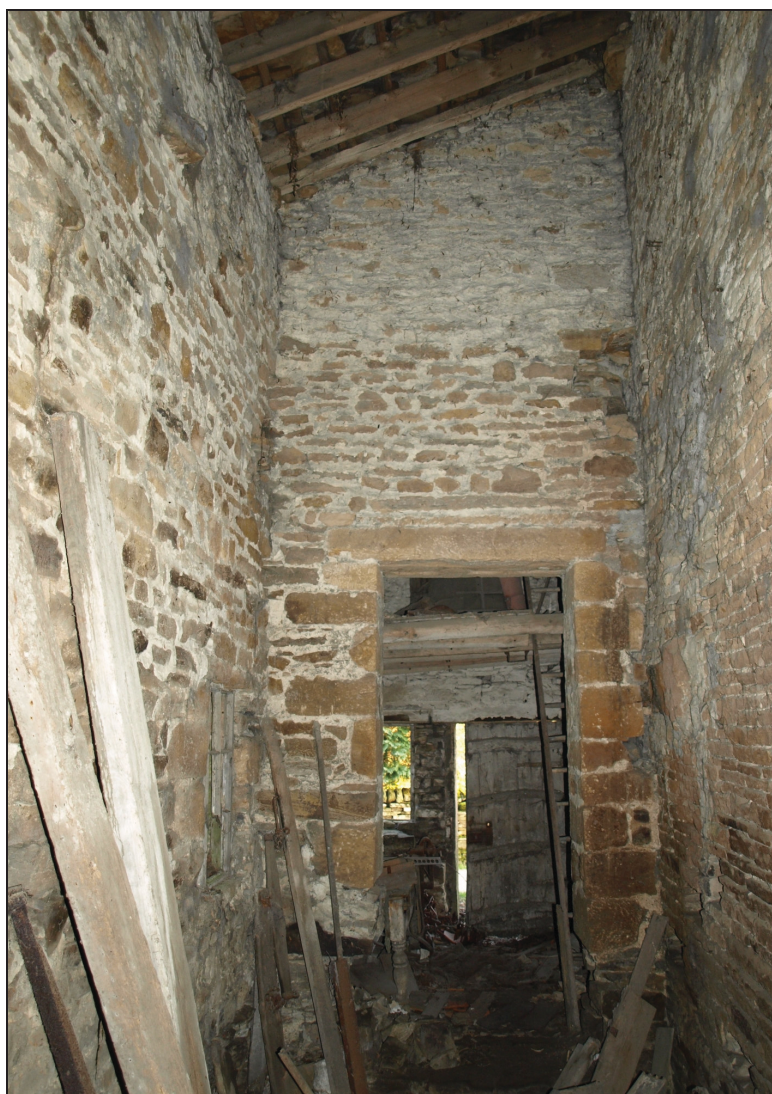
Photo 24: Interior of wheel-house, from the north-west

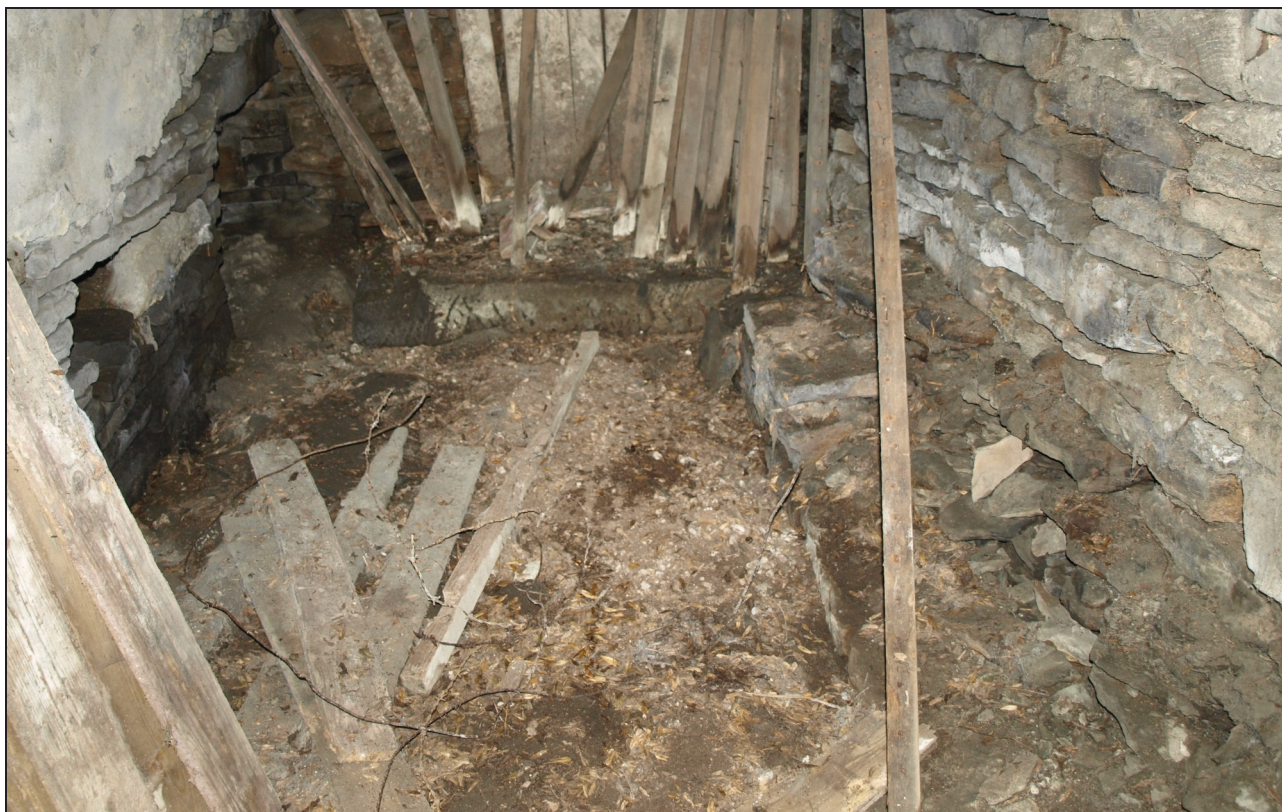
Photo 25: North-west end of infilled wheel-pit

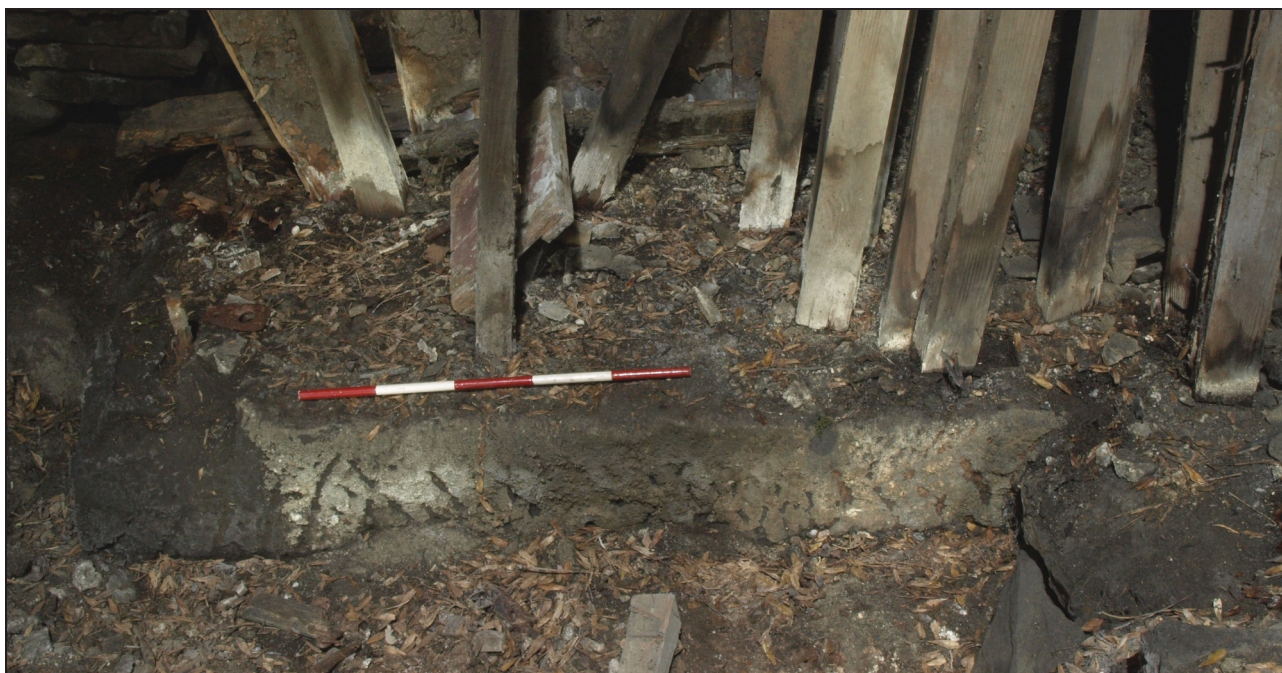
Photo 26: Stone block with embedded bolts at north-west end of wheel-pit

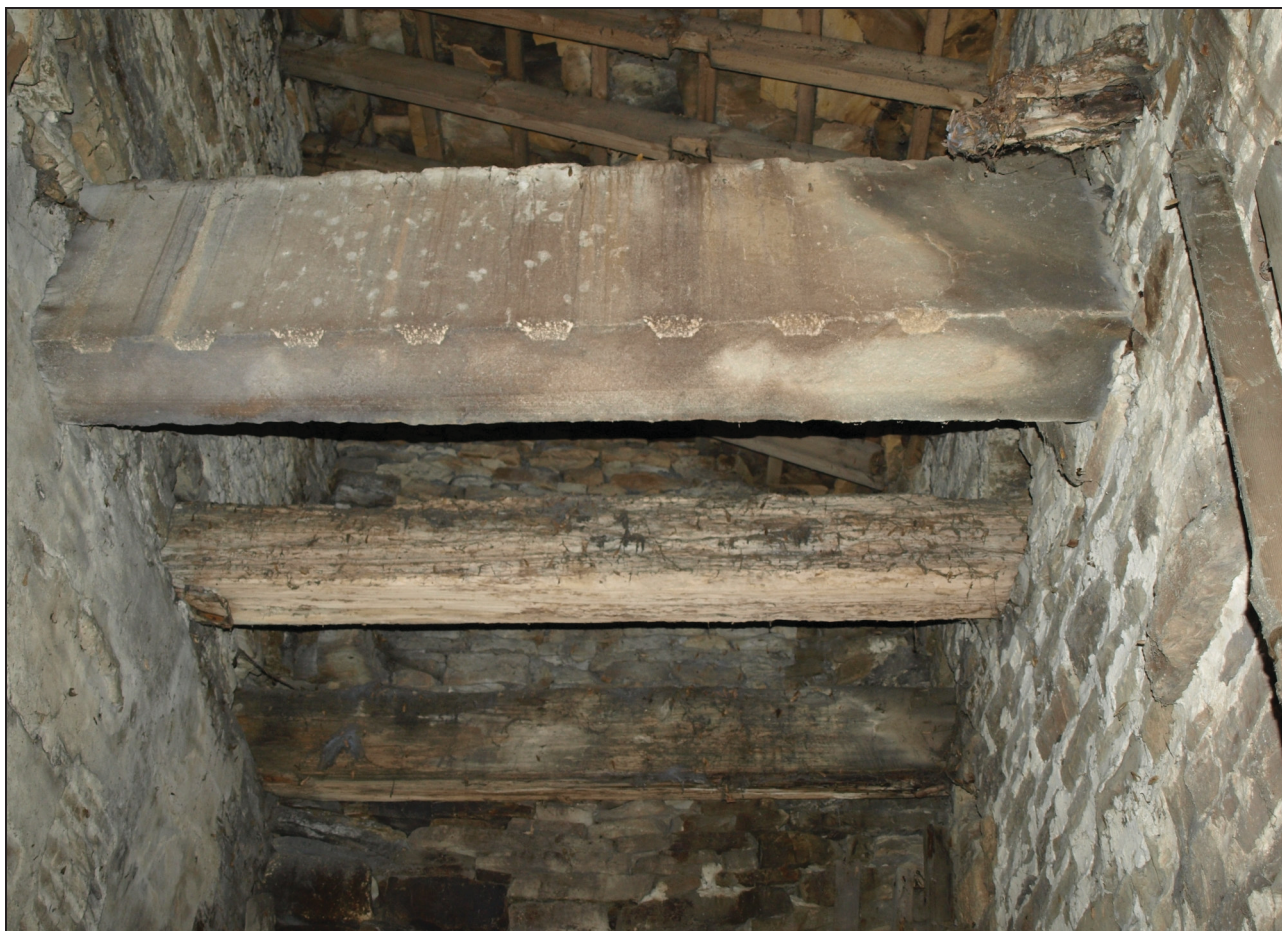
Photo 27: Stone block and timber beams spanning north-west end of wheel-house

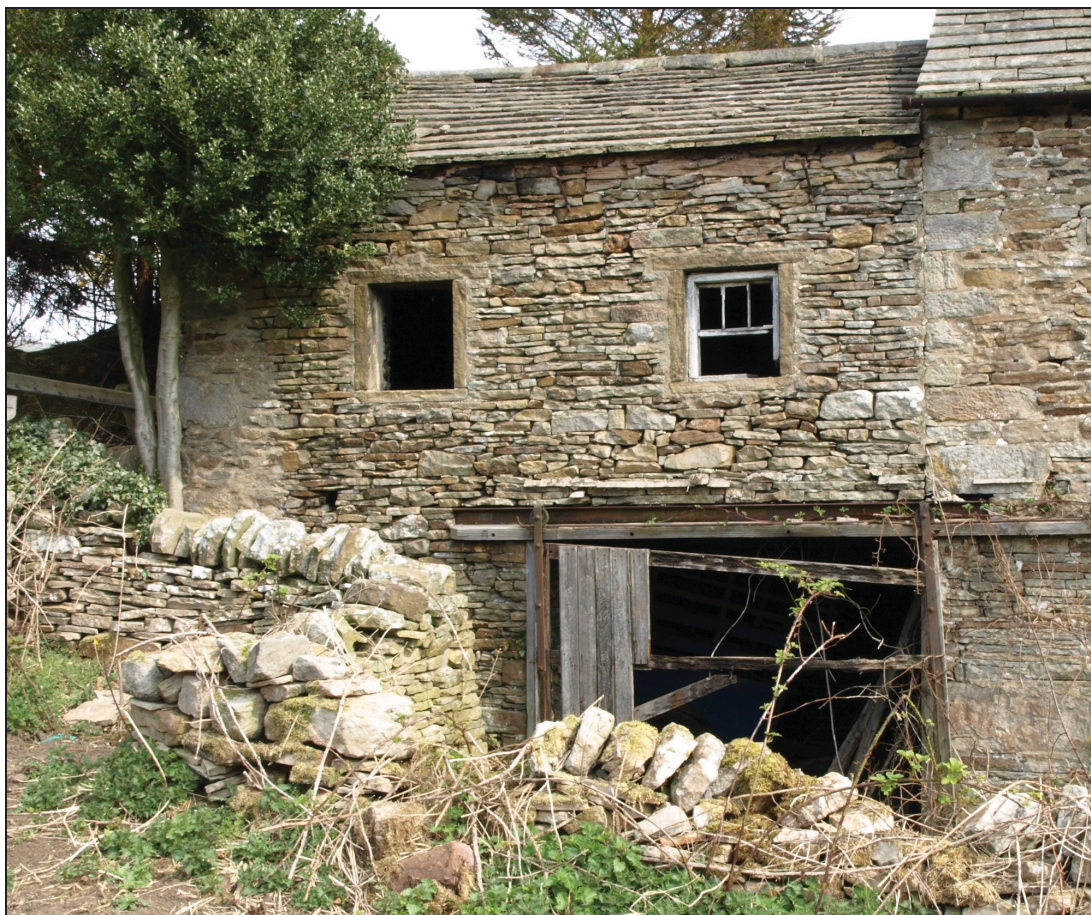
Photo 28: Front of added store at north-west end of main building

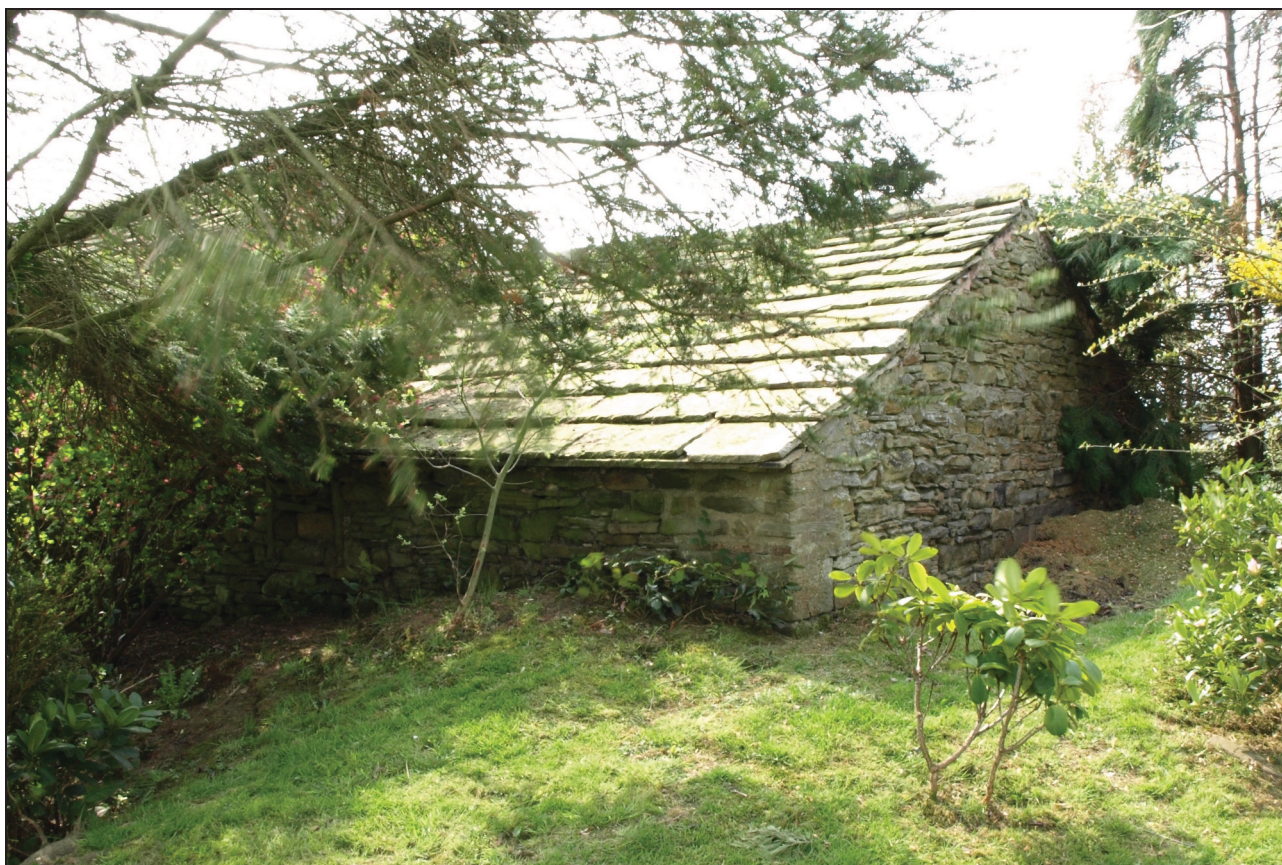
Photo 29: Rear of added store at north-west end of main building

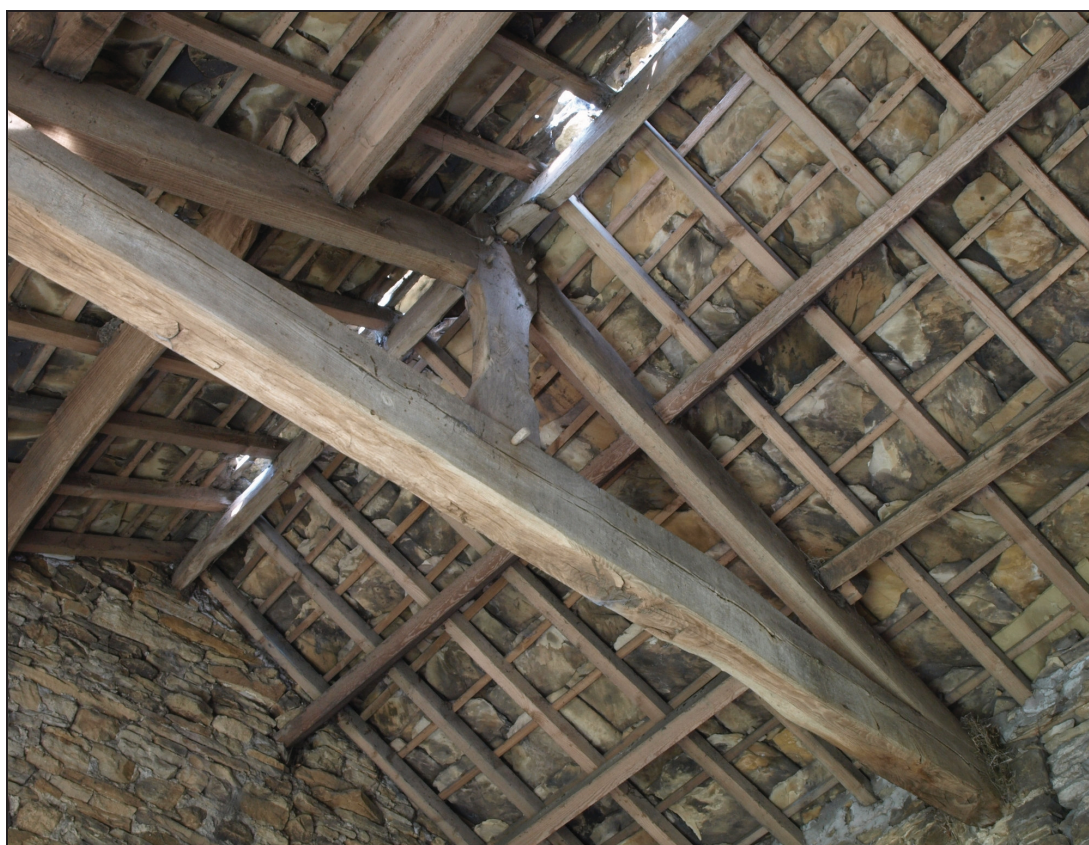
Photo 30: Pegged oak roof truss in added store

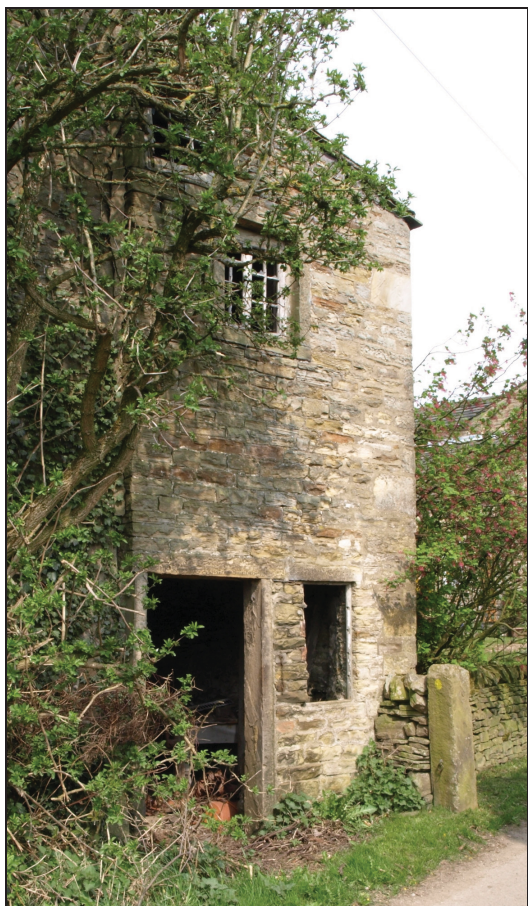
Photo 31: Added store at south-east end

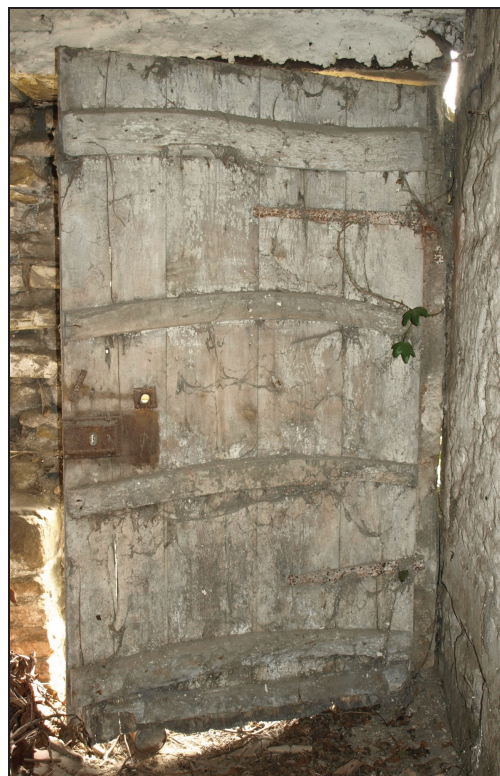
Photo 33: Door to added store at south-east end

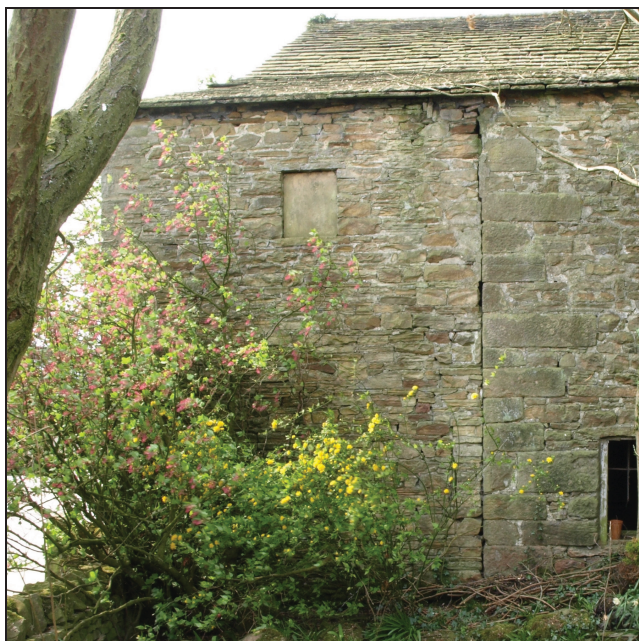
Photo 32: Side elevation of added store at south-east end

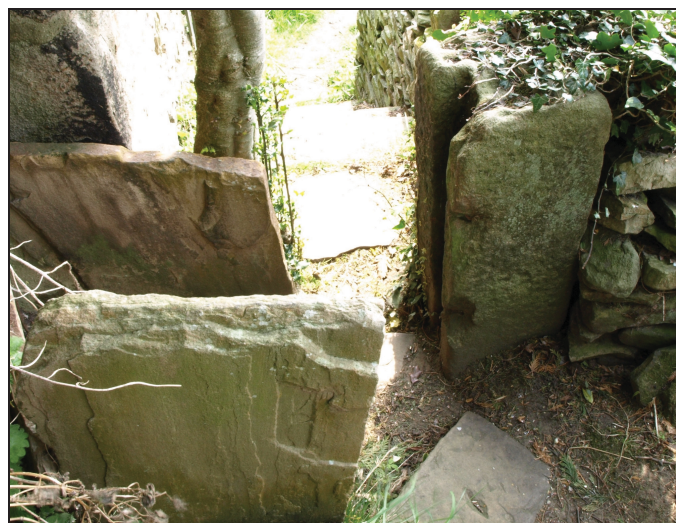
Photo 34: Re-used stone in stile at west corner of building
