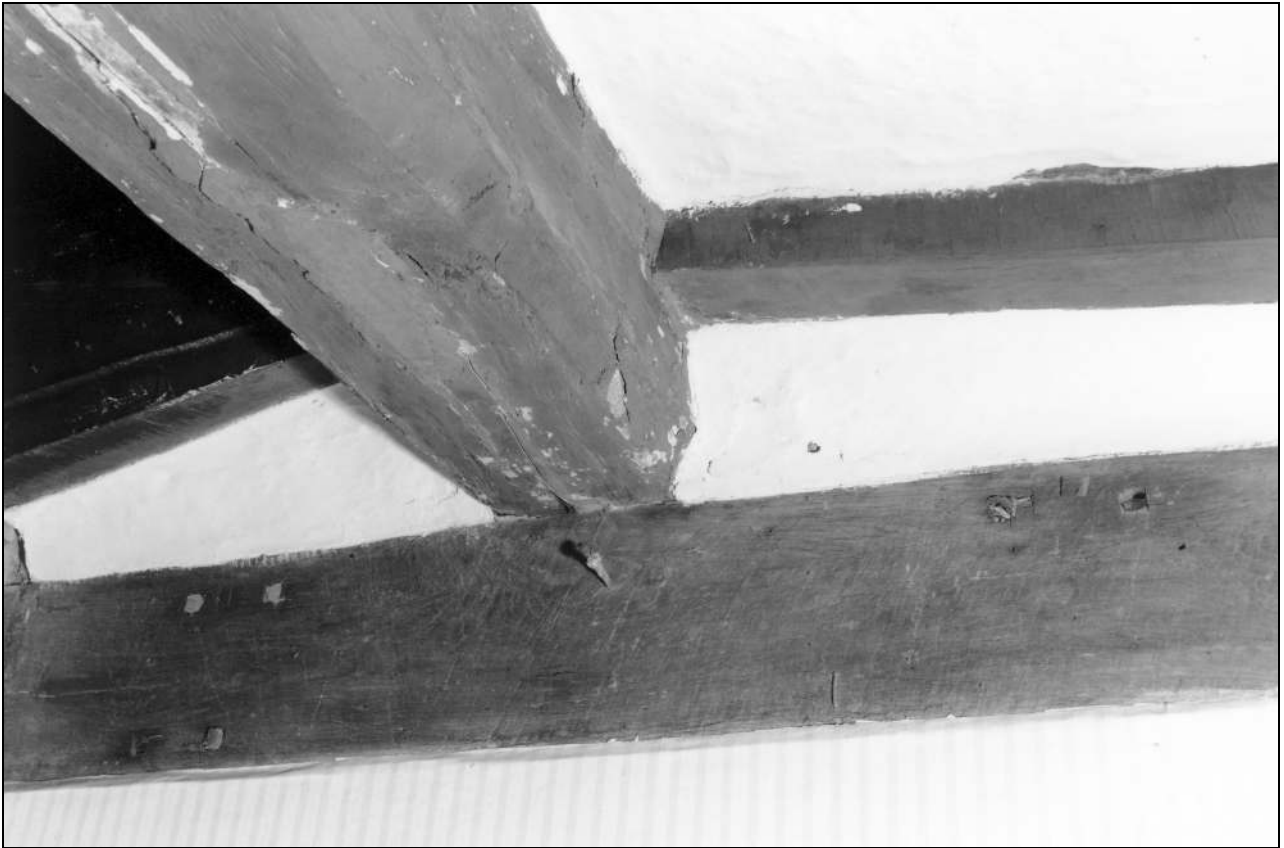
Photo 25: First floor: north end of spine beam, resting on tie beam of truss, with pegs and numbering of struts to each side

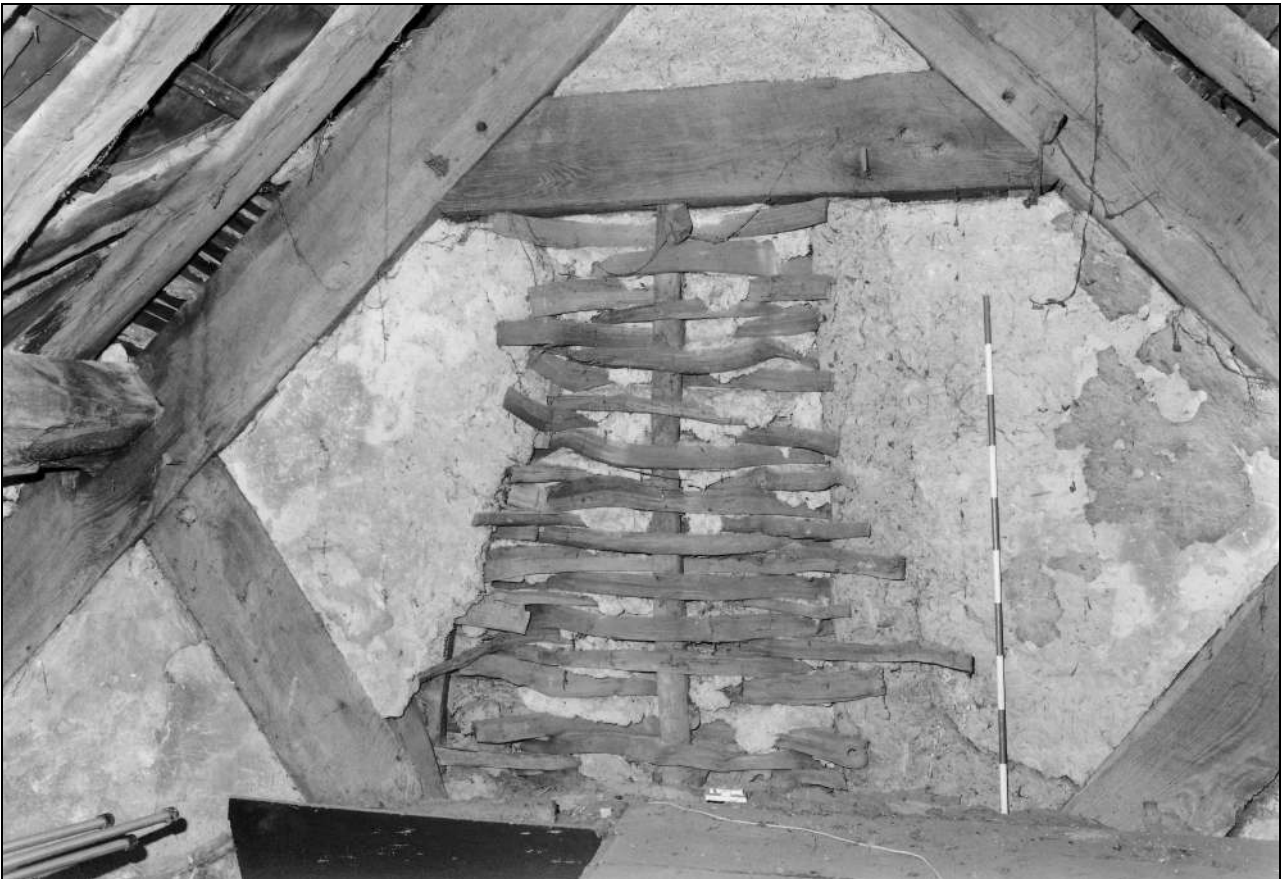
Photo 26: Wattle and daub infill, within truss forming north side of no.247

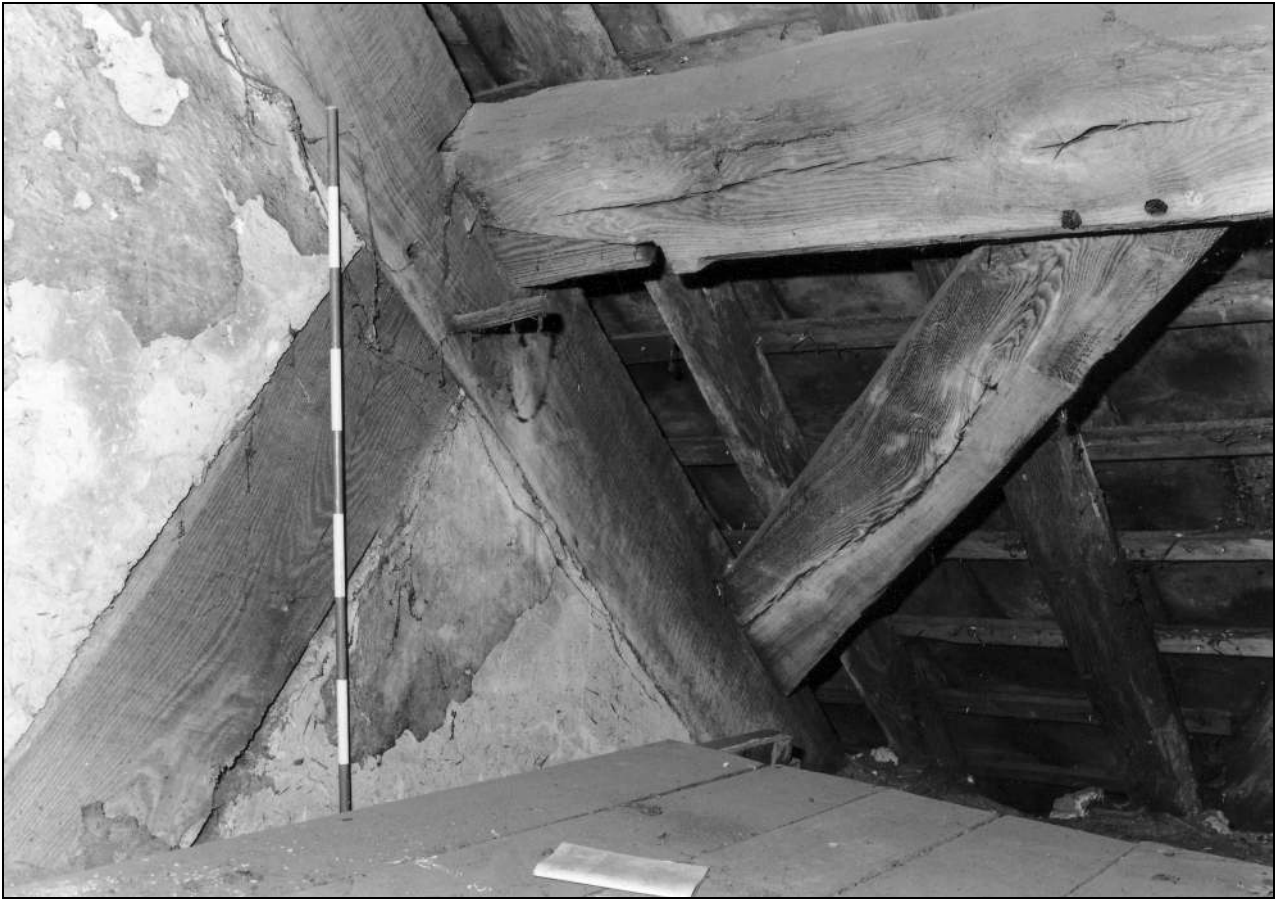
Photo 27: Detail of wind brace on east side of truss, and scarf joint in chamfered purlin

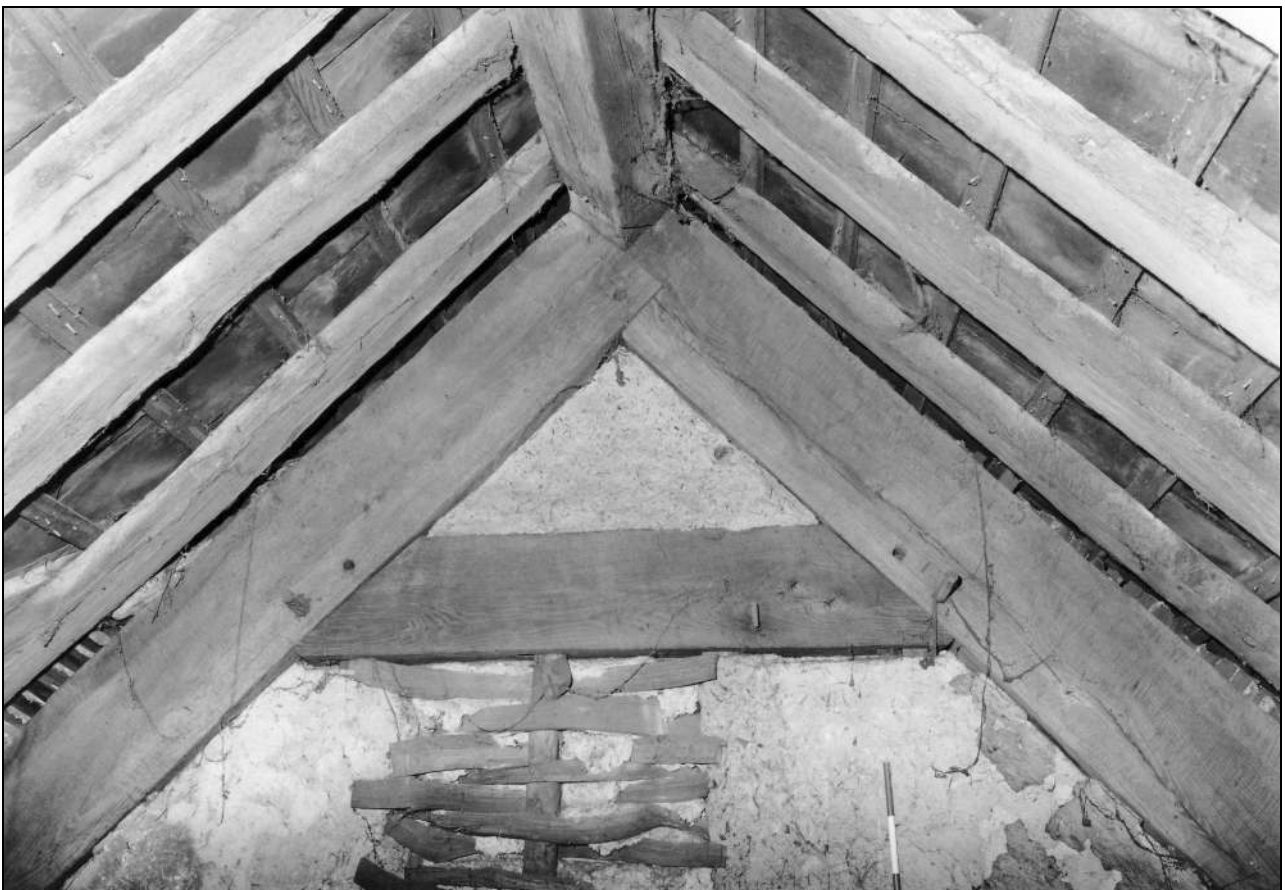
Photo 28: Collar and ridge of truss forming north side of no.247

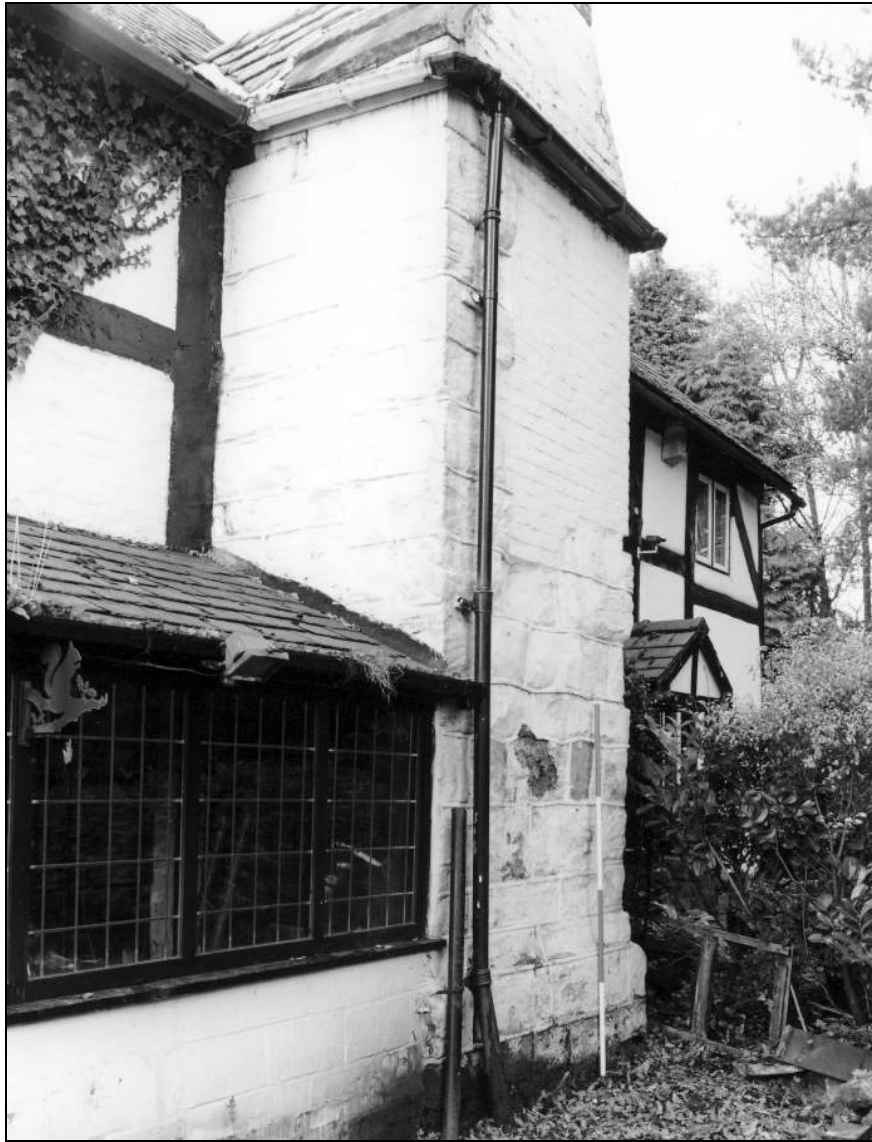
Photo 29: East wing: chimney stack and rear part (no.246), from the south-east

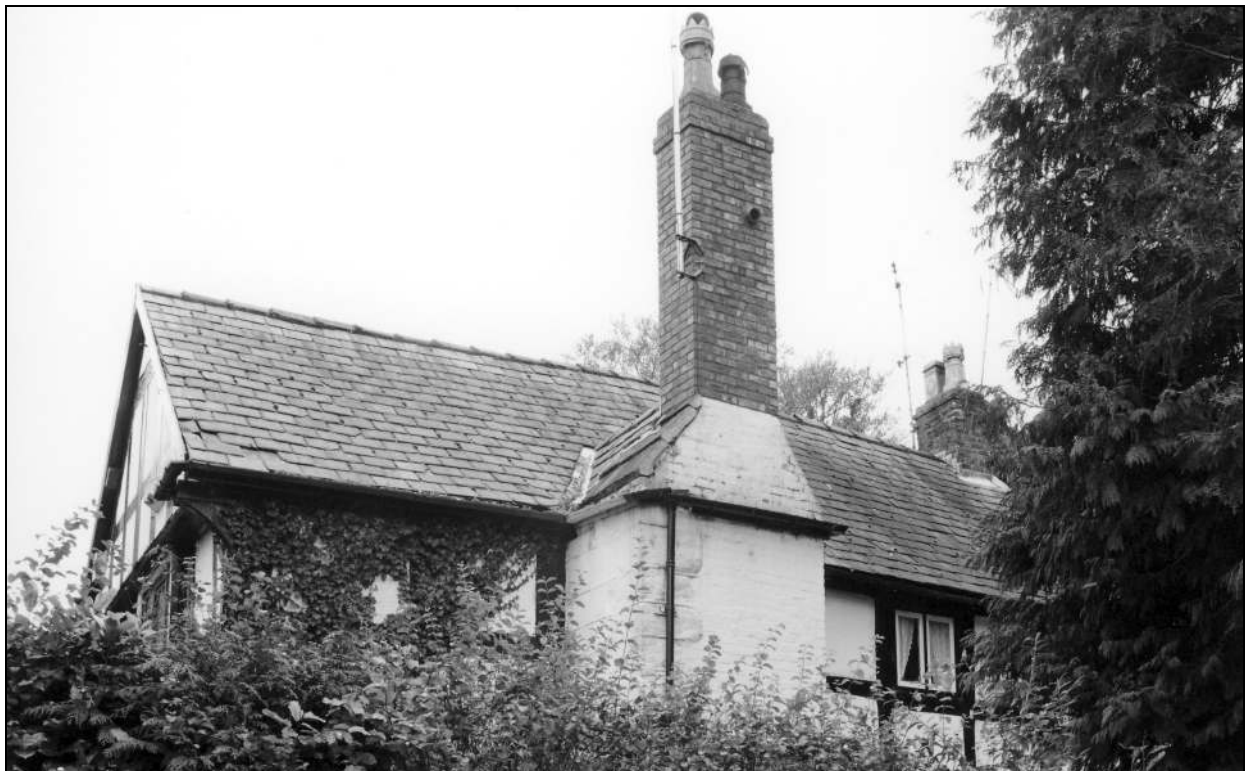
Photo 30: Chimney and roof of east wing, from the east

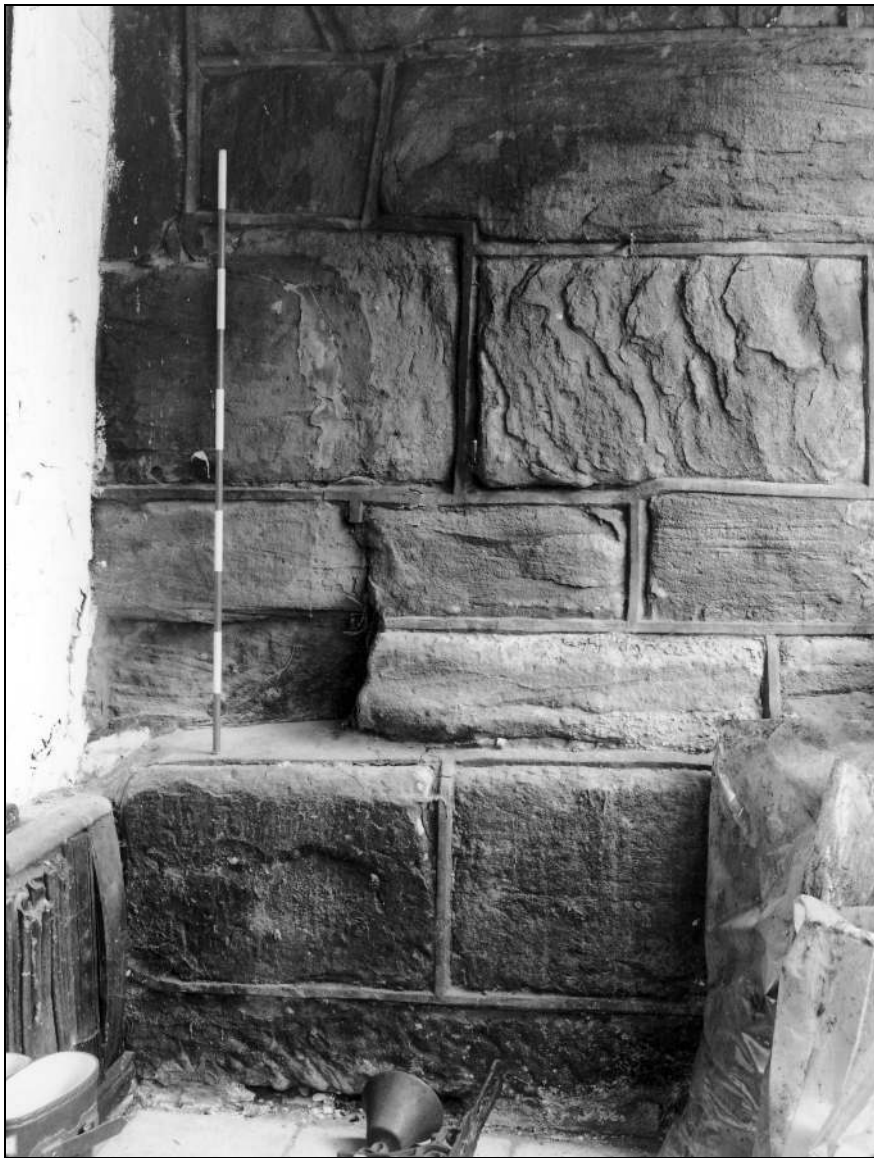
Photo 31: Detail of stonework forming the south side of the chimney to the east wing

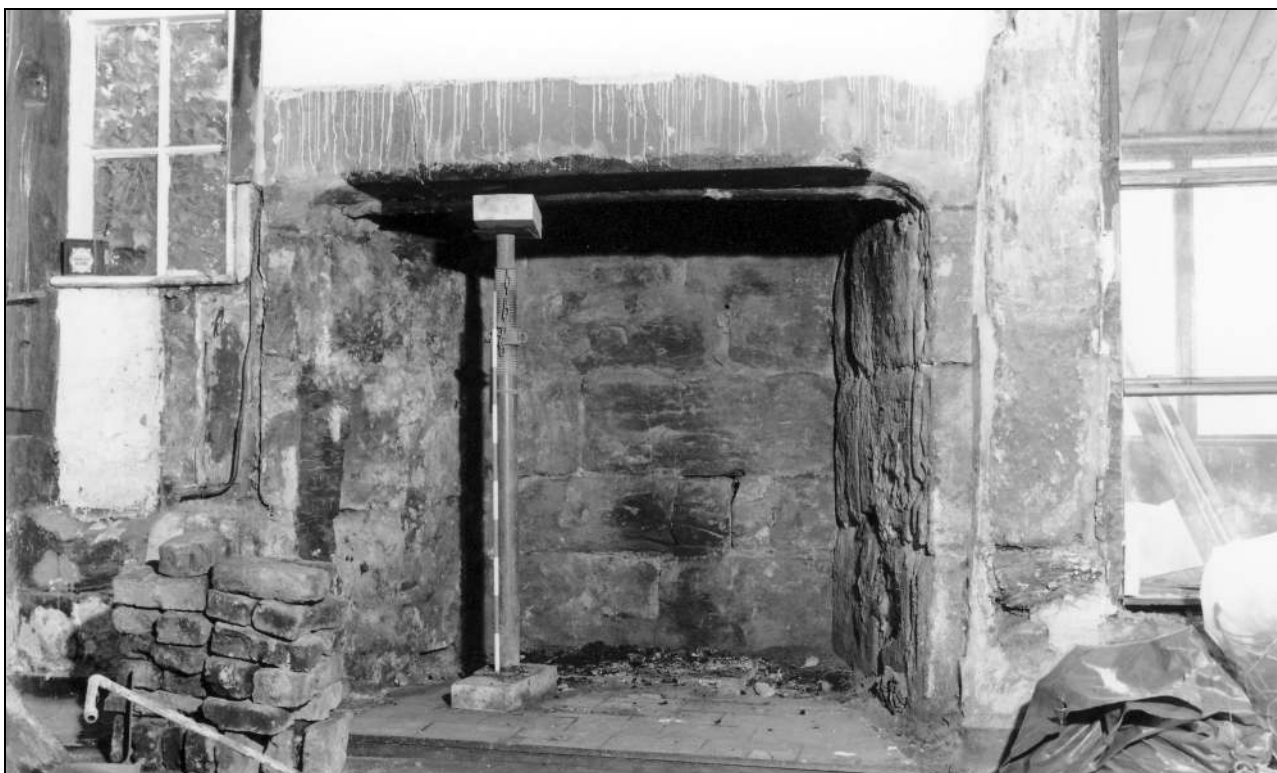
Photo 32: Detail of fireplace

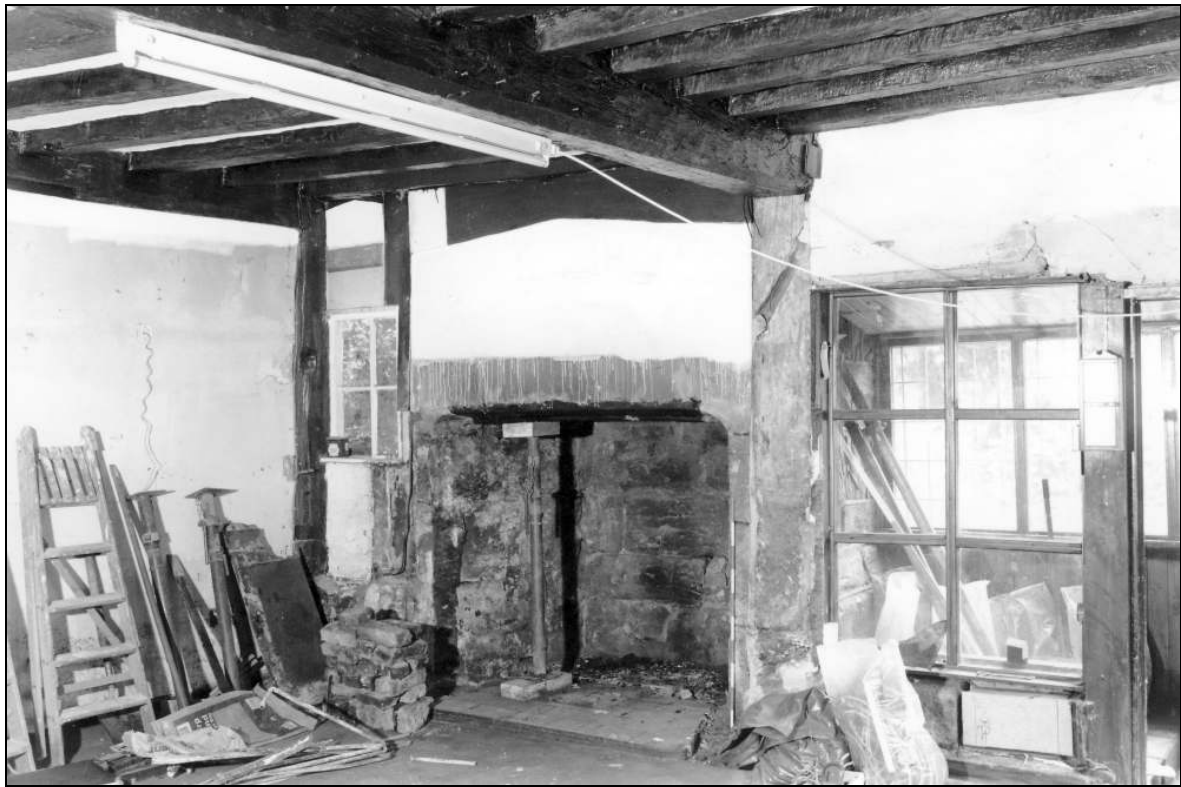
Photo 33: Ground floor room of no 247, from the south-west

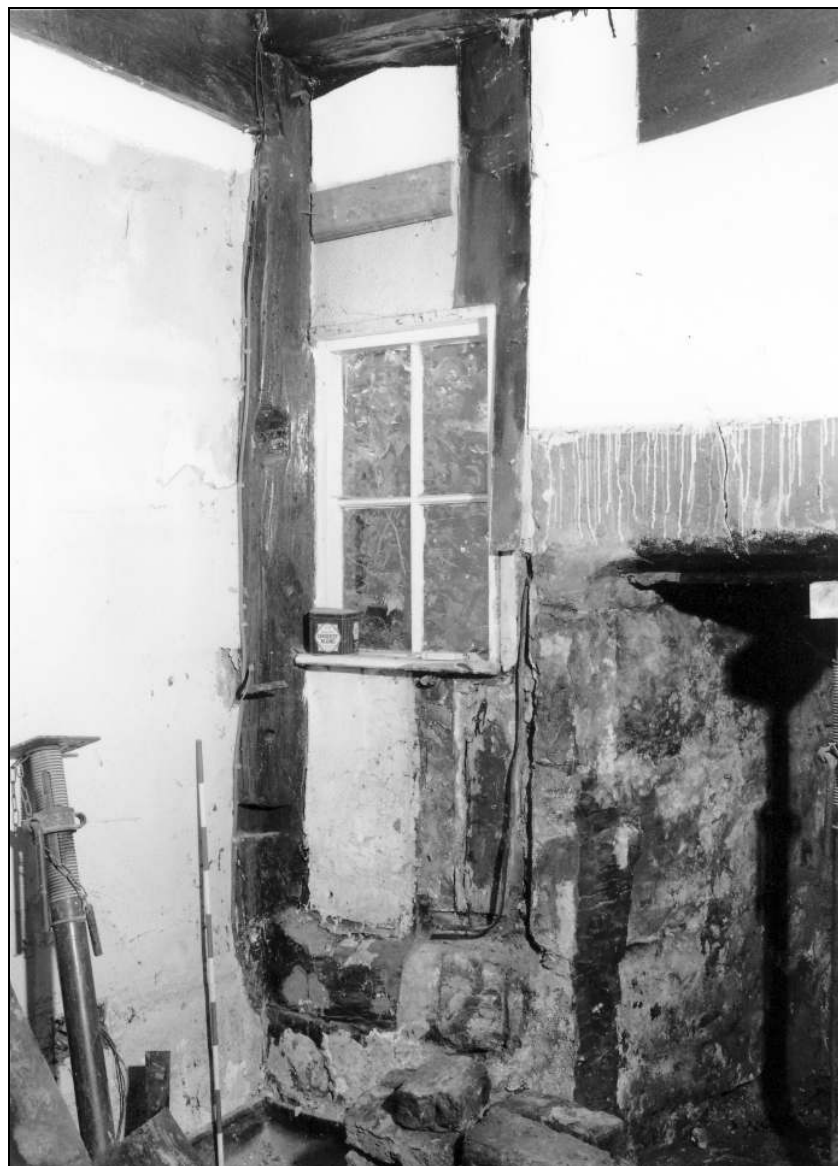
Photo 34: Detail of post and stud at north-east corner of ground floor

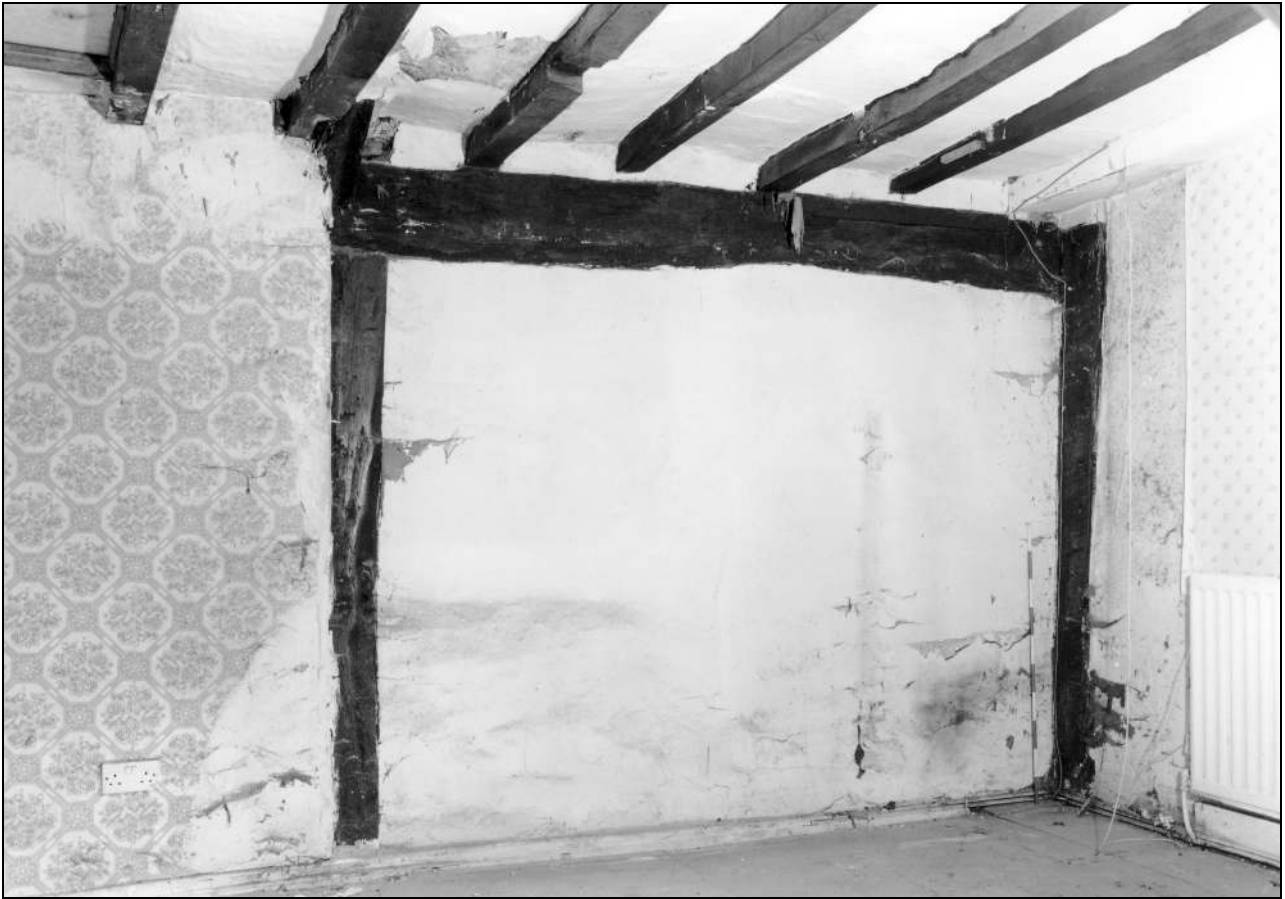
Photo 35: First floor: timber framing at south-east corner, the chimney stack to the left

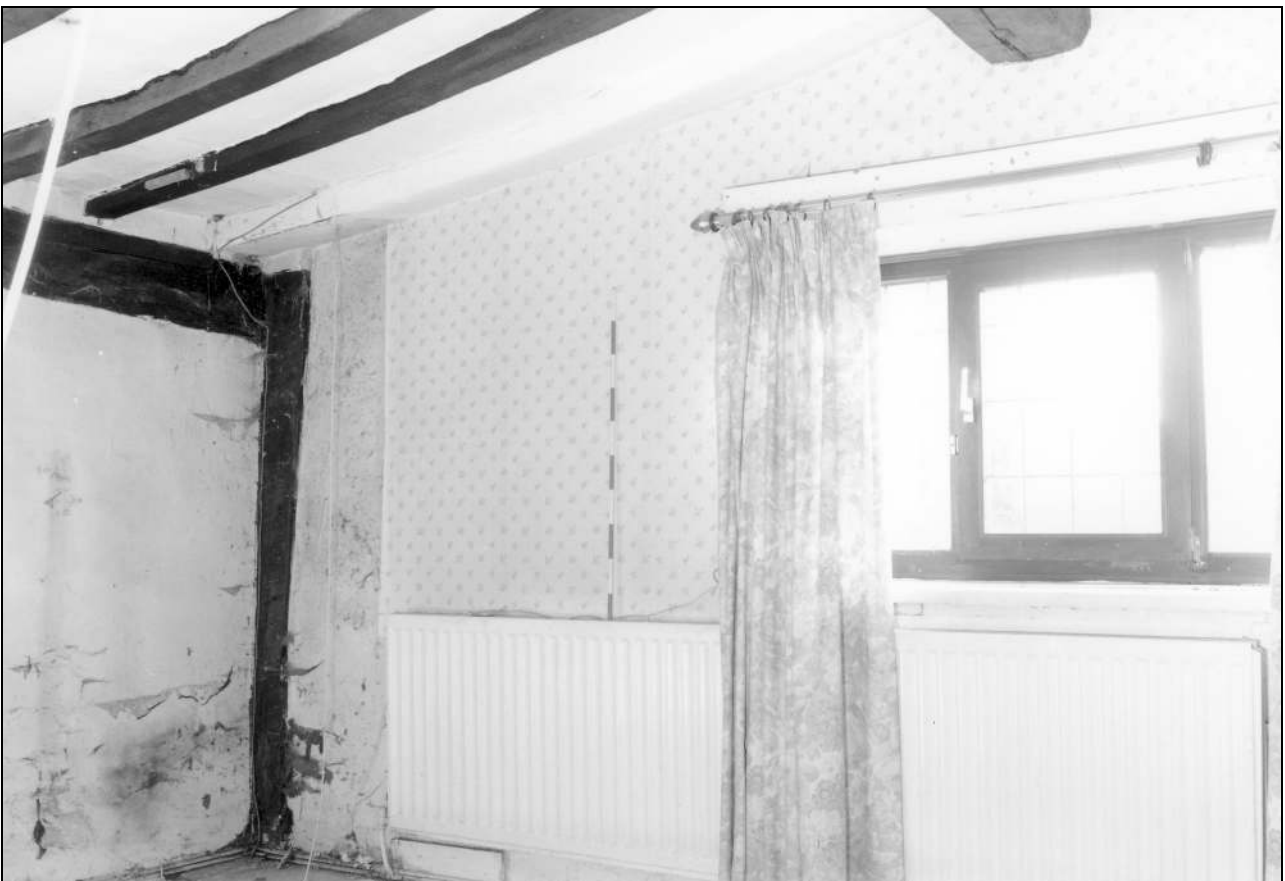
Photo 36: First floor: south side of main room

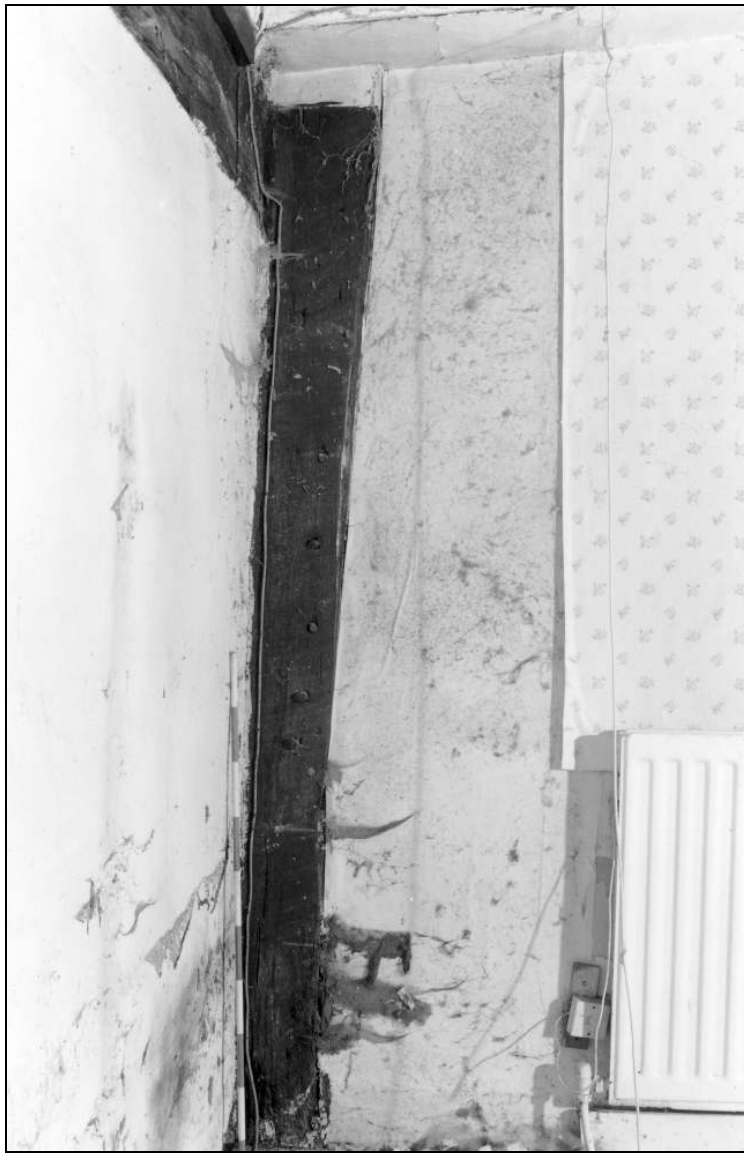
Photo 37: First floor: internal view of south-east wall post

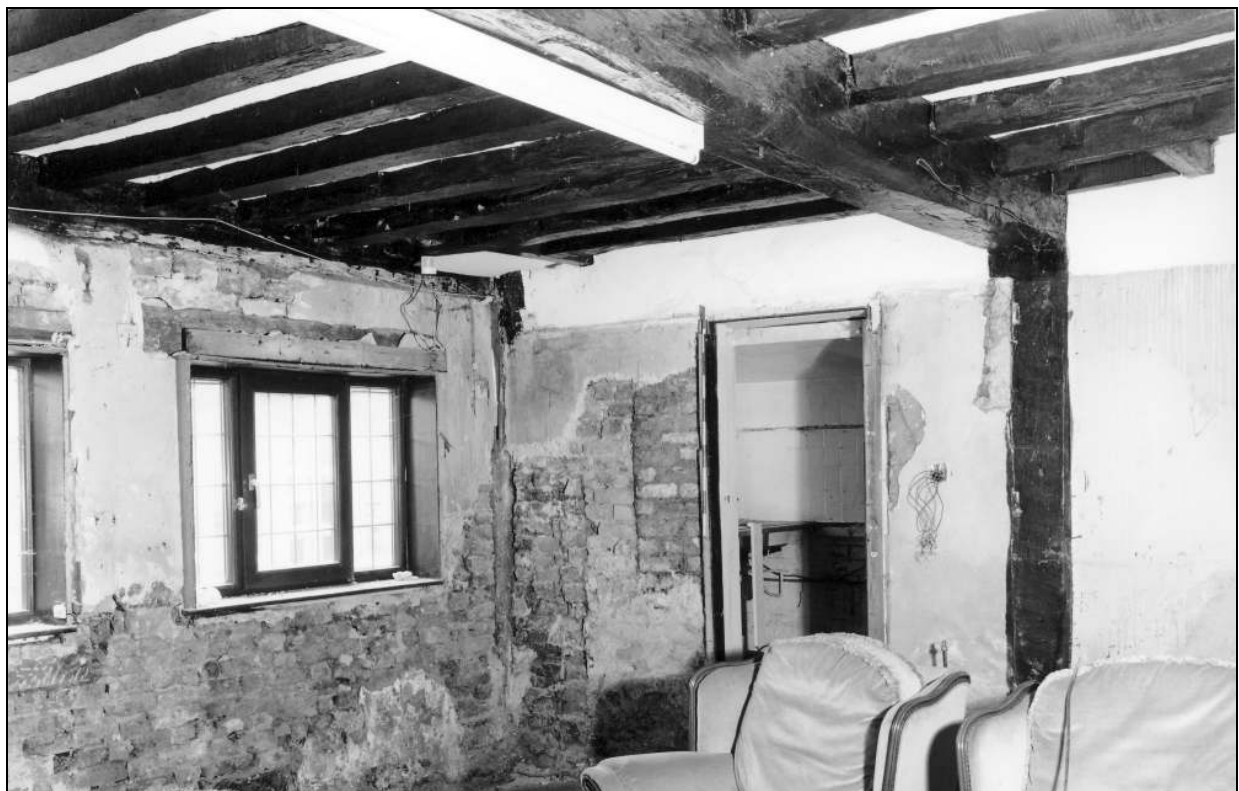
Photo 38: Ground floor room of no 247, from the north-east

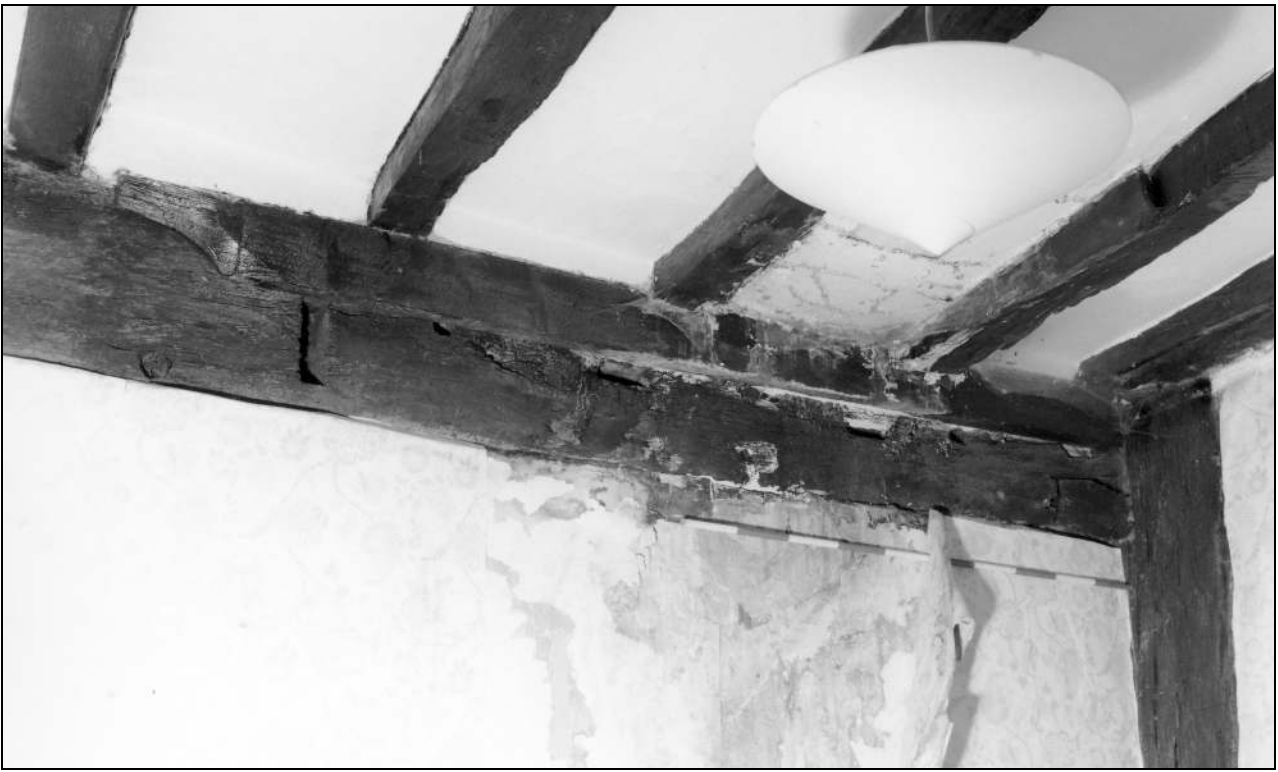
Photo 39: First floor: internal view of west wall plate, showing slot at left and joint with wall post at right

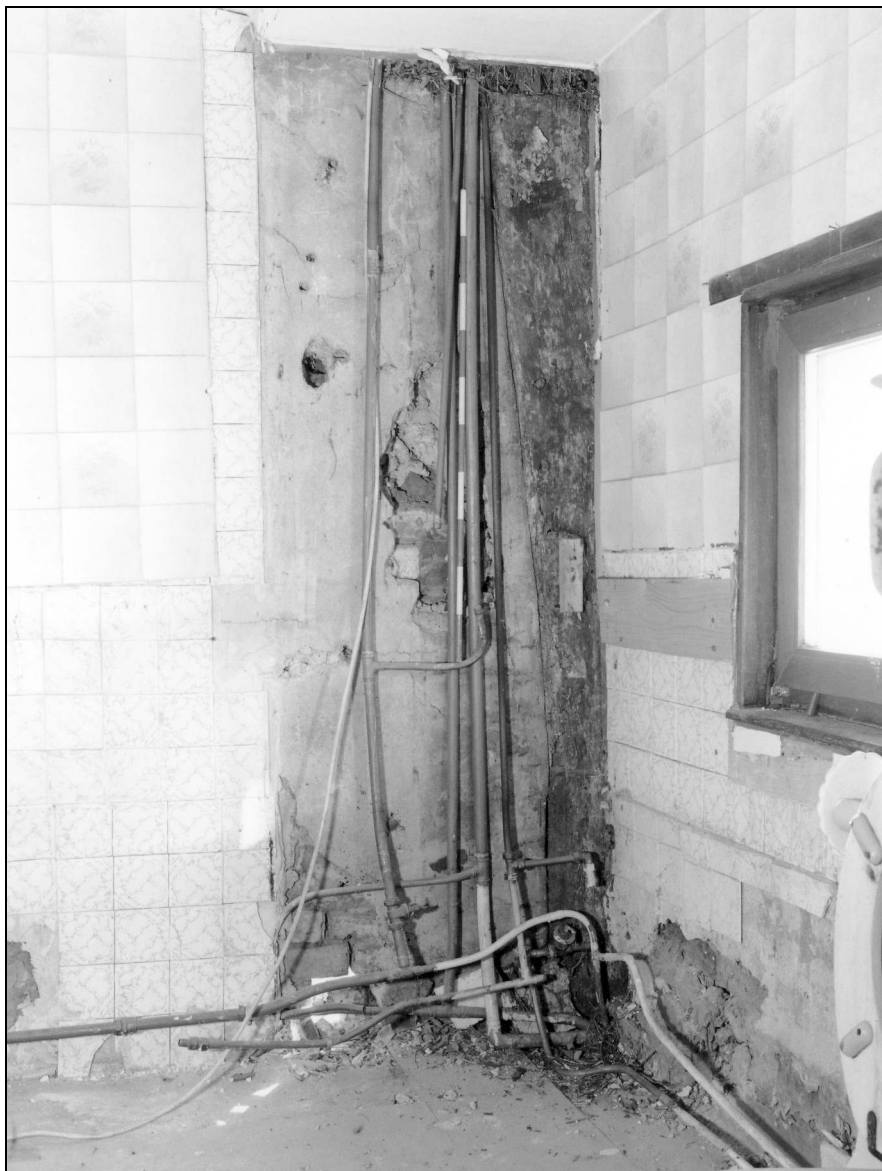
Photo 40: First floor: internal view of south-west wall post

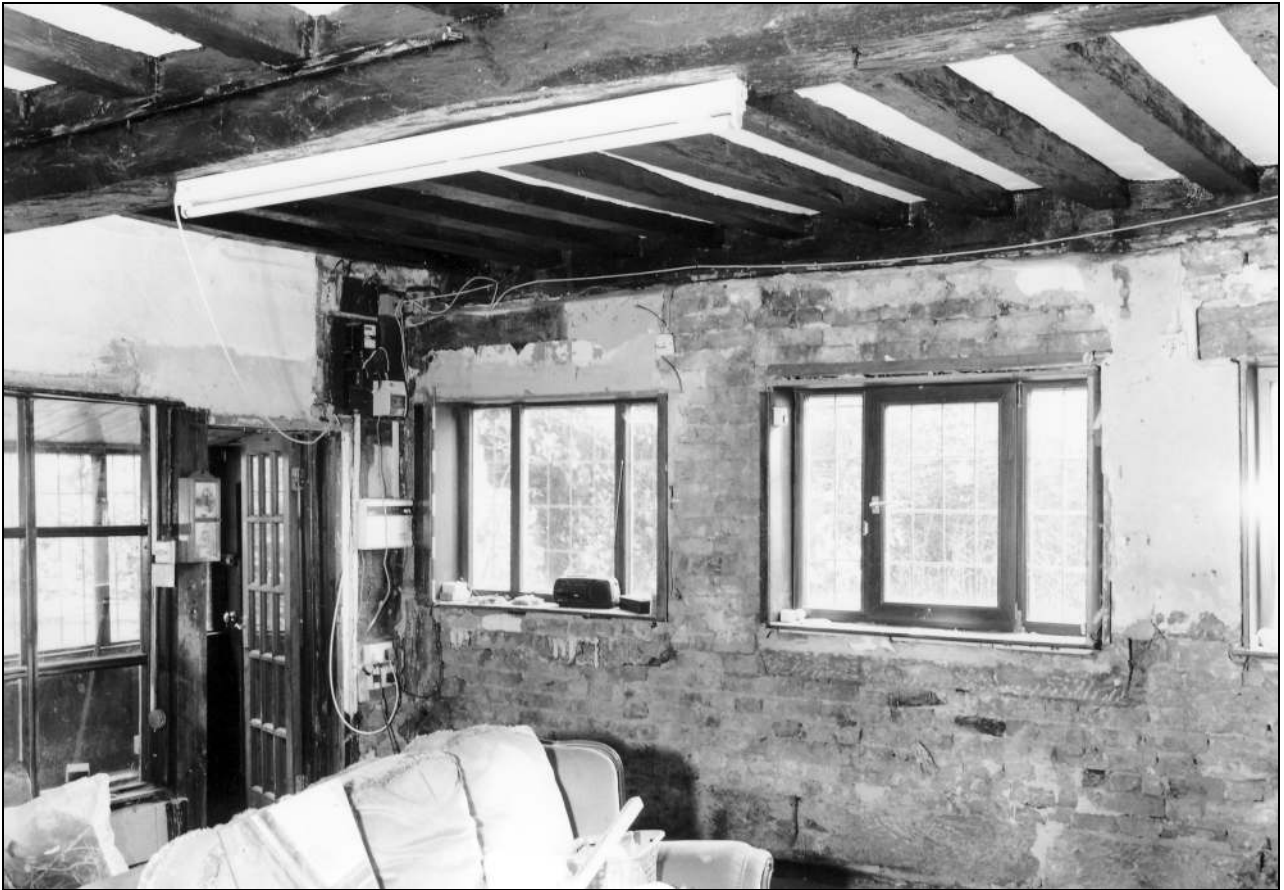
Photo 41: Ground floor room of no 247, from the north-west

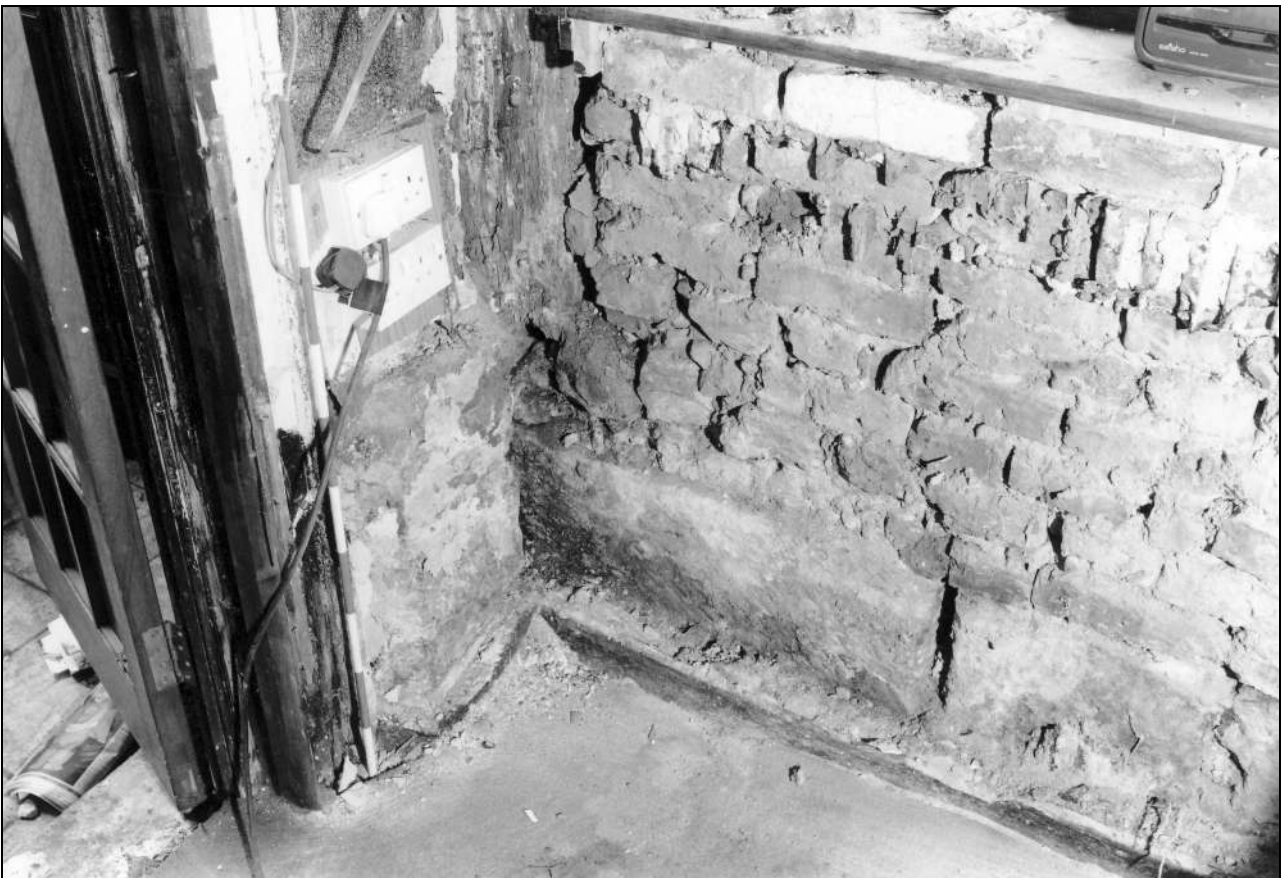
Photo 42: Detail of stone plinth and remnant of sill beam at south-east corner of ground floor

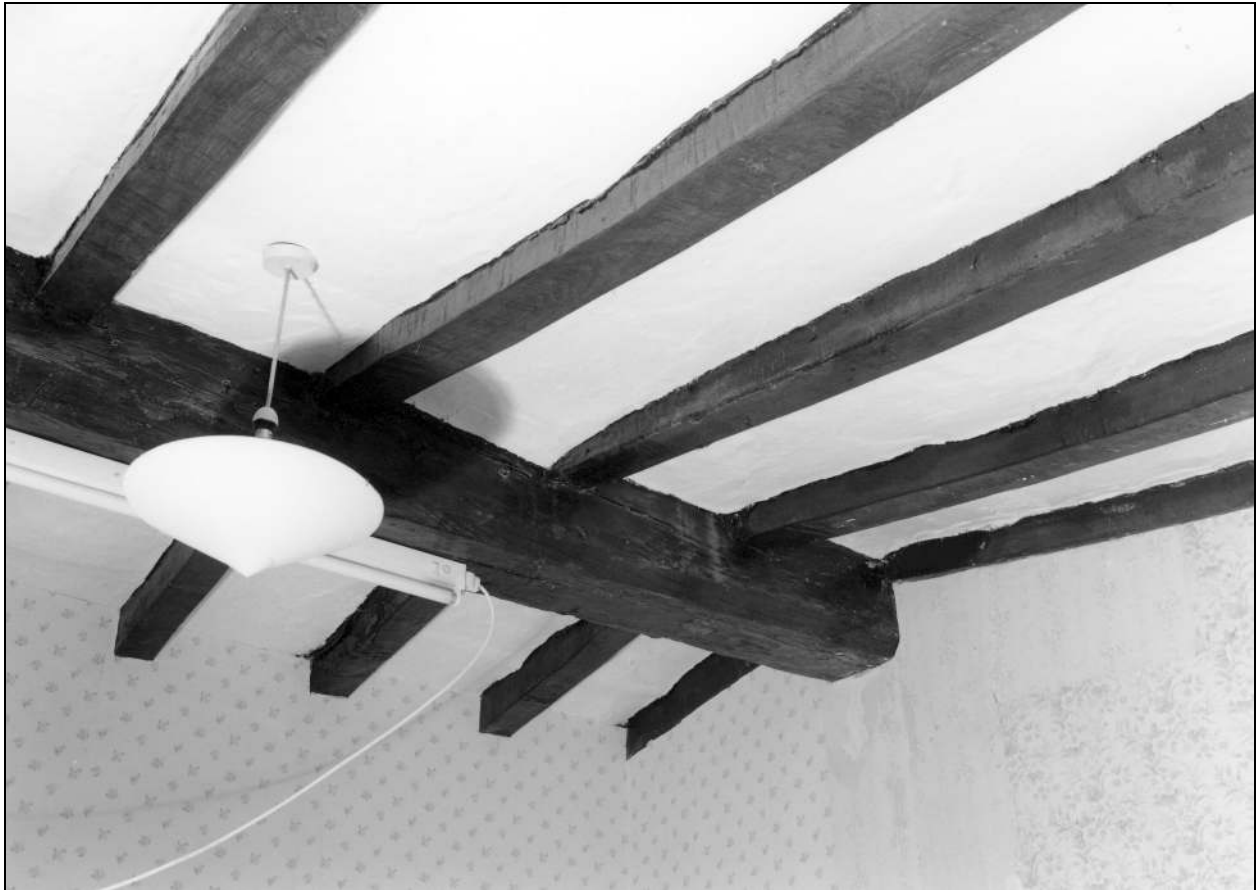
Photo 43: First floor: spine beam and ceiling joists over main room, from the south-east

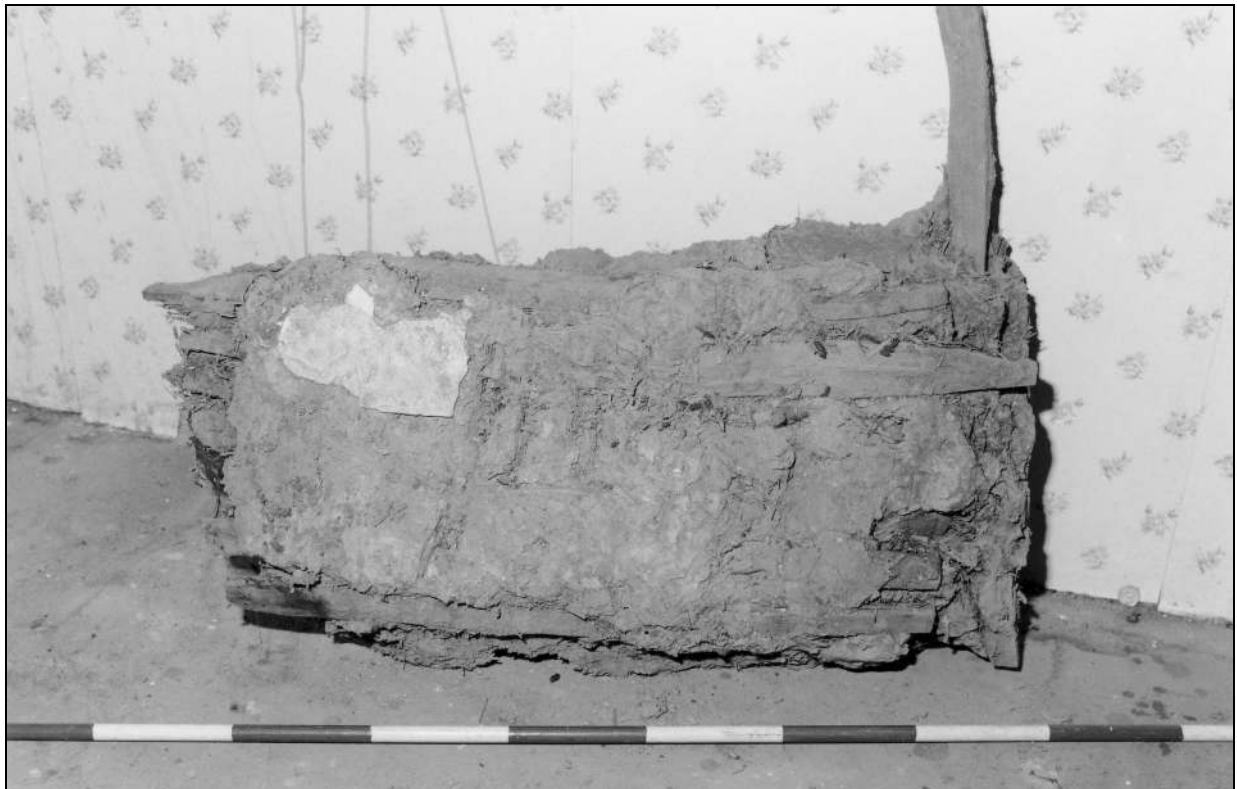
Photo 44: Portion of wattle and daub, removed from ceiling over first floor

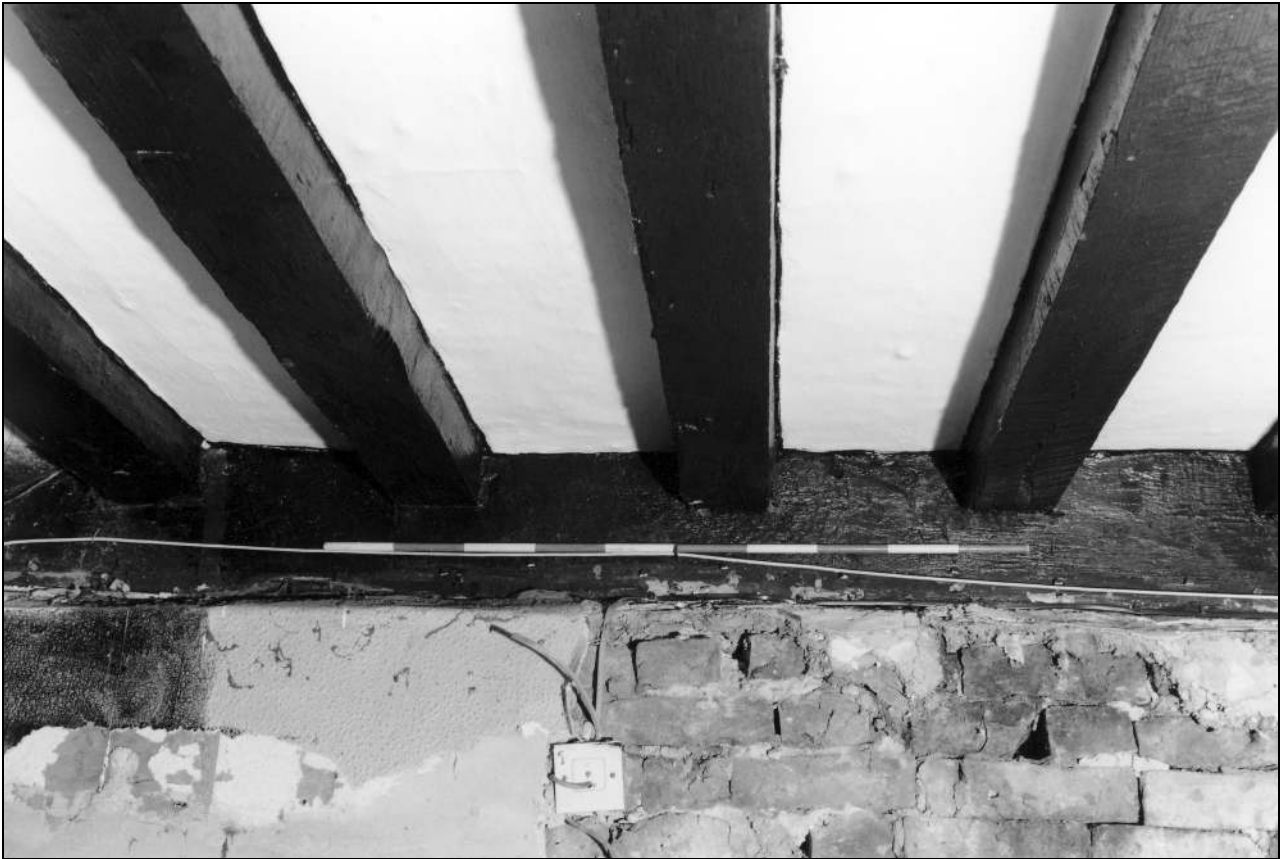
Photo 45: Detail of joists over ground floor room
