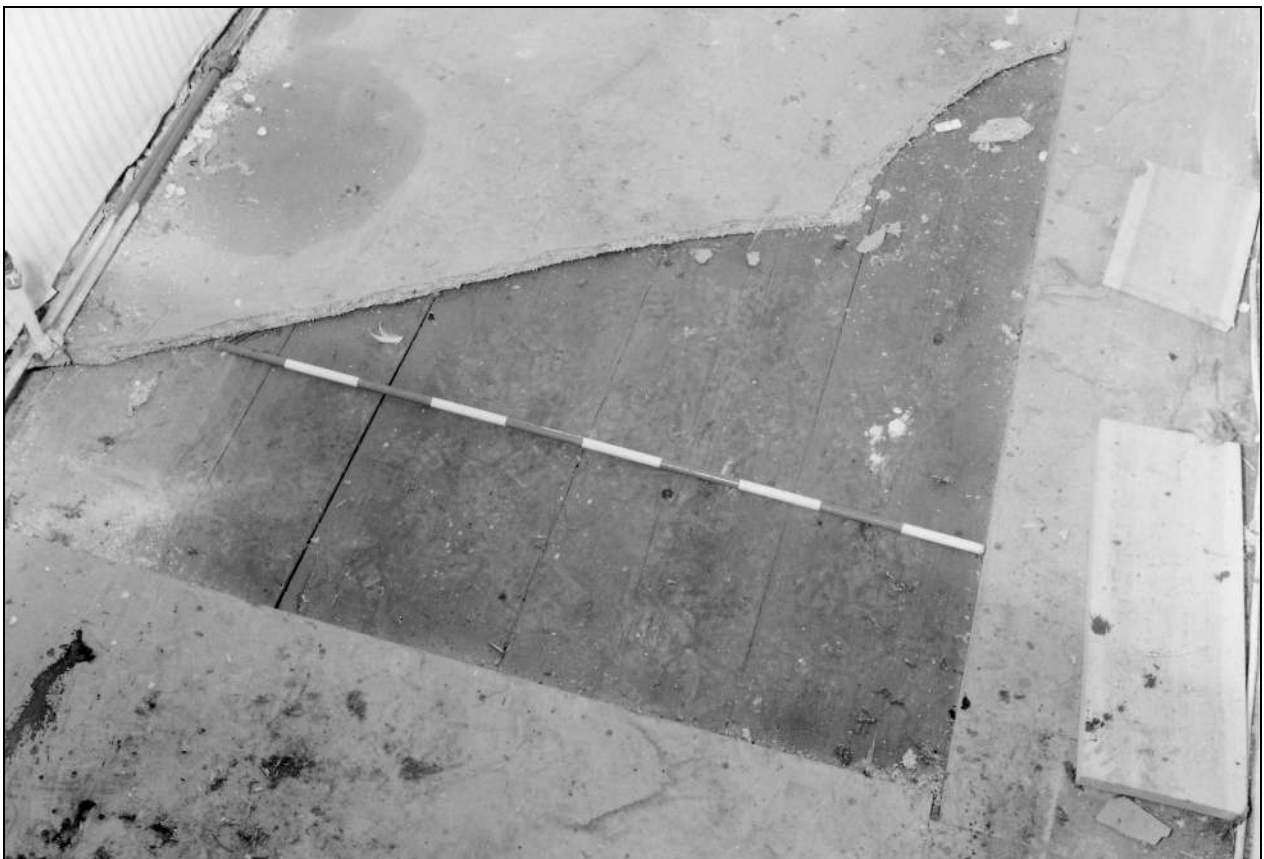
Photo 46: Detail of floor boards exposed in rear bedroom on first floor

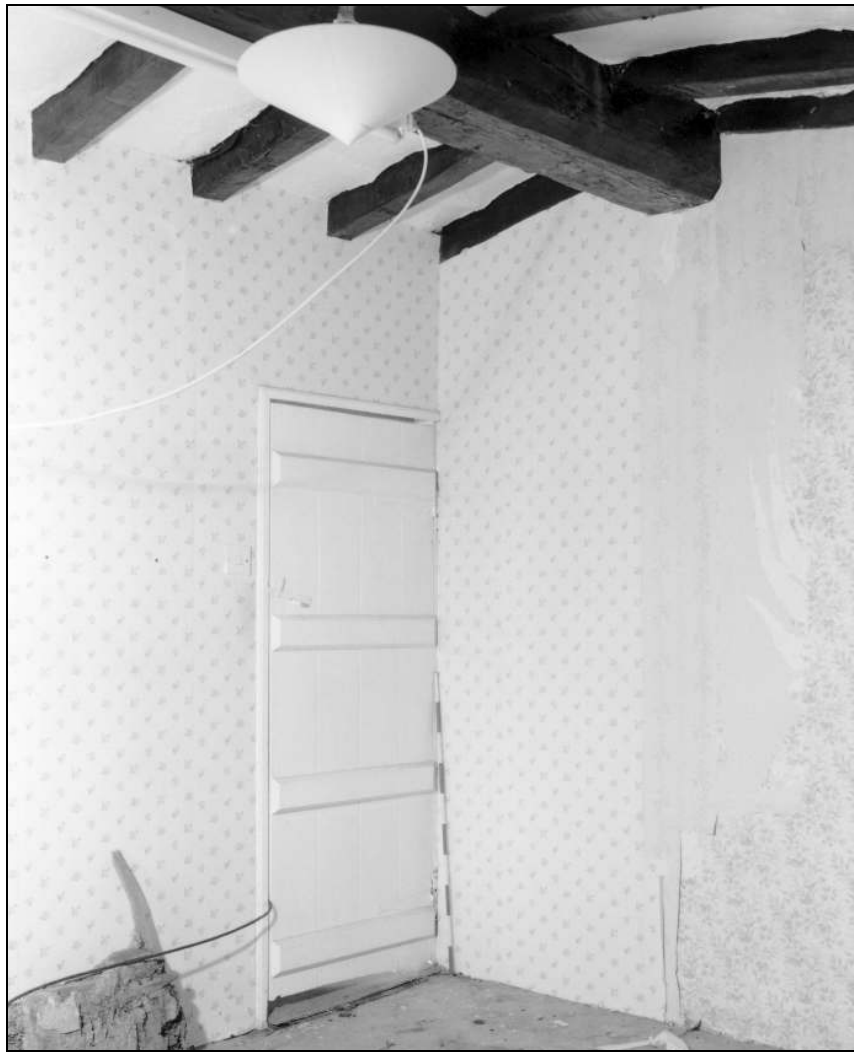
Photo 47: First floor: north-west corner of main room, showing spine beam and 19th century door

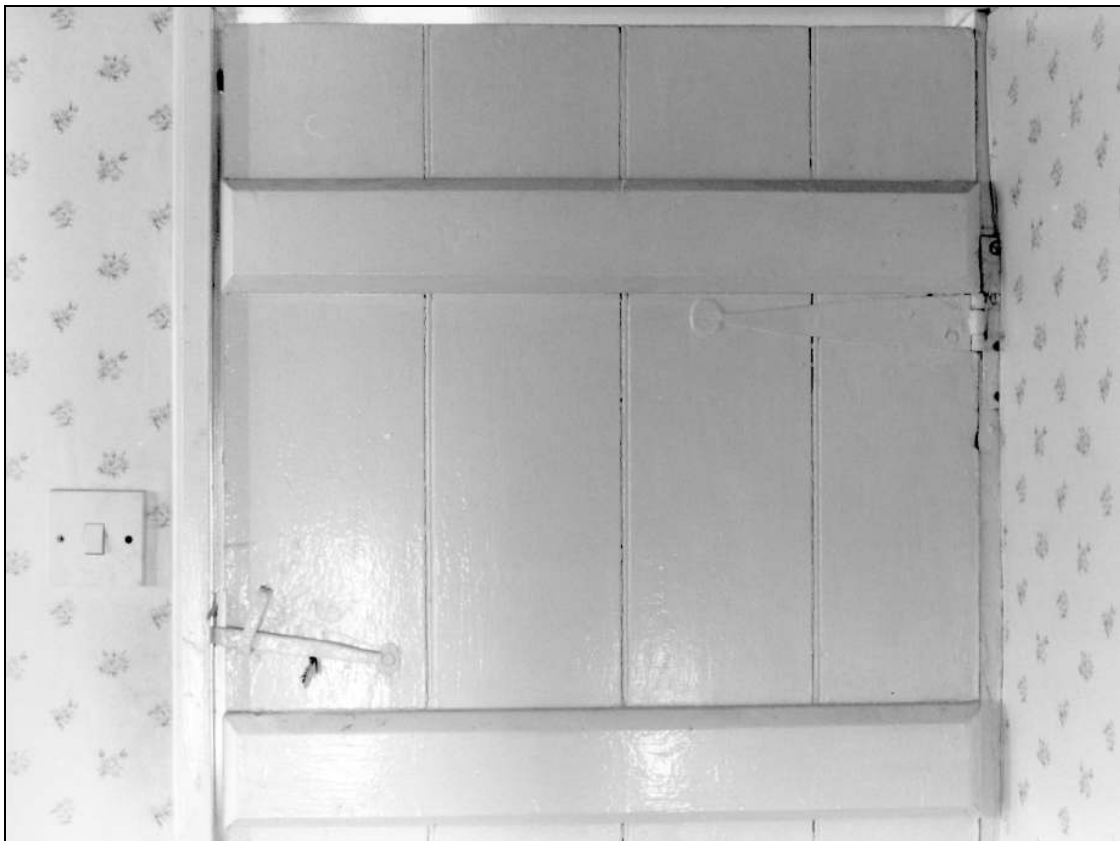
Photo 48: Detail of construction and furniture of 19th century door to main bedroom
