Former Corn Mill  
Mill Lane, Low Bradley, North Yorkshire:  
Historic Building Recording

May 2010

# Former Corn Mill Mill Lane, Low Bradley, North Yorkshire: Historic Building Recording

### HISTORIC BUILDING RECORDING

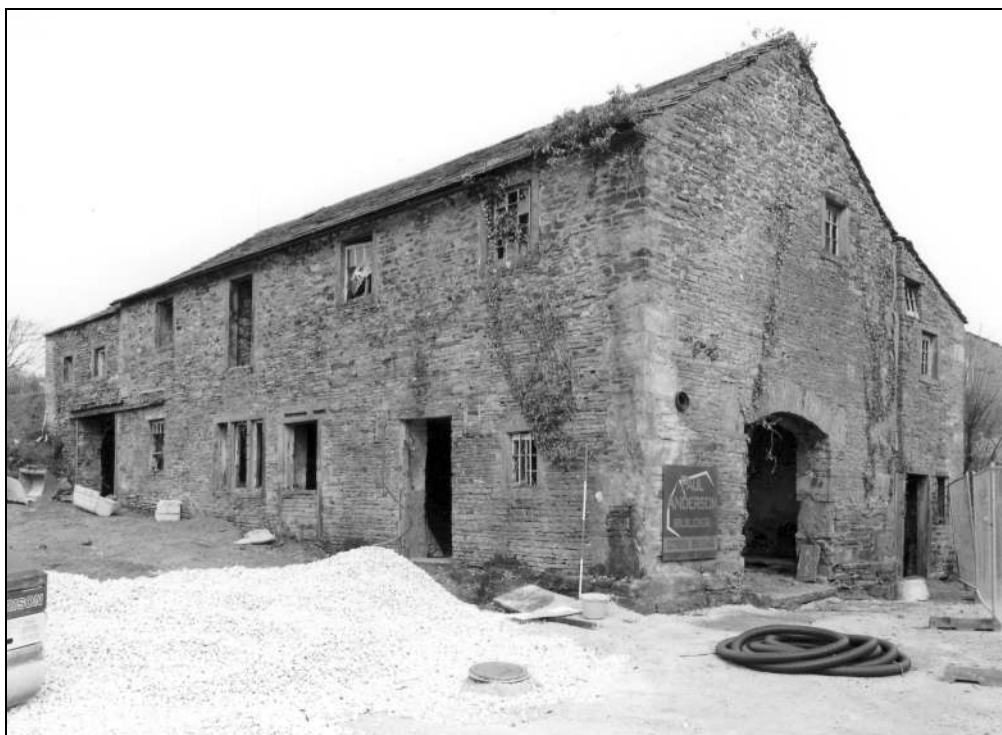
- 7.2 The main building is of two storeys and has walls of flaggy sandstone, with edge-laid quoins to the lower parts (**1,2**), and the upper extent of these coincides with a clear change in the masonry about 1.8m below the present eaves, where the upper stonework is more random and lacks quoins, thereby showing how the building has been heightened to its present size. This change is thought to have taken place in the 18th or 19th century, but it begs the question as to whether the building was formerly tall enough to accommodate milling machinery, and it may be that the upper parts of the building were dismantled as part of this change, perhaps because of a fire in its roof.

Photo 1: General view of the mill, from the south

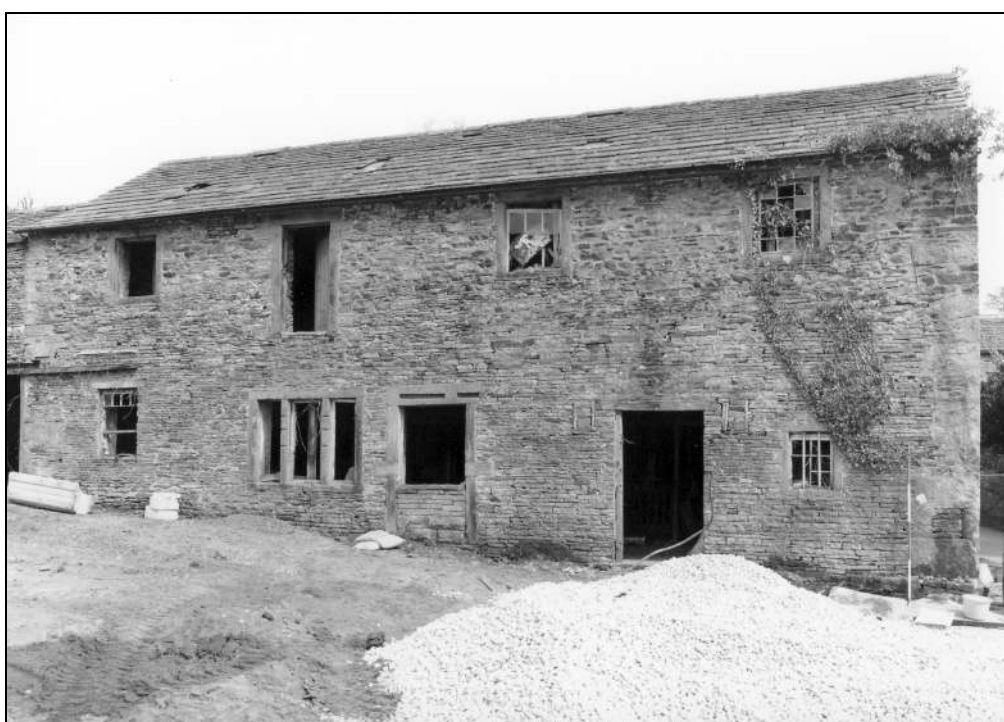
Photo 2: General view of the mill, from the south-west

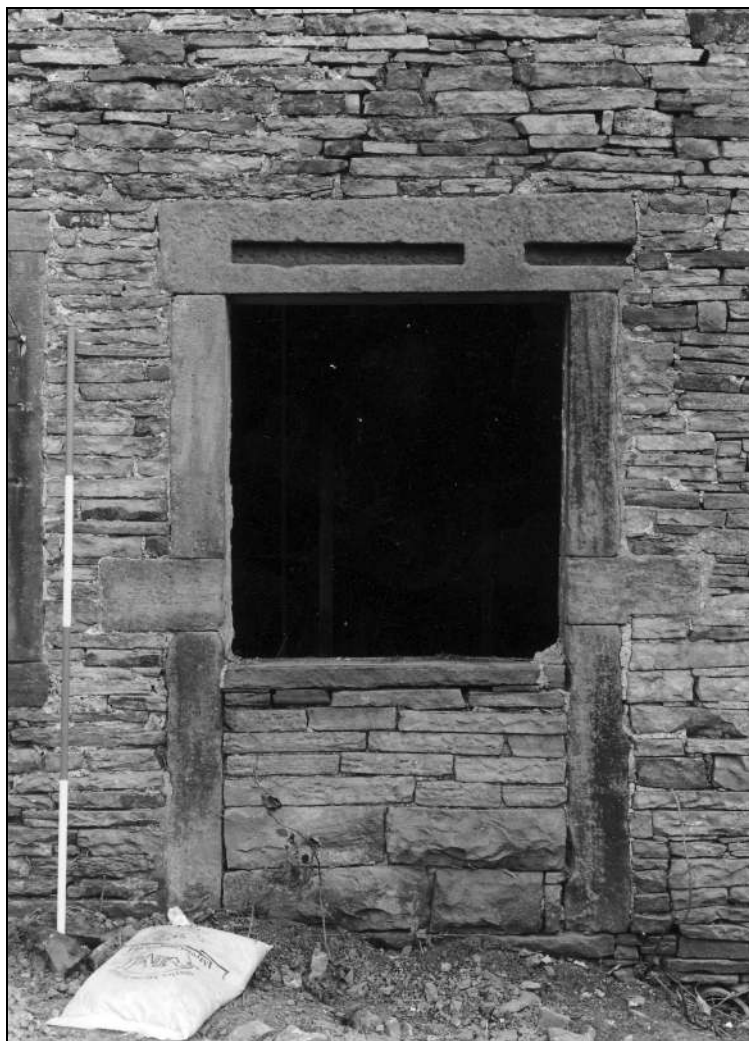
Photo 4: Detail of entrance in front elevation, with slotted lintel

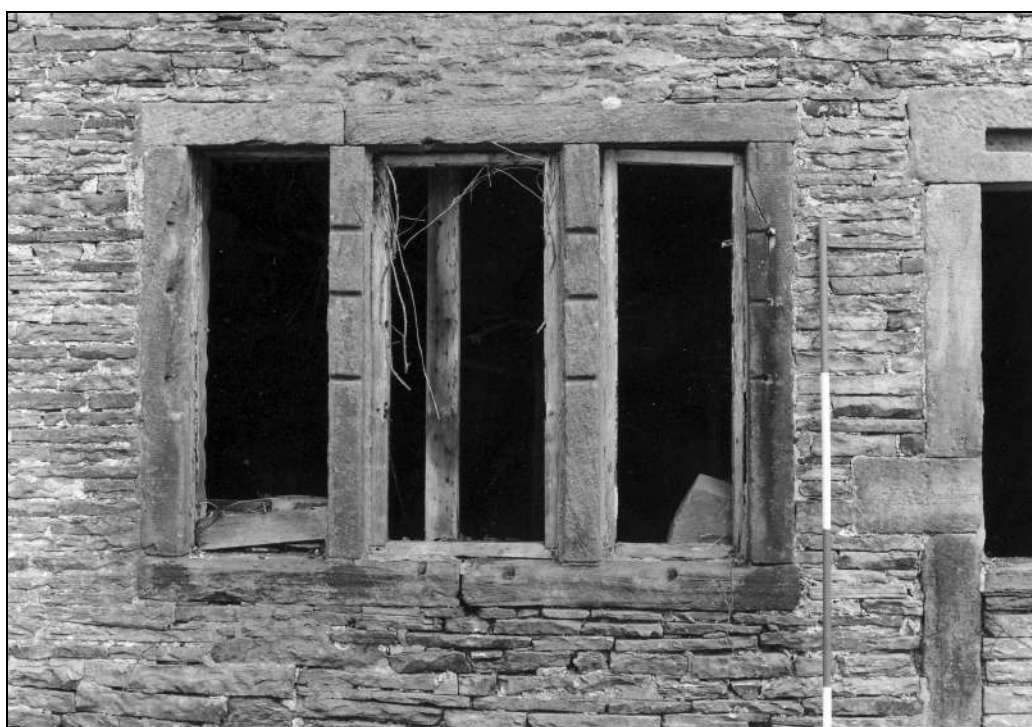
Photo 5: Detail of three-light window in front elevation

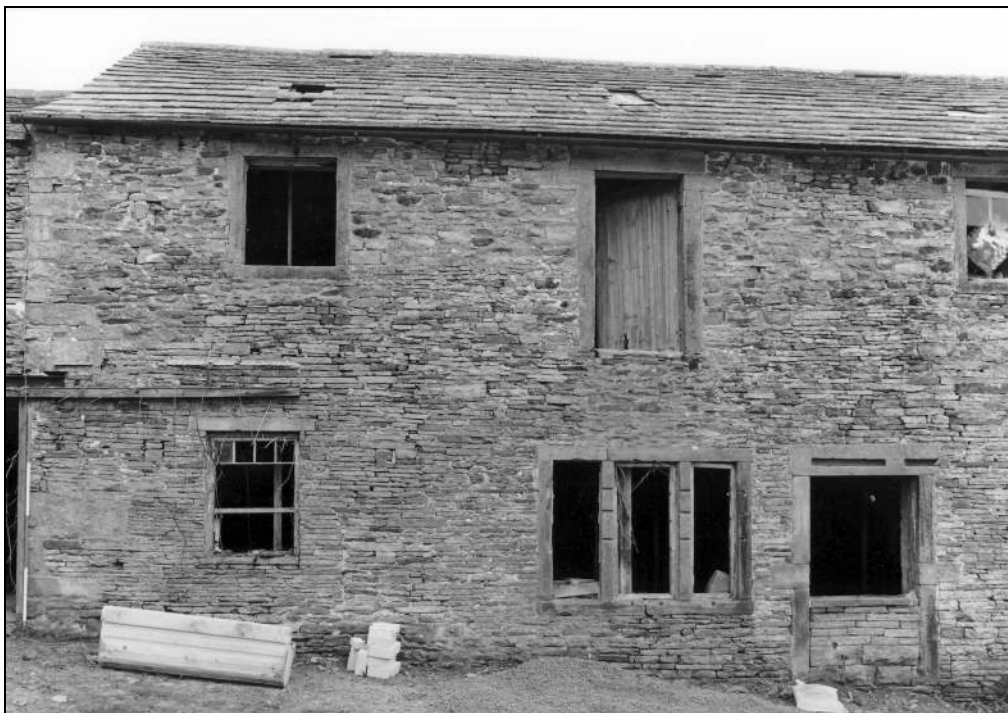
Photo 6: Front elevation (north-west end)

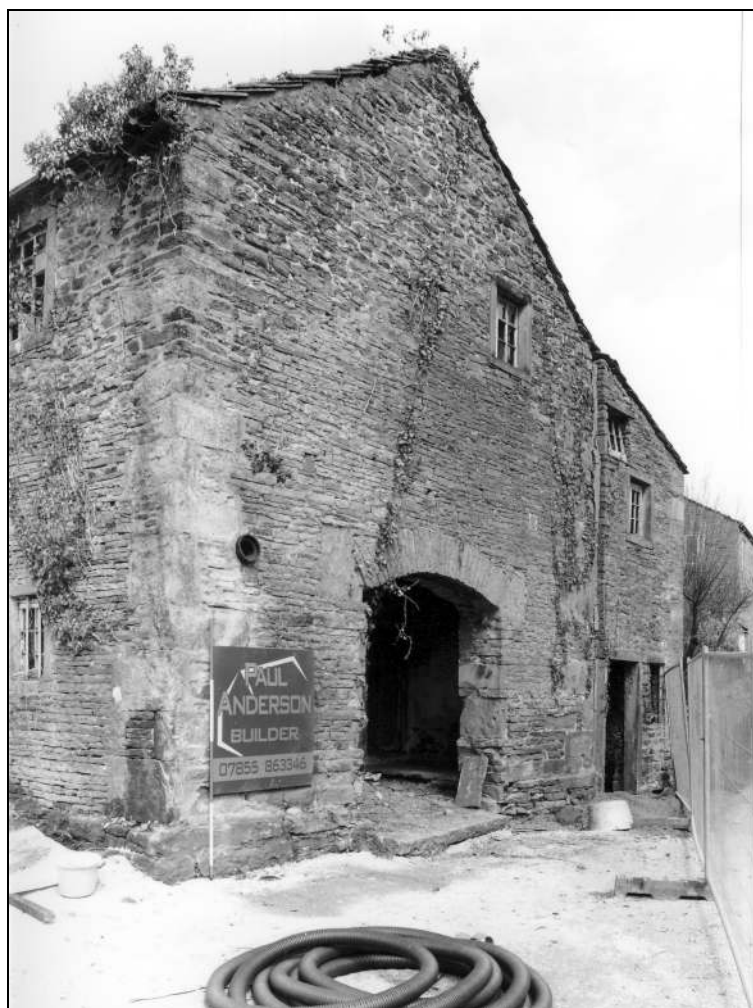
- 7.4 The mill's south-east gable also clearly shows the two phases, with later, more random masonry above the neater apex of the original gable (7,8). Openings within this wall include an original, wide cart entrance with segmental arch (9), and a small window to the later, higher level masonry. There is also the pipe for a stove flue, close to the south corner. A pair of harr-hung, ledged plank doors which were formerly fitted to the cart entrance had been removed by the time this recording took place (and are intended to be restored and re-fitted). A later wall within the building, again probably dating from the conversion to a shippon, means that this doorway could no longer be used for carts, but previously it would have allowed vehicular access into the mill.

Photo 8: South-east gable

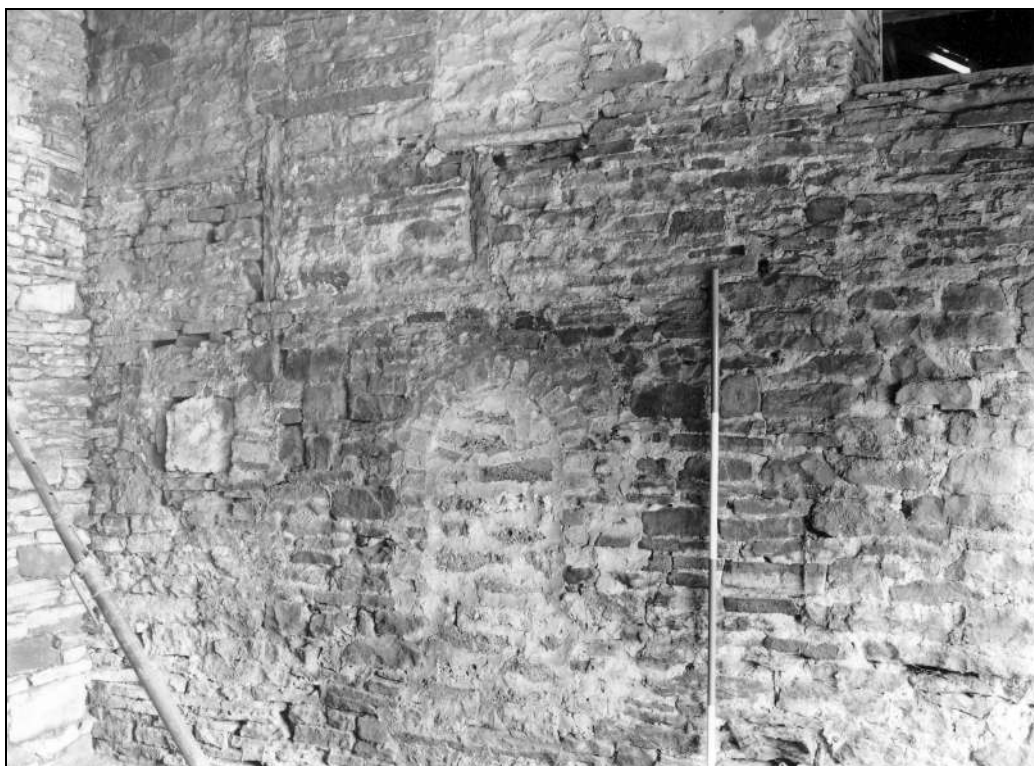
Photo 10: North-west gable of main building, within later store (ground floor)

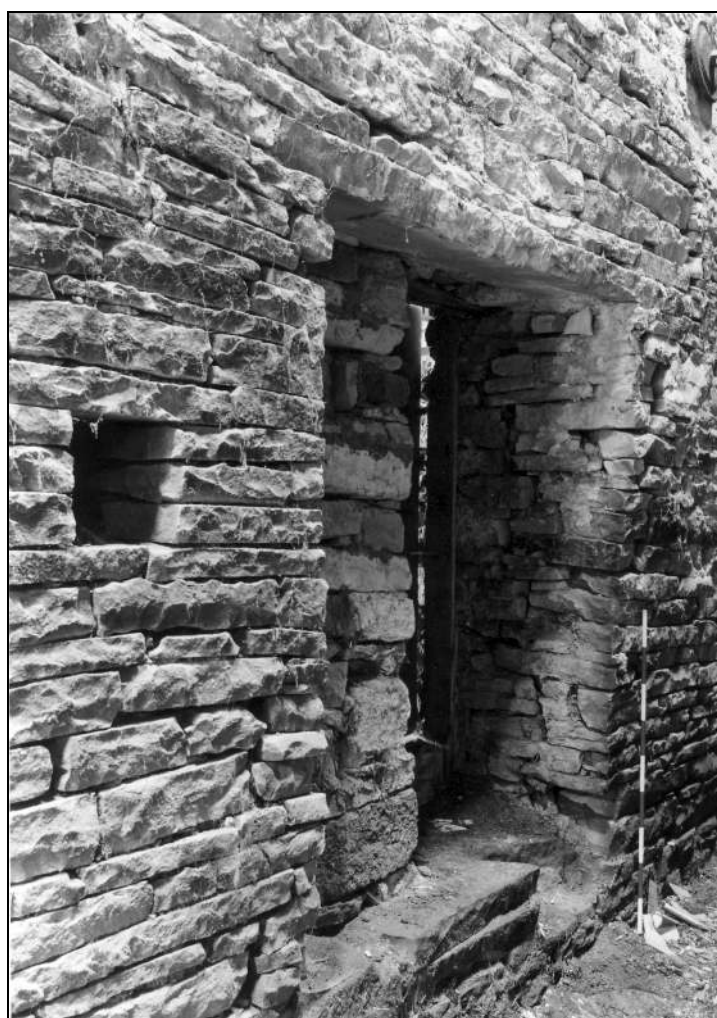
Photo 12: Doorway at position of waterwheel axle bearing, north-east side of mill

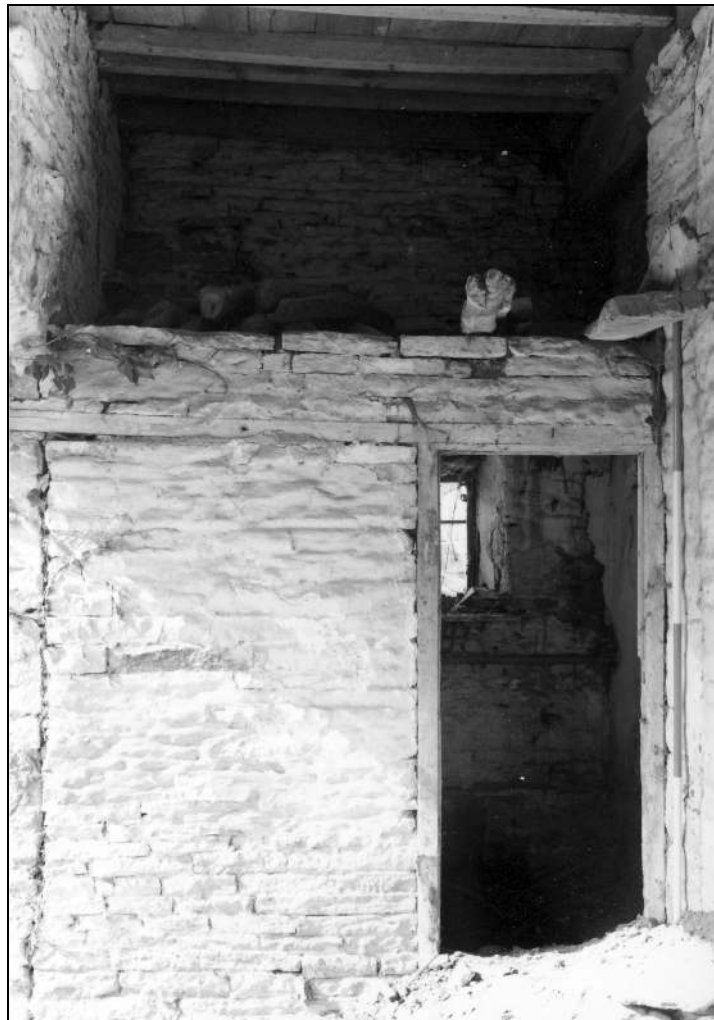
floor beam. The south-east bay now forms an entrance area with the small office to one side (**15,16**), the latter having a low ceiling of stone flags and formerly a small stove in the corner, to make a warm room. The doorway from the entrance area into the rest of the building has a plank door on which pencilled graffiti seems to record weights of materials (**17,18**).

Photo 16: Office in mill, from the north-east

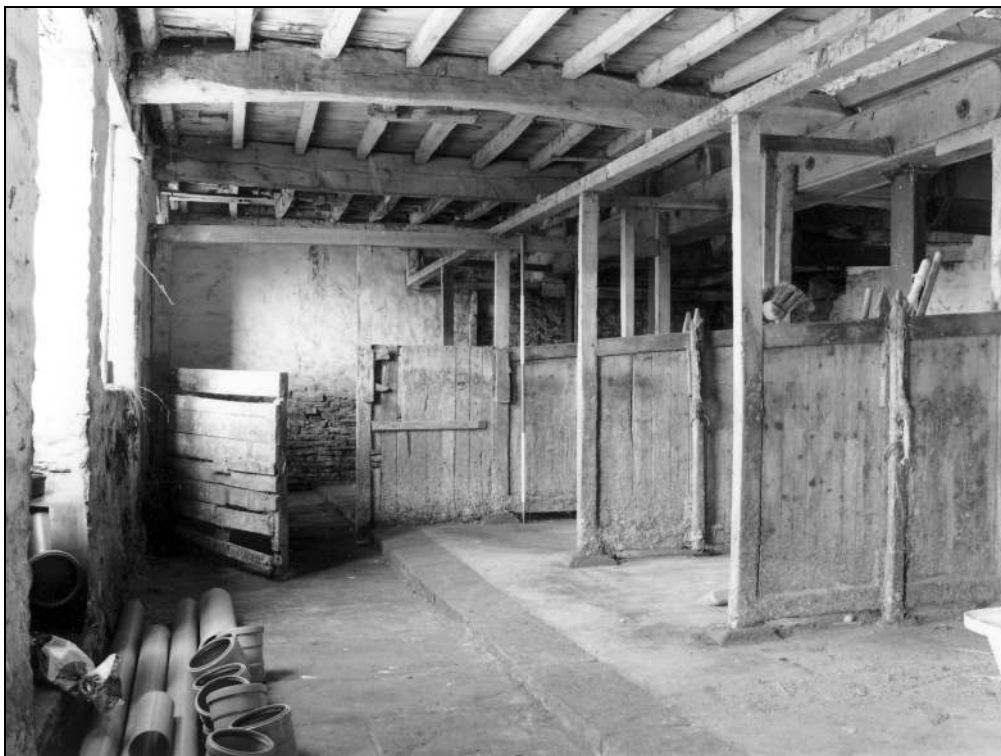
Photo 19: The shippon occupying the ground floor of the mill

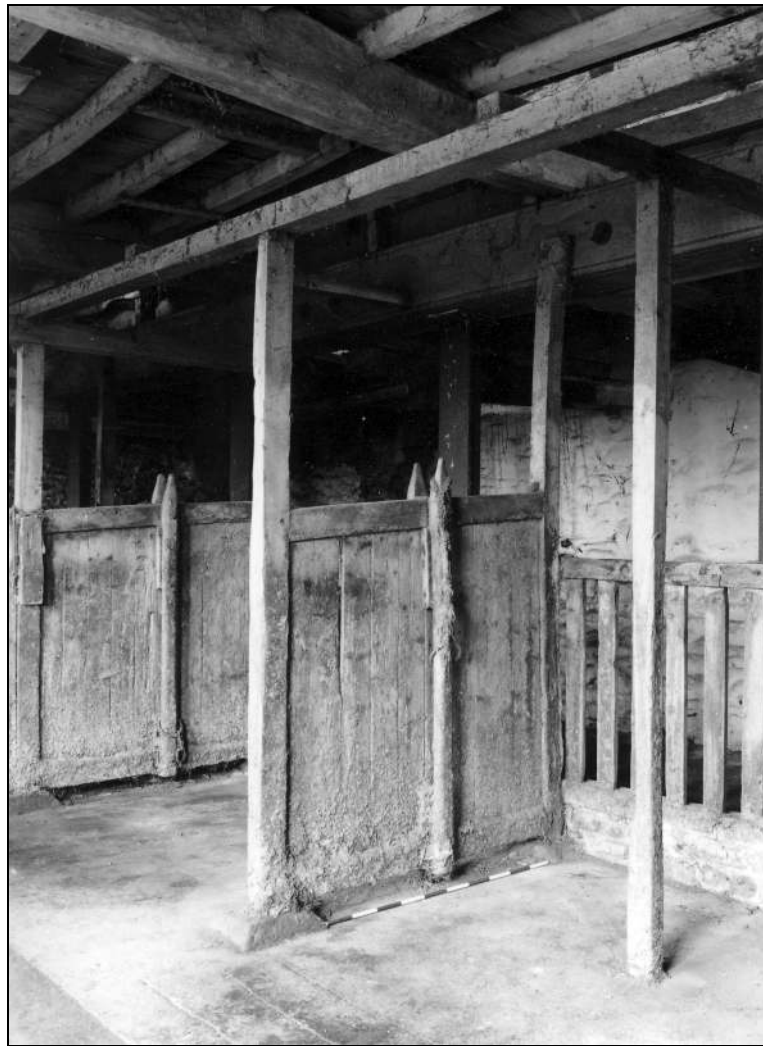
Photo 21: Detail of boskin in shippon

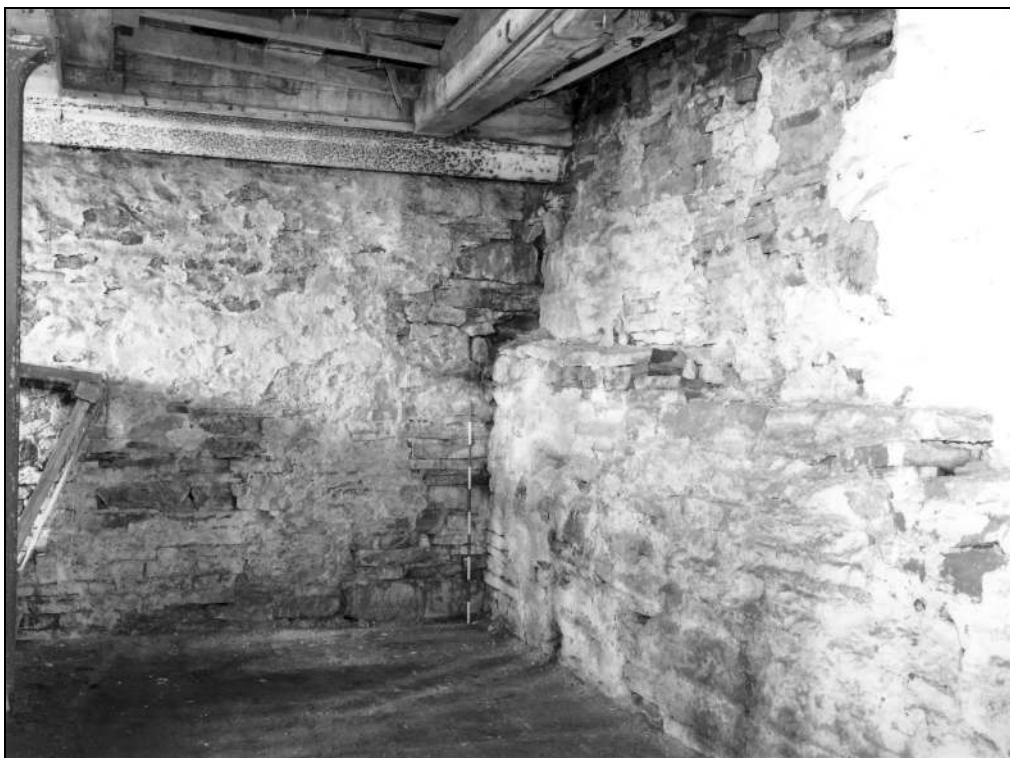
Photo 23: North corner of the mill, below hurst, showing thicker wall to right

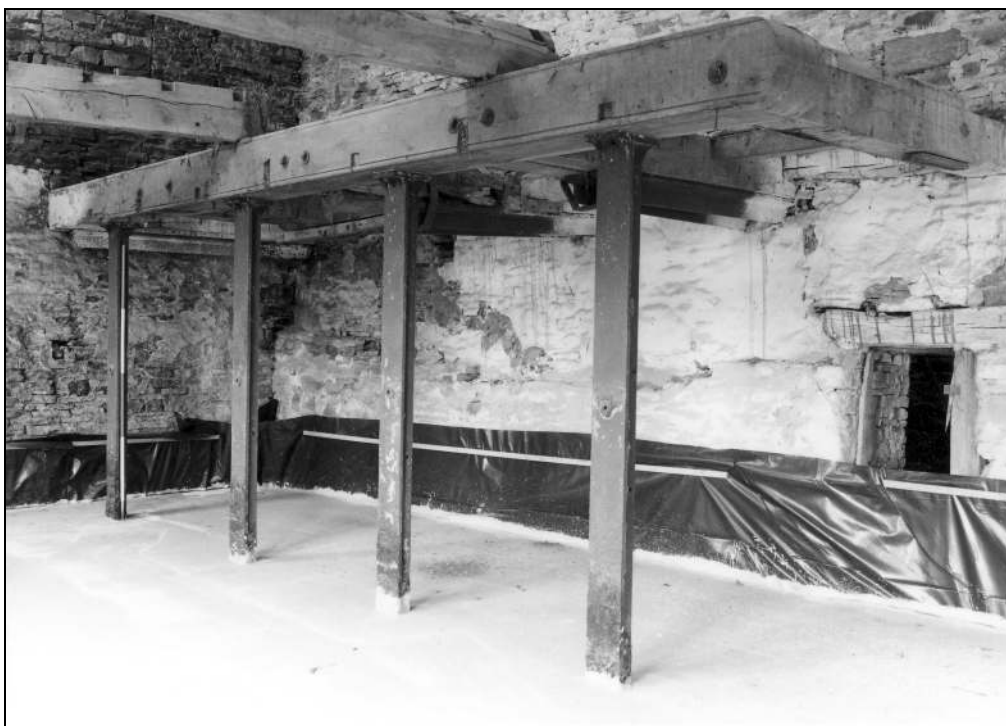
Photo 24: The hurst, after the removal of the shippon fixtures

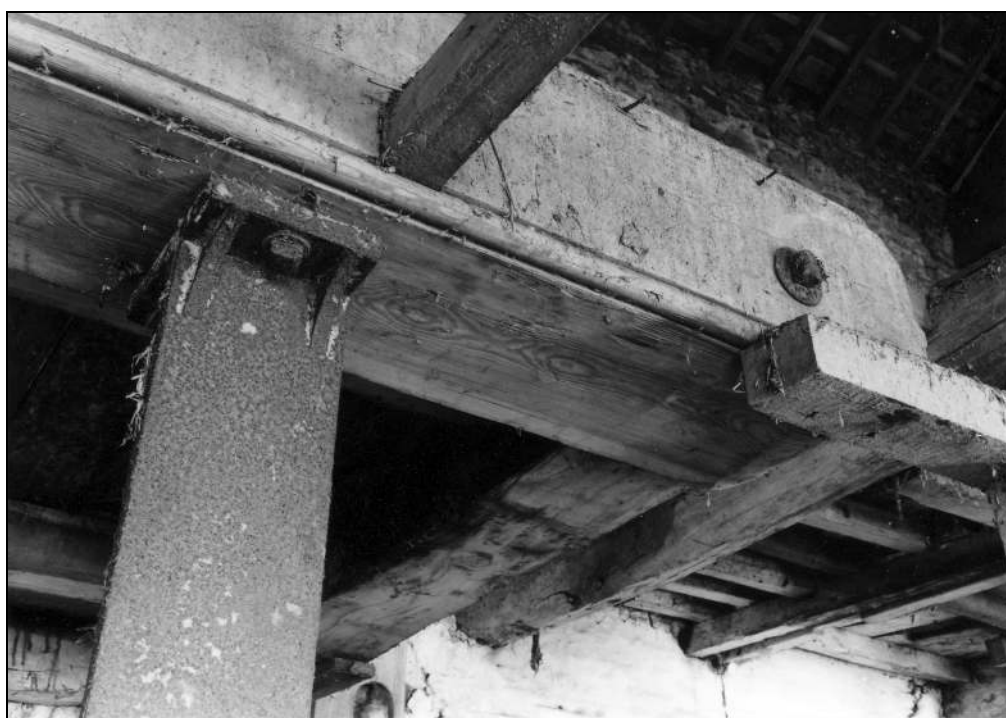
Photo 28: The beam forming the south-west side of the hurst

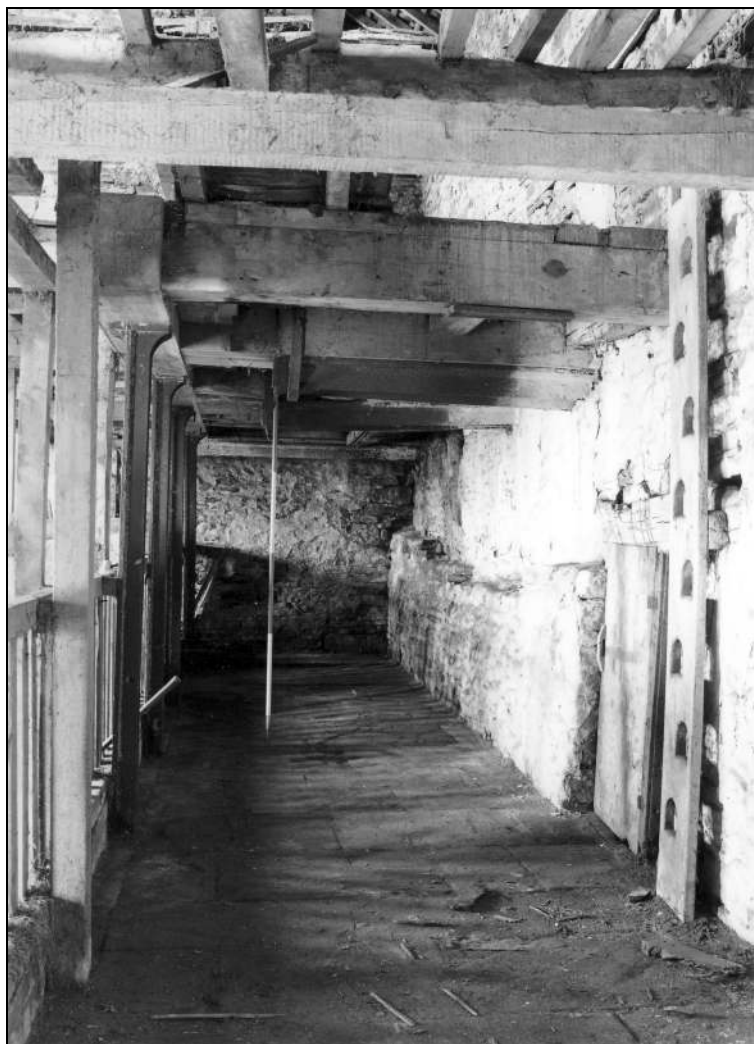
Photo 30: The hurst, and later feeding passage, from the south-east

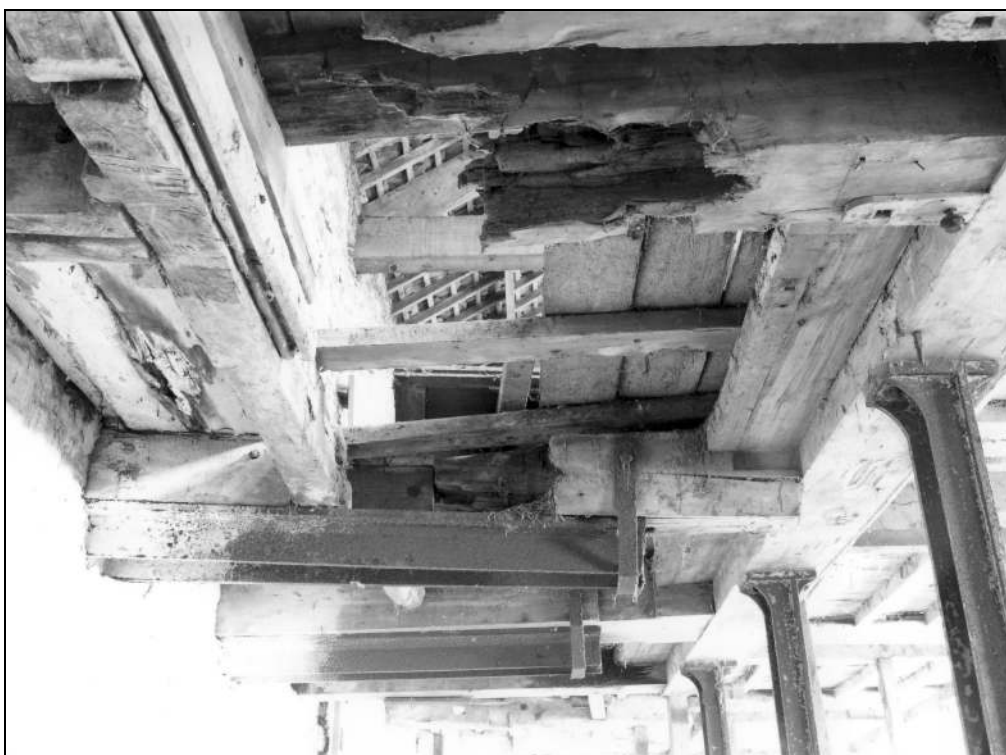
Photo 32: Underside of the hurst, from the north-west

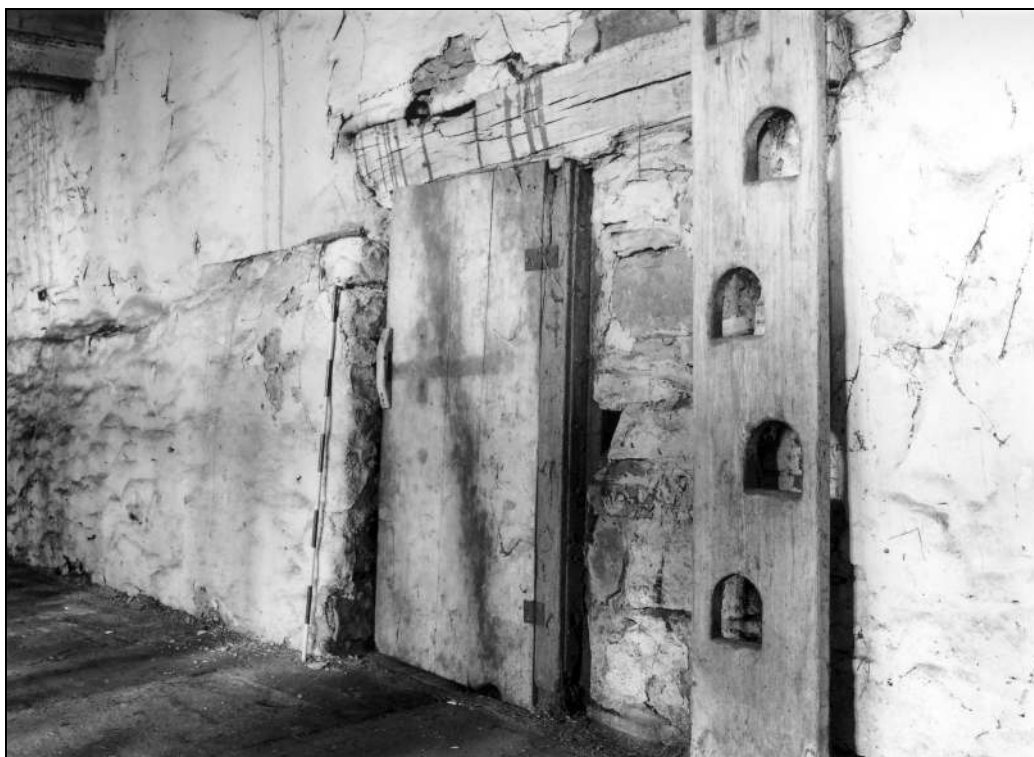
Photo 33: Doorway at former waterwheel bearing, and Jacob's ladder

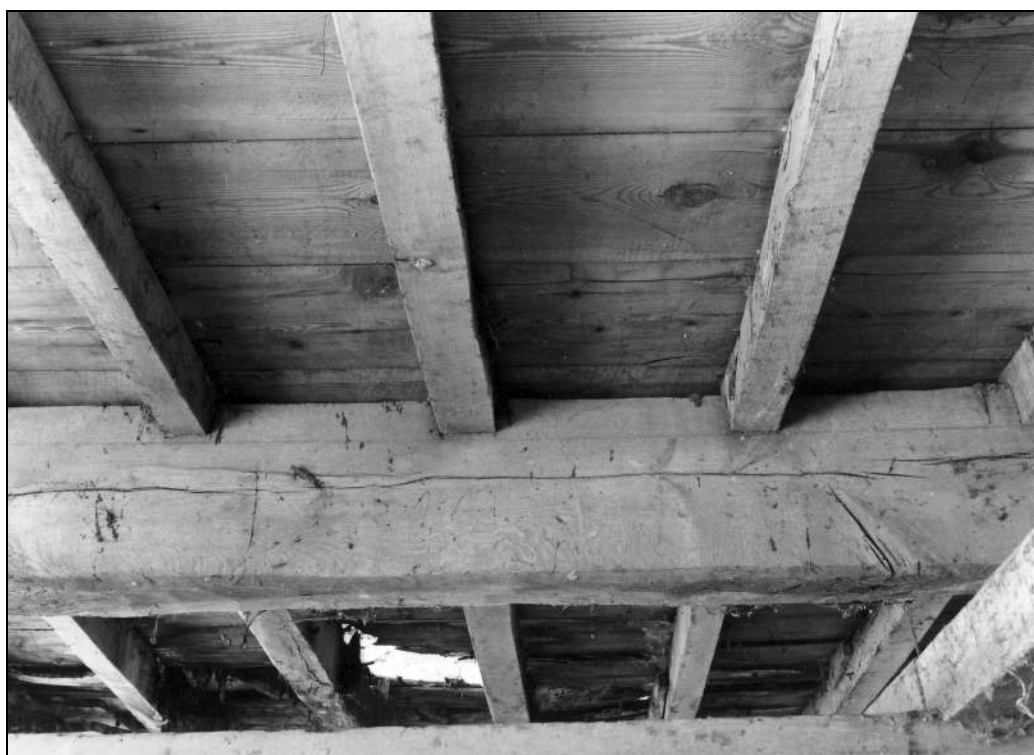
Photo 37: Underside of the first floor in mill, from the south-east

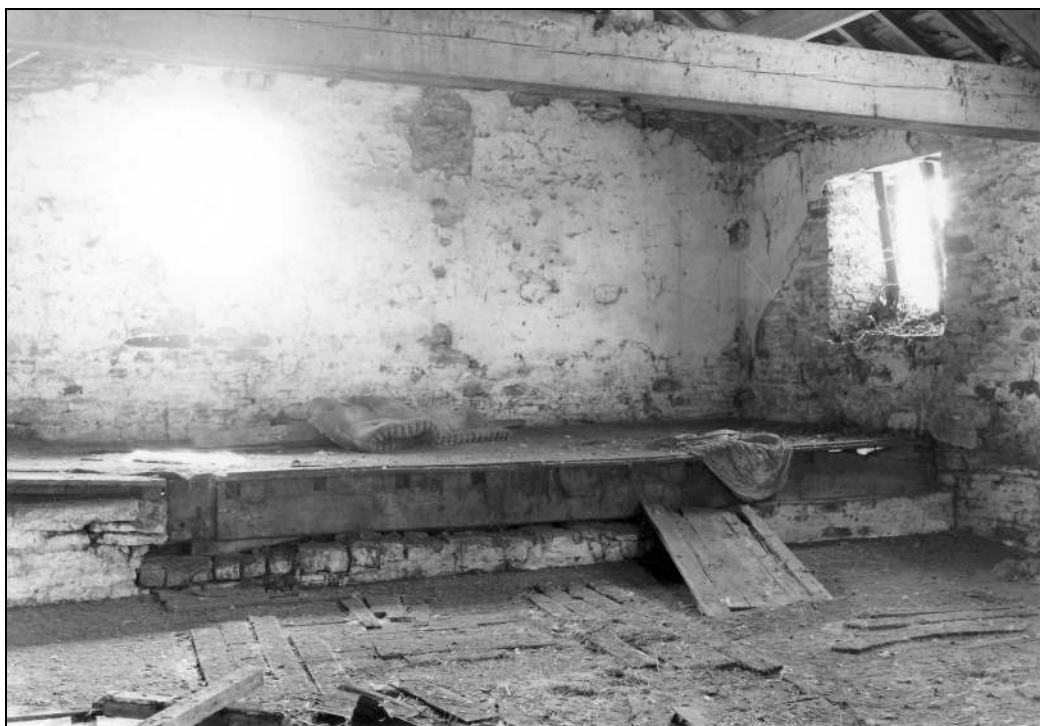
taken place in the early 20th century (38-39); the result was to allow the hurst to support the floor, whereas previously the first floor beams were independent of it. The floor level over the hurst itself is therefore lower still, as its framework forms the first floor (40). Most recently this upper floor must have served as a hay loft, but when the building was in use as a mill, most of it would have been for storage of unprocessed or milled grain.

Photo 38: First floor of mill: the south-east bay

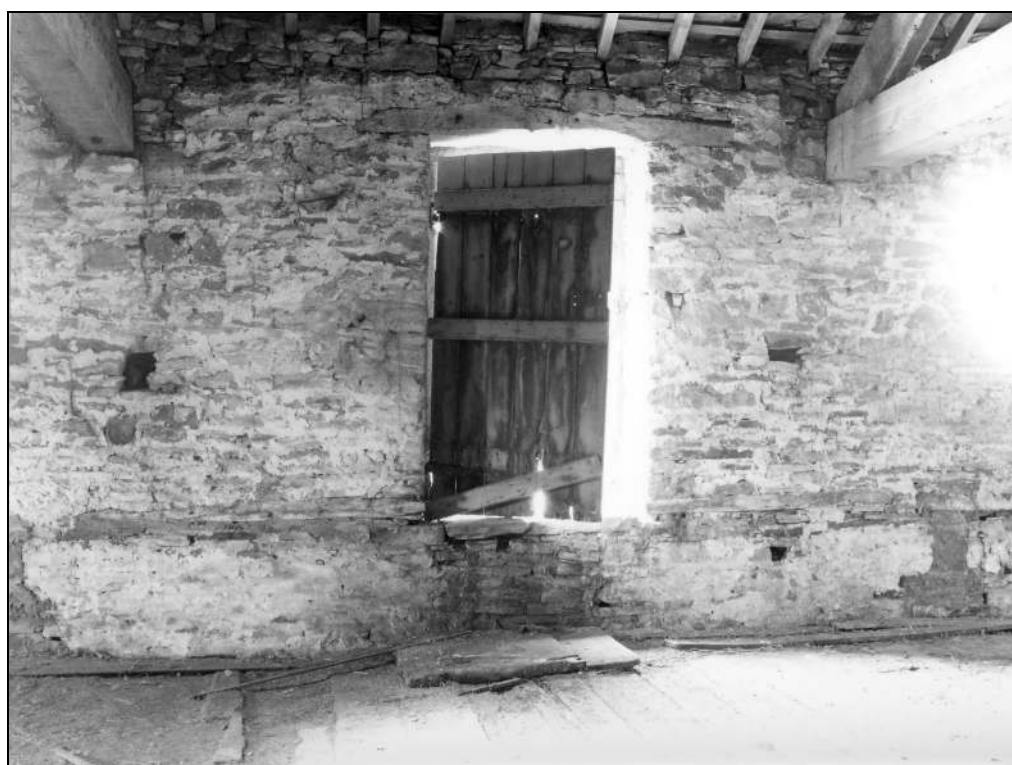
Photo 39: First floor of mill: taking-in door in south-west side, showing former floor level

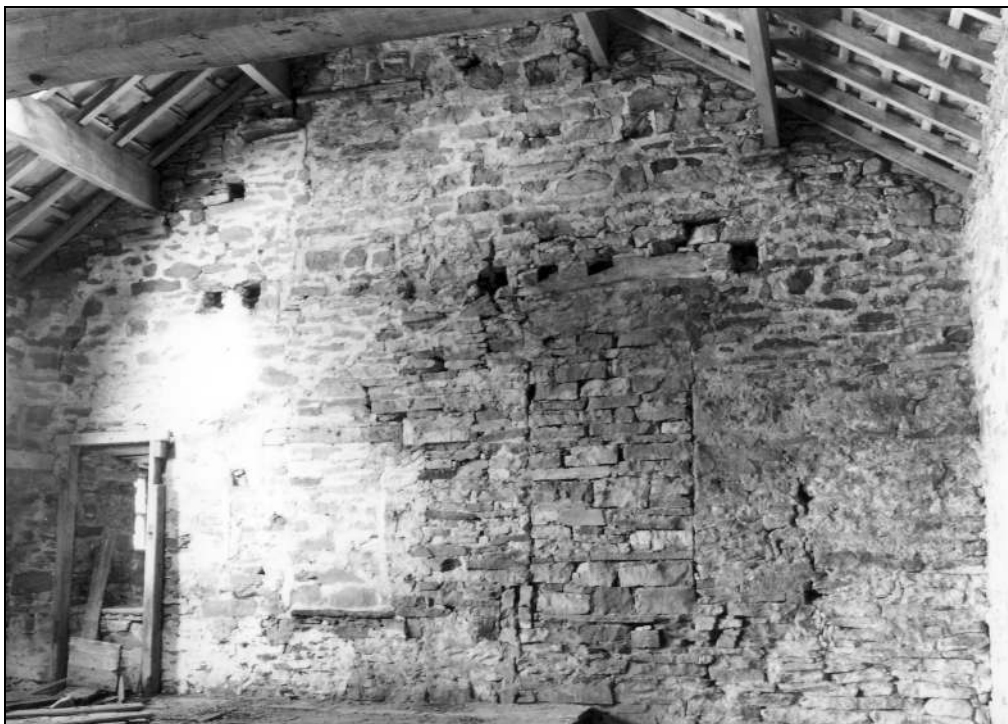
Photo 40: First floor of mill: the north-west end

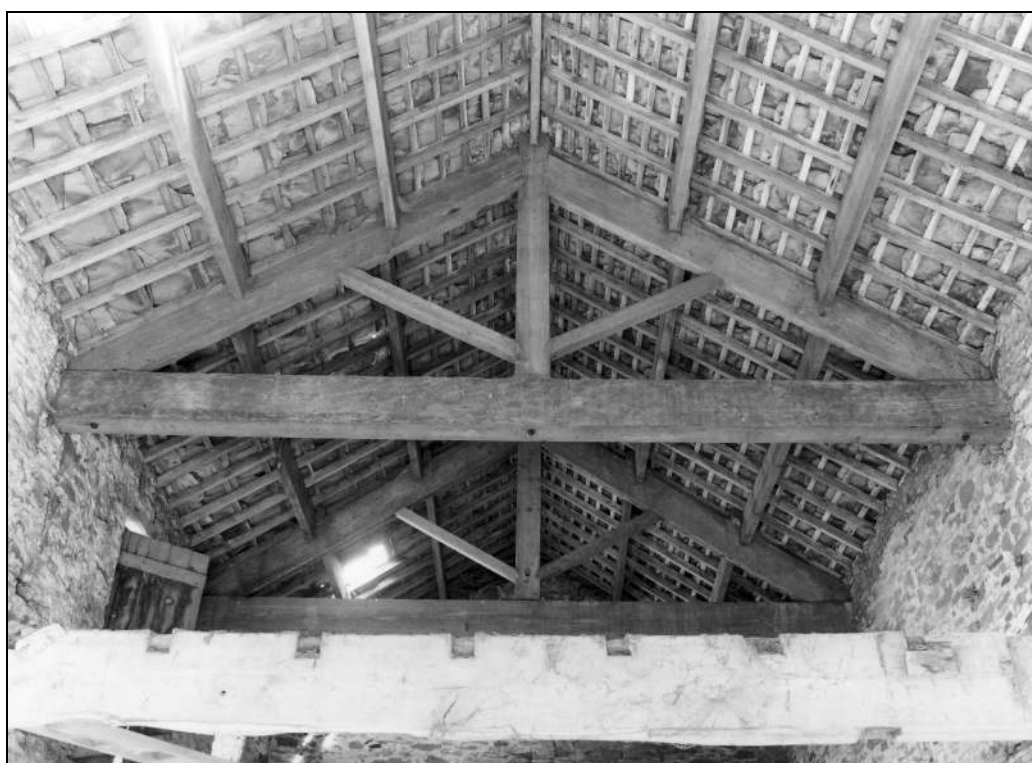
- 7.11 The present bolted king post roof trusses are formed entirely of square-sawn softwood and are 19th century (41,42); they may have replaced earlier trusses in the same position, as alterations in the adjoining stonework can be seen inside and outside the building.

Photo 41: Roof trusses in mill, from the south-east

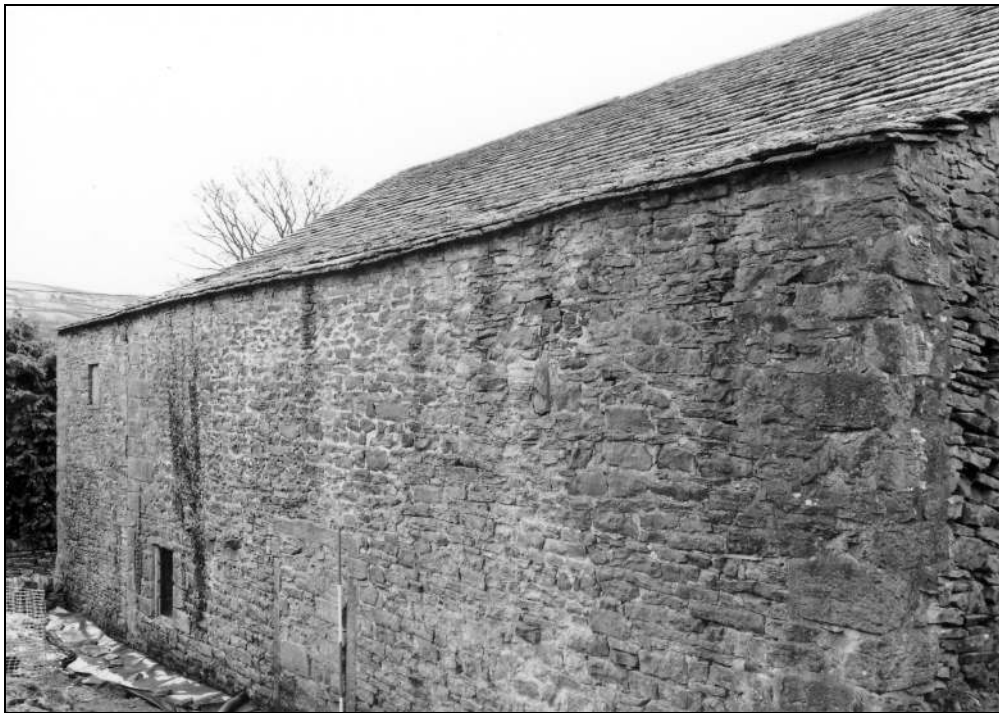
Photo 44: The wheel-house, from the north

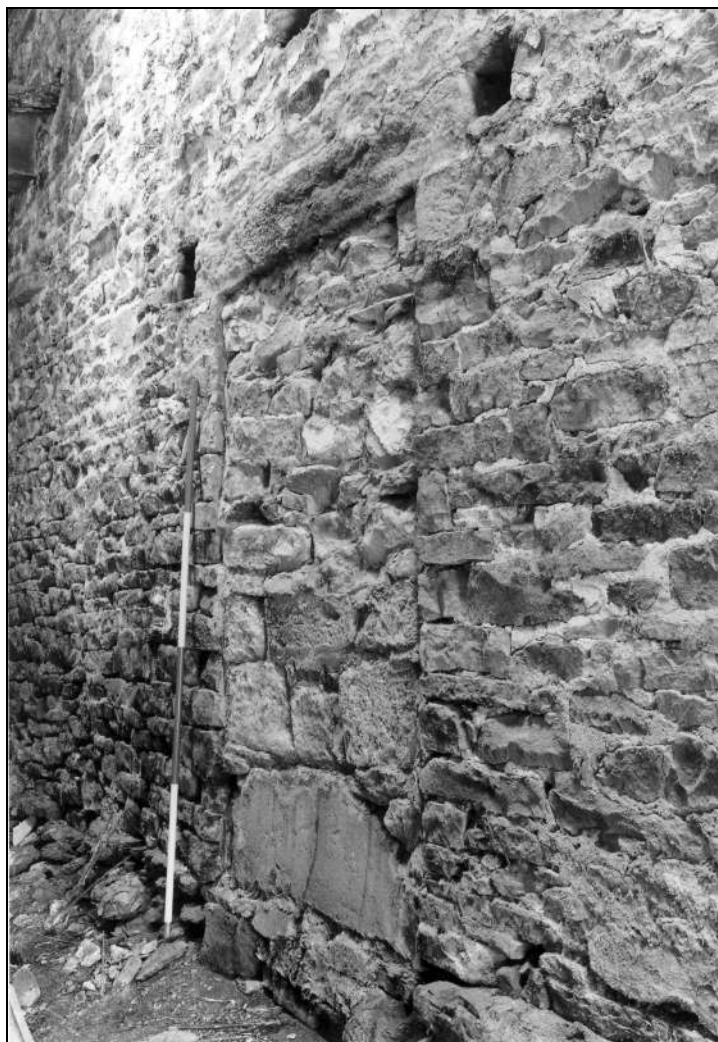
- 7.14 Openings in the outer walls of the wheel-house include a window and blocked doorway in the north-east side, the latter on the line of the axle (45,46), but there is no readily visible evidence of the former adjoining building which is shown on the maps of 1889 and 1907, and its purpose remains obscure. The wheel-house also has a doorway with good dressings in its south-east end, now communicating with the later building there, and with its threshold disturbed (47); the tail race would have run through below this opening before it was filled in. The doorway's lintel is very similar to the slotted stone used in the doorway in the front elevation (48), suggesting re-use of materials from an earlier structure, and many of the stones in its jambs are marked with the letter "I", probably the mark of the mason who cut them (49).

Photo 46: Blocked door in north-east side of wheel-house, from the south

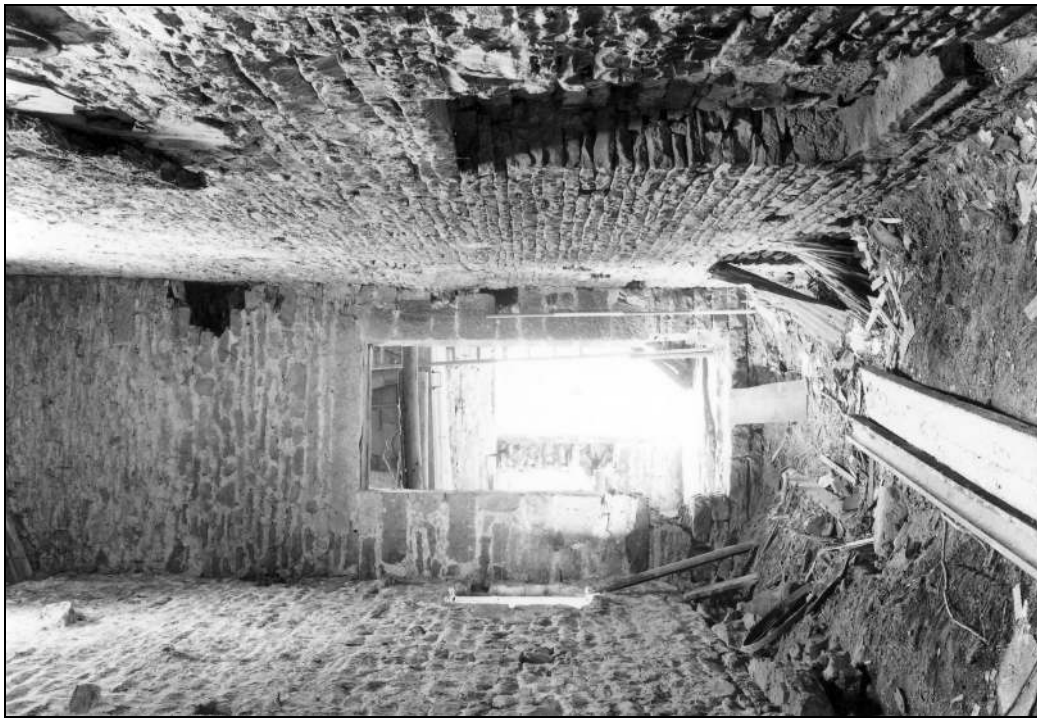
Photo 50: Interior of wheel-house, from the north-west

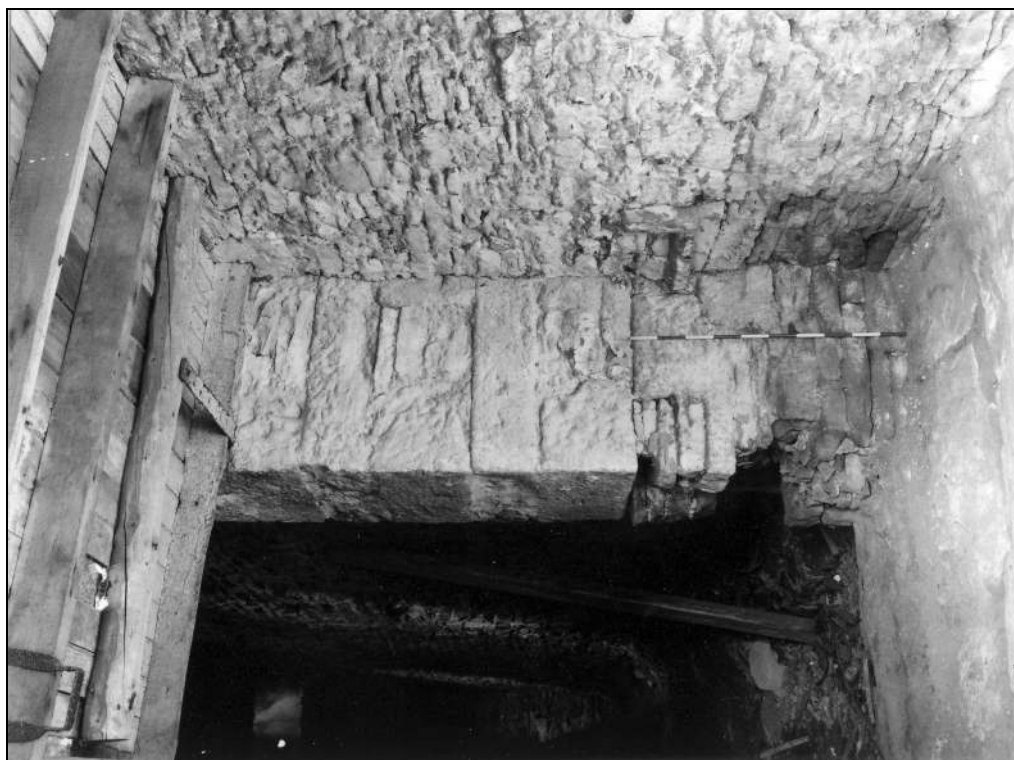
Photo 47: Lower part of doorway in south-east end of wheel-house, within later store

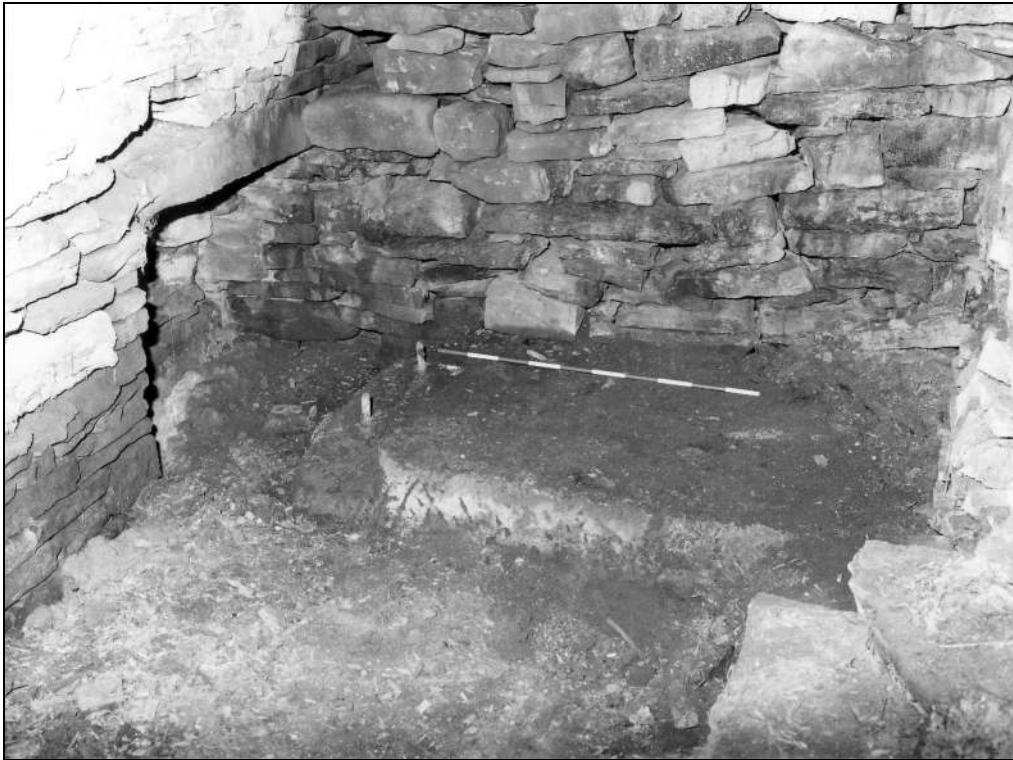
bolts marks its north-west end (51). As noted previously, this aligns with a low recess in the adjacent wall, but it is not known what function these components had. Over this end of the wheel-house is a large stone block and a number of timber beams (the latter in poor condition, so the stone may have been inserted as a substitute) (52,53), which conceivably carried a launder supplying the head-race to a breast-shot wheel. Despite there being no clear indication of any opening in the end wall of the wheel-house through which the head-race may have passed, excavation of the adjacent ground during the present development revealed the remains of a dry-stone buttress, or truncated wall on the outside of this building (54-57), which may have been the support for a launder running from the dam, a short distance to the north-west. The character of the stonework of this north-west end of the wheel-house is varied, the upper part being of better quality than the lower, suggesting there has been some rebuilding, which probably accounts for the lack of evidence relating to the water supply through it.

Photo 51: Stone block with fastening bolts at north-west end of wheel-pit

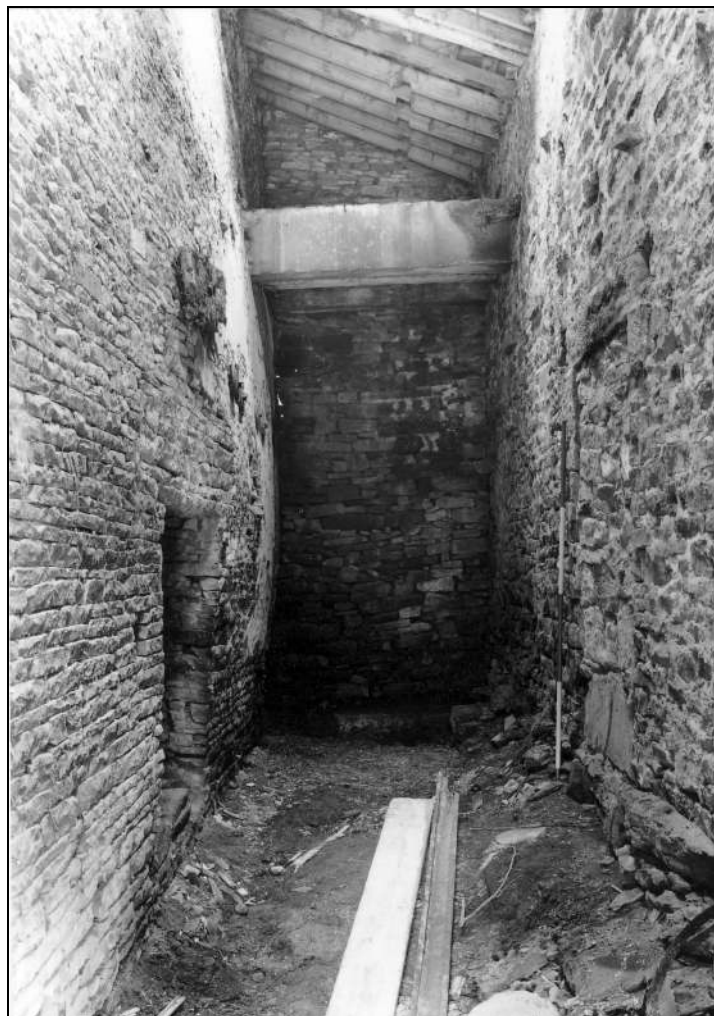
Photo 52: Interior of wheel-house, from the south-east
