Former Corn Mill  
Mill Lane, Low Bradley, North Yorkshire:  
Historic Building Recording

May 2010

# Former Corn Mill Mill Lane, Low Bradley, North Yorkshire: Historic Building Recording

### HISTORIC BUILDING RECORDING

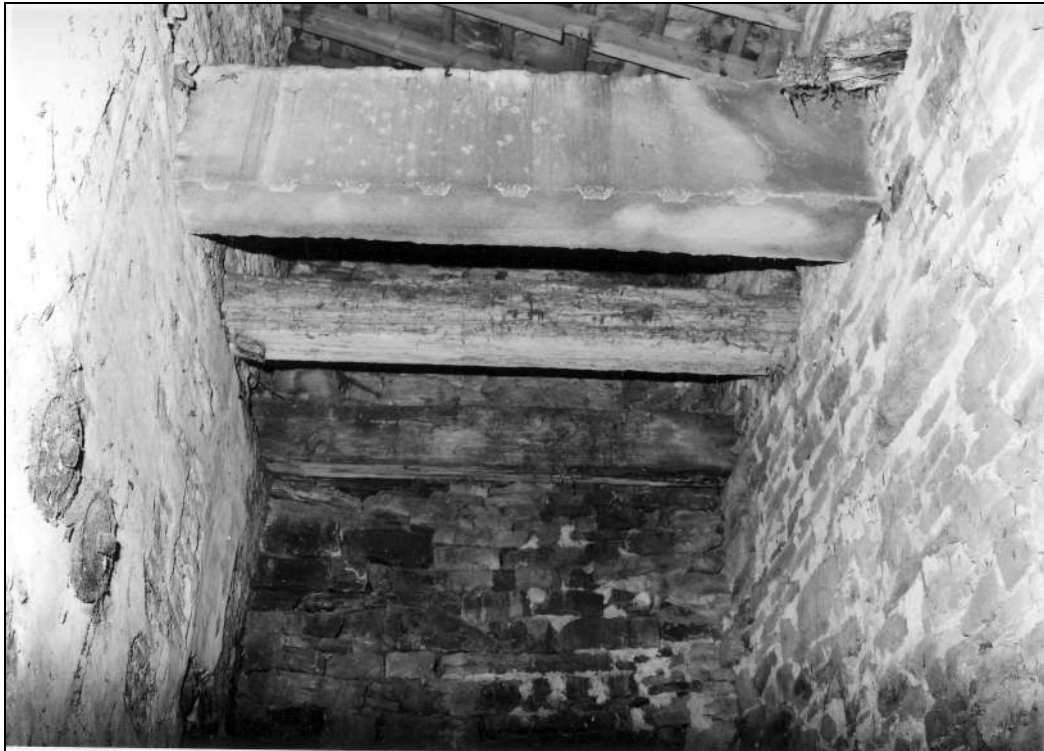
Photo 53: Stone block and timbers above north-west end of wheel-pit

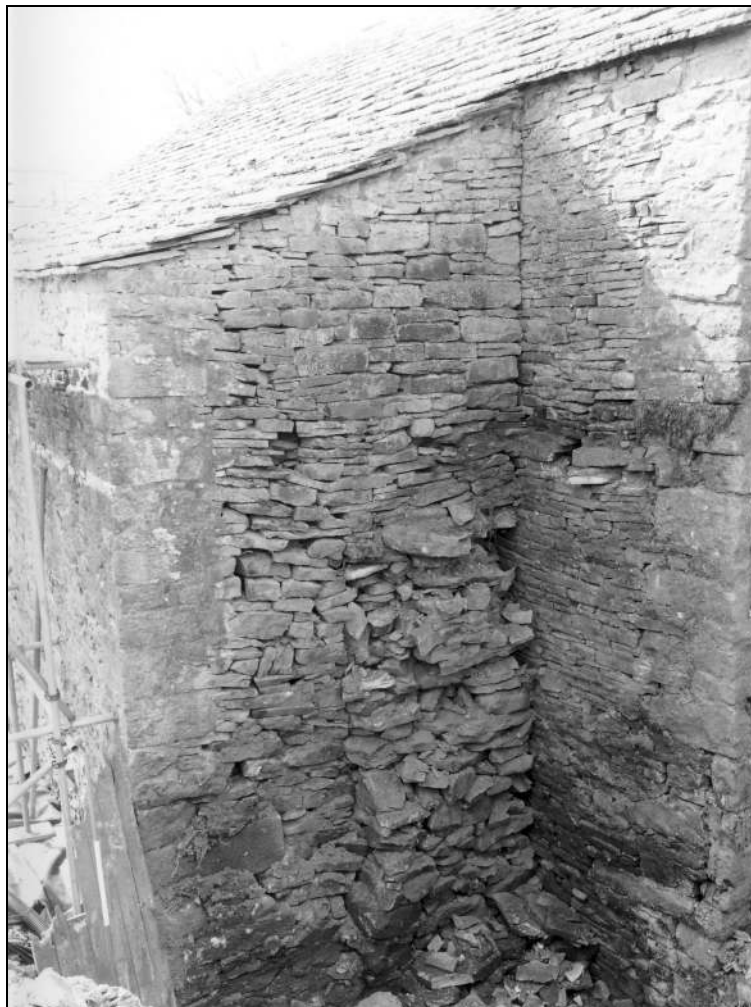
Photo 55: North-west end of wheel-house after excavation, showing buttress or laundry support

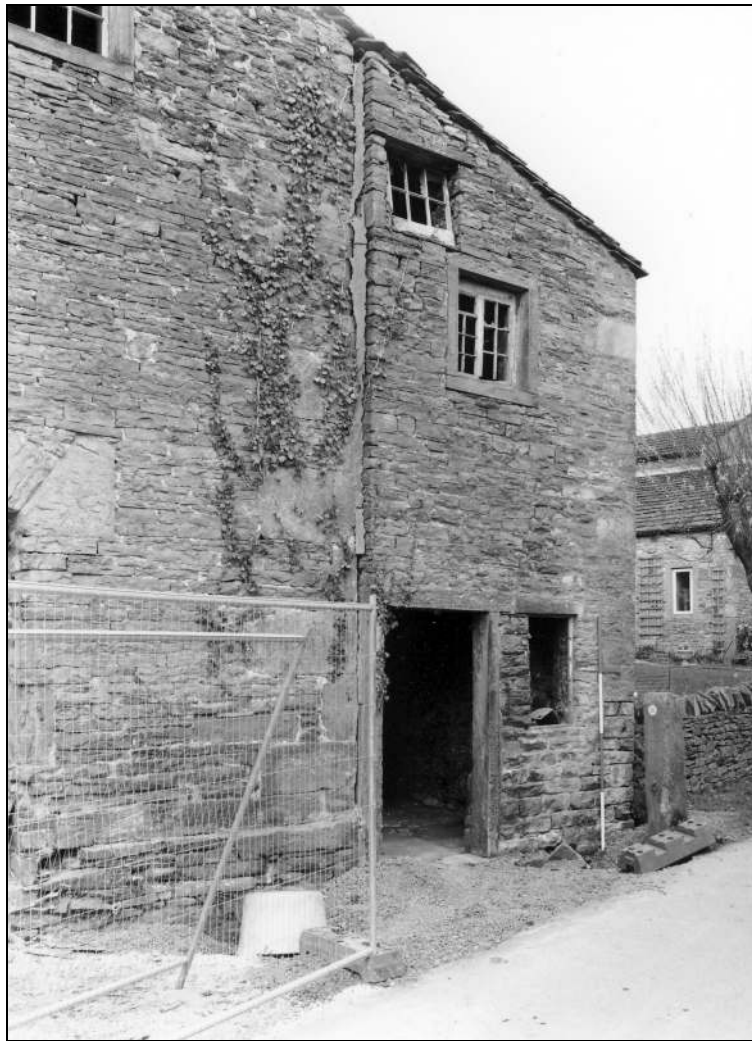
Photo 58: Added building at east corner of the range

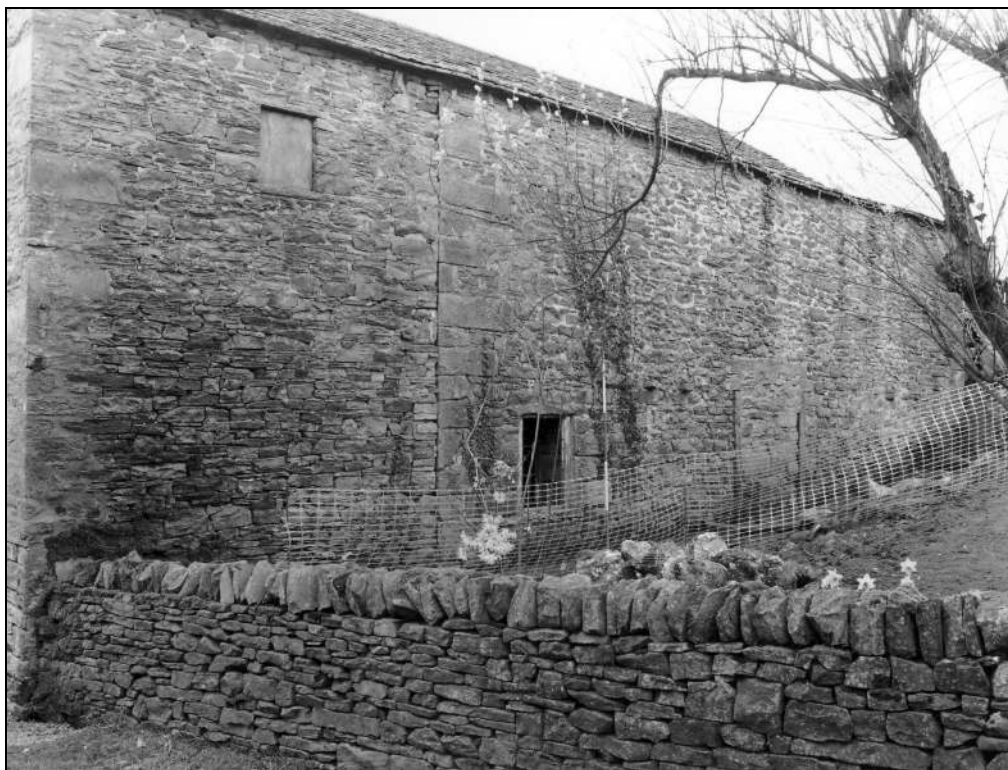
Photo 60: Wheel-house and added store, from the east

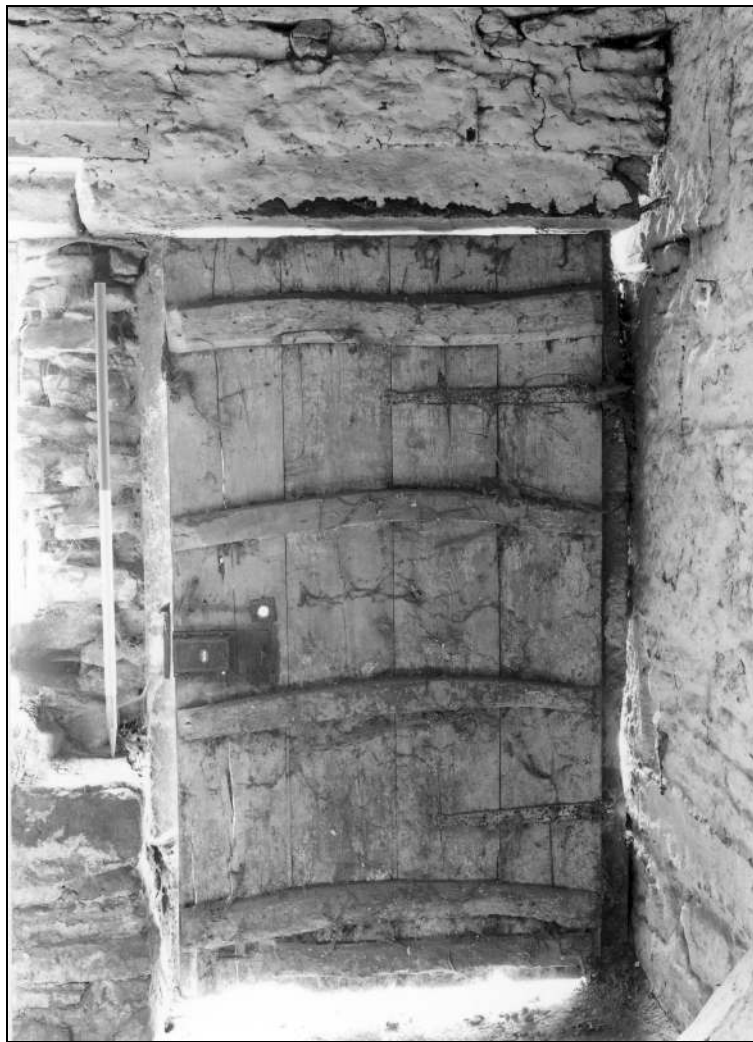
Photo 62: Door to added store (inner face)

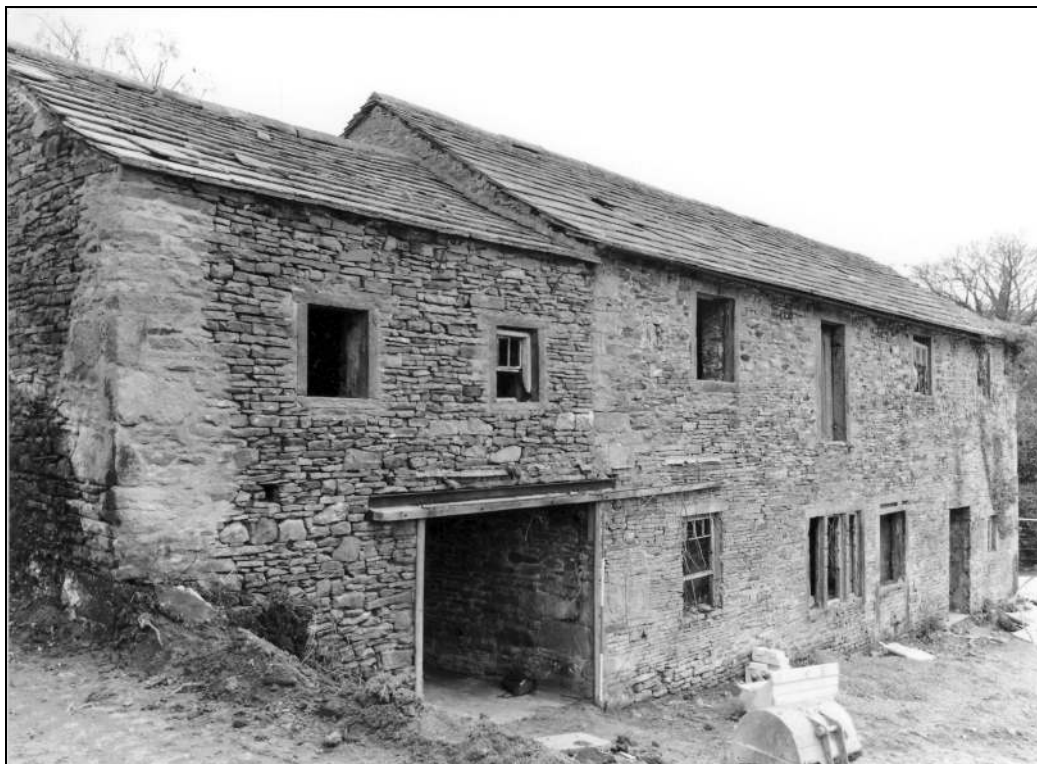
Photo 64: Added store at north-west end of range

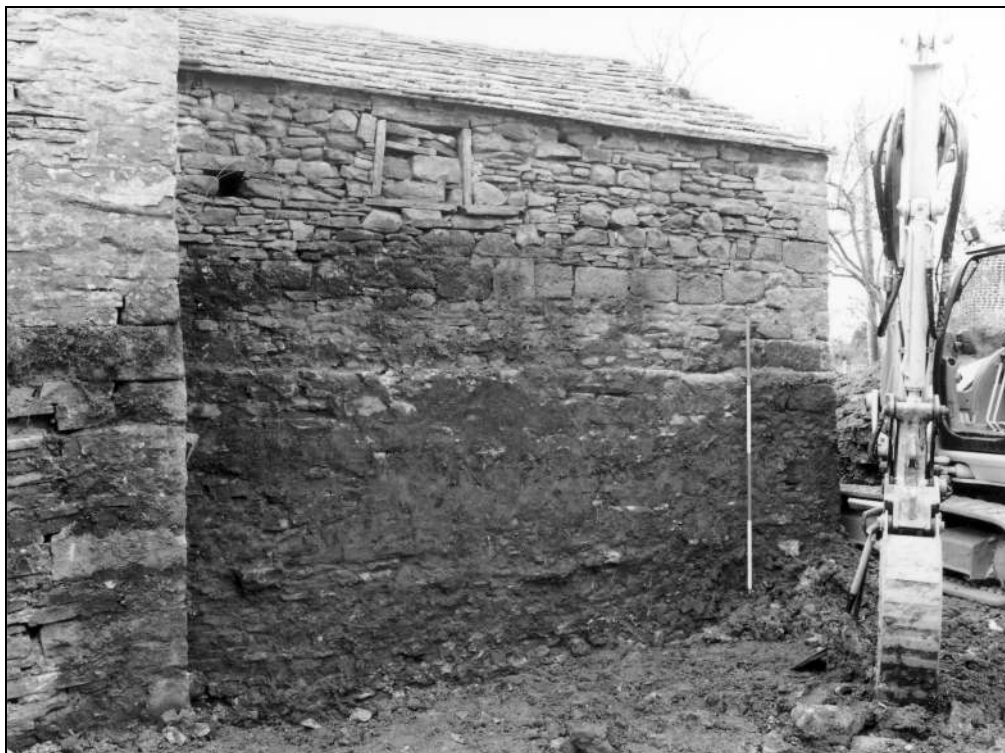
Photo 68: Added store: north-east side

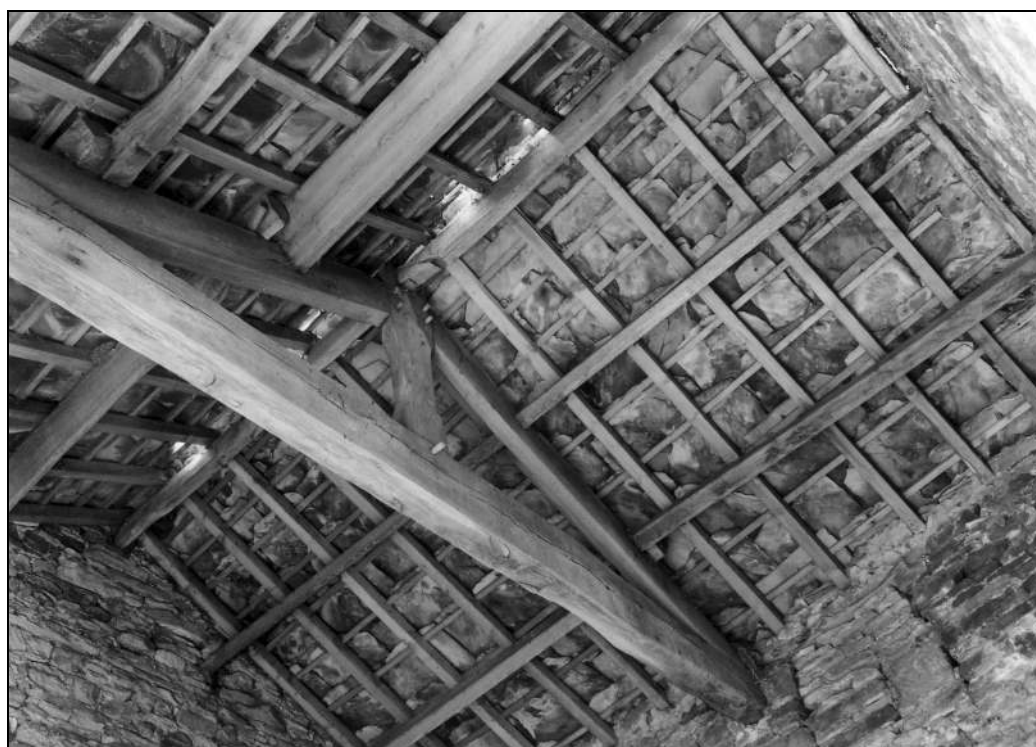
Photo 70: Added store: roof truss
