Cow Gill Cote
Bordley, North Yorkshire:
Historic Building Record

November 2010

STEPHEN HAIGH

Historic Building Record

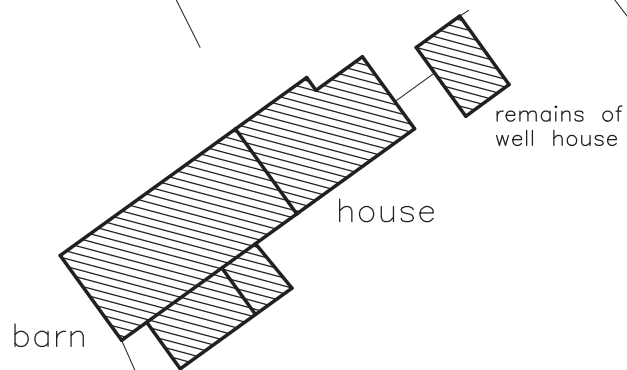
FIGURE 2:
SITE PLAN

- 2.2 The buildings at the site form a single range, facing south-south-east, with the barn at the west end and the house to the east. A large outshut adjoins the south elevation of the barn, and there are also the remains of a detached, ruined well house to the east of the house.

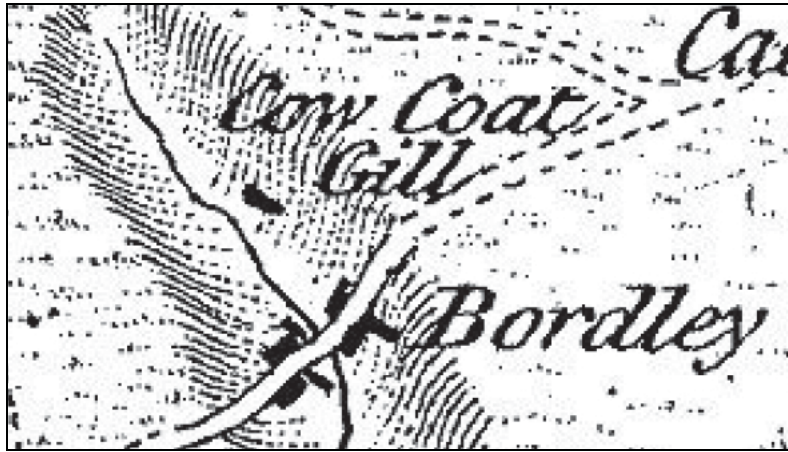
Figure 3: Extract from Jeffrey's map of Yorkshire, surveyed 1771

- 5.4 The earliest map known to show Cow Gill Cote is Jeffrey's map of Yorkshire, surveyed in 1771 (Figure 3), which names it "Cow Coat Gill". The Bordley tithe map of 1841 (Figure 4) shows the arrangement of buildings largely as it is today, with some differences however: there appears to be a porch to the front of the

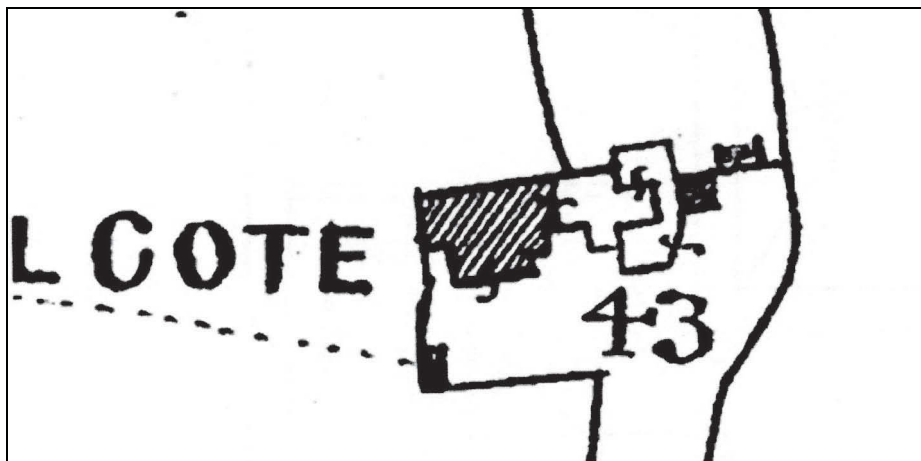
Figure 4: Extract from the Bordley tithe map, 1841
(NYCRO: MIC 1772/386-390)

house site, and an adjunct the south side of the barn, neither of which is now present. There is also a detached building shown to the south of the barn, no longer extant. (The symbol to the east of the well house appears to show a gate.) The slightly later Ordnance Survey first edition 6" to the mile map, surveyed in 1852 (Figure 5), shows a roughly similar arrangement, although the scale is too small to be certain of how the buildings are depicted, although the 1894 1:2500 map is more useful: it shows that the arrangement evident in 2010 is the same as that recorded at the end of the 19th century, a situation borne out by the 1909 edition of the map (Figures 6 & 7).
