**FINDLAY FARM  
ABERDEEN**

**ARCHAEOLOGICAL BUILDING RECORDING REPORT**

Cat Peters  
Aberdeen City Council Archaeological Unit  
September 2008

**FINDLAY FARM, ABERDEEN  
REPORT ON AN ARCHAEOLOGICAL BUILDING RECORDING  
(SITE CODE E95)**

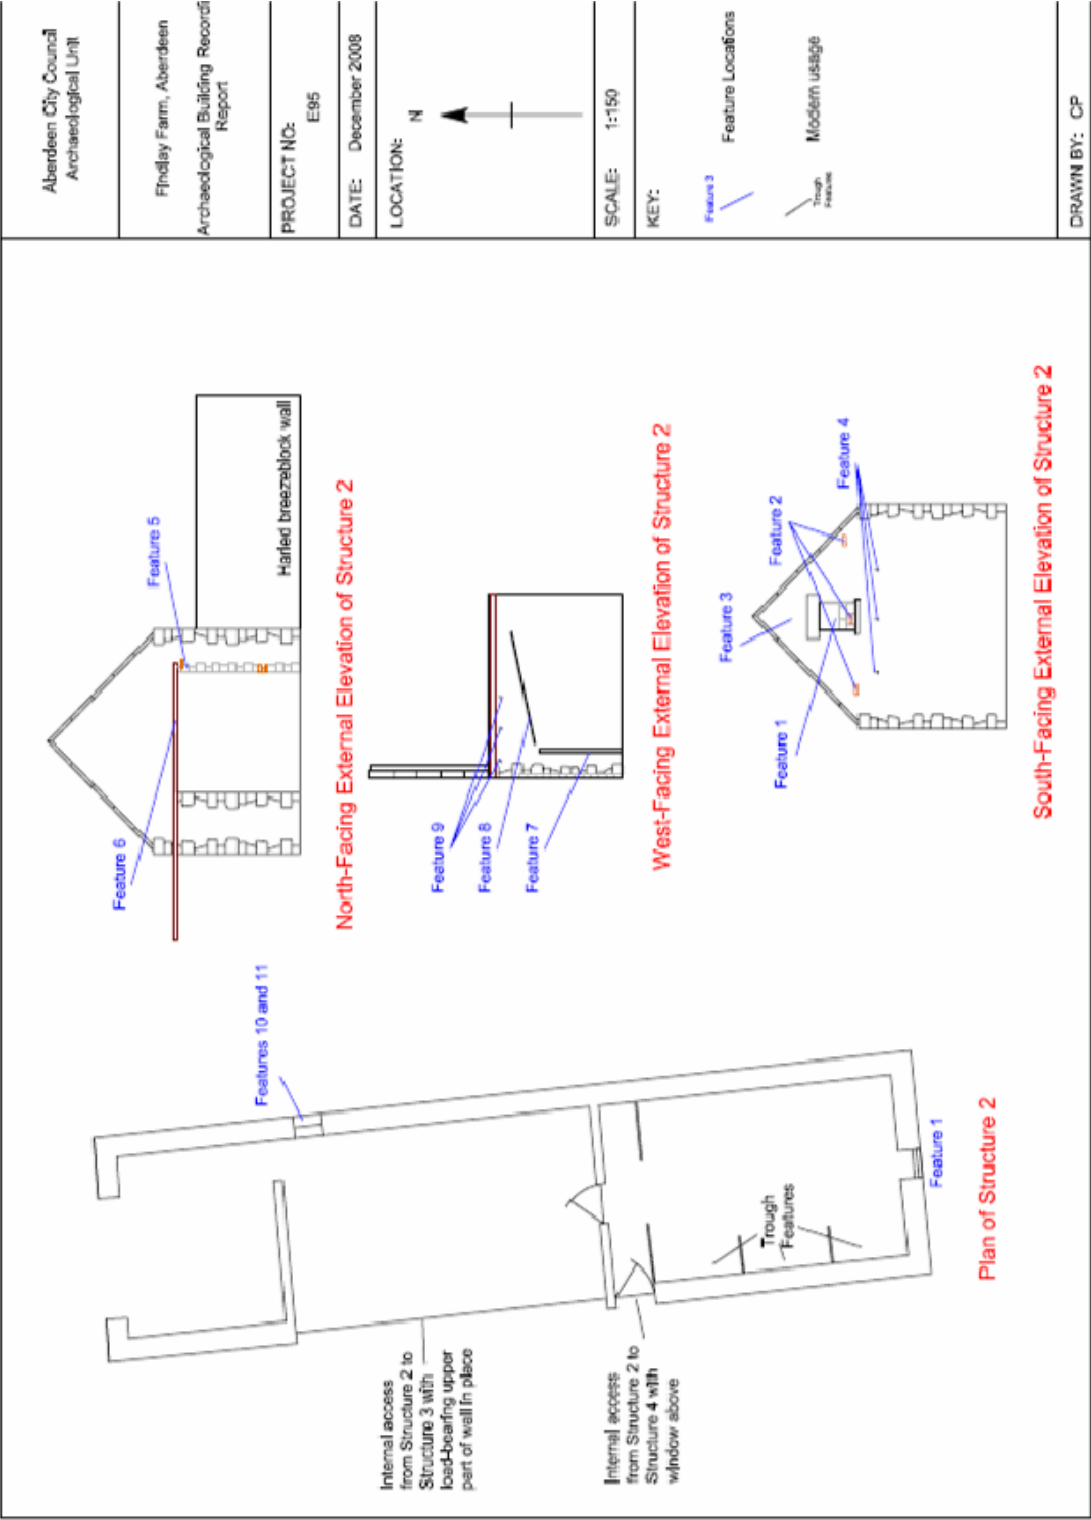
Figure 4 : Plan and Elevations of Structure 2

Structure 2 was a roughly north-south aligned structure. The adjoining nature of the structures forming the steading at Findlay Farm meant that externally, only the north and south-facing elevations of Structure 2 were fully visible. The northern part of the west-facing elevation was also recorded. The structure stood to a height of 6.4m, was 5.7m wide and 20.75m in length and was rectangular in plan (Figure 4). It was built of coarse granite blocks with smaller fragment infills consistent with the local traditional style. The gabled roof was finished in slate tiles. The south-facing exterior elevation revealed quoins, and a window, partially blocked with breezeblock, close to the roofline (Feature 1). Fragments of tiles were observed on a diagonal line beneath the window stretching across the elevation (Feature 2). The upper part of the elevation showed evidence for re-rendering (Feature 3), and was of a smoother finish. Metal hooks survived beneath the re-rendered area (Feature 4).

The north-facing exterior elevation of Structure 2 was furnished with a large entranceway with granite quoins at its eastern extent, matching the style at the edges of the structure, and a mixture of brick and breezeblock lining the western edge of the entranceway, and the top section of the eastern edge (Feature 5). The top of the entranceway was provided with a concrete lintel (Feature 6) with a timber horizontal strut nailed to it.

The visible part (northern extent) of the external west-facing elevation of Structure 2 showed a construction fabric consistent with the rest of the structure. The far northern extent was obscured by an abutting wall 5.84m in length, protruding westwards from the north-facing elevation, although quoins were visible. This was 0.25m in thickness, and was of harled breezeblock construct. A vertical tar stain 0.54m from the northern extent of the elevation (Feature 7), and a further diagonal sloping tar stain (Feature 8) were recorded beneath a row of metal hooks attached to a timber strut (Feature 9).

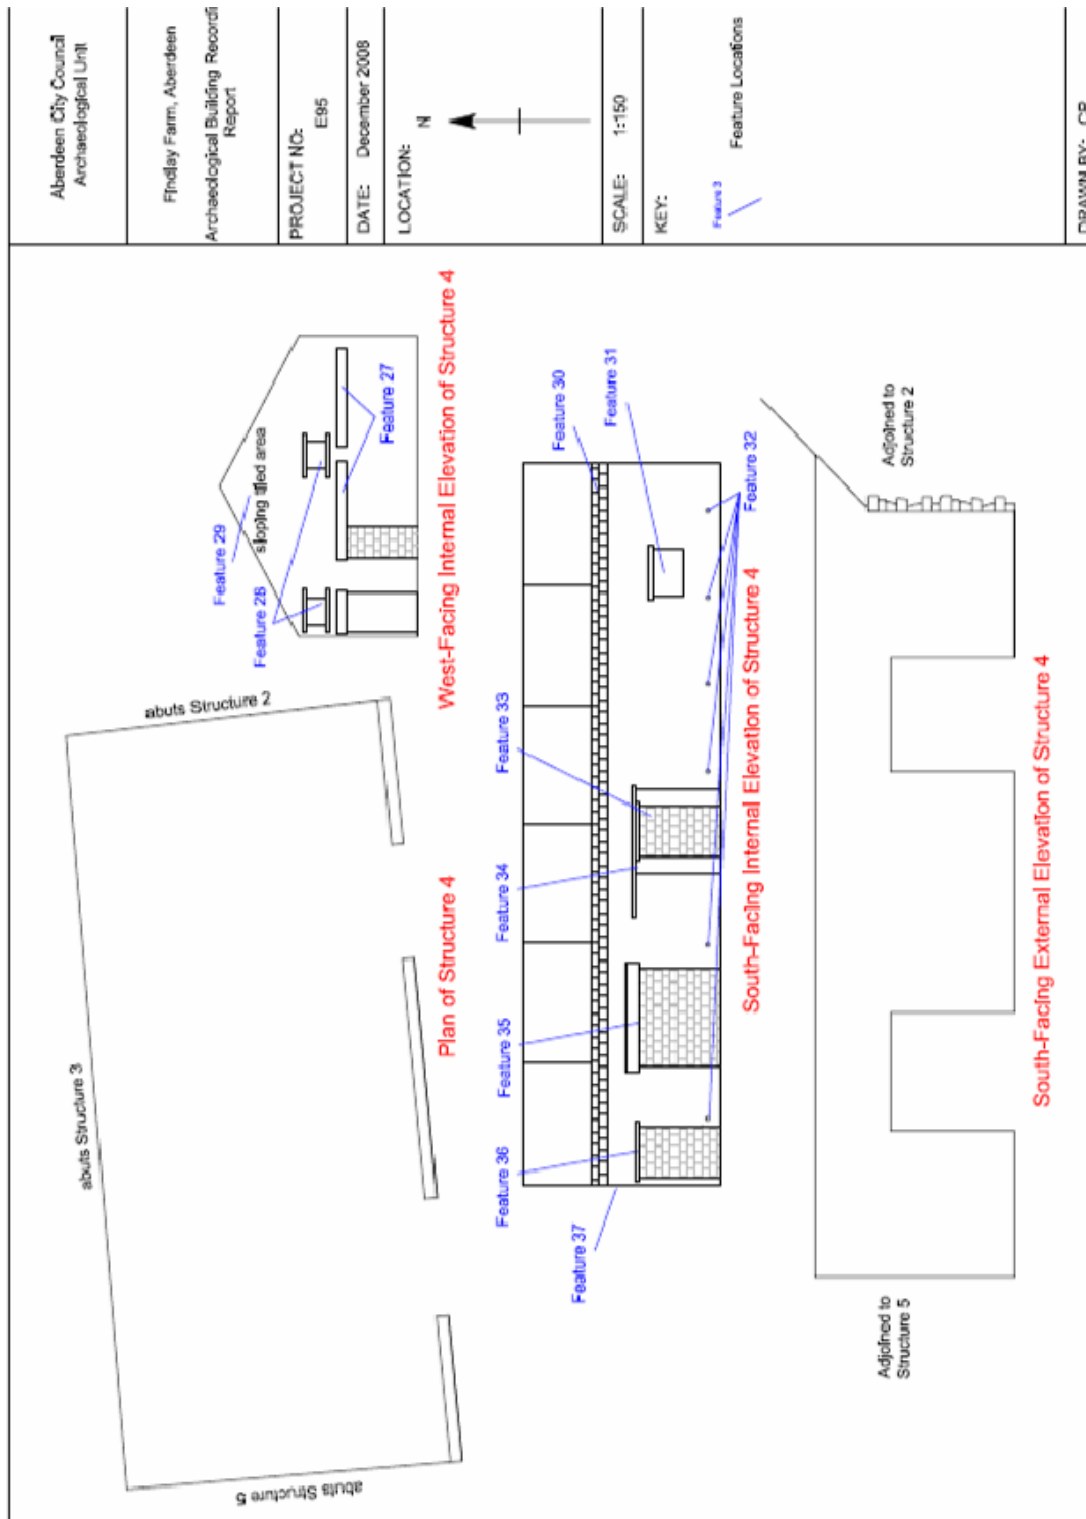
Figure 6 : Plan and Elevations of Structure 4

Structure 4 was a further roughly east-west aligned structure adjoining Structure 3 to the north, Structure 2 to the east and Structure 5 to the west. Structure 4 was rectangular in plan, measuring 36.3m in length, 8.5m in width, and standing to a height of 5m (Figure 6). Structures 2, 3 and 5 obscured all of the external elevations, except the south-facing elevation. This wall was 0.48m thick and 3.3m high and was completed in harled breezeblock. It included two large entranceways, each measuring 2.9m in width and 3.1m in height, one 3.65m from the western extent of the elevation, and the other 3.66m away from the eastern extent of the elevation. The roof was completed in corrugated iron, with steel trusses. No features of archaeological or architectural interest were observed on the exterior, and all seemed to be of one build.

The interior north-facing elevation matched that of the south-facing exterior one, and no further features were observed. The west-facing interior elevation was completed in granite, matching that of Structures 1, 2 and 3, and had a doorway at its northern extent with a granite lintel, leading through into the interior of Structure 2. To the south, two large horizontal granite blocks were recorded (Feature 27), with breezeblocks visible below, parts of which had been whitewashed. The whitewashed areas occurred within an animal pen

feature which existed within the south-eastern corner of the interior. Two windows were recorded at a higher level, one immediately above doorway, both of which were roughly square with granite lintels and sills (Feature 28). Hardboard blocked them from the other side. Above the windows was a sloping tiled area, which sloped eastwards (Feature 29).

The south-facing interior elevation of Structure 4 was of granite construction, similar to that observed on Structures 1-3. It extended to a height of 2.8m, above which were two courses of breezeblock (Feature 30), on which the roof trusses were established. Towards the eastern edge of the elevation was an area of granite blocks with mortar which did not match the rest of the elevation, consisting of a wider area at the top above a squared area (Feature 31). Below this, and across the elevation, except where disturbed by other features, was a series of six circular holes, 0.1m in diameter, and equally spaced in the eastern part of the elevation (Feature 32). Towards the centre of the elevation was a granite lintel, below which breeze blocks could be seen blocking the entry from the northern side of the wall (Feature 33). A timber slat on a metal runner further blocked access (Feature 34). To the west of this was a longer concrete lintel with whitewashed breezeblock beneath, blocked from the other side of the wall (Feature 35). At the far western extent of the elevation was a granite lintel, with breezeblock below- blocked from the northern side of the wall (Feature 36).

Much of the southern half of the east-facing interior elevation of Structure 4 was obscured by a cement-smoothed and whitewashed finish covering any surviving features beneath. The northern part of the wall was of granite construct, to a height of 2.1m, comparable to Structures 1-3 and 5. Above this level was 13 courses of breezeblock (Feature 37). A window was observed at its northern extent, which had been blocked from the other side of the elevation (Feature 38).

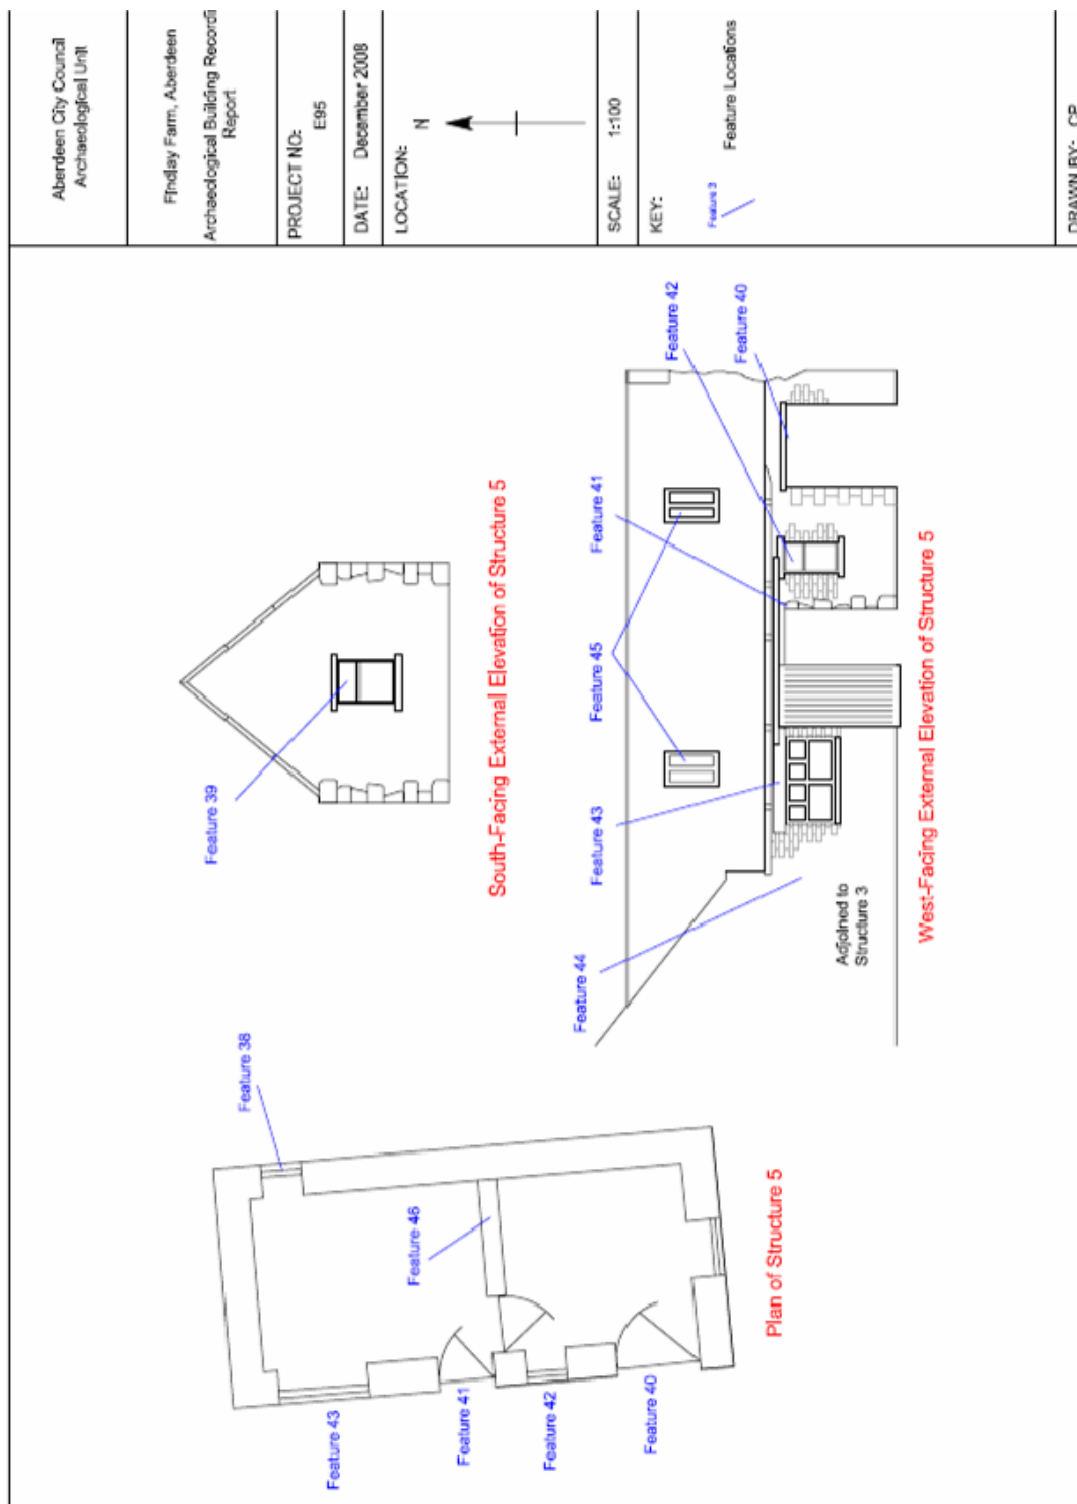
Figure 7 : Plan and Elevations of Structure 5

Structure 5 was a roughly north-south aligned structure located at the western extents of Structures 3 and 4. Of Structure 5, only the south-facing and west-facing external elevations were visible, the north and west being abutted by Structures 2 and 4. The structure itself was rectangular in plan of granite construction with quoins and a slate gabled roof (Figure 7). The external south-facing elevation included a central window with granite lintel and sill (Feature 39). The external west-facing elevation included more features. At the southern end was a doorway with a concrete lintel, grey brick surround at its southern edge, and breezeblock at its northern edge (Feature 40). It was also quite wide, measuring 1.4m. The far southern extent of the elevation had started to collapse. To the north of the first doorway was a narrower second doorway with quoins at its southern extent and a granite lintel (Feature 41). A metal runner and metal sliding door obscured the fabric on the northern side of the doorway. Between the two doorways (Features 40 and 41) a narrow window was recorded, surrounded to the north and south by brick infill, and provided with a granite lintel and concrete sill (Feature 42). To the north of the central doorway (Feature 41), was a further window, this one much wider, with

a white painted concrete lintel and sill, and grey brick surrounds (Feature 43). The northern extent of the elevation had been built into the west-facing elevation of Structure 3, seen by the stone fabric (Feature 44). The roof had 2 skylights incorporated within it (Feature 45).

Internally, the structure had been divided into two by a breezeblock wall (Feature 46), providing each space with a window and doorway on the west-facing external elevation. The southern area also had a south-facing window (Feature 39), and the northern area an east-facing window (Feature 38). The northern area seemed to have more recently been used for storing milk, as a large tank and pipes were still in place. More recent debris in the form of mattresses and other discarded items meant further detailed study of the interior was impossible.

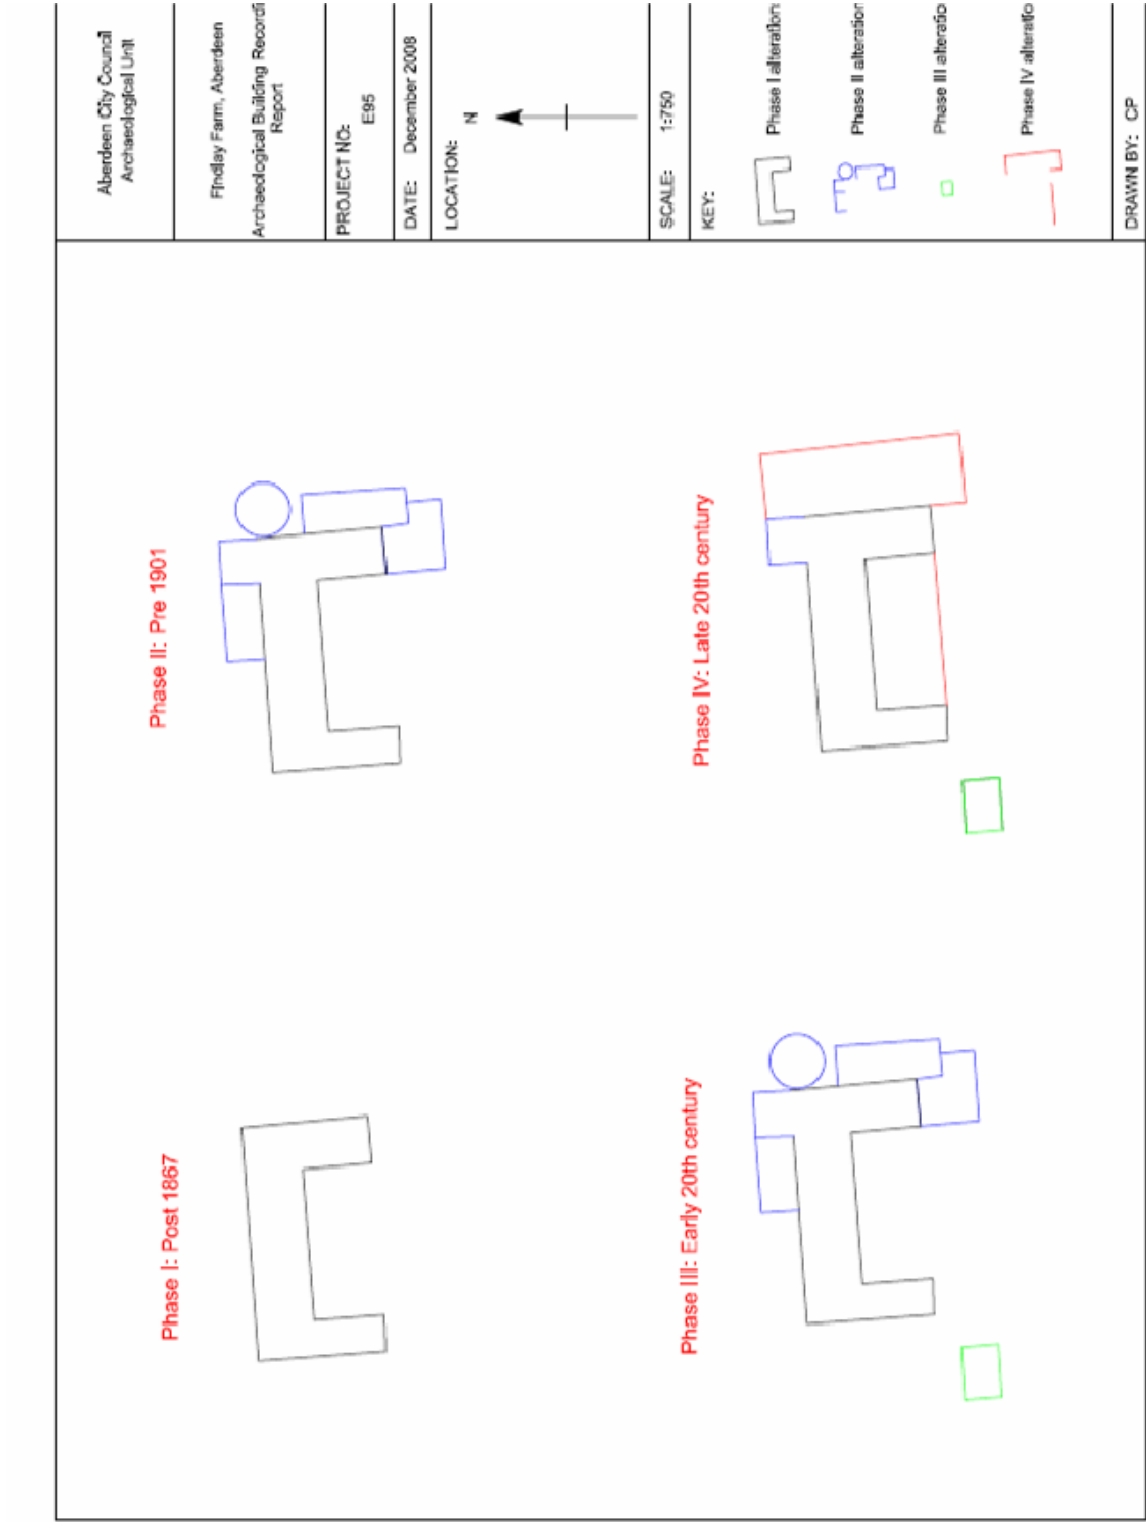
Figure 10 : Proposed Major Structural Phasing Sequence of the Findlay Farm Steadings

Four rough phases have been established (Figure 10). The nature of farming, and the necessity for minor alterations to adapt to changing needs means that not all of the features described could definitively be assigned to these major structural phases, and in this case, a rough date has been proposed. The phases are useful in establishing the key sequences in the development of the Steading at Findlay Farm.
