**WALLS, GATES AND TOWERS**

**LINCOLN CASTLE**

**ARCHAEOLOGICAL  
INVESTIGATION**

**REPORT  
NOVEMBER 2015**

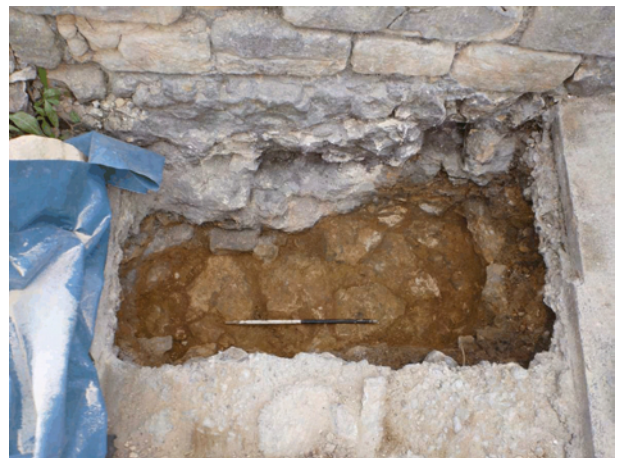
**Plate 10** Test pit cut into the south curtain wall walk, west end

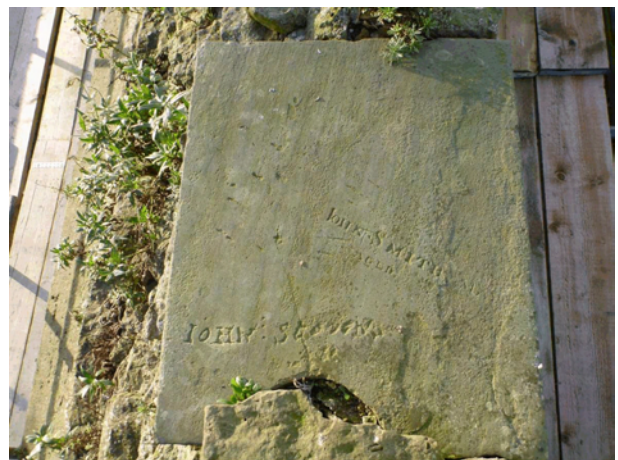
During repairs to the wall-head of the tower it could also be seen to have received considerable repair and alteration in the 19th-century and most of the stonework had either been replaced, or re-bedded, in hydraulic lime mortar. Some reused slabs had been used to provide wall capping. One stone carrying graffiti of 18th or possibly early 19th-century date which, with part of a large aperture remaining in it, was probably a lavatory seat (Plate 15).

**Plate 15** Reused stone on the wall-head of the Lucy Tower

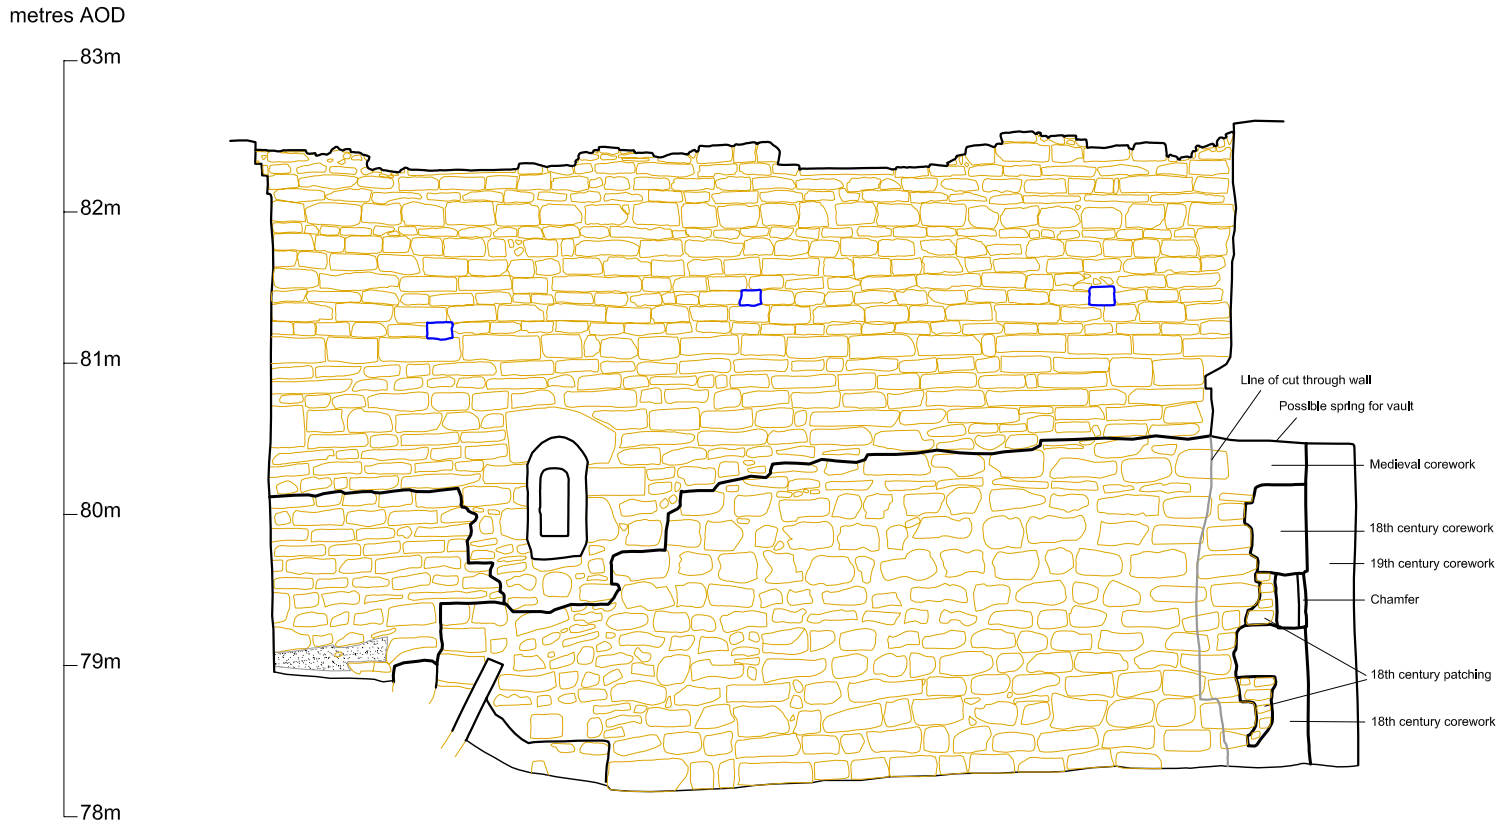
Lucy Tower, internal north elevation of the west chamber block showing medieval fabric exposed during unblocking

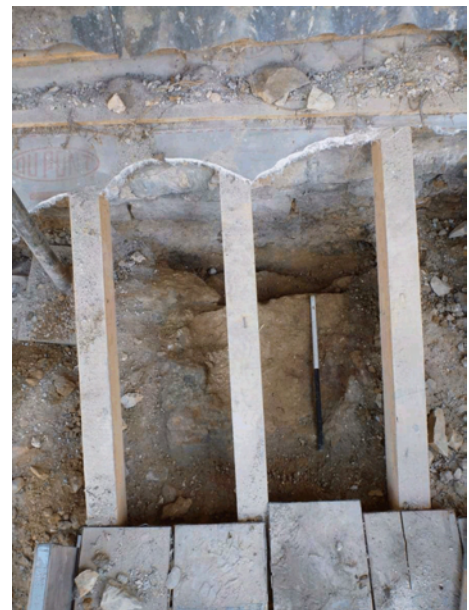
**Plate 19** Junction between the east curtain wall and east wall of the east range

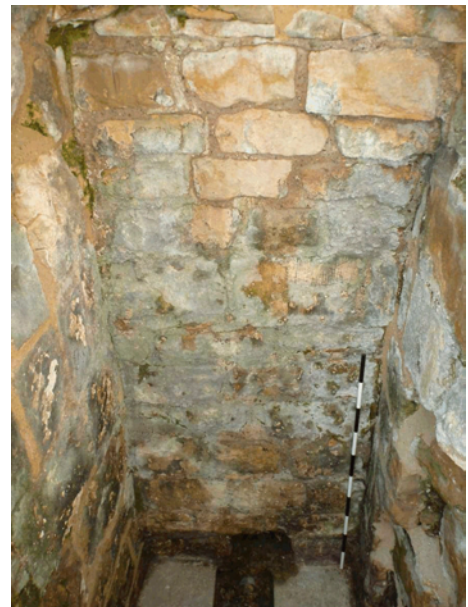
**Plate 20** East Gate, blocked doorway in north bartizan turret

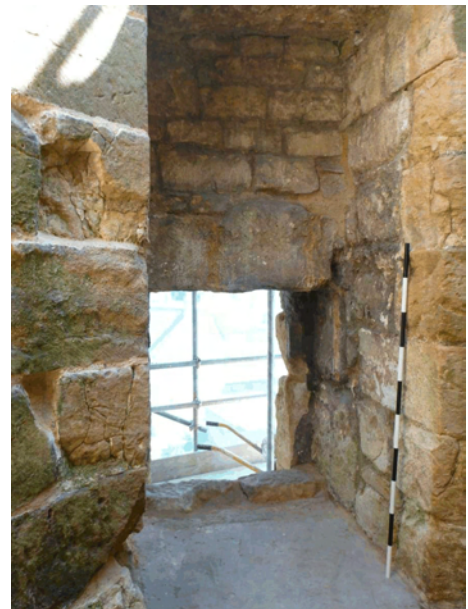
**Plate 22** East Gate, interior of north bartizan turret

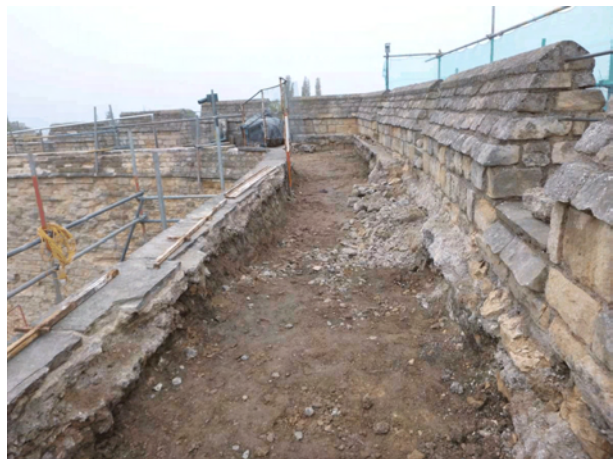
During repair works the modern wall-walk surface and some of its associated bedding material was removed. The depth of modern bedding material on much of the north curtain wall was such that the medieval core-work was only contacted where existing drains were replaced. However, at the western end, a greater depth of material was removed uncovering the top of the medieval core-work (Plate 26). In contrast to other stretches of the curtain wall circuit, the medieval core-work had been levelled and cut into by a significant degree by alterations undertaken in the late 20th century. The result was an up-stand of medieval fabric along the inner edge of the wall and, to a lesser degree, beneath the 19th-century parapet. The medieval core material observed was largely consistent with the composition of the wall-head core-work seen elsewhere on the curtain wall.

**Plate 26** Medieval core-work exposed on north curtain wall
