Walnut Cottage, Middle Blagdon Lane, Lower Blagdon, Paignton, Torquay, TQ3 3YE

Results of an historic building assessment and archaeological
monitoring and excavation

Document No: ACD251/2/1

Date: October 2011

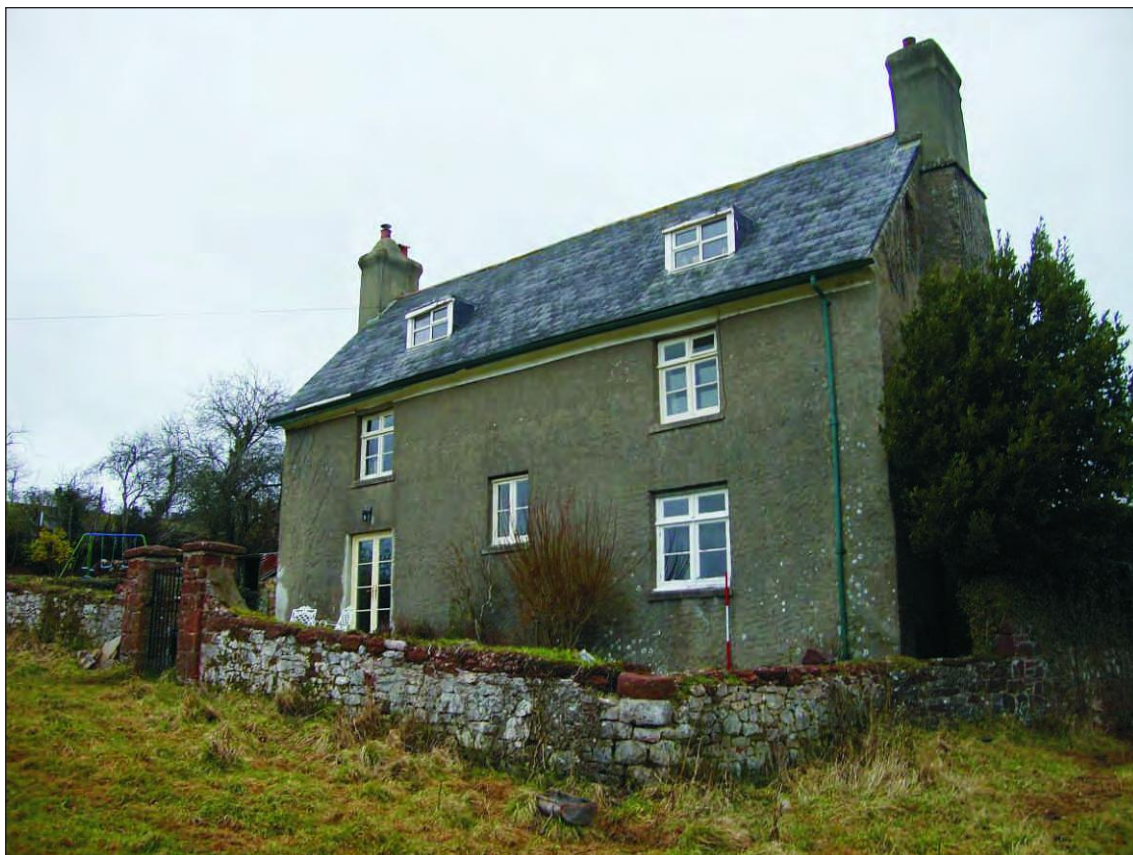
This elevation was originally the main façade of the house and has an architectural treatment which is absent elsewhere. The facade is recessed within a small walled enclosure with stone gate piers defining a central gateway and was formerly symmetrical, though now slightly compromised by later alterations (Plate 1). The façade is two storeys high, with a rendered surface covering local stone rubble masonry (or possibly facing bricks). It is crowned with a coved plaster cornice beneath the slate roof. Cornices of this type are characteristic of the domestic architecture of the late 17th and early 18th centuries and it is likely that the building dates from this period. The windows are of the mullion-and-cross type, typical of the same period, though all of the existing windows appear to have been renewed in the late 19th or early 20th century. The ground-floor window to the western room has been cut down and converted into a pair of French windows, and a similar alteration is proposed to the ground-floor window in the eastern room.

There is no central doorway in this elevation, though it seems likely that there may formerly have been one before the stairs were rebuilt in their present position. The window to the stairs is oddly positioned, halfway down the wall between the floor levels, and it is highly likely that this is an alteration. The two dormers in the roof are modern replacements in UPVC, with flat roofs. These are to be replaced with pitched roofed dormers more in keeping with the character of the building.

Plate 1: View of the south façade of the house, looking north west, showing the coved cornice beneath the eaves and the late 19th or early 20th century fenestration (Scale 2m)

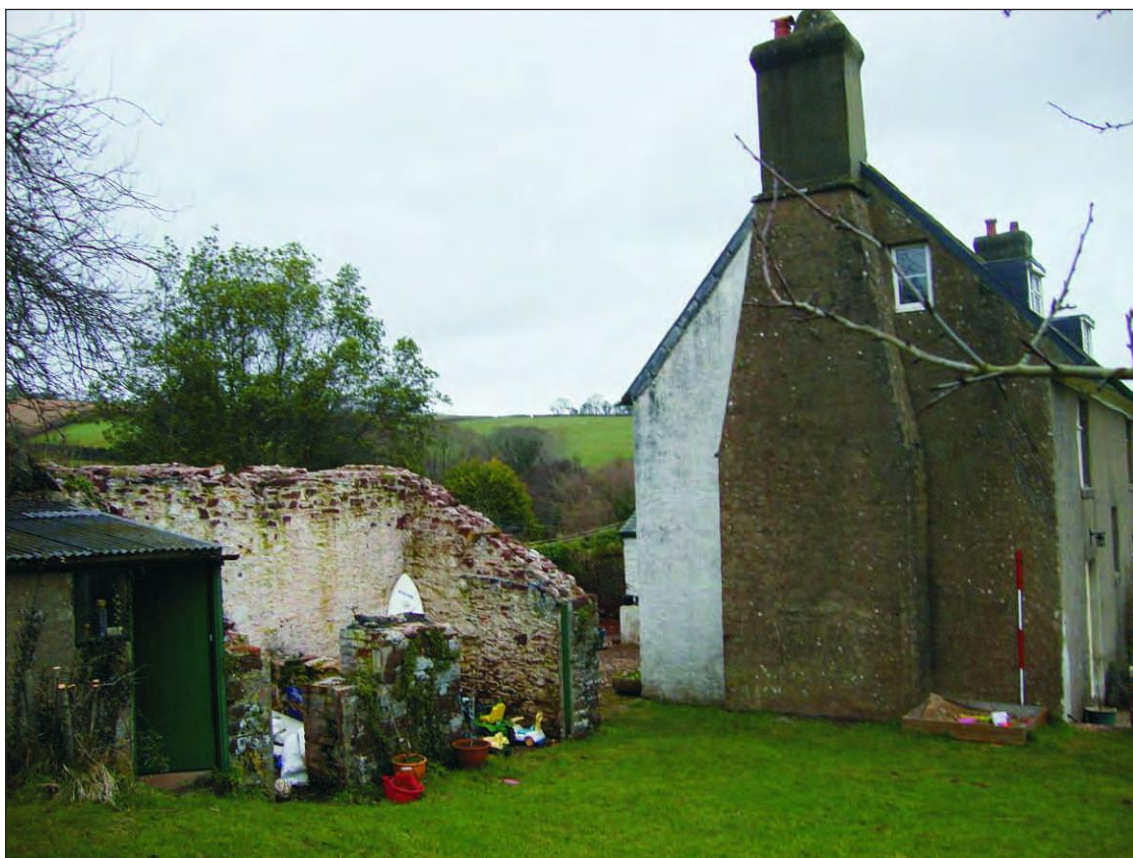
The two gable ends of the house are dominated by very large chimney stacks with pronounced battering and small windows alongside lighting the attic rooms (Plate 2). There is no suggestion of any structures extending to east and west of these, and it is presumed that the primary core of the building

survives more or less as built. The house is thus flanked and defined by the two chimneys, which appear to have stone bases surmounted by brick shafts capped with decorative brickwork, now concealed by later render.

Plate 2: View of the house from the southwest showing the remains of the pigsty and a typical end elevation of the dwelling house (Scale 2m)

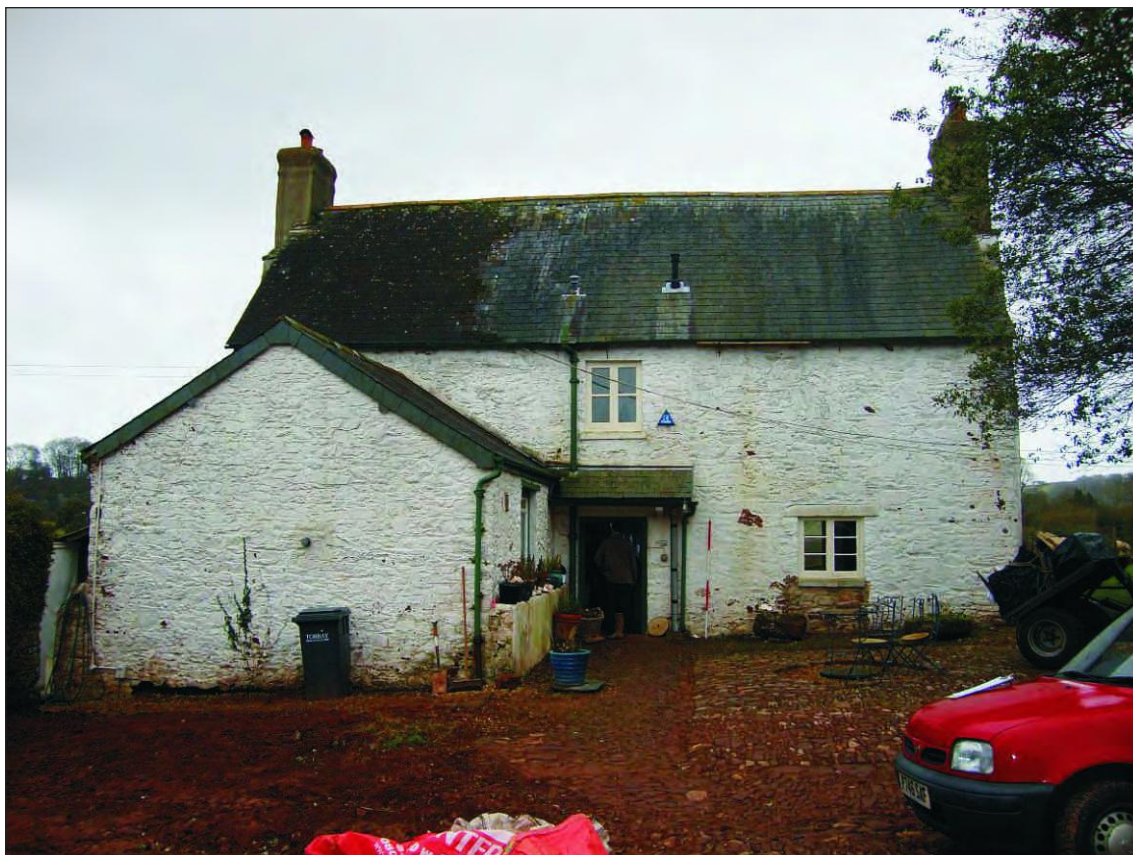
Part of this elevation is obscured by the northern extension, which may very well be part of the primary building. The wall is entirely constructed of stone rubble, painted rather than rendered (Plate 3). There are very few openings in this wall, probably because of the proximity of the demolished farm buildings, which seem to have approached so close as to allow for only a narrow alley around this side of the house. The western part of the façade has a small two-light window, probably of late 19th century date, which may have replaced a doorway. The wall beneath the window looks like it has been rebuilt, and it is possible that this represents blocking of a former opening. There is no corresponding opening on the first floor.

The doorway at the centre of the façade lies under an early 20th century porch but has a flat-arched head of stone voussoirs and may be an original opening. Above this is a modern double-glazed window. A large two storey porch will be constructed in this position, and the window will be enlarged to form a doorway at first-floor level communicating with this. Further doorways are to be made in the walls of the north wing. Although these will probably affect primary masonry, there do not appear to be any archaeological features of significance in these areas.

Plate 3: View of the north elevation of the house showing the position of the north wing. Note the absence of fenestration (Scale 2m)

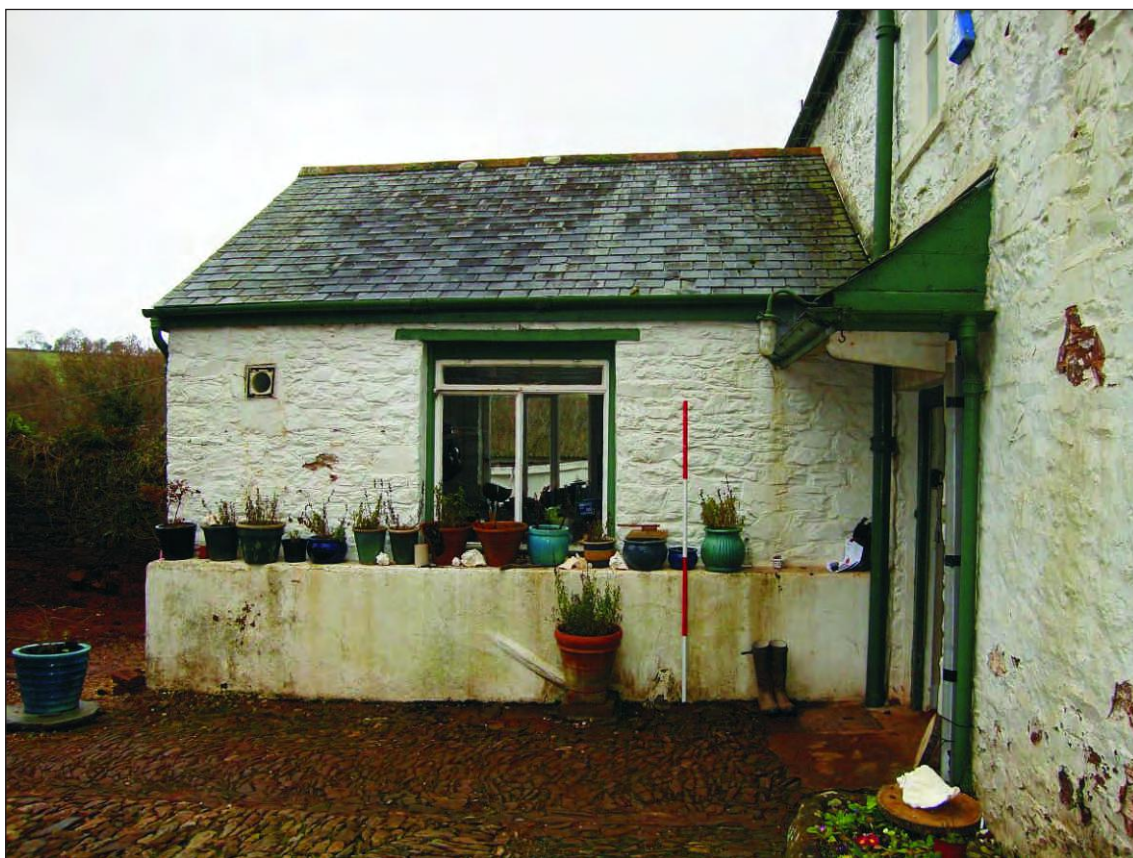
The north wall of this range faces the present cobbled courtyard and gardens to the north of the house and may be a late 19th or early 20th century rebuild, constructed after the demolition of the buildings to the north. It contains no visible features, but it is highly likely that the wall replaces a chimney breast containing a large fireplace, possibly serving the original kitchen; there is no evidence in the other walls of a chimney heating these rooms. A chimney is known to have been present until 1993 – the 1993 Paignton Blue Back entry for Walnut Cottage describes the service wing as having an ‘*internal lateral service stack with a shaft projecting through the roof*’. Excavations in the area immediately to the north of the house within the footprint of the new extension (Fig. 2: Area 1) were monitored and the results are discussed below (see Section 7.1).

The east wall of the kitchen has a large, three light, mullioned window with chamfered mullions of uncertain, but definitely not of early, date. Adjoining this is a doorway communicating with an alley alongside the house separating it from the eastern outbuilding. The window in the west wall is a steel-framed ‘Crittall’ window, which it is proposed to replace (Plate 4). These walls may be older, but contain no datable architectural features and the extent of rebuilding after the truncation of the wing cannot be established with confidence. Traces of wider stone walls near the base of both the eastern and

western walls might represent footings or, possibly, imply that the whole structure was rebuilt from the ground up.

Plate 4: View of the western elevation of the north wing, showing the projecting plinth at the base of the wall and the metal-framed 'Crittall' window in the upper section (Scale 2m)

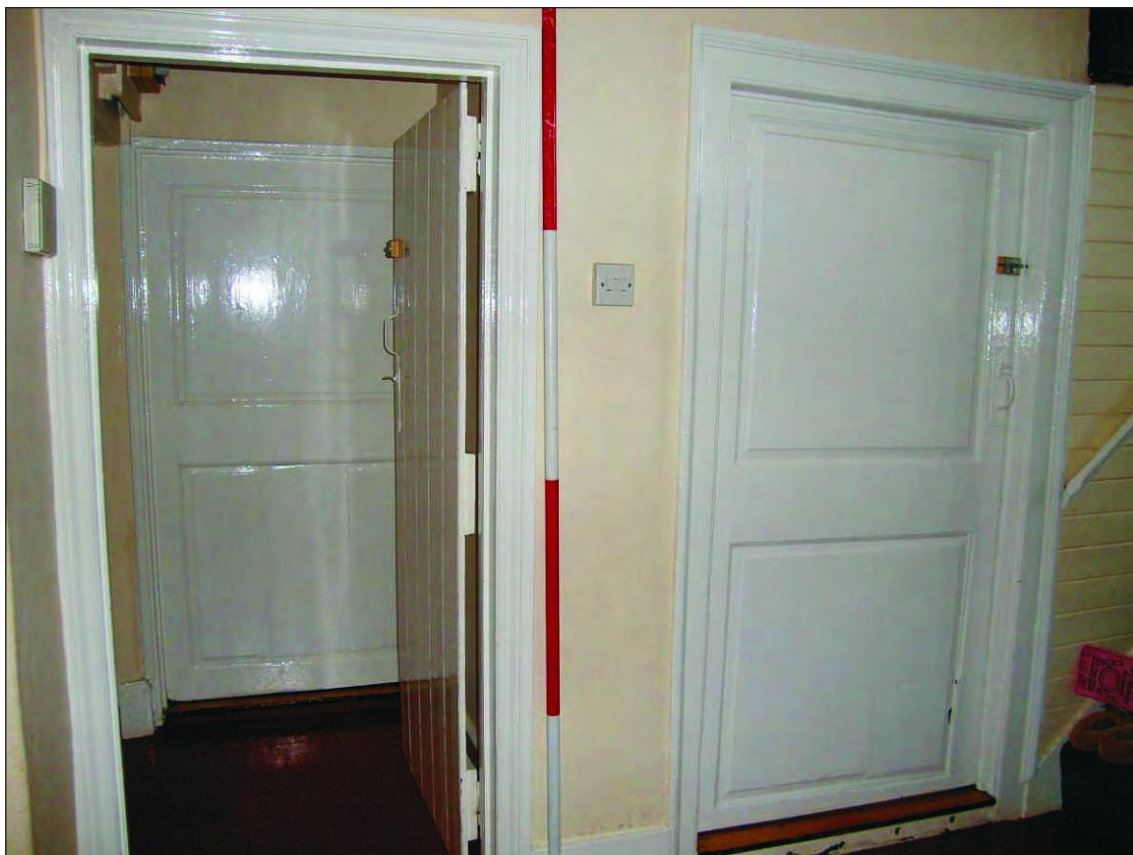
As noted above, the plan of the house essentially survives intact (apart from the staircase, which appears to have been reconfigured, since it now blocks an opening into the eastern room). The main circulation area is the entrance hall at the centre of the main body of the house from which doorways open to the eastern and the western rooms. Both the doorways retain 18th century two-panelled doors with raised-fielded panels. They are hung from flat architraves by H-L hinges, and retain attractive late 19th century door furniture (Plate 5). Two further doorways, to a cupboard beneath the stairs and to a lobby communicating with the kitchen, have later planked doors, possibly dating from the 1900s.

Plate 5: Details of the 18th century panelled doors in the hallway, showing the door to the dining room and the later lobby to the left (Scale 2m)

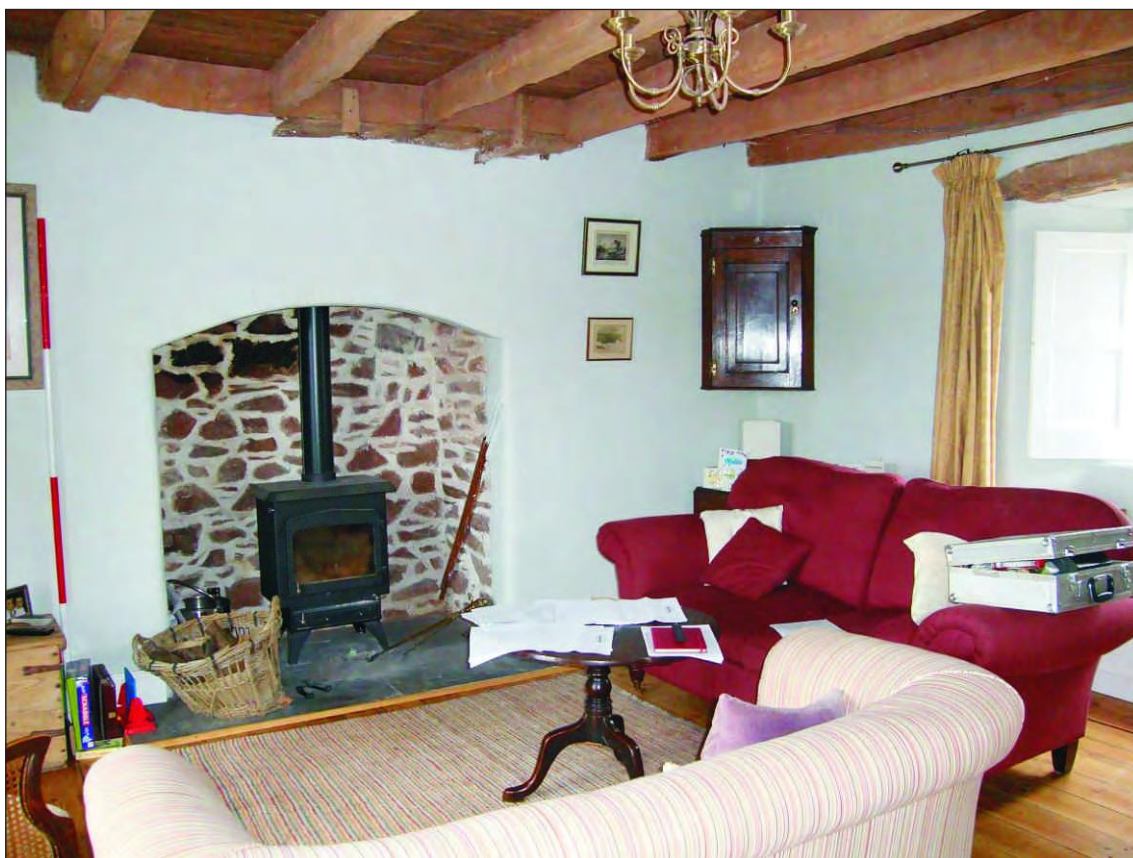
This room is now the drawing room; it has a large modern fireplace and fitted shutters to the northern window, which must date from after its conversion from a doorway to a window. The ceiling has been removed, revealing large, unsquared joists, possibly of elm, or some other softwood (Plate 6). These were not designed for display and it is likely that the room was originally ceiled. No other historic fixtures are visible.

Plate 6: View within the drawing room showing the modern fireplace, exposed ceiling joists and the shutters to the northern window (far right) (Scale 2m)

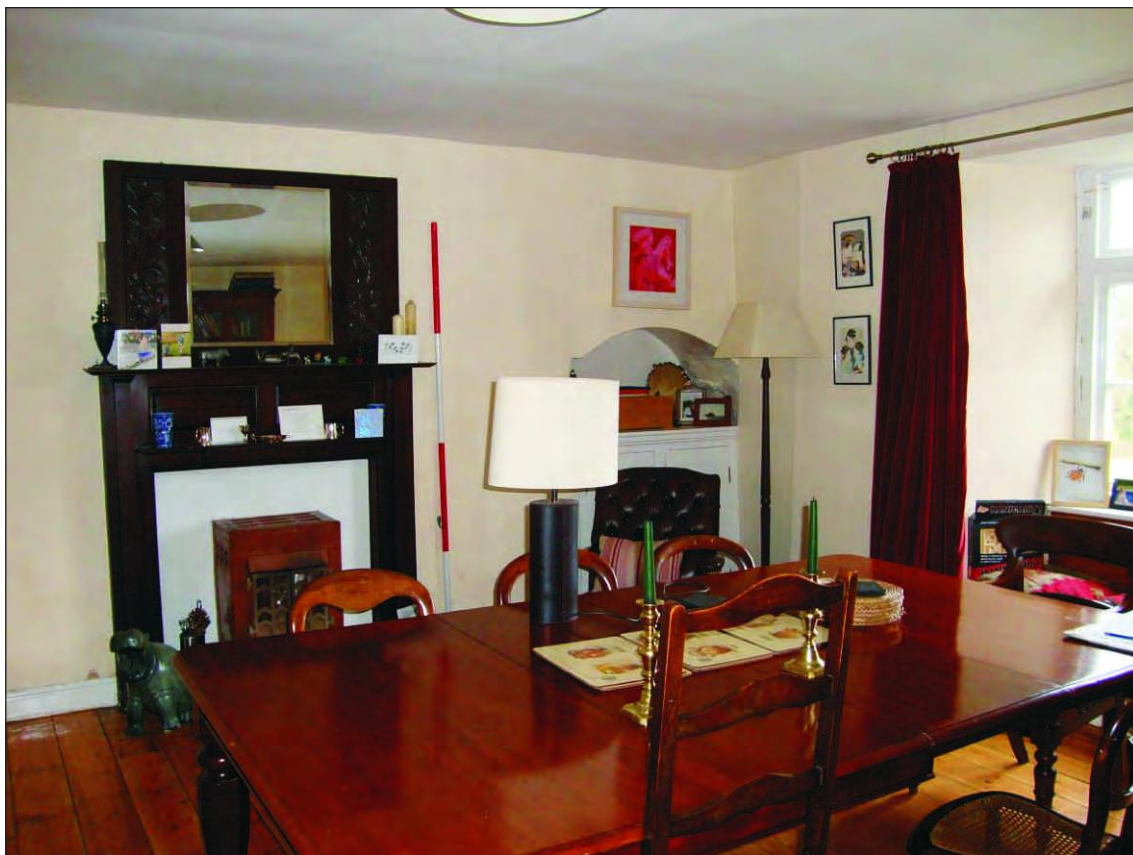
This is now the dining room; it is a large room with a 20th century chimney piece and some unusual features, including a cupboard, with a door with a raised-fielded panel hung on H-hinges, which occupies the lower part of a larger blocked opening in the east wall. The upper part of this opening is discernible as a scar, but is in conflict with the half landing on the stairs. This strongly implies that the staircase has been reconfigured. There is also an enigmatic arched recess in the south-eastern corner (Plate 7).

Plate 7: View of the dining room showing the arched recess to the south of the fireplace (Scale 2m)

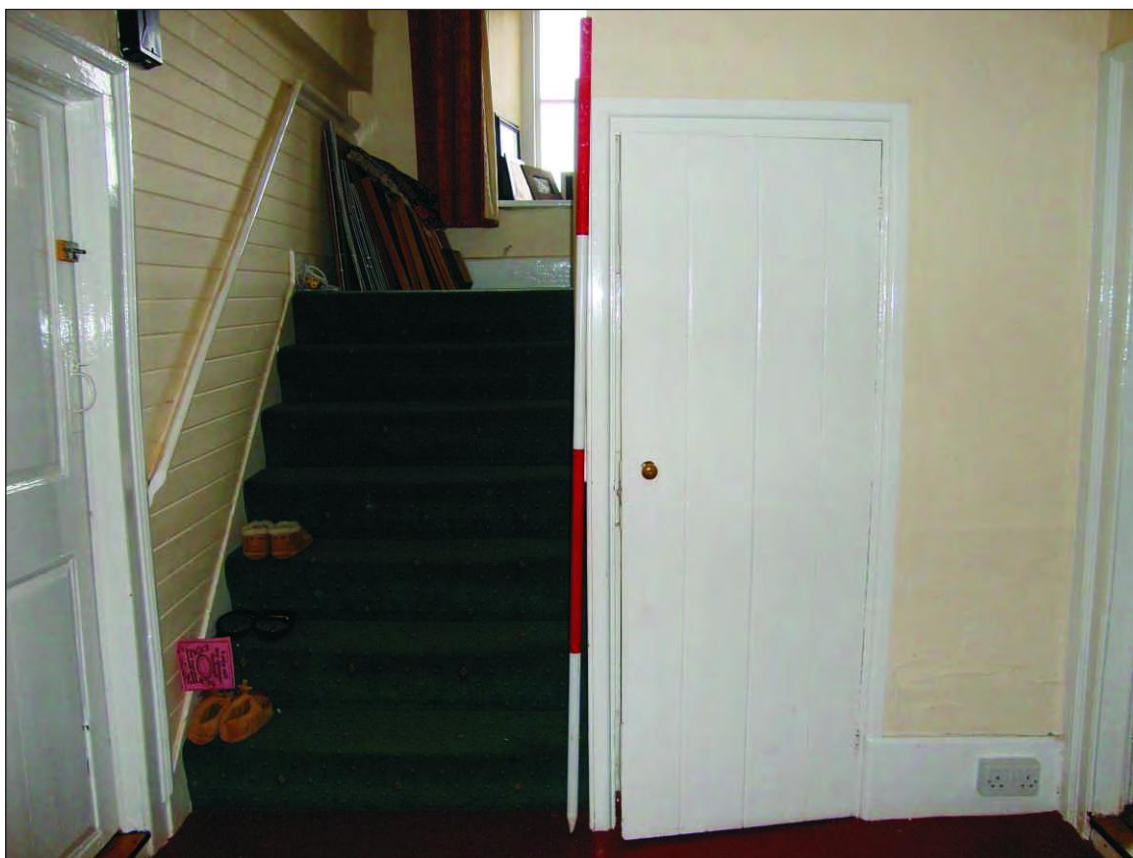
The staircase (Plate 8 & 9) rises against the partition shared with the dining room, cutting across the opening in its eastern wall. It then turns to the east and north in a dog-leg around a partition dividing the upper and lower flights. There is no balustrade. At the base of the stairs is a large cupboard. The blocked opening to the dining room strongly suggests that the stair is not in its original position or that it has been reconfigured. The original position of the staircase is difficult to determine without further evidence, though it seems certain that it climbed within the volume of the present hall and landings above. It may have lain against the north, rather than the south wall of the house, or perhaps simply rose in an anti-clockwise rather than a clockwise spiral. The stairs may have been rebuilt here when the

northern doorway became the main entrance of the house, perhaps replacing an earlier entrance in the south wall. A blocked doorway beneath the stairs seems likely, if only because the proximity of the farm buildings formerly standing to the north of the house makes a main entrance within the north wall improbable. The doorway may have been blocked and the staircase reconfigured after the demolition of these buildings in the late 19th or early 20th century. This may well be the date of the render covering the south frontage, which may have been applied to conceal alterations to the windows and doorways.

Plate 8: View of the base of the stairs, looking to the south towards the possible position of the original main entrance, behind the staircase (Scale 2m)

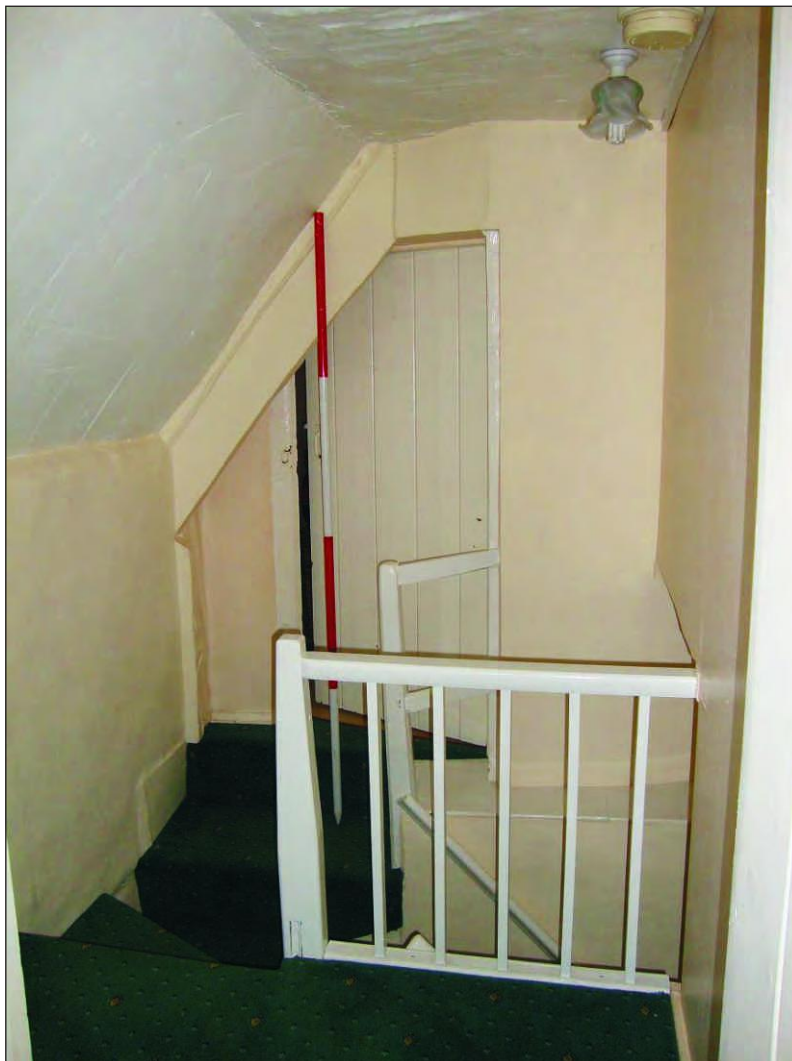
Plate 9: View of the summit of the staircase on the second floor showing the complex arrangement at the stair head, suggestive of alterations (Scale 2m)

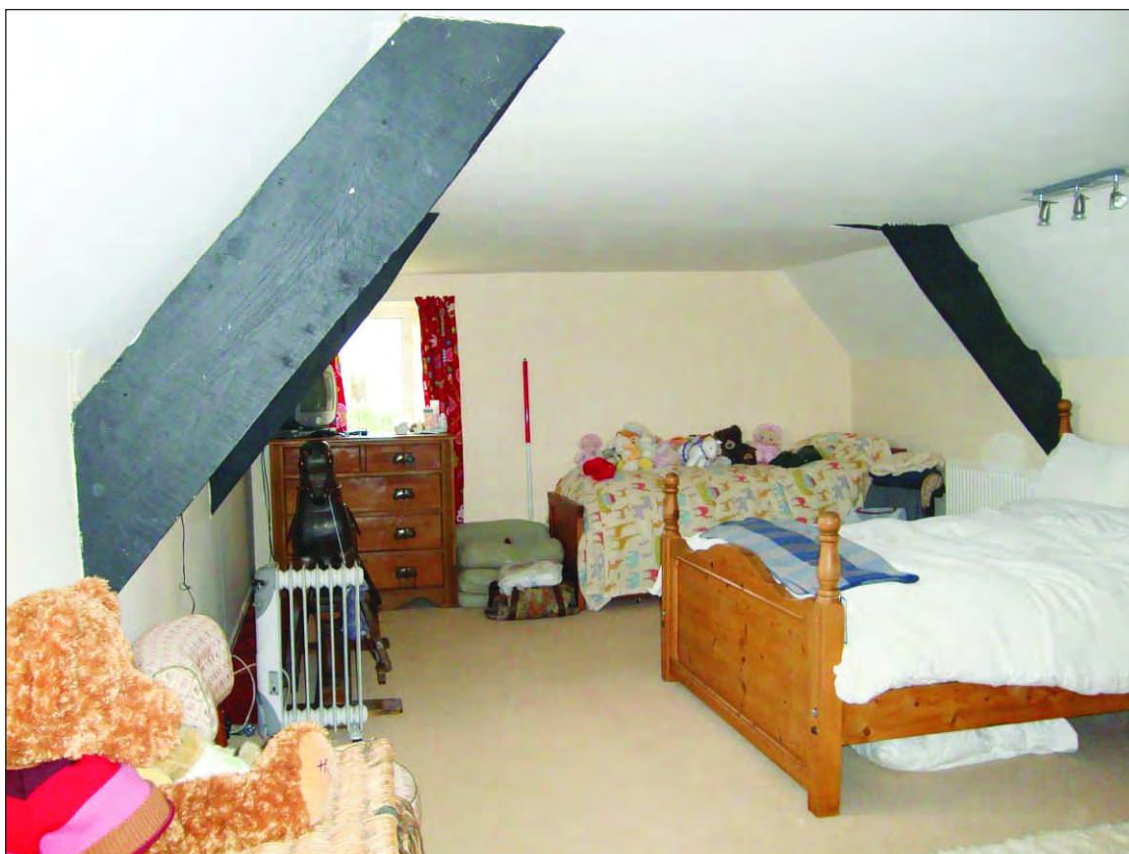
The stairs up to the second floor arrive at an unusually-shaped landing which, again, may suggest that the stairs have been altered. The balustrades at the top of the stairs have crude tapering newels which cannot be easily dated stylistically. On either side, the two attic rooms have plastered ceilings penetrated by the blades of the roof trusses (Plate 10). These rooms are lit by small windows in the gable ends and by south-facing dormers, which have been replaced in the 20th century.

Plate 10: View within the attics, looking west, showing the substantial blades of the principal rafters (Scale 1m)

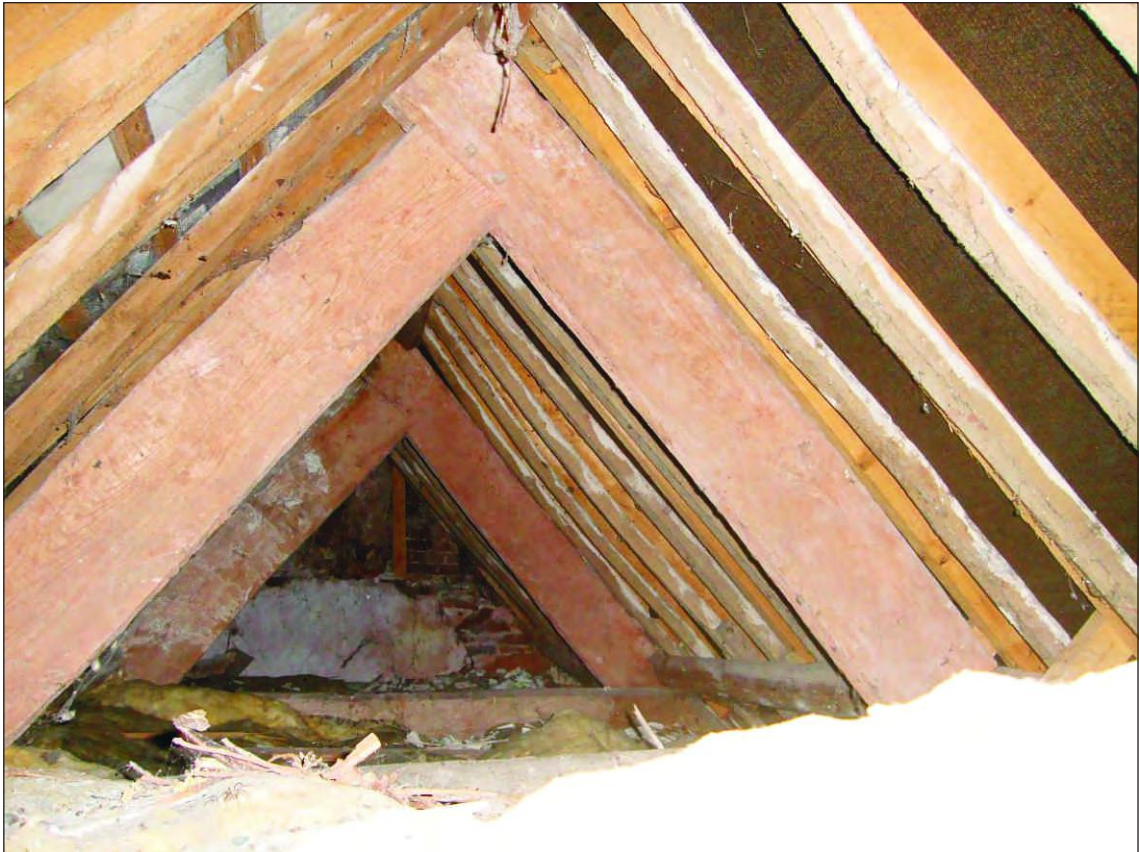
Access to the roof spaces was limited by concerns about the ceilings and the roof areas were inspected from the attic hatch. The roof structure over the main house is supported by A-frame trusses, notched, tenoned and pegged together at the top, with applied collars concealed within the structures of the ceilings. There is a square, diagonally-set ridge tree and one visible set of purlins just above the collars (Plate 11). Traces of plaster on the gable ends suggest that the original ceilings were at a higher level than at present, and it is possible that the rooms were originally open to the apex of the roof, though perhaps ceiled on the underside of the common rafters. Most of the primary common rafters survive,

and these seem to preserve triangular voids reflecting the former pitched roofs of the dormers. No evidence of earlier roofing materials was observed and it seems probable that the roof has always been slated. This form of roof construction appears to be consistent with an early 18th century date for the house.

Plate 11: View within the roof space, looking west, showing the substantial roof timbers and evidence of plastering on the interior of the west wall

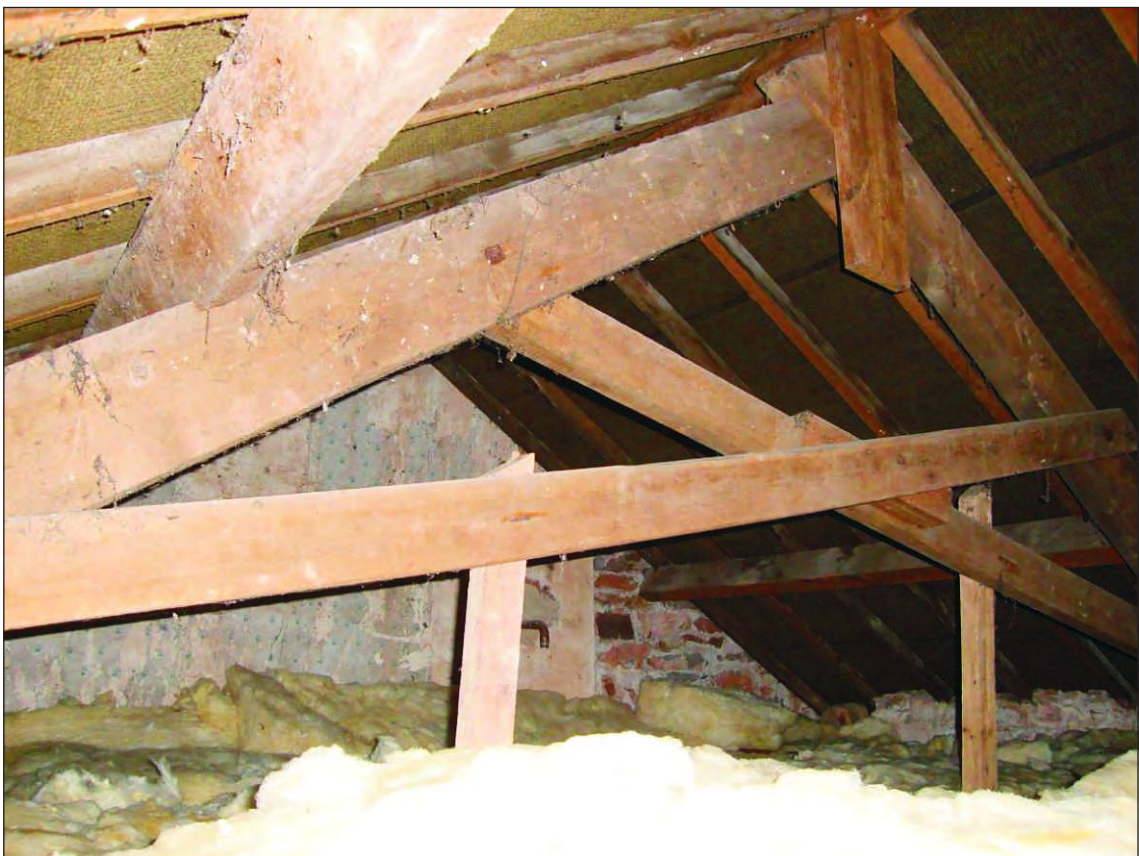
The roof of the north wing is of late 19th or early 20th century date, consisting of principal rafters linked by diagonal-scissor braces, secured to the principals by large iron bolts (Plate 12). This roof probably dates from the time of the truncation of the house in c.1900. Its removal will not involve the loss of a significant historic structure.

Plate 12: View of the roof space above the north wing, looking south west, showing traces of wallpaper on the wall indicating that there was formerly an inhabited upper storey

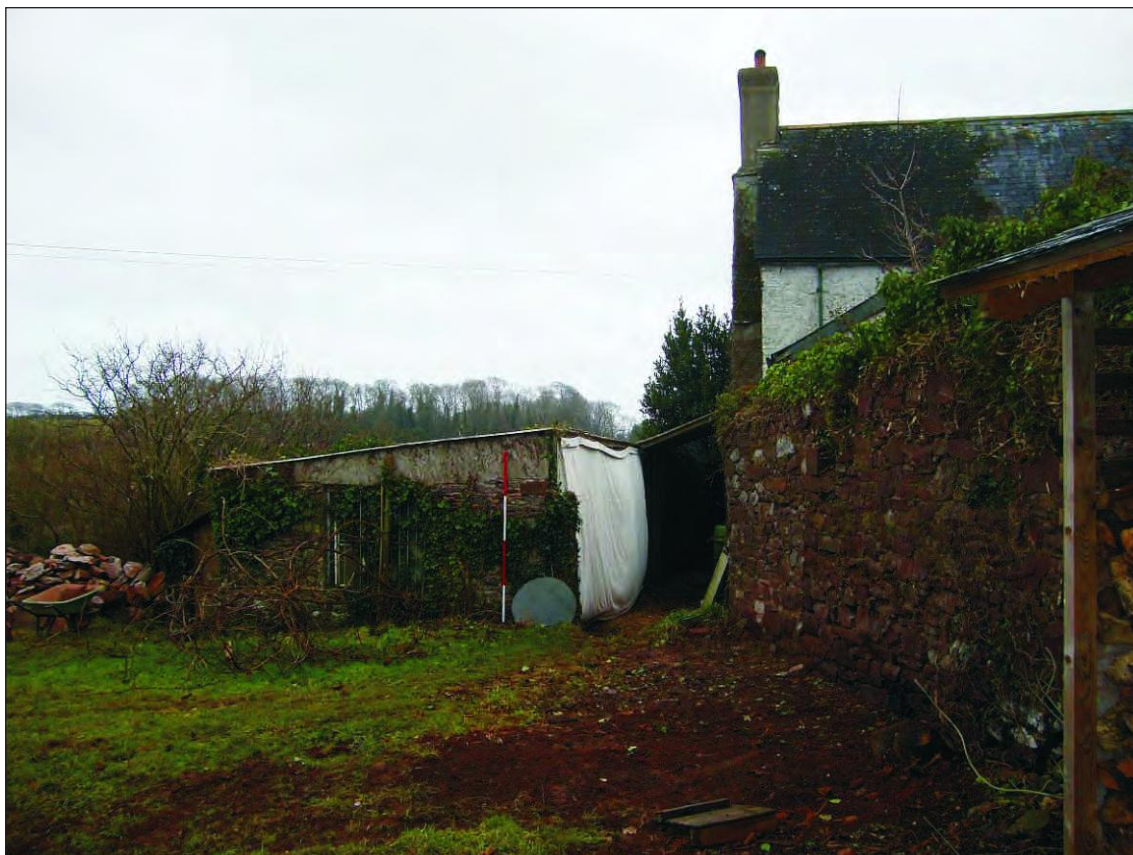
The eastern outbuilding is in poor condition; it has been reduced to three walls, sheltered under a modern mono-pitched roof (Plate 13). The north wall contains a broad, splayed window opening and is plastered internally (Plate 14). This might have been part of the domestic quarters; however, since it is shown coloured grey on the tithe map of the area, it is more likely to have been a well-appointed outbuilding such as a dairy. The east wall has no visible openings, but there is a clear building break externally, about half-way along the wall. This scar does not appear to extend to ground level, and may relate to a blocked opening, or, perhaps to an internal wall dividing the building into two sections, part of which remains as a wall stub. To the south of the stub of the internal wall the internal surfaces are unplastered and whitewashed. At the lower, south-eastern corner of the room, low down, is a square drain with a drip-moulding above it.

Plate 13: View of the eastern outbuilding, looking south, showing its relationship to the adjacent house and to the surviving walls of the demolished north range (Scale 2m)

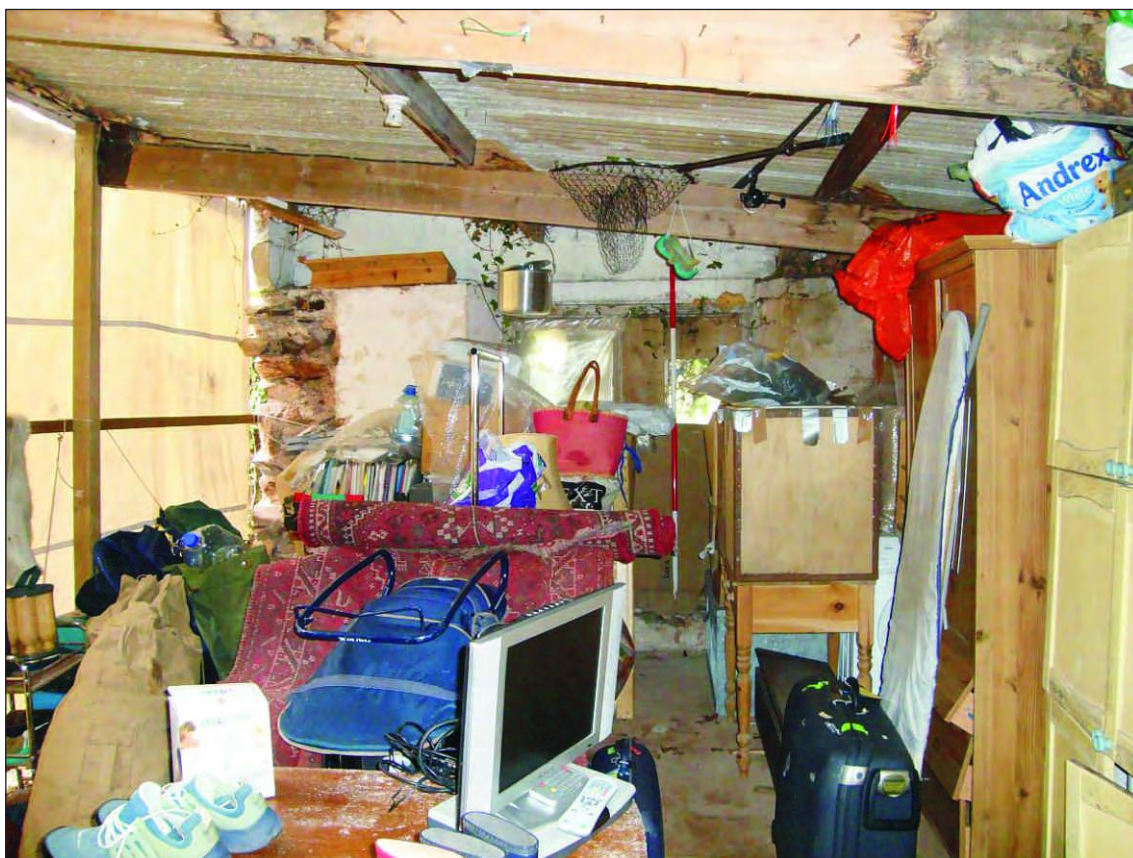
Plate 14: View of the interior of the outbuilding, showing some remains of plaster and a window embrasure in the north wall (Scale 2m)

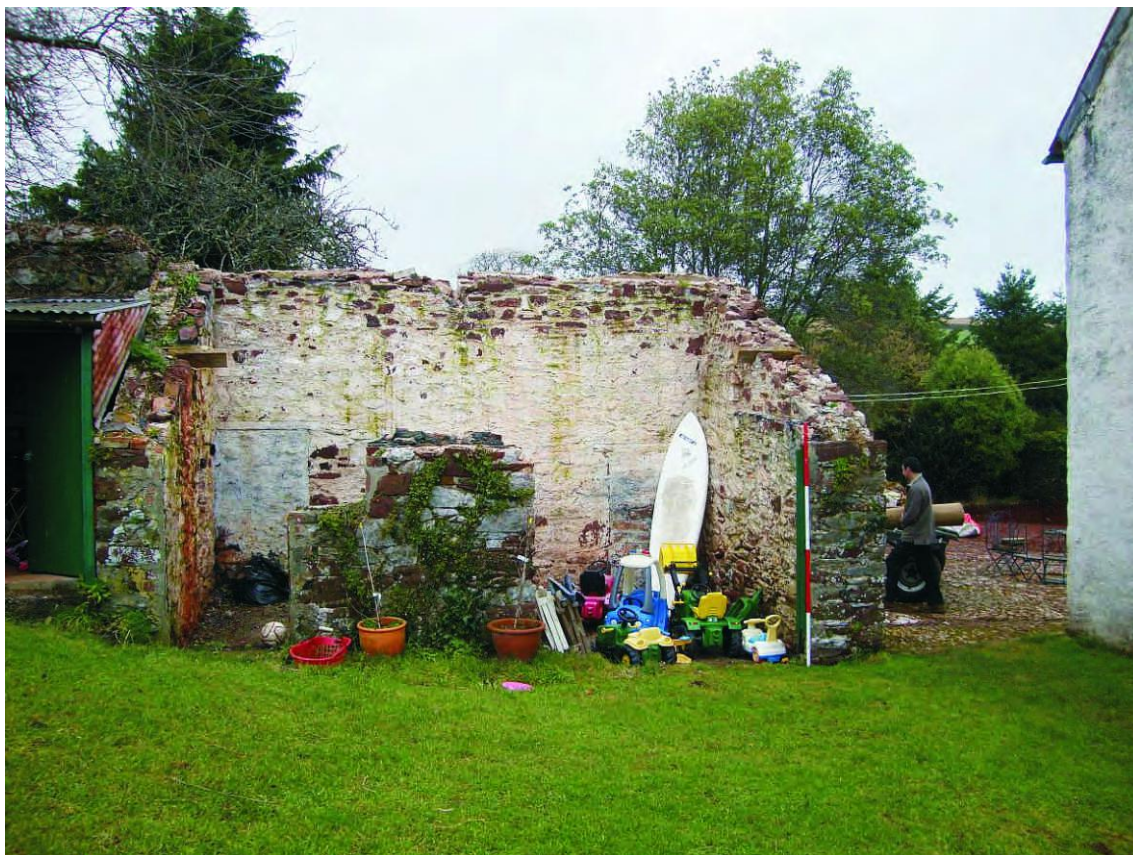
The pigsty to the west of the house survives today only as a roofless ruin (Plate 15). Three walls, a small part of the south frontage and part of an internal division remain but there are no dateable features. The pigsty appears to have been constructed as a lean-to or out shut against the south wall of a much larger building, only part of which survives. Both are shown on the tithe map of 1840. Two small, low doorways with plain timber lintels opened into this building; these have been blocked, presumably after the demolition of the adjacent structure.

Plate 15: The remains of the pigsty to the west of the house, showing the blocked openings in the rear wall of the building, which formerly opened into a larger structure, now demolished (Scale 2m)

The former pigsty will be converted into a family garden room; the south wall is to be realigned, the wall dividing the pigsty is to be removed and a new roof constructed. The west wall is also to be demolished and replaced. Excavations in this area (Fig. 2: Area 2) were monitored as part of the project and the results are discussed below (see Section 7.2).

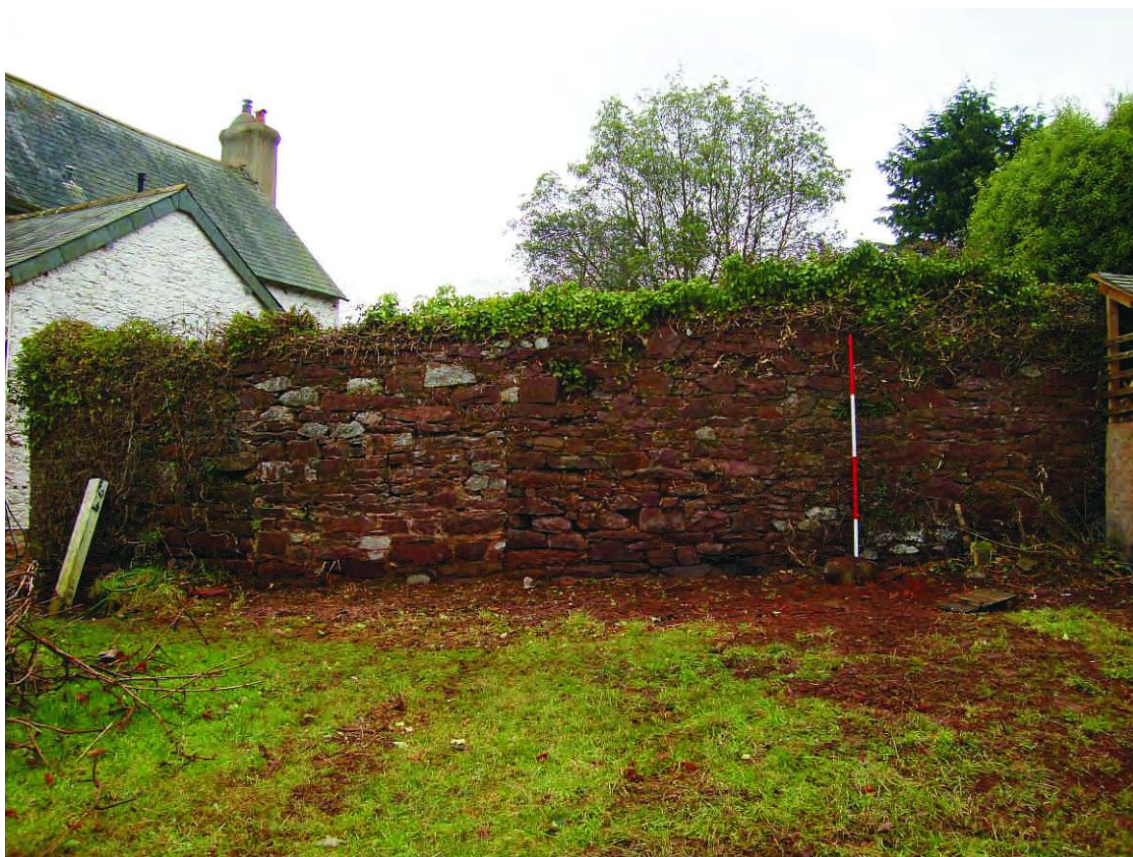
These walls run northwards from the east wall of the northern extension and then turn to the northwest. They seem to have been part of a long range of buildings, which are shown coloured grey on the tithe map of 1840 (Appendix 1: Map 1) and are most likely have been farm buildings, perhaps ranges of linhays, stables or shippens. On the western side are traces of a cross wall running from east to west across the building, and there is also evidence of a wide opening in the west wall (Plate 16). It is possible that this was a cart entrance to the yard or, possibly, a doorway beneath which a cart could be drawn up for loading. The ground levels are different on each side of the wall; however, these levels may well have been altered by erosion or dumping of material since the demolition of the buildings. Excavations in the area were also monitored and the results are discussed below (see Section 7.1).

Plate 16: Part of the wall, lying to the north of the house, possibly connected with the demolished northern range of farm buildings. A blocked gateway lies just left of centre (Scale 2m)

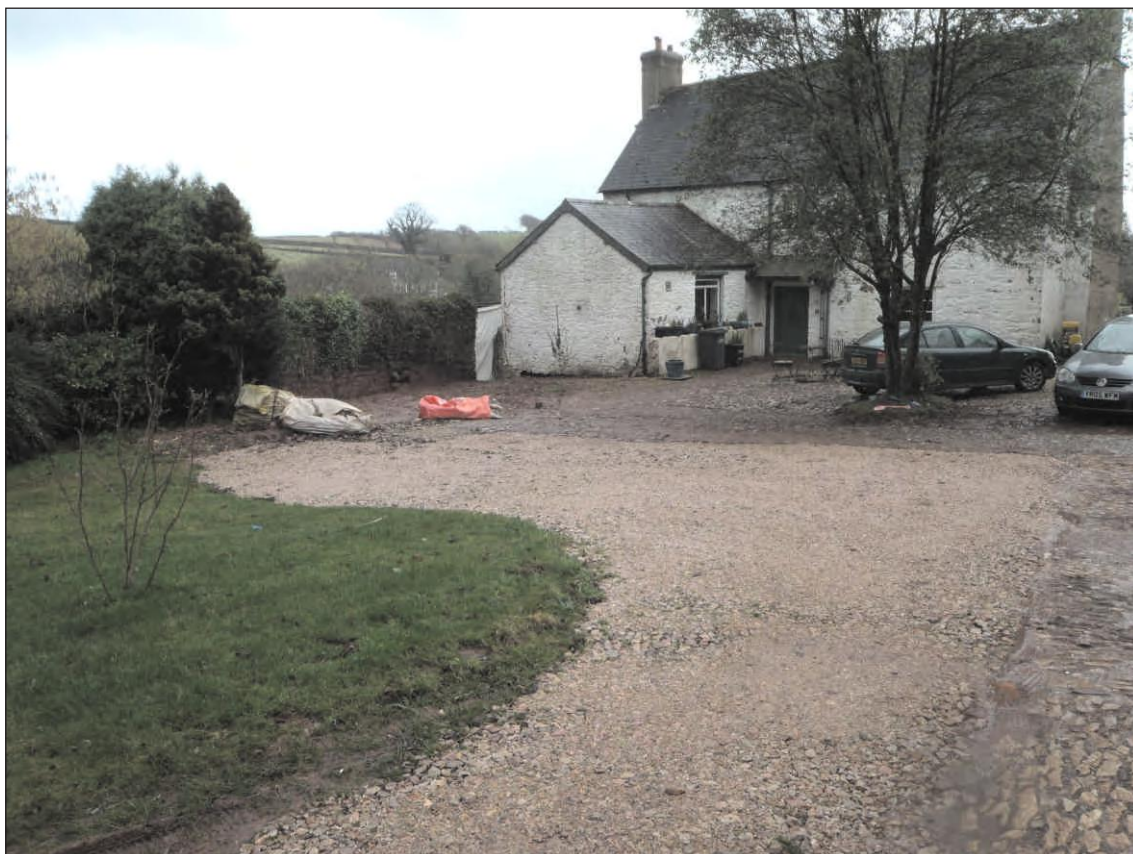
The ground reduction within the northern extension immediately to the north of the present kitchen (Area 2), measured 7.5m long x 5.25m wide (Plate 17), with the eastern boundary following the line of the garden wall. The whole area was reduced by a depth of 0.6m. The overlying garden soil deposit (104) was dark reddish-brown silty clay, some 0.3-0.4m deep, which overlay the natural clay subsoil (105) at the southern end of the new extension area.

Plate 17. General view of the northern extension (Area 2), view from northwest

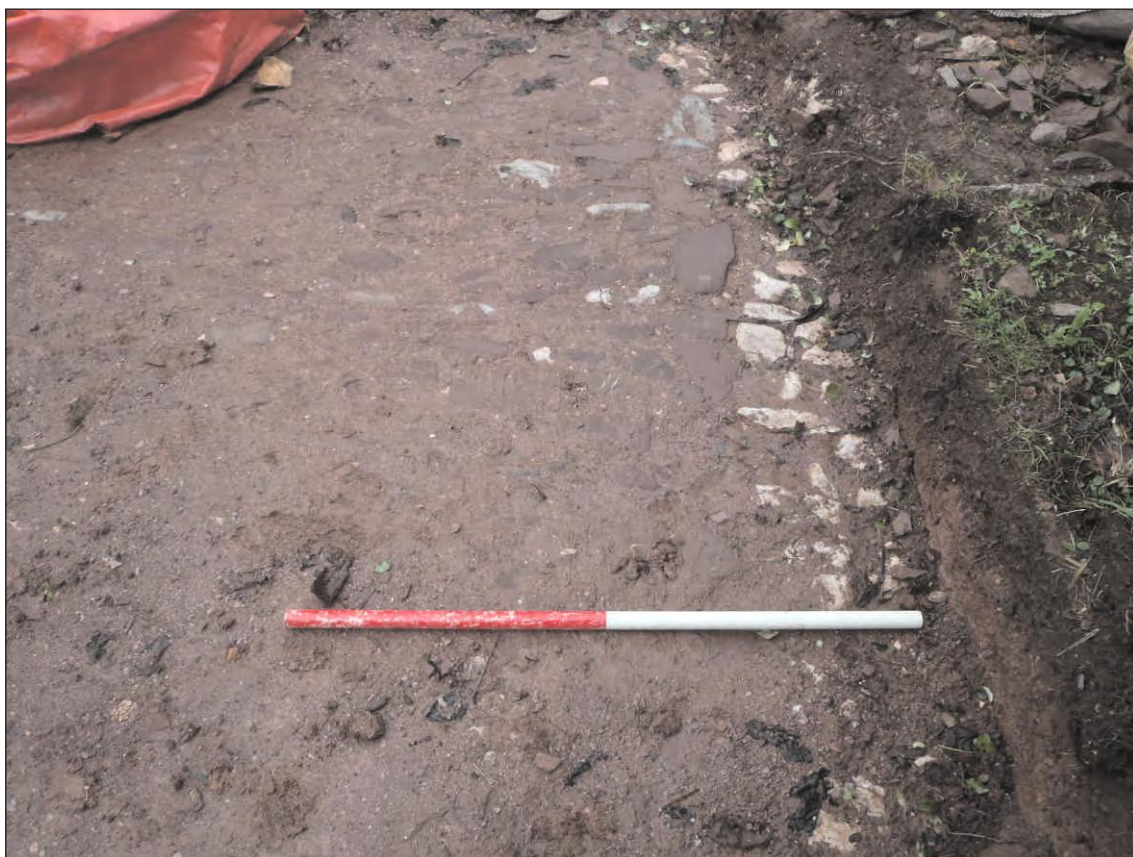
The ground reductions in the northern section exposed a stone lined culvert (106) some 0.6m wide and 0.4m deep, running east to west across the extension area. It was constructed from sandstone slabs measuring on average 0.5m x 0.5m. A cobbled surface (109) was noted to the north of the culvert (Plate 18). It is likely that it represents the remains of a surface within the former northern extension of outbuildings, as shown on the tithe map of 1840 (Appendix 1: Map 1). A number of post-1850 Post Medieval blue and white transfer printed pottery sherds were noted but not retained.

Plate 18. The cobbled surface (109) - view from northeast (scale 1m)
