Walnut Cottage, Middle Blagdon Lane, Lower Blagdon, Paignton, Torquay, TQ3 3YE

Results of an historic building assessment and archaeological
monitoring and excavation

Document No: ACD251/2/1

Date: October 2011

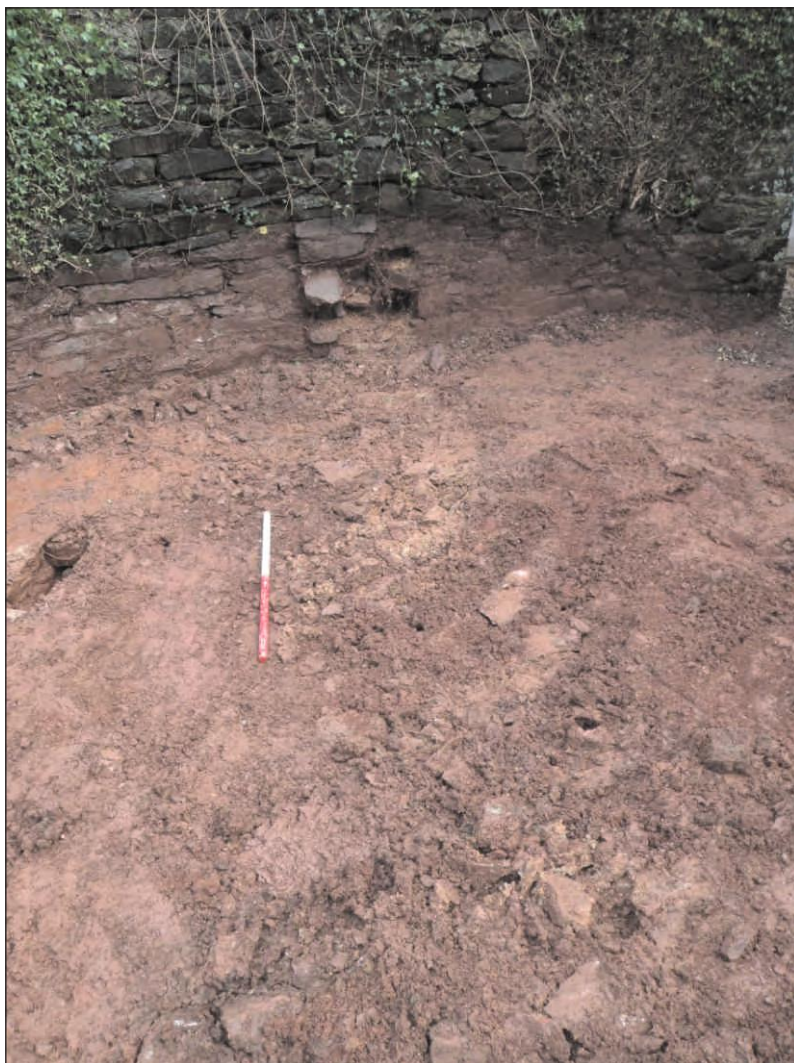
The remains of a wall footing (107) were also recorded running roughly parallel with the culvert, some 0.8m to the south. It appears to have been keyed into the existing garden wall (Plate 19), which is known to have formed the eastern side of the former range of outbuildings, as depicted on the tithe map of 1840 (Appendix 1: Map 1). This wall footing is therefore thought to relate to an earlier subdivision of the original northern extension of outbuildings. A modern brick soak-away (108) had been cut into the western end of the footings.

Plate 19. Wall footing 107 and the stone lined culvert 106 - view from west (scale 1m)

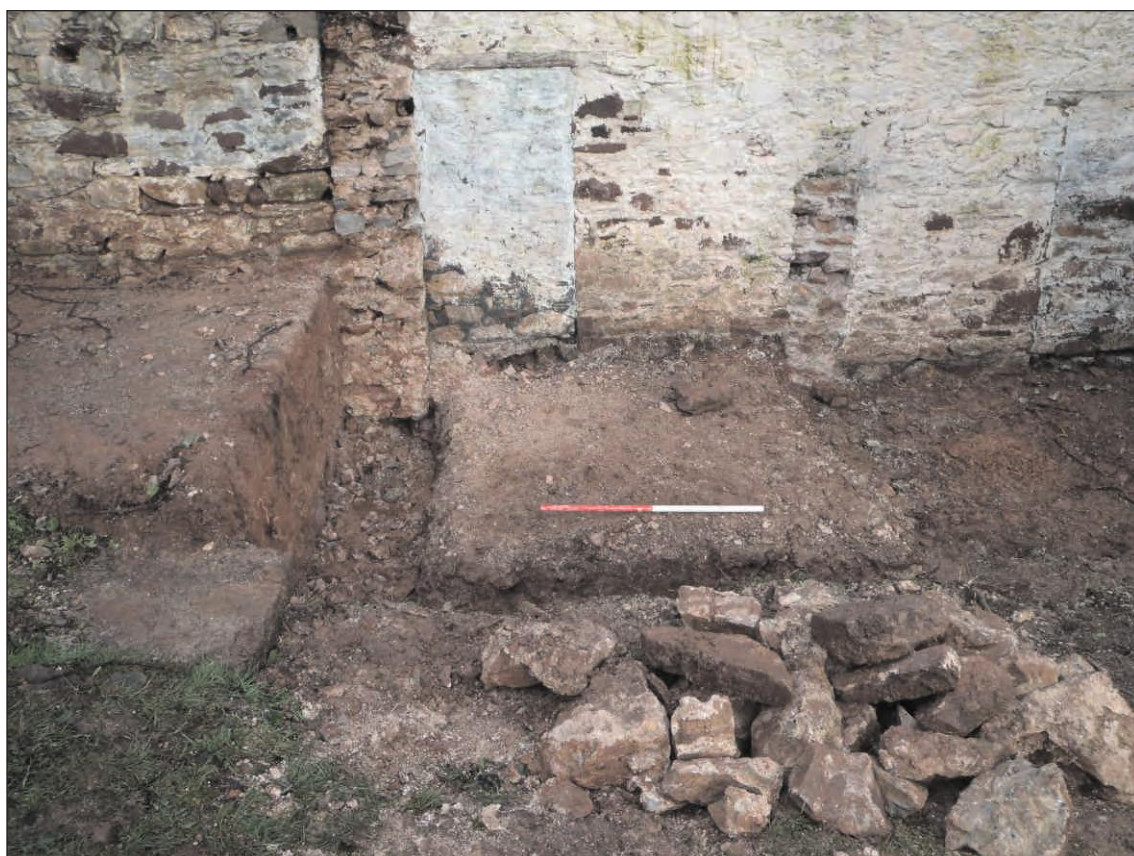
The original footings for the former pigsty measured 5.5m long and 2.6m wide; these were extended by another 3m to the west, making the new footings for the garden room 8.5m x 2.6m wide.

Plate 20. View of Garden Room (Area 1) reduction, view from south (scale 1m)
