Trinity Leigh, East Leigh, Coldridge, Devon
(SS 6099 0523)

Results of historic building recording

Mid Devon District Council ref. 08/01363/LBC

Document No: ACD360/1/0

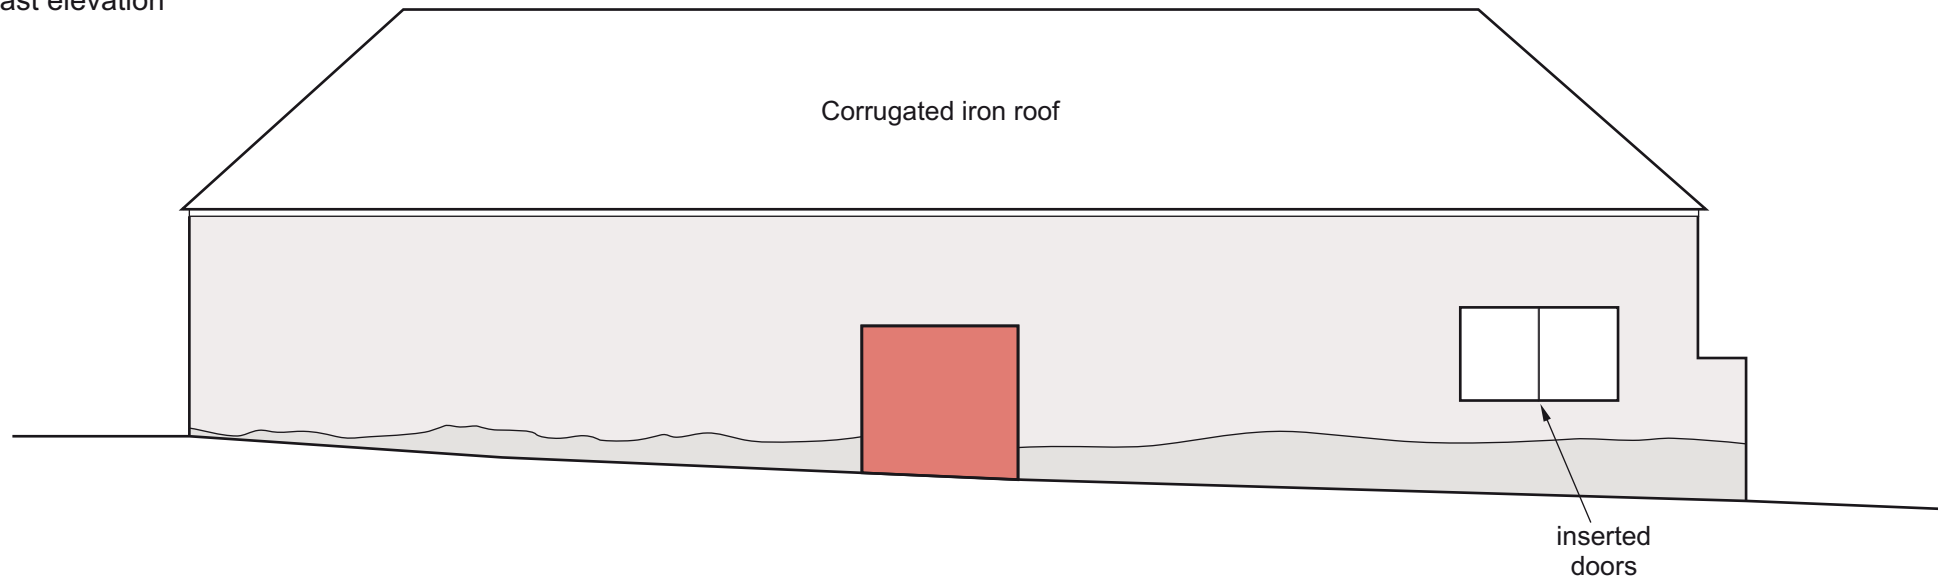
a) East elevation

The east elevation is in a poor state of repair, with several voids in the cob and evidence of it collapsing outwards. It is currently propped up. This structural failure has been partially rectified by the addition, in the mid 20th century, of a battered red brick buttress to the centre of the elevation (Plate 2). At the north end of the elevation are a pair of double doors, made up of wide vertical planking all within a wooden frame, which probably represents an inserted feed hatch into the cowhouse.

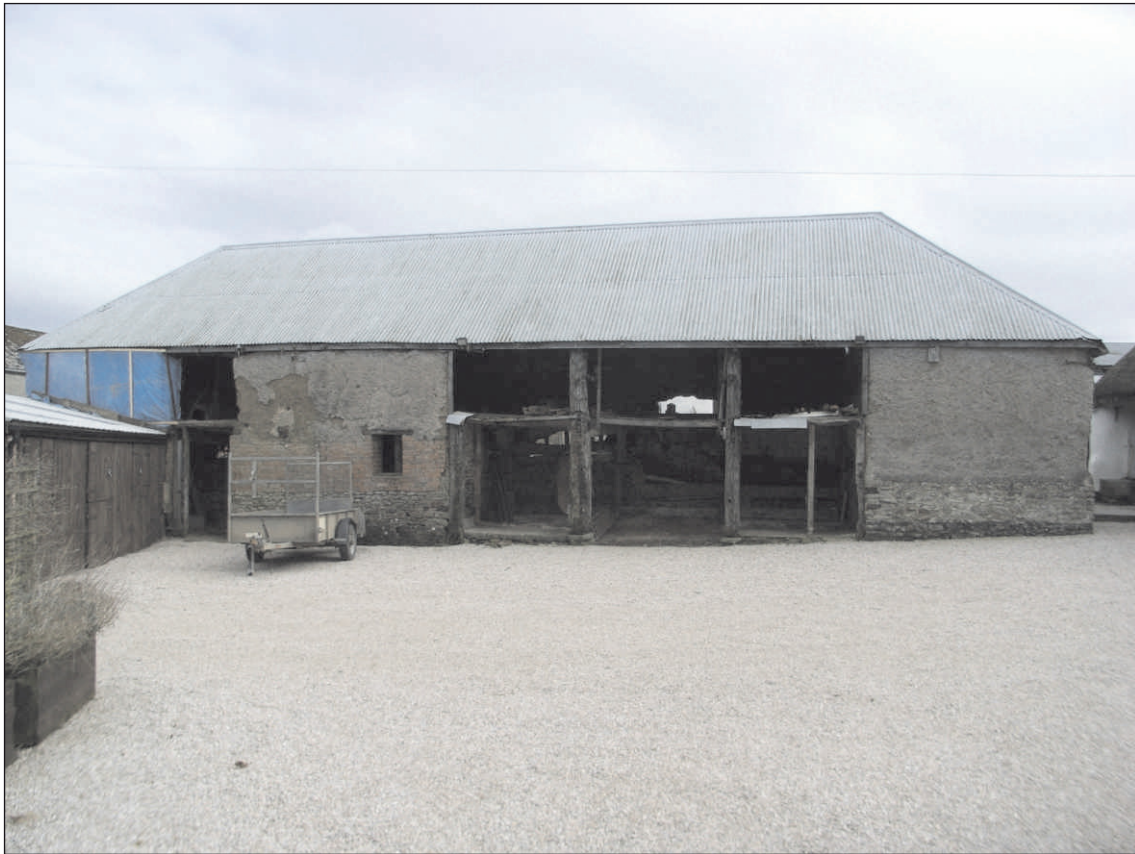
In the west cowhouse elevation is an area of c. early 20th-century brick repair, laid in stretcher bonded faced over the primary cob (Plate 1). To the left of the elevation is a later, single storey lean-to constructed mainly of cob upon a low level stone wall.

Plate 1: The west elevation of the barn, looking east.

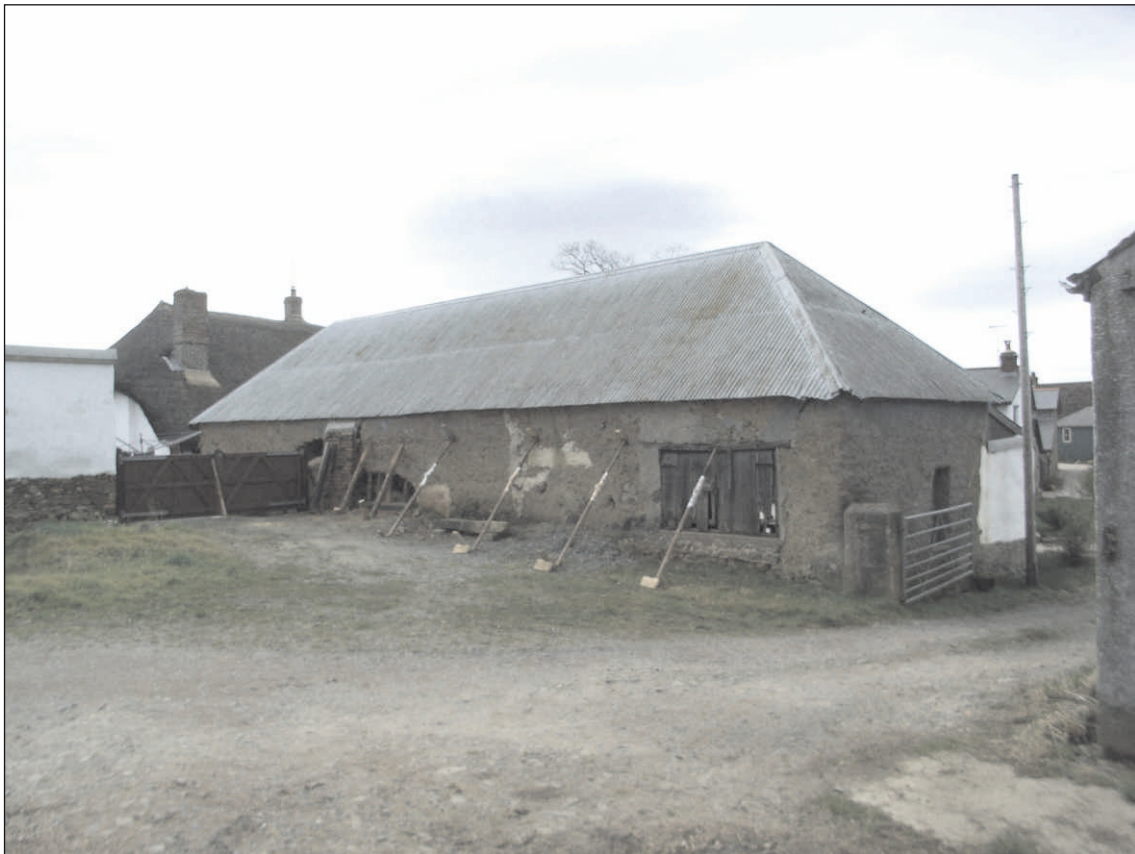
Plate 2: The east elevation of the barn, looking southwest.

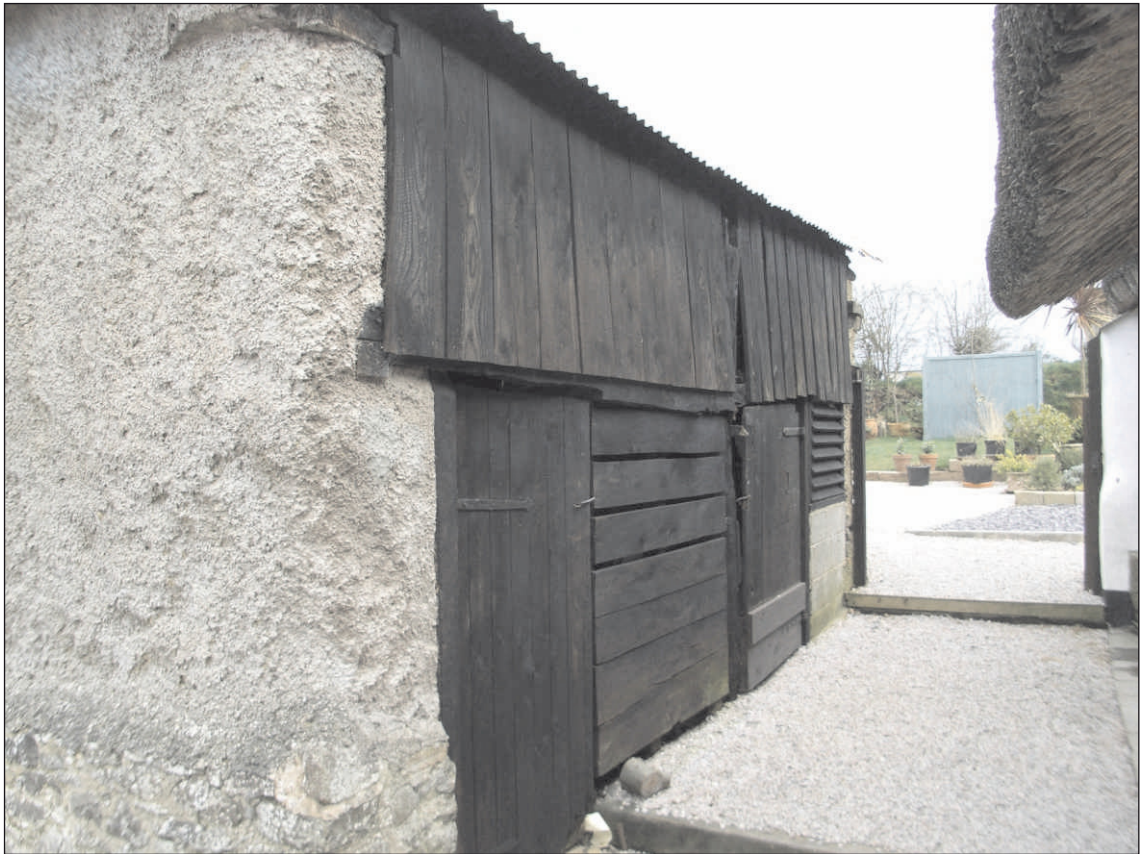
The south elevation is formed by timber panels and incorporates two doors, as well as a further opening, partially infilled with concrete blocks above which is an area of slatted vents (Plate 3).

Plate 3: The south elevation of the barn, looking to northeast.

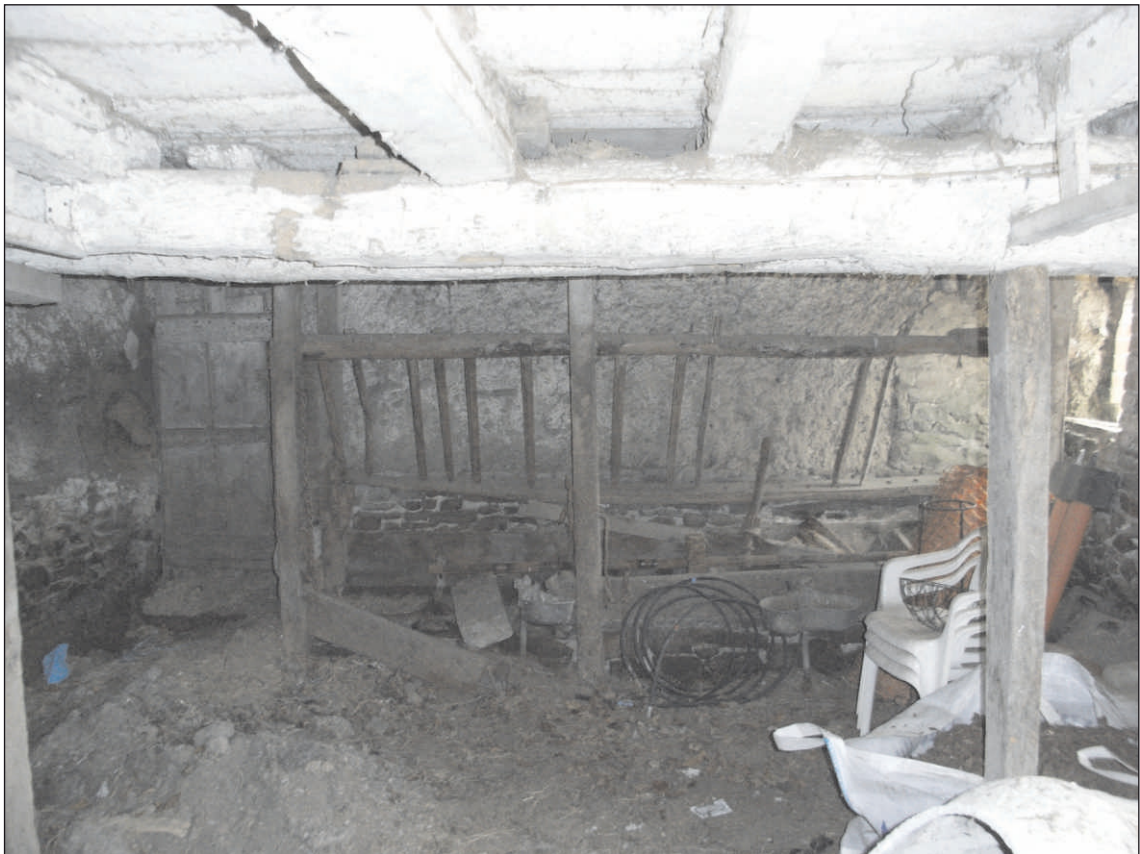
Plate 4: The manger and feeding troughs in the cowhouse, showing the door to the feeding passage in the linhay to the left, looking south.

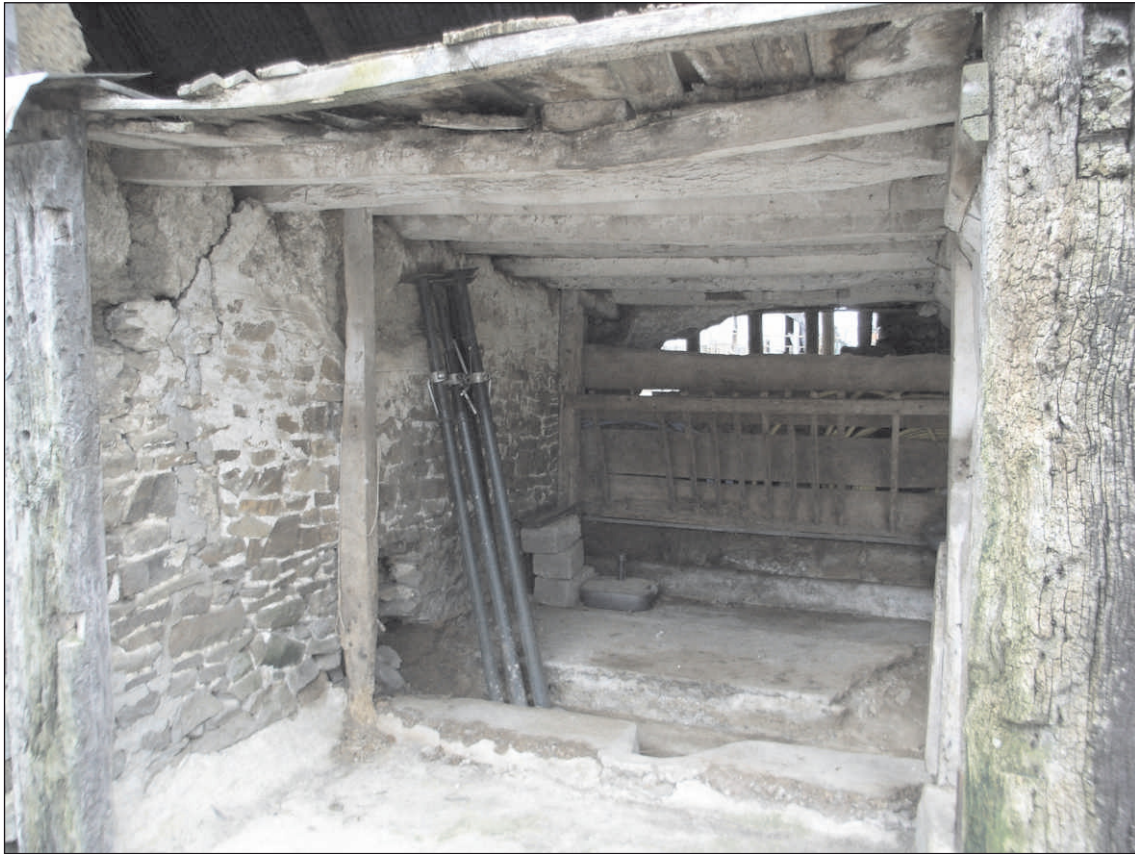
The linhay is open-fronted on both floors and is divided into three bays by two timber posts that support the first floor and roof. The posts are set into circular pads. The floor beams are attached to the posts using tongues. Sockets for two securing pegs are visible on each beam. The feet of the trusses rest on the top of the posts. There is a feeding passage running along the east side of the building divided from the cattle stalls by wooden planks. In the northern bay the remains of a manger survive attached to the planking. The original pitched cobbled floor has been overlaid in concrete. The latter, where it survives, incorporates stalls and a drain (Plate 5).

Plate 5: The stall in the northern bay of the linhay, looking northeast.

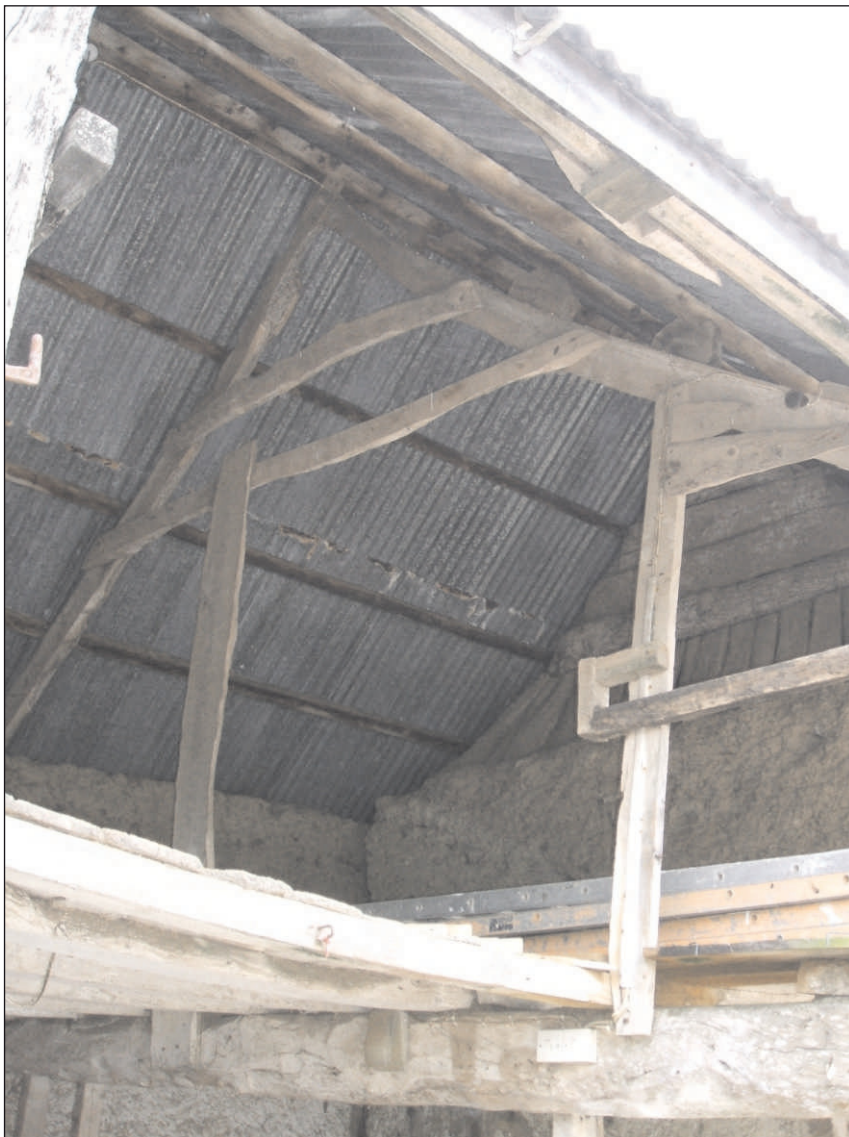
The first floor is an open hayloft that extends across the linhay, and partially above the cowhouse. As discussed above, it would have originally have continued across the whole of the cowhouse. The floor planking is simply abutted to one another and utilises boards of various widths. Boards attached to the truss over the linhay are evidence for a former partition (Plate 6).

upon the large vertical timbers that divide the bays on the west elevation (Plate 6). There are no trenches or sockets for the purlins in the original rafters, so the roof must have been carried on back purlins. The surviving truss has two applied collars.

Plate 6: A surviving roof truss over the linhay, looking southeast.
