Four Bowl Barrows on Bursdon Moor, 270m north west of Summerville Cross, Hartland, Torrridge, Devon

Results of an archaeological watching brief

Document No: ACD466/1/2

Date: October 2012

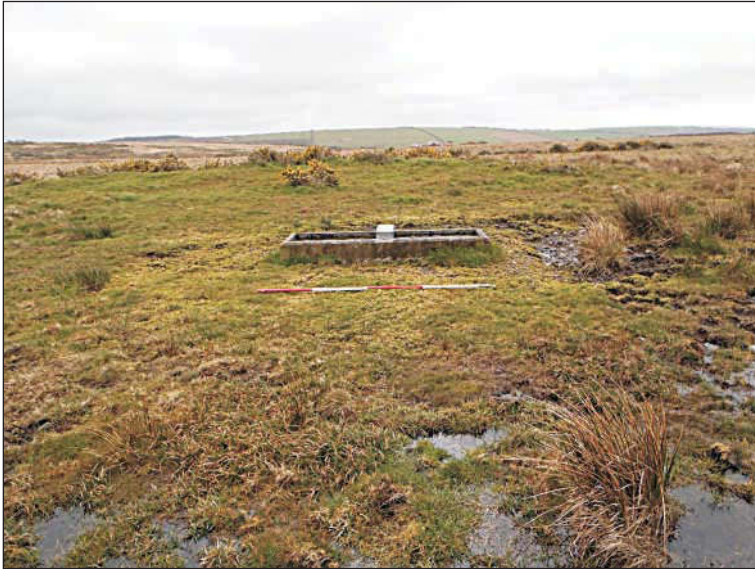
Plate 1: The existing trough on Barrow 110 showing erosion scars. View to the south (2m scale).

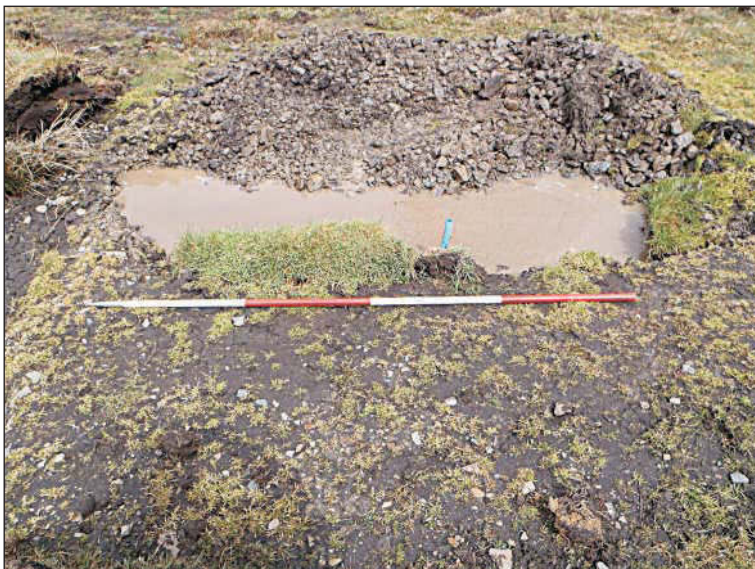
Plate 2: Barrow 110, the exposed stone sub-base under the trough. View to the north (2m scale).

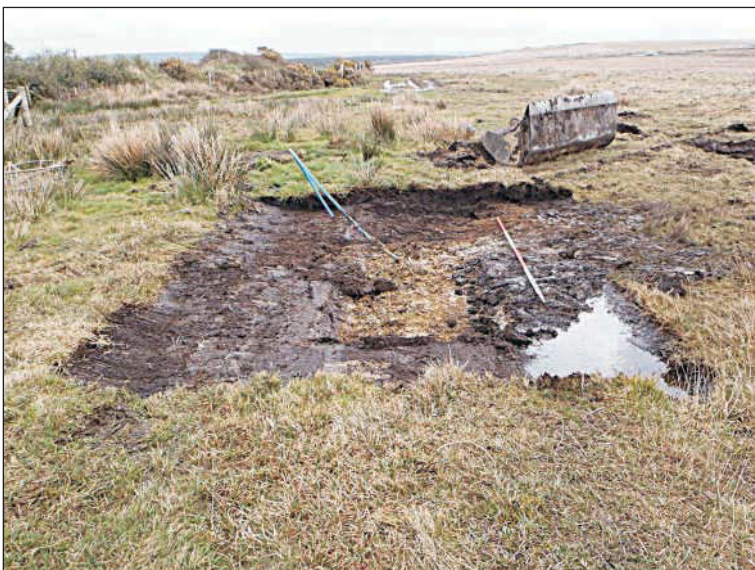
Plate 3: The excavation for the resited trough. View to the northeast (2m scale).

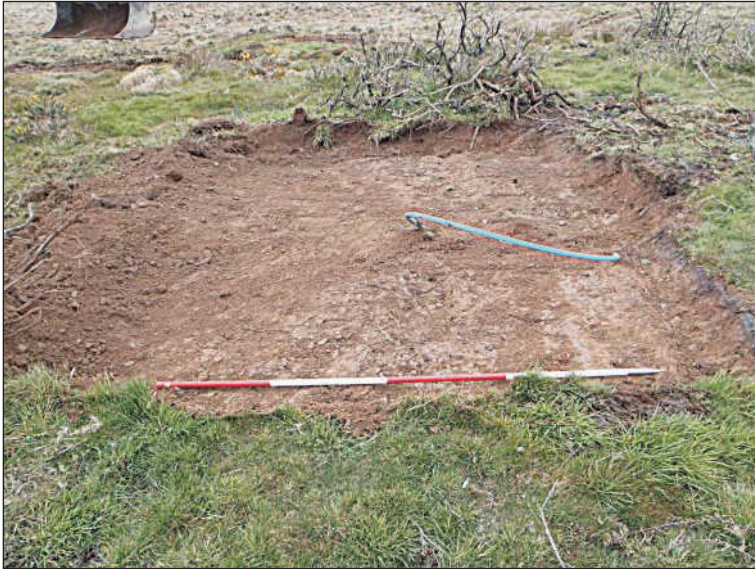
Plate 4: The excavation for the second trough.
View to the south (2m scale).

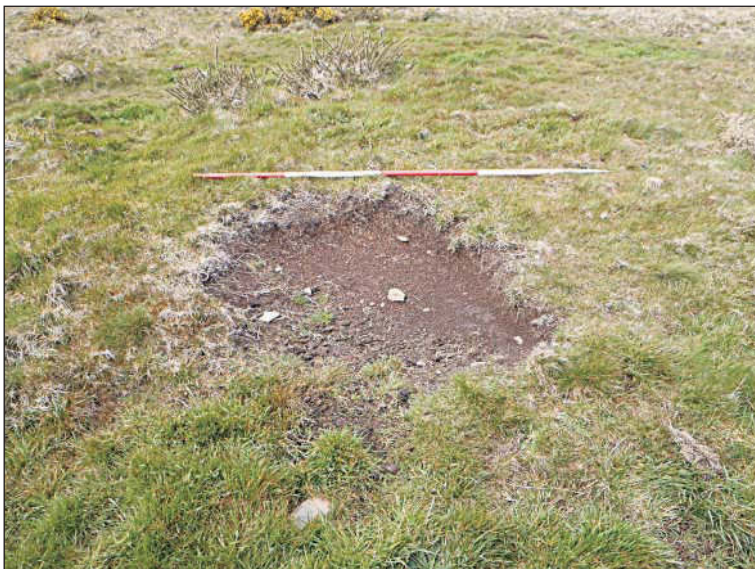
Plate 5: Barrow 109, southern erosion scar.
View to the north (2m scale).

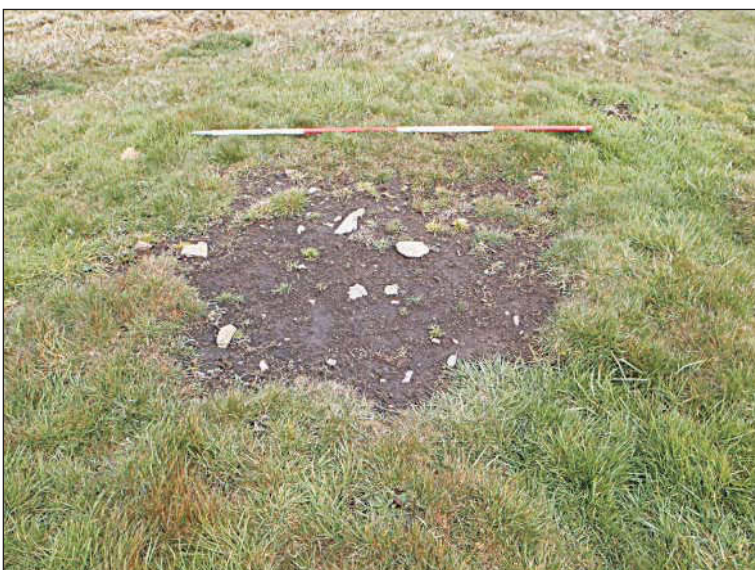
Plate 6: Barrow 109, northern erosion scar.
View to the north (2m scale).

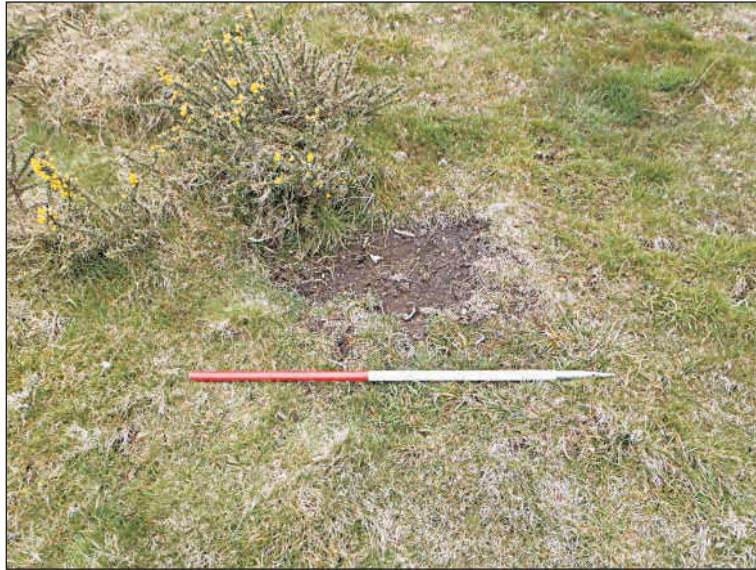
Plate 7: Barrow 12410, erosion scar. View to the west (2m scale).

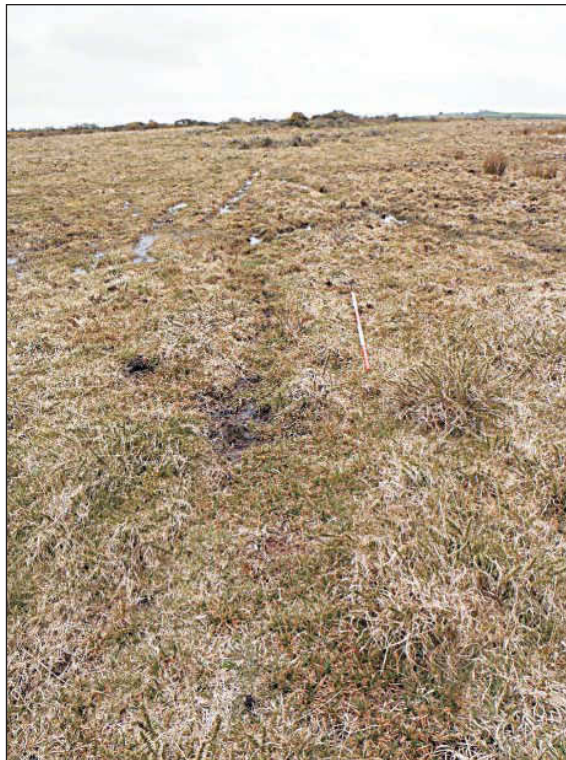
A record was prepared of erosion scars on the barrows. One new area of erosion was noted, along with some vehicle tracks.

Plate 8: Barrow 111, vehicle tracks. View to the east (2m scale).
