# Lower Molinnis Pan Kiln Chimney, Near Bugle, Treverbyn, Cornwall

Results of historic building recording

Document No: ACD566/1/0

Date: October 2012

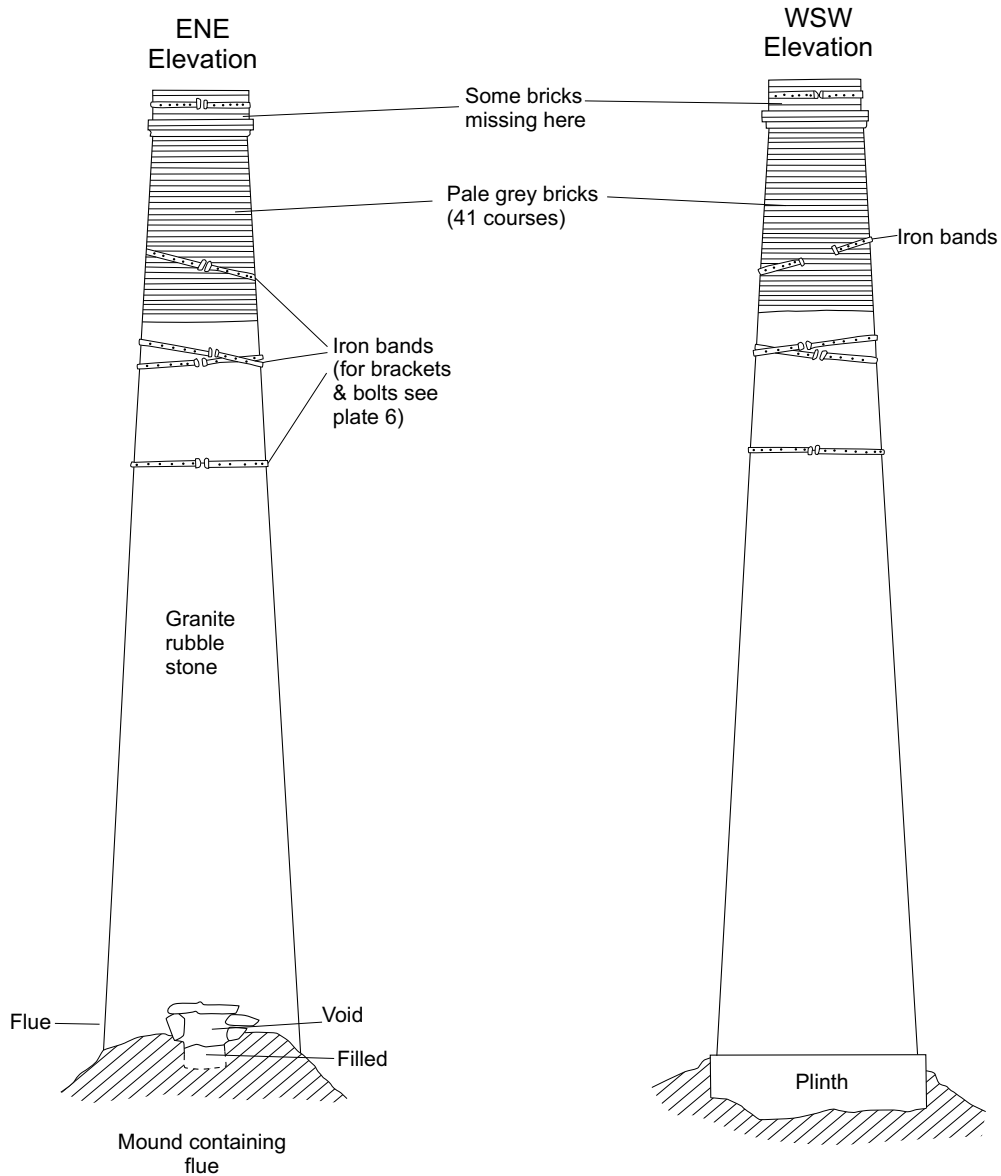
Fig. 5: Molinnis chimney, east-northeast and west-northwest elevations

- 4.1** The round chimney stack (Fig. 5 and Plates 1-6) stands to a height of approx.14m, including a 10cm-wide plinth around the base which has a diameter of 2.9m (9ft 6ins). Construction is in the traditional manner using granite rubble stone for most of the stack, tapering towards the top 3.05m (10ft) which is finished in coursed bricks. The condition of the chimney is poor. The original lime mortar has weathered although there are places low down that have been re-pointed with cement at some time.

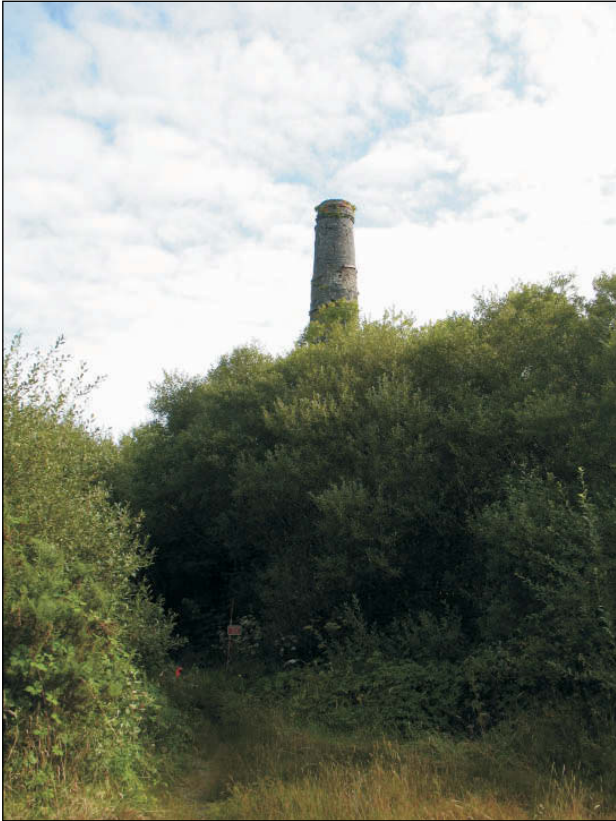
Plate 1: Molinnis chimney rising above woodland, indicating the hidden nature of this industrial site, view from west-southwest

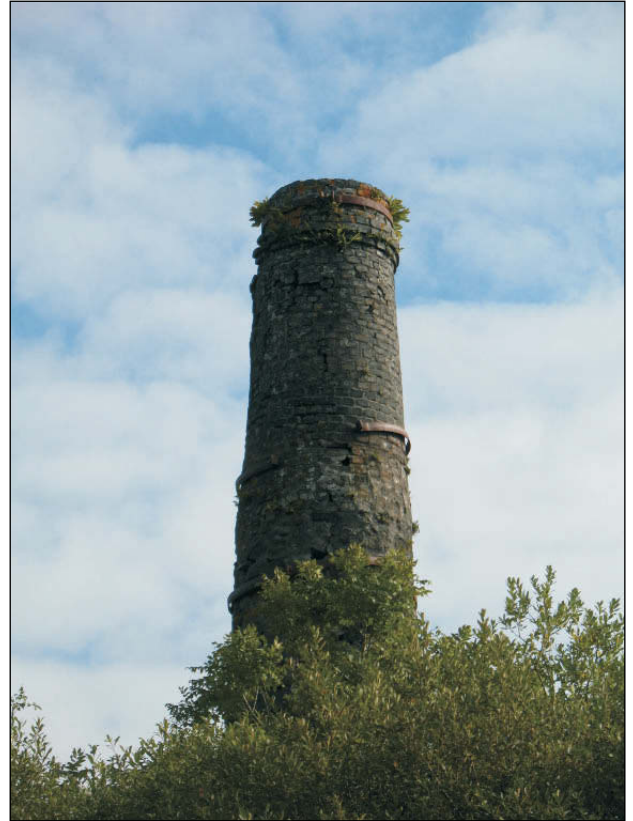
- 4.3** Five iron bands of wrought iron strapping survive high up, the middle three of which have come loose and slipped down the stack. Each band is in two sections, with flanged ends bolted together and tightened on opposite sides of the stack (Plates 2 and 6).

Plate 2: Molinnis chimney top brick courses and iron bands, view from west-southwest

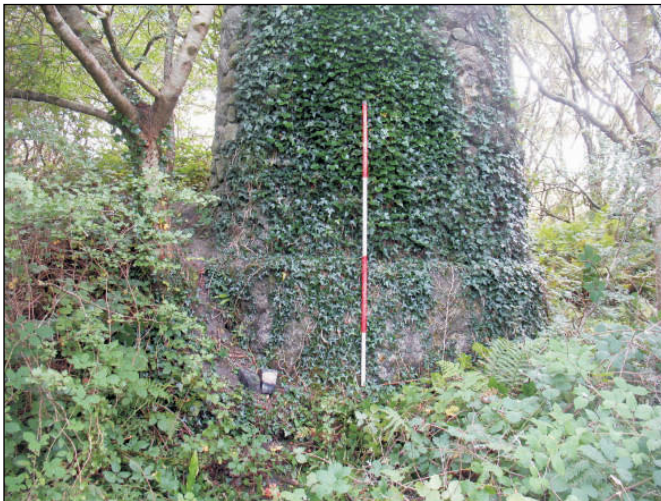
Plate 3: Molinnis chimney base showing the plinth foundation, view from northwest. Scale 2m

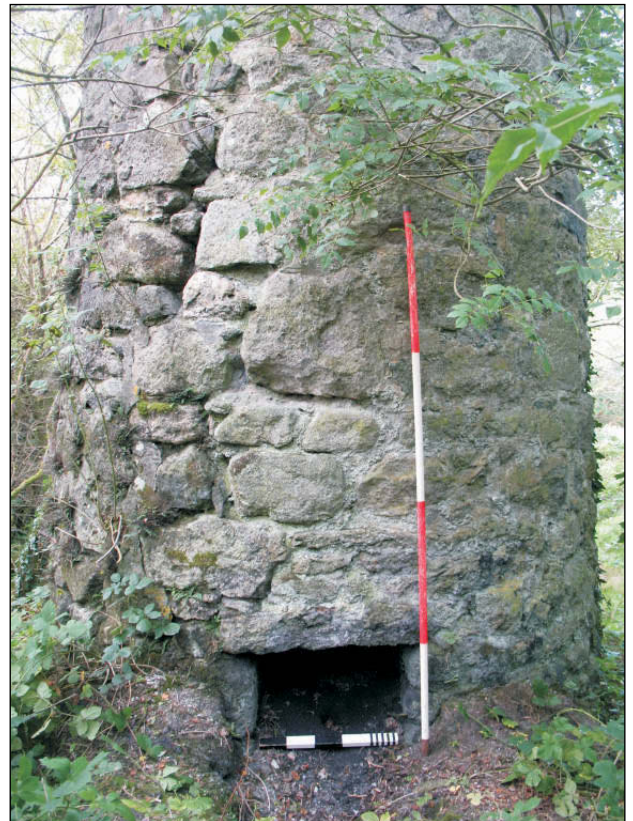
- 4.4** The chimney flue opening survives just above the level of the base plinth, its lintel c. 1.6m above ground level (Plate 4). The stonework is good, although it is partly

collapsed inside. In front, a 1m-long hole probably had a removable cover to gain access to the flue and chimney. The main flue has stone side walls and stone capstones or lintels (Plate 5). As in the chimney, there is much evidence of soot showing it was well-used in its time. A long mound containing the flue can be identified at a slight angle and sloping gently down towards the site of the (now demolished) west end of the pan kiln, a distance of c. 17m from the chimney. The chimney is in the correct place on the 1971 map but, interestingly, the 1907 map shows one in a different position, nearer the kiln but out of line. If this is not a mistake, it is evidence that the chimney had to be rebuilt for some reason. The map also shows an unexplained chimney-sized feature near the west end of the kiln (see Figs 3 and 4).

Plate 4: Molinnis chimney base with opening for flue, view from east-northeast. Scales 0.20m and 2m

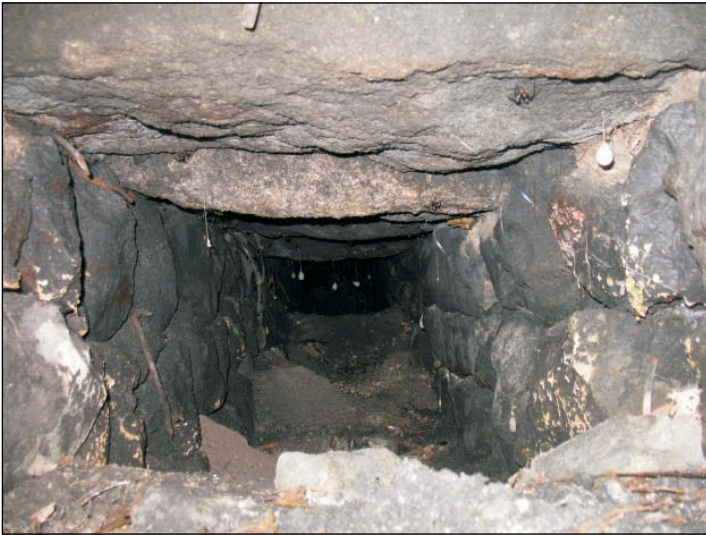
Plate 5 : Molinnis chimney flue interior, showing the stone capstones or lintels, view from west-southwest. The width of the soot-encrusted flue passage is 0.55m

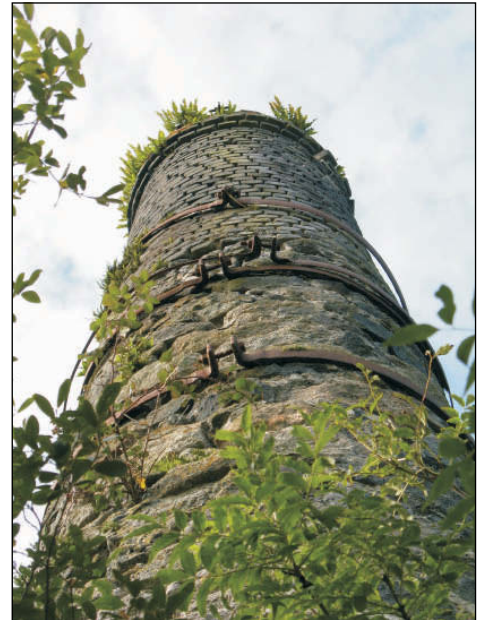
- 4.2** The brick top is in the poorest condition, especially on the north side where fallen bricks have left a hole; trees prevented this from being viewed or photographed successfully. There are 41 brick courses, with a widening formed by three capping courses near the top. Bricks fallen onto the ground are tapered and typical of the type specially made for building stacks of a small diameter. Unfortunately they are not impressed with a maker's name but their firebrick-like texture suggests they came from a local manufacturer in the St Austell clay district (Plate 7).

Plate 6: Molinnis chimney top, looking up from east-northeast, showing the poor state of the brickwork and the slipping iron bands.

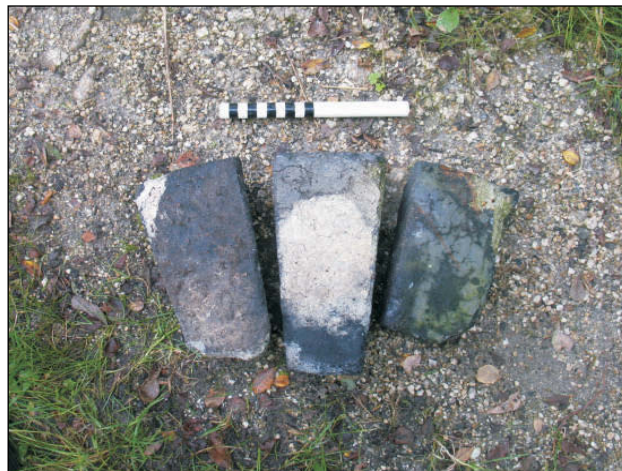
Plate 7: Examples of fallen chimney stack bricks, specially designed with a taper. Scale 0.20m

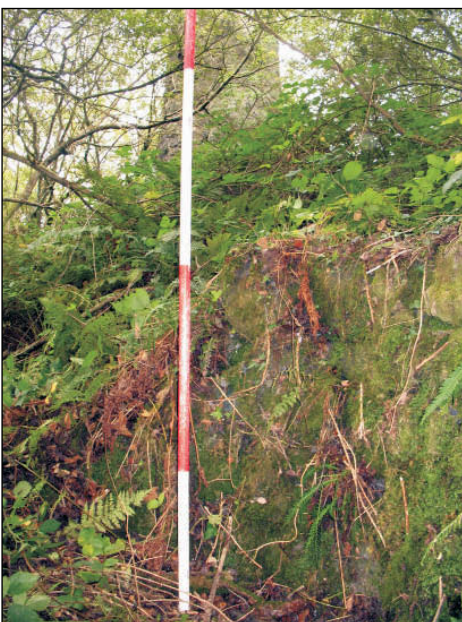
**5.4** The layout of the four settling tanks is still recognisable, although several sections of wall have been demolished. Sample measurements show the very overgrown walls are between 1.2m and 2m wide and up to c. 1.4m high. Much of the main tank wall, shared by the pan kiln, remains, despite some demolition. There is one surviving opening from the largest tank into the pan kiln. It is 1.25m wide but no longer contains the hatch boards once held in timber guide frames.

Plate 8: Settling tank No.3, showing the curved northwest corner, with the chimney stack beyond, view from east-northeast. Scale 2m

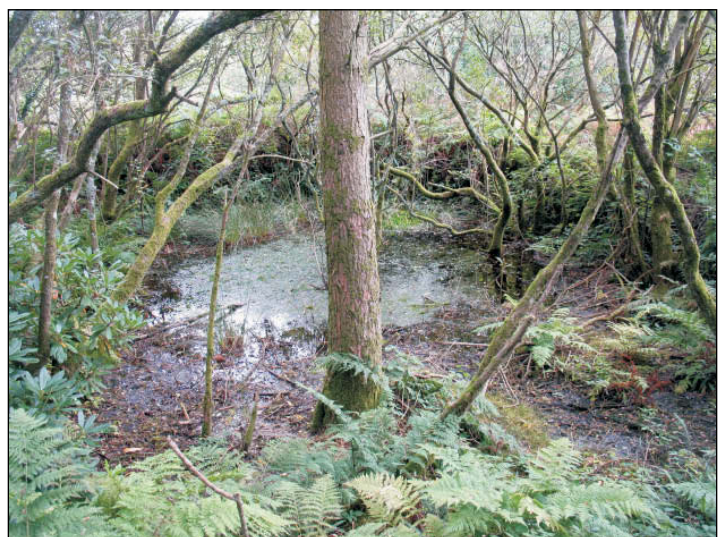
**5.3** The settling tanks are fewer, squarer and smaller than the long types more usually associated with pan kilns. The tanks also differ in their layout, being off-set from the pan kiln. When the works was established there were three tanks, called for the purpose of this report, Nos. 1 to 3. From east to west, Tank No.1 measured 12m by 16m, Tanks No.2 and No.3 were smaller and almost square, each being 12m by 11m (Plate 8). By the final phase, sometime between 1938 and 1963, Tank No.2 had been lengthened to 24m long and Tank No.4 had been added in the space in the corner between tanks No.2 and No.3, with the same dimensions as the latter (Plate 9).

Plate 9: Settling tank No.4, flooded and overgrown, view from NW. This dates from an enlargement of the site sometime in the mid-twentieth century.
