# The Castle Hotel Outbuildings, Taunton, Somerset

# Results of historic building recording

Document No: ACD422/2/1

Date: June 2013

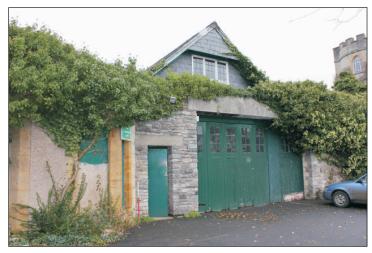
The principal south elevation fronting Castle Green comprised a series of different masonry buildings and features. A photograph of *c*. 1910 (Bush 1988, 6) shows that the majority of the recorded façade was a refacing that comprised coursed fine sandstone blocks incorporating a window. This had three lights with the upper sections divided into two panes, the lower of which opened. This masonry survived in the eastern side of the elevation, and had been covered with a cement render. Internally, an area to the east of the window had been rebuilt in concrete blocks. The earlier masonry comprised irregularly laid stone and brick fragments bonded in loose grey-brown stony silty clay. A print of 1866 depicts an unfenestrated elevation. To the west, a large sliding door had been inserted creating access to room 5, along with an adjacent contemporary pedestrian door. The opening had a boxed-in RSJ faced externally in concrete, supported on piers of lias, granite and shale masonry. During demolition, patches of brickwork were exposed behind the external face. The *c*. 1910 photograph shows a doorway into room 5 with a large sign attached to the adjacent wall.

Above the inserted openings was a straight gable forming the end of a first-floor room in the roof space. This incorporated a three-light window, with 12 leaded panes. The gable was clad in slates attached to a wooden frame. This replaced an earlier narrower gable, again incorporating a window, with the top formed by a pediment.

At the east end of the elevation was a projecting bay window with Hamstone jambs. This was set within an opening flanked by oolitic limestone jambs. One window opening had been blocked. The glass had been removed but the windows appeared to have had two casements of differing sizes.

Plate 1: South elevation, viewed from the southwest. 1m scale.

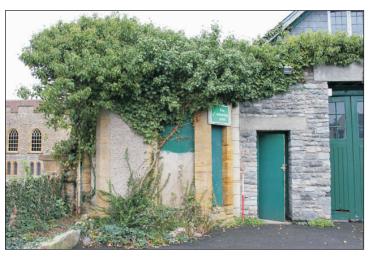
Plate 2: South elevation, west end, viewed from the southwest. 1m scale.

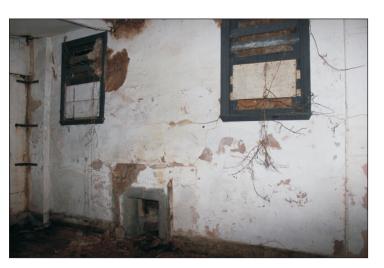
This room was situated at the southwest corner of the building. The floorboards were rotten and its ceiling was collapsing and therefore pre-demolition recording was limited. Similarly the adjacent room 2 could not be entered due to rotten floorboards (over a basement boiler room). Its east wall was constructed of red bricks mostly laid in stretcher course, but with some rows of header course. It incorporated a blocked doorway, and a fireplace opening. The latter had been broken through to create the present entrance, and it is unclear whether it heated room 1 or 5; the latter seems likely. Alternatively it may have formed the chimney stack from the boiler in the cellar, but it is situated to the south of the boiler room, not directly over it. The walls had been covered in render and supported an original tall skirting board. The north wall had been demolished and replaced by a rendered brick wall when the adjacent room 2 was added. It supported a lower skirting board than the other walls.

Plate 4: Room 1, west elevation showing fireplace and windows, viewed from the northeast.

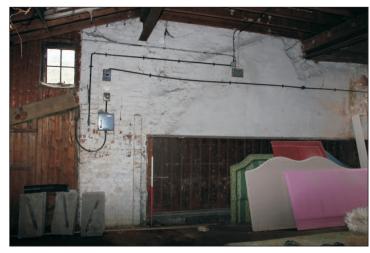
The upper floor and roof of this building had been altered. On the east elevation was a scar of a pitched rear roof. The present first floor was supported on R.S.J.s that rested on brick piers. These had been inserted into the earlier side walls of the room.

Plate 7: Room 5, east elevation sowing panelling with scar of former roofline above, viewed from the east. 1m scale.

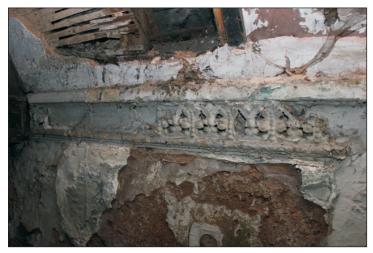
Plate 6: Room 5, cornice in the stairwell to the first floor, viewed from the east.

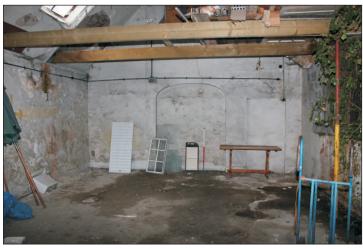
The north wall of this room was constructed from small roughly coursed sandstone, which on this elevation was rendered and painted white. The east elevation was probably of the same material. At ground-floor level it incorporated a brick blocked doorway and a wide, infilled arched central opening. The room had a concrete floor. It was opened to the roof, but its structure was obscured by lath and plaster. Below the collar level there was a ceiling of 8x2 intersecting panelled beams infilled with tongue and grooved boards. The primary rafters were chamfered and sat on projecting corbels. Between the trusses was an ovolo-moulded cornice. This was not present on the gable elevations. The north pitch incorporated two roof lights. Modern tie beams had been added to provide support and provide a base for storage.

Plate 8: Room 6 showing east elevation with openings, viewed from the west, 1m scale.

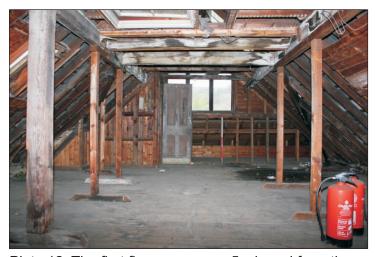
The recorded roof structure was the product of at least three phases of activity. The primary, lower section comprised a slate covering laid onto thin batons nailed to the back of closely-set primary rafters. It incorporated inserted single skylights in each pitch. Disused hip rafters at its north end related to this first structure, and a contemporary scar of the roof below was observed at ground floor level. The ceiling of the stairwell preserved earlier lath and white-painted plaster, set within black-painted wooden batons creating a mock-Tudor effect. At floor level were curved braces attached to the rafters. The lower parts of these timbers displayed scars of laths and plaster and it is likely that the primary ceiling was a pointed arch or mock barrel-vaulting.

Plate 12: The first floor over room 5, viewed from the south. 1m scale.

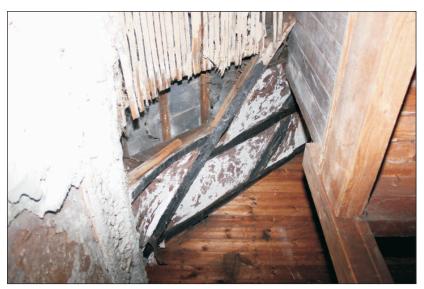
Plate 13: The panelling in the stairwell to the first floor, viewed from the south.

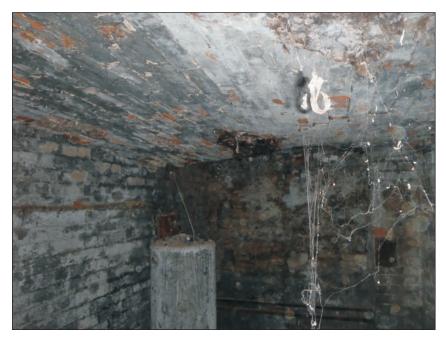
This was situated under room 2 and was entered by an external flight of steps, set within a brick-lined well, on the east side of the building. This was open, but had formerly been enclosed with an arched roof. Adjacent to the doorway was a small, high-level, bottom-opening window. The north, south and west walls were constructed of brick, with the north and south walls built into an earlier north-south aligned rubble stone wall. The ceiling was vaulted and constructed using drilled red bricks. Inside, a water boiler survived. Within a pier in the southeast corner were two iron pipes, an iron box, and a sawn-off pipe. There was a further lagged pipe attached to the north wall.

Plate 14: The cellar showing the features in the east elevation, viewed from the west.
