MAGNOLIA HOUSE AND ACACIA HOUSE, FRIAR'S GREEN, EXETER, DEVON

Results of historic building recording and archeological
watching brief

Document No: ACD604/2/2

Date: June 2013

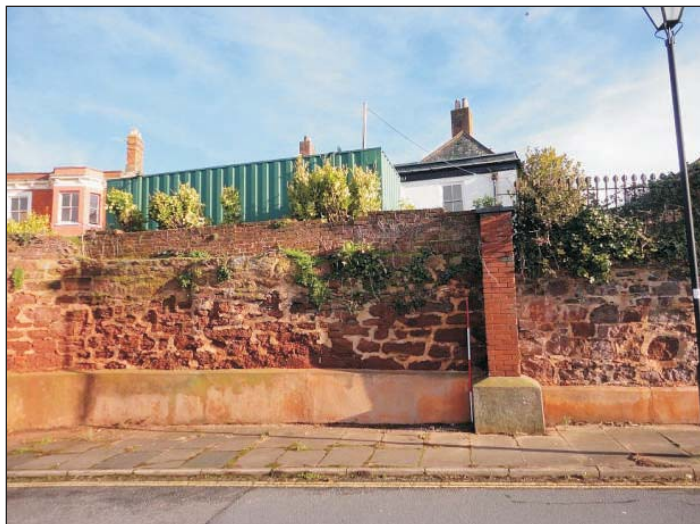
Plate 1: View of the southwestern boundary wall showing the breccia fabric underlying later brickwork

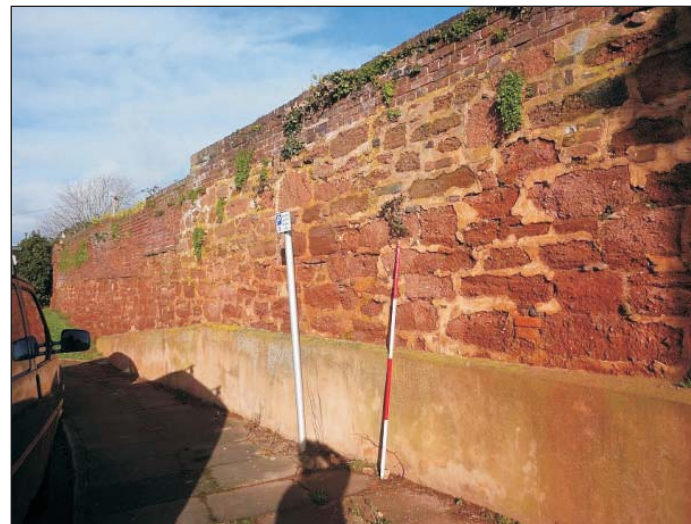
Plate 2: View of the same wall, looking towards the northwest, showing the breccia fabric stepping down as though with a fall in the land. Scale 2m

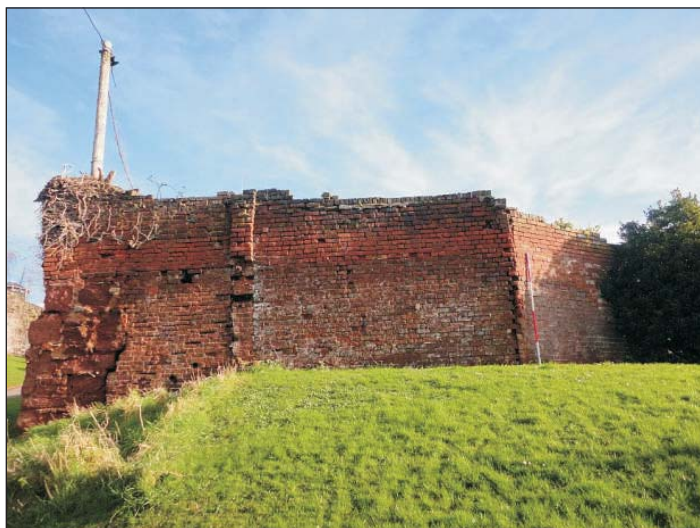
To the west the ground rises into a modern grassy landscaped mound on the site of gardens of the Horse Lane and Quay Lane houses. Beyond the summit of this mound the wall changes back to its former alignment for a short distance (Plate 3). At this point the whole height of the wall is of brick, though constructed in several clear stages. The lower section, approximately 2m high, is of dark brick laid in Flemish Bond, decorated with burnt headers. This might date from the 18th or early 19th century. Overlying this is a band of orange bricks, much discoloured towards the summit. This section of the wall is in very poor condition and is coming apart at the angles. All these phases are earlier in date than the wire-cut bricks to the east. There is a flat pilaster buttress roughly at the centre, probably representing the scar of the rear wall of a demolished house in Quay Lane. To the west of this the zig-zag scar of a staircase can be made out in the lower part of the wall. Over this is a band of orange bricks, 7 courses deep, and overlying this, a band of darker bricks 9 courses deep. This upper part seems to represent the end wall of a large 19th-century glass house in the gardens of Acacia House which appears on the 1876 1st edition 1: 500 map of the area (Devonshire Sheet 80.6.22).

At the westernmost angle of the perimeter is a massive baulk of breccia masonry incorporating extremely large blocks. Although there appear to be inclusions of brick, arranged in courses, these may simply be 19th-century patching of horizontal fissures created by the erosion of the breccia. If any part of the perimeter walls contains medieval fabric this corner, with its massive construction, is the most likely area to represent a survival of the friary precinct walls or of the mansion which succeeded it.

Plate 3: Detail of the corner of the site boundary showing successive brick builds, evidence of a staircase and the baulk of early masonry at the corner.

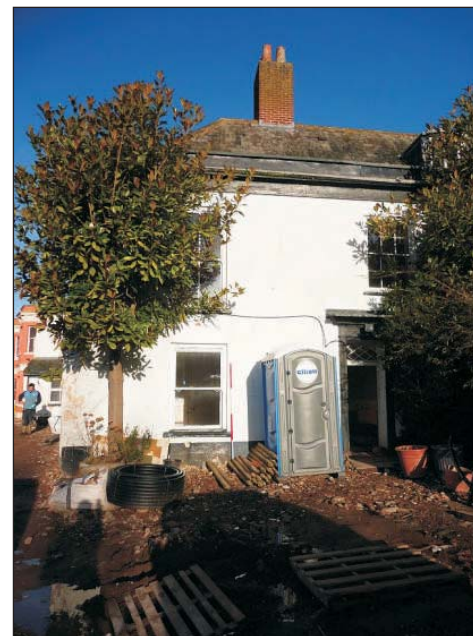
This represents the south-western end of the original façade of the house and has only two bays. The proportions of the façade are unusual, with a low ground floor and a taller

first floor, suggesting that the first-floor rooms may have been of greater importance (Plate. 4).

Plate 4: Detail of the front elevation of Magnolia House. Scale 2m

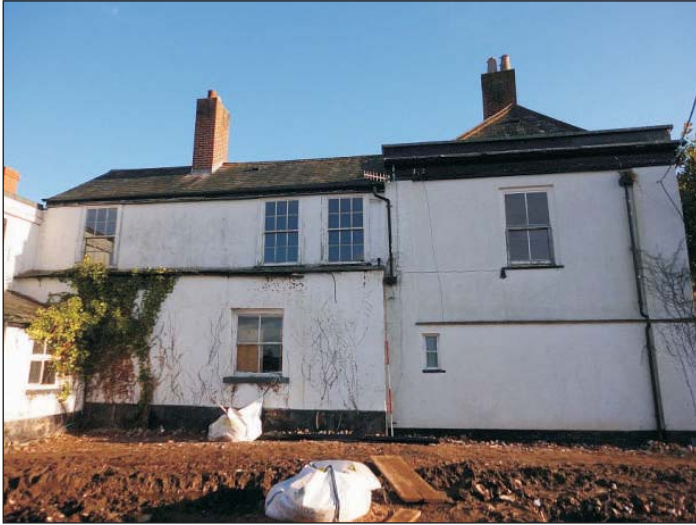
The lower part of the south-western wall is thicker than the upper part, with an offset at first-floor level. On either side, 'pilasters' rise above this offset, flanking a recessed section of the facade; these 'pilasters' are not symmetrical, and are not treated architecturally; they may represent the stubs of truncated walls relating to buildings extending further to the south west. Traces of the footings of a large wall of Heavitree breccia can be traced running through the gardens on a similar alignment to the south-eastern wall of the house. This represents a boundary wall between the garden of Acacia House and Friars Green as depicted on the 1876 1:500 Ordnance Survey map but it is possible that this was retained from an earlier and more substantial structure.

Plate 5: The side elevation of the house and service wing. Scale 2m

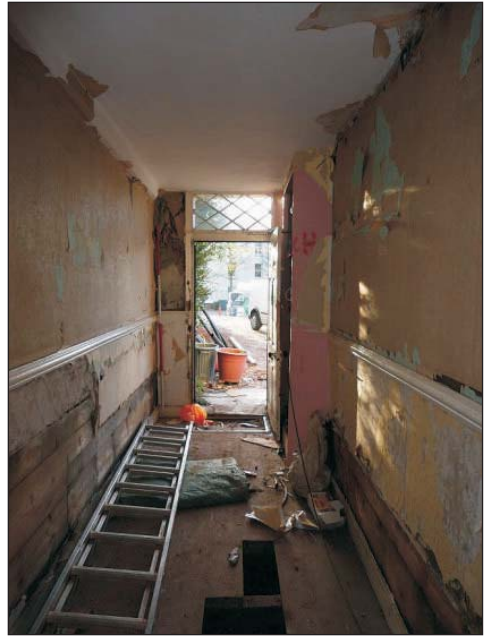
From the main doorway a narrow entrance passage runs the width of the building and then links with a corridor running along the rear wall of the house (Plate 6). The passage may have been divided off from the end of a large room, now within the adjoining property, when the house was subdivided, and it is suggested that the north-eastern wall of the passage may be an early 19th-century insertion. This wall has been partly stripped of plaster revealing that the lower part of the wall, rising to a height of approximately 0.75m, is boarded, whereas the upper part is plastered. This may be consistent with a low panelled dado or wainscoting, now removed. Alternatively, the boarding, which rises to a different height on the opposite side of the hallway, might represent an attempt to deal with an attack of damp or rot, and the boarding may perhaps replace damaged plaster at the base of the wall. The south-western wall may be earlier, perhaps a primary partition, and contains the base of a large chimney. The end of the passage is defined by a wide, segmental arch, which may have been mutilated by the removal of pilasters, and the imposts are now supported by three small shaped brackets or dentils. Under the soffit of the arch is a star ornament, but this appears to have been applied later and may be modern.

Plate 6: View of the passage showing boarded treatment below the dado. Scale 2m

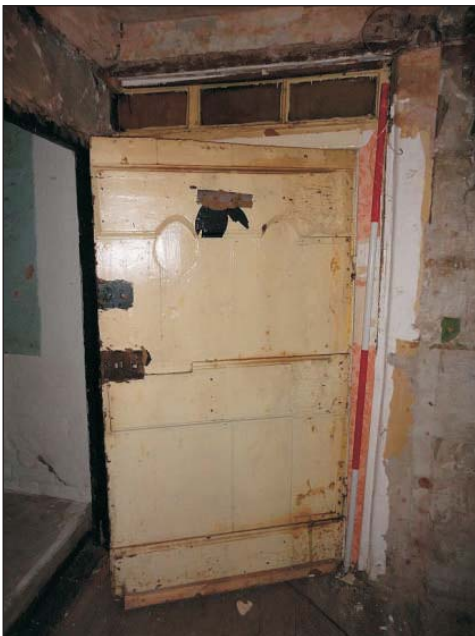
Plate 7: Detail of the historic door to the service wing showing original 'L'-hinges. Scale 2m

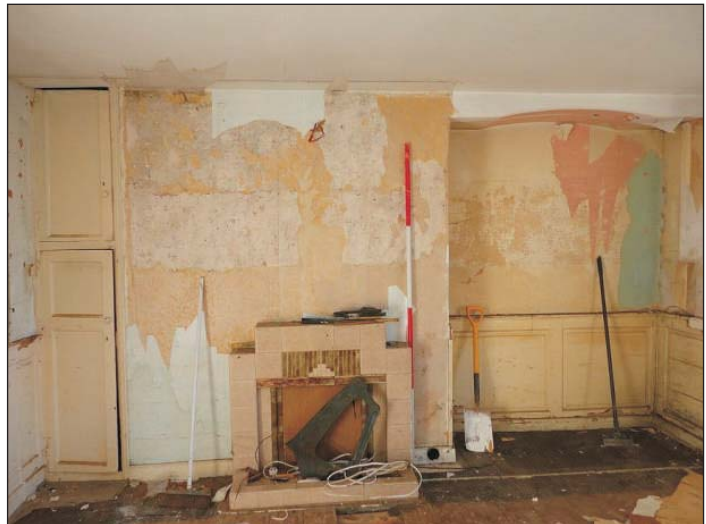
The parlour is a high-status room that preserves its original door (described above), and also raised-fielded panelling forming a dado around the lower part of the walls (Plate 8). The panelling fits the room exactly and seems likely to have been made for it. The removal of the piano, which had been built into a cupboard within the alcove to the east of the fireplace, has revealed panelling surviving in this area which appears to be *in situ*. A curious domed ceiling over this area may survive from an arched head to the alcove, or might perhaps be related to a fixture such as a dresser or china cabinet, presumably either pre-dating or secondary to the panelling, which does not survive. The fireplace in the north-eastern wall has been revealed by the removal of later cladding and shelving, but remains obscured by a mid-to-late 20th-century tiled chimneypiece and raised hearth. There is a narrow cupboard to the northwest of the chimney breast with doors hung on 18th-century 'H'-hinges. The panelling of the south-eastern wall respects the existing window embrasure and is probably contemporary with it. There are two small vertical panels on either side of the embrasure and another beneath, now obscured by later cupboards. The window retains folding shutters with plain, moulded panels.

Plate 8: View of the northeastern wall of the parlour showing the panelling and fireplace after stripping out. Scale 2m

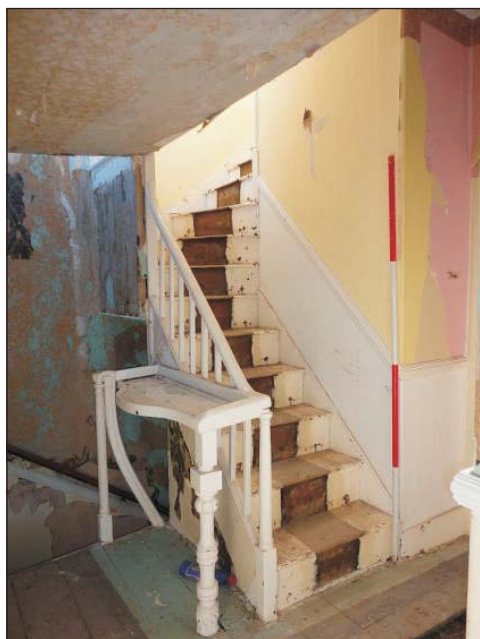
Plate 9: Detail of the staircase from the first-floor landing. Scale 2m

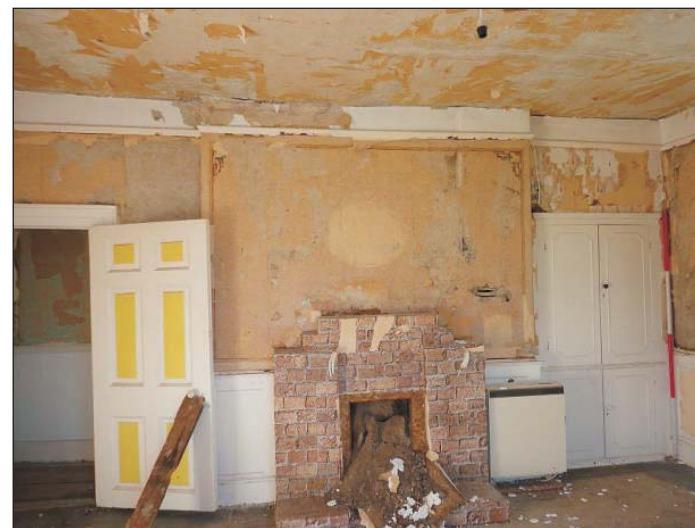
Plate 10: View of the northeastern wall of the main bedroom showing features after stripping out. Scale 2m

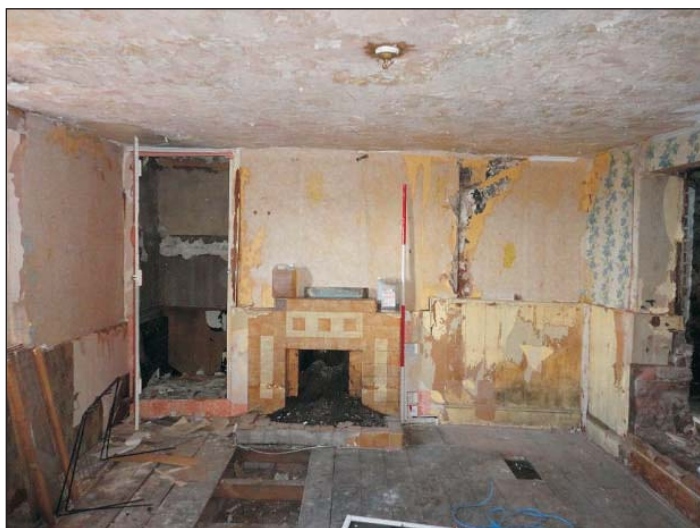
Plate 11: View of the northwestern wall of the main room in the service wing after stripping out. Scale 2m

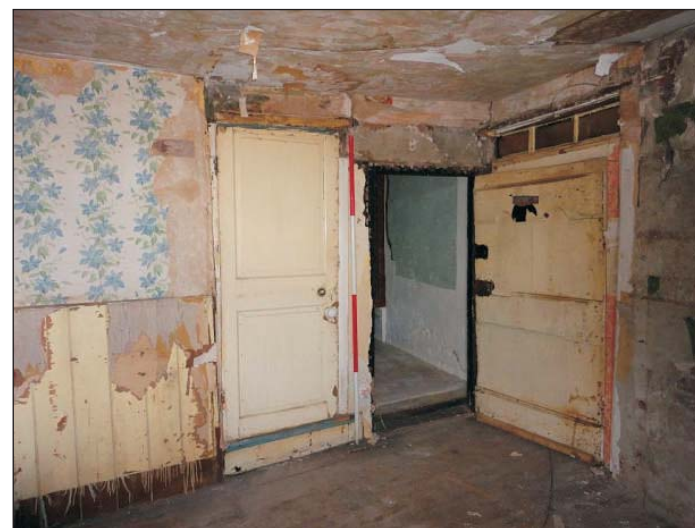
Plate 12: Details of the doorways and passages in the western corner of the service wing. Scale 2m

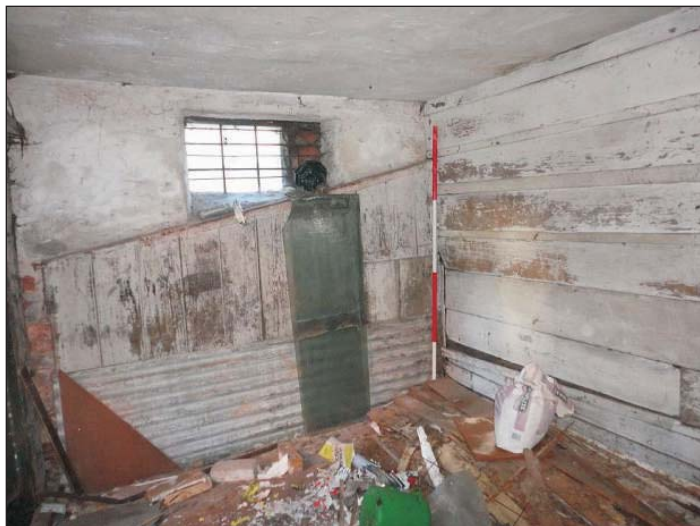
Plate 13: Detail of the surviving stallwork in the stable.
Scale 2m

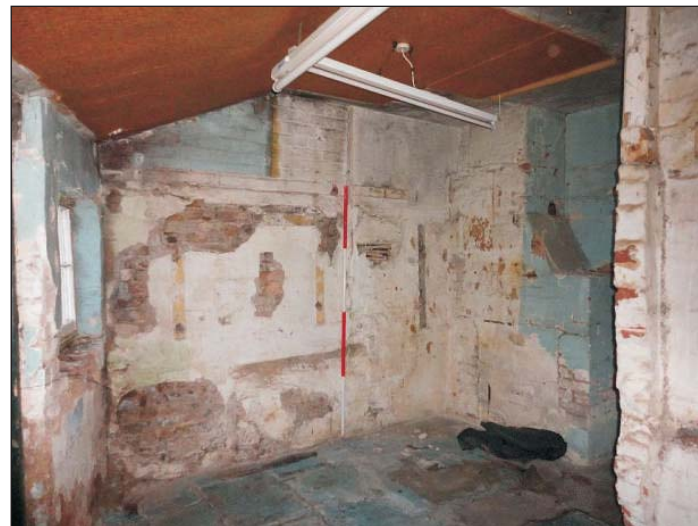
Plate 14: View of the lean to after stripping out showing the fireplace and chimney in the southeastern wall.
Scale 2m

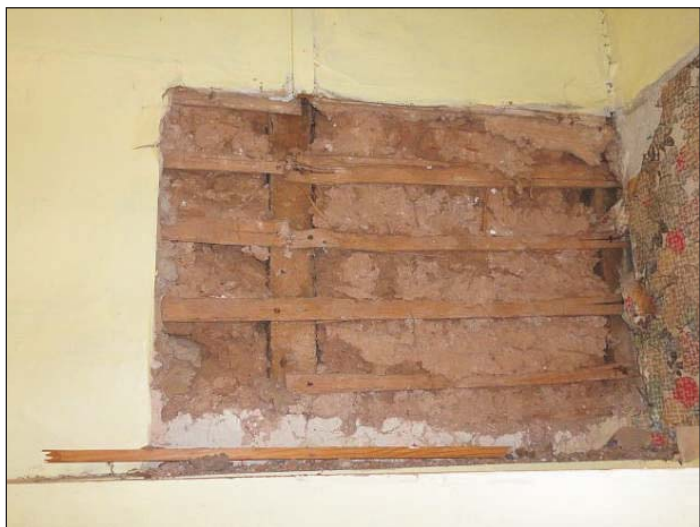
Plate 15: Detail of the method of construction, utilising cob infill panels, on the first floor of the service wing.

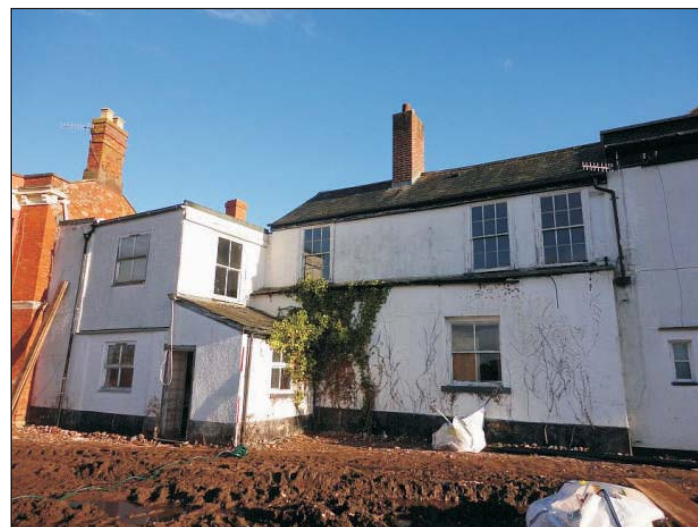
Plate 16: View of the buildings from the south, showing the relationship of the service wing and the annexe.

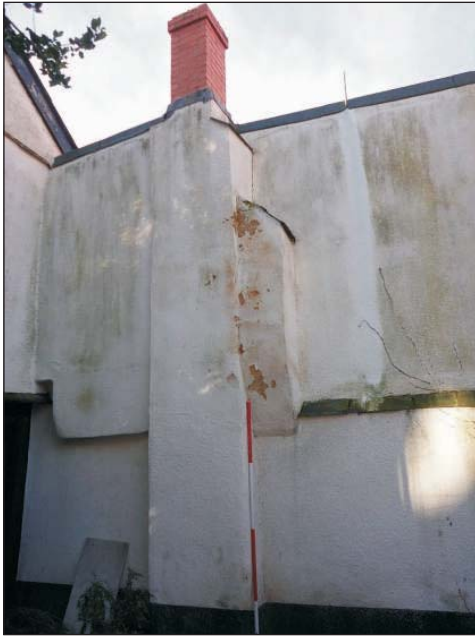
Plate 17: View of the rear wall of the annexe showing jettying and recessed features. Scale 2m

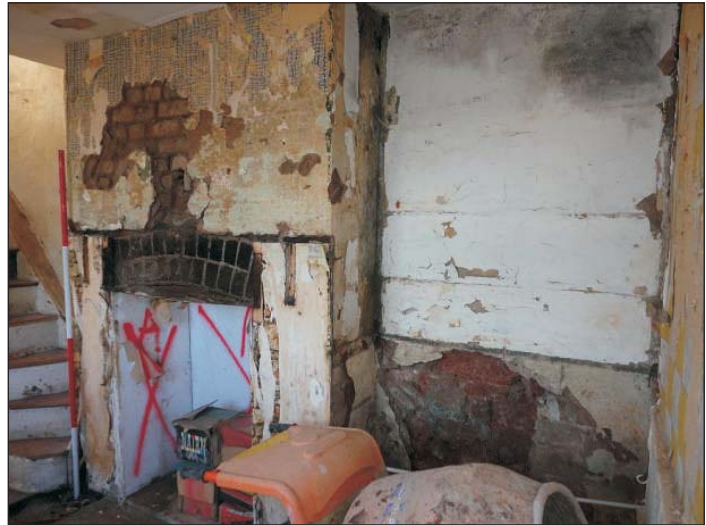
Plate 18: View of the larger ground-floor room in the annexe showing a 19th-century brick fireplace built against an earlier wall constructed of large blocks of breccia. Scale 2m

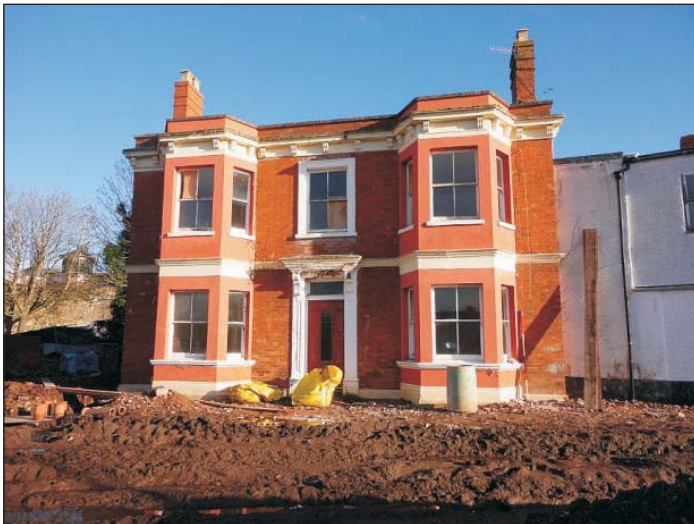
This is a handsome 19th-century double-fronted house with its main facade looking southwest over the river towards the Haldon Hills (Plate 19). The building is entirely constructed of orange bricks laid in Flemish bond and dates from 1868, though it is likely that it replaces an older building on the same site. The house is only one room deep and two storeys high. The rooms on each floor are arranged on either side of a central entrance hall and staircase.

Plate 19: The front elevation of Acacia House. Scale 2m

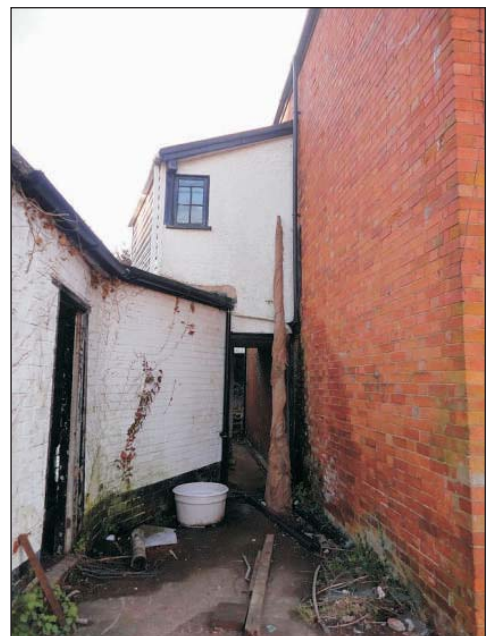
Plate 20: The rear elevation of Acacia House, showing the curious bathroom projection.

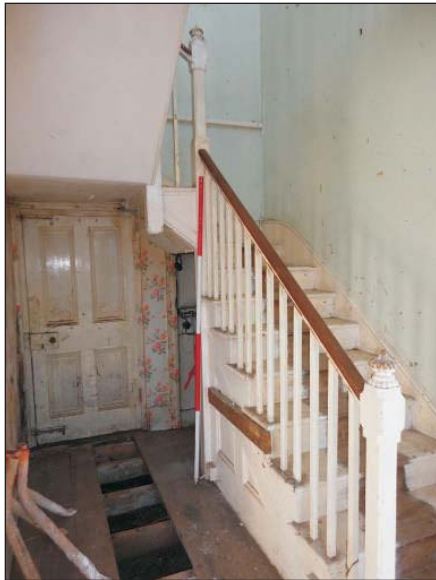
Plate 21: Detail of the staircase at the centre of Acacia House. Scale 2m

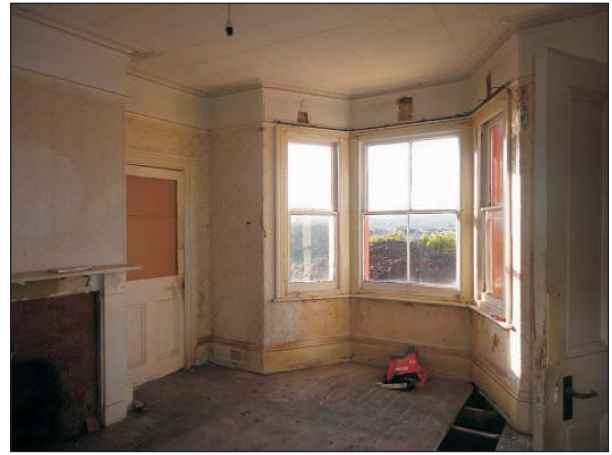
Plate 22: A typical interior of Acacia House.

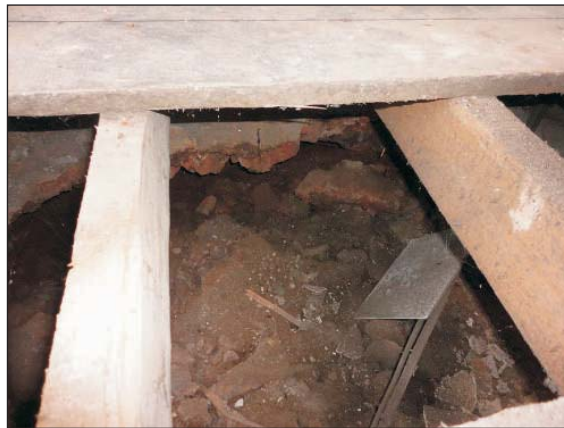
Plate 23: View of the collapsed vault underlying the southeastern ground-floor room of Acacia House.

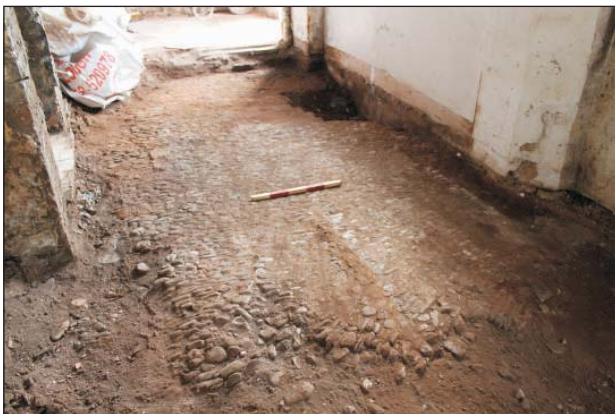
Plate 24: Surface 1001 within the Acacia House annex. Scale 0.50m

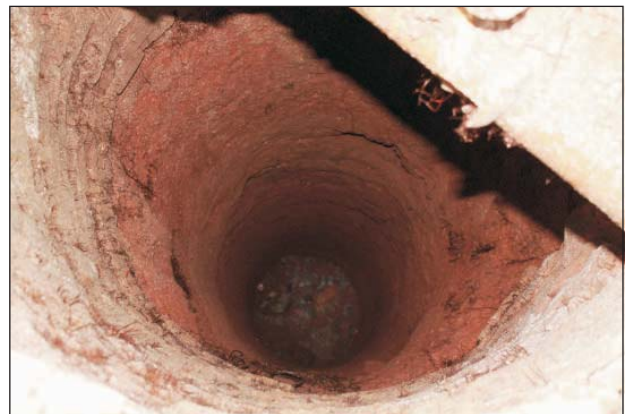
The well is not depicted on historic maps, but is shown on one of architect's drawings for Acacia House. As has been noted above, the drawings show the proposed rather than the executed design and footprint. The well is depicted to the rear of the house's northeast corner rather than to the east. It is likely therefore that the final design of the position house was altered and its footprint moved to the northwest.

Plate 25: Well 1000 behind the Acacia House annex showing the lower courses of brickwork.
