STOKE CANON BRIDGE, STOKE CANON, EAST DEVON

Results of archaeological monitoring and recording

Document No: ACD659/2/0

Date: October 2013

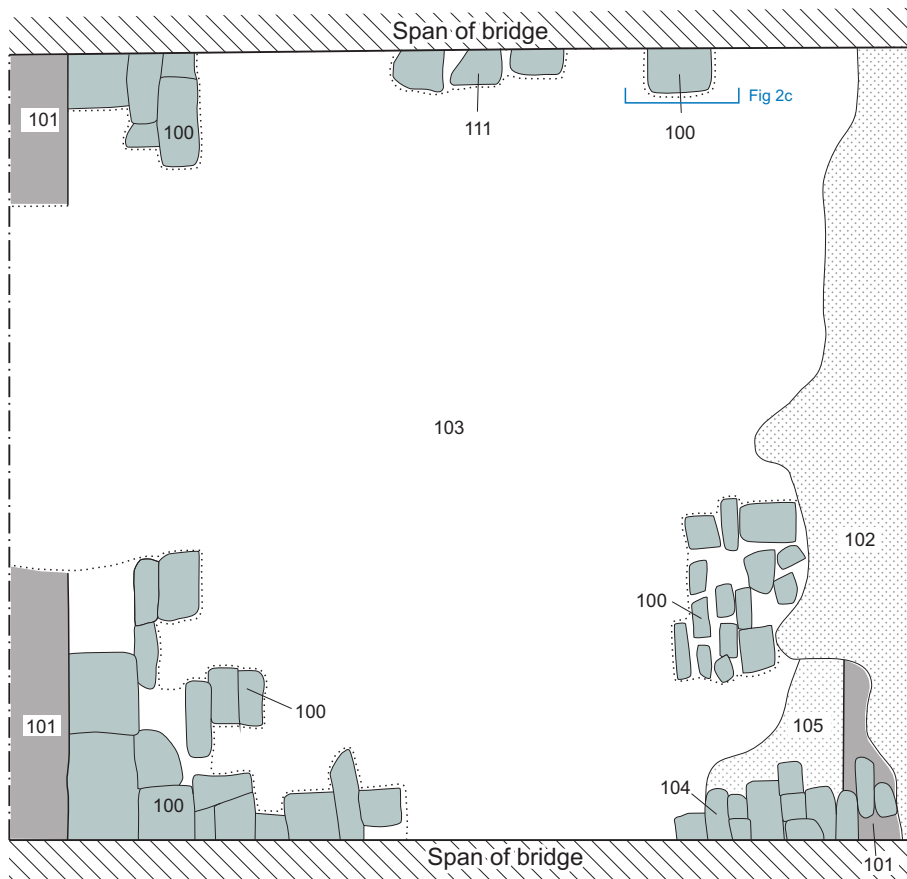
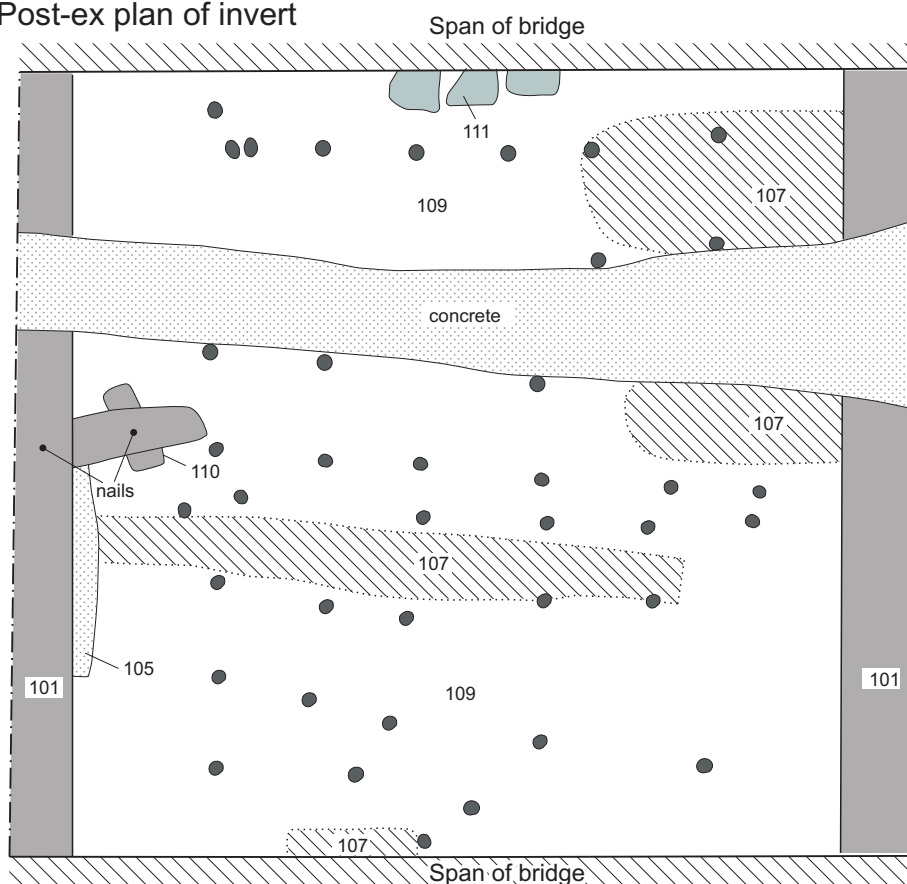
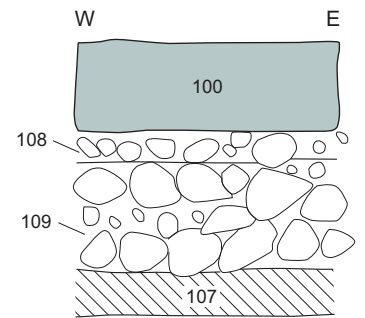
Fig. 2: Plans and section of the invert

5.1 The invert measures 5.90m by 5.20m, and is defined on its north and south sides by the span of the bridge (Plate 1). The east and west sides are defined by wooden beams (101) set between the faces of the arch at a slightly lower level than the invert. These beams measured 0.40m wide by 0.30m deep. The stone invert (100) comprised blocks of square and ashlar limestone measuring upto 0.75m long, 0.45m wide and 0.40m deep, although the average size was around 0.3m long, 0.1m wide and 0.1m deep. The surviving stones were randomly coursed and bonded with a light buff lime mortar. On the east side, there were two areas of modern repair – grey concrete (102) and buff yellow, angular mortar bedding (105); the stones above this bedding (104) were reset from the earlier invert and had been partially laid over beam 101 (Plate 2). In addition, the scour hole had recently been in-filled with modern rubble and gravel (103) to allow the invert to be used for access.

5.2 Removal of the surviving *in situ* invert 100 exposed a red gravel bedding layer (108). This overlaid a waterlogged deposit that consisted of variously-sized water-derived oval or rounded pebbles within a matrix of blue-grey silt (109). Below 109 several patches of preserved brushwood branches (107) were exposed that had been laid between rows of stakes (107) at a depth of 0.3m from the surface (see below). The brushwood consisted of a series of branches laid out parallel to each other, with a maximum of five branches laid between each row of stakes (Plates 3-8). The largest surviving patch of brushwood was c. 3m long and 0.75m wide. The branches were all of a similar size with an average diameter of 0.06-0.08m. Tooling marks were identified on one of the brushwood branches; this is likely to have been made with a metal axe.

5.3 The stakes (106) were aligned in approximate rows running north-south and east-west. The stakes varied slightly in shape and size but generally had rectangular profiles and were spaced between 0.65-0.75m apart. They were approximately 0.1m wide and 0.1m thick. The largest stake was exposed up to a depth of 0.4m; the total length of the stakes is unknown as they were left *in situ* and the invert was reconstructed around and above them.

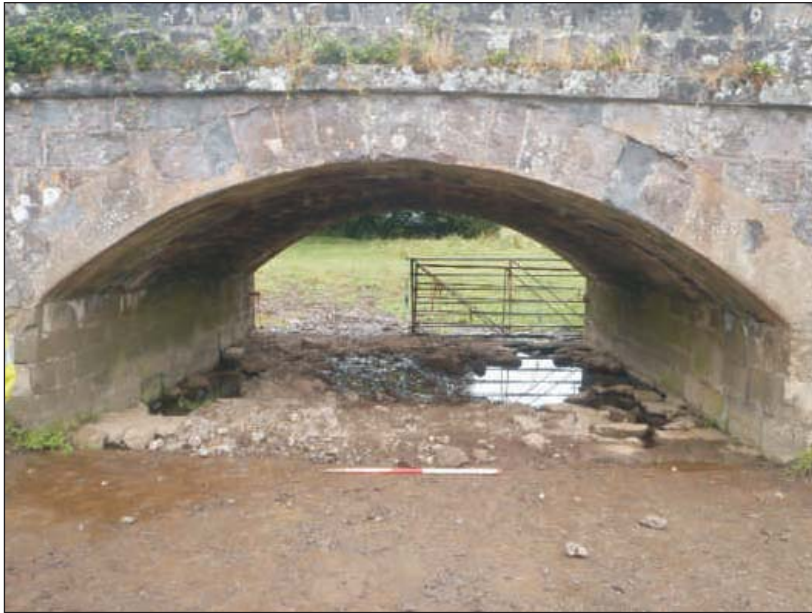
Plate 1: View of the invert before commencement of the repairs, taken from the east. Scale 1m

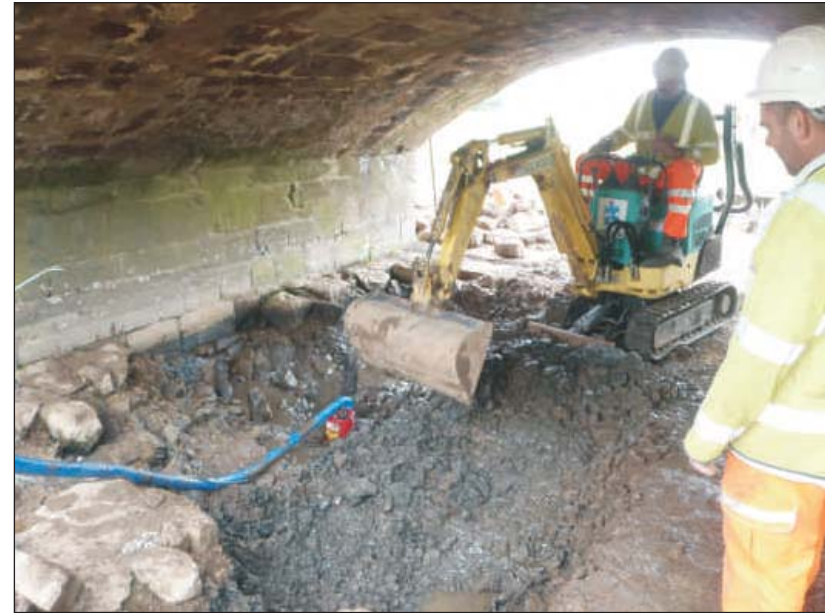
Plate 2: Working shot showing repair 104 in foreground, taken from the northeast

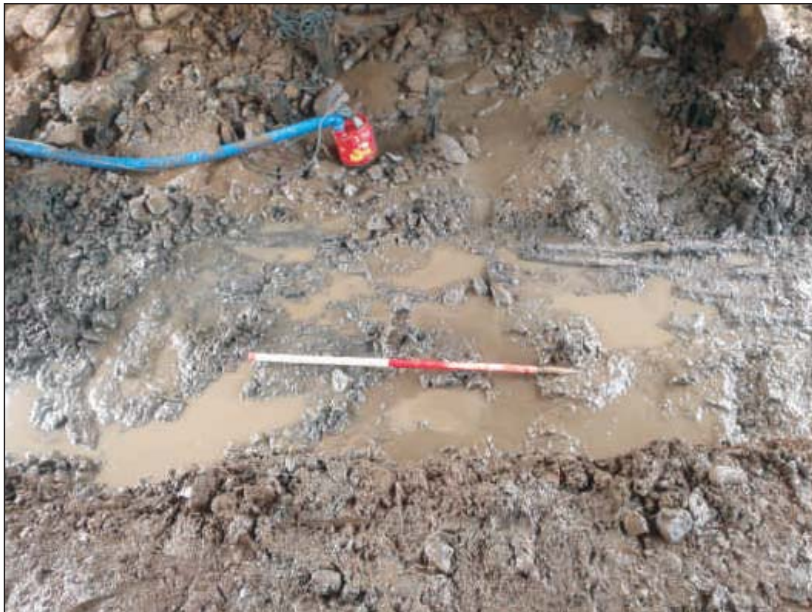
Plate 3: View of preserved wooden stakes (106) and brushwood structure (107), taken from the north. Scale 1m

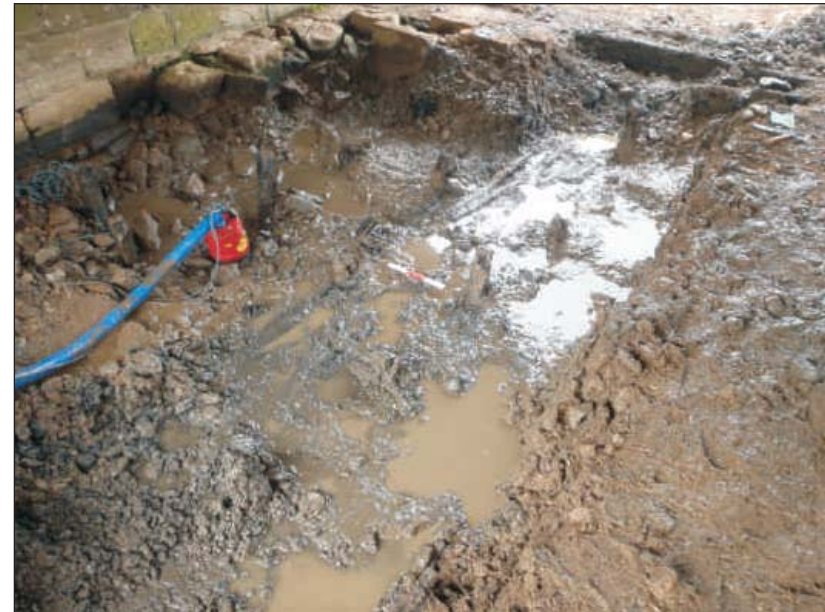
Plate 4: General view of preserved wooden stakes (106) and brushwood structure (107), taken from the northeast. Scale 0.3m

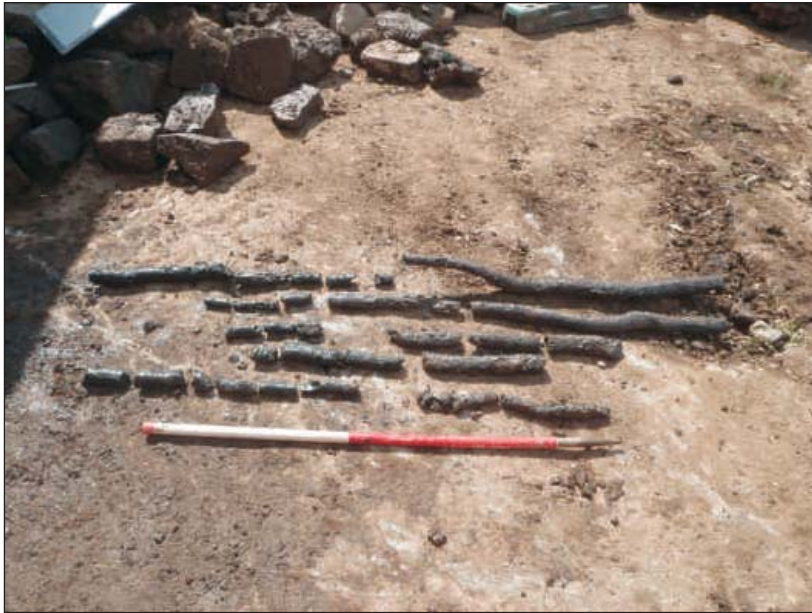
Plate 5: View of a section of the removed brushwood (107). Scale 1m

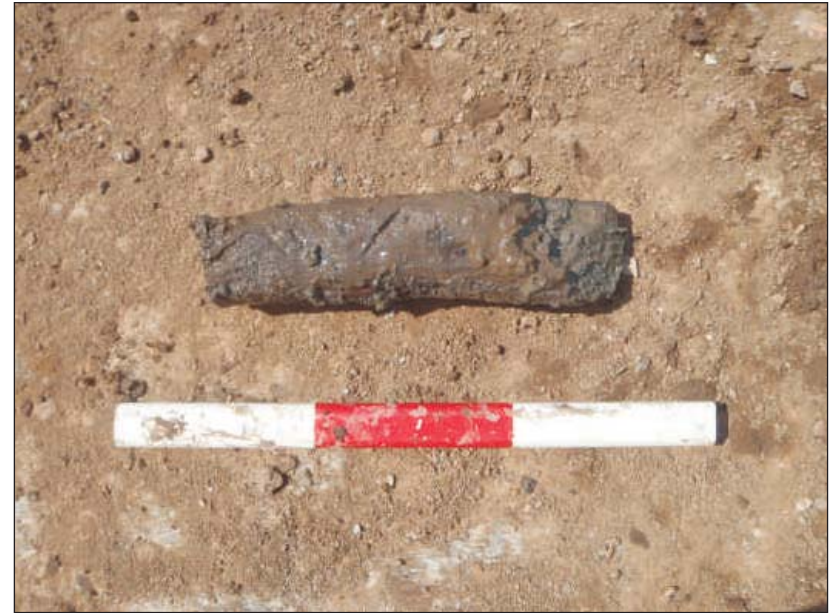
Plate 6: Piece of brushwood with cut marks. Scale 0.3m

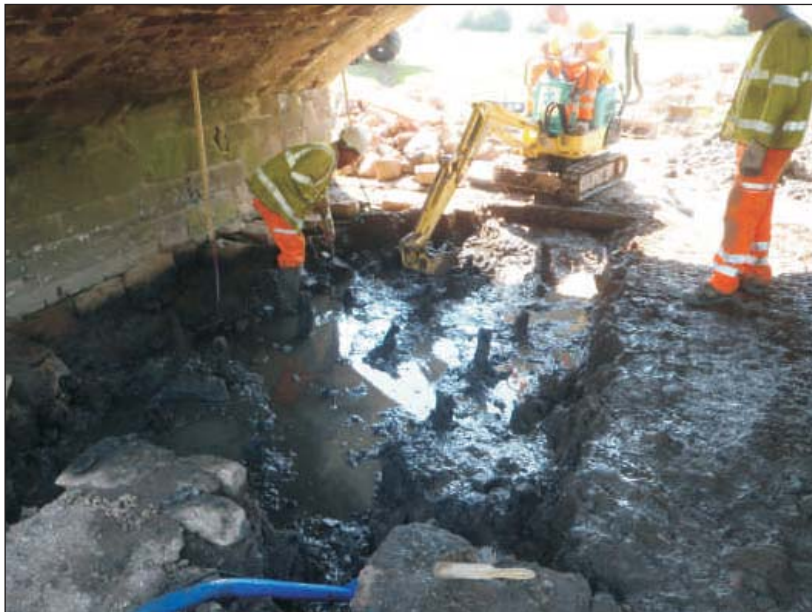
Plate 7: General working shot taken during the excavation of the scour hole showing stakes 106. Taken from the east

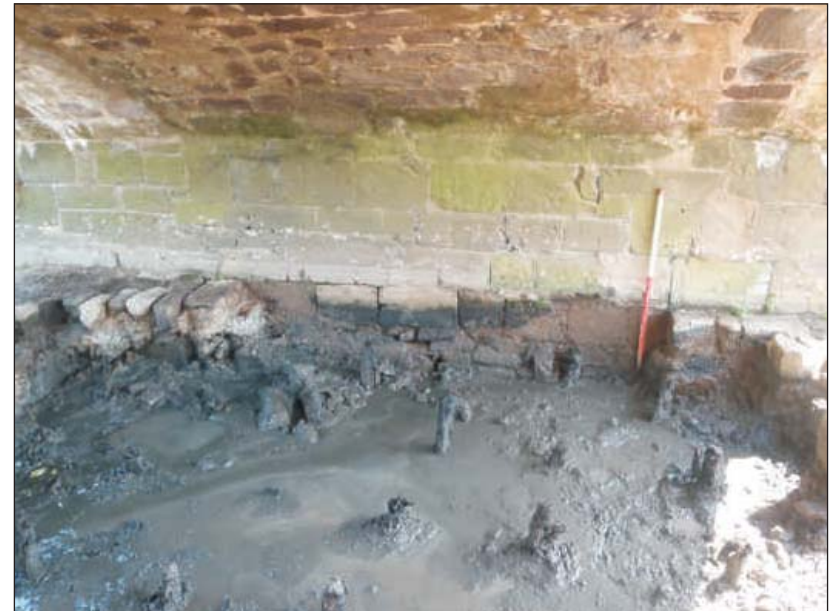
Plate 8: View of part of the bridge abutment exposed once the invert had been removed, also showing stakes 106. Taken from the north. Scale 1m

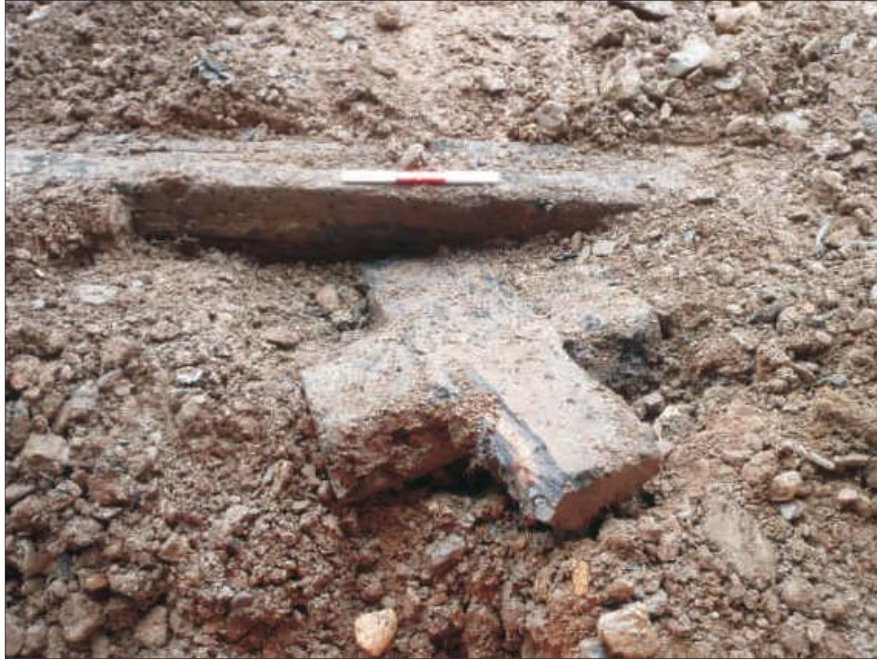
5.4 A pair of attached timbers fixed in a cross-shape (110) was exposed at the west end of the invert (Plates 9-10). They were positioned beneath the large beam (101) defining the end of the invert, and had been pinned together with a large iron nail. The upper surface of the wood was flat and smooth, the underside was rounded and a notch had been cut into the back on the longer section to receive the shorter piece

Plate 9: General view of the position of cross-shaped beam 110, taken from the east. Scale 0.3m

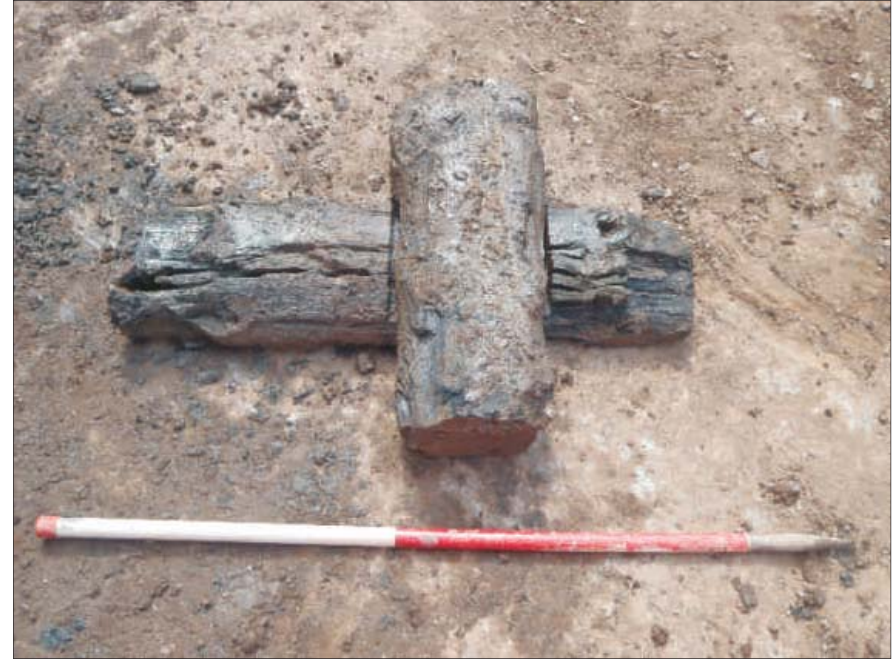
behind it. The ends of the wooden beams displayed saw marks. It seems likely that both pieces were part of the same tree trunk that has been cleaved in half. The longer section of the structure had been pinned underneath 101 with a large iron nail which was c. 0.25m long and had a rectangular profile and head and a rounded end. The function and date of this structure is uncertain as it did not appear to be in its original position, but had clearly been attached to the beam 101.

Plate 10: View of the underside of the cross-shaped beam 110. Scale 1m

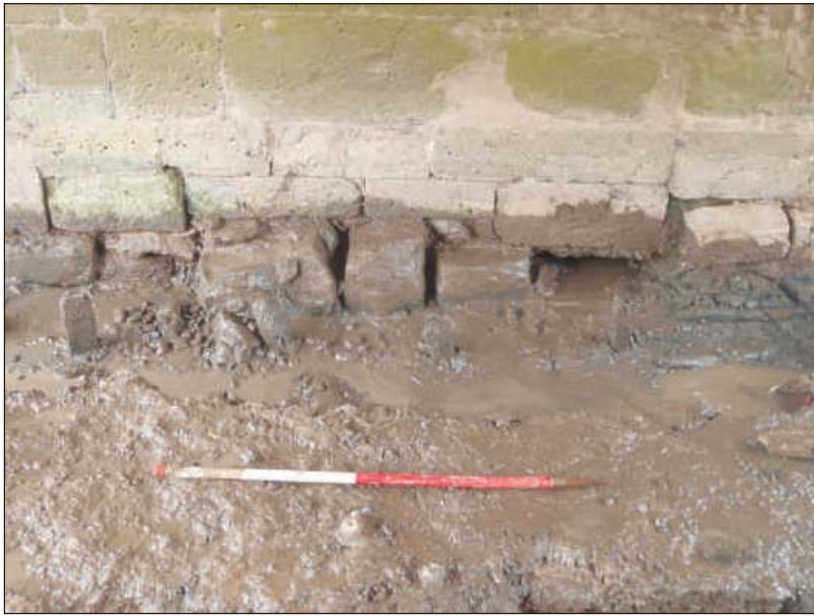
At least five square or rectangular limestone blocks (111) were exposed, projecting out from the north side of the bridge arch, three of which survived *in situ*. These appeared to be part of the foundations of the arch since they continued under the bridge to the north, rather being flush with the face of the arch as the invert stones 100 had been laid (Plate 11). These measured between 0.3m and 0.45m wide.

Plate 11: View of part of the bridge foundations (111), taken from the south. Scale 1m

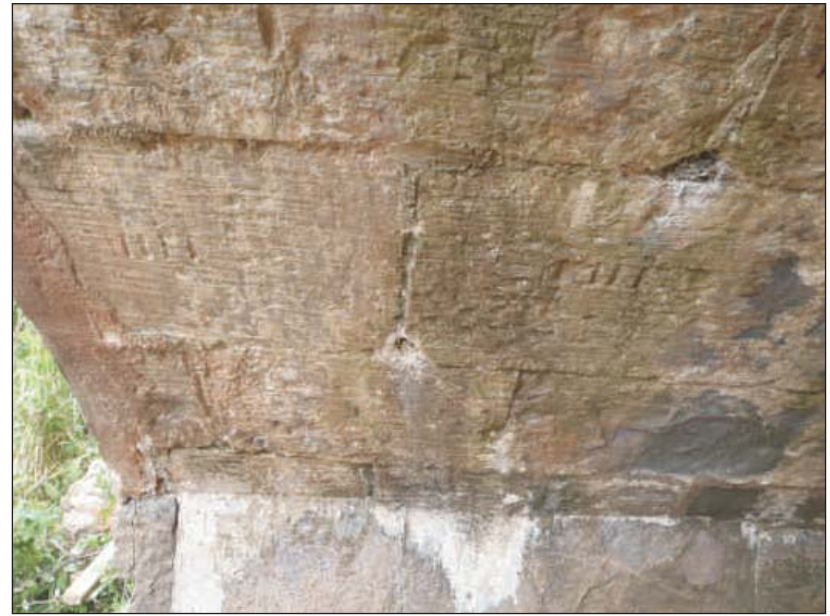
Several masons' marks were identified on the underneath of the bridge arch within the medieval fabric at the northwest corner (Plates 12-13). There were two different marks. One consisted of a set of four vertical, parallel lines, each measuring c. 0.05m long. These marks were present on two blocks located next to each other. The other type of mark was a V shape, cut into two blocks located close to one another. The V measured c. 0.05m long and up to 0.05m wide.

Plate 12: View of masons' marks under the bridge arch, taken from the south

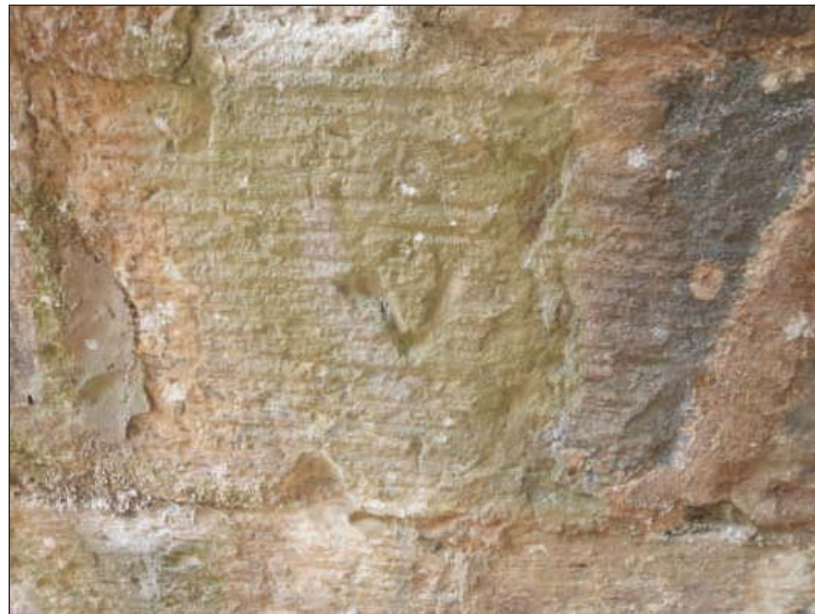
Plate 13: View of masons' mark under the bridge arch, taken from the south
