Champerhaies Bridge, Bradninch, Devon

Results of archaeological monitoring

Planning reference: Mid Devon District Council 13/00441/LBC

Document No: ACD689/1/0

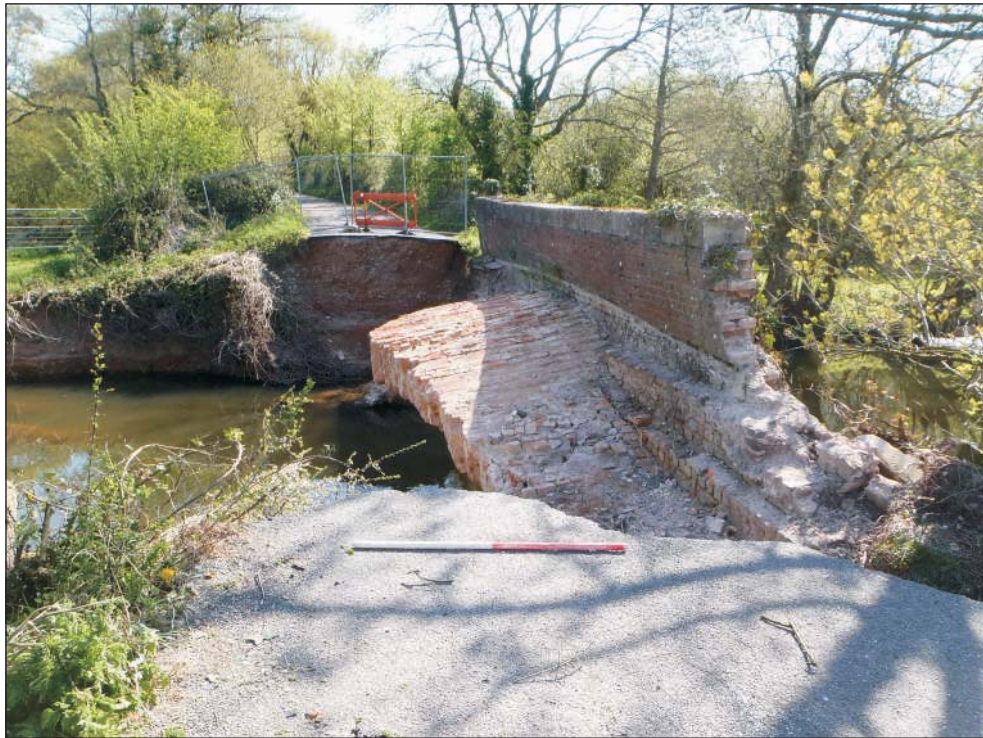
Plate 1: The collapsed bridge prior to demolition, viewed from the west. 1m scale.

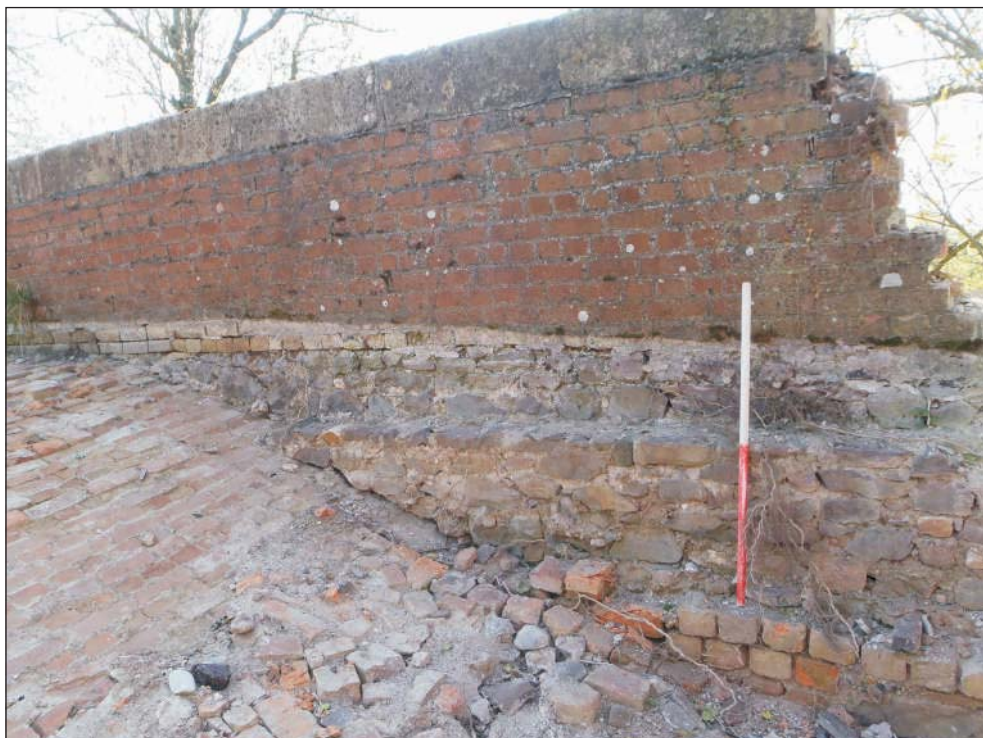
Plate 2: Close-up view of the bridge showing the brick arch and stone and brick face and parapet, viewed from the northwest. 1m scale.

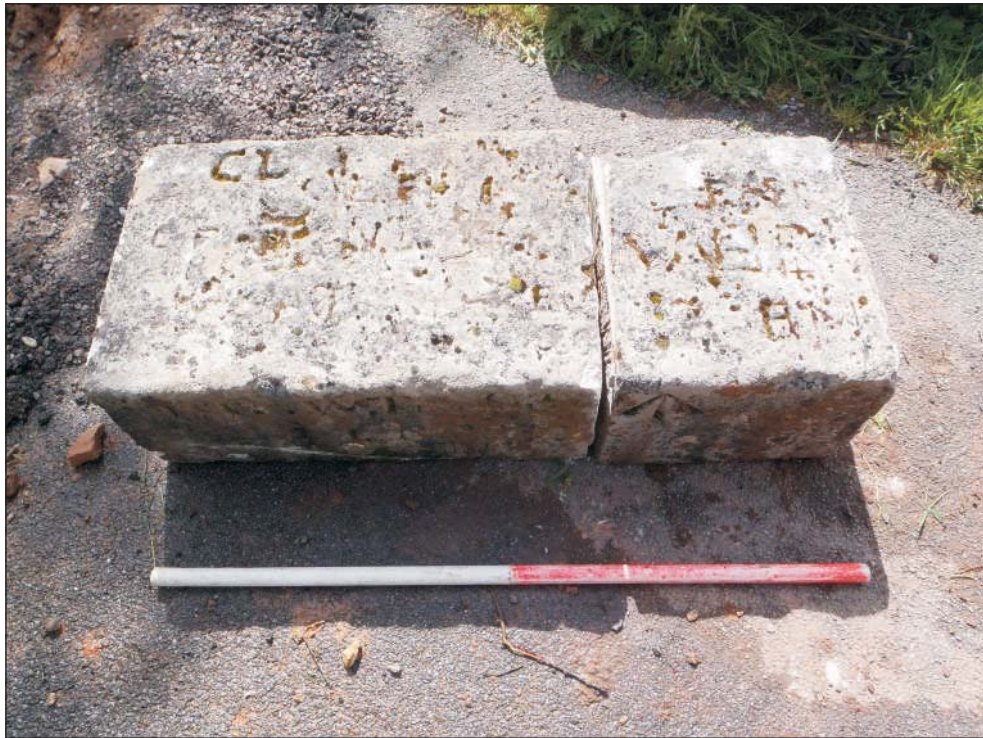
Plate 3: The top face of the parapet capping stones showing graffiti. 1m scale.

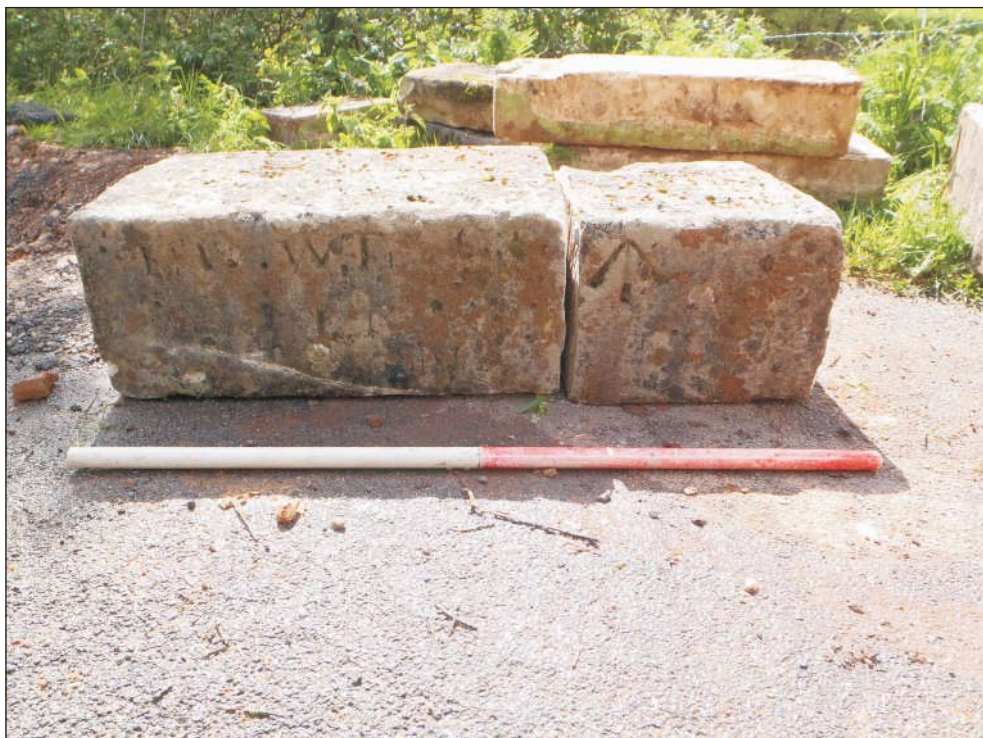
Plate 4: The inner face of the parapet capping stones showing graffiti and bench mark. 1m scale.

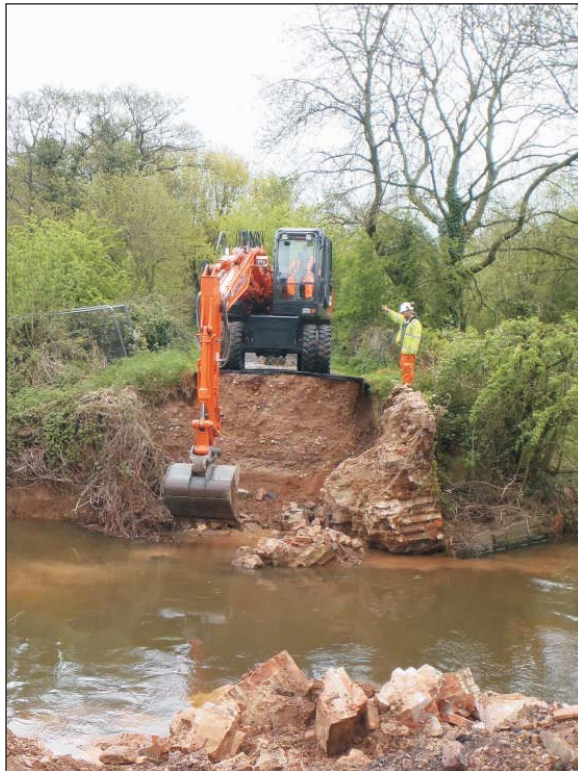
Plate 5: The section through the eastern approach road, viewed from the west.

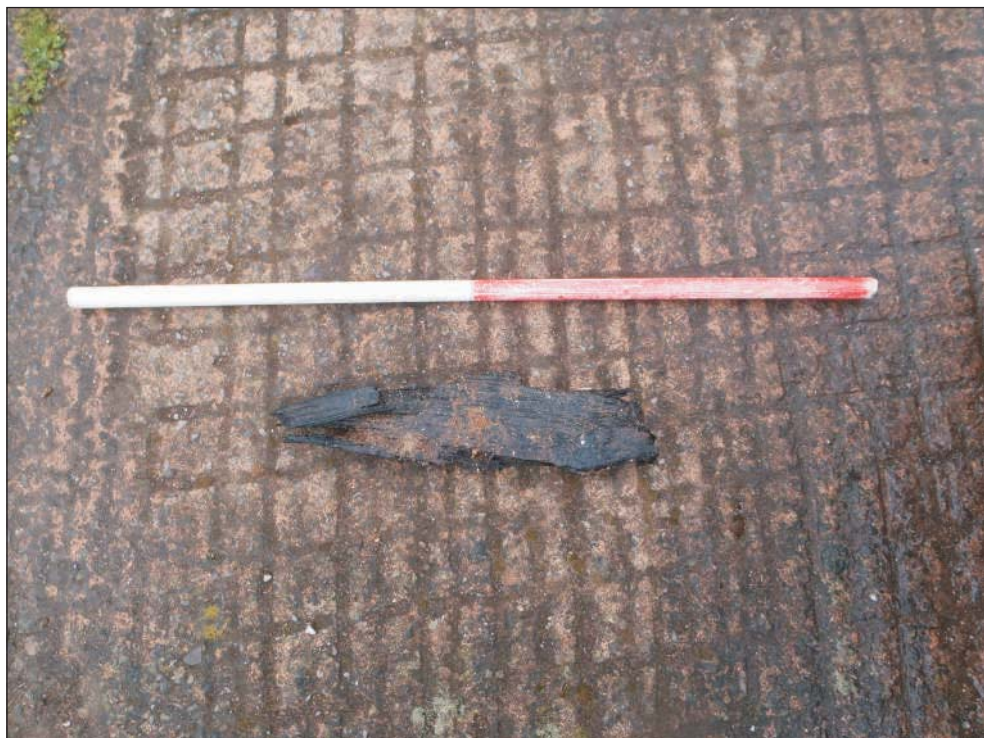
Plate 6: The timber plank recovered from the river. 1m scale.
