Wilsden, Tivington, Selworthy and Minehead Without, Somerset

Results of historic building recording

Exmoor National Park Authority planning reference 6/23/13/104LB, condition 3

> > Document No: ACD715/2/0

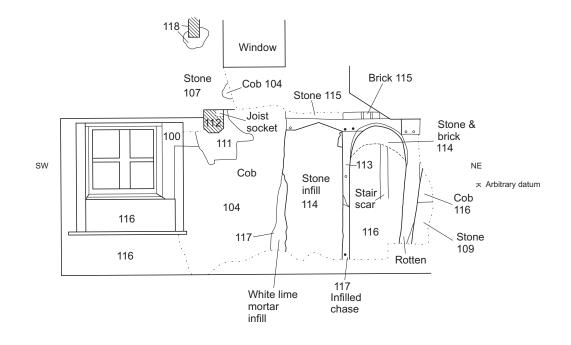
a) NW wall, interior elevation

The ground floor section of the north wall was recorded following the removal of the stairs and associated lobby and removal of most of the plaster (116). Limited plaster was removed in the first floor-landing to reveal the foot of the roof truss in the wall. Two skins of plaster were present; the earliest was painted white, whilst the later one had been painted white (twice), blue and green at various times.

The main cob wall (106) was exposed at the southern end of the room (Plate 4), and also at the eastern end where it had been laid on a stone plinth (109). A small area was also exposed on the first floor, although the majority of the fabric here was stone 107. Window 100 was set into this wall. On this elevation one side of the opening was splayed and the below the window the opening incorporated a window seat. Stone masonry associated with the insertion of the window was partially exposed within the splay.

Set into the north end of the wall was a double doorway opening defined by the remains of a timber frame (113). The head spans both doorways and has both shallow pointed and arched openings, the latter incorporating a chamfer. It displays some smoke blackening. Two of the three vertical elements to the frame survived, with those surrounding the northern opening having a continuation of the chamfer from the head. This terminated close to the top of the opening. The southern upright was missing and the head had been cut off leaving only half of the mortice (and associated peghole) visible. The bases to the other two uprights were rotten. All elements of the frame were pegged. The central upright has a chamfer on one side and a flat rebate for a door on the other, both largely obscured by later blocking. A peghole was also visible.

The doorways had been blocked using closely-packed red sandstone (114) bonded with mud, although some brick was also present in the northern opening (over which the plaster was not fully removed), which may represent a later repair. Other later repairs involved the infilling of voids left by the rotten or removed uprights using creamy white cement (117).

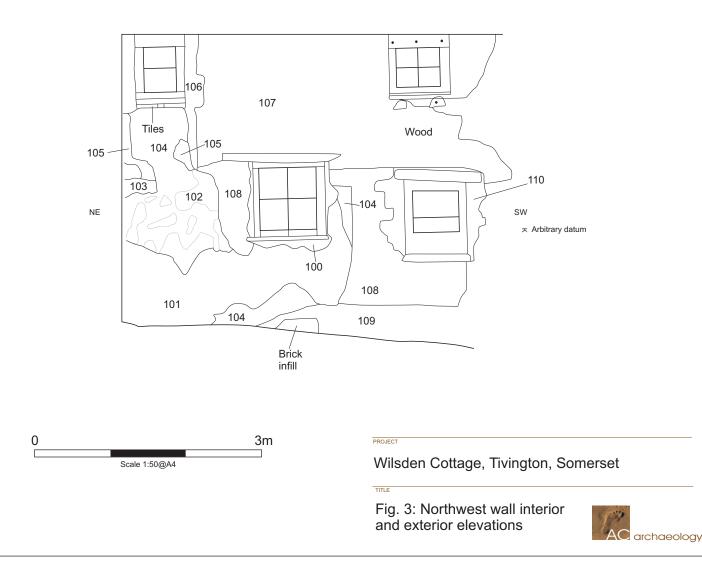
b) NW wall, exterior elevation

The elevation between the extension (room D) and the junction with the cross wing of Springfield was recorded (Plates 1-2). The majority of the visible wall is stone masonry, and on the basis of the observations both outside and inside the house (see 4.2 below) much of this must represent refacing. The earliest identified masonry was at the base of the wall, which comprised large blocks of roughly coursed red and occasional grey sandstone, incorporating an area of brick infill or patching (109). This probably represents the stone footing for the cob wall above.

The cob was light brown and gravelly and was present at the north end of the ground floor (104). This was almost entirely obscured by pebbledash render (101) that was removed to expose the underlying wall (Plates 2-3). The pebbledash was in poor condition and had been partially repaired using gravelly white cream cement render (102) and grey buff fine gravelly cement (105). A small patch of grey and red sandstone (103) at the north end of the wall may represent a repair to the cob.

In the south half of the wall the cob has been replaced with red and occasional grey sandstone, which has been repointed in cream gravelly lime mortar (108). This masonry continues across the opening to the cross passage (room C in Springfield), which may provide a context for the refacing. The former cross passage is lit by a window. The present opening is a 20th-century feature and has a timber-framed, frosted glass window set within brick jambs bonded with gritty cement, laid between a concrete cill and a concrete lintel (110). A further window (100) has been inserted into this masonry to light the hall (room A). The present window is modern, has a thin slate cill, and the surrounding masonry is repointed in gravel buff/cream cement. A timber is present below the window within 108.

At first-floor level the cob has been refaced with red and blue sandstone repointed in cream gravelly lime mortar and mid red gravelly cement (107). Both these episodes of repointing are modern, with the former being contemporary with the replacement of the wall plates and the last rethatching of the roof. The masonry incorporates two first-floor windows set below the eaves line. The northern window is a modern replacement and is set within rebuilt jambs of red sandstone and dark grey siltstone with a tiled cill, all bonded with a cream gravelly lime mortar (106).

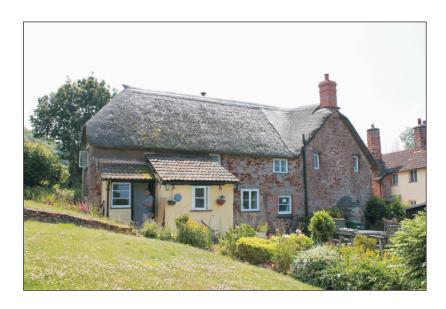
Plate 1: The front elevation of the house viewed from the north, showing the bathroom extension (painted yellow) with the hall, blocked cross passage and gable of the south wing beyond.

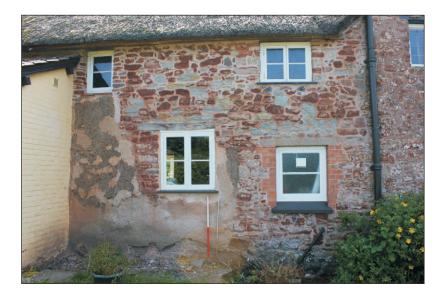
Plate 2: The west wall external elevation prior to removal of render, viewed from the northwest. 1m scale.

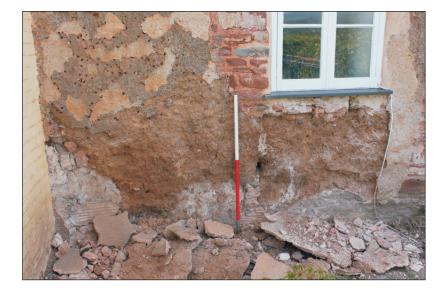
Plate 3: The west wall external elevation after removal of render exposing primary cob fabric, viewed from the northwest. 1m scale.

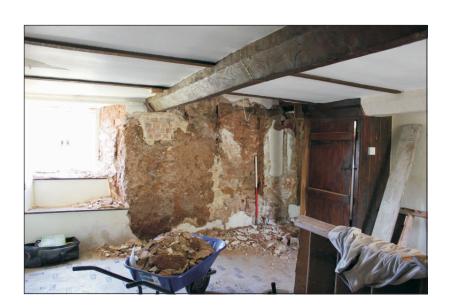
Plate 4: The west wall interior elevation after removal of plaster, viewed from the south. 1m scale.

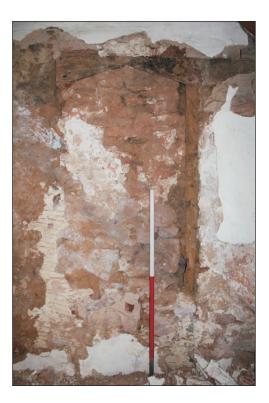
Plate 5: The southern of the two blocked doorways, viewed from the northeast. 1m scale.

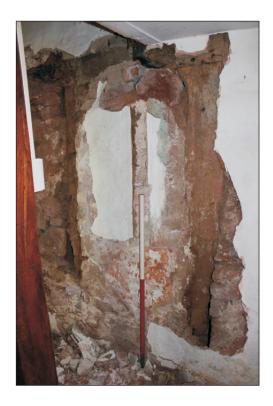
Plate 6: The northern of the two blocked doorways, viewed from the east. 1m scale.

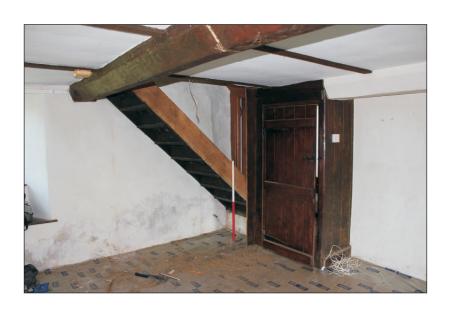
The staircase (which has been described in detail in the 1996 National Trust survey) rose from a small lobby between rooms A-C, and was enclosed by its own door, as well as by tongue and grooved partitioning with room A (Plate 7). The latter also formed an understairs cupboard. The lower stairs were cut into a rebate in the adjacent wall. Removal of the plaster adjacent to the stairs exposed an area of brick and stone (115) above doorways 113. This probably represents infilling of a chase for a former floor joist that was removed when the stairs were inserted. Removal of the staircase partition exposed a single *in situ* north-south aligned floor joist set into the top of beam 112. This displayed scars of a former lath and plaster ceiling (Plate 8). The present ceiling is painted chipboard with applied batons replicating joists. Three joist sockets were exposed between this joist and the exterior wall set, 230mm (9") apart (Plate 9). The joists themselves were removed when the stairs were inserted. The floorboards of the landing (room H) are of 19th- or 20th-centry date, but earlier floorboards survive in the bedrooms.

Plate 7: The stairs and adjacent door after removal of the partition, viewed from the south. 1m scale.

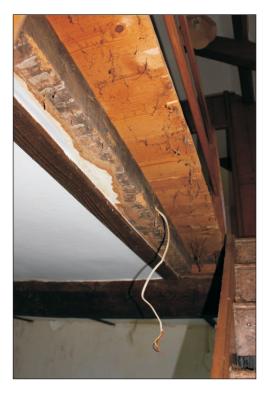
Plate 8: The exposed floor joist, showing evidence of a former ceiling, viewed from the north.

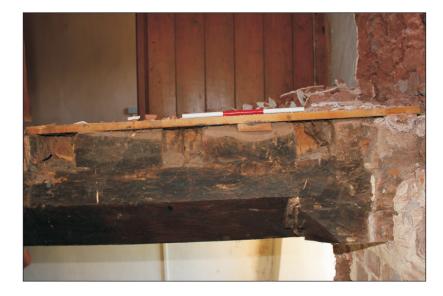
Plate 9: Exposed floor joist sockets in the beam following removal of the stairs, viewed from the northeast. 0.30m scale.
