BARN AT GLADHAYES FARM, CLAYHIDON, DEVON

Results of an historic building evaluation

Mid Devon District Council planning reference 14/00011/FUL

Document No: ACD858/2/1

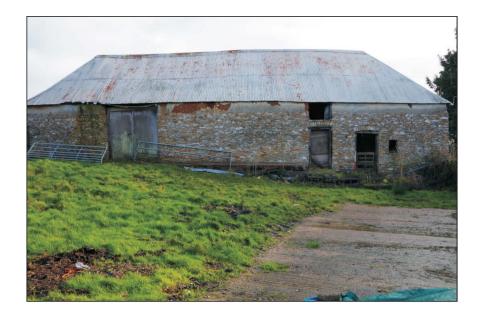
Plate 1: The west elevation, viewed from the west. 1m scale.

In the west elevation there is a large modern opening at the north end, with a wooden frame, lintel and doors, as well as two doorways and two window openings towards the south end (Plate 1). The windows and doors all have wooden frames. The north doorway has been partially infilled with modern breeze blocks. The southern two doorways and the window are defined by stone voussoirs. The land slopes down to the south along this elevation and a band of concrete has been applied along the base of the wall and steps have been added outside the doorways, indicating that the farmyard surface has been lowered during the 20th century.

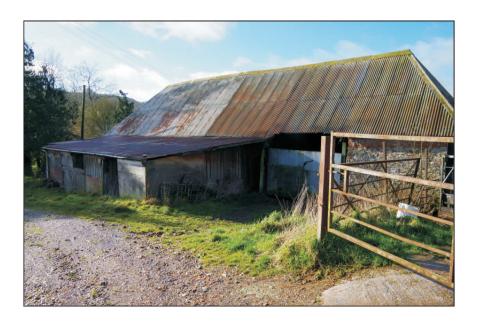
Plate 2: The east elevation, viewed from the northeast.

Only the northern part of the east elevation is visible externally; the rest is obstructed by the modern stables (Plate 2). The exposed fabric incorporates a large modern opening crudely chopped through the masonry. The opening has some breeze block repairs on one side. It has no lintel, and two metal posts have been inserted to support the ends of the principal rafters and to hold the metal door.

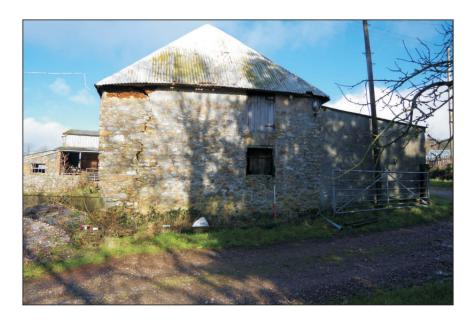
Plate 3: The south elevation, viewed from the south. 1m scale.

In the south elevation there is a ground-floor window opening and a loading hatch above (Plate 3). The window opening has stone voussoirs, whilst both openings have single wooden shutters. A large proportion of this elevation has modern repointing in a hard grey cement mortar.

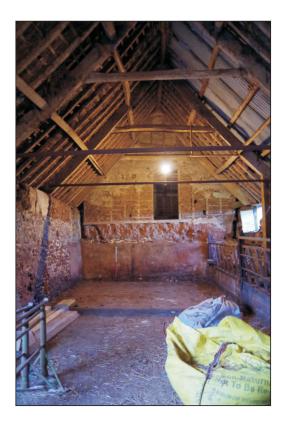
Plate 4: The interior showing the partition, viewed from the north. 1m scale.

The barn is formed of seven bays (as defined by the roof trusses), and has a partition wall separating two bays at the southern end (Plate 4). The partition wall is constructed from several materials. The lower portion is built of stone masonry identical to the external walls, above which is a layer of cob. The top of the cob is lower than the eaves line of the external walls. Above this, the partition continues to the apex, and is formed from vertical wooden posts or studs, its panels infilled with cob, which are covered by nailed horizontal laths that hold the cob in place and are used to support a layer of lime plaster. Both the laths and plaster only partially survive. A central gap in the lath and plaster is an original opening. The frame is not as wide as the lower portion of the wall; it lies flush with the wall on its north face but is set back from the wall on its south face.

The cob on the top of the wall has lime plaster present in some areas and this is present on the lower stone portion of the wall in the northeast corner. The lower walls particularly to the north of the partition wall have patches of repointing in a medium pink to grey cement mortar.

- The partition at the south end of the barn is separate from the fabric of the exterior walls, and must be secondary. However, the positions of the adjacent doorways indicate that it is an early feature, and it is possible that it was added soon after the shell of the structure was built, but before the barn was completed.

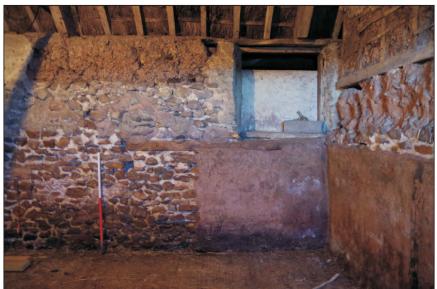
Plate 5: The blocked opening in the east elevation, viewed from the west. 1m scale.

A window in the east elevation, immediately north of the partition is blocked externally (Plate 5). This has a wooden frame, lintel and a cill. The latter is unusually long and extends around 1m beyond the window reveal. There is modern plaster below the window, and it is likely that the window has been formed from an earlier doorway.

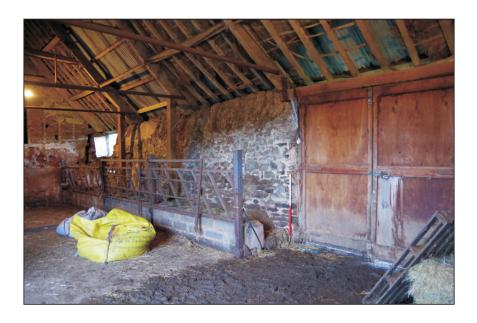
Plate 6: The modern fitting against the west elevation, viewed from the northeast. 1m scale.

The area to the north of the partition has most recently been used to house livestock (Plate 6). This part of the barn has a concrete floor. There is a feeding

passage raised up on breeze blocks with a metal railing along the west side. There was a metal gate, now removed to divide this livestock area from the northern storage area. Livestock access was through the large modern openings in the east and west elevations. The lower part of the partition wall (to the height of the rails) within this livestock area has been rendered with concrete. The feeding passage partially blocks the doorway in the west elevation. The current floor level is higher than the blocked doorway indicating that the internal surface has been raised and levelled when the concrete floor and feeding passage were inserted.

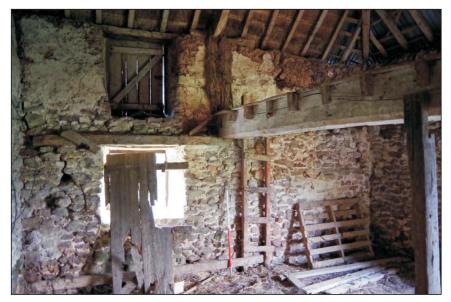
Plate 7: The southern room showing floor beam and ladder, viewed from the northeast. 1m scale.

The area to the south of the partition formerly had a first floor used as a hay loft, which was accessed via a wooden ladder attached to the south elevation (Plate 7). The floor has been removed, and only the supporting horizontal timber remains, retaining sawn off joists. The external walls have holes present for the floor joists. There is a central vertical post under the floor beam. This is not structural but appears to be the remains of a livestock pen. The floor in this part of the barn is concrete. The ground-floor window openings are slightly splayed, whilst the internal wooden lintels of the doorway and adjacent window are reused beams displaying sockets – the former on two faces.

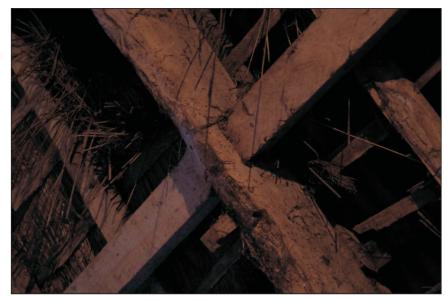
The roof is hipped at both ends and currently covered with corrugated iron sheets. The supporting structure is formed from six principal rafters (Plate 8). Their apexes are obscured by saddles supporting diagonal ridge purlins. Most of the collars are lap jointed and fixed with pegs. There are two rows of through purlins, and where visible, these appear to be butt jointed using tenons, and fixed to the principal rafters (Plate 9). The purlins support closely-spaced principal rafters that have batons attached. The original roof covering was thatch and the lower layers of this survive across around 60% of the barn, attached to the rafters with spars.

Some elements of the historic structure have been removed, and the roof has been strengthened in some areas. Two vertical timbers have been added on the west side to support the ends of the principal rafters. These have metal straps to hold them onto new purlins. Three horizontal metal bars have also been added to principal rafters running across the barn just above wall height.

Plate 9: Detail of a through purlin, viewed from the northeast.

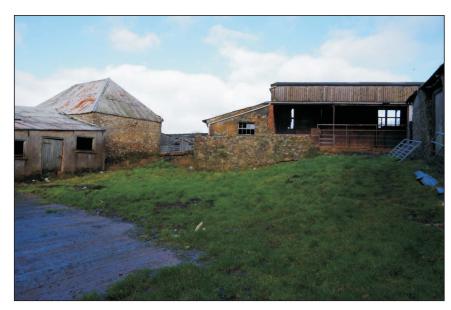
Plate 10: The farmyard showing the barn to right, and other historic buildings, viewed from the south.

The setting of the barn can be considered to be its immediate environs, in particular the farmyard and the remains of the other historic farm buildings to the north and west, and the field to the east. The architectural evidence – the historic and modern doorways in the east and west elevations – demonstrate a relationship with these areas.
