WADDETON BARTON BARNES, STOKE GABRIEL, DEVON

Results of historic building recording

South Hams District Council planning reference 52/1249/10/F,
Condition 20

Document No: ACD845/2/0

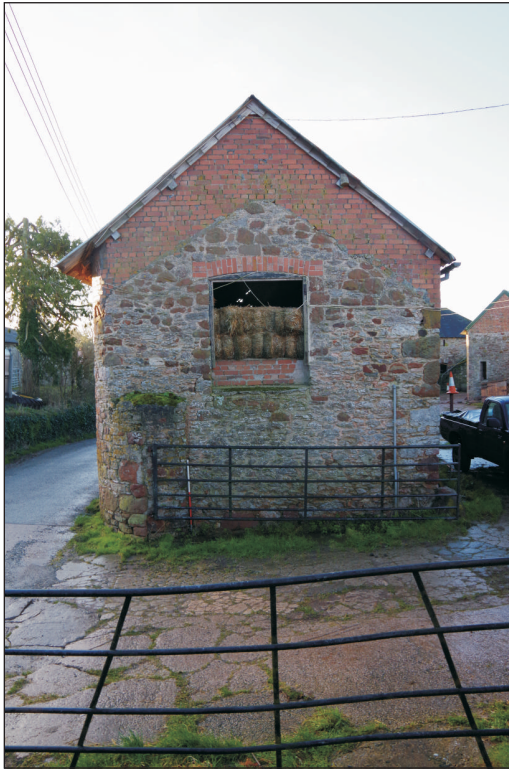
This is constructed of rough rectangular blocks of limestone with occasional red sandstone, laid in rough courses bonded with hard, light pinkish-white, cement mortar containing common sub-angular gravel inclusions. It has quoins on the west corner, whilst the north corner is rounded, with a projecting rounded buttress forming its lower part. The roof level has been raised twice. The first phase is represented by masonry containing a higher concentration of red sandstone. Within this masonry is a first-floor central opening with a wooden frame set below a brick arch; it has some red sandstone jambs. The opening has been partially blocked with bricks that are set back from the wall face. The roofline was subsequently raised with red bricks laid in English and stretcher bond.

Plate 1: Building 1, northwest elevation showing raised rooflines, viewed from the northeast. 1m scale.

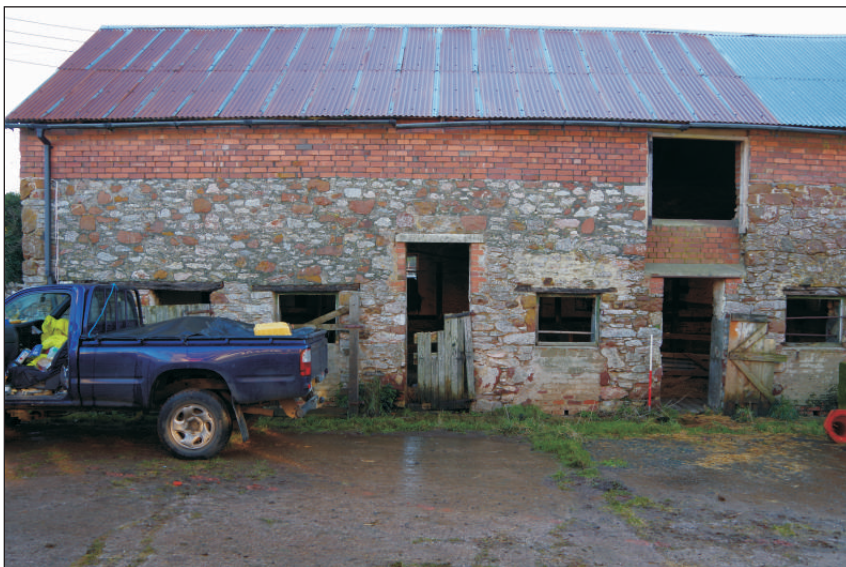
This elevation consists of the same three phases of masonry as recorded on the other elevations. At the north end of the building, the primary masonry is lower than to the south, and the building may have comprised two elements – a single-storey structure to the north and a two-storey structure to the south – although it is possible that the north end has been more heavily rebuilt. There are some patches of repair to the mortar in this elevation in a hard, yellow cement mortar.

At ground-floor level there are seven low openings, two larger openings and a central opening with a loading door above. All appear to be primary doorways. The five shorter openings have wooden lintels. A total of four have been partially infilled to create windows using concrete blocks and bricks and then rendered. These have wooden frames but no glass is present. The two taller openings have been raised into the second phase of masonry using brickwork, and have wooden lintels that have been covered with parts of a sheet of asbestos. They retain wooden doors. The ground-floor central opening has also been heightened using bricks and has a wooden lintel covered with cement. It also has a wooden door. Above this is a wider loading doorway that has been partially blocked with bricks set back from the wall face. Parts of a wooden frame survive, on which are metal pintles to hang a door or shutter.

Plate 2: Building 1, southwest elevation, north end, showing raised rooflines and altered openings, viewed from the southwest. 1m scale.

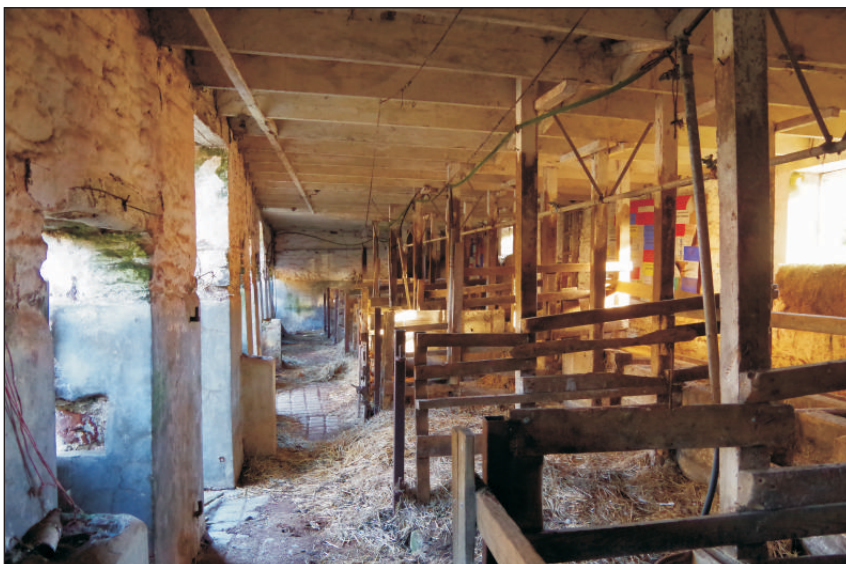
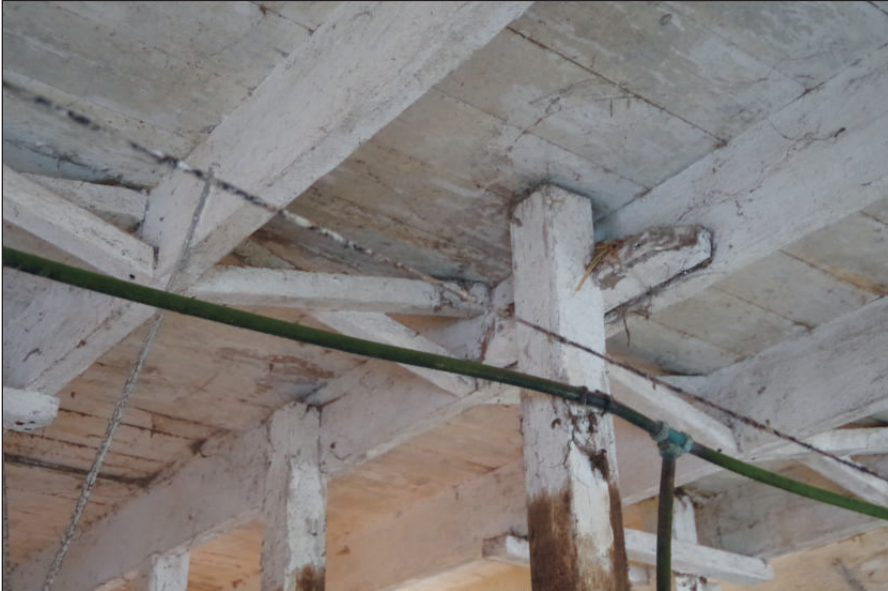
This area contains stalls for animals in the centre of the room with passageways against the long elevation. There is access to building 2 at the south end. The floor is concrete finished with an inlaid grid pattern. The floor level is highest on the northeast side within the feeding passage and it steps down in the stalls and again in the walkway on the southwest side. The stalls are formed from wooden posts and planks, along with metal posts to hang the doors on, although none of the latter remain. There is a feeding trough on the northeast side of the stalls built of breeze blocks and bricks.

The vertical posts to which the stall dividers are attached rise to the base of the first floor planks. They do not seem to support this floor, although some of the posts are fixed to the bridging beams with small pieces of timber. There is scissor bracing between some of the beams. There is a hay feeder in the stall at the south end. Other fittings include galvanised steel water pipes fed by plastic pipes.

Plate 3: Building 1, interior, viewed from the southeast.

Plate 4: Building 1, detail of the first-floor structure, viewed from the northwest.

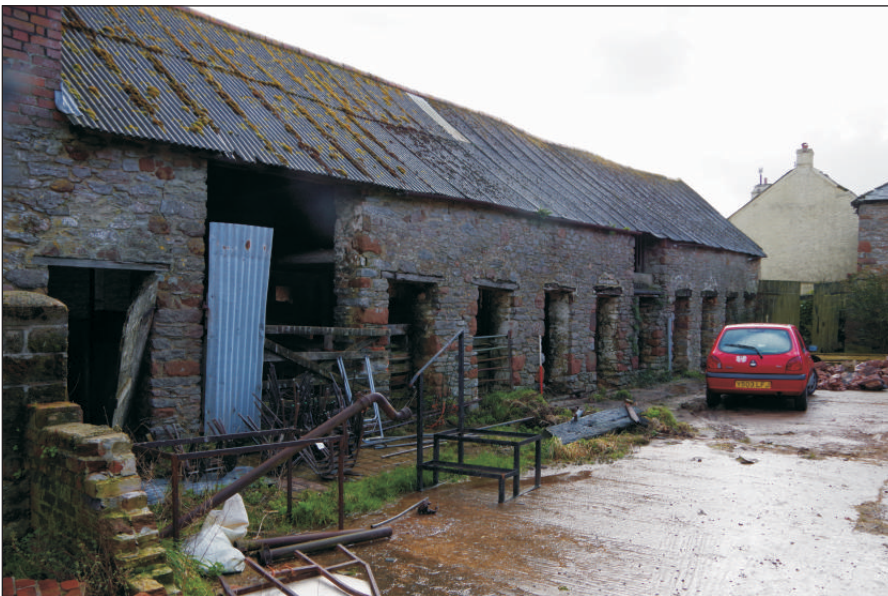
This elevation is constructed of the same masonry as the northeast elevation. There are some patches of repair to the mortar using in a hard, yellow cement mortar. It incorporates 10 low openings with wooden lintels, some of which retain metal pintles for hanging doors. Towards the north end of the elevation there is a full height opening with a wooden lintel and metal pintles for a door. One of the doorways has a square opening above it with a wooden frame and door. It has been partially blocked with breeze blocks set back from the wall face.

Plate 5: Building 2, southwest elevation viewed from the northwest. 1m scale.

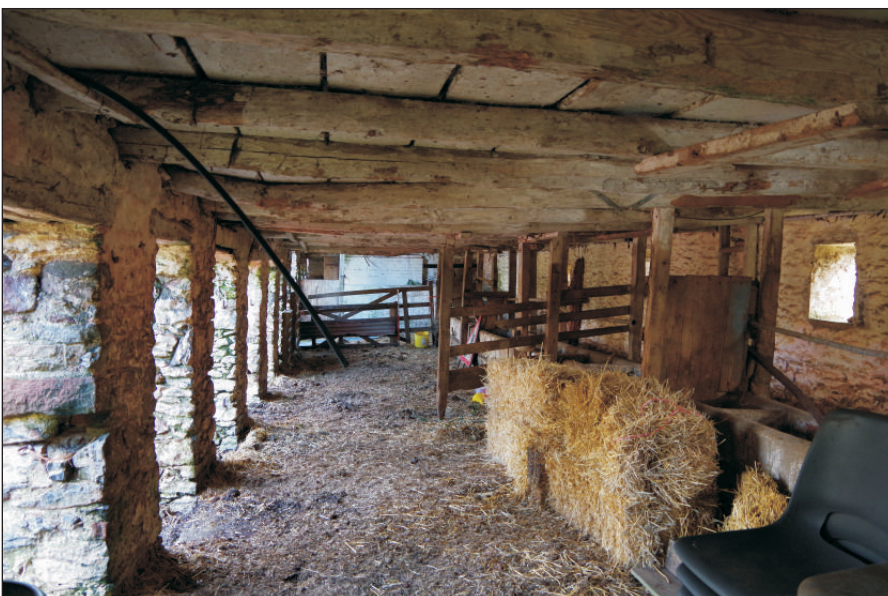
At the northwest end, the inserted division with building 1 is a brick wall with doorways on either side. The internal faces of the walls are whitewashed. This building was used for housing livestock. It has a concrete floor. There is a feeding passage on the northeast side, adjacent to which is a row of feeding troughs constructed from breeze blocks and bricks lined in concrete. There is an individual pen at the northwest end, otherwise the stalls are largely open but partially divided by vertical posts supporting horizontal planks and beams. The posts do not support the first floor, although some of the posts are fixed to the bridging beams. Some of the bridging beams supporting the first floor are unshaped tree trunks.

Plate 6: Building 2, interior, viewed from the southeast.

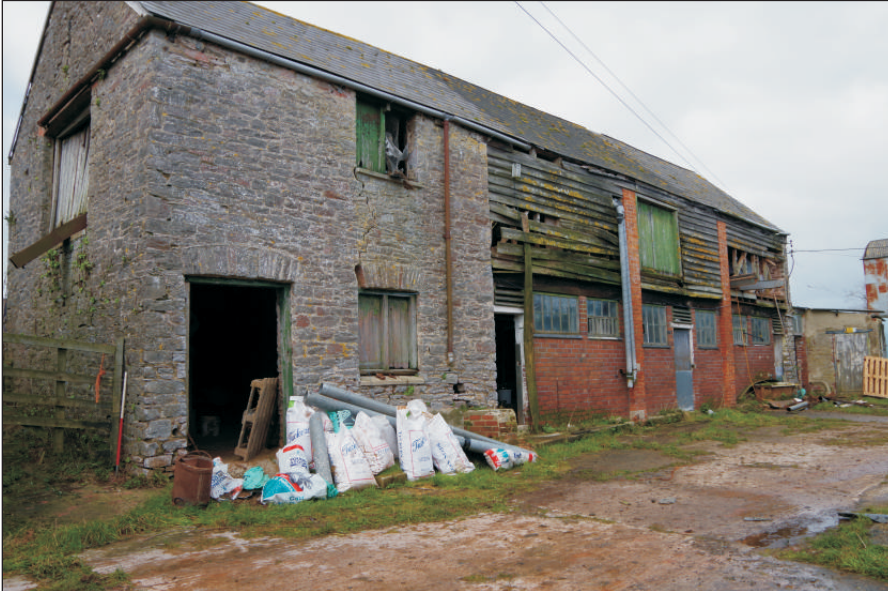
The masonry of the southeast end of the elevation is a continuation of that in the southeast elevation. On the ground floor there is a doorway with a wooden frame and door, under an arched stonework head. There are single windows on both floors, each with concrete sills, wooden frames and shutters. The ground-floor window has an arched stonework head.

The remainder of the elevation is of completely different, later masonry. The ground floor is constructed of brick laid in stretcher bond with projecting brick pillars extending to the eaves level. Within each bay there are doorways with concrete lintels and wooden frames and doors. There are six wooden-framed windows. Most are divided into 10 glass panes, although two contain wooden ventilation slats. The first floor is timber framed supporting weatherboarding.

Plate 7: Building 3, southeast and northeast elevations, viewed from the southeast. 1m scale.

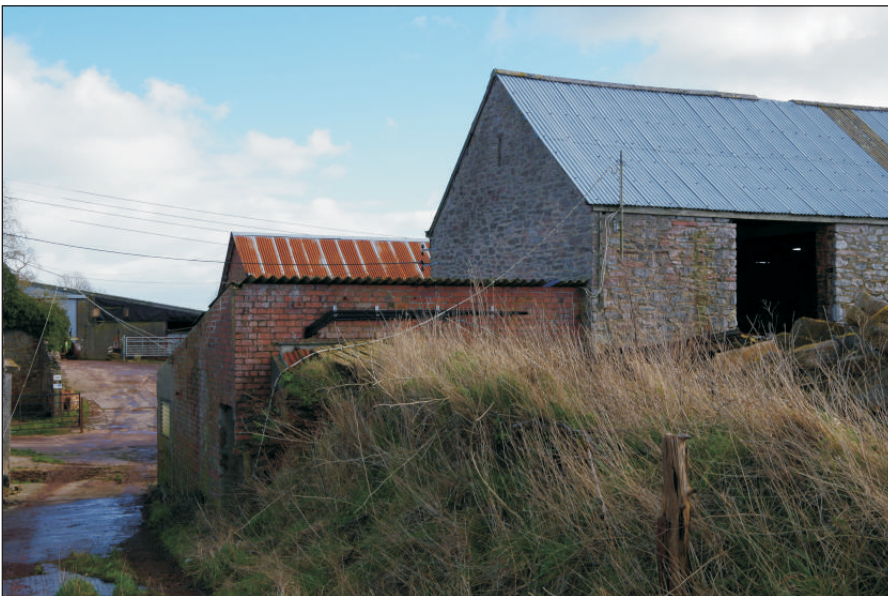
This is constructed from the same limestone masonry as described above. It is largely obscured by a later extension, although a central, tall, rectangular ventilation slit is visible in the gable. The extension is constructed of red brick laid in English bond. It has been extended to the east using red bricks laid in stretcher bond and concrete blocks. The pitch of the roofline has been heightened to cover this masonry. The roof is covered with corrugated asbestos sheets. The southwest elevation incorporates a projection with a blocked window. The northwest elevation incorporates a doorway leading into a passage to the main barn, and a window in the later extension. There is a large opening in the northeast elevation, and doorways in the southeast return.

This is constructed from the same limestone masonry as described above. At either end of the elevation there are large doorways with concrete lintels. The doorframe and door in the southern opening is modern. To the north there is an area of smaller, less well-defined masonry that might represent a blocked opening. Further north there is a small window opening under the eaves.

Plate 8: Building 3, southwest elevation (north end) and northwest elevation, showing later extension, viewed from the west.

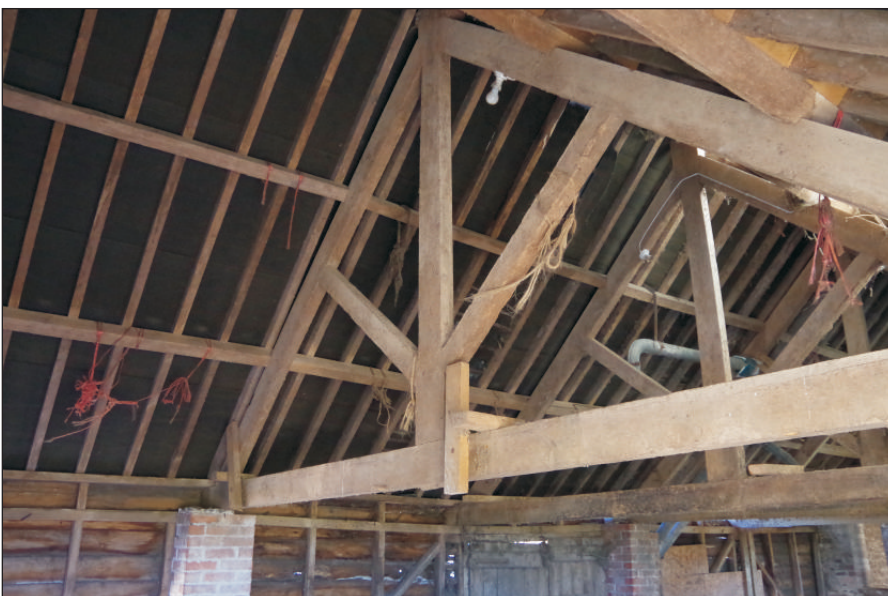
A stone wall incorporating a wide central doorway divides a smaller southern room from the larger northern area. There are three large steel grain hoppers within the southern room. The northern room was last used to store grain. A number of galvanised steel pipes are also currently stored in the room, and must have been formerly used in association with the hoppers. Both rooms have wooden floorboards. Other than some later 20th-century electrical equipment there are no fixtures and fittings *in situ*. The barn has a king post roof with diagonal struts. The trusses are supported on the side elevations including the brick piers on the front elevation. The roof covering (corrugated metal sheeting on the southwest side and slates on the northeast side) is supported on wooden rafters and purlins slightly trenched into the trusses.

Plate 9: Building 3, the roof structure, viewed from the northwest.

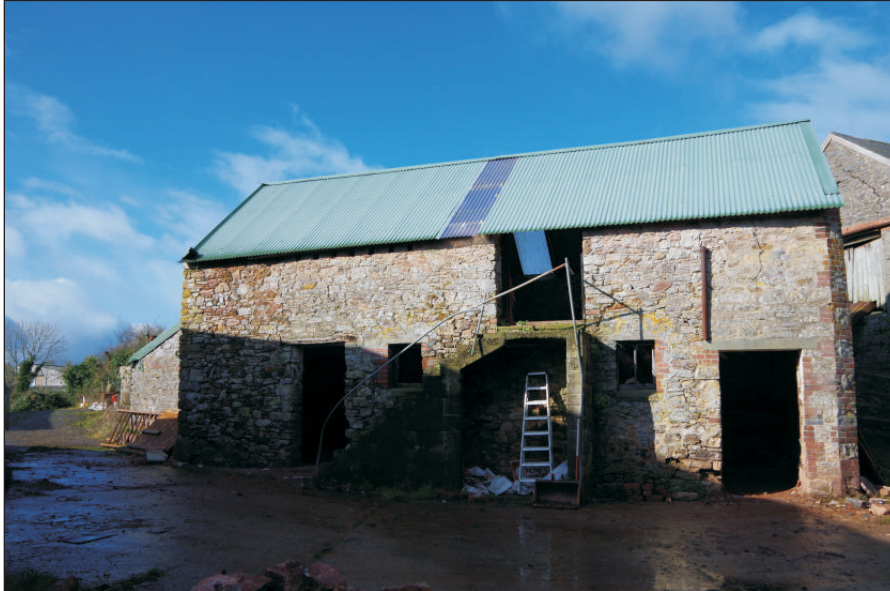
At ground-floor level there are doorways at either end. The northern opening has been raised and has a concrete lintel. This alteration is contemporary with the rebuilding of the northeast corner forming a 45⁰ angle. This work was undertaken using red bricks and limestone. Between the doorways are two inserted small square windows with concrete sills, wooden lintels and frames, although neither have glass. Some of the jambs are brick, but some stonework is visible, and these may have been widened from narrower ventilation slits. Between these openings is an external staircase constructed of breeze blocks with a metal hand rail. This leads to an earlier first-floor doorway with a wooden frame and door. Given the early age of the door the external staircase may replace stone stairs as present on the building to the south (not within the present site).

There is a rough break in masonry at the southwest end and to the south, there is a slight change in the stonework with more red limestone used, bonded in a hard, yellow-grey mortar with common sub-angular gravel inclusions. The southwest corner has quoins of large sandstone blocks up to 0.90m long.

Plate 10: Building 4, southeast elevation showing alterations, viewed from the southeast. 1m scale.

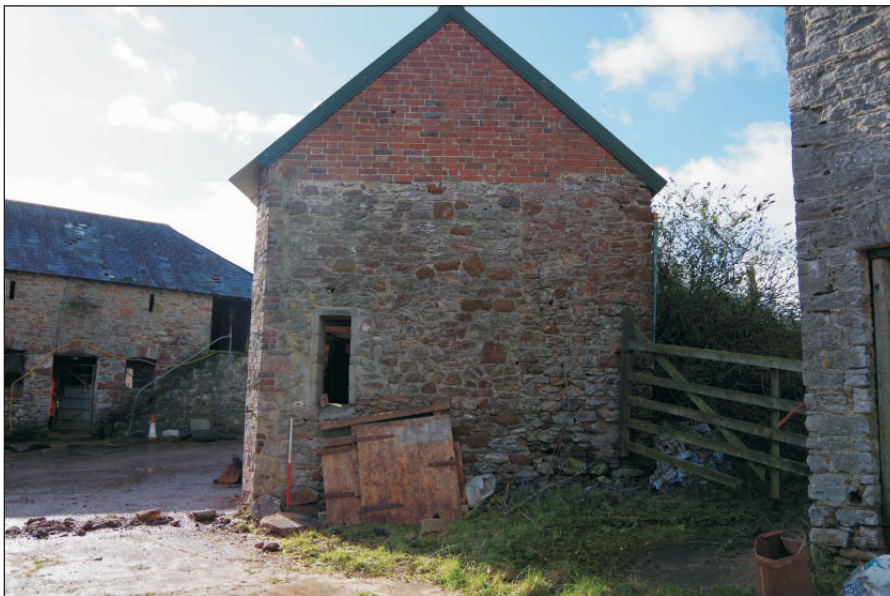
The southeast corner of this elevation has been rebuilt as discussed above. There is a vertical break approximately 1.5m from the west corner, almost down to the ground level, where it turns 90° horizontally. This divides the two types of masonry observed in the southeast-facing elevation, and from this elevation it is clear that the southeast side of the building has been rebuilt. The whole elevation has been heightened with the gable formed from brickwork laid in an irregular bond. The only opening is a narrow rectangular window or vent with breeze blocks forming its sides.

Plate 11: Building 4, northeast elevation showing alterations, viewed from the northeast. 1m scale.

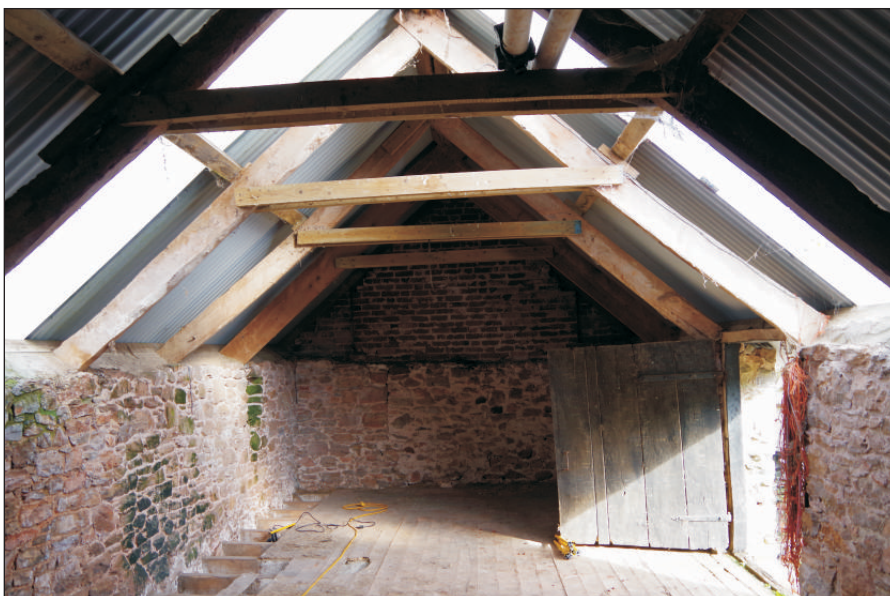
This was probably used as a hay loft, but had been cleared ready for use during the conversion of the barns. It has wooden floor boards, and there are no historic fixtures and fittings. The breaks defining the rebuilt east side of the barn are very clear internally. Within the northwest elevation, which could not be inspected externally, two narrow, splayed rectangular ventilation slits are present. The brickwork used to heighten the building is not as thick as the original stone walls.

The principal rafters of the roof trusses appear to date to the period of the heightening of the gables, and have halved apexes. All of the other timbers and the corrugated metal sheeting covering is modern.

Plate 12: Building 4, first floor showing roof timbers and break in northeast elevation, viewed from the southeast
