# CIDER PRESS BARN, HAYE FARM, LUDBROOK, UGBOROUGH, DEVON

Results of historic building recording and an archaeological  
watching brief

Document No: ACD794/3/1

Date: June 2014

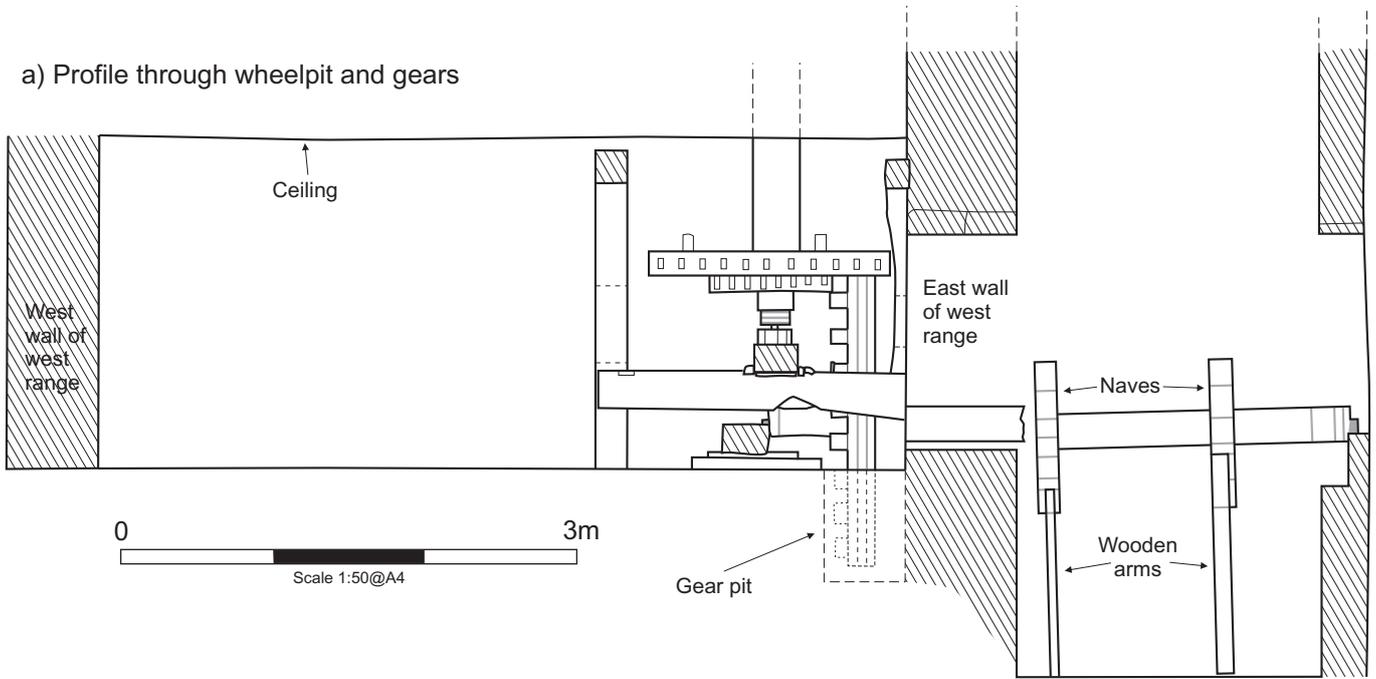
a) Profile through wheelpit and gears

The wheel pit is two storeyed, with the waterwheel on the ground floor and a penstock at first-floor level. The north elevation features an opening above the penstock, and is part rendered and part lined with corrugated sheets suspended from the wall on iron bars. The side walls are also partially rendered, and on the east side there is a scar of a waterwheel which gives a rough radius for the wheel of about 1.2m.

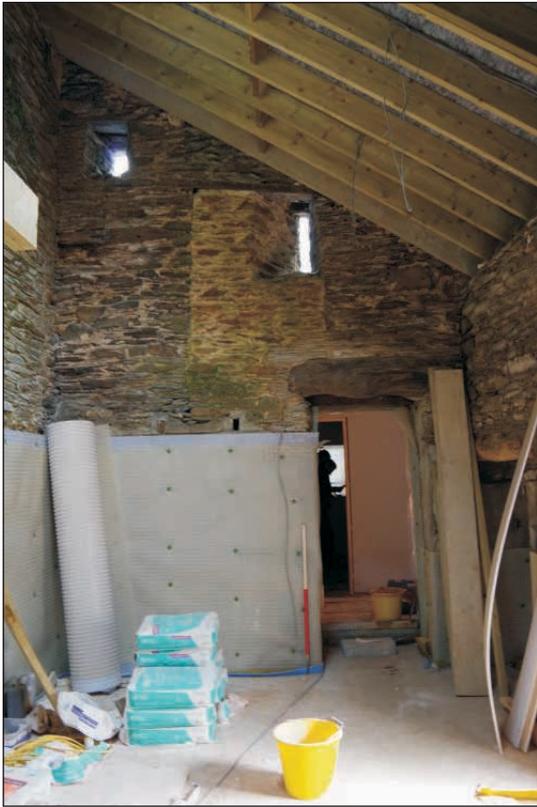
In the east elevation of the 19th-century cow house a blocked ground-floor doorway was recorded; it has been reopened as part of the present works. Above this in the centre of the elevation is a further loading door that had been partially blocked and converted into an angled ventilation slit (Plate 1). No other evidence for an original first floor was observed.

In the early 19th-century extension to the north range further openings than previously recorded were noted. These included a blocked loading door which would have given access to a small hay loft over the cow house.

Plate 1: The east wall of the 19th-century addition to the north range showing opening, viewed from the west. 1m scale.

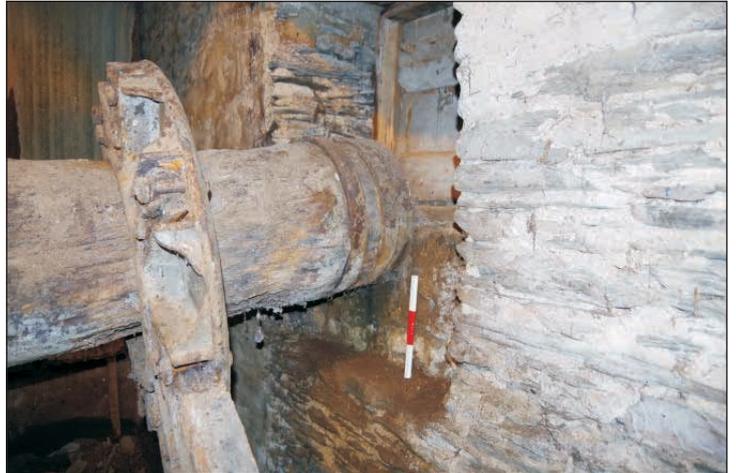
The east axle bearing niche is situated about 1.60 m above ground level (Plate 2). It is bolted to a granite block laid on at least one course of bricks. Above this is a large slate lintel. Above the niche on the west side are three wooden lintels. To the south of the present axle bearings there is evidence of blocked openings in the west and east walls, both with slate arches (Plate 3). These openings were larger than the later niches and their north sides had been disturbed when the latter were inserted. The outflow from the wheelpit was located in the southwest corner of the room and had been blocked using rubble masonry.

Plate 2: The east axle bearing, viewed from the southwest. 0.30m scale.

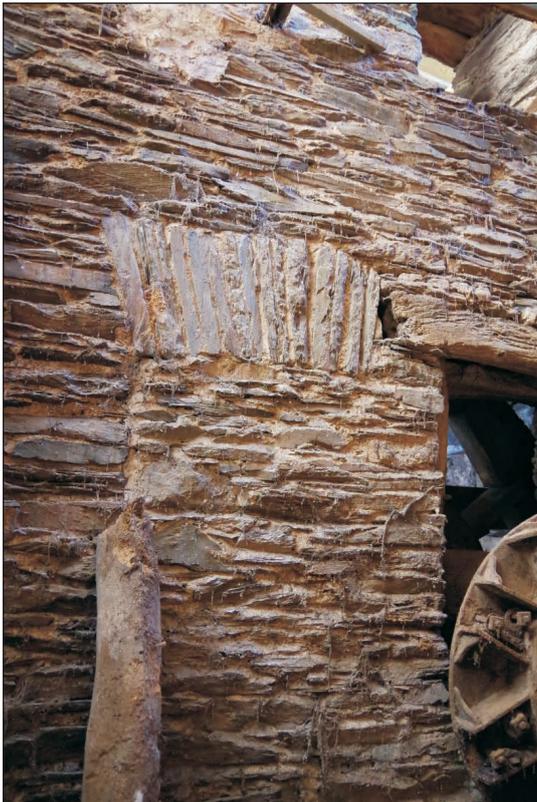
The observations in the wheelpit – the blocked openings and the scar of a larger waterwheel than that recorded – indicate that the present waterwheel and associated gearing is not an original feature. It is likely to be a 19th century replacement.

Plate 3: The blocked axle bearing socket in the west wall of the wheelpit, viewed from the southeast.

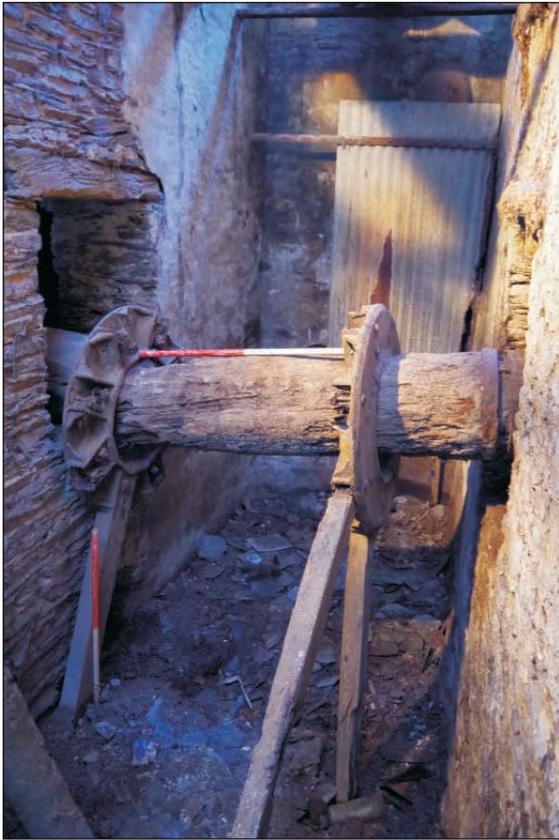
Very little remains of the wheel; what does, consists of a central wooden wheelshaft, which has partially collapsed, and the 0.98m diameter cast-iron central naves (Plates 4 and 5). The wheelshaft has a diameter of 134mm and is supported by three iron bracing rings. The naves incorporate sockets for eight wooden arms, which were attached with nuts and bolts. Two arms survived and are 1.50m long by 150mm wide by 90mm deep. Towards their outer ends each has a hole for the attachment of outer shrouds.

Plate 4: The remains of the waterwheel, viewed from the south. 1m scales.

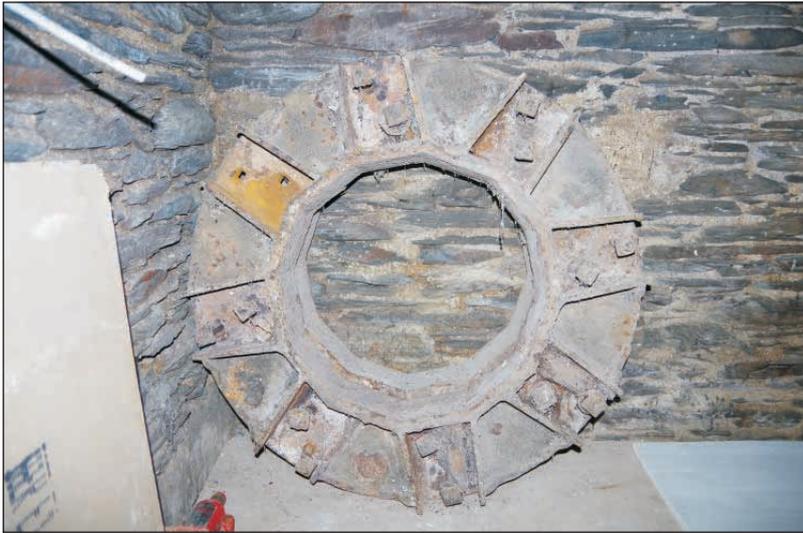
Plate 5: The removed waterwheel naves.

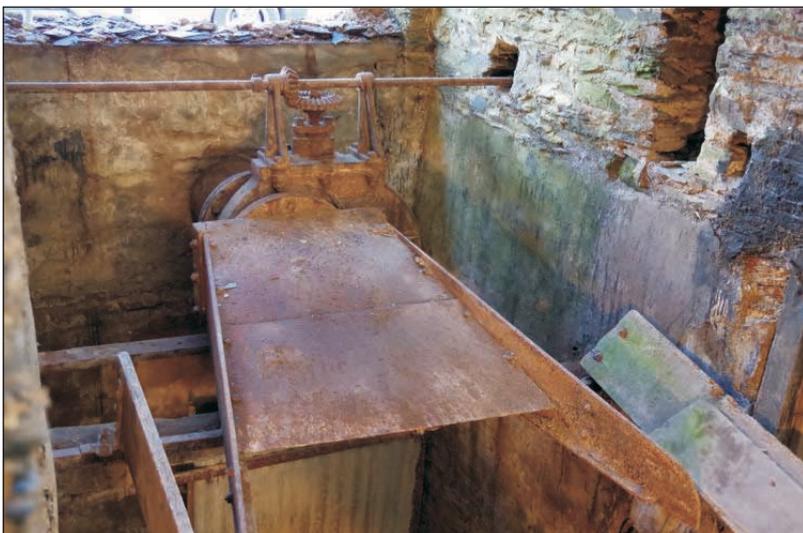
The penstock is fed by a cast-iron pipe that protrudes through the north elevation. It terminates in a large sub-circular housing containing a sluice or valve (Plate 6). This is operated from the adjacent workshop on the first floor of the west range. A hand-turned wheel connects to a shaft leading through to the wheelpit where it

incorporates a bevel gear. This connects with another gear attached to a shaft leading into the sluice housing. The base of the housing is supported on a rectangular steel bar attached to the side walls. The penstock is a cast-iron trough with bolted angled sides. It is supported on a large I-beam and a smaller rectangular steel bar.

Plate 6: The penstock, viewed from the southwest.

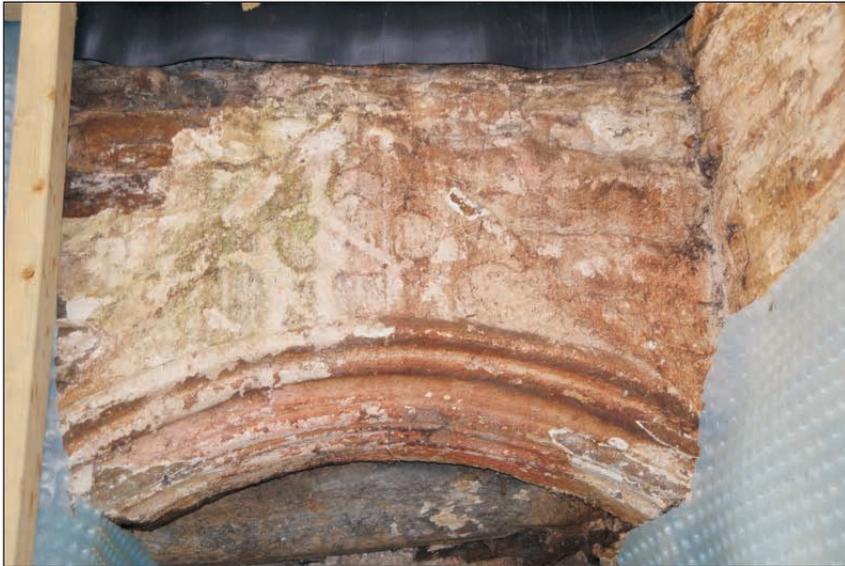
The spandrel is reused, on its side, as the head of a doorway in the east elevation. The ends are partially obscured by the north wall of the east range and by later render on the external wall of the north range; it has minimum dimensions of 0.60m (original height) by 0.56m (original width). It is decorated with a quatrefoil overlaid by a shield embossed with a vertical line. The main exterior edge has a roll moulding and there is a further smaller triple ovolo moulding between this and the underside of the arch.

Plate 7: The reused spandrel, viewed from the east.

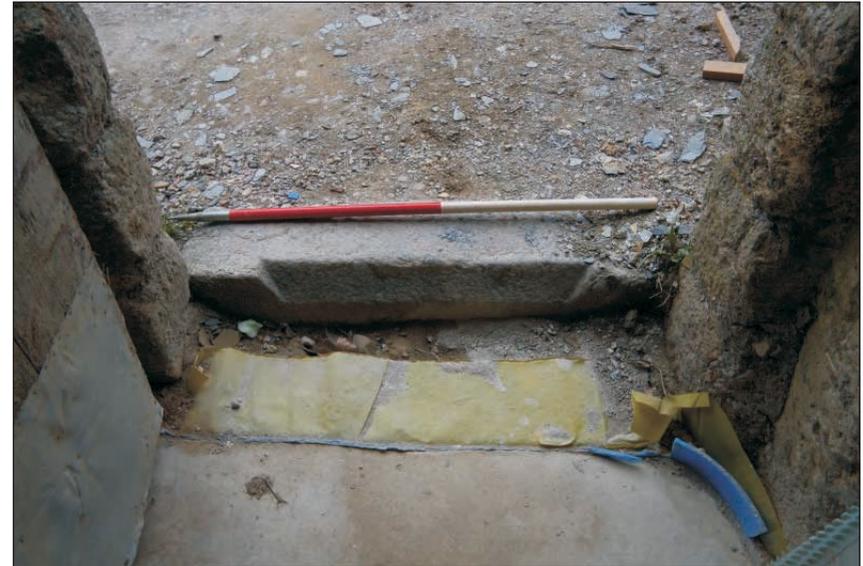
The threshold of the doorway into the northern room is a reused granite window lintel or cill (Fig. 5c; Plate 8). It measures 1.08m long by 0.18m wide, and has a chamfer along one corner. It has been laid on its side and is partially buried. No evidence for glazing is visible, although from its visible features it would have derived from a single light window.

Plate 8: The reused granite window lintel, viewed from the west. 1m scale.

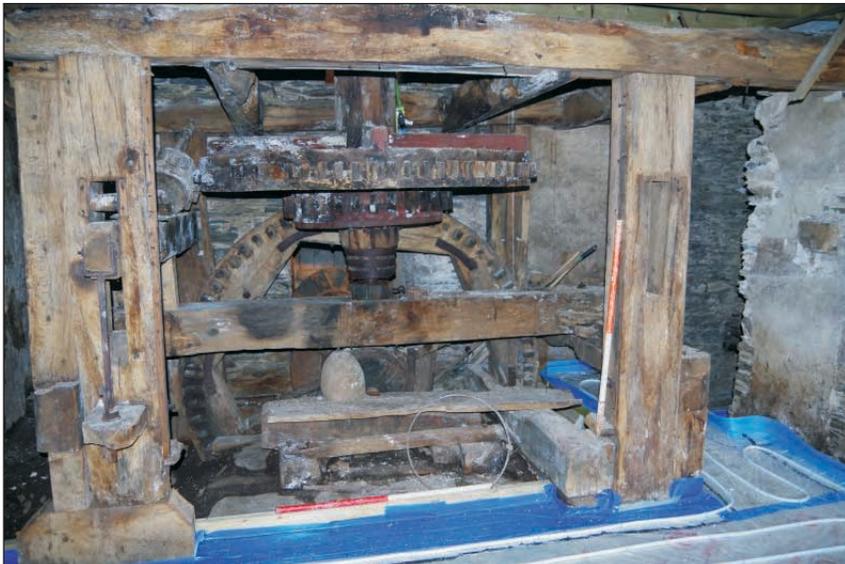
This shaft could be disengaged from the machinery via a small moveable cog located on a short axle attached to the north side of the frame. It had been dislodged but would have been set into a (surviving) horizontal beam, which would have pivoted, disengaging the cog from the spur gear. Part of the iron handle to move and support the beam, along with an associated weight, survive. The vertical timbers on the southern side of the frame incorporate rectangular sockets for a further horizontal beam, and the frame must have been designed to house a second vertical transmission and cog.

Detailed analysis of the frame supporting the gears has revealed that it was designed to take two transmission shafts to the first floor, although in the present arrangement there is evidence that only one was fitted. The design of the frame would indicate that it originally powered two pairs of millstones on the first floor. Given the design of the barns it is unlikely that corn milling took place in Cider Press Barn, and it seems logical that the machinery (and waterwheel) was reused from the nearby corn mill at Ludbrook, and was adapted to power a single piece of machinery on the first floor.

Plate 9: The gears prior to restoration showing the engaging mechanism (and axle) and holes for removed engaging mechanism in the frame, viewed from the west. 2m scales.

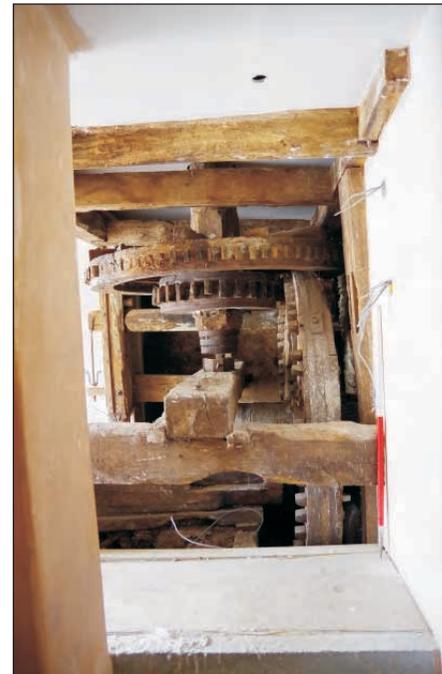
The vertical beam continues through to the first floor where a cast-iron pintle is visible in its end. The bearing beam has been removed. Below this the axle contains two pairs of rectangular vertical sockets for removed timbers. No other machinery survives *in situ*. A single short length of beam with a small-diameter gear was recovered by the developer, but its original location is unknown.

Plate 10: The restored gears showing the pit gear in its pit, viewed from the south. 1m scale.

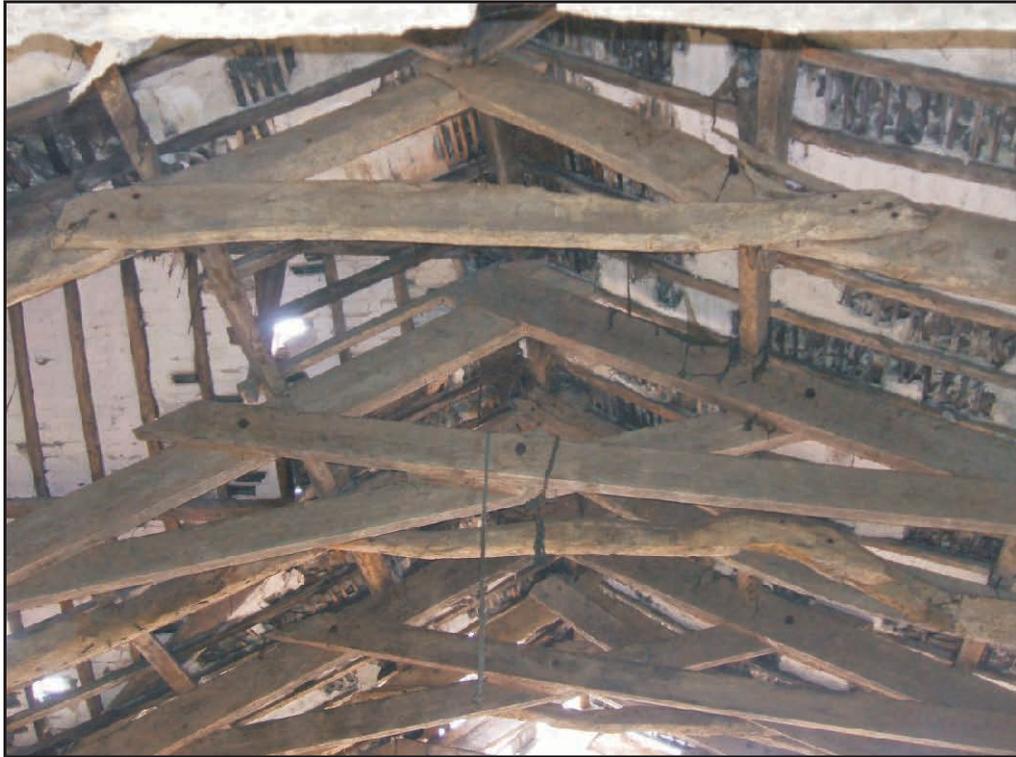
The roof retains three of its original trusses (Pl. 9). These comprise principal rafters with applied collars attached using pegs and nails. The remainder of the trusses have been replaced and comprise principal rafters each with diagonal braces, fixed with bolts.

Pl. 9 Barn 3, west range, roof structure, looking south.
