41 STOKES CROFT, BRISTOL

Results of historic building recording

Bristol City Council planning reference 14/04413/LA

Document No: ACD1077/2/0

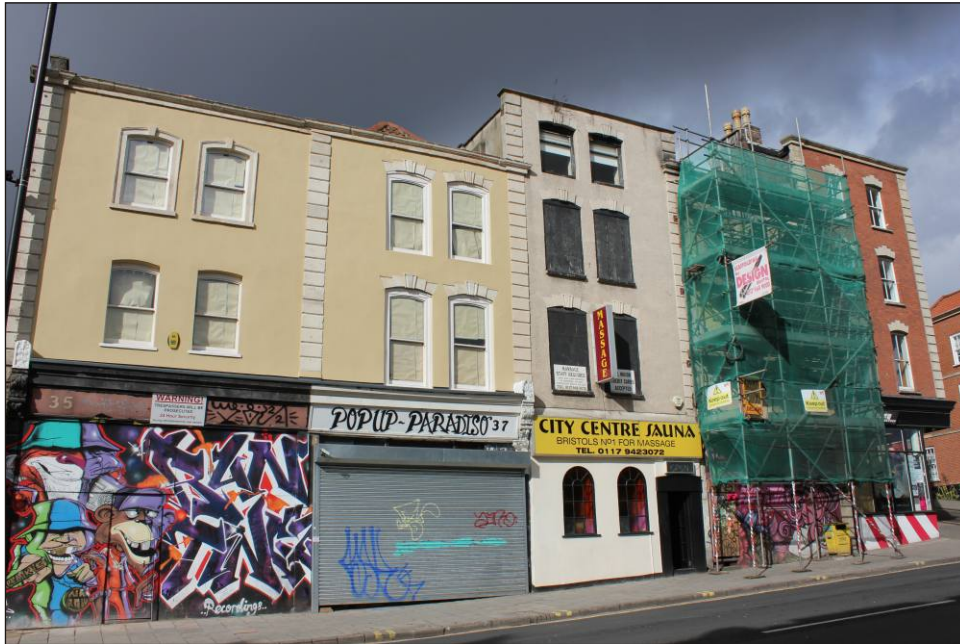
- 2.5** The 1910 OS 2nd edition map (Fig. 5) depicts the same footprint, but does not show part of the rear structure as glass roofed. Between the surveying of these 1880 and 1910 maps the adjacent No. 43 had been rebuilt. The area was very substantially damaged by the Bristol blitz during the Second World War, at which time the entire terrace to the south west of No. 35 was either destroyed or removed in the post-Blitz clearance of damaged structures, and five houses of the original terrace now remain. Beyond Hillgrove Street a short length of a comparable terrace remains, though here, rather than truncating the house plots in order to exploit the premises as commercial buildings, the shop fronts were extended over the areas to project out from the frontages. These houses together represent an important fragment of the 18th-century streetscape of Stokes Croft (Plate 1).

Plate 1: The surviving block of 35-43 Stokes Croft, viewed from the south.

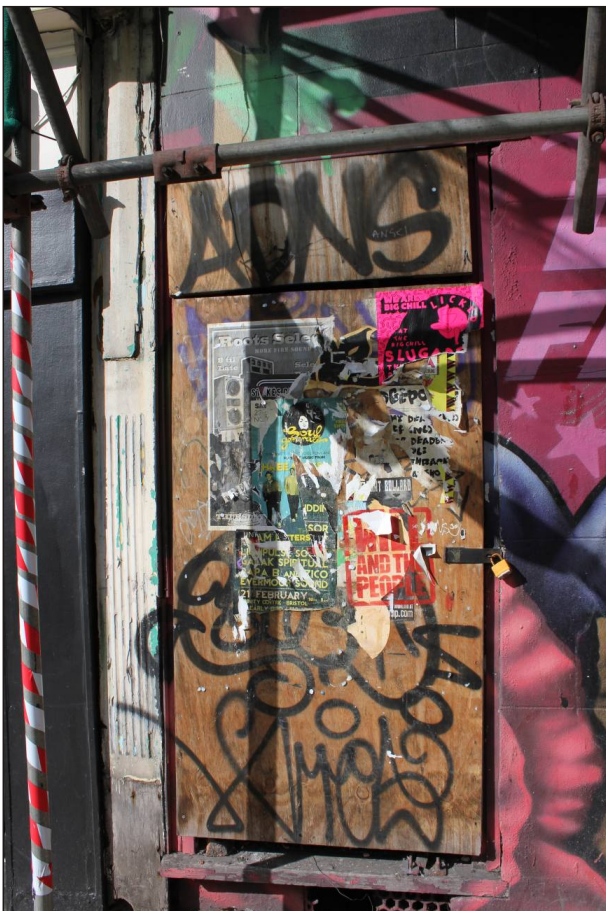
Plate 2: The fluted moulding adjacent to the front door, viewed from the southeast.

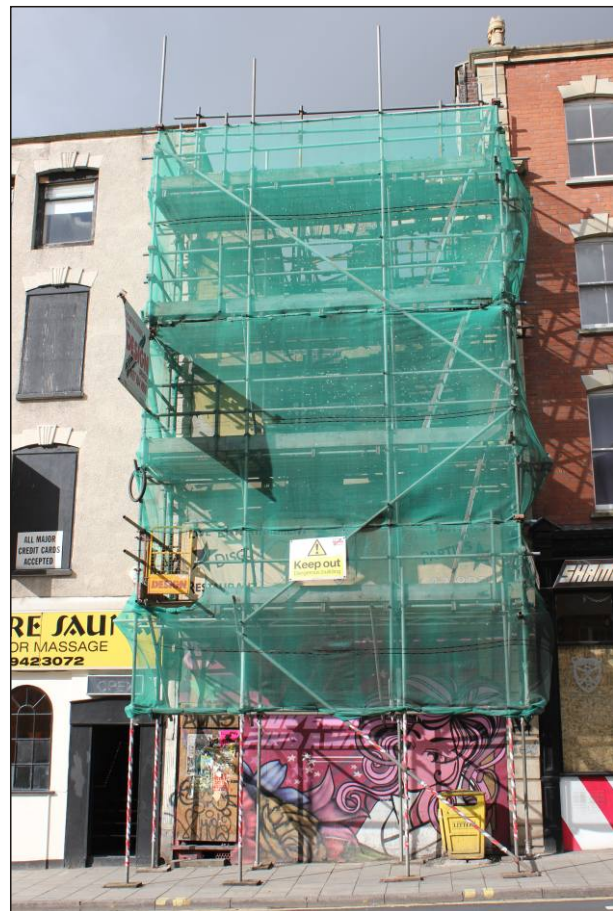
Plate 3: The front elevation of the property, viewed from the southeast.

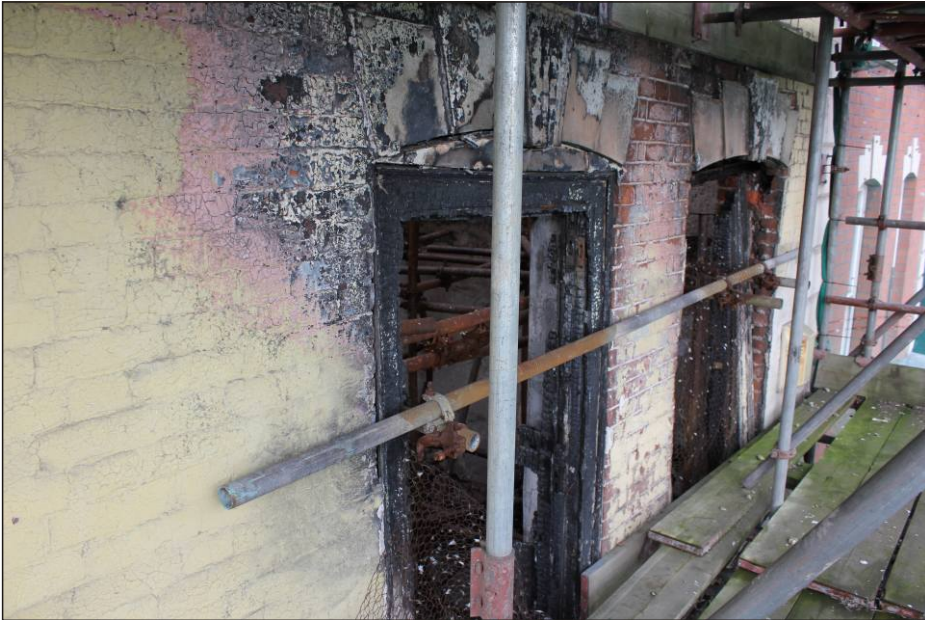
The masonry of the first and second floors is red bricks laid in stretcher bond using very hard cream slightly gravely lime mortar (Plate 4). This has been painted yellow, and more recently this finish has been overlaid with 'pebbledash' concrete render, which has partly come away due to the heat of the fire. On the second floor there is evidence that the interior face has been rebuilt using concrete blocks and concrete lintels over the windows. On both floors there are pairs of window openings offset towards the east side of the elevation. These contained sash windows that have been destroyed by the fire. On the first floor parts of the frames, set flush to the

Plate 4: The first floor of the front elevation showing brickworks and window openings, viewed from the south.

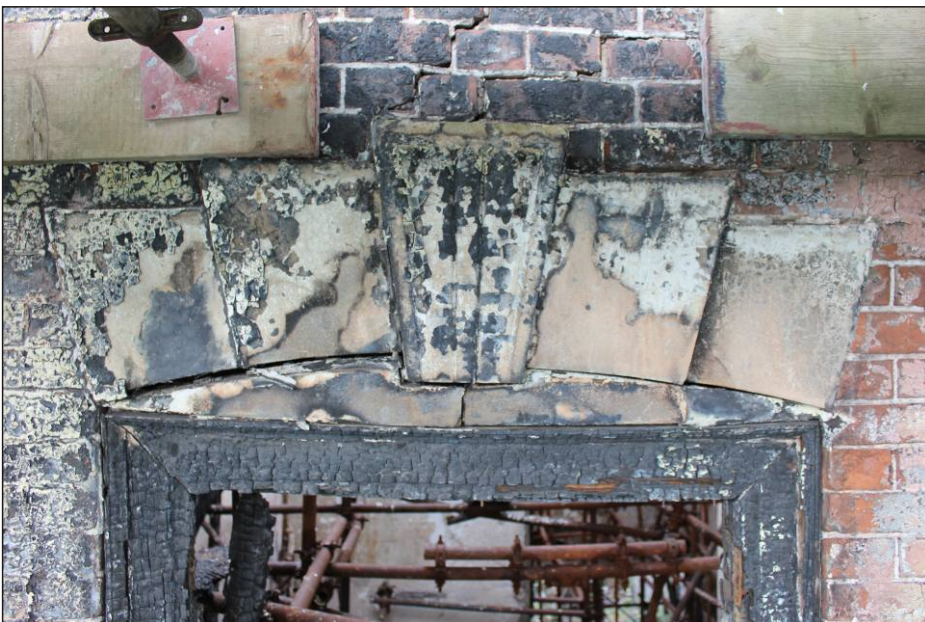
Plate 5: The stone detailing to one of the front windows, viewed from the southeast.

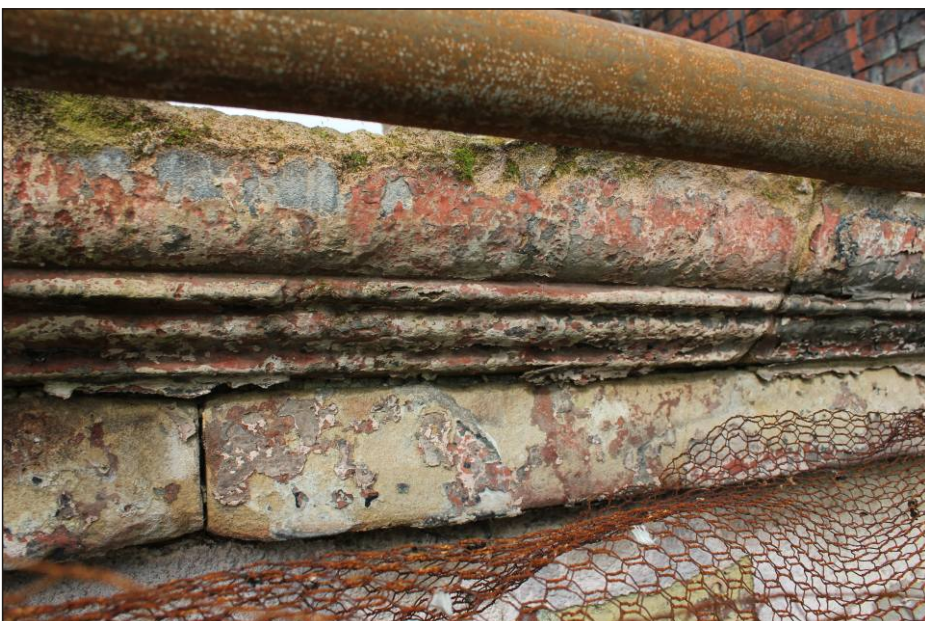
At eaves level is a cornice of bath stone blocks, slightly projecting from the façade, finished with ogee and hollow mouldings (Plate 6). The top face slopes back in towards the building, presumably to a former gutter that has been destroyed by the fire. On the west party wall the Bath Stone quoins continue up to the extended eaves level of no. 39, with the rear of the blocks being infilled with brick. The quoins have also been extended up on the raised eaves level of No. 43 where they terminate in a cornice with curved and straight-edged mouldings.

Plate 6: Detail of the cornice at eaves level, viewed from the southeast.

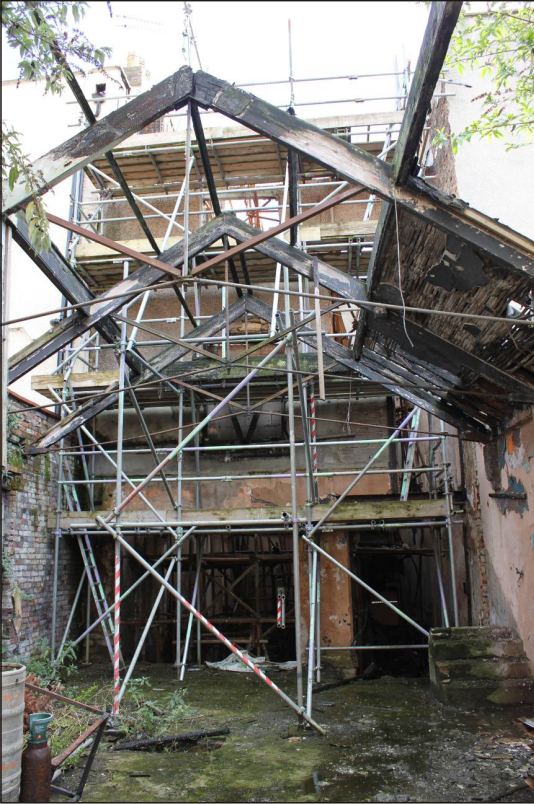
This elevation is constructed of rubble lias, red and yellow sandstone and bricks, which has been finished with plaster and cement renders. On the ground floor there is a doorway on the west side under a rolled steel joist. To the east there is a further large opening. On the first floor there is a primary window opening at the west end that has been reduced in width using concrete blocks to form a doorway, possibly a fire exit. To the east there is a central window that has been infilled using concrete blocks; this extended up to the ceiling level. On the second floor there is a doorway at the west end. This is at a lower level than the second floor, and may be another inserted fire exit. A chase for the floor and stairs down to the doorway are visible in the plaster and masonry of the adjacent elevation (Plate 8). To the east there is a deep window that extends down from the eaves level.

Plate 7: The rear elevation, with the later extension to the front, viewed from the northwest.

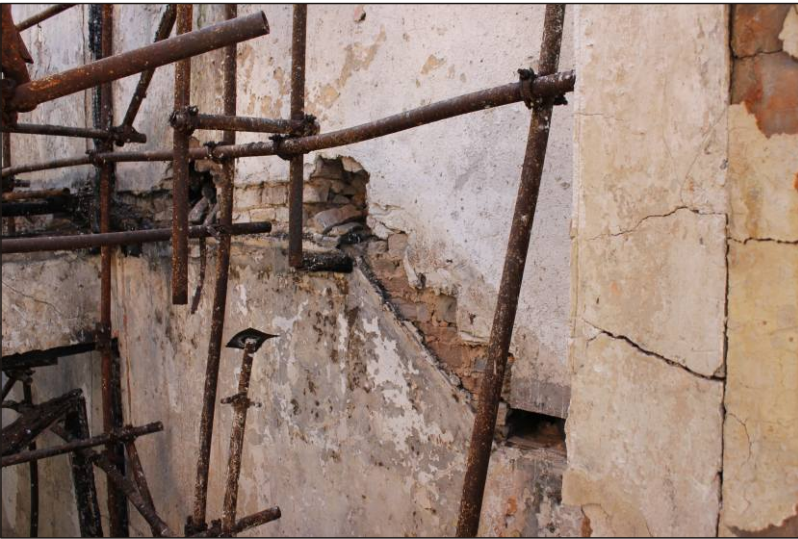
Plate 8: The chase for the stairs to the rear first-floor door, viewed from the north.

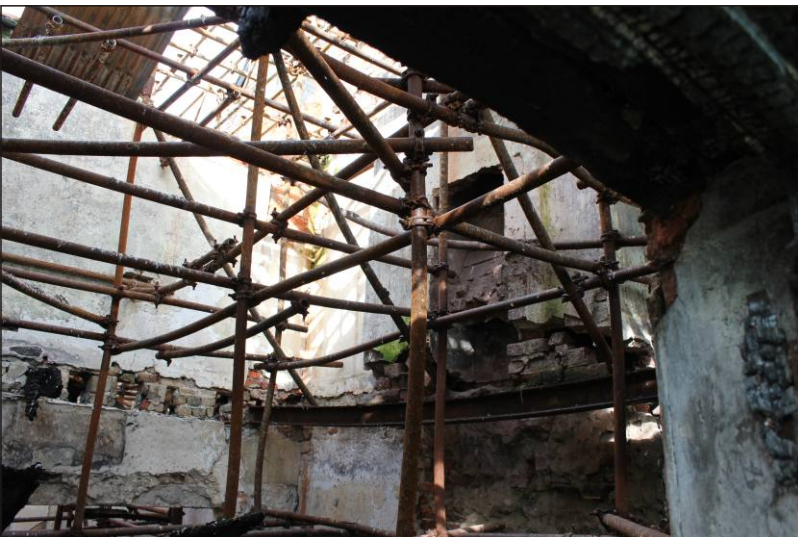
Plate 9: The first-floor fireplace in the front room, viewed from the south.

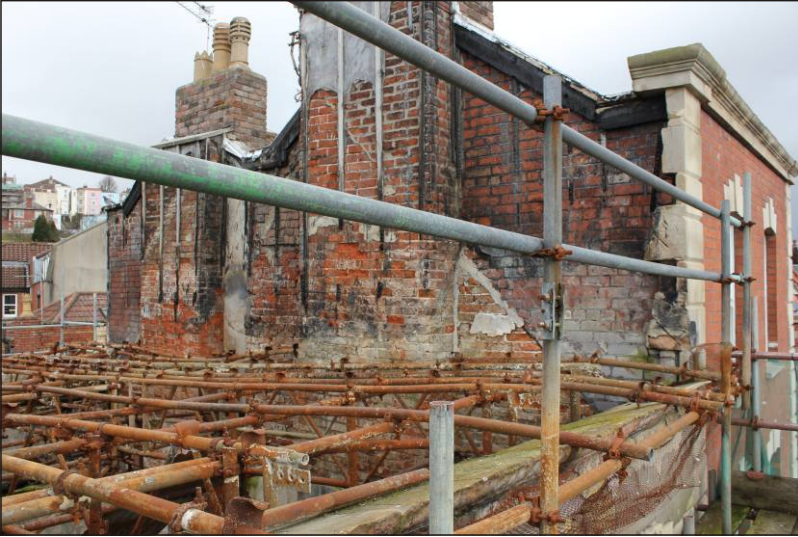
Plate 10: The chimney stacks at roof level, showing the scars of the rooflines and the extended masonry of No. 43, viewed from the south.

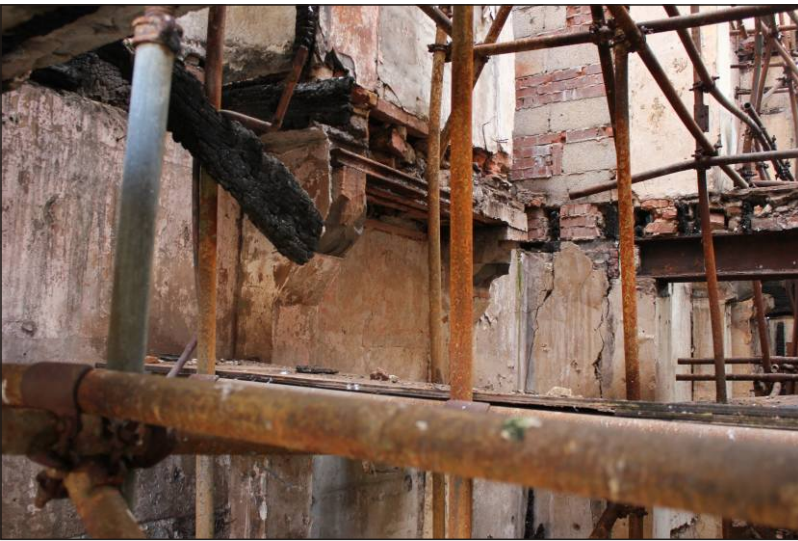
Plate 11: The supports for the first-floor fireplace in the rear room, viewed from the west.

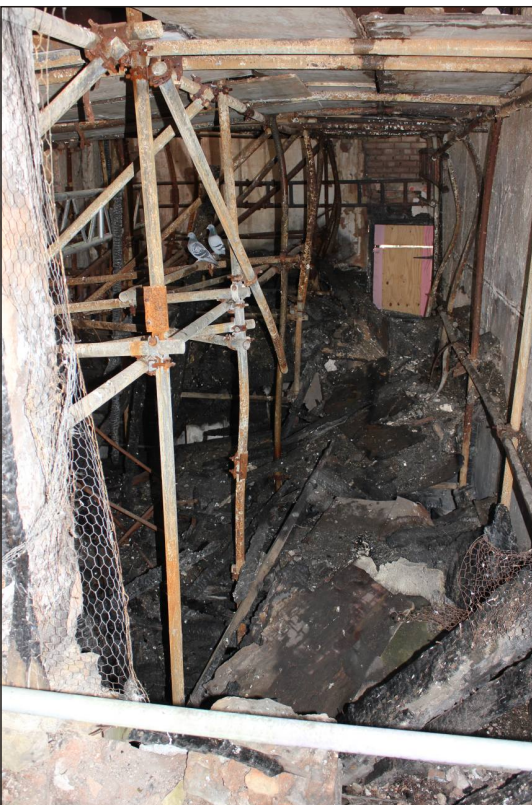
The ground floor is currently a single open place. A central dividing wall has been removed, with the masonry above now supported on a single long rolled steel joist. The building may originally have had a corridor along its west side, probably incorporating the staircase, and this arrangement may have continued until the fire.

Plate 12: The ground-floor looking southeast along the line of the possible corridor.

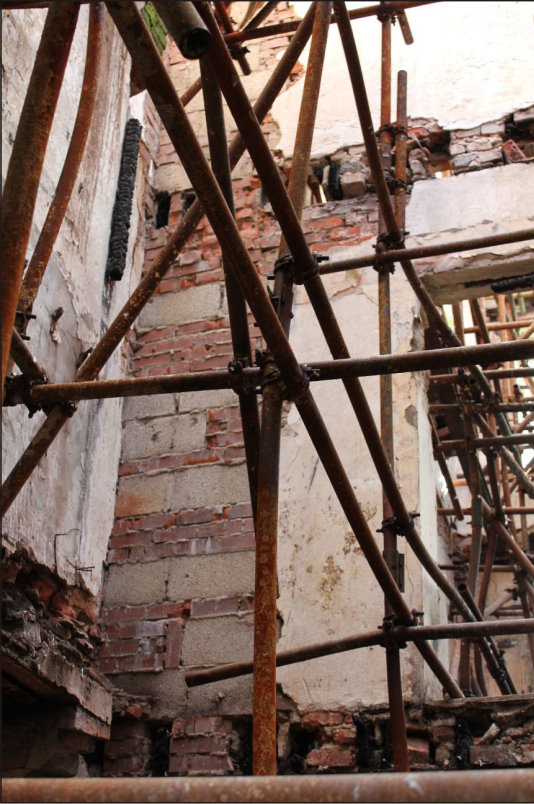
This floor is divided by a central brick partition in the centre of the property that incorporates a primary doorway at its west end, and an inserted opening under a concrete lintel towards its eastern end. Beyond, the masonry has been rebuilt, in the late 20th century, using concrete blocks and brickwork. Sockets for the burnt-out joists of the floor have been exposed at the base of the wall. The front of the property has been reconfigured in the 20th century as a single large room. The walls have been replastered, to which the skirting board has been attached.

Plate 13: The first-floor partition wall showing joist sockets, inserted doorway and rebuilt masonry, viewed from the northwest.

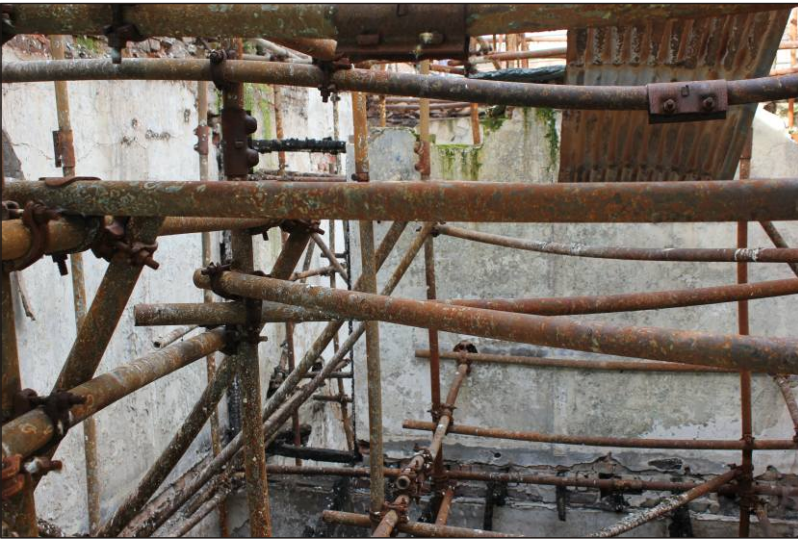
This floor is divided by a central brick partition in the centre of the property that incorporates a primary doorway at its west end. The eastern end has been rebuilt, in the late 20th century, using concrete blocks and brickwork. A scar on the south side of this wall indicates that the front of the building was divided into two rooms. The partition must have been staggered since its projected course conflicts with the western window opening. The scar may therefore represent a doorway at the end of a corridor that gave access to two front rooms of unequal size. Sockets for the burnt-out joists of the floor have been exposed at the base of the wall.

Plate 14: The second-floor partition wall showing the scar of the removed/destroyed partition, viewed from the southeast.

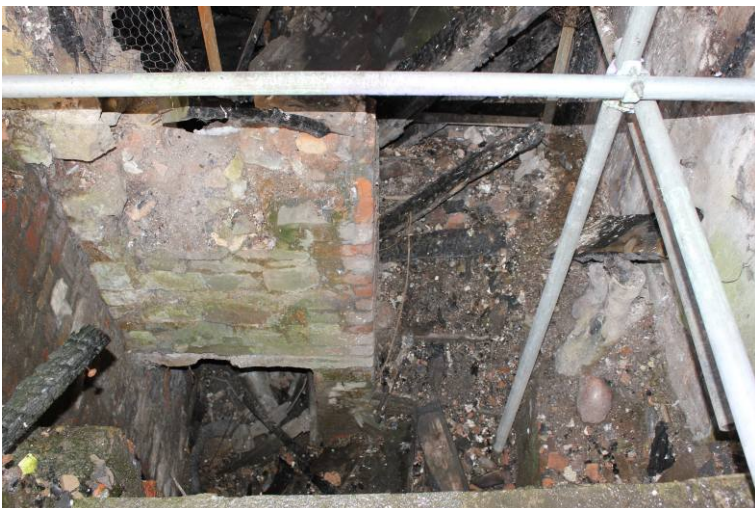
Below the property is a basement or cellar. The extent of this is not clearly visible due to debris from the fire, but it may be present under much of the building. There is however no evidence in pavement for former entrance steps, a lightwell or coal chutes. There is an opening into the cellar, probably via an internal flight of steps, at the northwest corner of the building.

Plate 15: The possible rear entrance to the basement, viewed from the northwest.

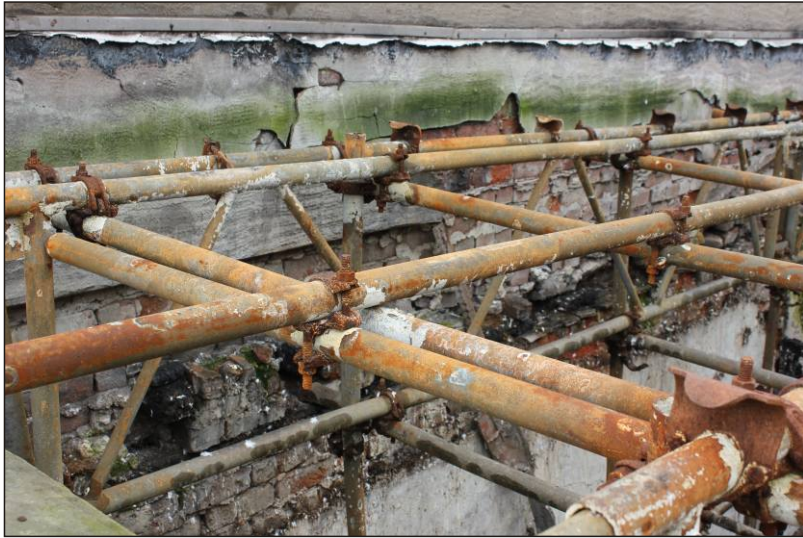
Plate 16: The joist sockets of the second-floor ceiling within the party wall with no. 39, viewed from the east.

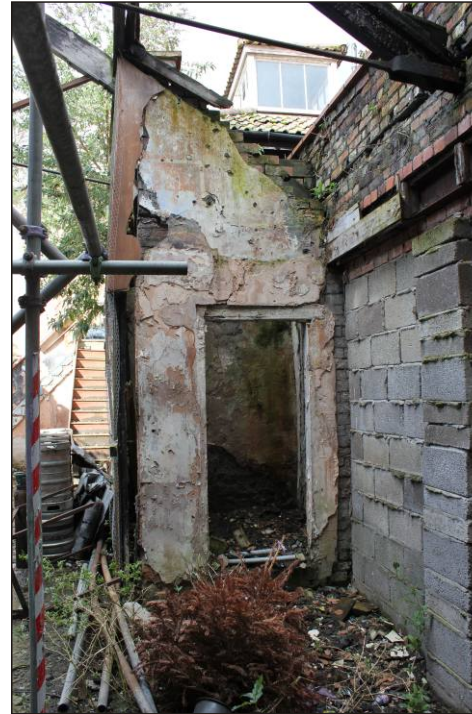
Plate 17: The rear east wall showing inserted and blocked doorway and small outbuilding beyond, viewed from the southeast.

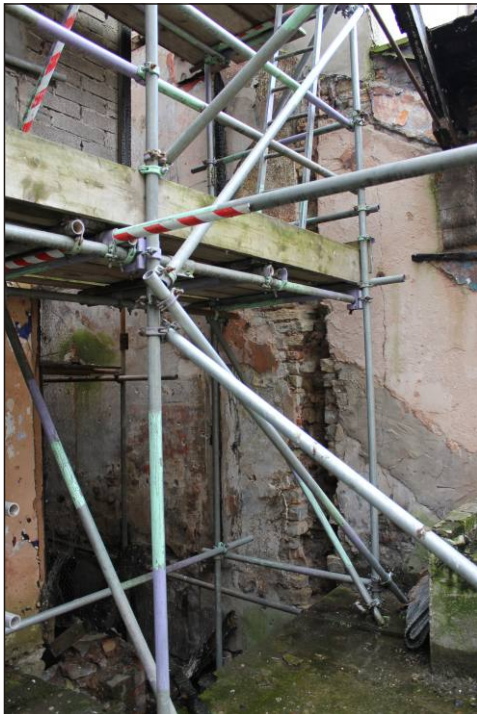
Plate 18: Scars of the roof and stairs in the west boundary wall, viewed from the north.

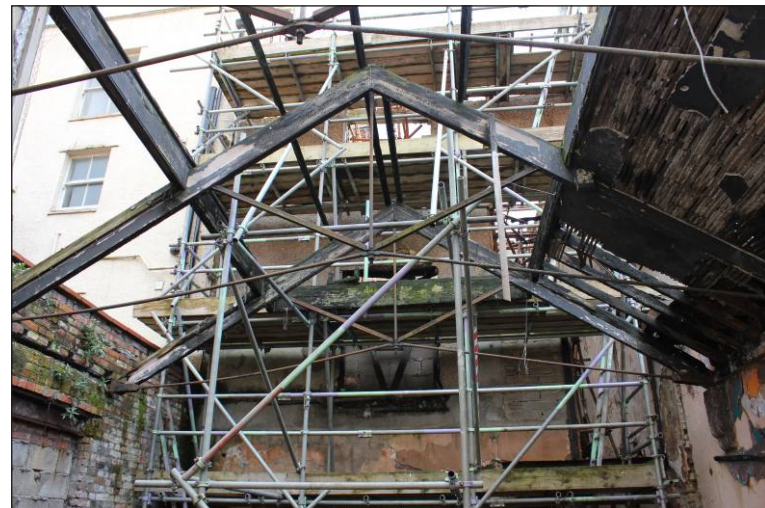
Attached to the rear lobby is a single storey outbuilding covering the width of the yard, which must have replaced the earlier greenhouse or conservatory depicted on the first edition OS mapping (Plate 19). This utilised the boundary walls and had three roof trusses formed from pairs of sawn timbers supported by attached cast-iron frames consisting of rods and L-shaped bar supports. The interior of the roof was lined with lath and plaster. This structure incorporates the brick outbuilding at its northeast corner. The floor of the whole yard is concrete, which within the outbuilding incorporates an infilled, possibly brick-lined, void. This may be associated with the former printing works.

Plate 19: The roof structure of the rear outbuilding, viewed from the northwest.
