OLDAPORT CAMP, MODBURY, DEVON

Report on Conservation Works and Additional Archaeological Survey

Scheduled Monument: Iron Age promontory fort known as Oldaport Camp (National Heritage List No. 1020234)

Document No: ACD1130/1/0

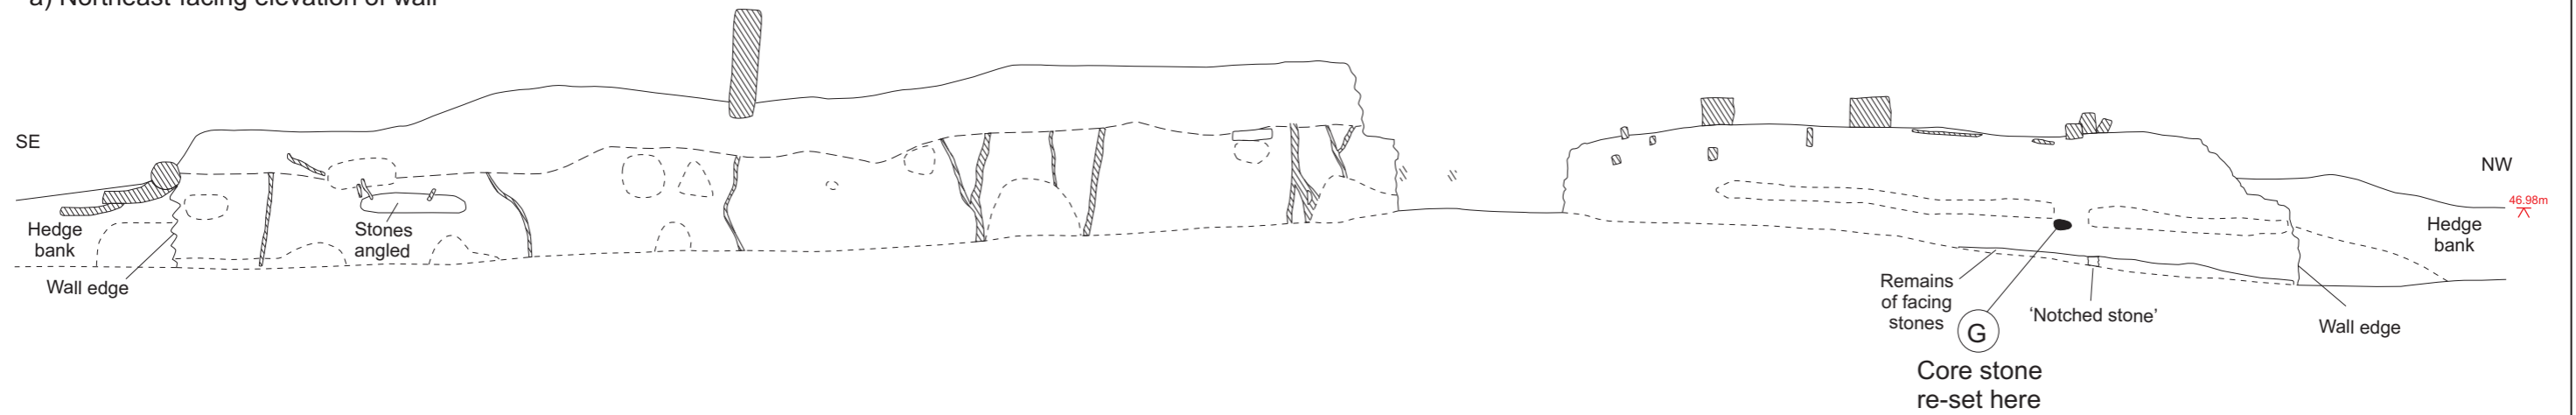
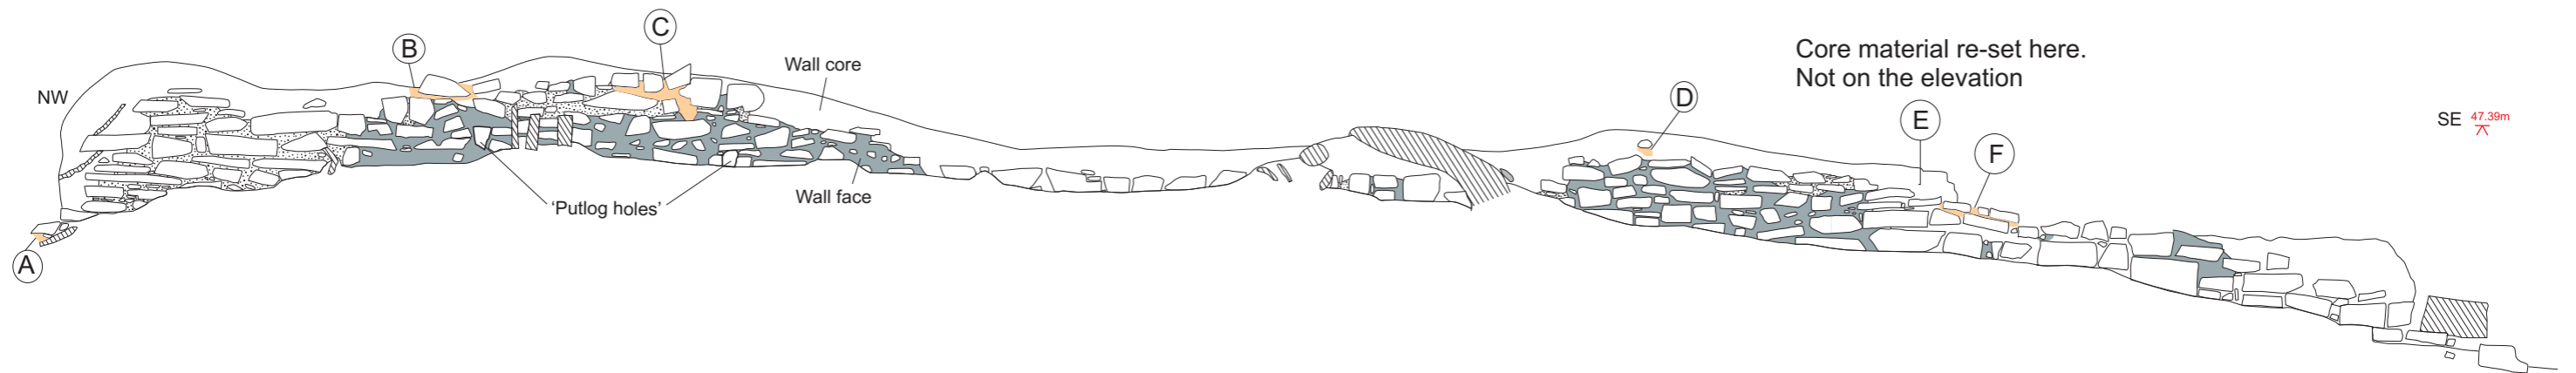
The conservation works comprised the re-setting of 16 stones on the northeast wall and their repointing. The positions of the works is presented in Fig. 3. The hydraulic lime mortar used for these works was St Astier NHL 3.5. The inclusions to the mortar were chosen to be distinct from the historic mortar, but also not to undermine the aesthetics of the ancient wall. The re-set stones were bedded in a mortar coloured a distinct pink by the inclusion of 2 parts Sowton Red sand and 1 part Yellow Heathfield 50/50 sand. The pointing was a white matching the historic mortar, but with smaller inclusions making it distinct and made with 2 parts Lee Moor silver sand and 1 part Yellow Heathfield 50/50 added to the lime mortar. Some of the finished work is illustrated in Plates 1 and 2.

R7: The northeast wall should be sensitively consolidated, by repointing where necessary and the top capped to prevent water ingress and inhibit plant growth. This work, although somewhat preserving the aesthetic, should not use materials that may in future be confused with the original surviving fabric, which at present contains the only securely datable material on the site.

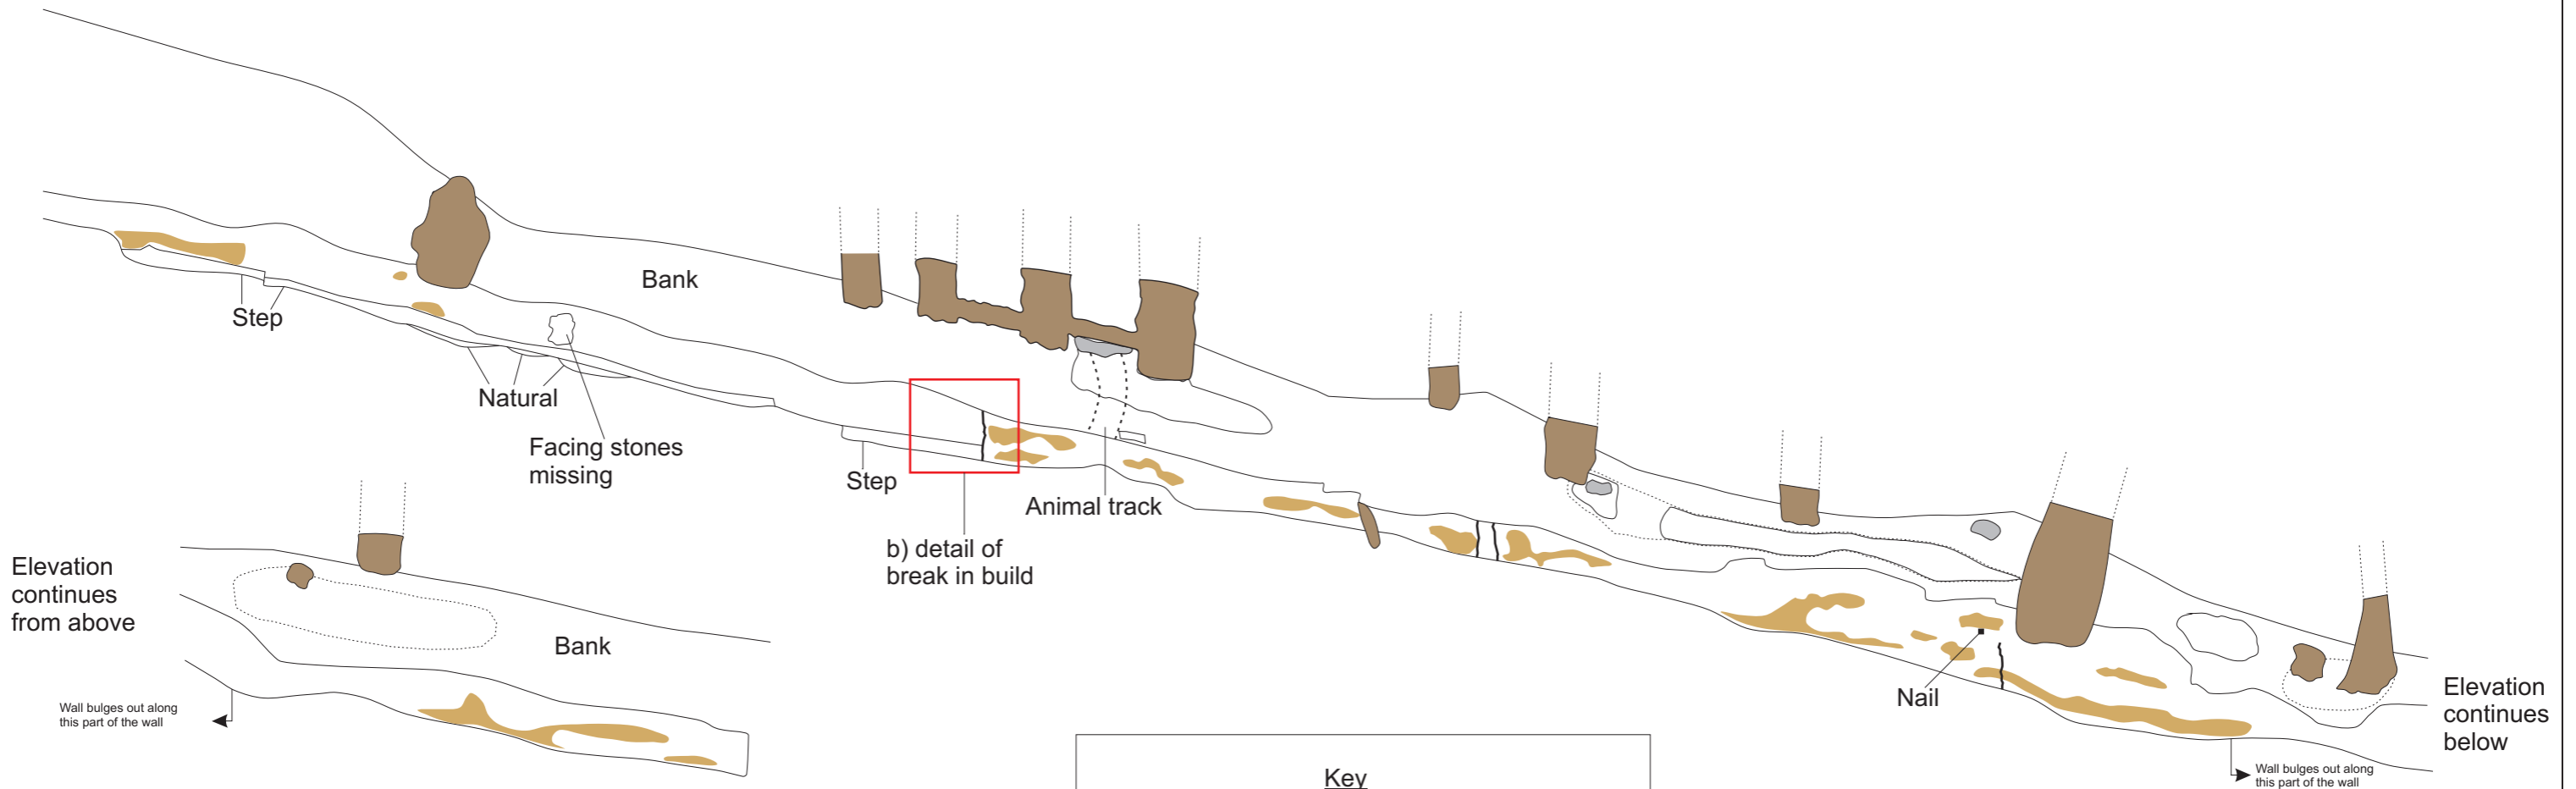
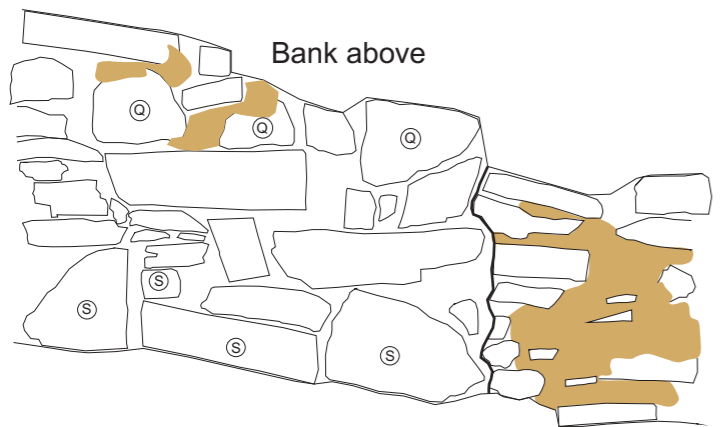
TITLE
Fig. 4: Zone 2, elevation of the northwest wall

- 6.3** *Archaeological description:* The wall is constructed of local stone with some quartz (Plate 3). It appears to have been built in the form of a revetment with a flat face one stone wide in front of a rubble core with earth behind. The stonework is bonded by a hard off-white mortar with rare inclusions. Evidence of an off-white lime render survives in small patches. The stone work, where revealed by erosion, is approximately 1m thick. The front of the wall is irregularly coursed with an upper (eastern) stretch of large squared blocks (Plate 4), with a distinct break to a small stone rubble coursing (Plate 5), beyond which (lower down the slope) the course becomes more mixed with some squared blocks and patches of rubble work. In general the coursing is angled downslope, but is occasionally horizontal. The exposed height of the standing front of the wall ranges from 0.3m and three courses to 1.55m with approximately 12 courses. In places the lowest courses of the wall are obscured by dumps of soil and stone eroded from the earth bank above. Elsewhere, at the upper (eastern) end the lowest course appears to have been exposed as this course appears to sit on soil. In this area the lowest course is stepped out by approximately 0.1m to 0.2m (Plate 6). Where render is visible in the area of the step, it is always above the height of the step and this may indicate that the stepped course was originally footings, forming a plinth course, and possibly positioned in a foundation trench. The revetted bank is considerably higher than the standing front of the wall in all places, and erosion has exposed the rubble core within this bank indicating that the wall face probably stood to an original height of at least 2m (Plates 7 and 8). The original size of the structure is also indicated at the top end of the wall at the point where it joins the northern boundary of Zone 1 where there is an erosion cone beneath a large ash tree. The erosion cone was not drawn but is an estimated 2.5m high, and approximately half way up the slope is three courses of stone, matching the line and type of the wall further downslope, and in addition above the coursed stones and angled away towards the top of the bank an area of rubble and mortar core is exposed (Plate 8). Beyond the erosion cone the northern boundary of Zone 1 is of a different character and appears to abut the earlier northwest angle wall. A single heavily corroded iron nail, possibly square, was recorded on the face of the wall. The Scheduled Monument description details the remnants of a ditch fronting the wall 15m wide and 0.3m deep, but no evidence of this was observed.

- 6.4** *Condition:* Of the upper end of the NW wall exposed the standing wall is generally in good condition. One section of approximately 4m length is heavily bowed due to pressure from tree growth and is in imminent danger of collapse. Elsewhere a previous fallen tree, although sawn to reduce further problems, has deformed the wall beneath it, although this appears to be stable. Towards the upper (eastern) end of the wall a small area, measuring approximately 0.35m by 0.35m, is missing its facing stones. In the bank above the standing wall wild animal burrowing and tracks causing erosion was noted in three places (Plate 9) and at the bottom (western) end of the exposed structure (approximately central to the length of the entire wall), an area eroded by stock animals gaining access to the top of the bank is present. It is apparent that the major threat to the standing wall in the area exposed is through damage to the bank above by tree growth and animal erosion. As part of the current HLES scheme the hedgebank has already been heavily reduced, but several large mature oak trees remain, and those that are on the outer edge of the hedgebank, closest to the wall face, remain a threat to the stability of the structure.

- 6.5** *Management recommendations:* The circuit of the fort on this northwest side is still poorly understood. The process of revetment leading to a major drop from the inside of the fort to the outside and down a steep slope is difficult to envision, but this clearly represents a major piece of work, notwithstanding whether it was also fronted by a ditch. Further vegetation reduction and management to inhibit future large tree

growth is recommended alongside previous recommendations to reduce the potential for stock animal access to the wall and bank by fencing. The remainder, lower half, of the wall also needs to be cleared and recorded and its condition assessed.

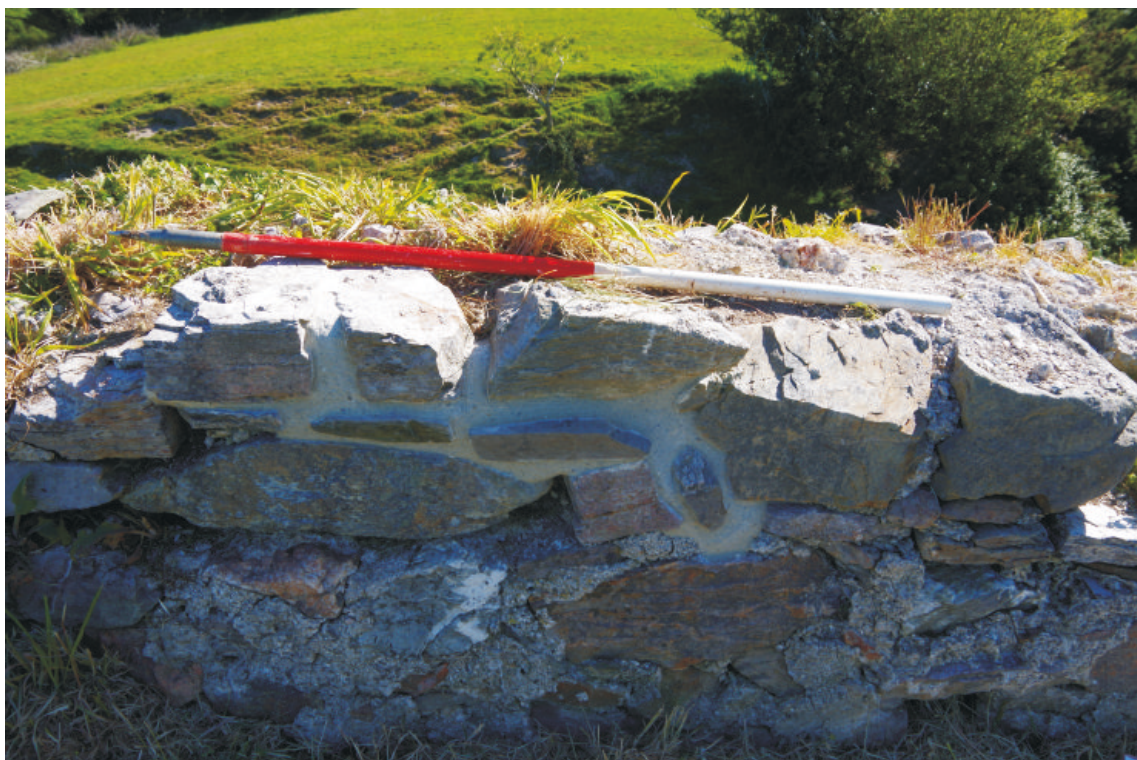
Plate 1: Zone 1, northeast wall interior, reset stones (C), viewed from the southwest.
1m scale

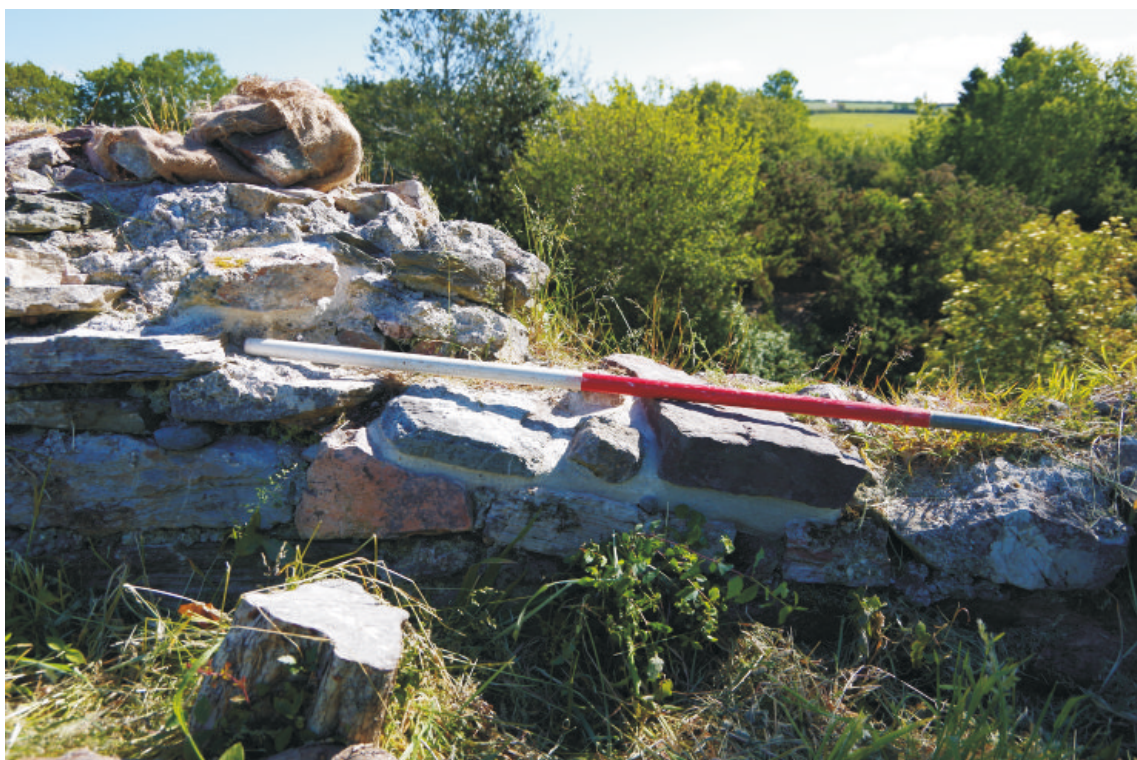
Plate 2: Zone 1, northeast wall interior, reset stones (E and F), viewed from the southwest.
1m scale

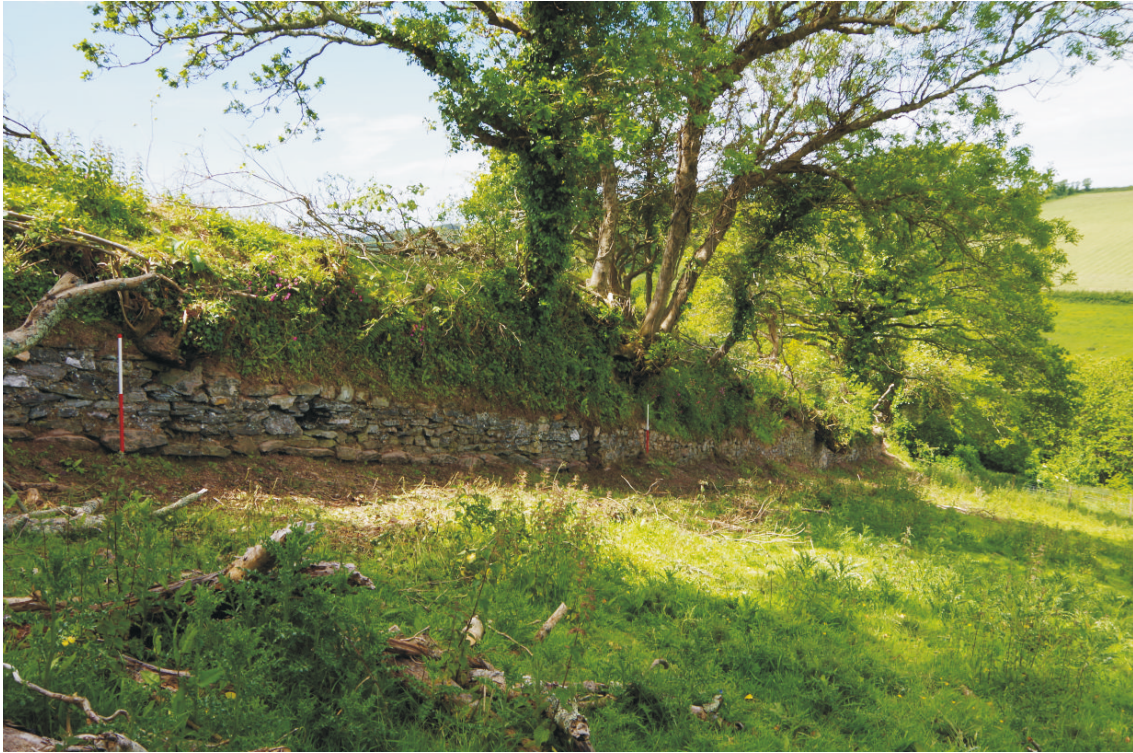
Plate 3: Zone 2, northwest wall, viewed from the east. 1m and 1m scale

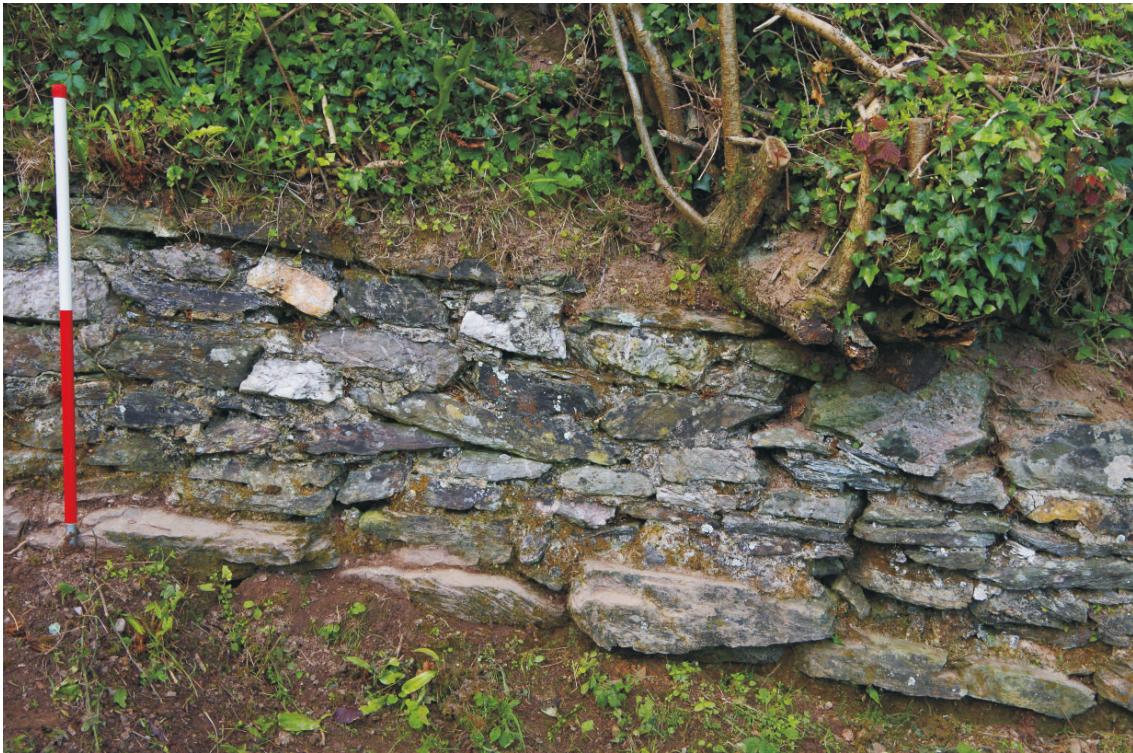
Plate 4: Zone 2, northwest wall, squared block coursing and base step, viewed from the north. 1m scale

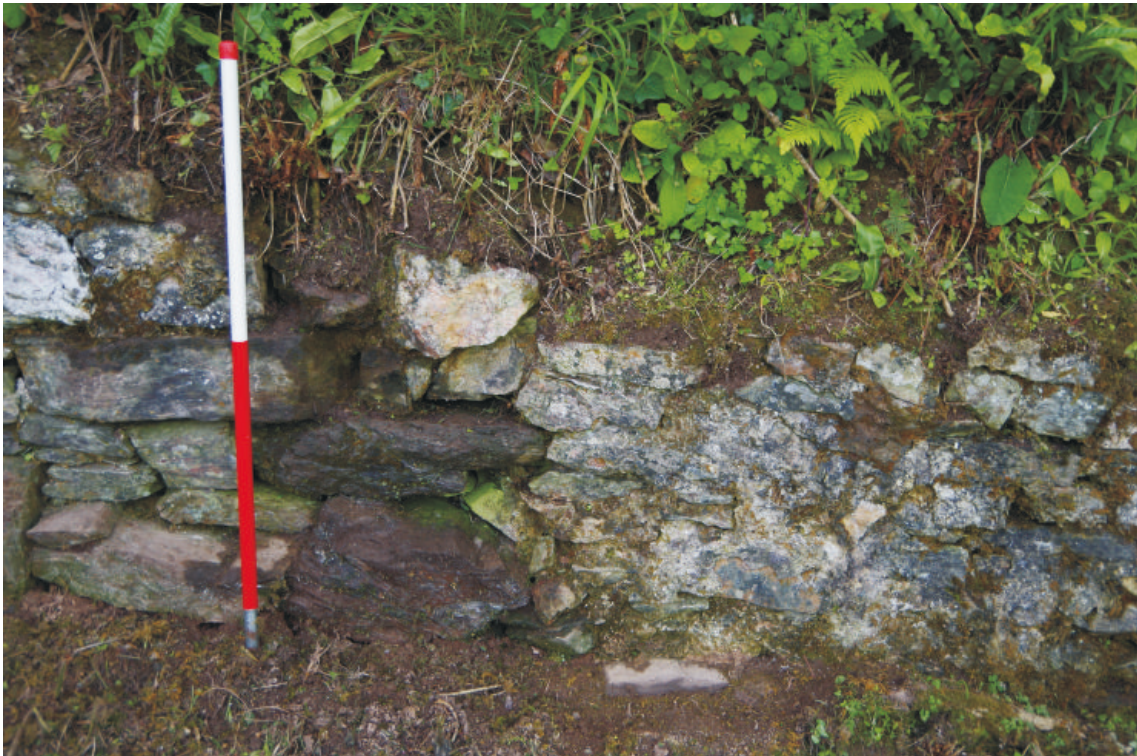
Plate 5: Zone 2, northwest wall, break between block and rubble coursing, viewed from the north. 1m scale

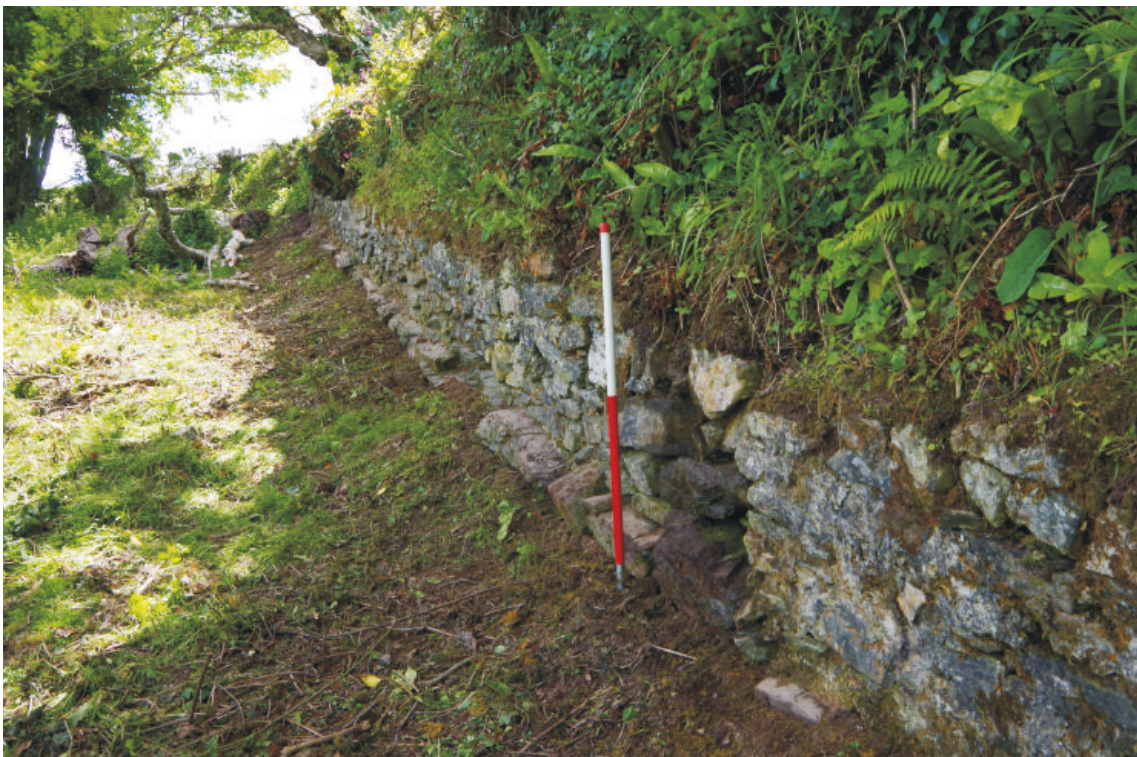
Plate 6: Zone 2, northwest wall, showing stepped coursing at base, viewed from the northwest. 1m scale

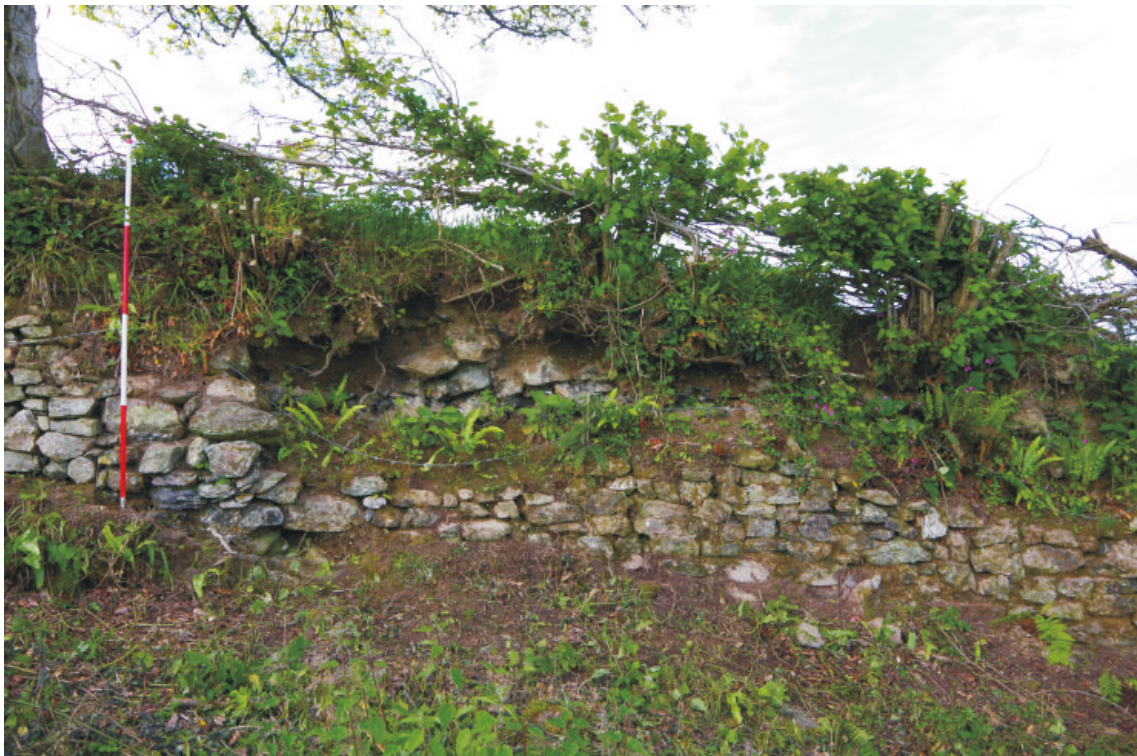
Plate 7: Zone 2, northwest wall, showing exposed core, viewed from the northwest. 2m scale

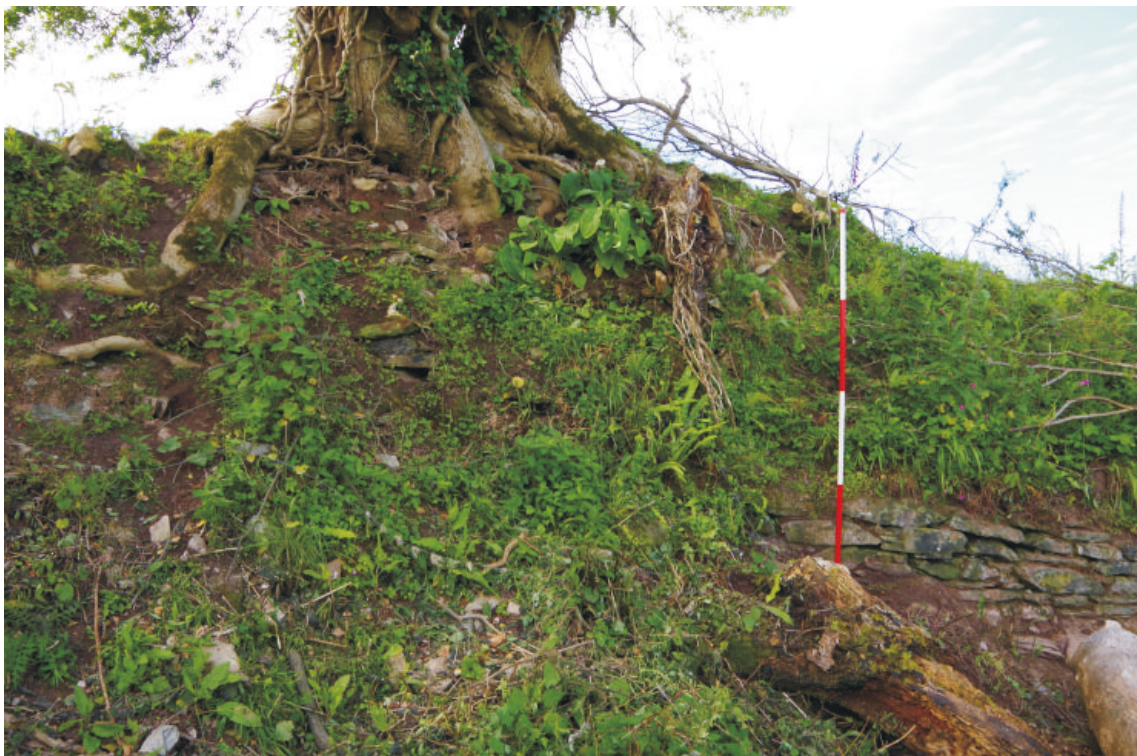
Plate 8: Zone 2, eastern corner of northwest wall, showing erosion cone, viewed from the north. 2m scale

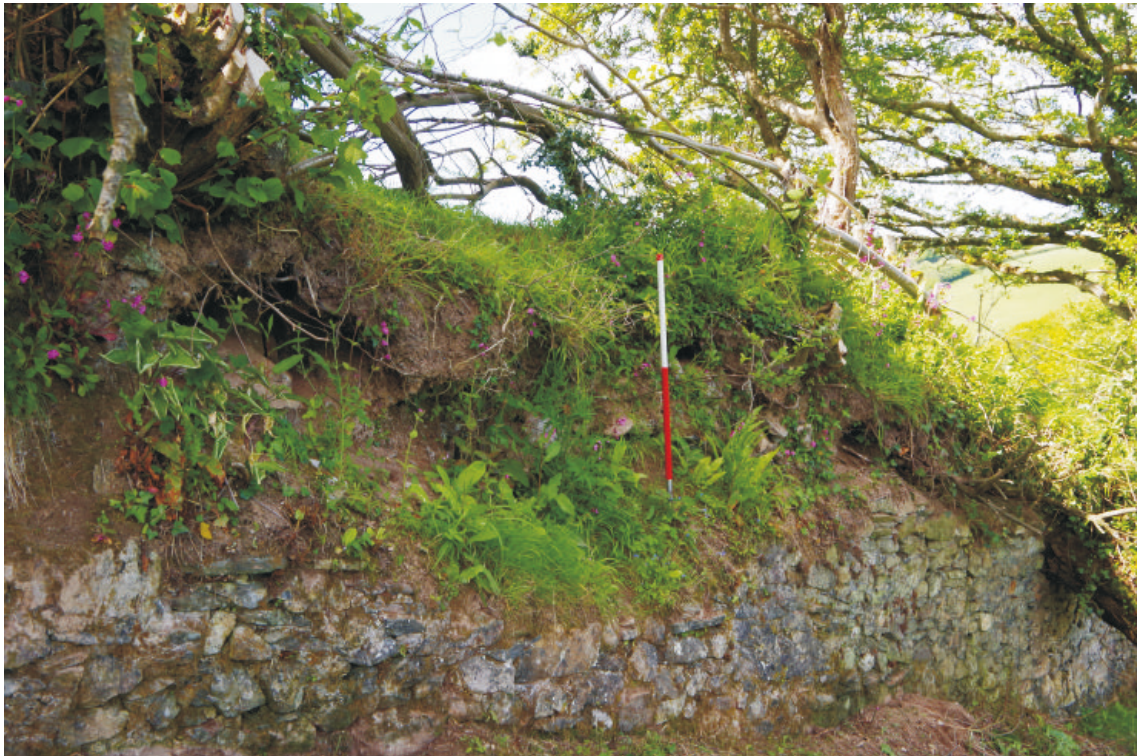
Plate 9: Zone 2, northwest wall, wild animal burrowing, viewed from the northeast. 1m scale

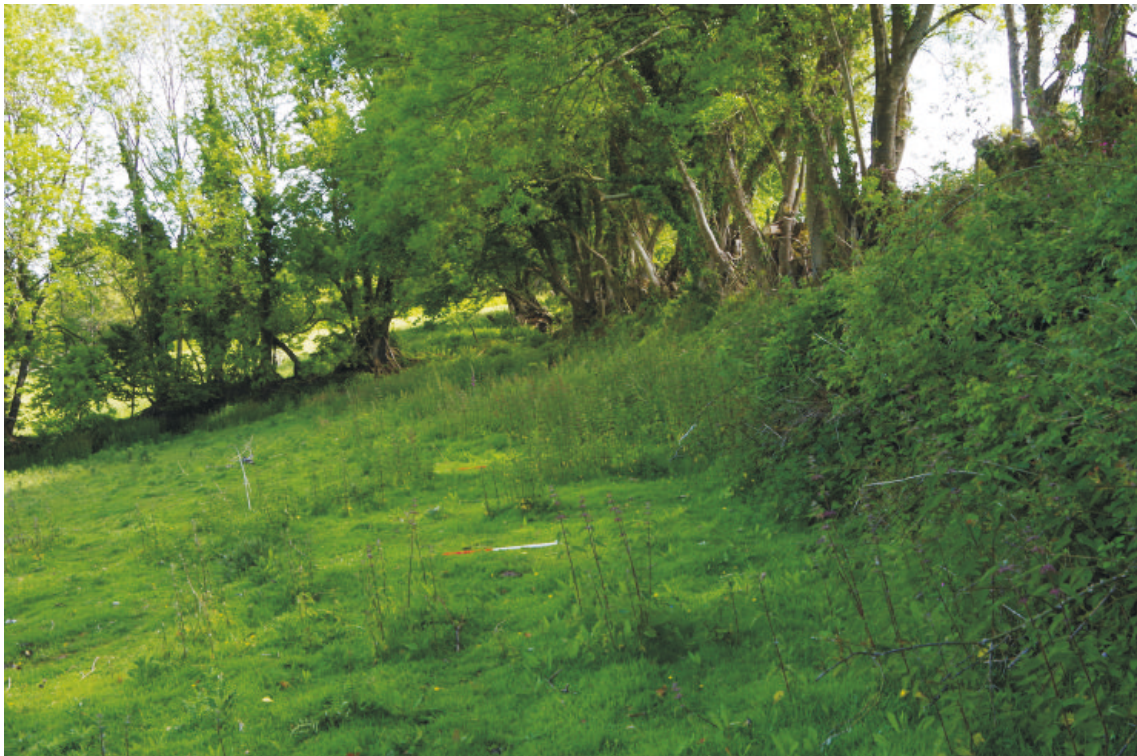
7.2 *Description of works:* Following a visual inspection an off-set survey was made of the features identified. It was found that below the tree-formed boundary line the bank slopes steeply to a narrow berm, up to 1.5m wide, below which a scarp averaging approximately 0.5m deep that forms the southeast side of a terrace measuring approximately 5m wide. The terrace sits above the natural slope of the steep hill on this side. The terrace and scarp appear to run for a length of approximately 100m in front of the boundary; although it should be noted that detailed observations were made difficult by a thick covering of nettles present during the survey work. The nature of these features does not appear to be agricultural or for a track and could be the surface remains of a ditch in front of the boundary on this side. The position of the berm may mark that of any formal structure, matching the walls found elsewhere, as the hedgebank appears to be heavily eroded. An indication of this can be seen at the southwest end where a fragment of drystone wall foundation, measuring approximately 3.2m long by 0.9m wide, follows a line at the level of the top of the hedgebank which when projected follows the line of the berm, perhaps indicating that the land at this level has been removed by erosion or quarried away since a wall was built here.

7.3 *Condition:* As part of the current HLES scheme the mature trees on the hedgebank have already been heavily cut back to reduce windage, and reduce shade which attracts livestock. No further work to the hedgebank other than continued management of the vegetation is recommended.

Plate 10: Zone 1, northern boundary terrace, viewed from the southwest. 1m scale

7.4 *Management recommendations:* The nature of the circuit of the fort on this northern side of Zone 1 side is not well understood and could contain evidence of both Phases I and II in the construction of the site (see Rainbird 2014). It appears that the majority of the evidence that might relate to a revetting of the bank (as found in the northwest wall) has already been lost, but there is potential for buried evidence to survive and potential for standing remains at the southwest end where it meets the northwest wall. The potential field evidence for an infilled ditch, which matches the width of the outer ditch identified in geophysical survey and as a cropmark on the northeast side of the earthworks between Zones 1 and 5, is a major addition to the archaeological potential of the site and any future programme of archaeological works should include a means to characterise the terrace feature as one of its aims.
