BARN AT GLADHAYES FARM, CLAYHIDON, DEVON

Results of historic building recording

Mid Devon District Council planning reference 14/01736/FULL,
condition 3

Document No: ACD1138/2/1

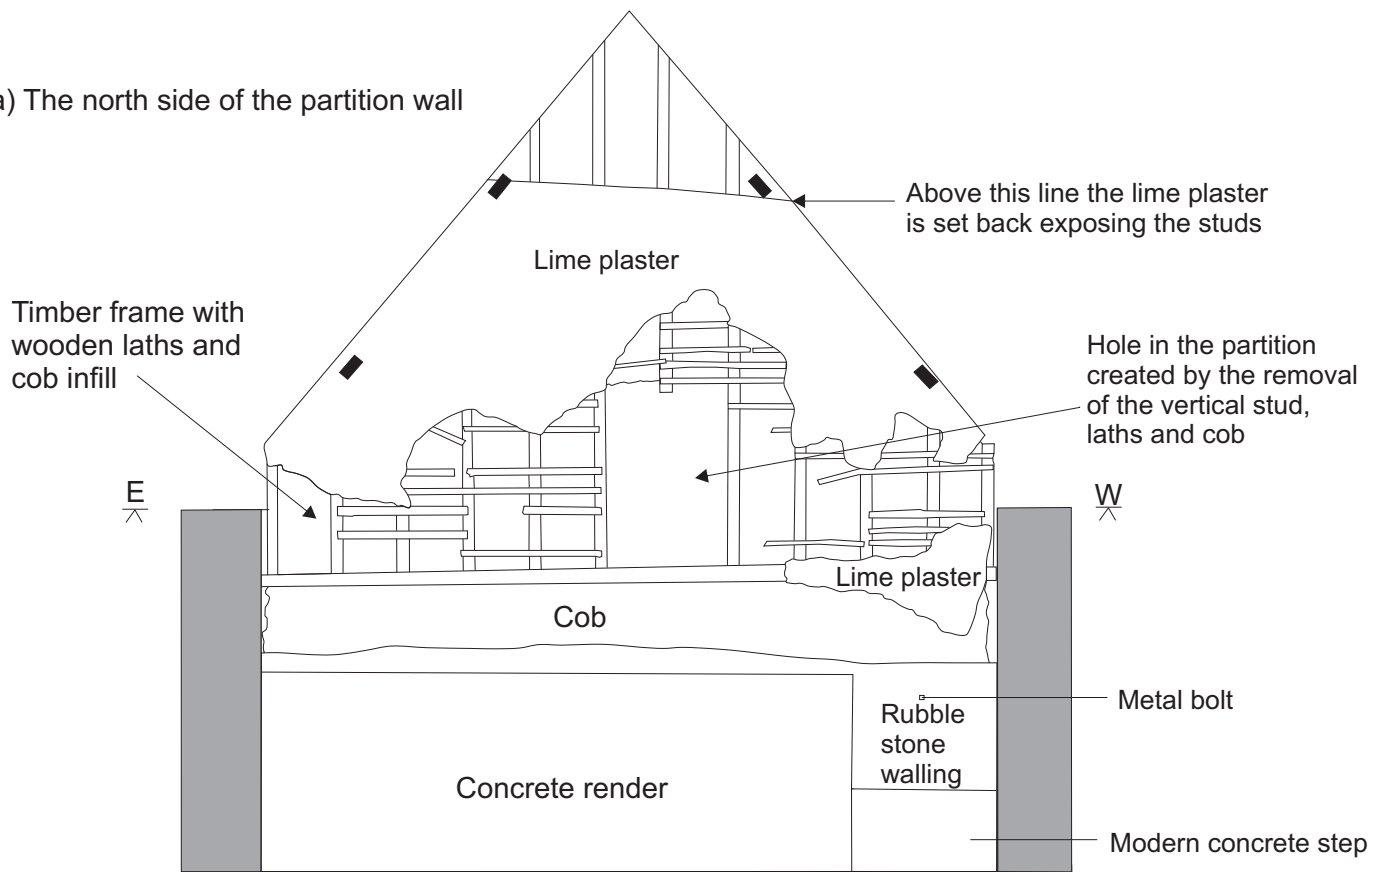
a) The north side of the partition wall

The partition wall is constructed from several materials. The lower portion is chert masonry bonded in lime mortar with patches of repair in cement, and a large area of

cement render on its north face. The stone masonry is identical to the barn's external walls. Above this is a layer of cob with a high clay content. The cob has crumbled at the edges and no longer reaches the side walls. It was previously covered with lime plaster and a small portion of this survives on the east side.

On top of this cob is a horizontal wooden beam which forms the base of the wooden frame in the upper part of the partition. The wooden frame continues to the apex, and is formed from vertical wooden posts or studs with panels infilled with cob. These are covered by nailed horizontal laths that hold the cob in place but primarily supported a layer of lime plaster. Both the laths and plaster only partially survive. The cob within the panels has less clay than the cob in the lower part of the partition and a much more mixed character. The frame is not as wide as the lower portion of the wall; it is flush with the wall on its north face but is set back from the wall on its south face. In the upper part of the partition on the north side the vertical posts stand proud of the lime plastered panels which are recessed in this area.

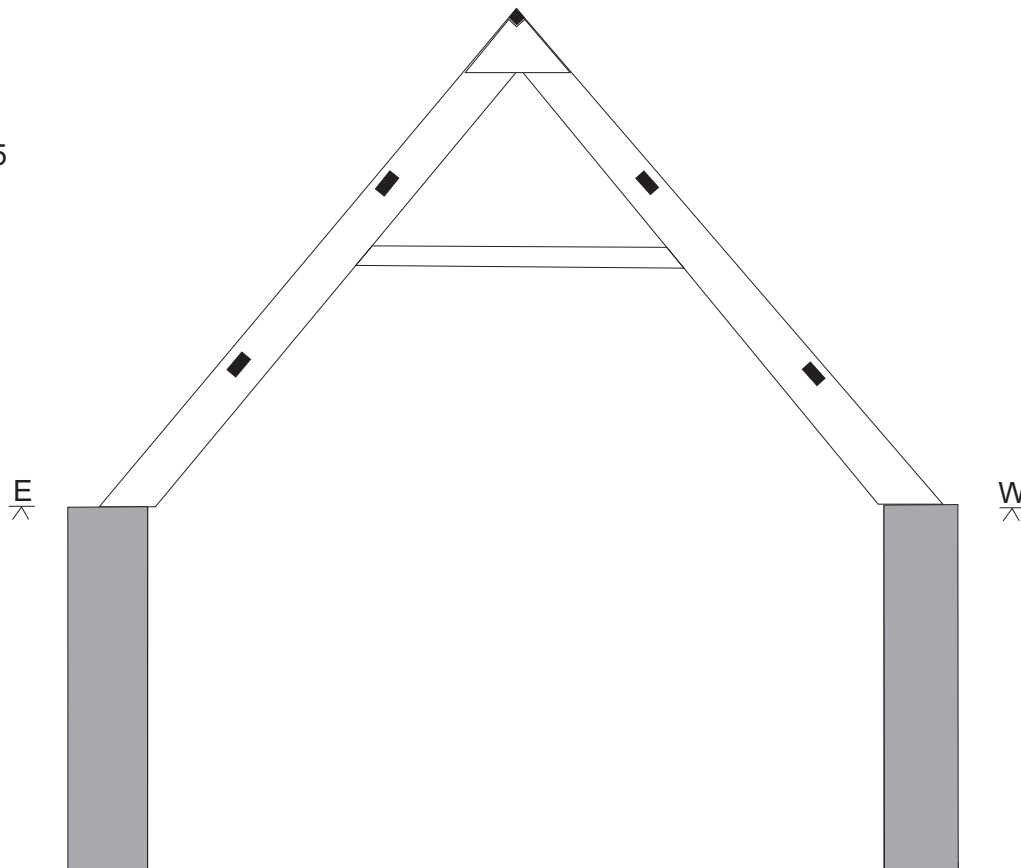
b) Truss 5

The ends of the principal rafters are supported on the rough-hewn lintels of the windows to the south.

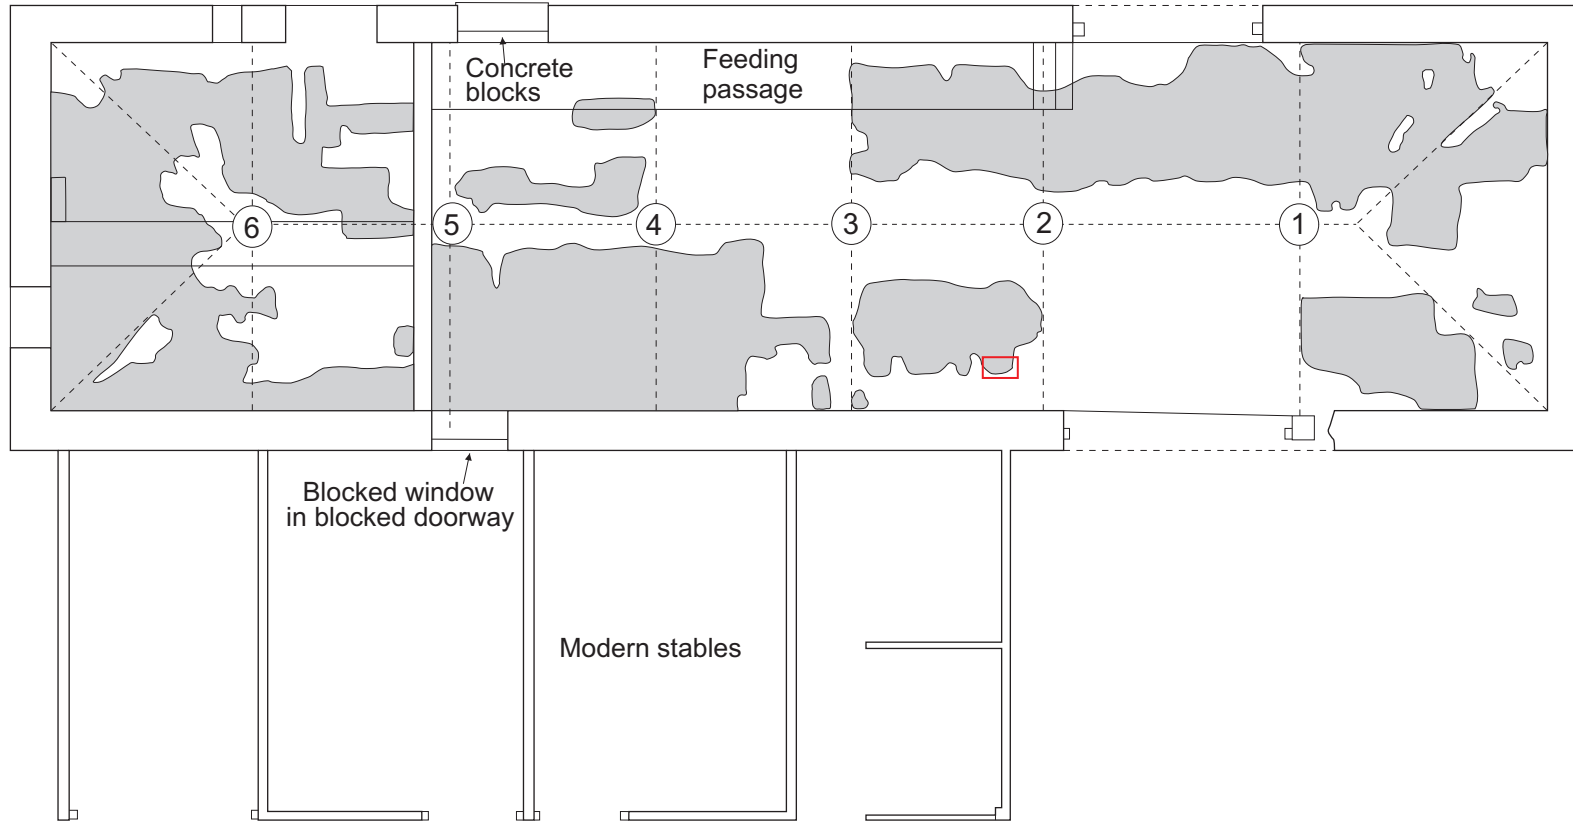
TITLE
Fig. 3: Plan showing
location of thatch

The historic building evaluation concluded that the original roof covering was thatch and that the lower layers of this survive across around 60% of the barn, attached to the rafters with spars. As part of this survey a plan of the location of the surviving thatch was created to show more accurately (than presented in the evaluation) the pattern of its survival (Fig. 3).

A sample of *in situ* thatch was retrieved from the underside of the surviving thatched roof. The thatch was positioned longitudinally over the closely-spaced batons attached to the secondary rafters. As would be expected for a purpose-built barn, there was no evidence for smoke-blackening of the thatch. It comprises wheat straw stems, traditionally used for thatching in Devon, with many of the wheat ear spikelets being well preserved and containing on average 10-12 glumes. Whether the thatch was a 'base coat' of threshing waste or represents the outer layer of 'spar' straw, which according to Letts (2001) often contained longer stems and was of higher quality, is not known; however, no other crop weeds, often indicative of threshing waste, were present in the sample, and the single-stems of wheat, including the ears were well-preserved. The location of the sample from the underside of the surviving thatch would not naturally indicate an upper spar layer but it does appear to be composed of higher-quality, homogenous and long-stemmed wheat straw.

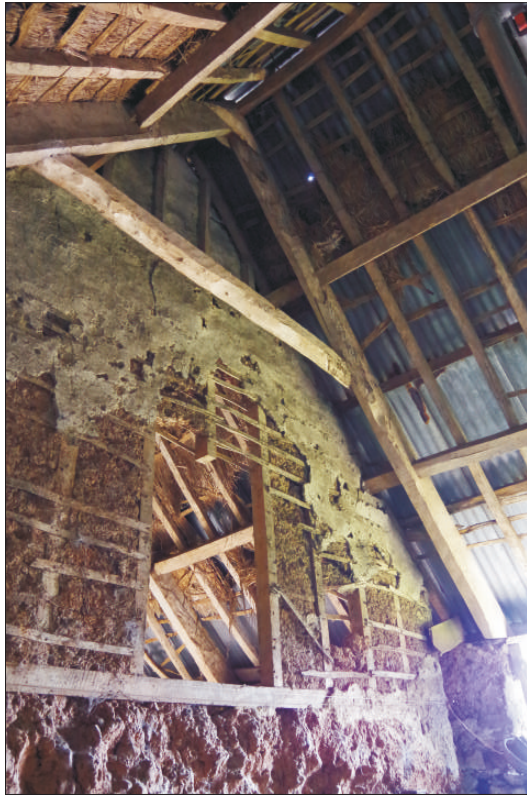
Plate 1: Partition wall within the barn, looking southwest

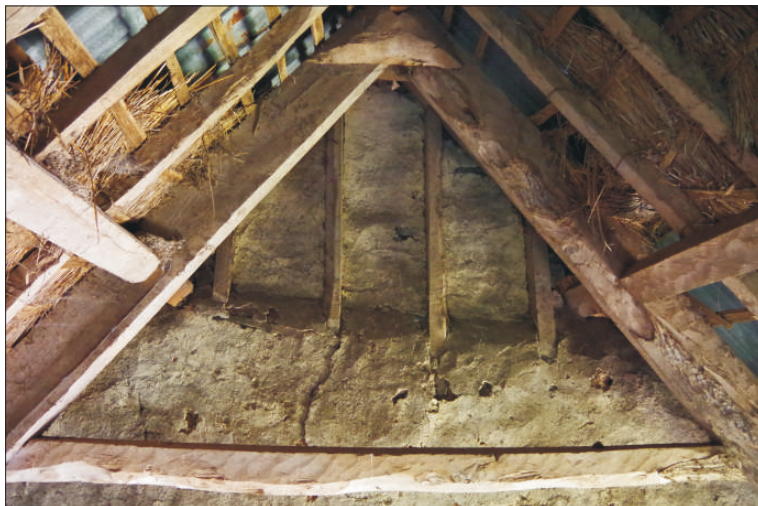
Plate 2: Top part of the partition wall and the upper part of roof truss 5, looking south

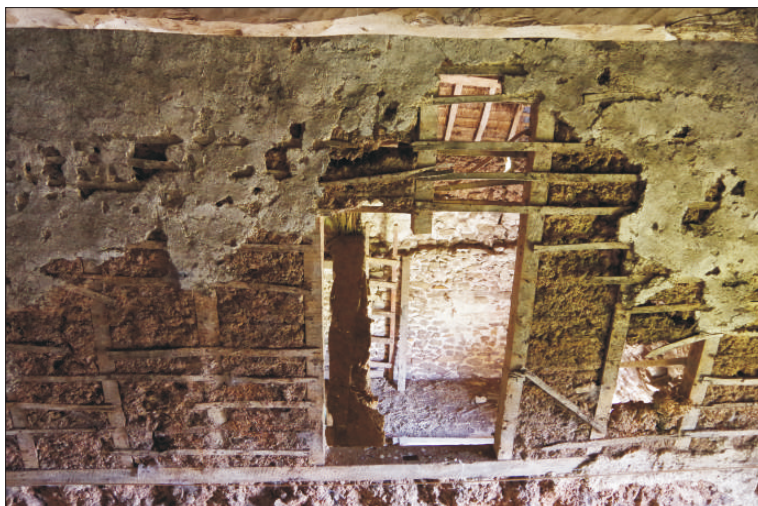
A central gap in the lath and plaster had been thought to be an original opening but closer examination has shown it to be a later feature. The opening has been created by removing part of one of the vertical posts and two panels of cob; the socket for the vertical stud is visible in the horizontal beam below.

Plate 3: Central part of the partition wall showing the removed stud and socket in the beam below, looking south

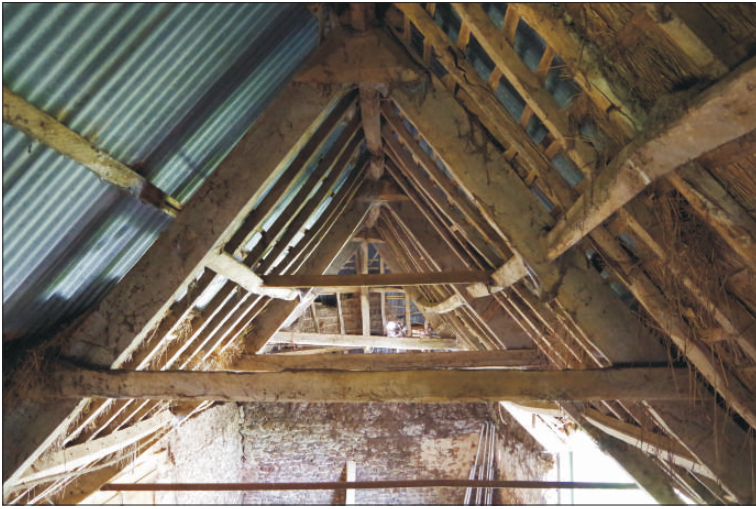
As with truss 3, an additional post has been attached to the underside of the west principal rafter, and a square steel tie beam has been added to the base of the truss. On the west side of the collar an L-shaped structure of thin batons drops from the collar and attaches to the principal rafter. This may be a disused bracket, perhaps supporting a now-removed pipe.

Plate 4: General view of roof trusses, with truss 4 in the foreground, looking north

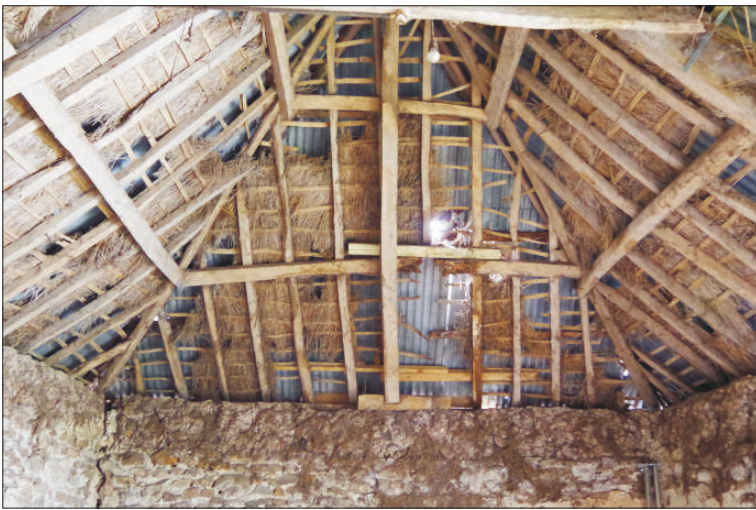
This is the hip rafter at the north end of the building. It has no distinguishing features. The hip itself has a central rafter that is trenched both into a short wooden plinth set into the top of the wall and at the apex where the ridge purlin is angled to meet it. Where the corner purlins meet the side purlins they have trenched joints except the lower east purlins, which are unjointed. The upper purlin has a slight trench joint attaching it to the central hip rafter. The lower purlin is rotten and an additional beam has been added to hold it together.

Plate 5: General view of north end of the roof, showing repairs, looking north

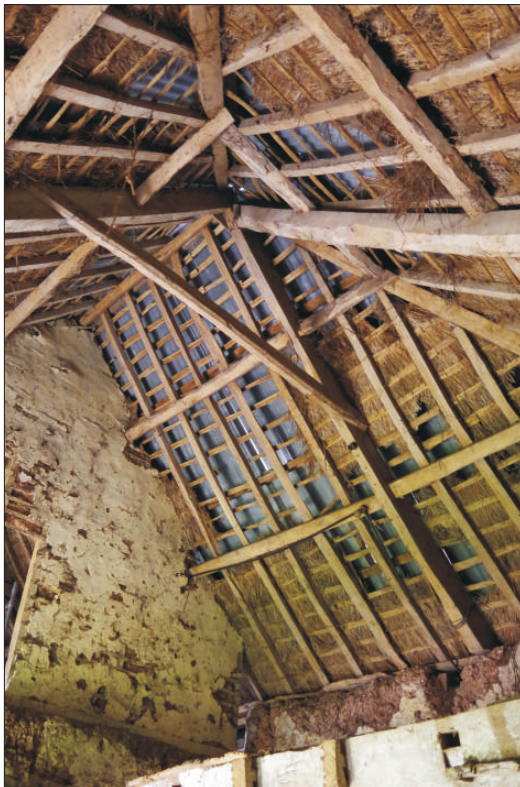
The central hip rafter has slipped to the west and no longer lines up with the ridge purlin. Where the end purlins meet the side purlins they sit on top of one another and are nailed except the lower east one where the two purlins have a trenched joint.

Plate 6: General view of the south end of the roof, showing where the central hip rafter has moved, looking northeast

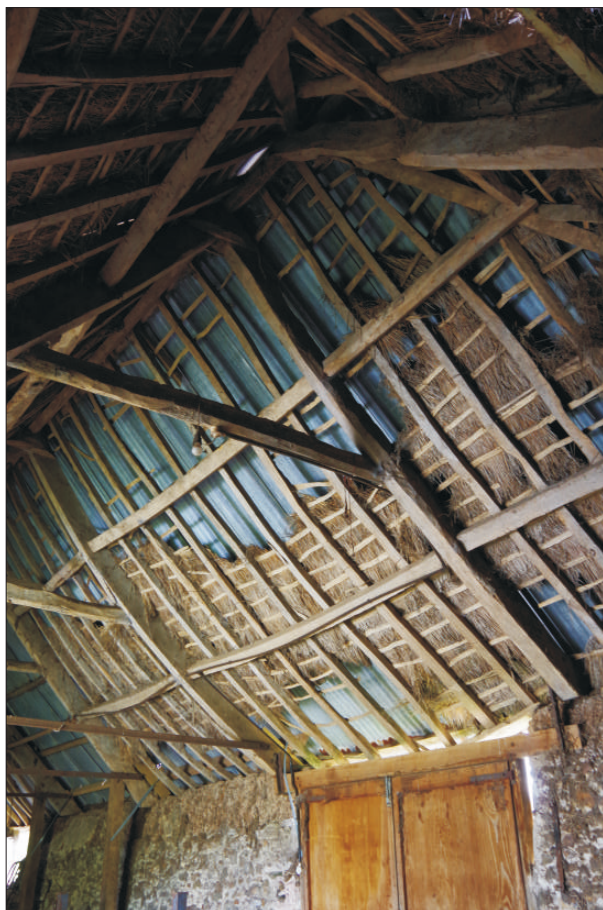
Plate 7: General view of roof showing trusses 1 and 2 and areas of thatch, looking southeast

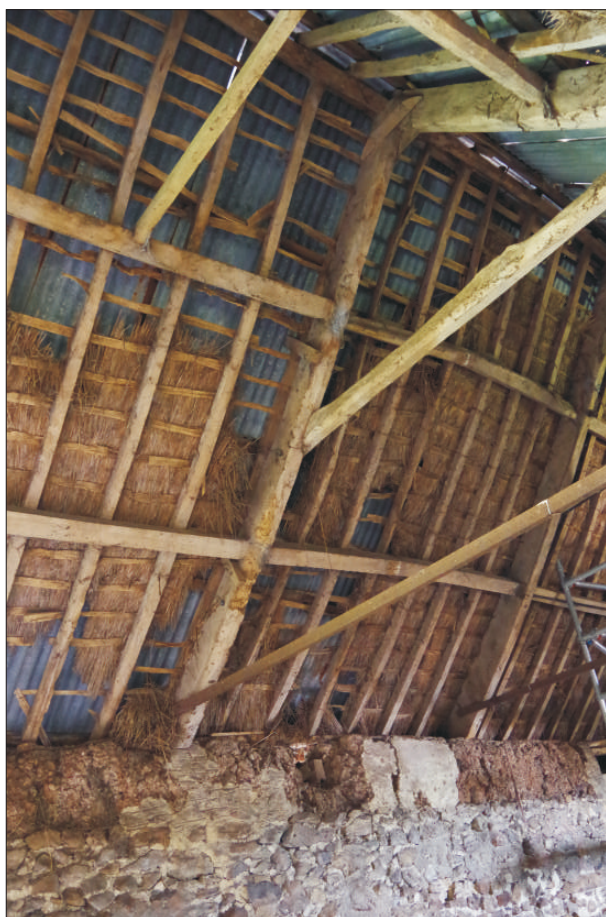
Plate 8: General view of roof showing trusses 3 and 4 and areas of thatch, looking southwest
