Document No: ACD219/2/1

# **LINHAY AT EAST DUNSTER FARM, CADELEIGH, DEVON**

## **Results of historic building recording**

**Mid Devon District Council planning references  
08/00756/FULL and 09/00262/LBC**

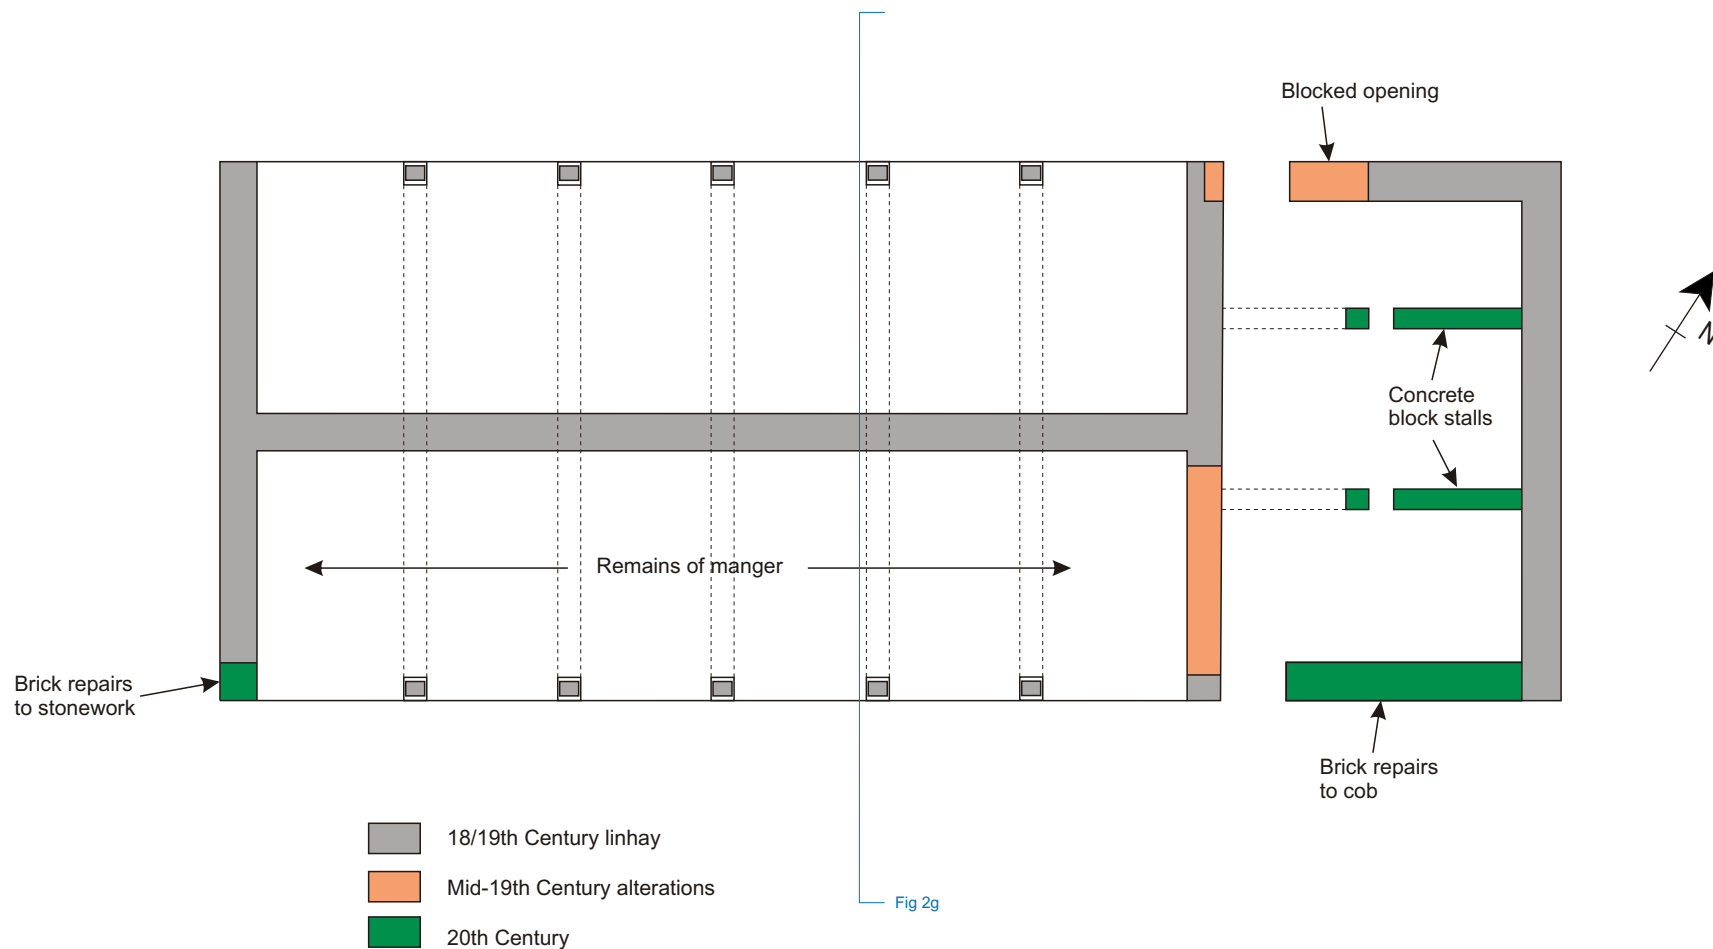
TITLE  
Fig. 4: Phased plan of  
the Linhay

- 5.2** The building has a rectangular plan with a central dividing cob wall, and a separate room at the east end; there were formerly haylofts over both the lincays and the east room. The walls are constructed of red cob on top of a tall red and grey sandstone plinth which is approximately 1.40m high. Here the masonry is laid in rough courses bonded in a pinkish white lime mortar (Plates 2-4). There are remnants of lime plaster on some of the internal walls. The cob has been repaired in several areas; in the east elevation this has been carried out with rubble stonework whilst in the south wall and southeast internal wall this has been executed in brick. There is an area of cement render on the west wall.

- 5.3** The roof structure above of the lincays, along with the former first floors, is supported on five pairs of vertical posts that rise from dressed granite pads. The supporting beams for the first floor are mostly original, dressed rectangular timbers although two in the south linhay have been replaced with unshaped round beams. Those in the north linhay retain a whitewash finish. The beams are attached using tongues that pass through the posts and are secured with two wooden pegs (Plate 5). Where the beams sit in the cob walls the openings are lined with wooden boards (Plate 6). The floor joists of the haylofts above the linhay have been removed but their sockets are visible in the end walls (Plate 7). The listing description provides additional information stating that the north linhay had a closely-boarded upper floor, whilst the south-linhay contained more widely-spaced timbers.

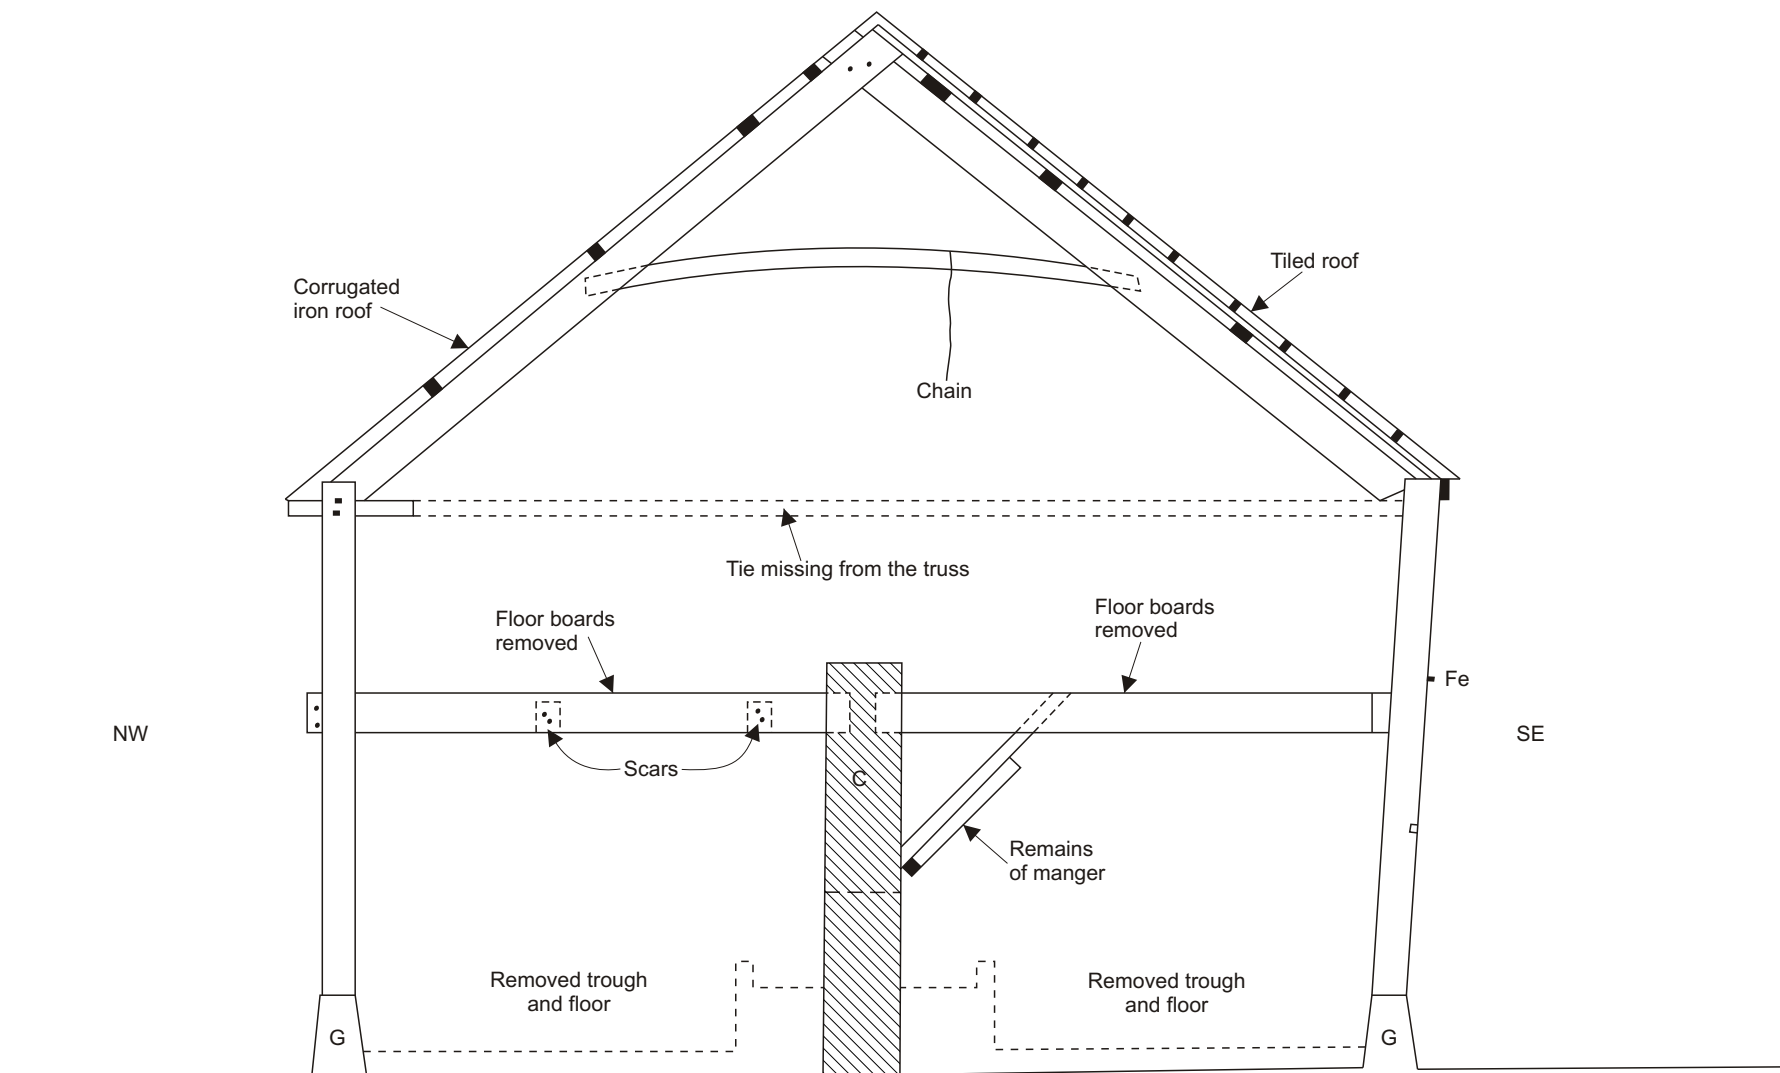
Fig. 5: Profile through  
the Linhays

- 5.8** The building has a hipped roof, the majority of which is currently covered with corrugated metal sheeting, although a large area of clay pantiles survive on the south pitch. It seems likely that these tiles replace an original thatched roof. The roof is supported on seven triangular trusses formed from principal rafters with tie beams at eaves level (Plates 13-14). The latter are set into notches in the top of the vertical posts, and extend beyond the wall line where they support horizontal timbers. The bases of the principal rafters are set into the tie beams at the junction with the vertical posts. The principal rafters have mortice and tenon joints at their apex, and are braced together with high-level halved collars fixed with nails. These are generally round and undressed timbers. Some of the original back purlins survive, and where visible are joined behind the principal rafters. The roof structure above comprises closely-spaced secondary rafters supporting the battens under the pan tile roof, and more widely-spaced replacement purlins directly supporting the corrugated iron sheeting.

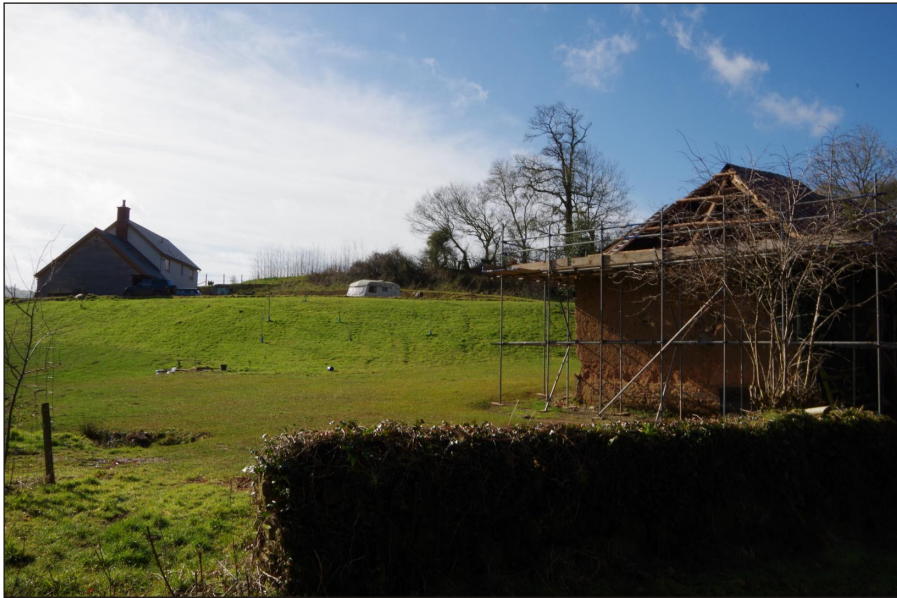
- 5.1** The building is a rare example of a traditional linhay constructed on a back-to-back basis, with its open sides fronting two yards, and an integral 'enclosed' room at its northeast end. It is aligned east-northeast to west-southwest (hereafter simplified as east-west) following the slope of the hill. The hill slopes down to the northeast to a small stream in the valley bottom that now flows into a modern pond. The original farmhouse was located to the northwest of the linhay but this has been demolished and a new farmhouse has recently been constructed to the southwest (Plate 1). All other farm buildings recorded on historic maps have been demolished.

Plate 1: General view of the linhay and modern farmhouse viewed from the northwest

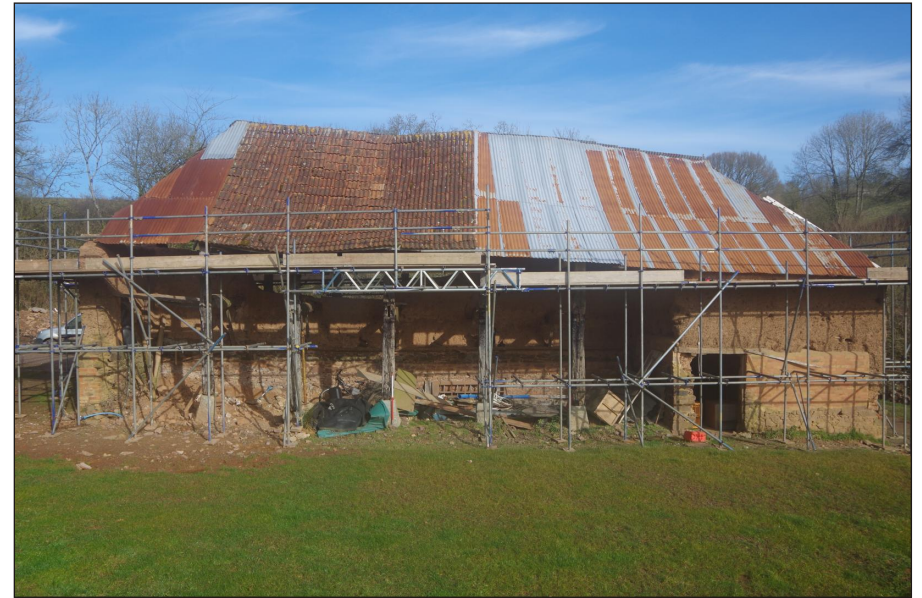
Plate 2: South elevation viewed from the south (1m scale)

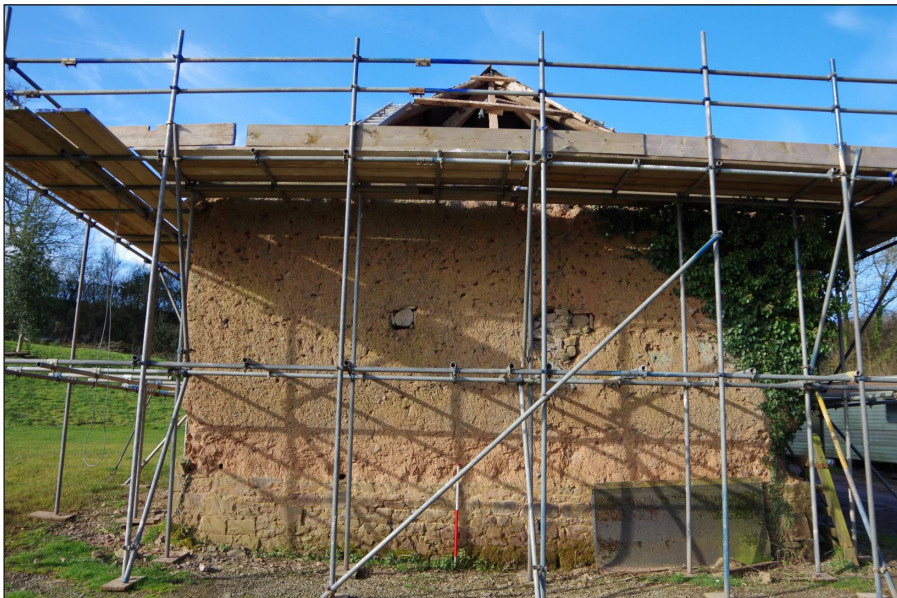
Plate 3: East elevation viewed from the east (1m scale)

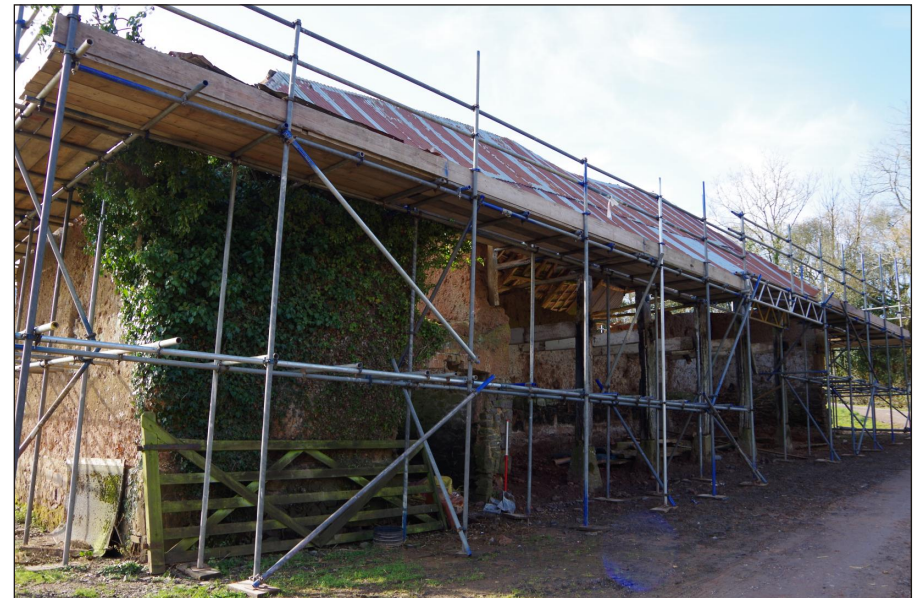
Plate 4: North elevation viewed from the northeast (1m scale)

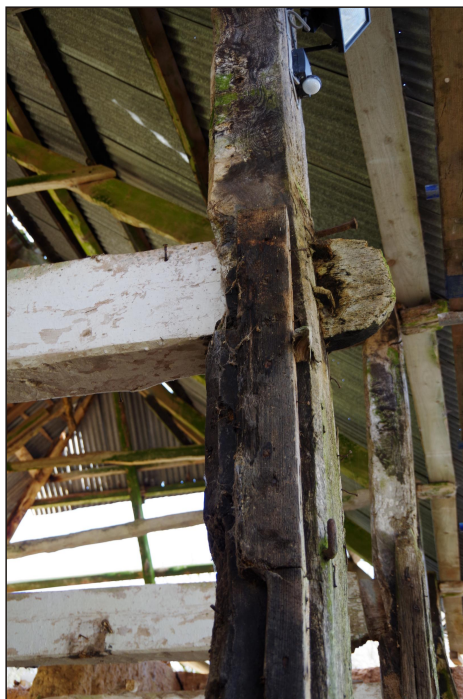
Plate 5: mortice and tenon joint on a first-floor beam and upright viewed from the northeast

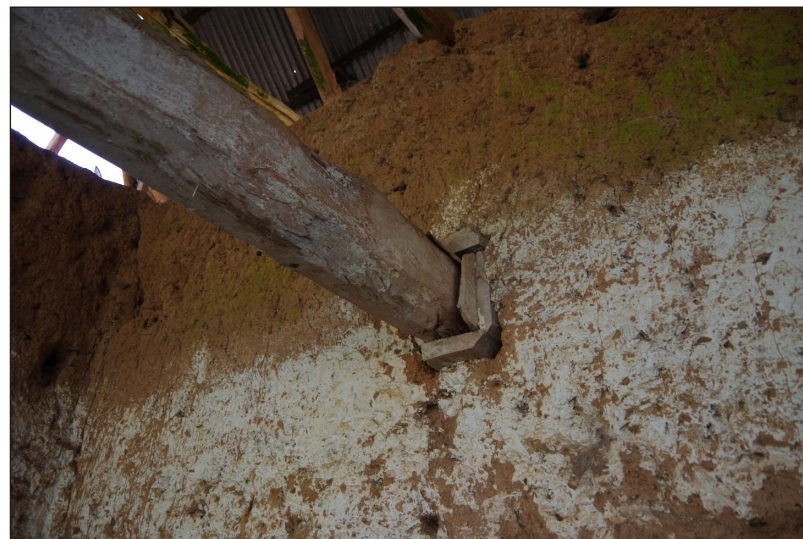
Plate 6: Boards surrounding a first-floor beam in the central cob wall also showing remnants of lime plaster viewed from the southeast

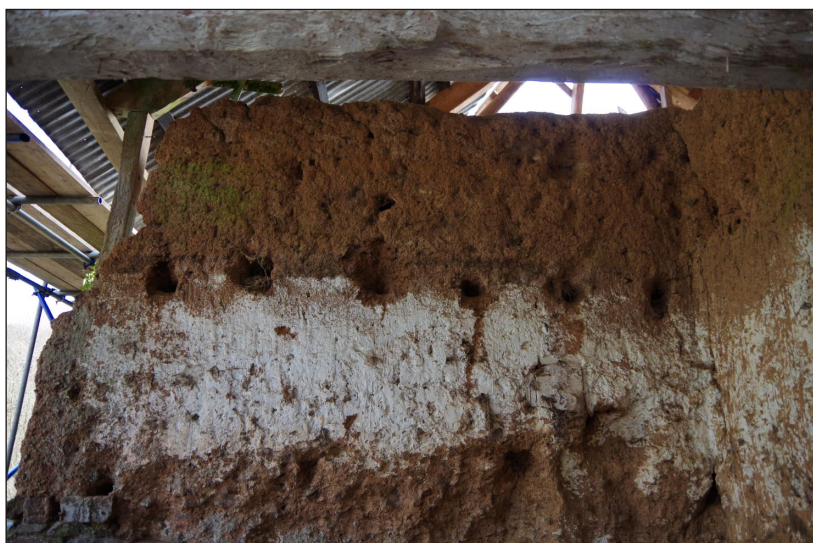
Plate 7: Sockets for the first-floor beams in the east internal wall viewed from the west

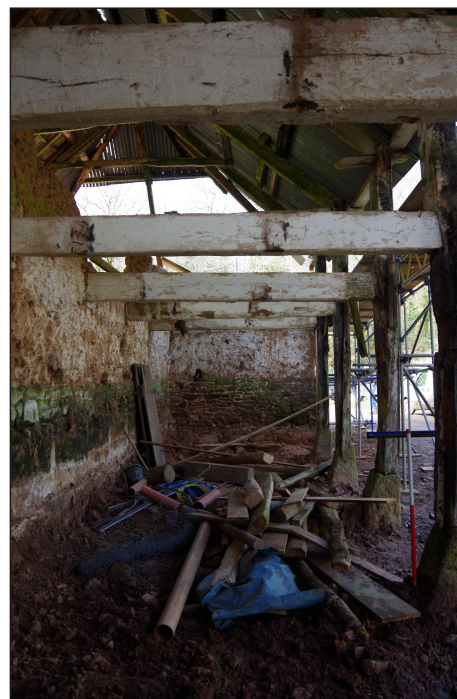
- 5.5** There are no significant surviving fixtures or fittings in the main lincays (Plate 8), though in the south linhay there are wooden battens attached between the floor beams and the partition wall which are indicative of the presence of a manger. Again the listing description provides more information stating that this area formerly contained a trough adjacent to the dividing wall. The listing description also records the presence for six now-removed cow stalls with troughs in the northern linhay. Here the floor beams display scars and nails related to former vertical battens that are probably associated with the stall partitions.

Plate 8: View of the interior of the north linhay from the east (1m scale)

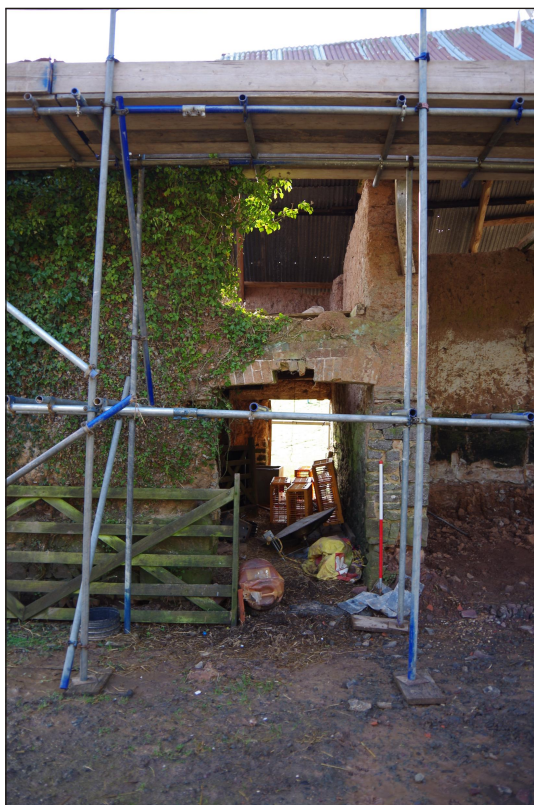
- 5.6** The room at on the east end is accessed via doors in the north and south elevations. The doorway in the north wall has been heightened and has an arched brick head (Plate 9). A remnant of the original, lower wooden lintel survives within the wall to the east, along with what appears to be an upright which is mostly obscured by plaster (Plate 10). The room contains three animal stalls with troughs, all constructed using

Plate 9: Doorways in the north elevation to the east room viewed from the north (1m scale)

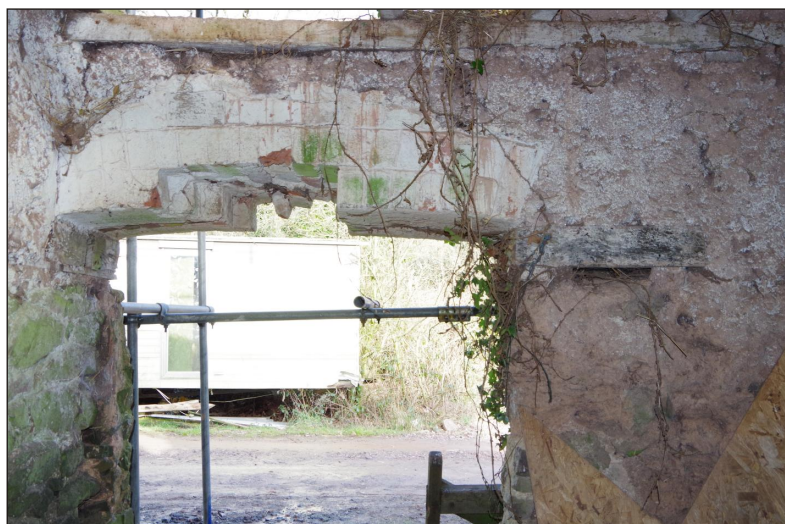
Plate 10: The remains of the wooden lintel in the east room viewed from the south

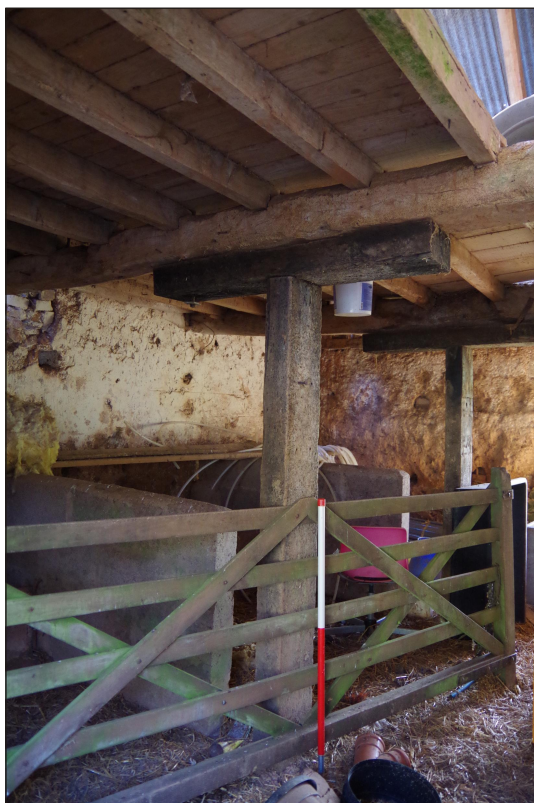
concrete and concrete blocks (Plate 11). In front of the troughs are steel taps and trays for providing drinking water.

- 5.7** The first floor of the eastern room is supported on two main horizontal beams running east to west; these are set into the cob walls, and supported in the centre of the room by additional modern posts, formed by two vertically-set wooden railway sleepers with wooden pads on top (see Plate 11). The main beams support north to south aligned joists, again set into the cob wall, but also resting on thin wall plates. Most of these timbers have been reused, and display evidence of peg holes associated with an earlier structure. The first floor would have functioned as another hayloft. There is a loading door in the north wall above the ground-floor doorway. Most of the floorboards are narrow, and machine cut, and are probably early 20th-century replacements (Plate 12). They incorporate a hatch to enable hay to be dropped down to the ground floor.

Plate 11: View of the ground floor of the east room viewed from the northwest (1m scale)

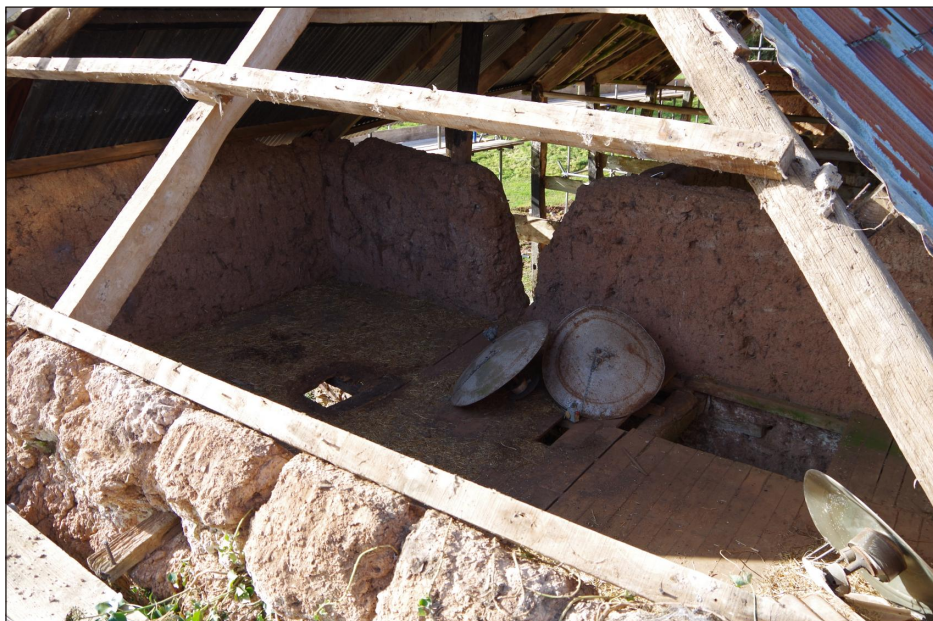
Plate 12: General view of first floor of the east room viewed from the northeast

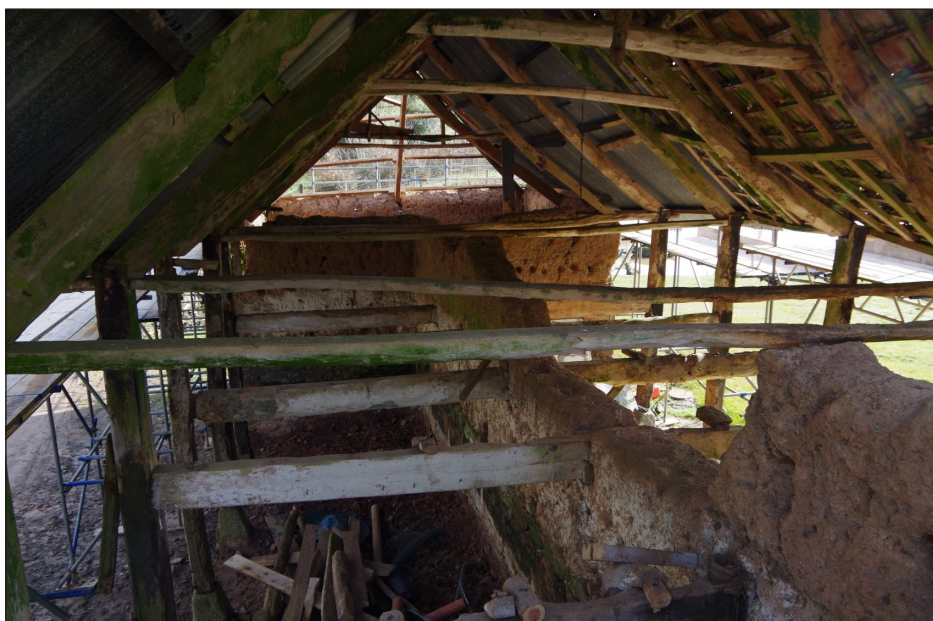
Plate 13: General view of the first floor area and roof structure viewed from the west

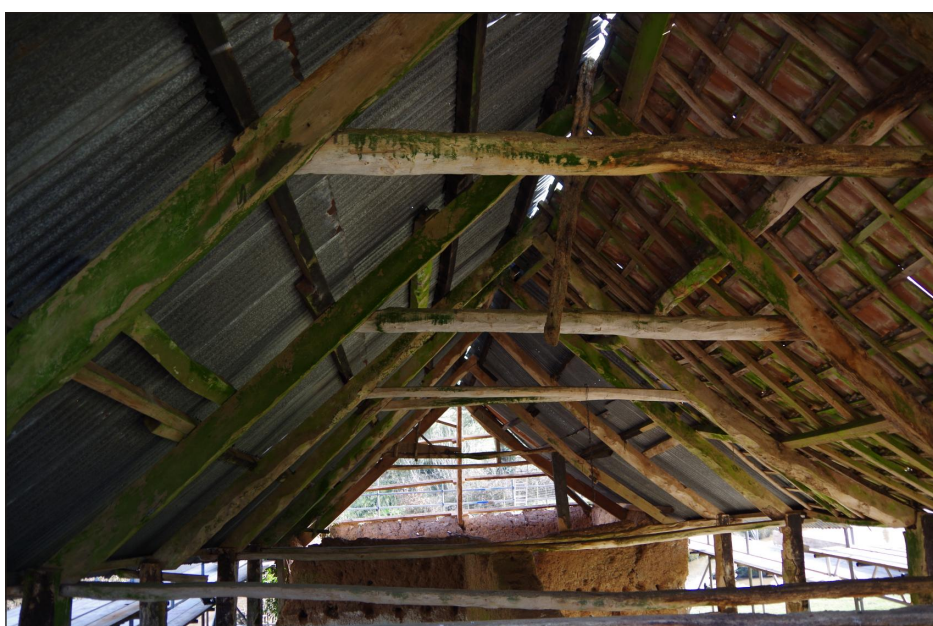
Plate 14: General view of the roof structure viewed from the west
