LAND AT WARRACOTT FARM, CHILLATON, LIFTON, DEVON

Results of Archaeological Investigations

West Devon Borough Council Planning Reference:
00498/2015 (Condition 12)

Report No: ACD1375/3/0

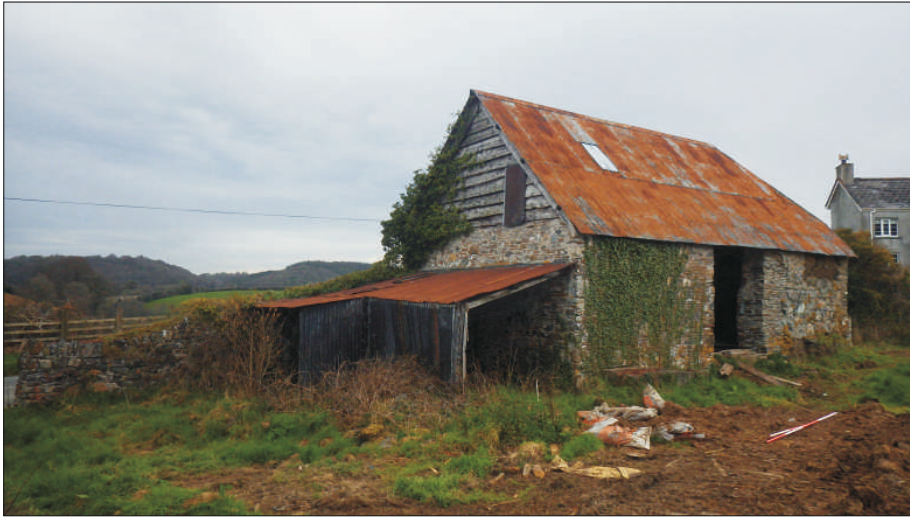
The corrugated roof on its southwest side included a basic roof light that has been blocked with a metal sheet. On the west side of the door in the southwest elevation there was a timber remnant to the former door frame and to the west of this opening, there was a brick animal trough (Plate 3). The upper part of the northwest elevation had timber weatherboarding with a metal plate repair (Plate 1).

Plate 1: General view of northwest and southwest elevations of the barn with the lean-to in the foreground, looking east

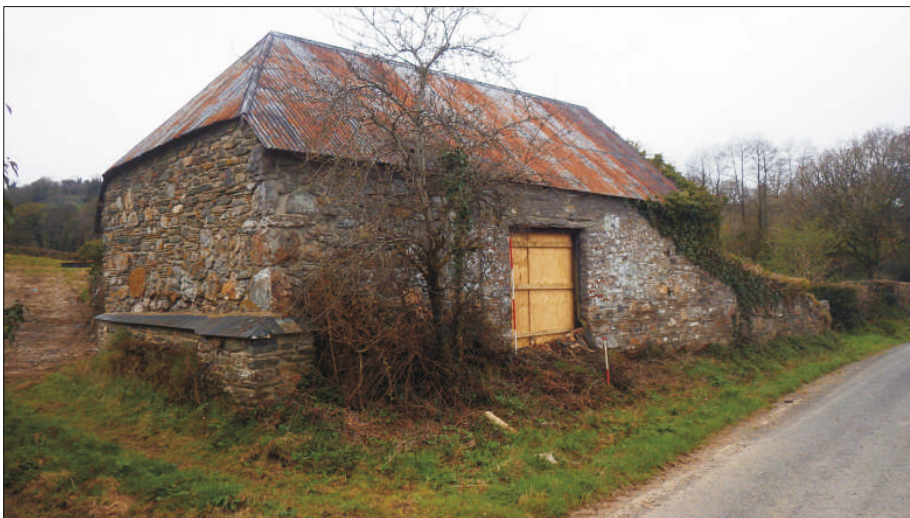
An area of exposed footings showed that the barn was constructed directly onto an outcrop of slate bedrock. The lower courses on the southeast elevation projected slightly and was topped with slates. This projection continued onto the east side of the northeast elevation (Plate 2).

Abutting the northwest corner, and continuing the line of the northeast elevation, was a sloping boundary wall, rebuilt at its northwest terminal to form the entrance into the yard. This was, in part, a potential remnant to the extent of the building range as depicted on the Marystow parish tithe map (Plate 2).

Plate 2: General view of southeast and northeast elevations of the barn with the boundary wall in the background, looking west (2m and 1m scales)

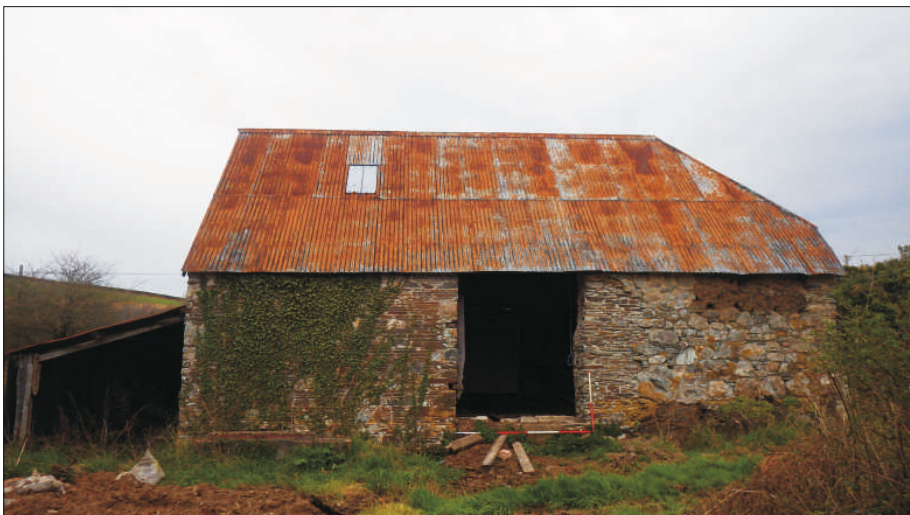
This included either side of the door on the southwest elevation (Plate 3). An area of cob infilling, representing an area of repair, was present within the upper courses of the southeast elevation, with this within the older fabric of the building.

Plate 3: View of southwest elevation of the barn showing the two phases of construction (2m and 1m scales)

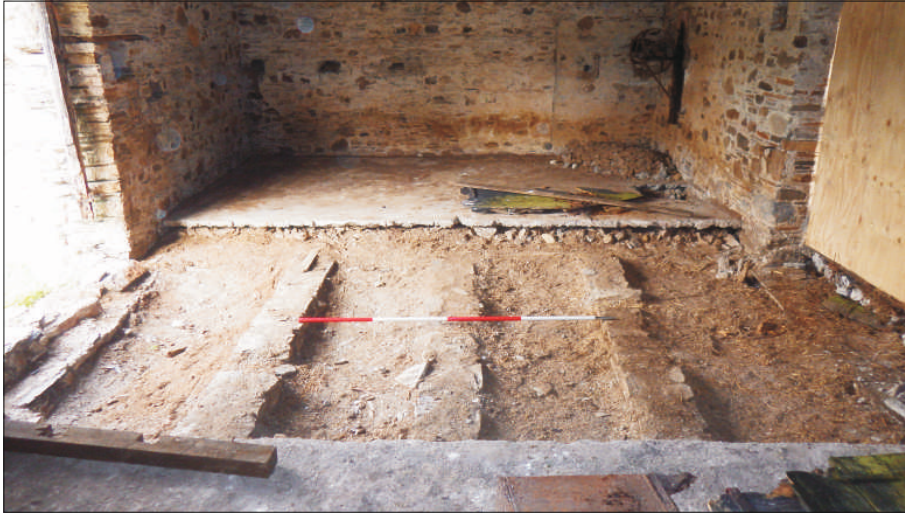
The barn had a concrete floor overlying an earth and rubble make up. Between the opposing doors, a section of the flooring had been removed exposing stone plinths aligned northwest to southeast that would have supported a wooden boarded threshing floor (Plate 4). The roof was supported on A-frame trusses that had mortice and tenon joints, which were pegged at the apex and had applied collars with peg joints (Plate 5).

Plate 4: Showing the floor surface with stone plinths exposed, looking northwest (2m scale)

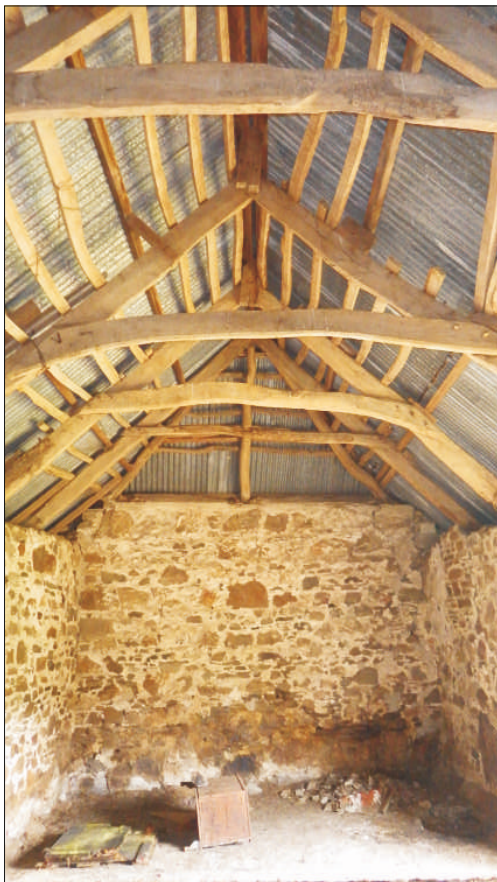
Plate 5: Showing internal view of barn and roof structure, looking southeast

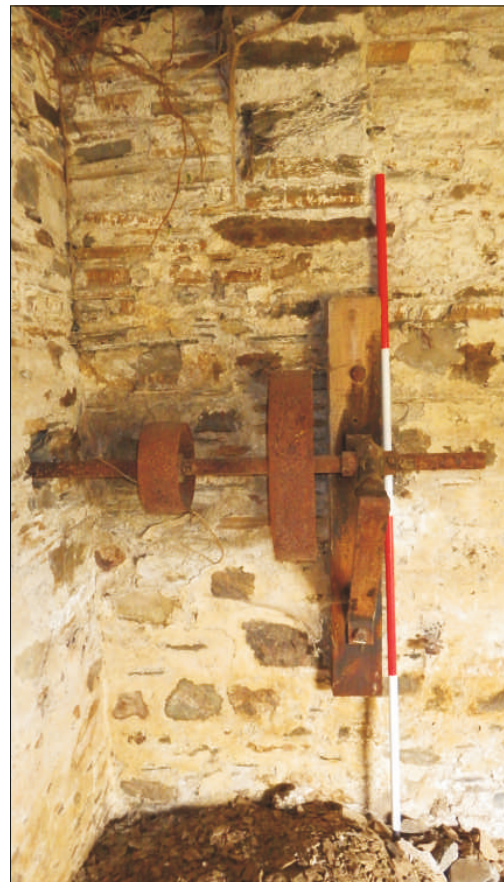
On the east side of the northeast wall there was a line shaft with large and small belt drive pulleys (Plate 6). This was supported on a metal bracket attached to the wall by a wooden plank. The line shaft went through the northwest wall into the lean-to store where there was another belt drive pulley. This was likely to have represented the position of removed machinery.

Plate 6: View of line shaft with belt drive pulleys, looking northeast (2m scale)

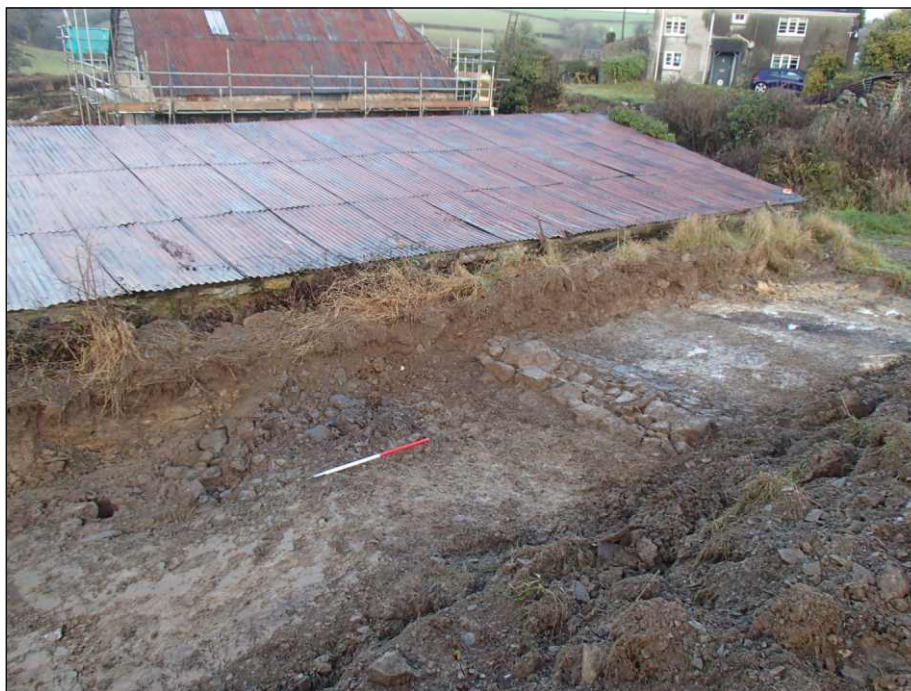
The area stripped to the south of the outbuilding measured 15.5m long and 3m wide. It was excavated to a depth of 0.45m onto natural subsoil (101). This was overlain by a mid greyish-brown silty-clay topsoil. The stripping exposed a stone wall (S105) and a possible ditch (F102).

Plate 7: View of stripped area. Looking northeast with barn in the background (scale 1m)

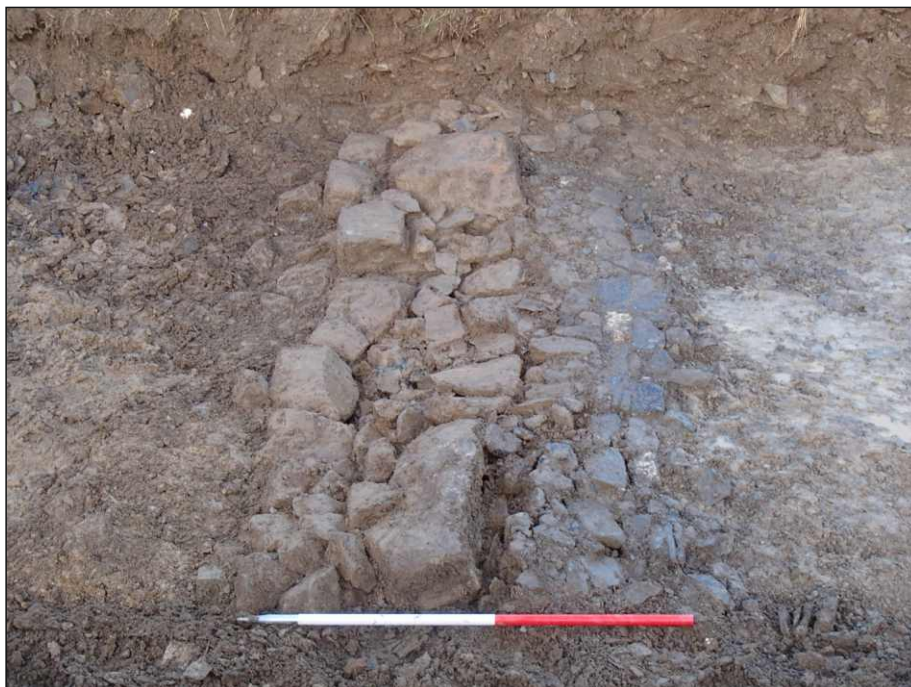
Wall S105 was approximately northeast to southwest aligned and set within a construction cut (F104). The wall measured 0.8m wide and was constructed from clay-bonded roughly faced limestone and slate blocks with a rubble core. It was

abutted on the southeast side by a 0.6m wide surface (106) comprised of 0.12m to 0.21m long cobbles within a mid-greyish brown silty-clay matrix.

8.2 Footing S105, exposed in the monitored area to the south of the outbuilding, represented the base of a relatively well-constructed wall. Its position is broadly comparable with the outbuilding shown on the 1839 Marystow parish tithe map suggesting that part of this former structure, which is then absent on the 1884 First-Edition Ordnance Survey map, was potentially exposed by the work. The narrow arrangement of cobble surface 106, as abutting the perimeter of the wall, is likely to have represented associated metalling, with this perhaps under the eaves of the former structure. No other associated surfaces were present, but the presence of layer 108 may have represented a made ground or levelling deposit.

Plate 8: Wall S105 and surface 106. View to northeast (scale 1m)

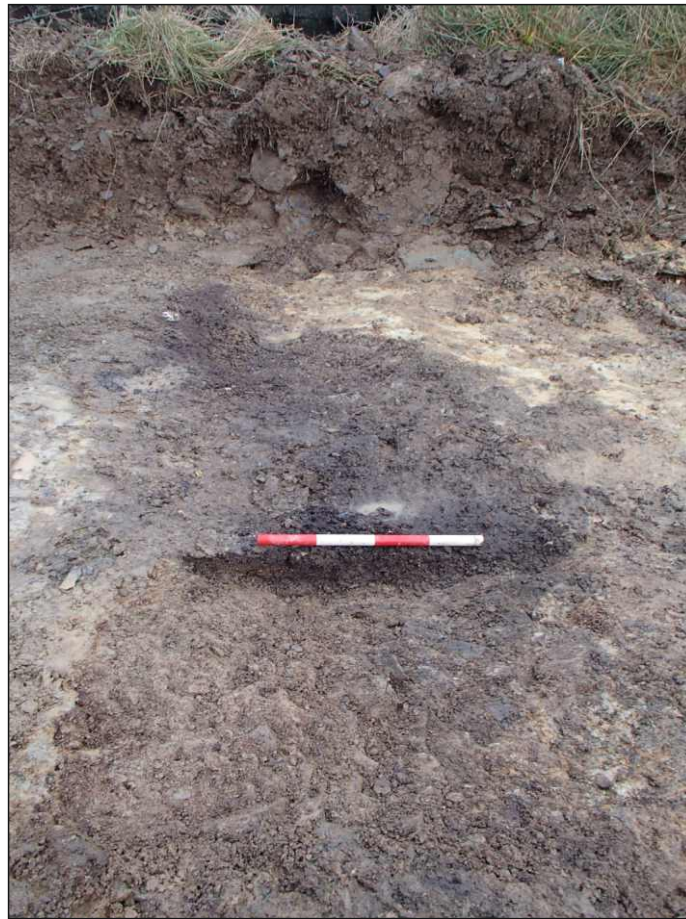
Possible ditch F102 was north to south aligned and irregular in plan. It measured 0.9m wide and 0.07m deep with a shallow concave profile. The possible ditch contained a dark brown clayey-silt loam fill (103) that was undated.

Plate 9: Possible ditch F102, view to north (scale 0.4m)

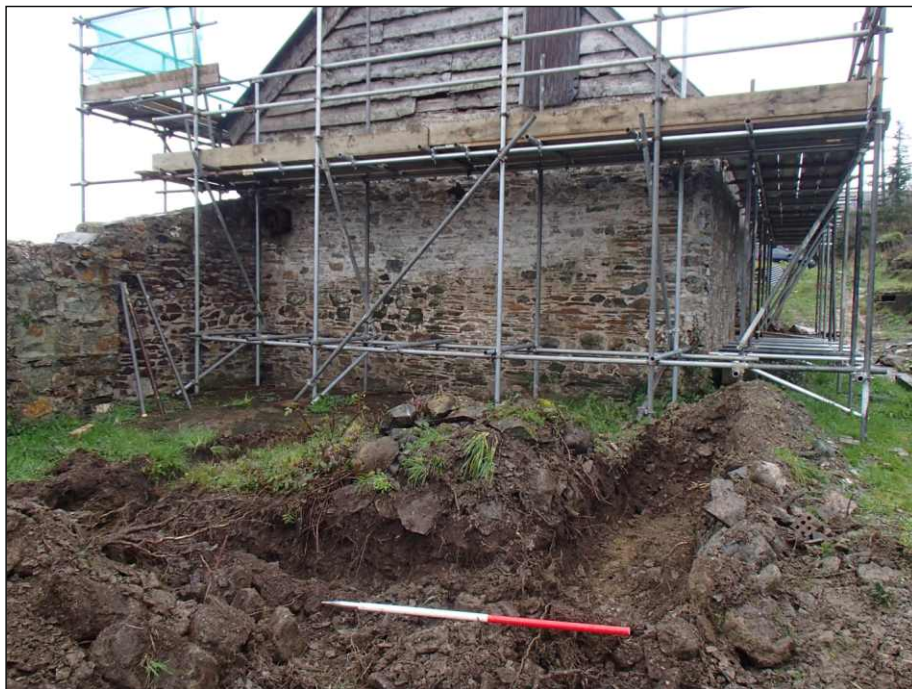
The monitored footings trench located to the northwest of the barn measured 0.8m wide and 0.6m deep. Natural subsoil was exposed at a depth of between 0.26m and 0.4m below existing levels and was sealed by a mixed, stone rubble rich topsoil. No archaeological features or deposits were exposed.

Plate 10: View of monitored footings trench. Looking southeast towards barn (scale 1m)
