ST MICHAEL'S CHAPEL, TORRE, TORQUAY

A new survey

On behalf of:
Torbay Council

Document No: ACD1067/2/1

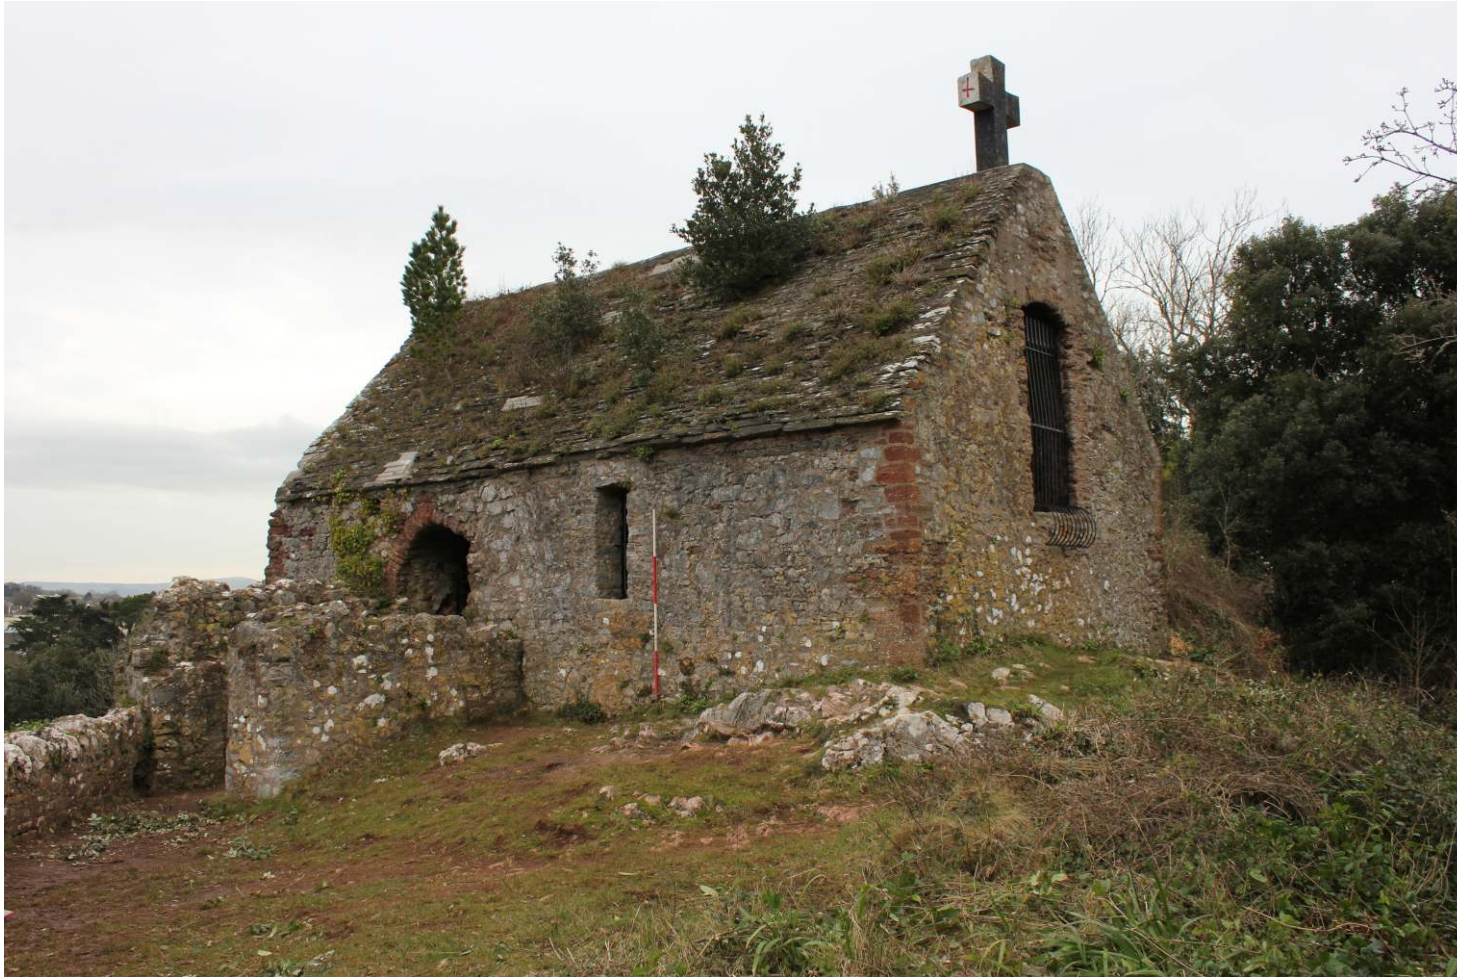
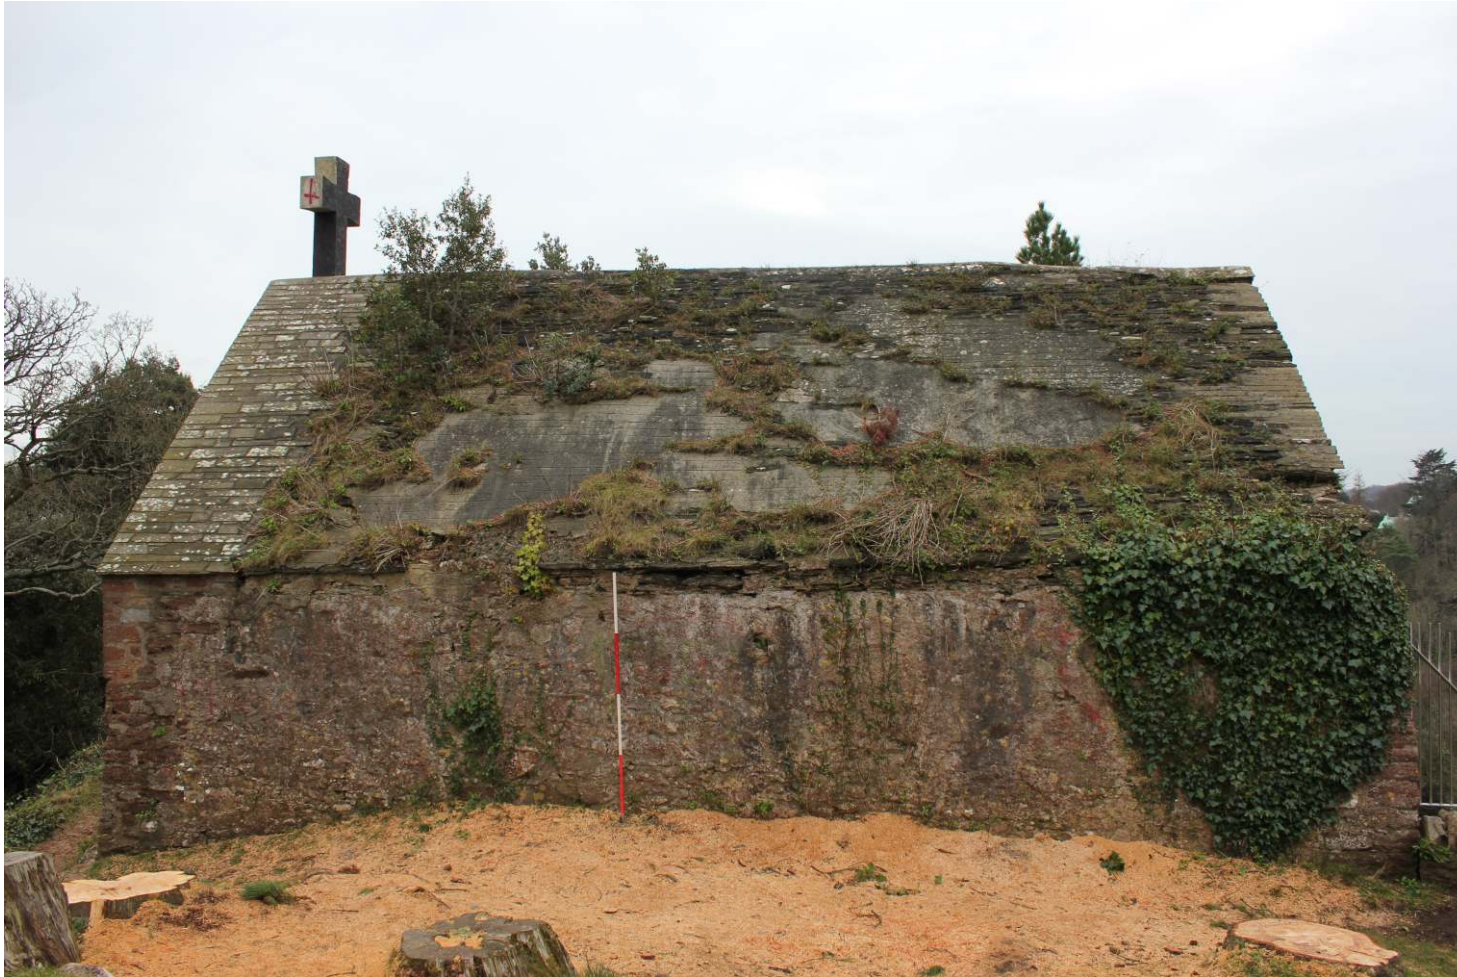
To a certain extent the mystery remains, but the popularity of the site as a place to visit dwindled dramatically in the second half of the 20th century. The chapel became overgrown and visited only by a few people. By 2015 (Figs 2 and 3) the chapel was defaced by graffiti and suffering from vegetation damage with access denied by an iron-railing door. The door was first inserted in the mid-1980s and continuously strengthened in the face of vandalism. At the same time a large internal wooden scaffold was inserted; ostensibly to maintain the integrity of the roof it proved to have had no structural relevance.

Fig. 2: St Michael's Chapel, Torre prior to conservation works. Viewed from the south-east (2m scale)

Fig. 3: St Michael's Chapel, Torre prior to conservation works. Viewed from the north (2m scale)

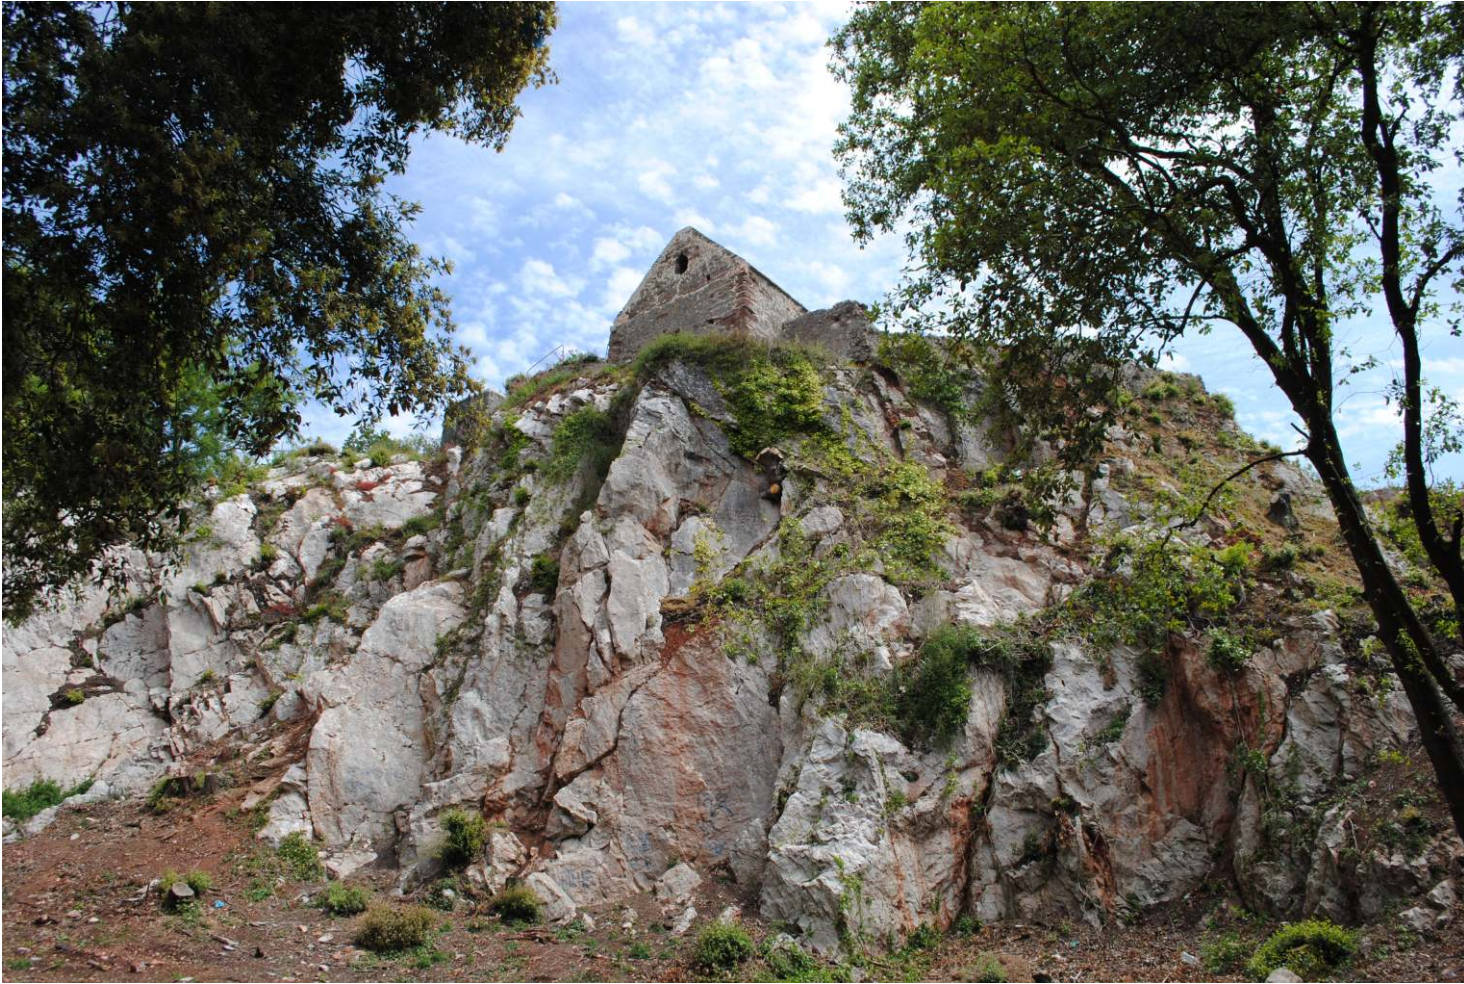
chapel are now to be had. The lofty location looks most impressive from the southwest (Fig. 4), but the steepness of the promontory on this side has been accentuated by quarrying for limestone (18th century – documented in 1788; cited in Travers 1998); the much ruined remains of a lime kiln survive at the base of the quarry close to the main road. The quarrying, involving blasting (the drill holes are still visible in the quarry face), stopped only at the foot of the chapel and there is a possibility that damage has occurred to the chapel resulting in loss and/or repair.

Fig. 4: St Michael's Chapel, Torre following the removal of trees from the limestone quarry. Viewed from the south-west

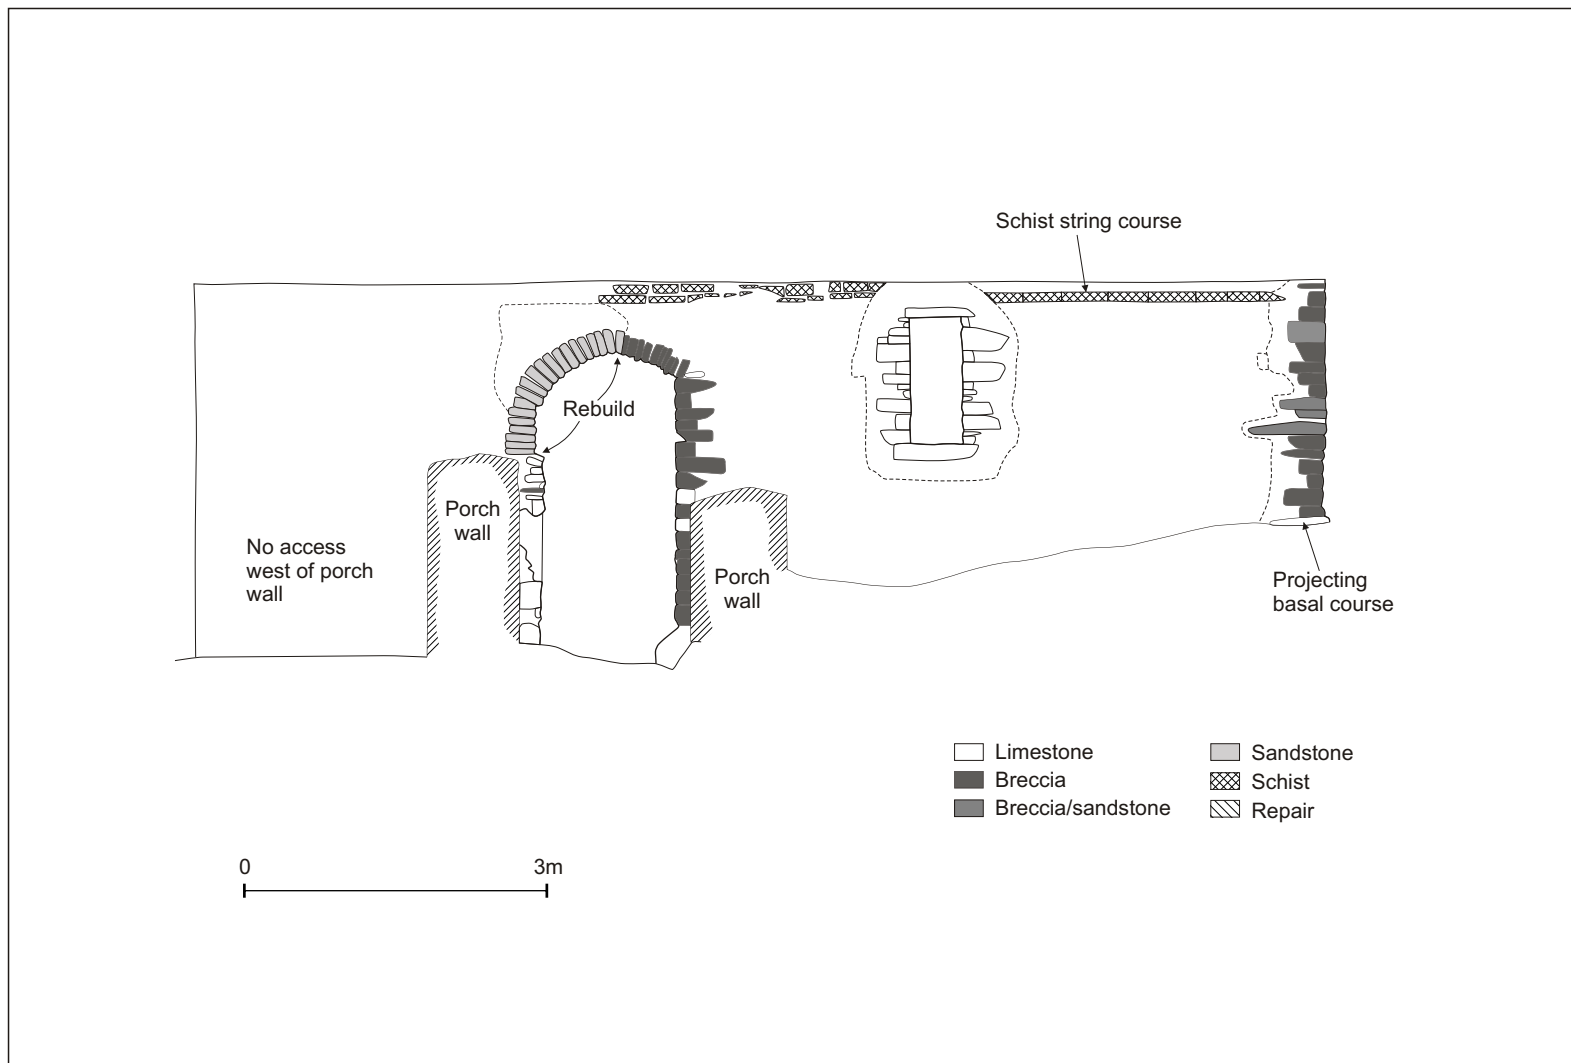
Fig. 7: St Michael's Chapel, Torre south elevation measured drawing

The main elevation faces south across Tor Bay towards Brixham. The southeast corner has red breccia quoins. Access to the southwest corner was not possible due to the proximity to the cliff edge, but it is clear that this too is dressed with breccia quoins. At eaves level there are two thin courses of masonry with the lower a string course of schist/slate and the upper mostly of schist/slate but with some red breccia. The primary splayed window facing south has been narrowed with limestone block jambs reducing the width from 1m to 0.45m, but retaining a height of approximately 1m. The original window features appear to have been removed, cutting the slate/schist string line above, and the infilled scar is set with light grey/light yellow cement which is distinctive from other repairs.

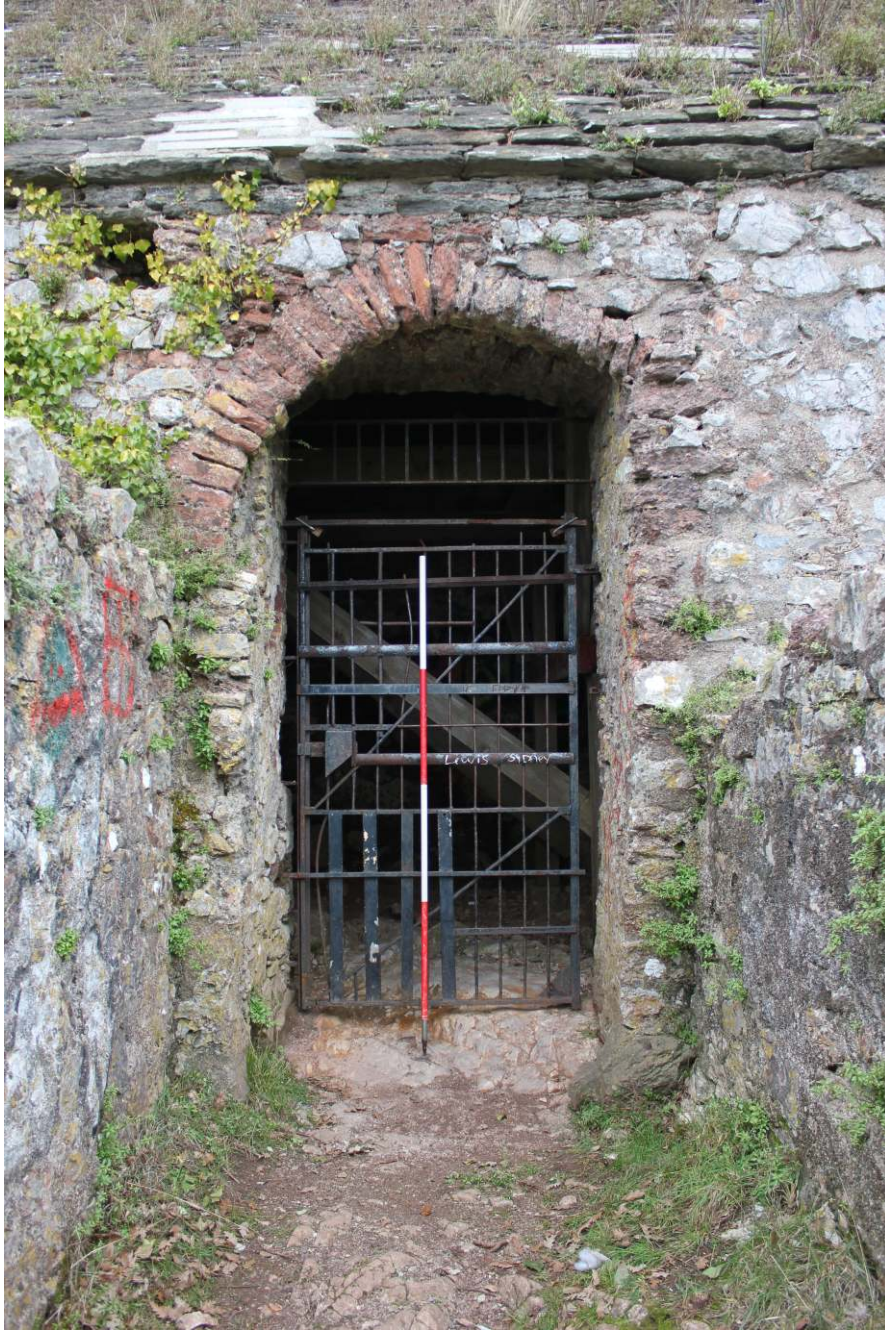
The doorway measures 2.8m high by 1.4m wide and on the east side has a red breccia jamb giving way to limestone and breccia towards the base which may be repairs (Fig. 8). The base stone on this east side has an external rebate for a door and an internal stop. It appears to be *in situ* as it has been dressed to overlie the natural bedrock. The west jamb is limestone and appears to be part of a rebuild, although the lowest courses may be earlier. The door head is arched and on the east side ten of the original voussoirs in breccia survive; the west side, including an off-centred keystone, are red sandstone replacements.

Fig. 8: St Michael's Chapel, Torre doorway, prior to conservation work (2m scale)

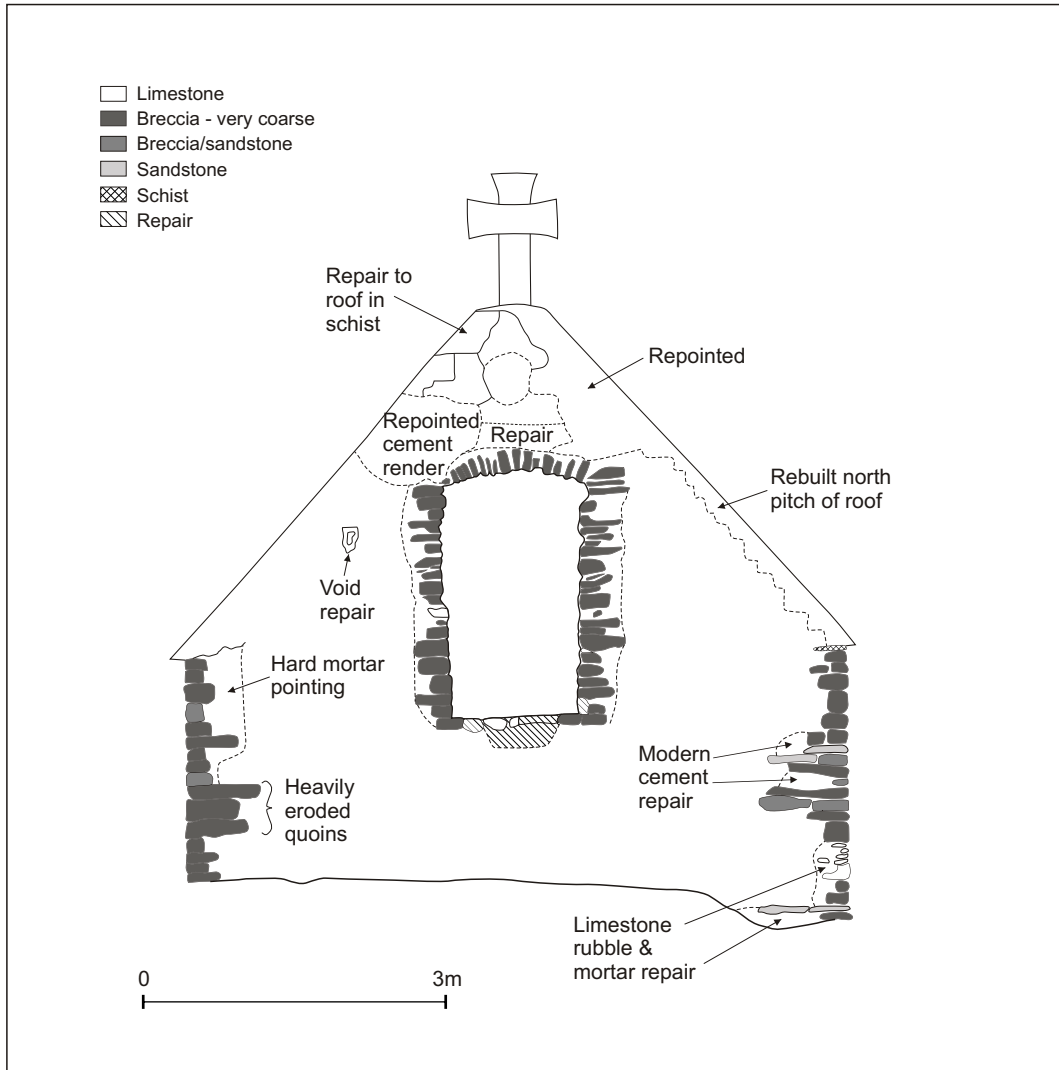
Fig. 9: St Michael's Chapel, Torre east elevation measured drawing

Much cement render survives, particularly higher up. Breccia quoin replacements are situated at both corners, with some lower down eroded ones perhaps being original; these are also in red sandstone, although some individual stones show bedding of both breccia and sandstone. The east window measures 2.5m high by 1.2m wide and has breccia jambs which are angled internally forming part of a splay. It has a shallow arched head which becomes a pointed arch internally. The cill has been repaired with three courses of mixed rubble. The window sits within a clearly defined break in the limestone masonry (also visible in Fig. 6), although this is less clear on the south side due to later cement repairs. Either the opening has been narrowed or the wall was prepared to accept the window once completed. The gable above the window has been subject to several repairs.

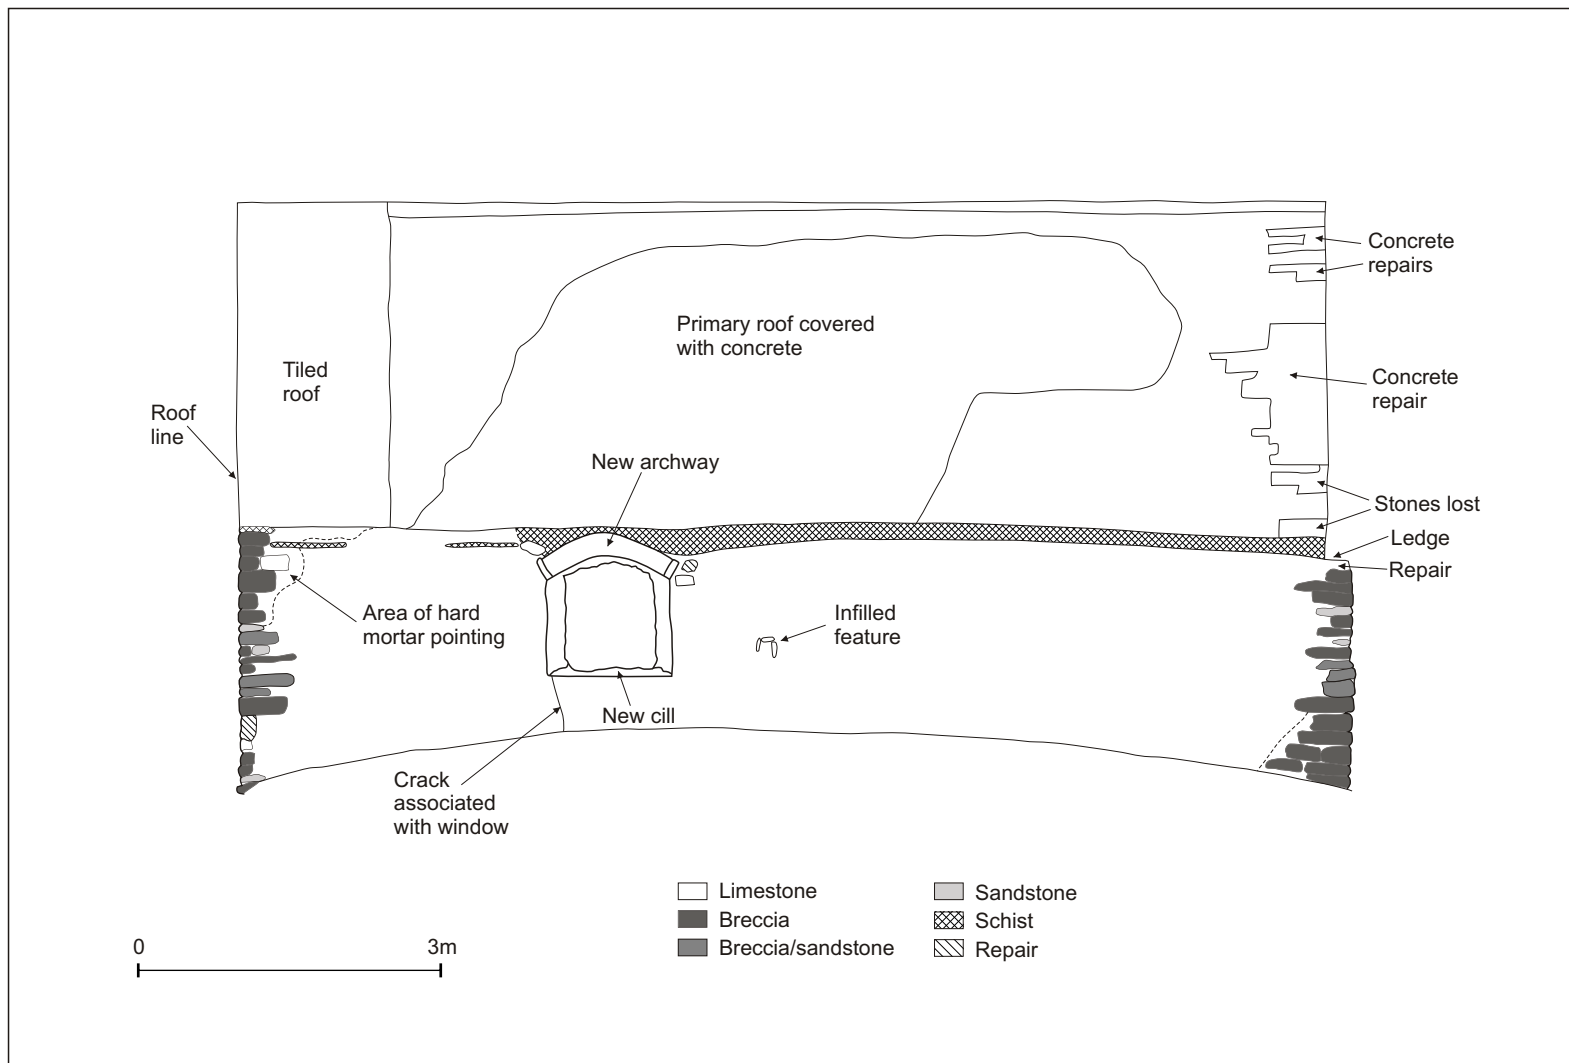
Fig. 10: St Michael's Chapel, Torre north elevation measured drawing

The northwest quoins are in breccia with a few repairs higher up. A step back on the west elevation close to eaves level is clear on this elevation. As with the south elevation a string course formed by two rows of schist/slate is located at eaves level. This has been cut above the north window, as on the south side, and lost to late 20th century repairs at the east end and becomes wider and less formal as it approaches the west end. The primary splayed window facing north had been blocked historically, but was reopened as part of this project; it measures 1m by 1m. No detail of the original window was exposed and a new shallow arch has been built. A possible infilled putlog hole was identified to the west of the window.

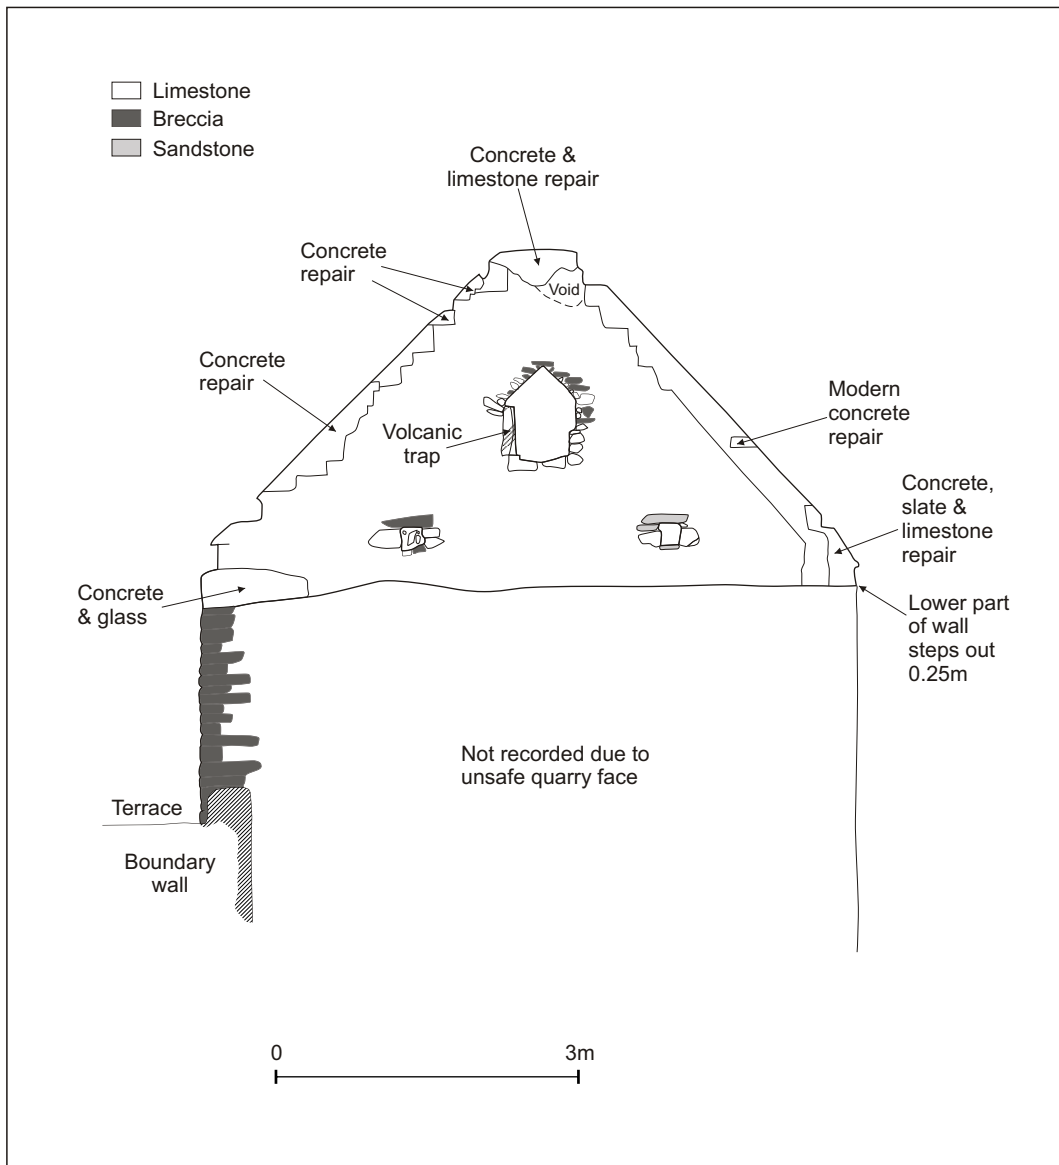
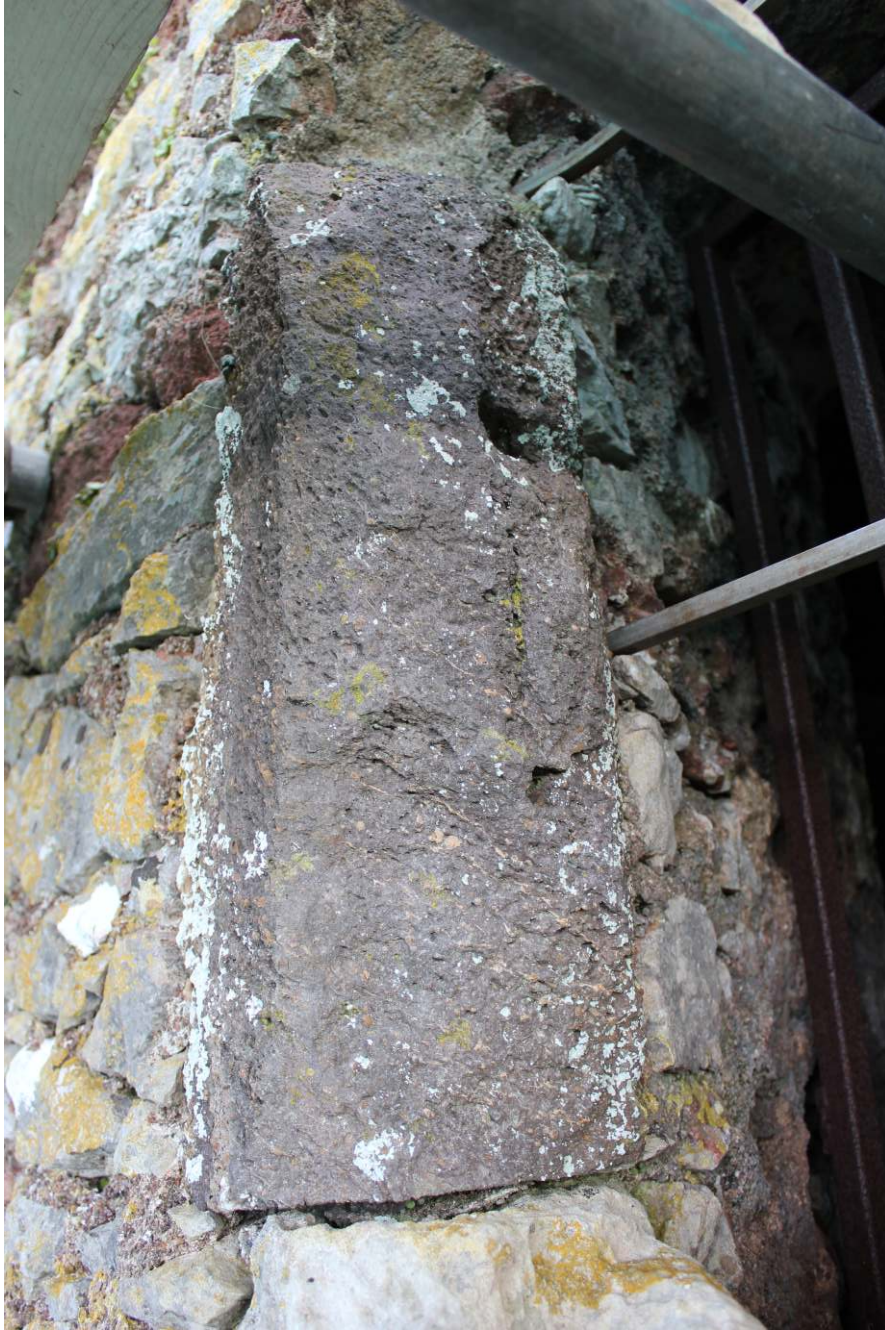
The west elevation sits above the steep drop into the quarry and access was restricted and only possible when scaffolding was present. At eaves level the elevation steps back creating a distinct ledge 0.25m deep. The upper gable contains more breccia than elsewhere in the chapel wall and is arranged roughly in rows of up to three courses; perhaps indicating that above the ledge is a distinct phase of construction or rebuild. The south pitch of the roof also appears to poorly match the top of the gable and is not keyed in. The vault was built east to west, with the gable being built up to it on the west end after the vault's completion. A pair of putlog holes are placed symmetrically close to the base of the gable; the northernmost is infilled while the other is open through to the interior. There are central windows to each section. The higher window is small, measuring 0.9m high by 0.5m wide and much masonry has been lost. It has two cill stones of oolitic limestone (possibly Bath stone). A single vesicular volcanic trap jamb survives on the north side (Fig. 12). It is heavily worn but has chamfered inner and outer faces. The side face of this jamb incorporates two glazing bar sockets; the upper one 30mm wide by 23mm deep and the lower 20mm wide by 15mm deep with both 15mm thick. The head of the arch is pointed but the dressing is missing (the window as a whole is splayed to a square internally). It was not possible to access the lower window externally to allow detailed description, but it is small, measuring 0.4m high by 0.3m wide, splayed and has heavily eroded red sandstone jambs, lintel and probably a cill of the same material.

Fig. 11: St Michael's Chapel, Torre west elevation of gable measured drawing

Fig. 12: St Michael's Chapel, Torre higher west window, detail of north jamb

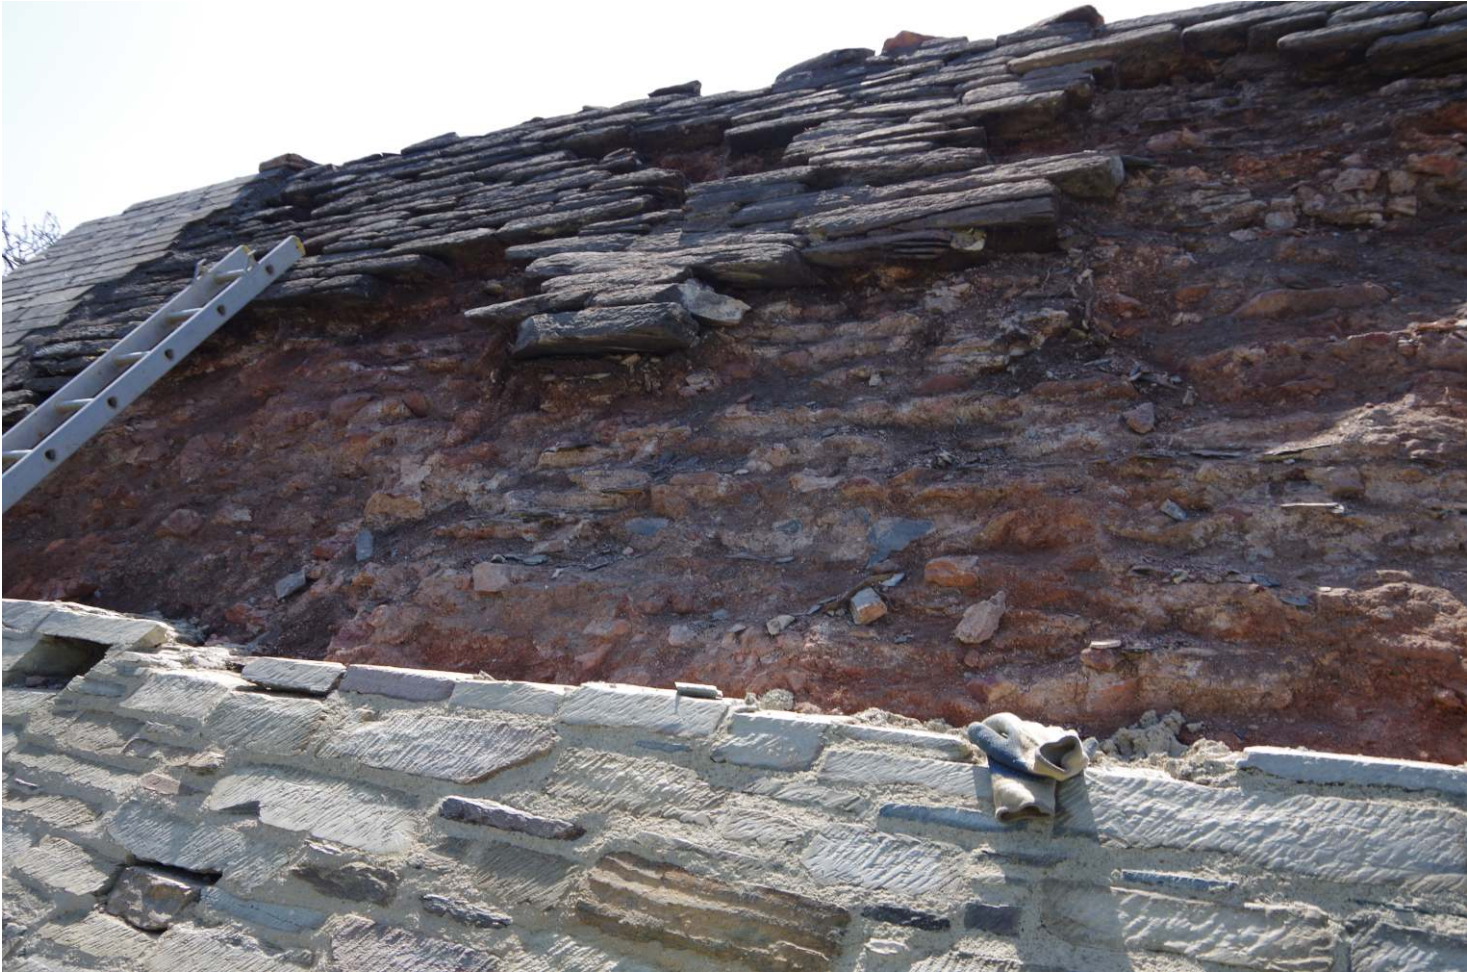
The roof is covered by schist/slate blocks laid horizontally with a bevelled outer edge matching the pitch of the roof. The ridge line is flat. The south pitch contains more original material than the north which has suffered from a significant amount of modern repairs. During the conservation works much of the modern repair work was removed and the core, or extrados, of the vaulted roof revealed. It comprises large blocks of breccia with voids into which the slate/schist is set. All is bonded by light cream gravelly lime mortar, with yellowish and pinkish hues in places.

Fig. 13: St Michael's Chapel, Torre northern pitch during conservation works, showing vaulted roof core material

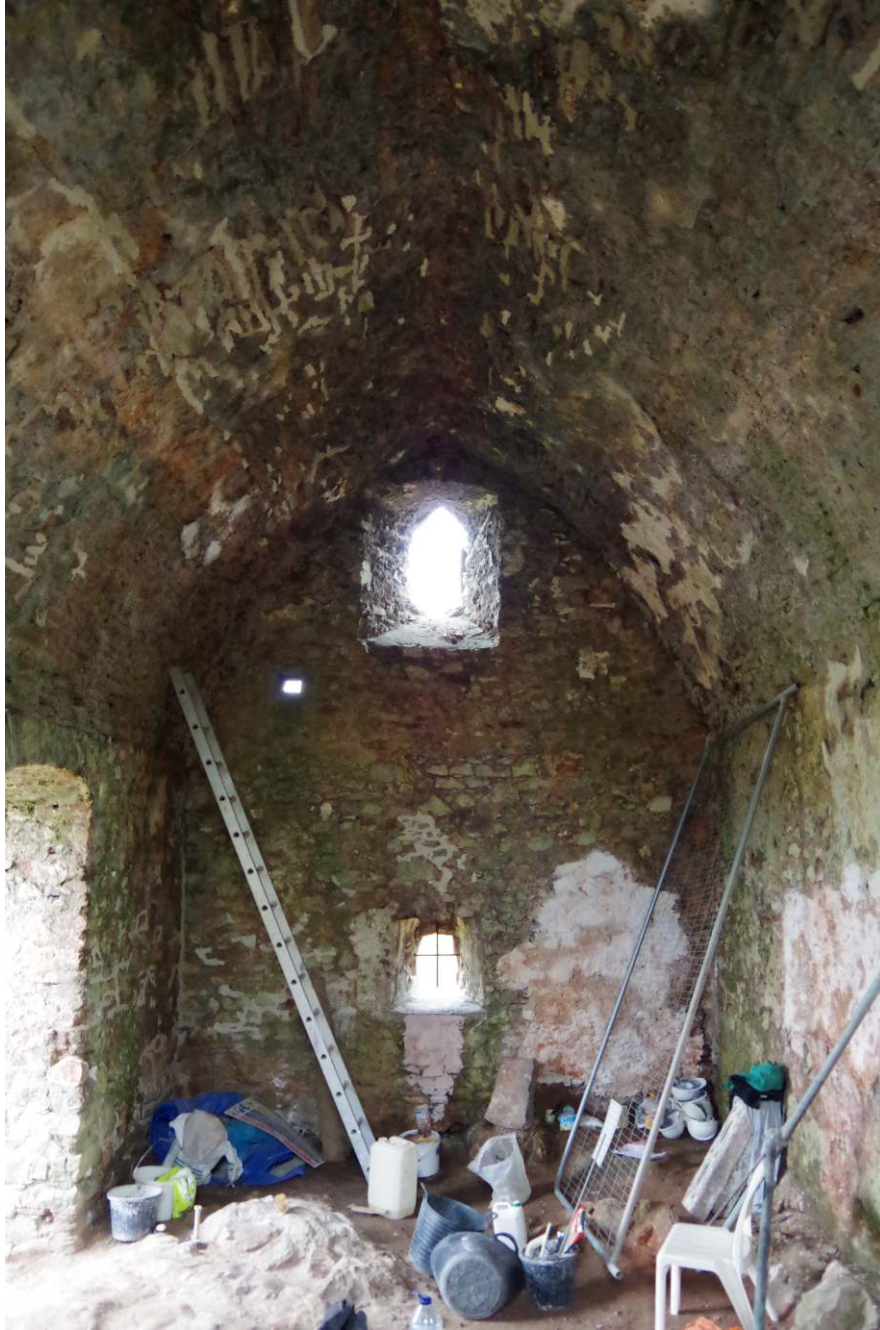
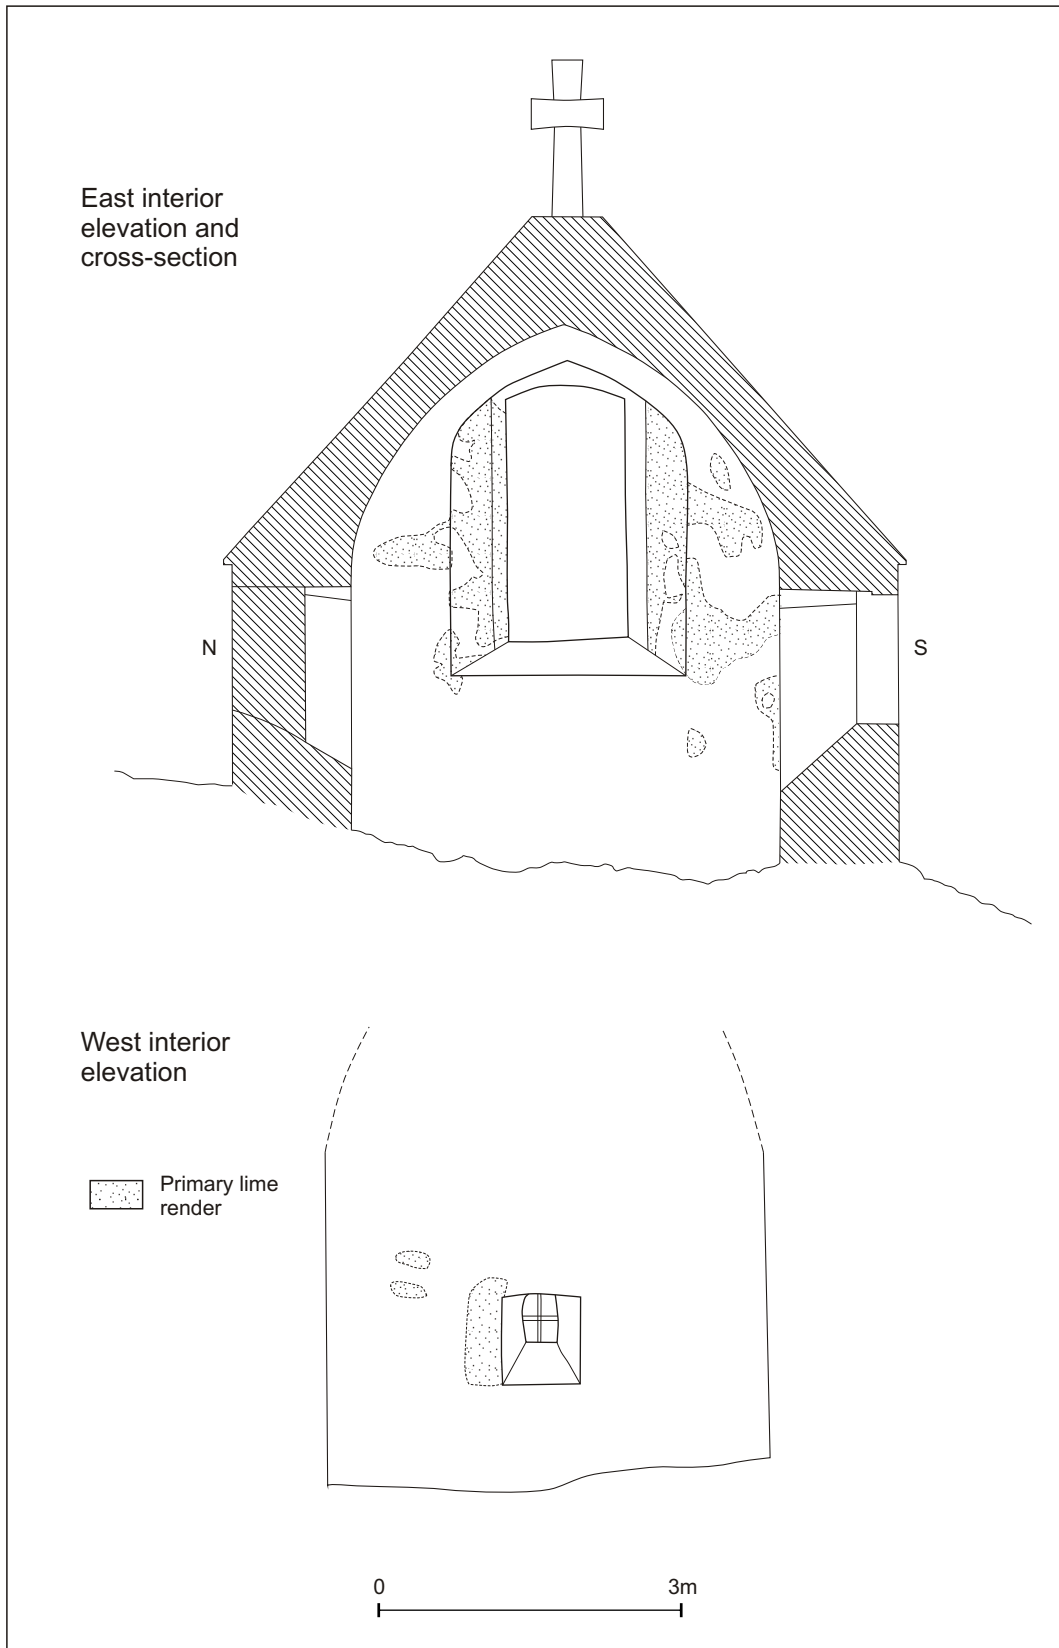
The interior has large patches of lime render surviving on the walls and ceiling. At the east end of the south wall is a square niche measuring 800mm by 800mm which is probably positioned to hold a piscina. The barrel vaulted ceiling converges on a central point creating a pointed arch (Figs 14

Fig. 14: St Michael's Chapel, Torre interior, during conservation works, showing vaulted roof and west end

Fig. 15: St Michael's Chapel, Torre, east and west interior elevations measured drawings

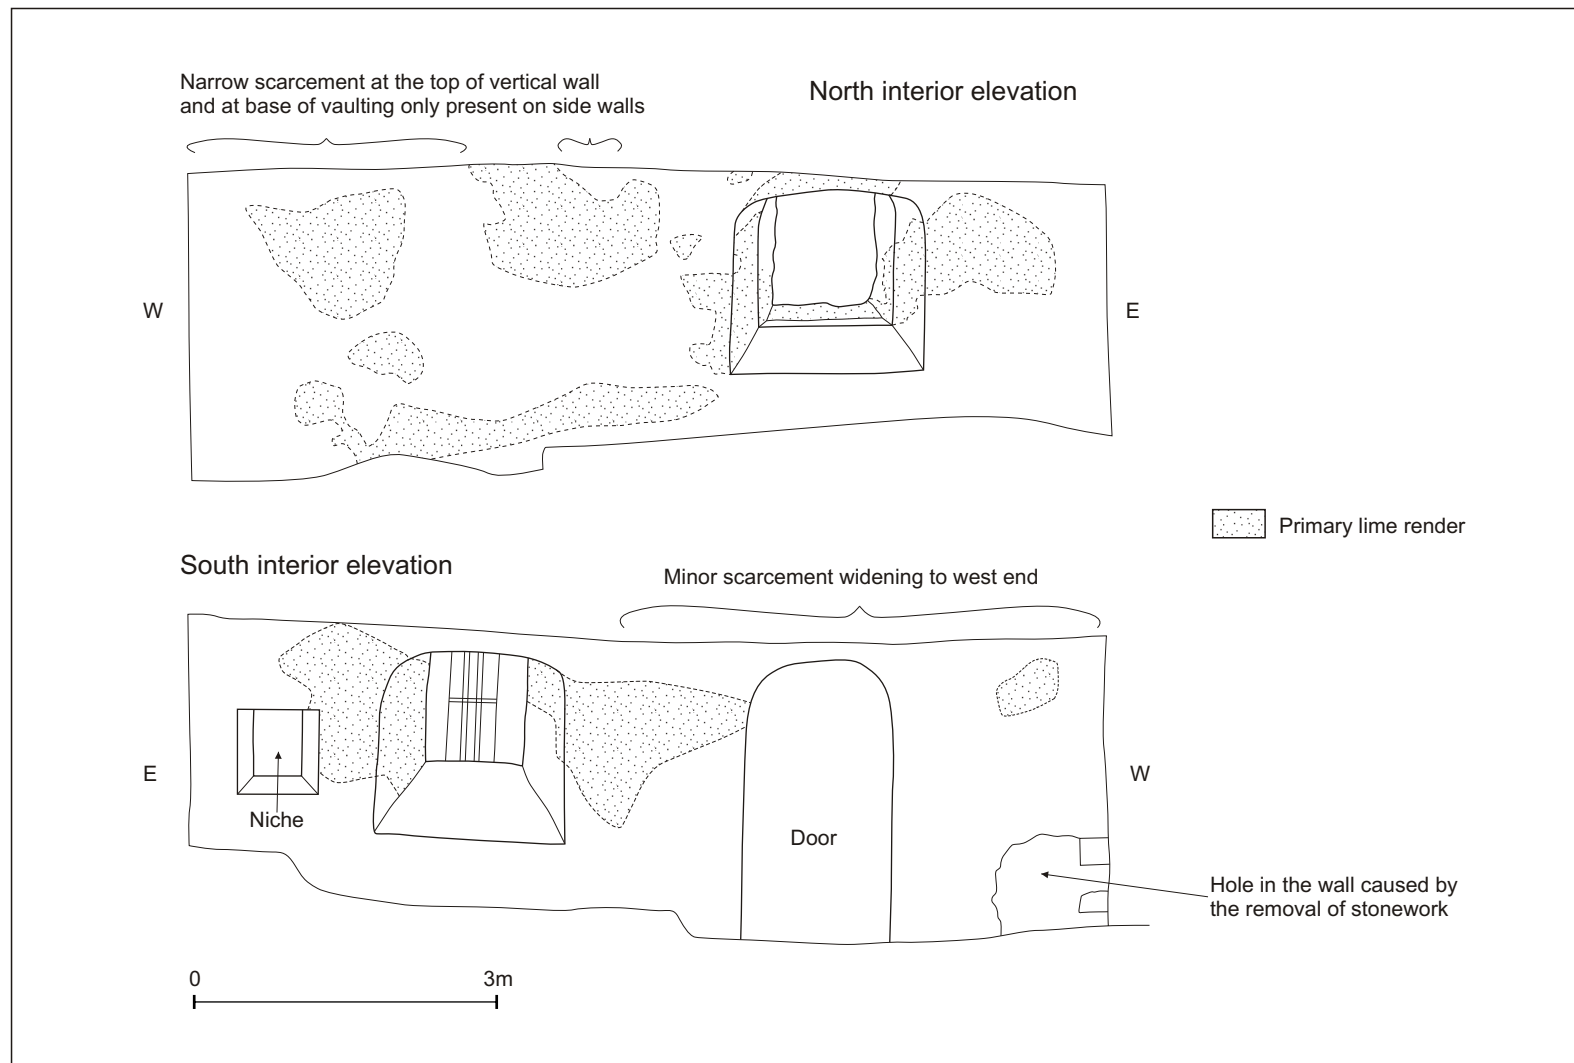
Fig. 16: St Michael's Chapel, Torre, north and south interior elevations measured drawings

and 15). From floor level it appears that the north wall and the west end of the south wall have a small ledge at eaves level (Fig. 16). Closer inspection of these show that the north wall feature is very uneven and narrow (a maximum of 30mm deep) and in places it is obscured by lime render. On the south wall it is a more formal feature, forming a level shelf up to 60mm deep continuing from the southwest corner for approximately 4.8m. Early thoughts that this ledge may be a scarcement to hold the floor for a loft at the west end of the chapel is not sustained by the small size of the features, along with its covering by render, and instead it appears only to mark the difference in build from the vertical wall to the barrel roof section.
