COLEBROOKE MILL, COLEBROOKE, NEAR CREDITON, DEVON

Results of historic building recording and an archaeological
watching brief

Planning ref. Mid Devon District Council 06/01323/FULL,
condition 11

Document No: ACD42/2/0

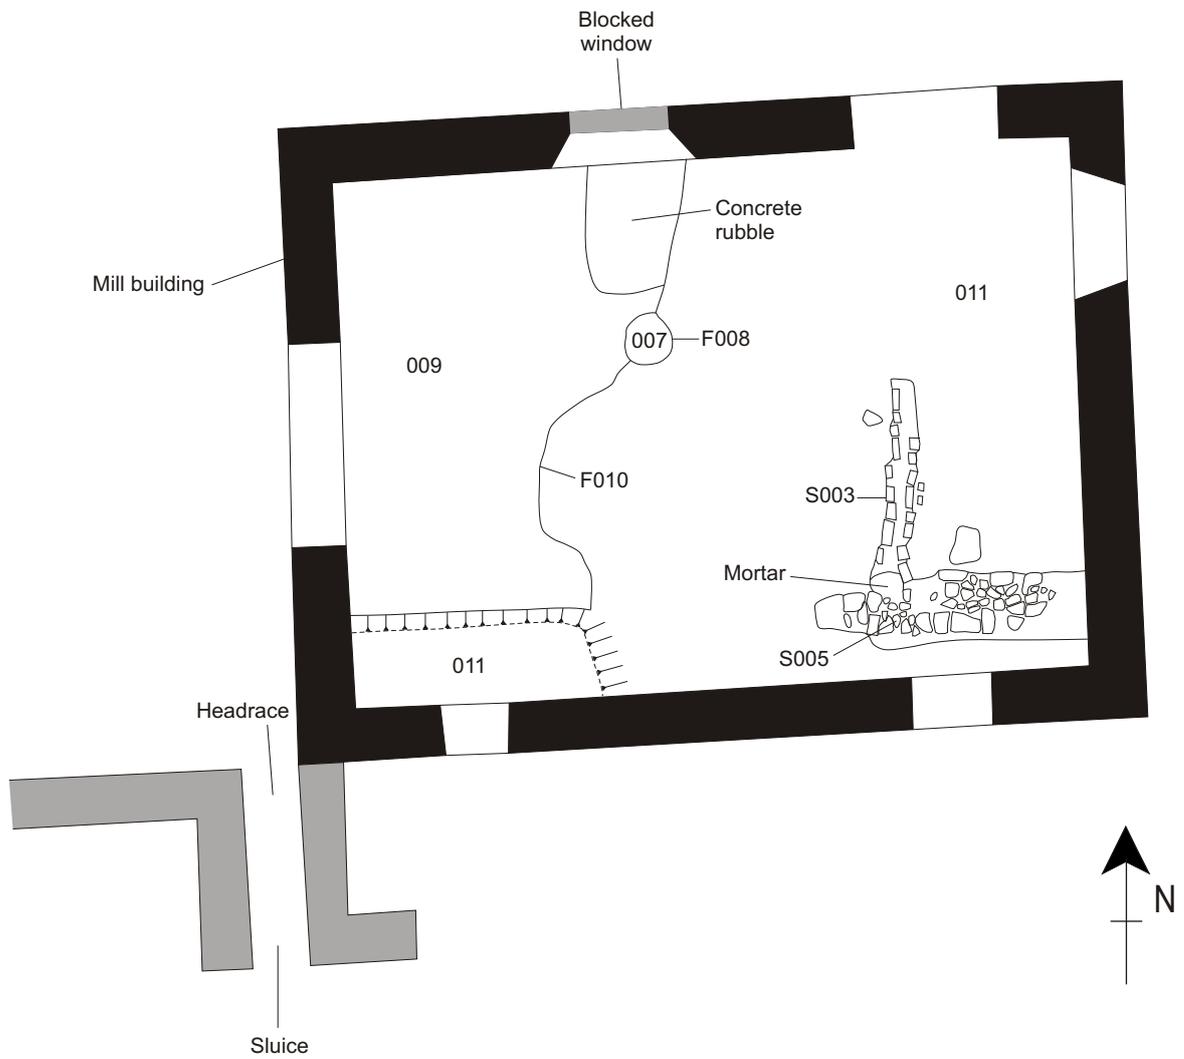
Fig. 5: Plan of features revealed
during ground reduction within
mill building

The ground reduction within the mill building removed a concrete floor (001) and foundation layer (002) for the concrete floor, and revealed a brick-lined drain (S003), a wall foundation (S005), a possible posthole (F008) and a rubble filled pit (F010) which are described below. Elsewhere, the natural subsoil (011) of dark red sandy-silty-clay was revealed, which in the southwest corner stepped up to create a distinctive platform 0.20m to 0.30m above the natural subsoil exposed elsewhere within the building.

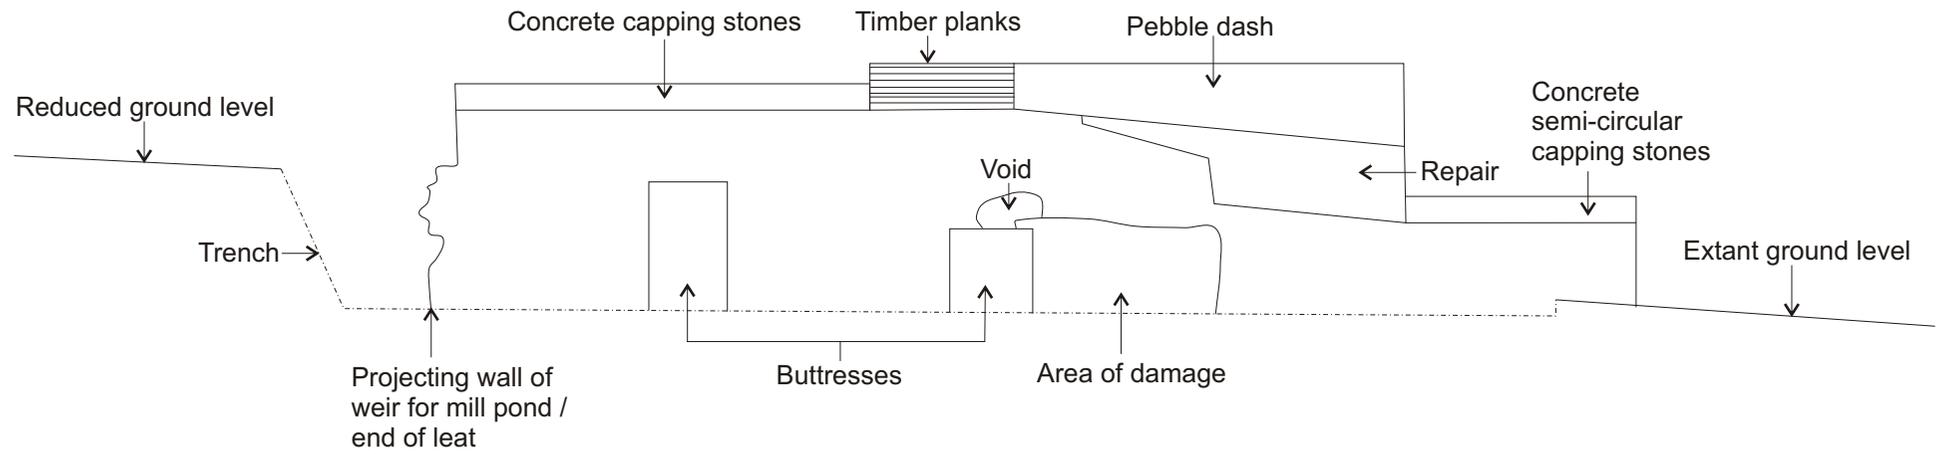
Fig. 6: East elevation of east range revealed during groundworks

The trench excavated along the south elevation was essentially the removal of modern rubbish debris and the topsoil from the ditch, with slight widening occurring (Plate 17). The return of the trench along the east elevation of the east range was excavated to a depth of approximately 2m at the south end and 0.10m at the north due to the sloping nature of the ground level (Plate 18). The formation level was the natural subsoil and the base of the wall was not reached; there was no foundation cut for the wall indicating that the building was constructed into a terrace formed by the present yard. The excavation revealed no archaeological finds, features or deposits. However, along the east elevation two buttresses were exposed, paced 3m apart and keyed into the wall (Fig. 6 and Plate 19). The northeastern buttress was at least 2.10m high and the southwestern was at least 1.60m; both were 0.60m wide and 0.50m thick. Directly to the northeast of the northeastern buttress was an area of damaged wall with frequent loose building material.

At the southeast corner of the east range wall, projecting south there was evidence of an additional wall appearing contemporary with the east range. This marks the end of the leat/millpond area and may have acted as a weir/dam wall retaining the water to the west. Also partly exposed at the west end of the south elevation was the location of the sluice and head race leading to the now removed waterwheel on the west

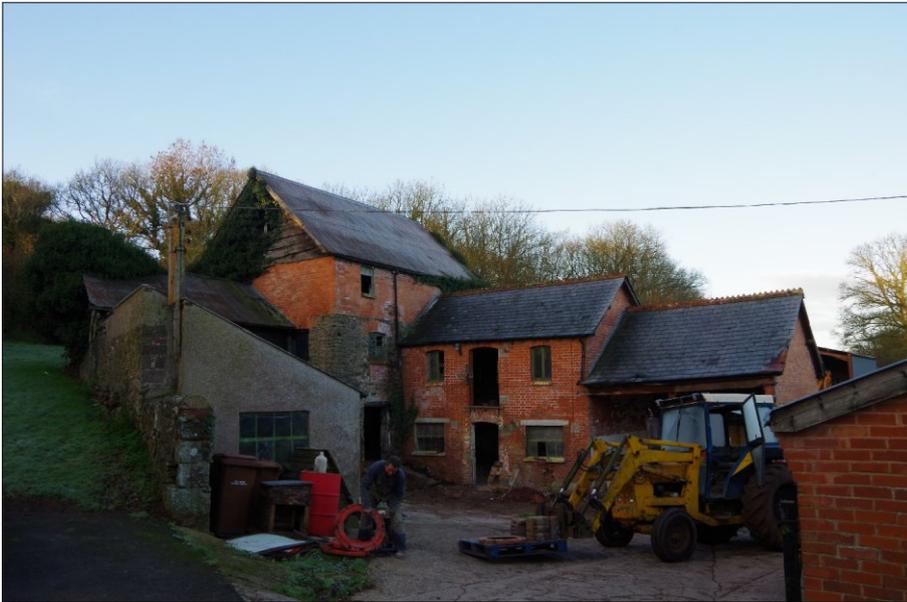
On the ground floor this elevation contained a two-pane window under a wooden lintel off-set towards the north side of the wall. An area of brick infill below the frame indicates that the current window has replaced an earlier deeper one. Above this window on the first floor was a loading door, with a brick arched head and brick sill. The second floor was plain brick masonry and the gable above finished with Timber planks surrounding a centrally placed window (Plate 1).

Plate 1: Colebrooke Mill, general view, looking southwest

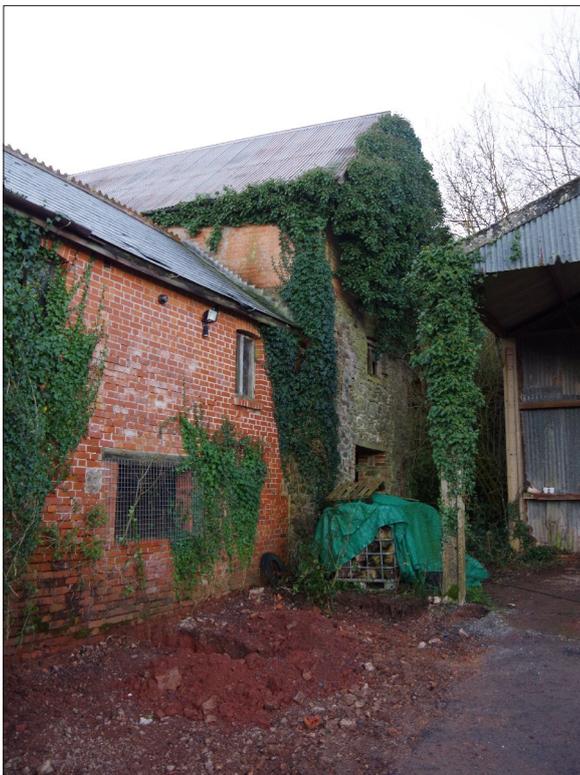
A large modern opening in the ground floor of the west elevation had a timber lintel and brickwork surround. On the first floor was a two-light window with a brick arch above and a brick sill. To the south of this a small square opening had a metal shaft projecting from it. Below this to the south was a brick blocked opening. The topmost part of the elevation was covered with vegetation which obscured any architectural features (Plate 2).

Plate 2: Mill building and north range, west elevations, looking southeast

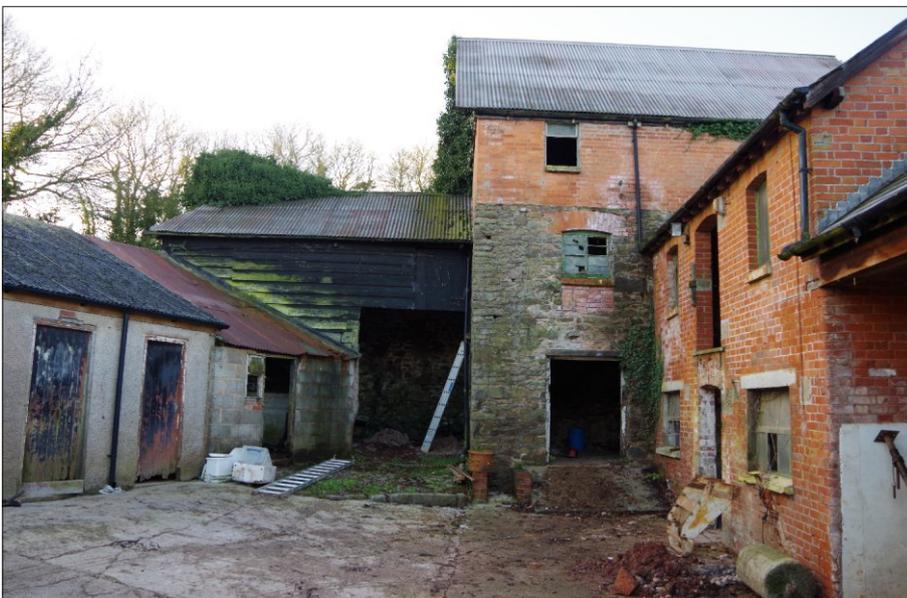
The north elevation was largely obscured by the north range. On the east side of the ground floor was a large door with a wooden lintel that was accessed from the yard by a concrete ramp (Plate 3). Above the door, serving the first floor, was a two-light window with an arched brick head and projecting brick sill. Below this window was an area of brick infill indicating that the window replaced a larger loading door at this level. Above this, and positioned slightly further east, was a window on the second floor, also with a projecting brick sill.

Plate 3: Mill building and east range, north elevations, looking south

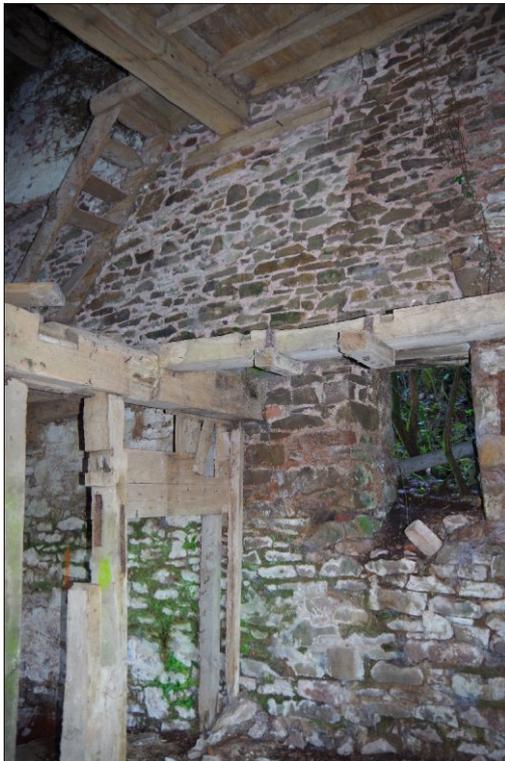
In the south wall at this end of the building was an opening situated approximately 1m above ground level; this had a stone sill sloping inwards (Plate 5). A similar open was present towards the eastern side of the building. In the upper part of the north wall was a large wooden hub to take a strap for driving a shaft (Plate 6). To the east was a concrete floor and a concrete feeding trough in the southeast corner. A blocked window in the north wall had splayed reveals and had been partially obscured by the timber partition (Plate 7).

Plate 5: Mill building, ground floor and upper levels structures, looking southeast

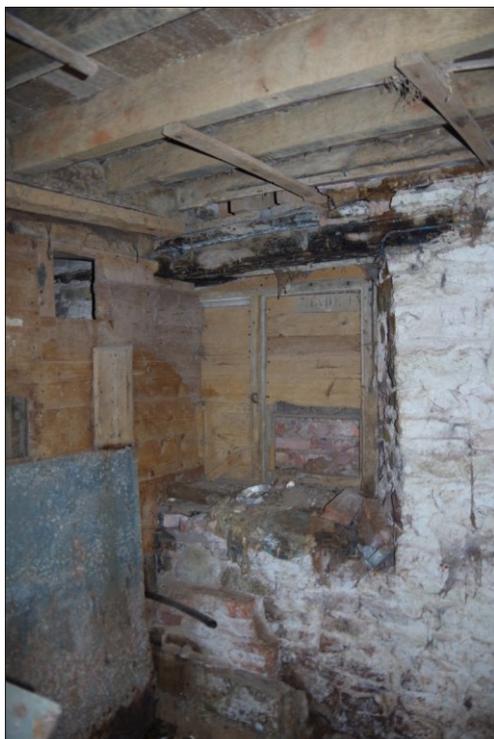
Plate 7: Mill building, ground floor, blocked window in the north wall, looking northwest

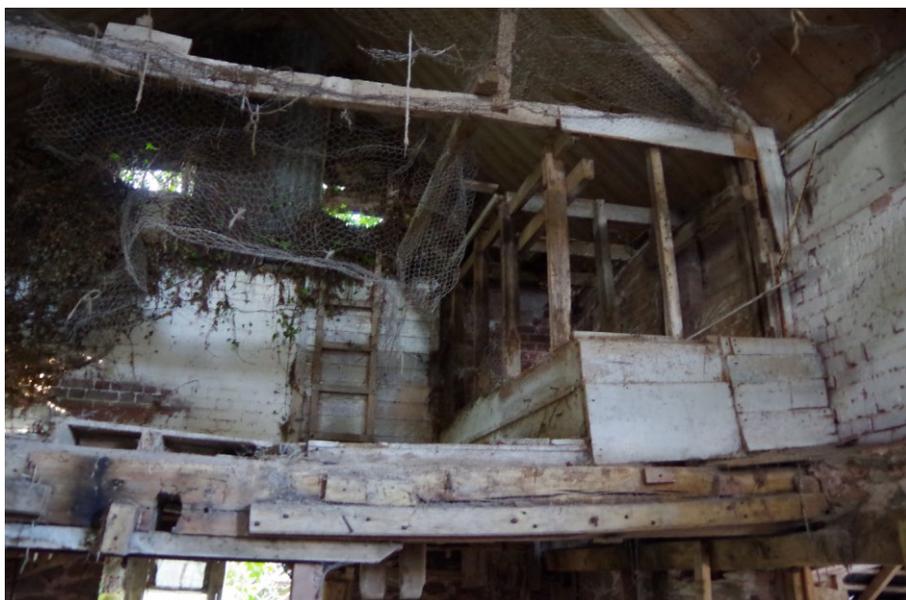
The second floor formed a mezzanine on the west side of the building directly above the location for the former pit wheel, but empty sockets in the north and south wall indicate that the second floor once extended across the whole building. Access was via open wooden stairs. In the floor were five further grain shoots and a wooden box for an Archimedes screw for moving grain (Plate 8). The floor also incorporates some iron fittings and displays oil stains associated with former line shafts to this level. There was a grain storage bin on the north side of the second floor (Plate 9) and in the south wall is an opening that could not be seen externally.

Plate 9: Mill building, second floor from first floor, looking east

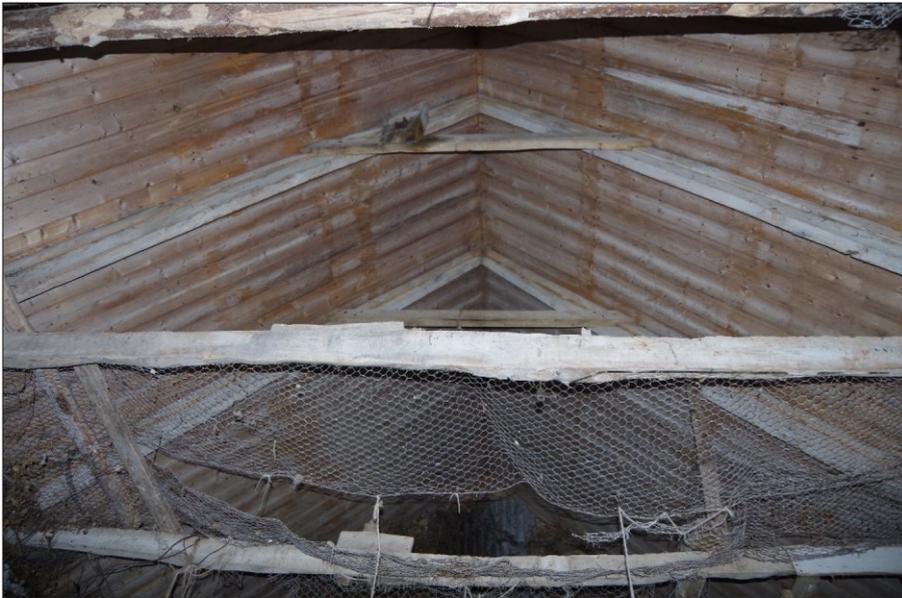
The roof was supported on three A frame trusses with bolted tie beams; additional beams had been added to the trusses for support (Plate 10). Wooden planks sit on the back of the trusses, and the roof has a corrugated iron finish.

Plate 10: Mill building, roof structure

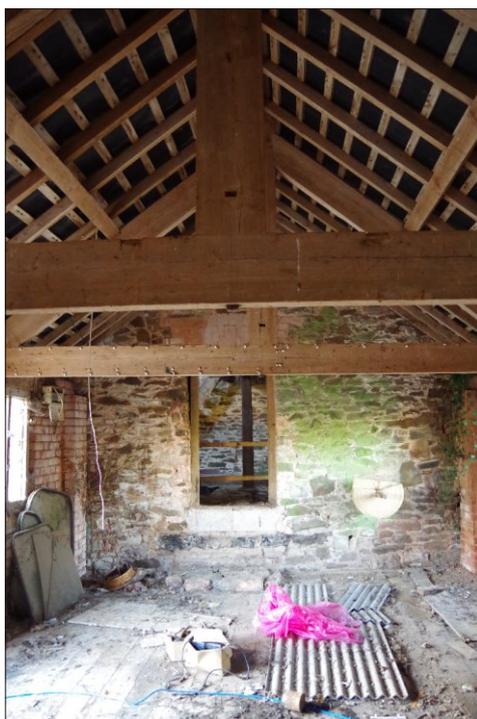
On the first floor a broken stone grinding wheel adjacent to the south wall was connected by a metal shaft to the wooden hub recording in the mill building (Plate 12). The brick buttresses continued upwards from the ground floor to eaves level. The roof was supported on two king post trusses that had bolted joints. The purlins sat on the back of the trusses with the rafters on the back of them, which appeared to be of late 20th-century date.

Plate 12: North range, upper floor, looking south

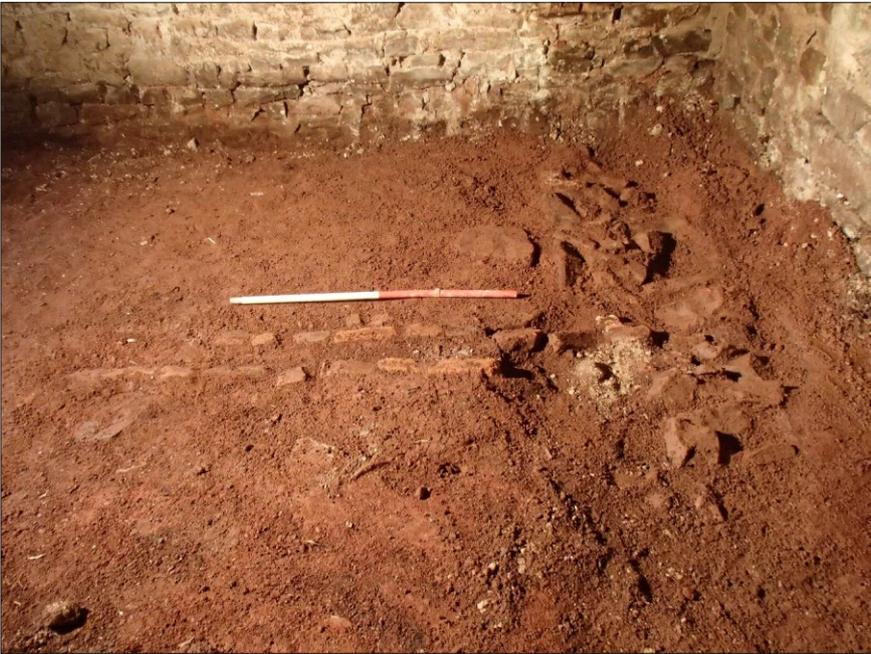
Drain S003 was aligned north-south and measured 1.80m long by 0.30m wide by 0.11m deep. It was constructed of two lines of bricks laid lengthwise and on their sides

Wall footing S005 was aligned east-west and measured 2.20m long by 0.60m wide by 0.10m high. It was positioned 0.30m in from the south wall of the mill building and was constructed of stone and brick bonded with lime mortar. It appeared to be contemporary with drain S003.

Plate 13: Mill building, drain S003 and wall S005, looking east (scale 1m)

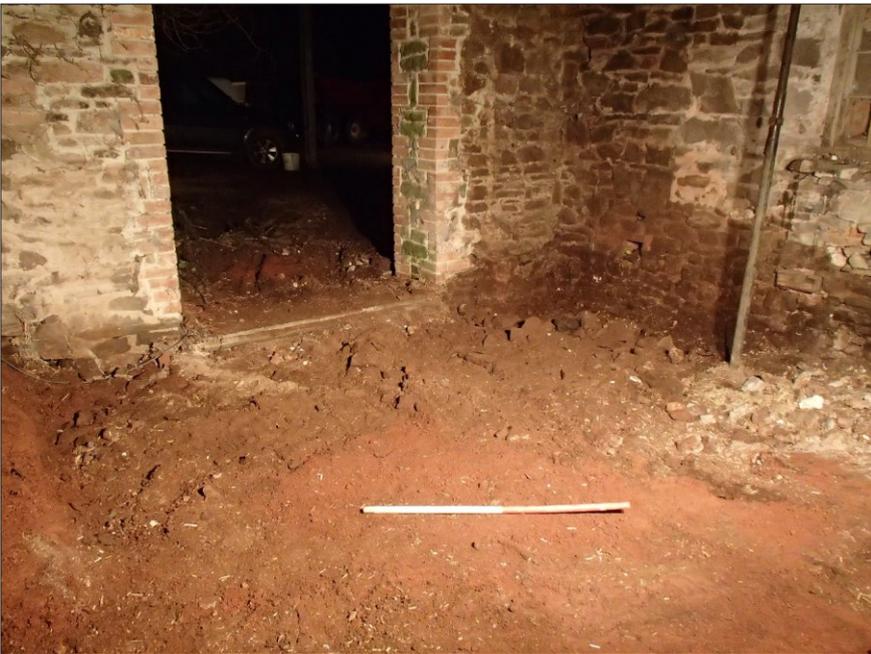
Pit F010 was irregular in shape but had maximum dimensions in plan of 4.16m long by 3.36m wide. It was located at the west end of the building and possible posthole F008 was located on its eastern edge. It was not excavated but had a fill (009) of stone rubble in a dark brown clayey-silt matrix.

Plate 14: Mill building, pit F010, looking northwest (scale 1m)

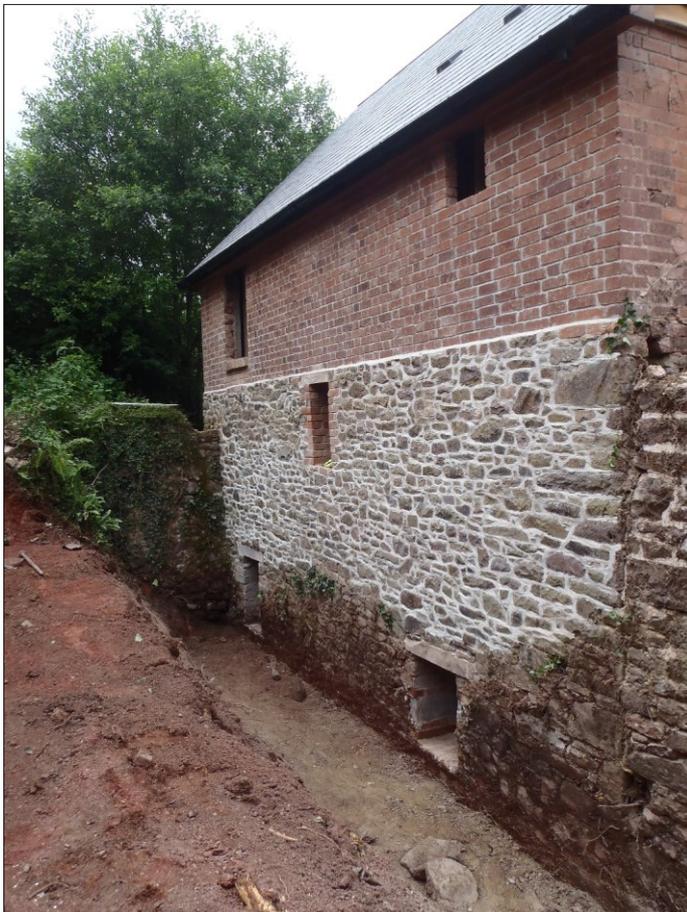
Plate 17: View of trench along south elevation of mill building and east range, looking northwest

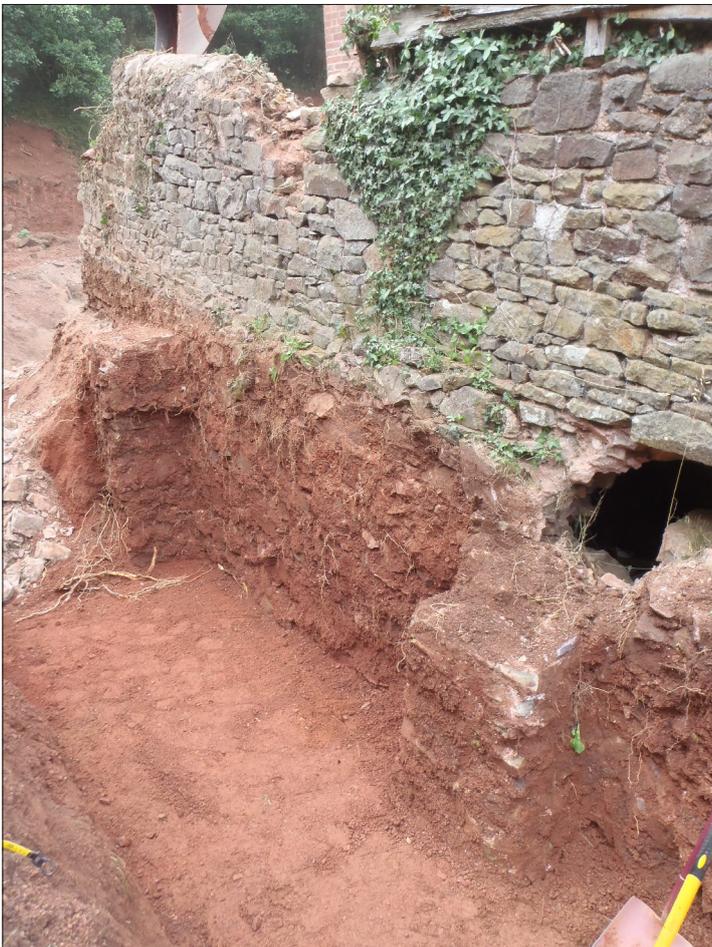
- 7.3 The east range was constructed with stone walls similar to those of the lower two storeys of the mill building, but this is probably an extension since in the south elevation the walls are only keyed together at ground-floor level. The east extension probably started life as a linhay extension to the mill building when it was in use as a farm building (cf Child 1995, 71). The store extensions to the east range were of modern date and must have replaced buildings in that location constructed between 1846 and 1889; parts of the east wall to the complex undoubtedly relate to the earlier structure, which, by the evidence provided by the buttresses, in-fills and voids was always unstable and requiring regular repair.

Plate 19: Detail of buttresses along east elevation of east range, looking southwest
