# TIVERTON EXTRA CARE SCHEME, ALEXANDRA LODGE, TIVERTON, DEVON

Results of historic building recording

Mid Devon District Council planning reference 15/01822/MFUL,  
condition 12

Document No: ACD1436/2/0

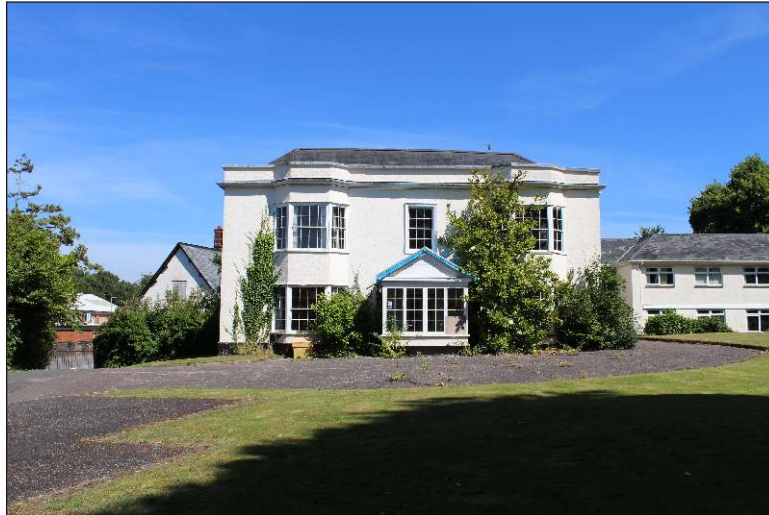
- 5.1 Alexandra Lodge is a two-storey house with further accommodation provided in the roofspace (Plates 1-3). The house connects to the late 20th-century day-care centre at its southeast corner. There is no visible evidence here for the wing depicted on historic maps and this wing was almost certainly removed and replaced when the 1960s care building was constructed. There is architectural evidence for the extension of the house in the mid 19th-century, as recorded on the historic maps. This evidence includes different styles of cornices and skirting boards, and the internal use of square-headed openings with fielded panels, rather than arched openings. The house is constructed of local rubble sandstone and mudstones, with the original north, west and south elevations (fronting the formal gardens) finished with stucco. The east elevation, along with the 19th-century extension, are unrendered, with exposed stone masonry. The rear of a chimney stack in the east elevation is faced with brick, a material that has also been used (in all historic phases of work) for most of the heads and jambs of the openings.

Plate 1: The lodge looking east showing its immediate context

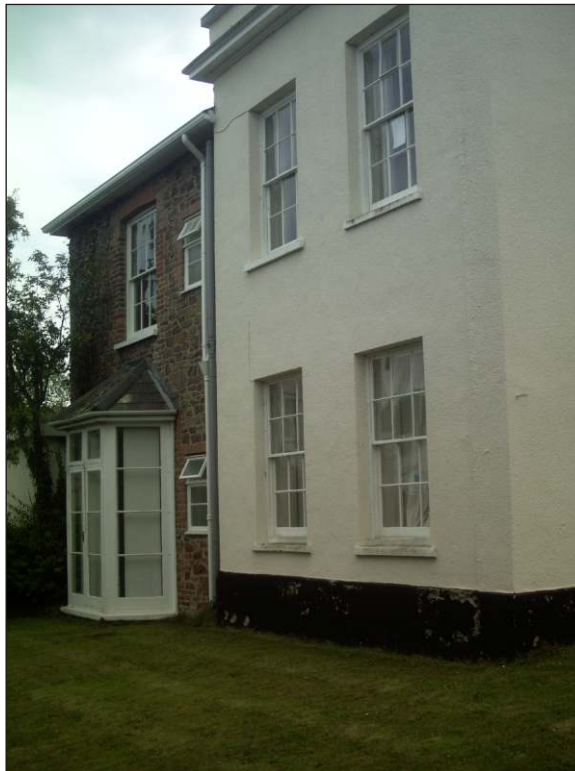
Plate 2: The north elevation showing the unrendered mid 19th-century extension, looking southeast

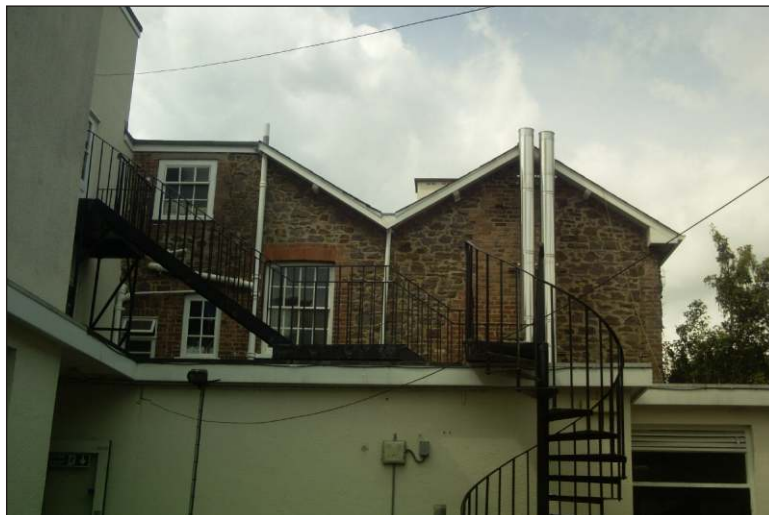
Plate 3: The east elevation showing the first-floor masonry above late 20th-century extensions, looking west

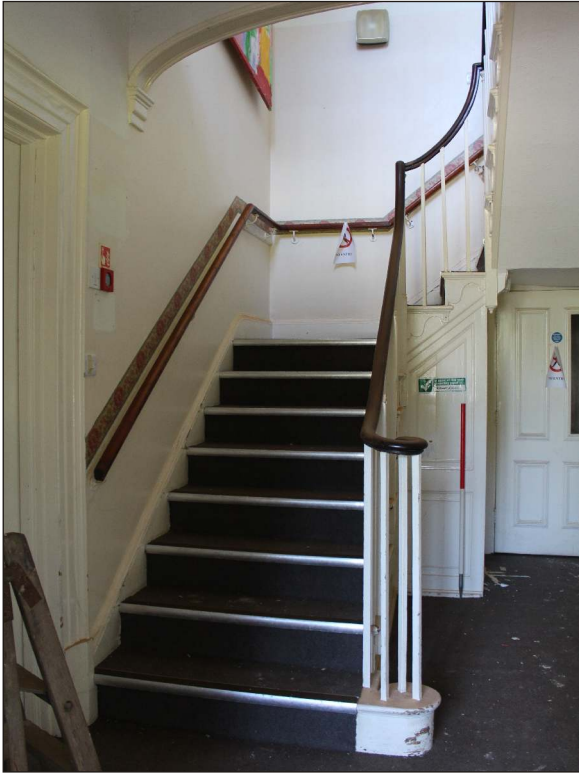
- 5.3** The *entrance hall* gives access to two rooms at the front of the house, and through a doorway to an L-shaped rear corridor that serves the rear rooms (Plates 4-5). It also contains the staircase to the first floor. The room is currently carpeted but retains its tall, moulded skirting boards. The openings have four-panelled doors, with some panels removed and replaced with safety glass, all set within wide moulded architraves. Other fittings include a deep, plain but slightly curved cornice and a moulded picture rail. The staircase has stick balusters and a ramped handrail without any formal newel posts. Further support is provided by attached late 20th-century modern rectangular balusters to the lower flight, and original slender turned balusters at the half-landing level. The stairs are finished with almost plain wavy brackets and the underside space is enclosed by panelling. This incorporates a cupboard door that has been painted shut.

Plate 4: The entrance hall showing the staircase, looking east. (1m scale)

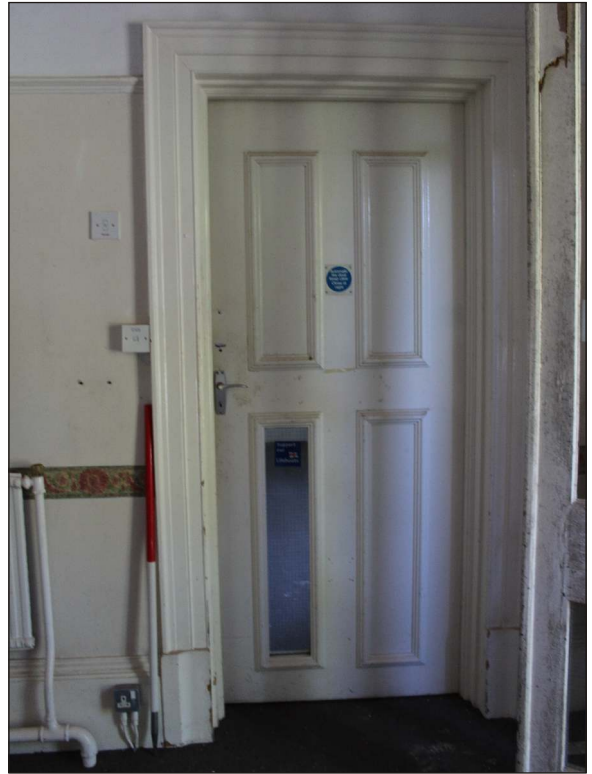
- 5.4** *Room 1* is located in the southwest corner of the house. It is lit by a walk-in bay window in the west elevation fitted with 8- and 12-pane sashes and there are double doors in the south elevation; the latter are in an original doorway opening but have been replaced, probably during the early 20th century. There is a fireplace in the east elevation; this has been rebuilt during the early 20th century using bricks (Plate 6). To the south of the fireplace is a small cupboard with two single panelled doors. Fittings in the room comprise tall skirting boards, a picture rail and a deep cavetto cornice. The ceiling is stepped, and lower at the north end reflecting the position of the first-floor stairs to the loft.

Plate 5: The doorway from the entrance hall to room 1, looking south. (1m scale)

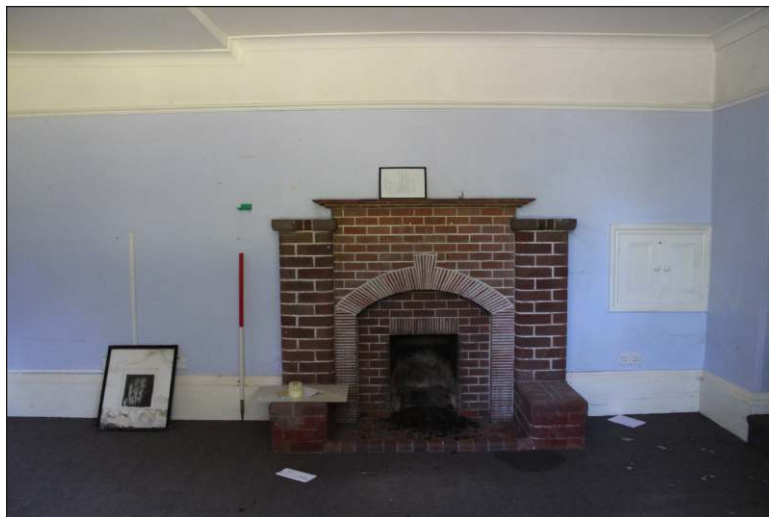
Plate 6: The fireplace and cupboard in room 1, looking east. (1m scale)

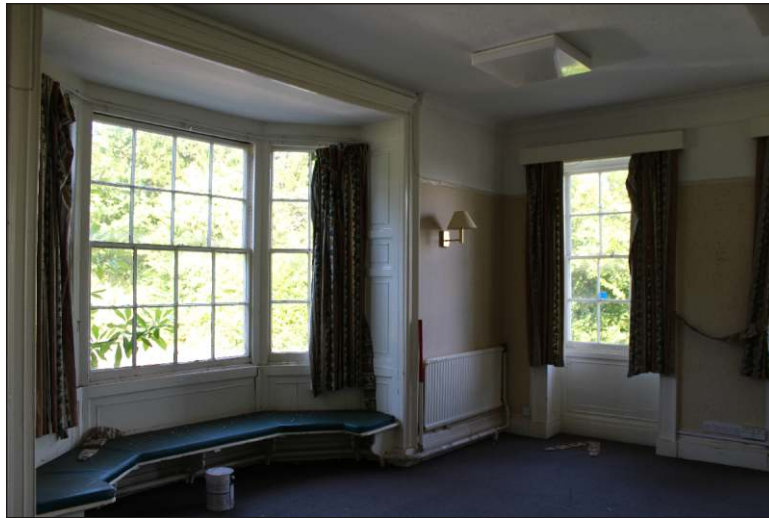
- 5.5** *Room 2* is located in the northwest corner of the house. It is lit by a central walk-in window fitted with 16- and 8-pane sashes in the west elevation and two 12-pane sash windows within near full height reveals in the north elevation (Plate 7). All reveals are panelled and the walk-in window is fitted with a low seat. There was formerly a fireplace in the east elevation that has been fully blocked; evidence for the fireplace consists of a brass vent. Other fittings are a cornice and skirting boards that are lower than in room 1.

Plate 7: General view of room 2 showing the windows, looking northwest. (1m scale)

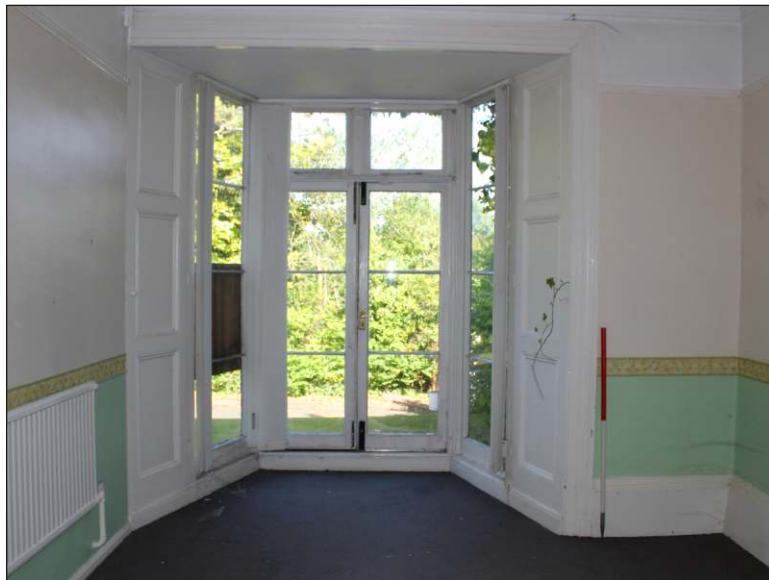
- 5.6** The *rear corridor* is L-shaped and gives access to rooms 3 and 4, a kitchen and a WC. *Room 3* is located in the northeast corner of the house, and represents the mid 19th-century addition depicted on the 1889 Ordnance Survey map. During the later 20th-century the room has been subdivided to create a lobby and a WC (*WC2*). Despite the subdivision the full extent of the room retains its original tall, skirting boards and cornice; the picture rail is a modern addition, as is the cornice on the partition wall to of the toilet. It is entered by a 6-panel door set within a square-headed panelled opening in the south wall, and in the north elevation is a wide bay window with central French doors (Plate 8). This opening retains its original panelled shutters to the reveals, but the doors and windows themselves have been replaced, and if originally present (which seems likely given the depth of the cornice crossing the opening) any panelling to the top of the window has been removed. The window to the WC is a 20th-century insertion. Within the WC there is an arched recess with a beaded moulding. This has been created within a void between the originally external projecting chimney stack and the north wall of the mid 19th-century extension. There is no currently no fireplace within the room. However, externally there is a brick back a stack integral to the east elevation, and within the room a length of skirting board has been laid over the former hearth opening.

Plate 8: Room 3 showing the bay window, looking north. (1m scale)

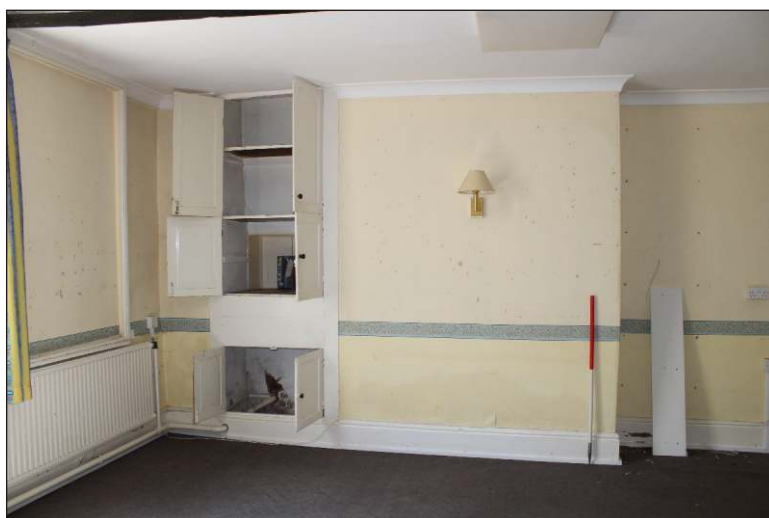
south elevation. There is currently no clear evidence for a fireplace. There are projecting stacks in the east and west elevations but no evidence for blocked openings. Three cupboards with panelled doors are set into west wall, south of the chimney stack (Plate 9); a modern high-level cupboard has been added to the recesses north of the stack in the east wall. Other fixtures comprise a low skirting board, which survives throughout much of the room, and a cornice. Two partially exposed beams support the ceiling and in the north wall two partially chamfered piers are set into the wall below these timbers; there are no corresponding piers on the south wall.

Plate 9: Room 4 showing rear of chimney stack and adjacent cupboard, looking west. (1m scale)

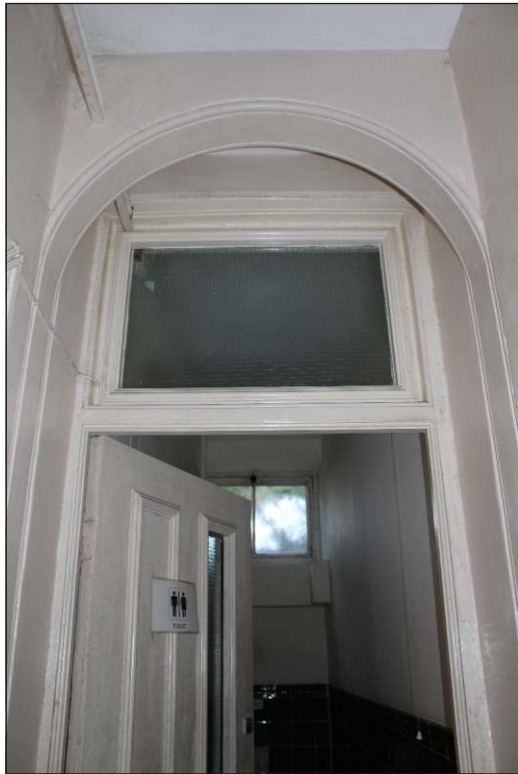
- 5.8** The spaces between rooms 3 and 4 have been extensively reordered. The present *WC1* was originally a passage and retains its primary skirting board. All other fixtures and finishes date to the later 20th century. It is lit by a small high-level window that has been set within an earlier doorway opening. The internal doorway is set beyond an original arch and has a glazed light above (Plate 10); the four-panel door has been reused with one panel converted to safety glass. The kitchen and southeast part of the corridor appear to have originally formed part of an original larger rear, service room, with the present corridor created through the south part of the space. The west partition wall of the kitchen is original and retains its skirting board, along with a six-panel door into the kitchen. The skirting board also survives on the west side of the adjacent corridor. In the kitchen the window is a 20th-century replacement, and a suspended ceiling has been added below the original ceiling.

Plate 10: Arched opening in corridor to WC1, looking east

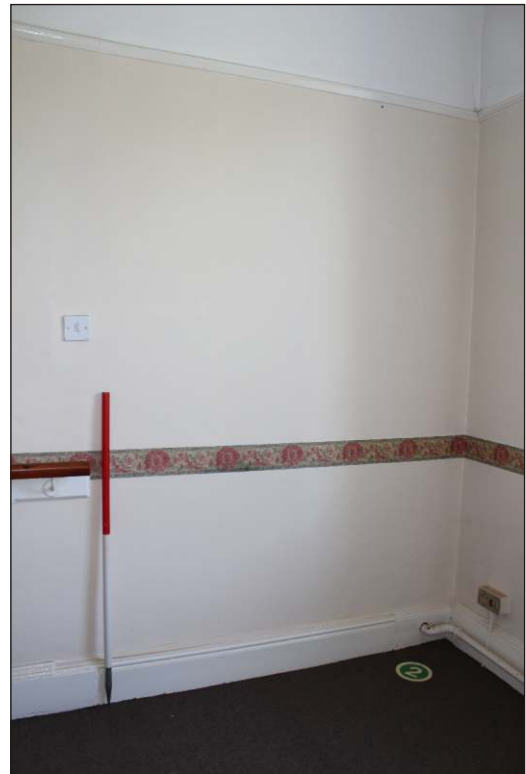
- 5.9** The first floor is entered from a half-landing; the stairs continue up to an open landing (*Room 9a*) over the front of the entrance hall. The balustrade to the stairs forms the south side of this space. It is lit by a tall 12-pane sash window set within a panelled reveal. The area has a moulded skirting board, picture rail, and a curved cornice. The skirting board on the north wall is a replacement and lower than the earlier fitting, whilst on the south wall there is evidence of a blocked doorway with an added section of skirting board (Plate 11).

Plate 11: Landing 9a showing blocked doorway in south wall, looking southwest. (1m scale)

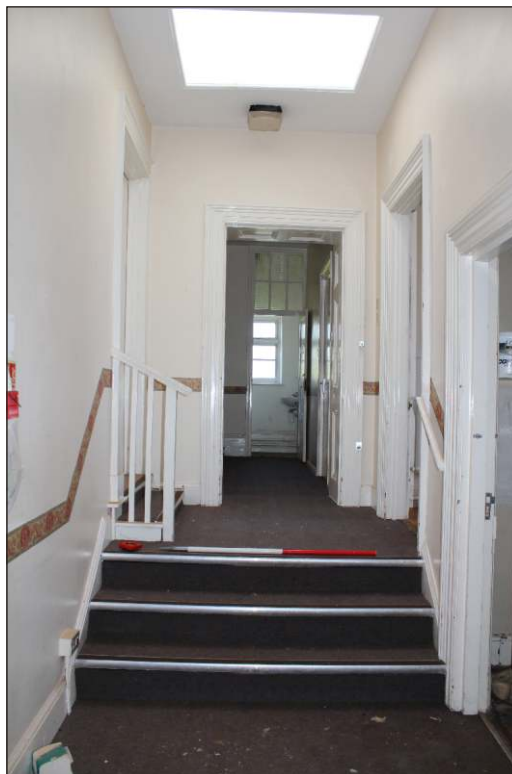
- 5.10** From the half landing *corridor 3* extends north-south through the centre of the house, and opens out into *corridor 4* at the rear of the property. Within the corridor steps lead up to the rooms on the north side of the house, which reflects the higher ceiling level of the rooms on the floor below (Plate 12). The corridor retains its skirting boards, and is lit at its south end by a small modern skylight.

Plate 12: Corridor 3 showing steps and doorway architraves, looking north. (1m scale)

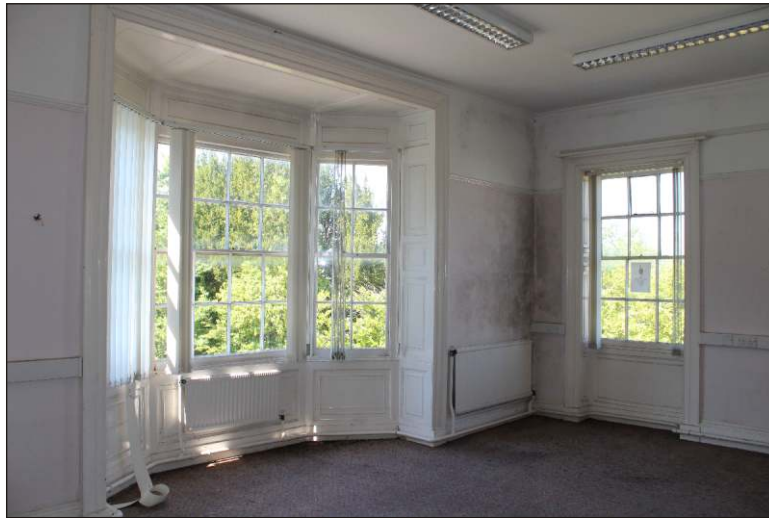
- 5.11** At the northwest end of the building is *room 5*, which is entered by two steps up from the corridor. As with room 2 directly below, it is lit by a walk-in bay window with 12- and 8-pane sashes in the west elevation and two tall, 12-pane sash windows in near full-height reveals in the north elevation (Plate 13). A fireplace in the east elevation has been blocked and skirting board added over the former opening. Fittings in the room comprise skirting boards, a picture rail and a shallow moulded cornice. In the south wall is a blocked doorway, with a section of inserted skirting board. Adjacent to this opening, a section of the skirting board has also been replaced.

Plate 13: General view of room 5 showing the windows, looking northwest. (1m scale)

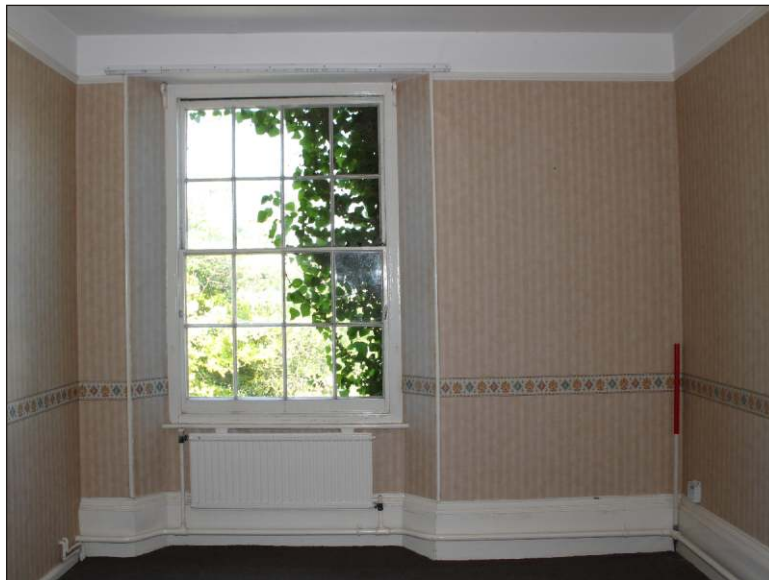
- 5.12** *Room 6* is located in the northeast corner of house and forms part of the mid 19th-century extension. As with room 3 directly below the space has been subdivided to create a corridor and WC. Despite the alteration the spaces retain a tall skirting board, and in the main room a picture rail. The original room was lit by a walk-in window fitted with a 16-pane sash (Plate 14), whilst a small, high-level window has been added to light the WC. A fireplace in the east wall has been infilled and a length of skirting board fitted over the former opening. In the corridor there are two steps up to a blocked opening in the partition wall with room 5. The skirting board on the south side of this opening has been altered, and the opening appears to have been partially infilled.

Plate 14: Room 6 showing walk-in window, looking north. (1m scale)

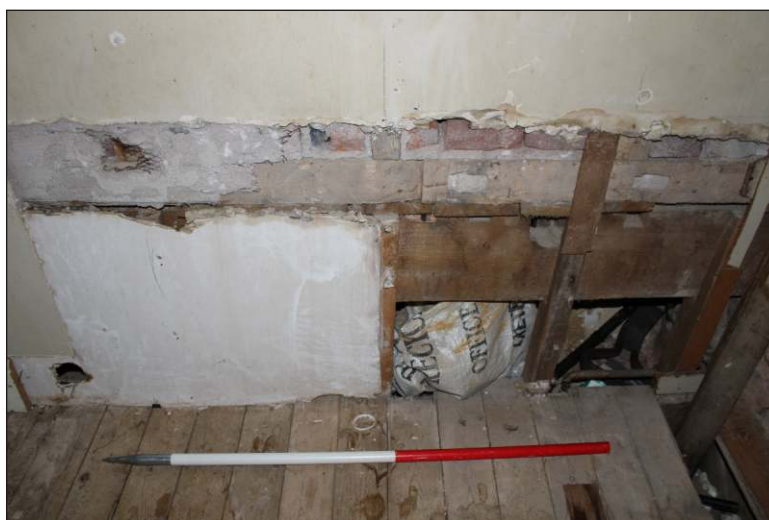
- 5.13** To the south of room 6 is a series of three small rooms set towards the rear of the house. The *kitchen* is an original narrow room lit by a tall and wide (for the space) 16-pane sash window set within a splayed opening. Fittings comprise a low skirting board and a 'dado' rail; the door is a modern UPVC 6-panel fire door replicating a historic fitting. *Room 7* has been partially stripped allowing elements of the building's construction to be identified. The partition with the kitchen is a timber frame with brick infill (Plate 15); a low skirting board partially survives on this wall, as well as on the other walls. The frame includes tall beams displaying mortices of the joists and the floorboards of the kitchen. The narrow wooden floorboards of room 7 are also exposed. The doorway is fitted with 20th-century wooden door, and the room is lit by a small high-level six-pane fixed window. To the south is WC3. The present door is a modern opening from corridor 4; an opening in the west wall has been blocked, but retains its moulded frame internally and a 6-panel door. The window in the east wall is a 20th-century insertion. The room contains no other historic fixtures and fittings. The ceilings of both room 7 and WC3 are stepped and lower towards the east reflecting the position of inserted WC4 on the second floor.

Plate 15: Room 7 showing construction of partition with kitchen, looking north. (1m scale)

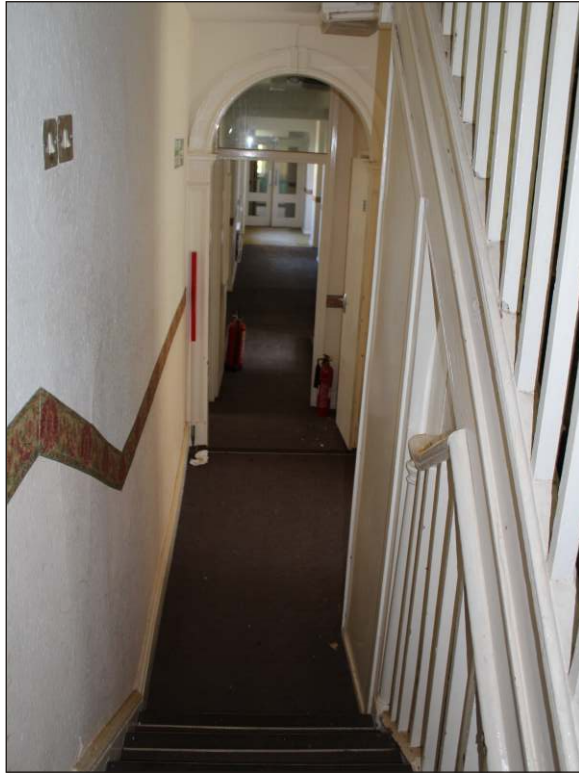
- 5.14** The south end of corridor 3 terminates in a small lobby in the centre of *corridor 4* that runs east-west through the house. The western half of the corridor gives access to room 9 through a six-panel door set in a moulded architrave as well as a staircase to the second floor. It is lit by an 8-pane sash window that has been set within the bay window of room 9; the partition wall between the rooms terminates within the window opening. The partition wall has a plainer skirting board than the corridor. The staircase has slender stick balusters, ramped handrail and turned newel posts, and below this is a narrow cupboard fitted with a modern door (Plate 16). The eastern half of the corridor gives access to room 8 and to the later 20th-century extension beyond. All fittings here date to the later 20th century.

Plate 16: Corridor 4 and stairs to second floor, looking east. (1m scale)

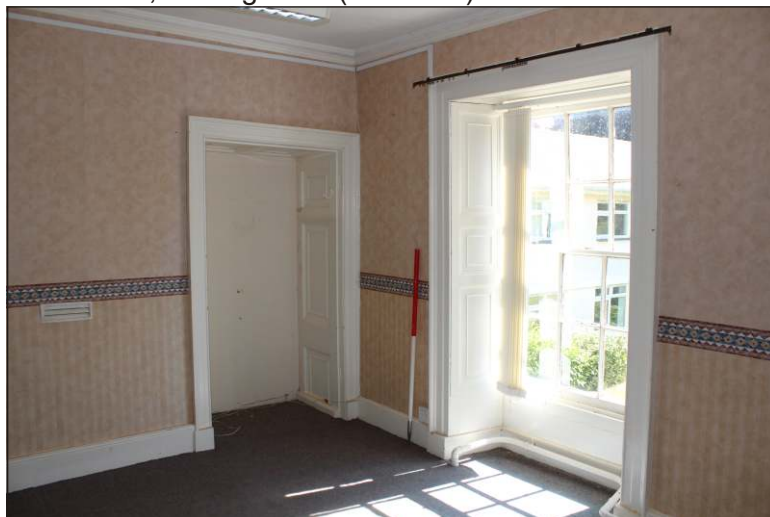
- 5.15** *Room 9* is situated at the southwest corner of the house, and is lit by a 12-pane sash window in the south elevation set within a walk-in recess with panelled reveals containing panelled shutters (Plate 17). Originally, like room 5, the room was also lit by a bay window in the west elevation. This has been blocked internally with the window now providing light to an internal secondary window to corridor 4. At the south end of the east wall is a blocked doorway into room 8, which has panelled reveals. Adjacent to the opening is a mid-level vent indicating the position of a blocked fireplace. Other fixtures and fittings comprise the skirting boards and cornice.

Plate 17: Room 9 showing south window and blocked doorway to room 8, looking southeast. (1m scale)

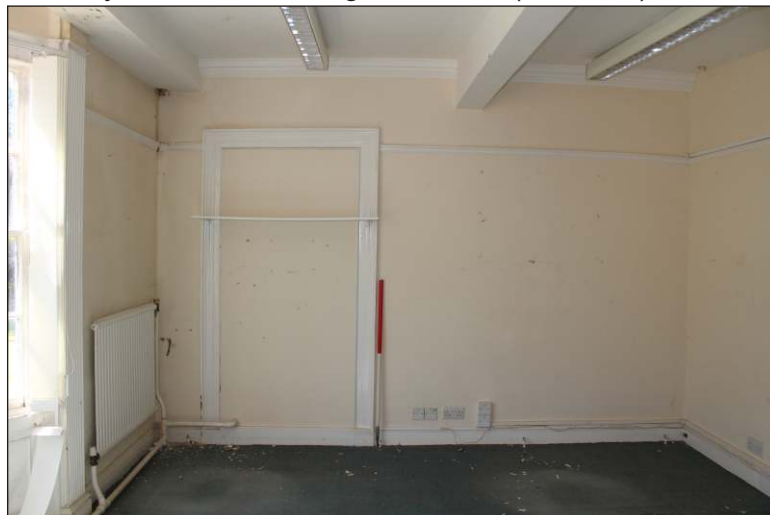
- 5.16** *Room 8* is located in the southeast corner of the house, and has been heavily modified. It was originally slightly wider, extending into what is now corridor 4; the line of the north wall is marked by a beam in the ceiling of the corridor. Additionally, the cornice is truncated by the present north wall, but the section on the west wall continues into the adjacent cupboard and returns slightly to the north. The room is currently entered via a door in the 20th-century north wall; the blocked door into room 9 has been noted above (Plate 18). The south wall is very narrow and appears to have been rebuilt, with the full width of the original wall marked by an adjacent beam; there is a second beam in the central of the room. The room is lit by a walk-in bay window in the south elevation containing a central pair of 8-pane sash windows, and flanked by 8-pane sash windows. The original ceiling is exposed behind a plasterboard covering. Other fittings comprise skirting boards, which are 20th-century replacements, and a picture rail.

Plate 18: Room 8 showing blocked doorway to room 9, looking north. (1m scale)

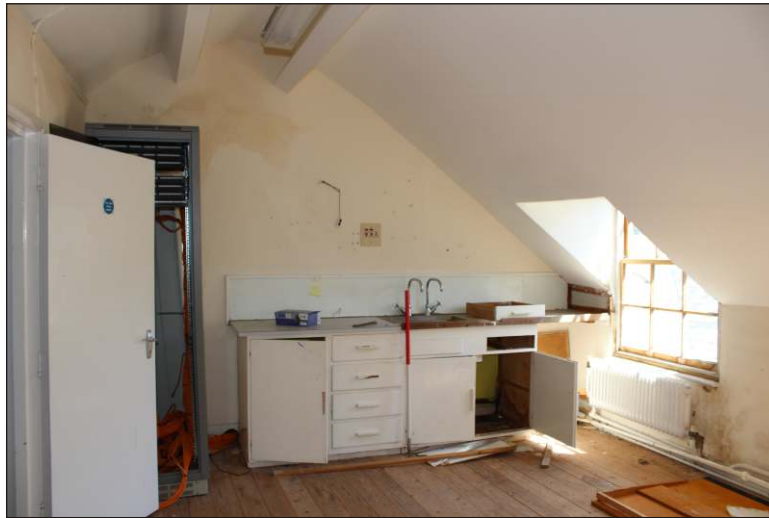
- 5.18** *Room 10* (Plate 19) is situated in the southeast corner of the house and lit by two modern sash windows set within dormers. The door from the corridor is 20th-century and set within a larger double-door width opening. The room has been heavily modernised, but retains its original skirting boards and a simple cornice on the north wall.

- 5.24** The south roof is almost entirely obscured by plaster ceilings. However, two possible trusses are visible as cracks in the plaster of room 11, and in room 10 there is a pair of high-level purlins just below the apex (Plate 19). These are very deep, and may be of later 20th-century date. It seems likely that the south pitch within this room was rebuilt when alterations were made to this part of the building (see 5.16 and 5.18 above). Again, due to the provision of

Plate 19: Room 10, general view showing purlins, looking east. (1m scale)

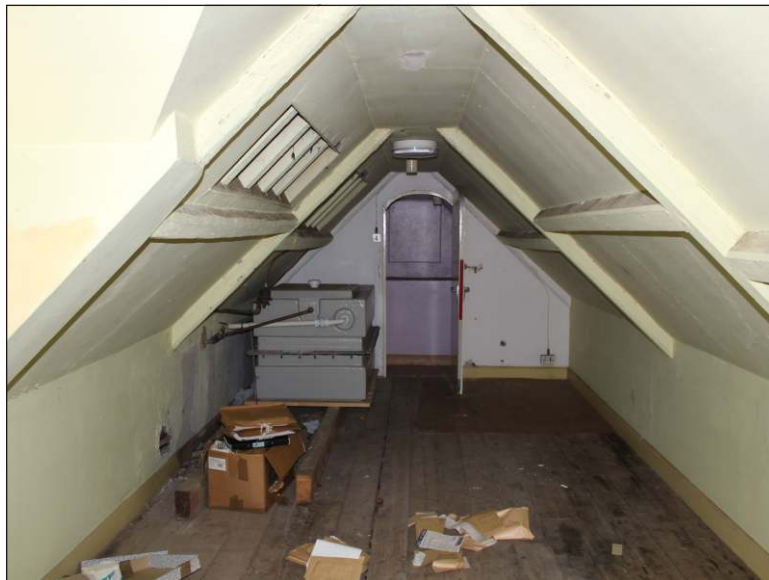
- 5.20** *Room 12* is located in the northwest corner of the house entered via semi-circular headed opening; the door is a 20th-century replacement (Plate 20). There is a dormer in the east wall incorporated into a chimney stack with small 20th-century windows set into its north and south sides. To the north is a small cupboard giving access to the roofspace. The room retains its original wooden floorboards and skirting boards.

Plate 20: Room 12, general view showing roof construction, looking south. (1m scale)

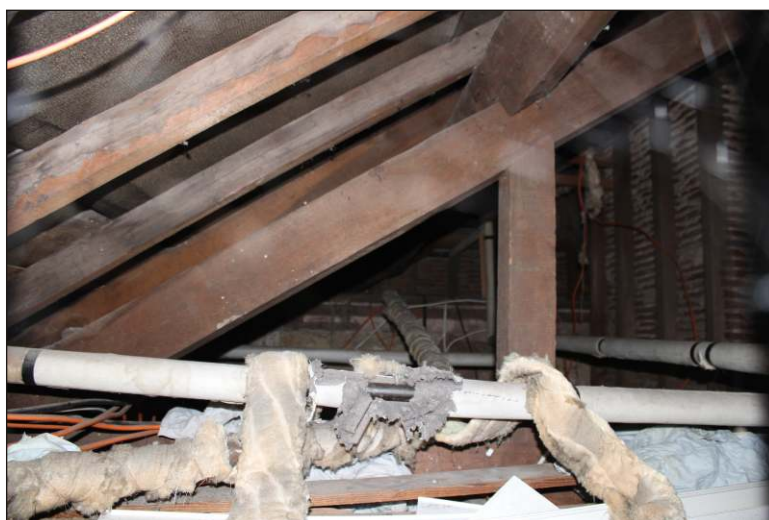
accommodation there are no collars or tie beams within this roof. The roof to the north is not accessible, but is partially visible through a small hatch in the west wall of WC4. A single tie-beam truss is visible with a supporting vertical strut and trenched purlins supporting closely-set secondary rafters, again backed by felt (Plate 21). Beyond a timber-framed lath and plaster lightwell for a skylight above corridor 3 is visible, as is the timber-framed lath and plaster east wall of room 12.

Plate 21: The rear central roof viewed from a hatch in WC4, looking south

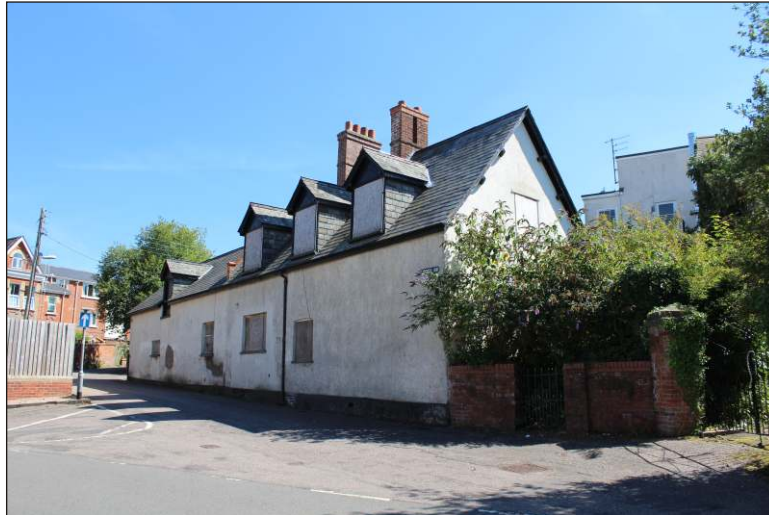
- 5.26** To the northeast of the house, set back from the line of its historic rear elevation, is a two-storey service building (Plates 22-23). This is aligned onto and abuts Lodge Road. The exterior walls are largely covered with plaster, but some cob is visible and brick was utilised in the gables. The building is two storied with a higher first floor in the western half; a brick partition wall divides these two levels. On the Lodge Road elevation there are four ground-floor windows of varying sizes, three dormer windows in the west end of the building and a first-floor loading door towards the east end. In the east elevation there is a modern garage, which is set within a larger, partially infilled opening. In the south elevation there are two doors and a window within the eastern part of the building; one door has a glazed light above whilst the other contains a panel above perhaps covering a former light. In the west end of the building there are three doors and a window. In the west elevation is a first-floor window. With the exception of the eastern door, all of the doors and windows are mid-late 20th-century replacements.

Plate 22: The north elevation of the outbuilding, also showing the gates into the property, looking southeast

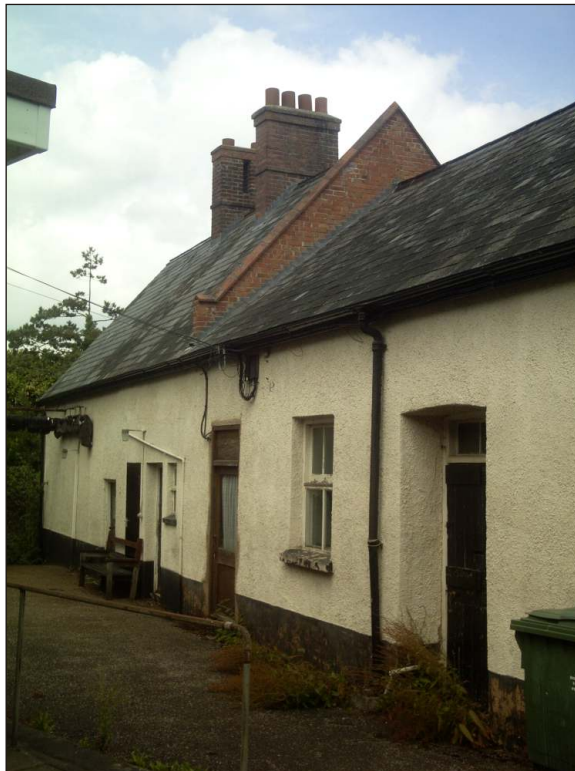
Plate 23: The south elevation of the outbuilding, looking northwest

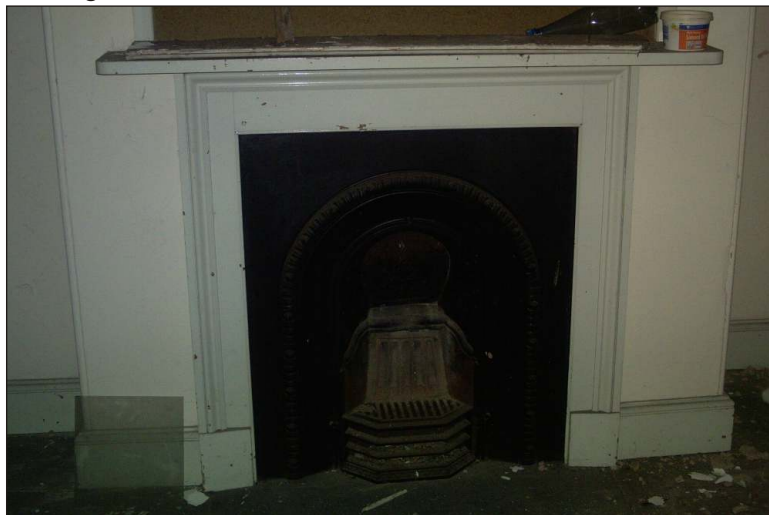
- 5.28** On the first floor of the cottage, 19th-century cast-iron fireplaces survive set within wooden surrounds (Plate 24), along with some panelling, skirting boards, as well as cupboards with plain panelled doors in the west elevation and over the stairs. The roof structure is obscured by the original plaster finish. However, this has been laid above two rows of purlins that are exposed on the first floor. These are also visible externally (with curved ends) where a diagonally-set ridge purlin is also exposed. Two brick chimney stacks rise high above the roof. The western stack has two flues each topped with a single pot, and served the western rooms of the cottage, whilst the eastern stack is topped with four pots and served two rooms on each floors.

Plate 24: A first-floor fireplace in the outbuilding, looking southeast
