CARY CASTLE, TORQUAY, TORBAY, DEVON

Architectural Assessment

Torbay Council planning refs: P/2016/1265 & P/2016/1304/LB

Document No: ACD1530/1/0

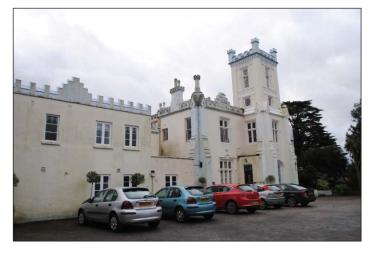
- 5.4 The northwest front of the east courtyard wing is two storeyed with one rectangular and four square casement windows arranged asymmetrically (see Plate 1). The parapet is crenelated with a central crow-stepped gable to match the main house (concealing a flat roof). On the west side, closest to the main house, is a single storey extension with a flat roof, behind which the first floor of an earlier phase of building is revealed (Plate 7); this has rendered brick crenelations above a deep projecting band, below which is a square casement window in a modern opening. To the west of the window is a projecting small possible flue or chimney stack although there was no internal indication of this and it would be at a peculiar height.

Plate 1: The house viewed from the approach along the drive, looking west

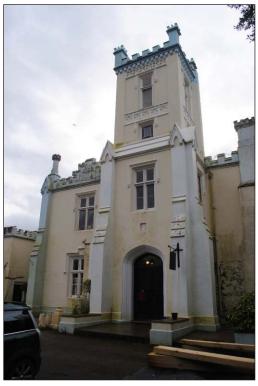
- 5.2 The main house is entered through a central tower that has a double door set in a pointed arch with deep ovolo moulding (Plate 2). There are angle buttresses topped by miniature gables and a chimney stack-like finial on each corner of the main house. The windows are of variable size, but usually of 2 or 3-lights (for the larger ones) with taller windows having thin glazing bars, generally square of mullion and transom type with lower sashes and fixed upper panes. They are ornamented by a drip mould which on the upper levels are finished with headstops (Plate 3). The ground-floor window to the east of the entrance has a cross in shield design above and simple protruding stops (Plate 4). Cracks beneath this window indicate that it has been modified and was originally deeper to ground level matching those existing on the southeast and southwest elevations (see below). The parapet is crenelated and on the east side has a central crow-stepped gable, incorporating a blank plague. On the west side a tall plain projecting chimney stack largely fills the space; it is topped by a corbelled projection and small crenelations. Beneath the stack is an external stairwell providing access to the basement. The west ground floor window of the tower is stained glass with the corresponding window in the east side blocked during the construction of a modern single-storey flat-roofed porch (Plate 5), which provides access through an eight-panelled wooden door with three lights above to stairs which formerly served two self-contained apartments on the first floor of the main house (it is proposed that this unsightly addition will be removed during the current works). The tower has angle buttresses on each external corner matching those on the main house. At the top it is decorated with blind quatrefoil banding below corbels supporting protruding crenelations with small crenelated tower finials in each corner.

Plate 2: The northwest side of the house showing the main entrance, looking south. (1m scale)

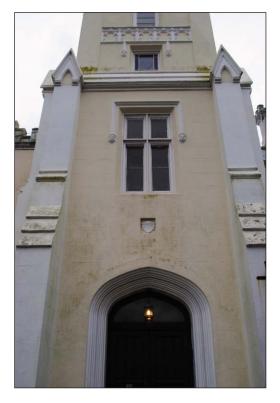
Plate 3: The northwest elevation showing the second-floor tower window and scallop shell in niche above the main entrance to the house

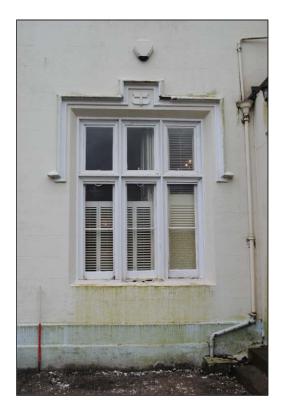
Plate 4: The ground floor window with a cross in shield design above and simple protruding stops to the drip mould with vertical cracks indicating the former larger opening, looking southeast. (1m scale)

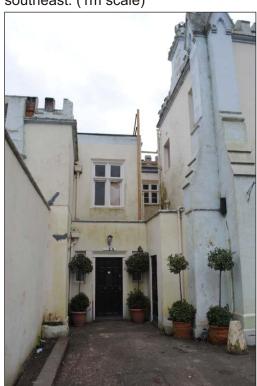
Plate 6: The central area of the northwest side showing the modern additions between the main house (right) and the east courtyard wing (left), looking southeast. (1m scale)

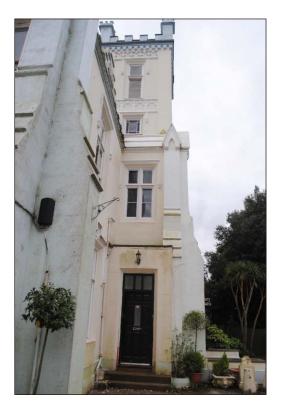
5.11 The modern porch (13) and stairwell (15) with wooden stairs formerly provided access to self-contained apartments on the first floor. The upper floor has been reinstated and the stairs are now defunct. In the west wall of the modern porch a recess matching the blocked window in the ground floor of the tower porch of the main house is present.

Plate 5: Modern porch added to east side of entrance tower and formerly providing stair access to first-floor apartments, looking west. (1m scale)

- **8.3** The proposed reconfiguration of the building involves no new extensions. The footprint will remain unchanged except for the demolition of the modern porch on the east side of the tower; this will have the benefit of restoring the original footprint to this elevation. In addition, it is proposed to reinstate the blocked window with stained glass matching that on the west side of the tower.

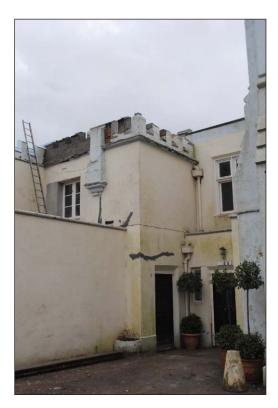
Plate 7: The northwest first floor of the east courtyard wing showing an early extension to the original building, looking southeast.

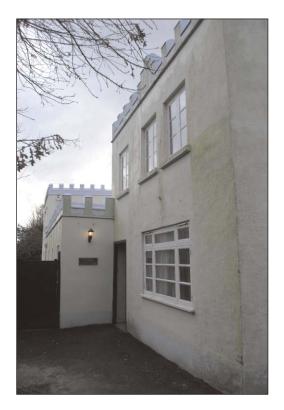
Plate 8: The northeast elevation of the east courtyard wing showing ground floor window in blocked arched opening and entrance to courtyard beyond, looking southwest. (1m scale)

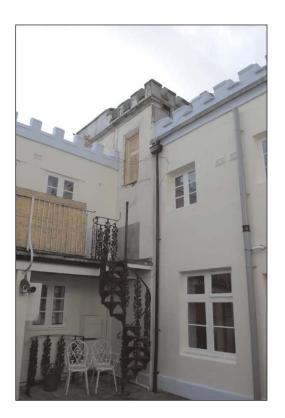
heavy crenelation above a deep projecting moulded band, a boarded first-floor window and two plinths at ground level (Plate 9).

Plate 9: East courtyard wing showing primary work in southwest corner beyond the black drain pipe, looking southwest

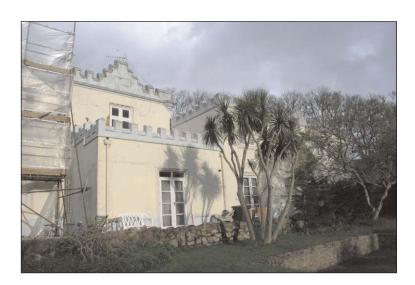
Plate 10: The southeast elevation with primary work with crow step gable visible above the single storey extension, looking northeast

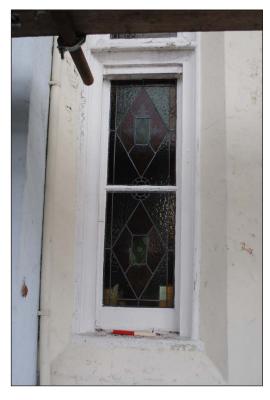
- 5.7 The southeast side of the main house was covered in enclosed scaffolding on the occasion of the site visit. This elevation is two storeyed and although continuing the style of the northwest elevation is of two distinct builds. To the west of the single storey extension the central area, which may have formed the service wing of the primary building, is set back from the line of the main house. It is of much slighter construction compared to the primary building and this section of wall is later than the original house and in the location of a demolished projection to the south (see section 4.13). Further support of this is the presence of an air brick within the bottom plinth (original vents are of metalwork). Its fenestration is different to that of the main house with windows arranged symmetrically with narrow single light tall windows on each storey flanking a pair of rectangular windows on the first floor and on the ground floor the easternmost of these is a French window. On the ground floor the westernmost tall window is filled with stained glass matching in design that within the entrance porch (Plate 11).

Plate 11: Stained glass window in the southeast elevation. (0.2m scale)

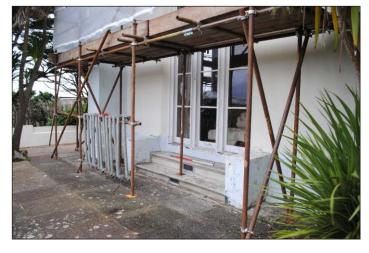
Plate 12: Westernmost window to the principal rooms in the southeast elevation, looking north. (1m scale)

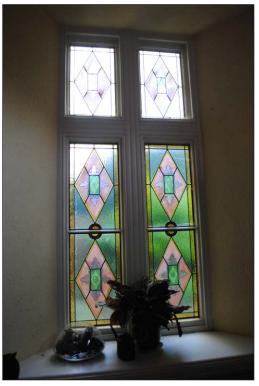
5.12 The lobby (1) has a wooden parquet floor, tall skirting board, dado rail and false ceiling. It is lit in the west wall by a stained glass window (Plate 13). The lobby opens to the hall (2) through late 20th century doors in a glazed partition inserted within a pointed arch. To the south is a modern lower arch which cuts the cornice formed of rose detail topped by crenelations. A second pointed arch has ovolo mouldings, beyond which is a false ceiling and inserted cupboard (5), which in part blocks the location of the original staircase, removed by a previous owner after listing in 1975. The flooring in the hall and principal rooms is wooden floorboards throughout. Original doorways off the hall have wide moulded architraves and panelled reveals. The doors are 9-panel with chunky 19th century hinges (Plate 14).

Plate 13: Stained glass window in the west wall of the lobby (1)

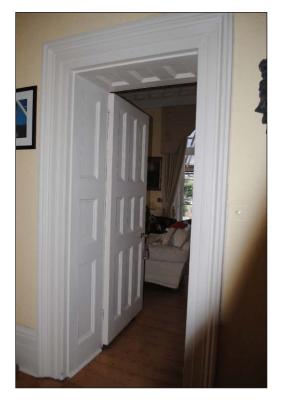
Plate 14: Original internal door between hall (2) and lounge (4)

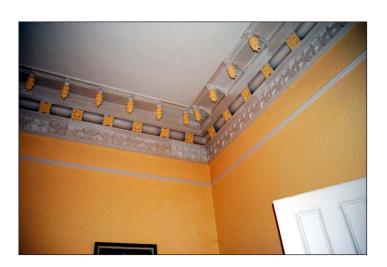
Plate 15: Cornice in dining room (3)

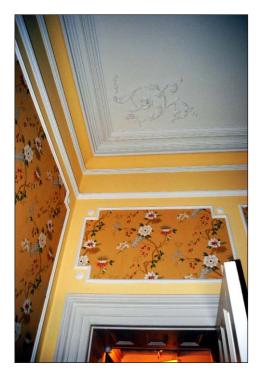
5.14 The southeast reception room (6) is currently a bedroom. It has an oval plaster ceiling with additional floral decoration in the corners and a double moulded cornice and double picture rails. The walls have plaster frames with external roses at the corners (Plate 16). A hearth for a blocked fireplace is present in the east wall. Either side of the fireplace are inserted doors, one to a bathroom (10), lit by a stained glass window and the other to a small lobby (7) providing access to a corridor (9a).

Plate 16: Plasterwork in southeast reception room (6)

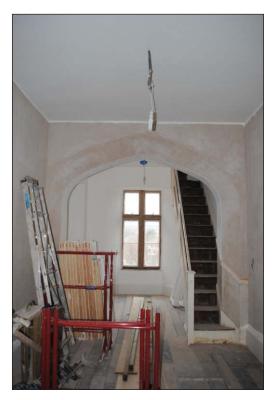
5.18 An open space is now present forming the first floor of the tower (57/58) and opening south through a pointed arch into an upper hall (56/60/61) (Plate 17). The tower room houses functional narrow wooden stairs to the upper storeys of the tower; these have the appearance of 20th-century replacements. A small fireplace with rusticated stone hearth sits uncomfortably in the southeast corner of the hall (56/60/61) adjacent to a modern inserted square arch providing access to the main landing/corridor (62/63/64/67).

Plate 17: First floor hall (56/60/61) and tower room (57/58) with access stairs to upper storeys of tower, looking northwest

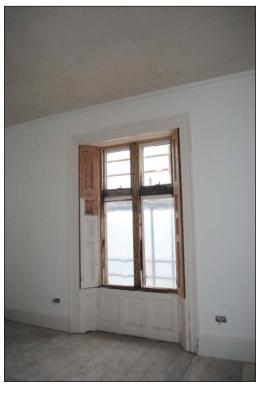
Plate 18: Shuttered and panelled walk in window in the south wall of the first floor southwest room (65/66)

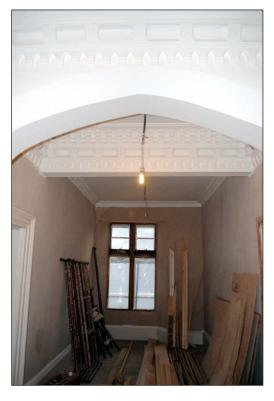
Plate 19: First floor lobby (63) and room (64) viewed from landing (62)

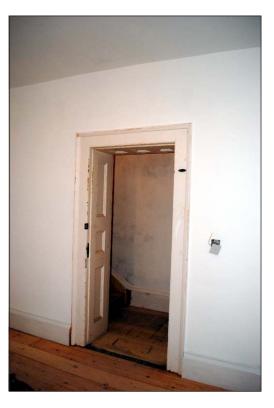
Plate 20: Original doorway in the north wall of room (71), looking northwest

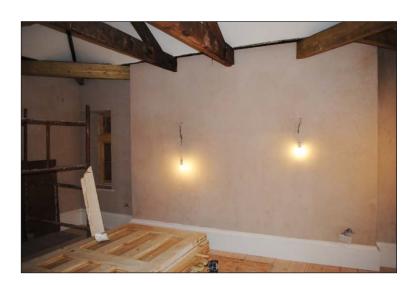
- 5.27 Modern corridor (77) gave access through a (removed) lobby area (78) and modern entrance in old fabric to a collection of rooms in various stages of renovation at the time of the visit. The southernmost room (79/87/88) had a large chimney stack projecting from the east wall, a boarded-up narrow window to its north (Plate 21) and a reduced height walk in window with modern frame and no shutters in the south wall. A probable blocked window in the north wall as shown on the plan was not observed. The flooring is a modern replacement. The roof structure was open and comprised a king post truss with struts fixed using mortice and tenon joints, and supporting back purlins on small rafters. In the west side over a partition wall is a smaller king post roof with struts and back purlins.

Plate 21: East wall of room (79/87/88) on first floor of the east courtyard block west range, showing chimney breast and boarded-up window, looking northeast

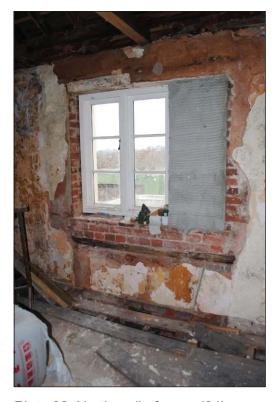
Plate 22: North wall of room (84) on first floor of the east courtyard wing west range, showing modern inserted window and blocked window below, looking northwest.

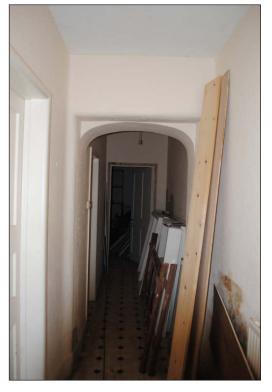
Plate 23: Corridor (35) on ground floor of the east courtyard wing west range, showing the arched insertion through the wall of the primary building, looking southeast

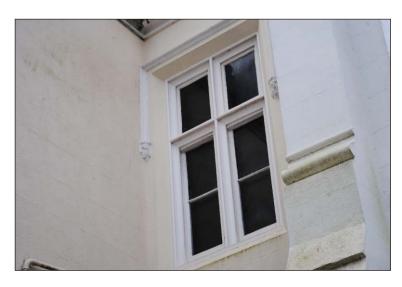
Plate 24: First-floor tower window showing uncomfortable arrangement where the wall junction cuts the dripmould and headstop
